**STRUCTURAL INSPECTION REPORT  
FOR  
THE BOVAIRD DRIVE STRUCTURES  
ENVIRONMENTAL ASSESSMENT**

Submitted to:

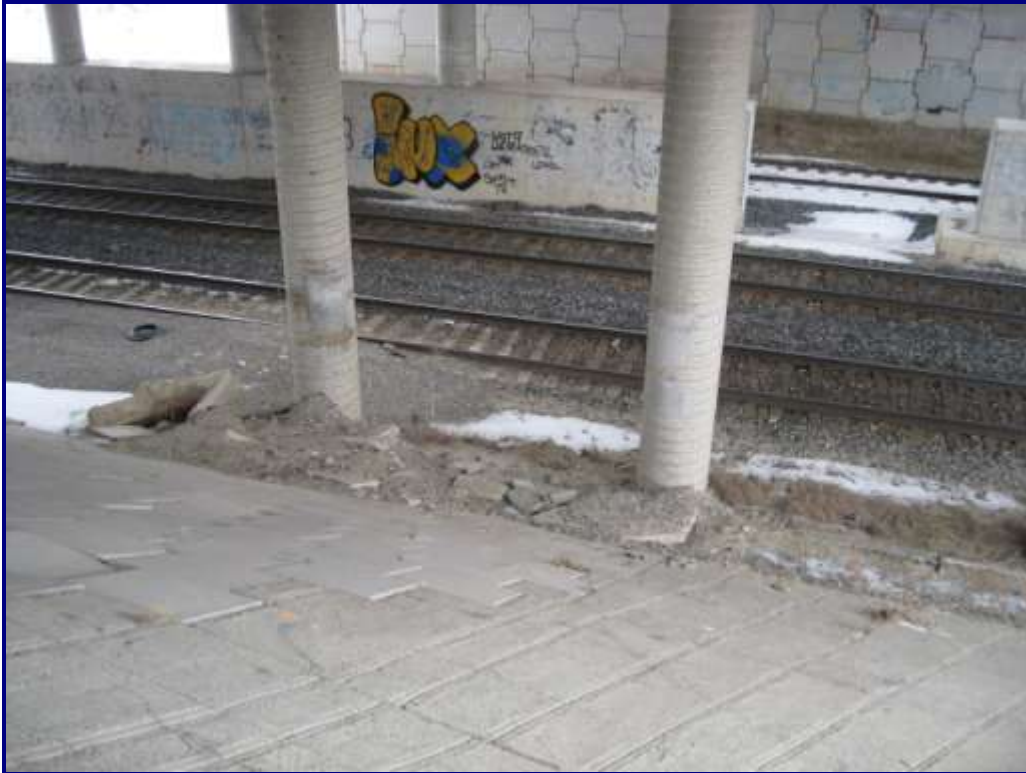
**Photo 6 – Structure No. 2: Two Tracks – Centre Span  
1 Track – West Span Slope Protection Deterioration**

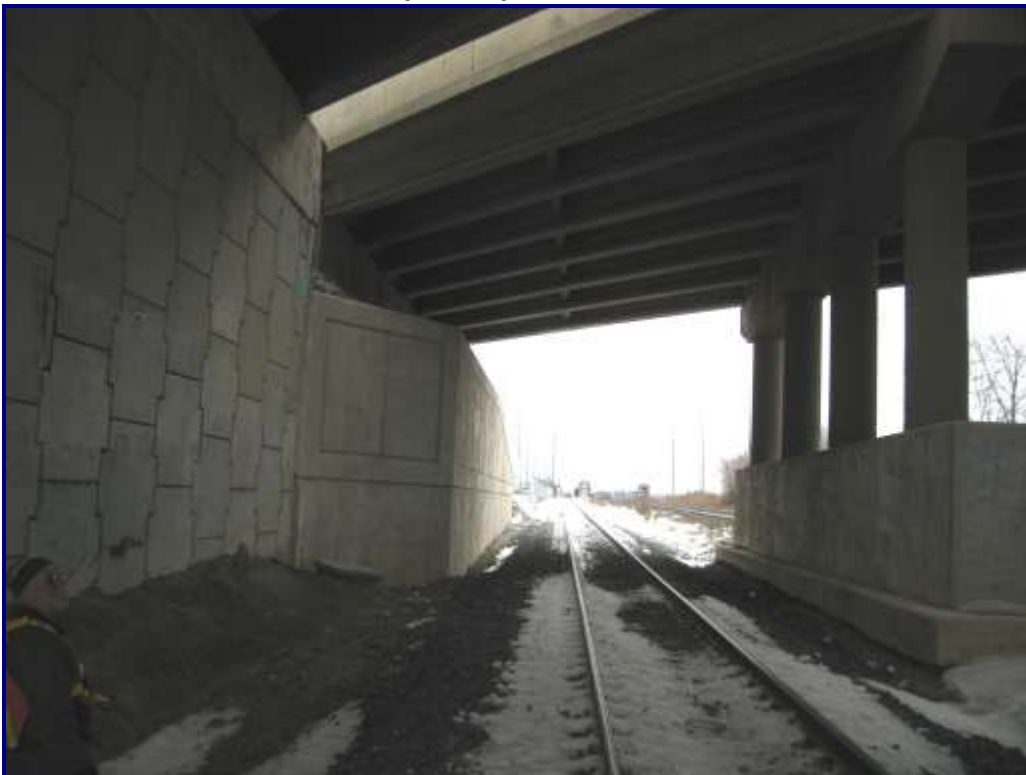
**Photo 7 –Structure No. 2: Lead Track to Gold’s Layover Facility Protection Wall**

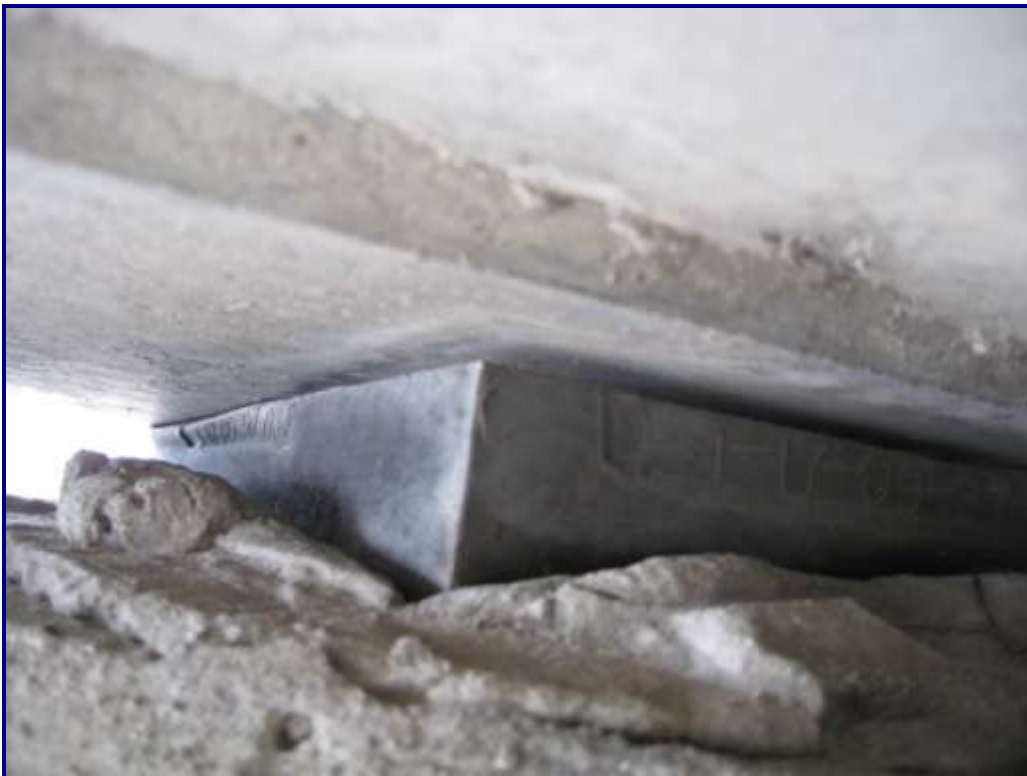
**Photo 9 –Structure No. 2: Light Cracking on Bearings –  
Gap between Girder and T/Bearing Pad**

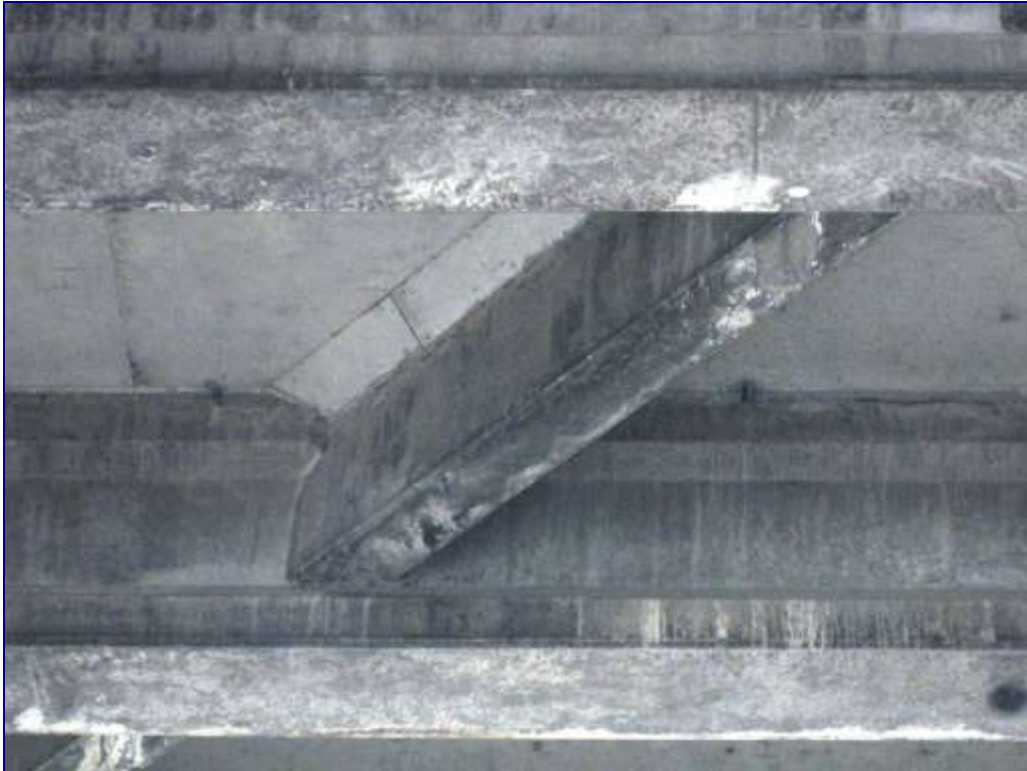
**Photo 10 – Structure No. 2: Deterioration of Diaphragm**

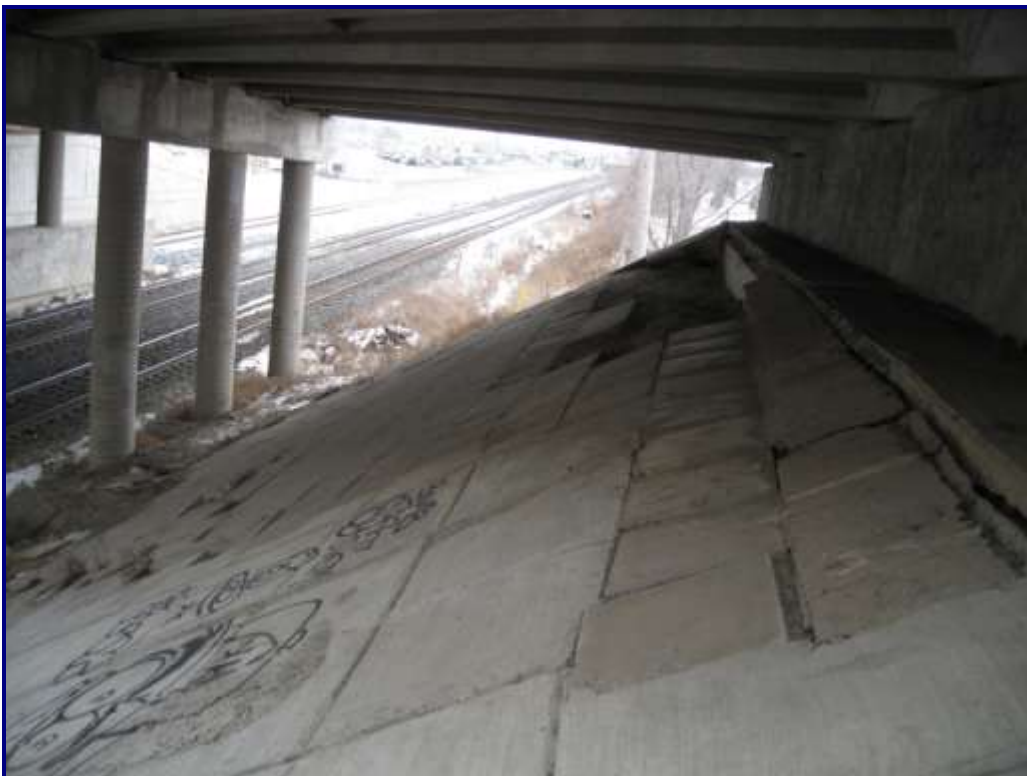
**Photo 11 – Structure No. 2: Slope Protection-Footing Exposed**

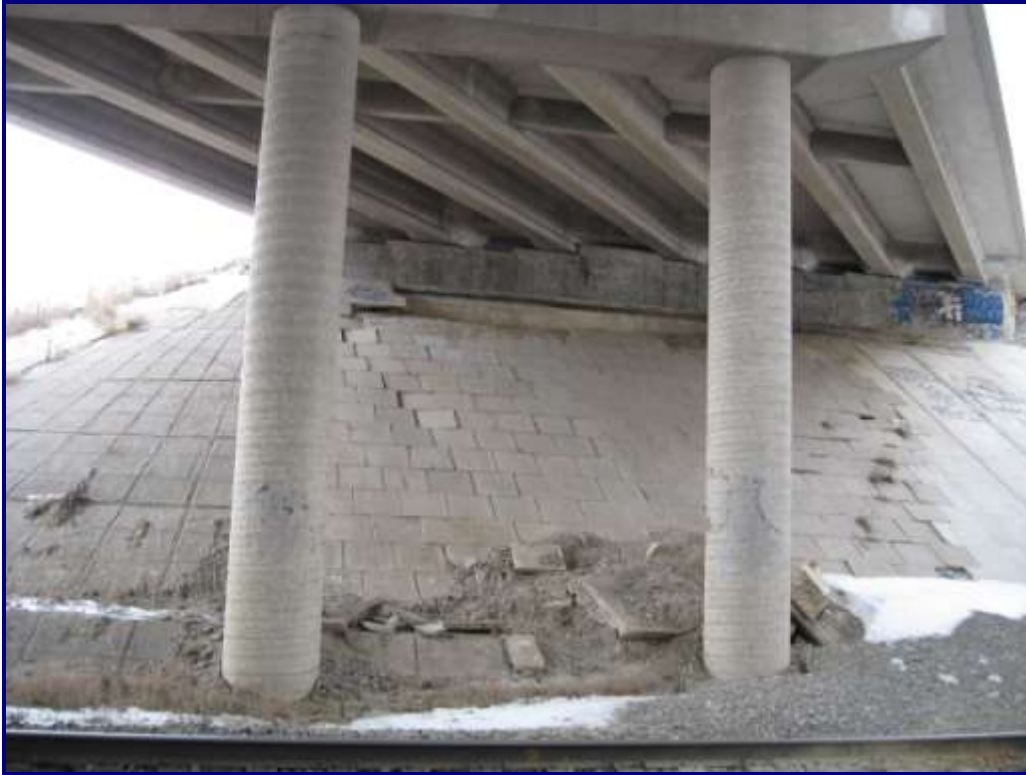
**Photo 12 – Structure No. 2: Protection Deterioration**

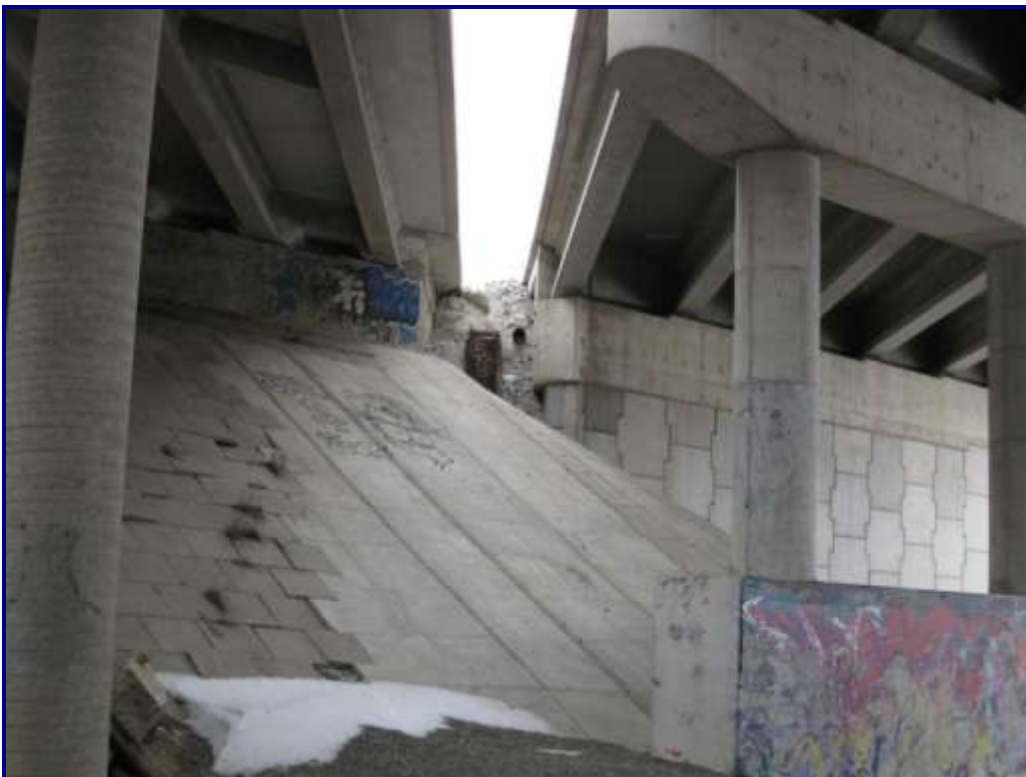
**Photo 13 – Structure No. 2: Slope Protection Deterioration and RSS Wall**

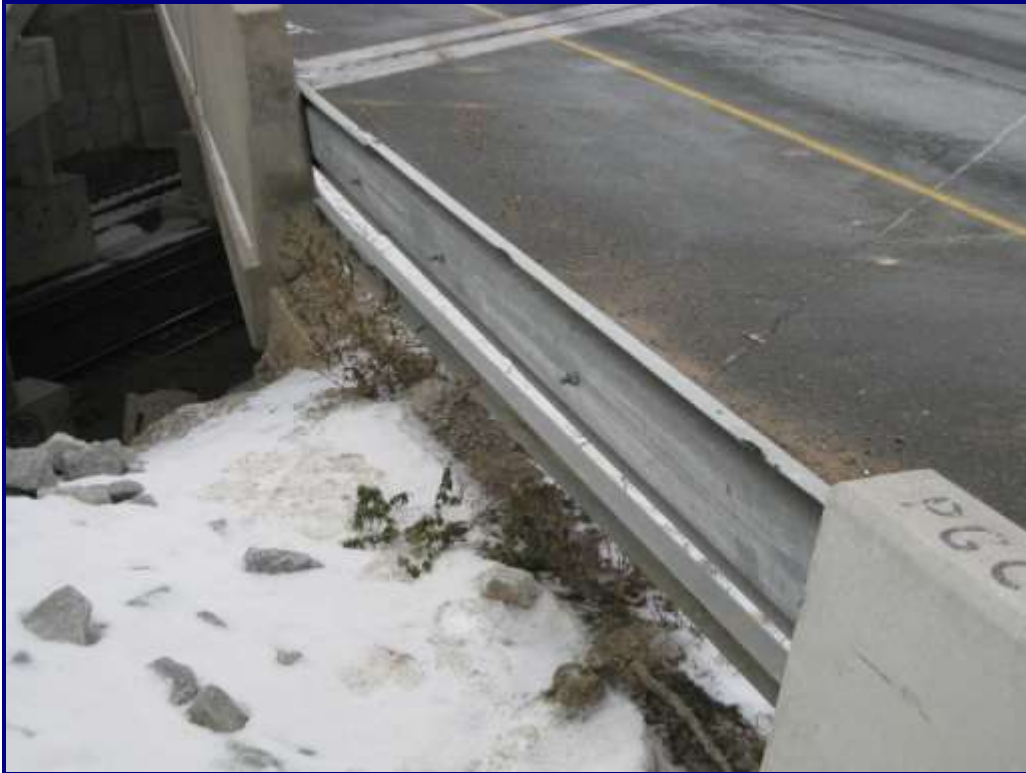
**Photo 14 – Structure No. 2: SBGR Posts Missing**

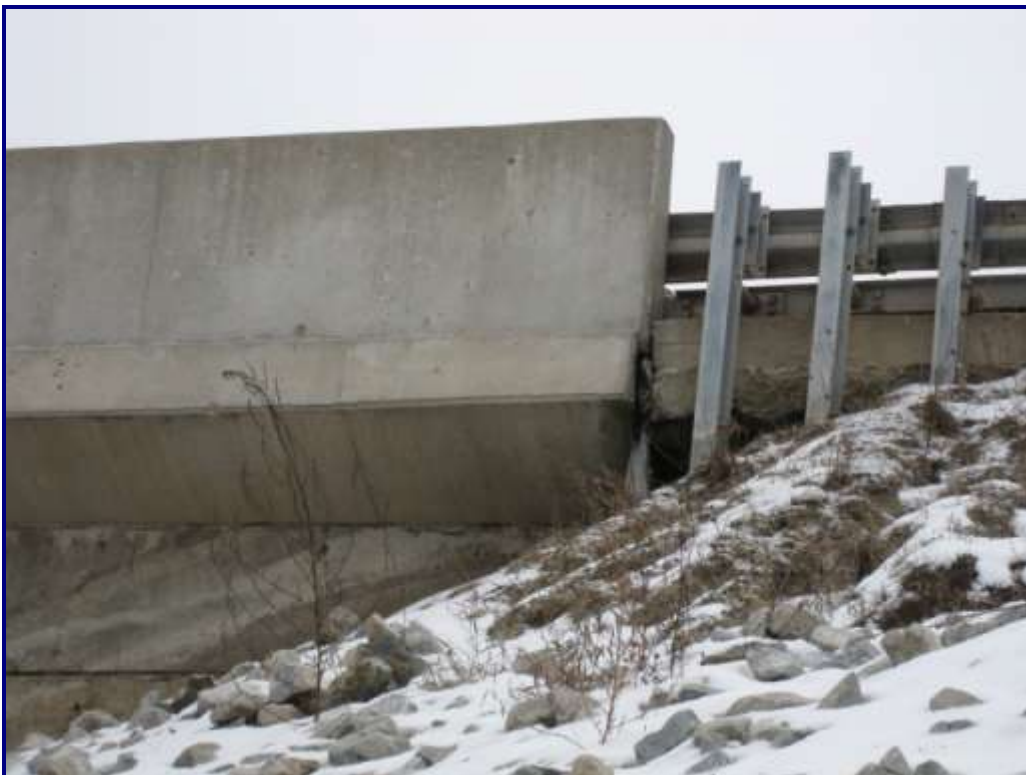
**Photo 15 – Structure No. 2: Erosion at End of West Wingwall – North Side**

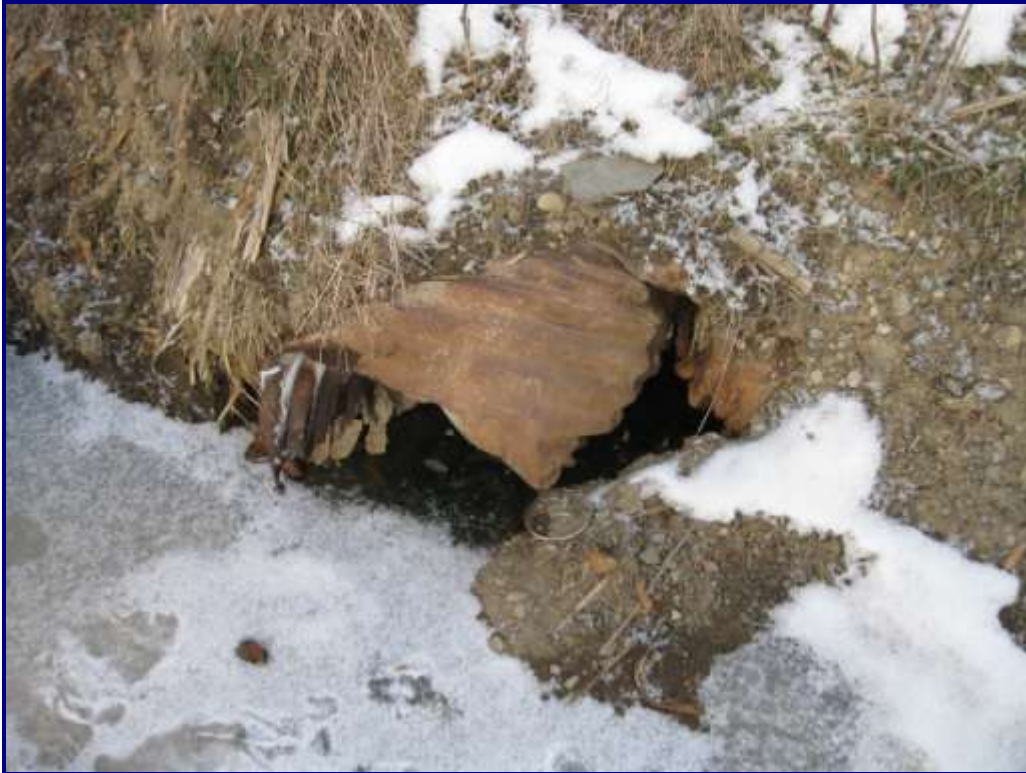
**Photo 29 – Structure No. 7: Damaged Culvert End**

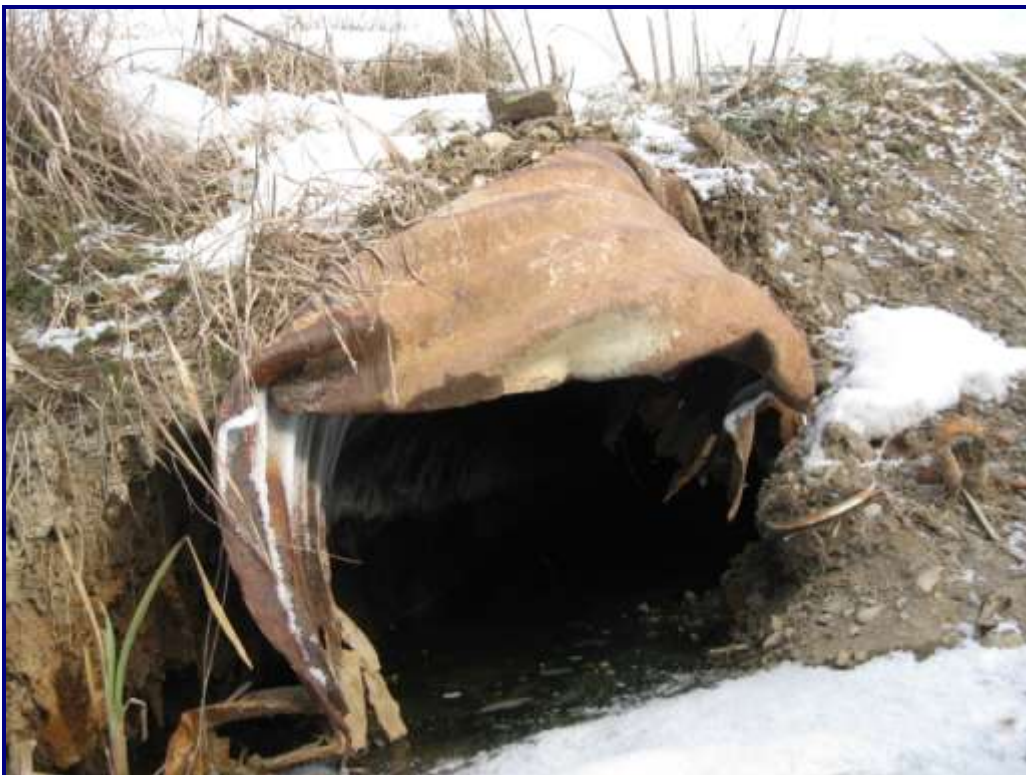
**Photo 30 – Structure No. 7: Damaged Culvert End**

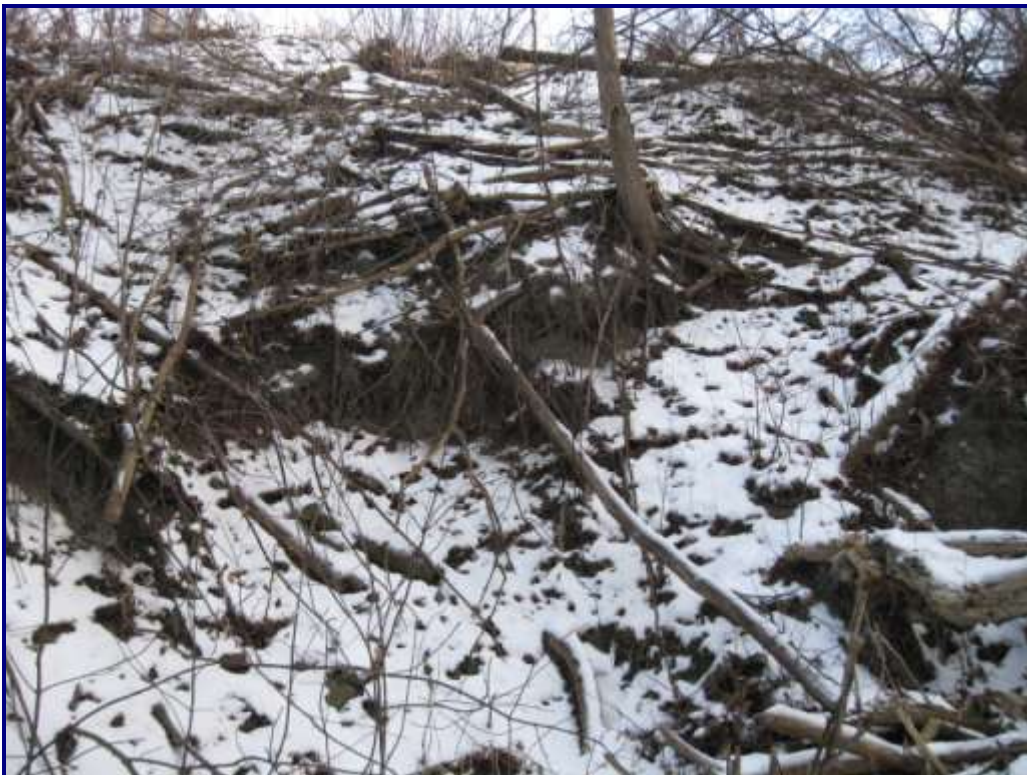
**Photo 56 – Structure No. 14: North Slope Failure**

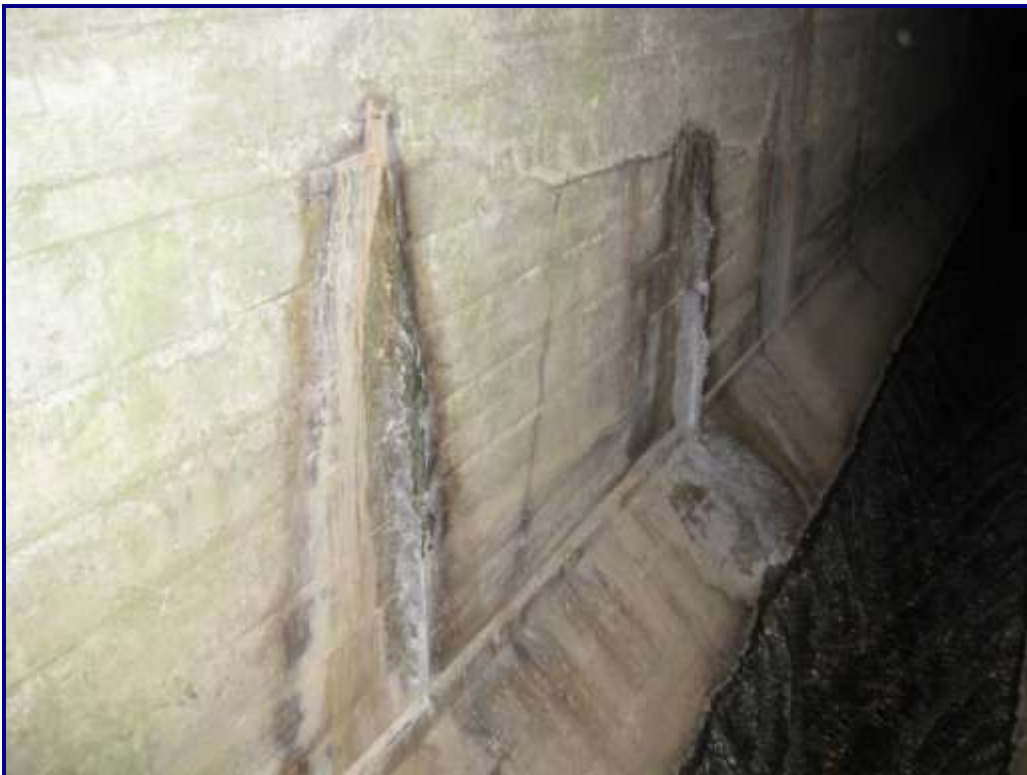
**Photo 60 – Structure No. 14: Typical Culvert Wall Cracks**
