D-3 SAFETY REVIEW OF EXISTING CONDITIONS

**Environmental
Assessment Study of
Arterial Roads Within
Highway 427 Industrial
Secondary Plan Area
(Area 47)
Safety Review of Existing
Conditions**

March 2016

CIMA
Partners in excellence

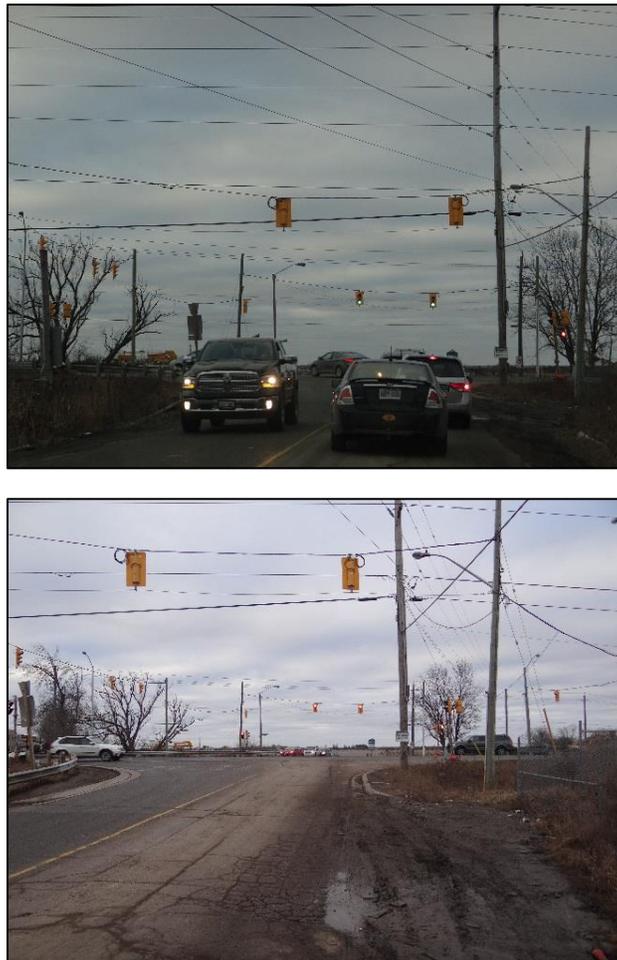
Figure 1: Elevated Intersection (Coleraine Drive and Region Road 50)

The intersection of Coleraine Drive and Regional Road 50 is elevated for motorists travelling in the eastbound and westbound directions. The presence of this condition reduces visibility to upcoming traffic for vehicles turning left from both eastbound and westbound directions or going through the intersection during the green phase as illustrated in Figure 1.

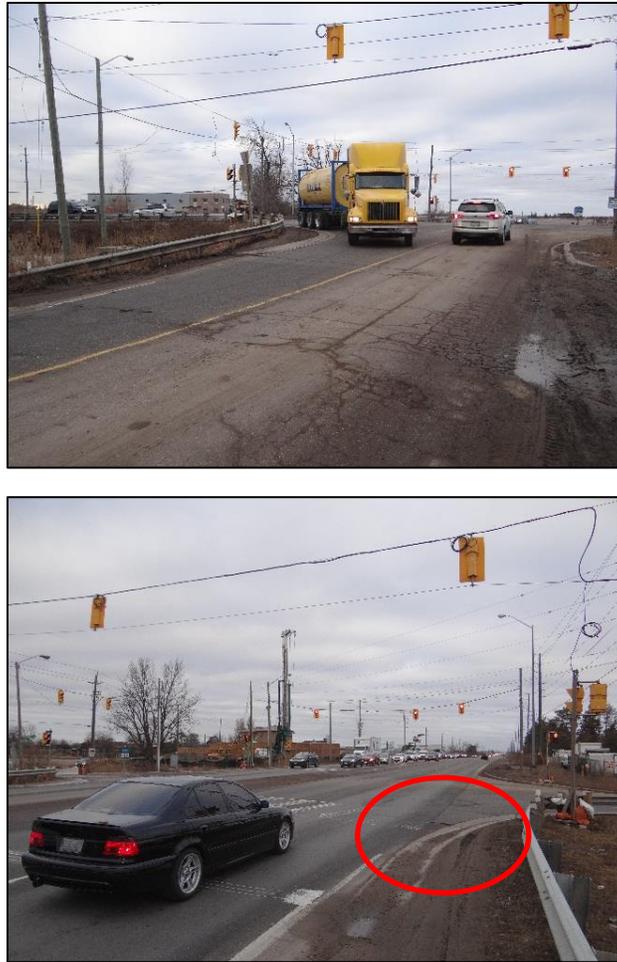
Figure 2: Limited Turning Radius (Coleraine Drive and Region Road 50)

At the intersection of Coleraine Drive and Region Road 50, heavy vehicles attempting to make a right turn are forced to drive over the sidewalk due to the limited available turning radius. This situation creates a potential safety hazard for pedestrians at the intersection. For illustration purposes, Figure 2 shows eroded surface along with a heavy vehicle clipping the shoulder due to the limited turning radius.

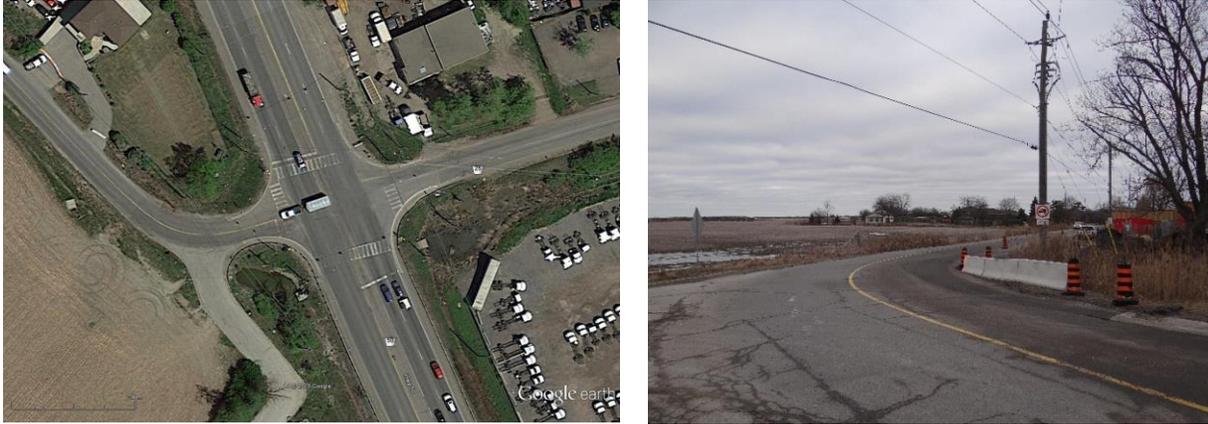
Figure 3: Skewed Intersection (Colerain Drive and Region Road 50)

- A 90-degree turn is located on the west leg of the intersection, which creates a potential safety hazard for unfamiliar motorists with the intersection due to the sudden change in road alignment;

The eastbound approach of Coleraine Drive is aligned with Regional Road 50 is at a 90-degree angle for approximately 30 metres from the intersection, where it turns towards the north. This situation creates a potential safety hazard of running off the road for unfamiliar motorists due to the sudden change in road alignment. This situation is illustrated in Figure 3.

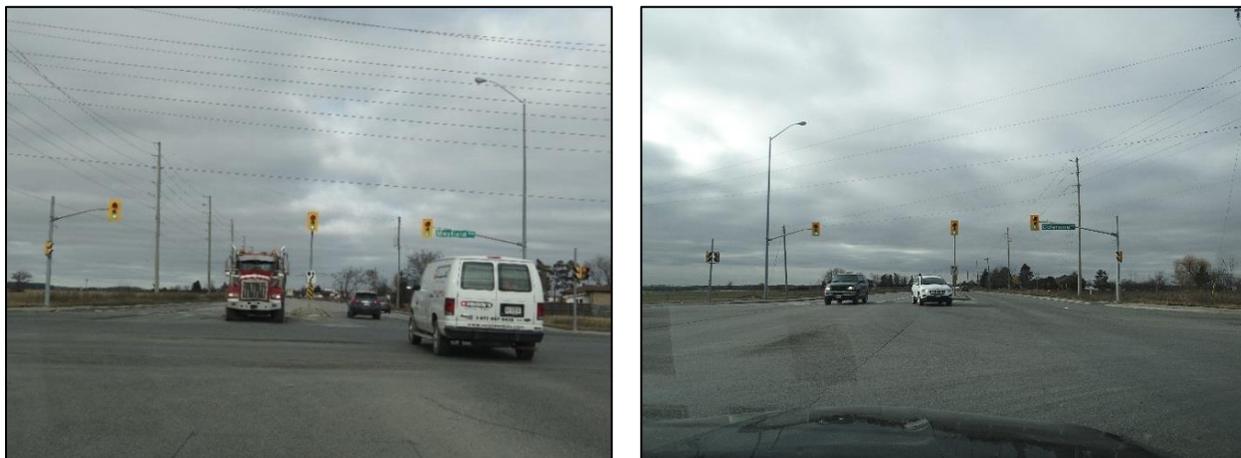
Figure 4: Offset Intersection Approaches (Colerain Drive and Region Road 50)

Existing left-turn lanes in all directions at the intersection of Coleraine Drive at Mayfield Road presents negative offsets. This configuration can create visibility restrictions to drivers attempting to turn left during the permissive phase when drivers in the opposite direction are attempting to perform the same manoeuver. This is aggravated when large vehicles, such as trucks, or in some cases large pick-up trucks, are in the opposing left-turn lanes as illustrated in Figure 4. This could be a contributing factor to turning movement collisions.

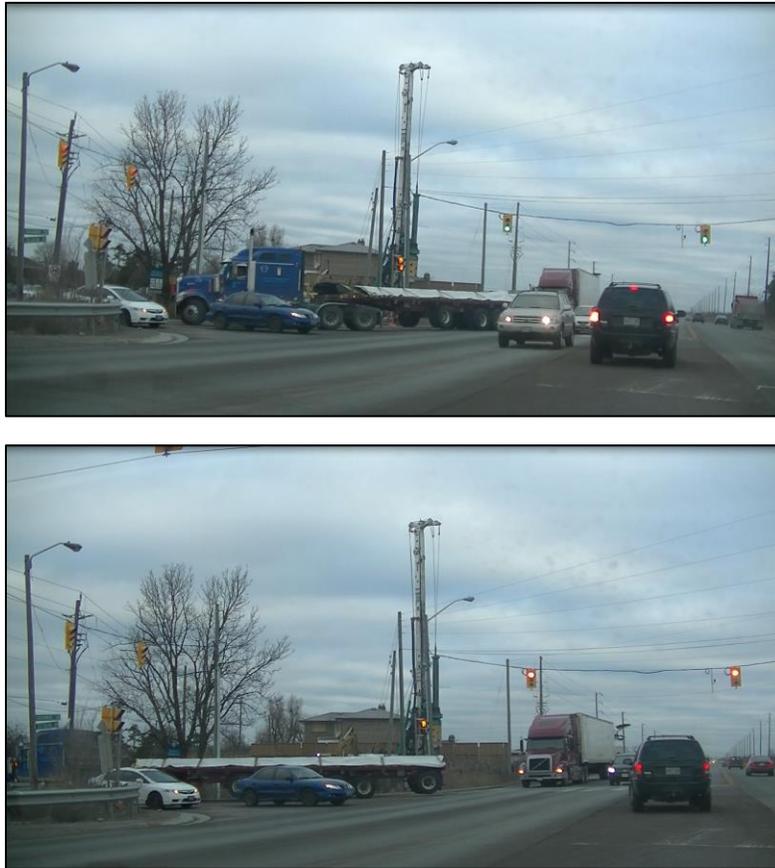
Figure 5: Access to Private Driveway (Colerain Drive and Region Road 50)

A large warehouse driveway is in close proximity of the intersection of Coleraine Drive and Regional Road 50. During peak hours, heavy vehicles turning into Coleraine Drive from Regional Road 50 are attempting to access the private driveway, which may end up blocking the intersection. Motorists queued in the east leg of the intersection block access to the private driveway during the all red phase. Heavy vehicles are required to stop and wait for a gap in-between these queued motorists to enter the property. Due to the close proximity of the private driveway and intersection, this scenario may cause queue spill back onto Regional Road 50 and increase the potential turning on red for the waiting vehicles in Figure 5.

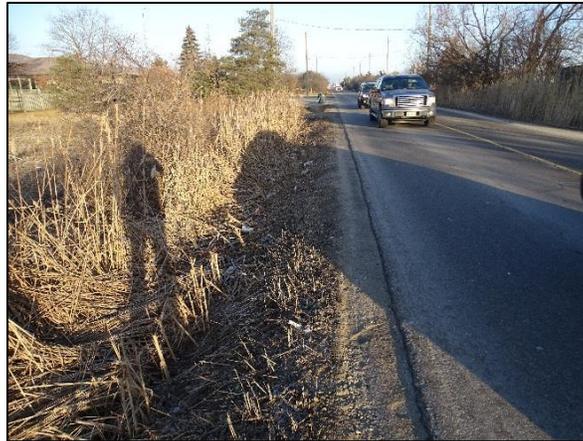
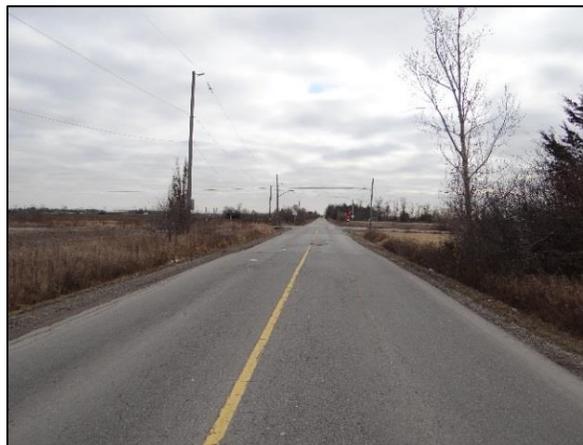
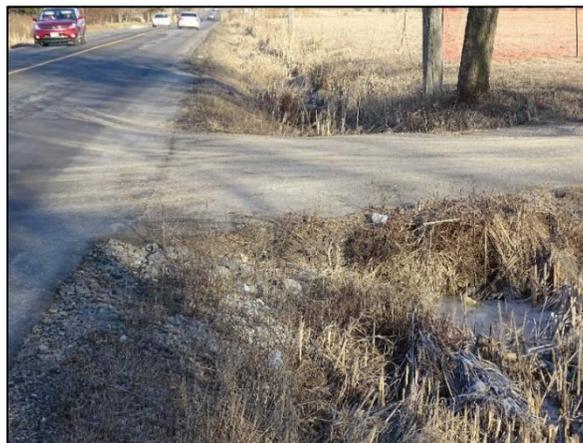
Figure 6: Narrow Shoulders along the Coleraine Drive Corridor

¹ 1999 TAC Geometric Design Guide for Canadian Roads, Table 2.2.4.1, Shoulder Widths for Rural Roads

The field investigation noted sub-standard shoulder widths. The widths of shoulders should be made consistent with applicable standards during the upcoming road widening.

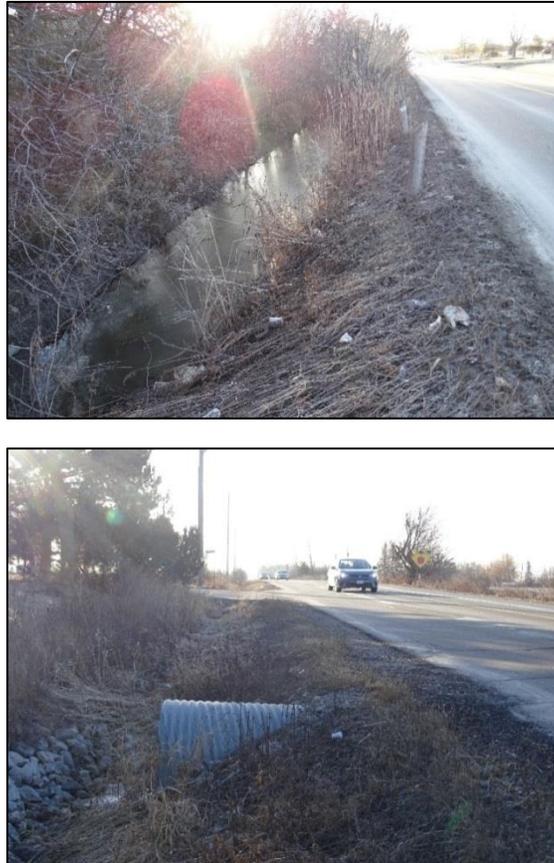
Figure 7: Side Slopes along the Coleraine Drive Corridor

slopes may not be able to recover and at some locations are likely to overturn. Recoverable slopes are generally the slopes flatter than 4:1 on which a driver can retain or regain the control of the vehicle in a run-off the road event. Non recoverable slopes are generally the slopes from 4:1 to 3:1. These slopes may be traversable, but the vehicle will continue to the bottom. Slopes steeper than 3:1 are known as critical slopes and are considered outside of the recovery zone. Vehicles encroaching on these slopes are likely to overturn. TAC notes that if critical slopes begin within the clear zone distance, a traffic barrier may be warranted if the slope cannot be readily flattened². Figure 7 illustrates a typical roadside slope within the clear zone.

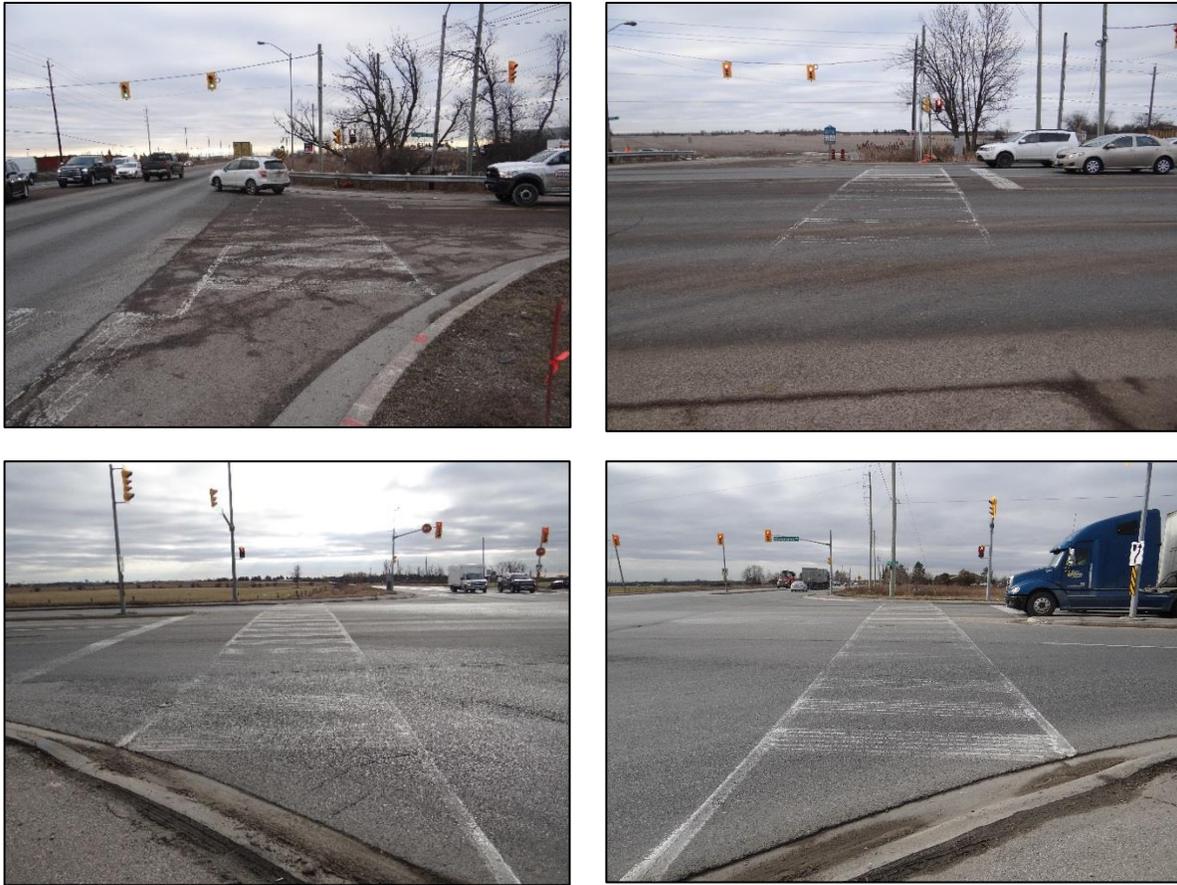
Figure 9: Offset Pedestrian Signals

Existing pedestrian signal heads at two intersections of Coleraine Drive and Regional Road 50 and Coleraine Drive and Mayfield Road are not properly aligned with the existing painted pedestrian crosswalks and sidewalks as illustrated in Figure 9.

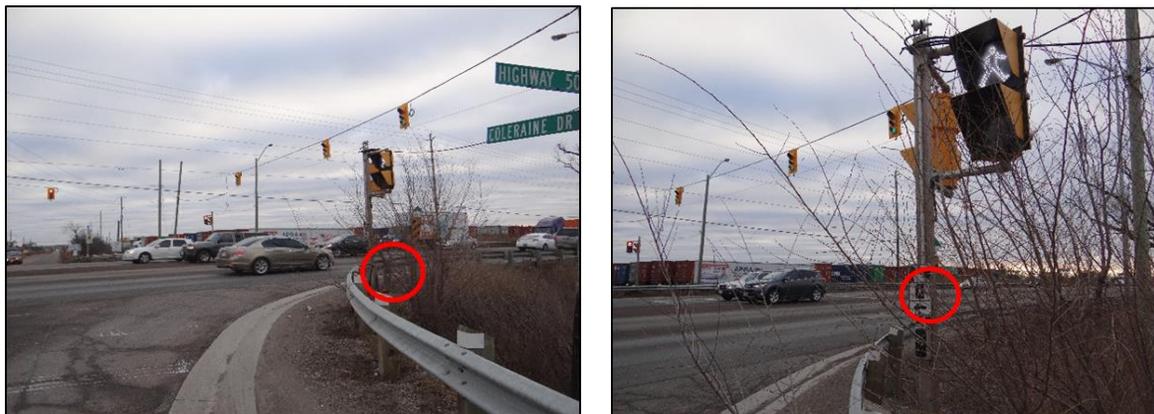
Figure 10: Obstructed Pedestrian Push Button (Colerain Drive and Regional Road 50)

The pedestrian pushbutton located at the southwest corner of the intersection of Coleraine Drive and Regional Road 50 is obstructed by tree branches. During the spring and summer seasons once branches bloom, it may be difficult for pedestrians to locate the push button and safely operate the intersection as shown in Figure 10.

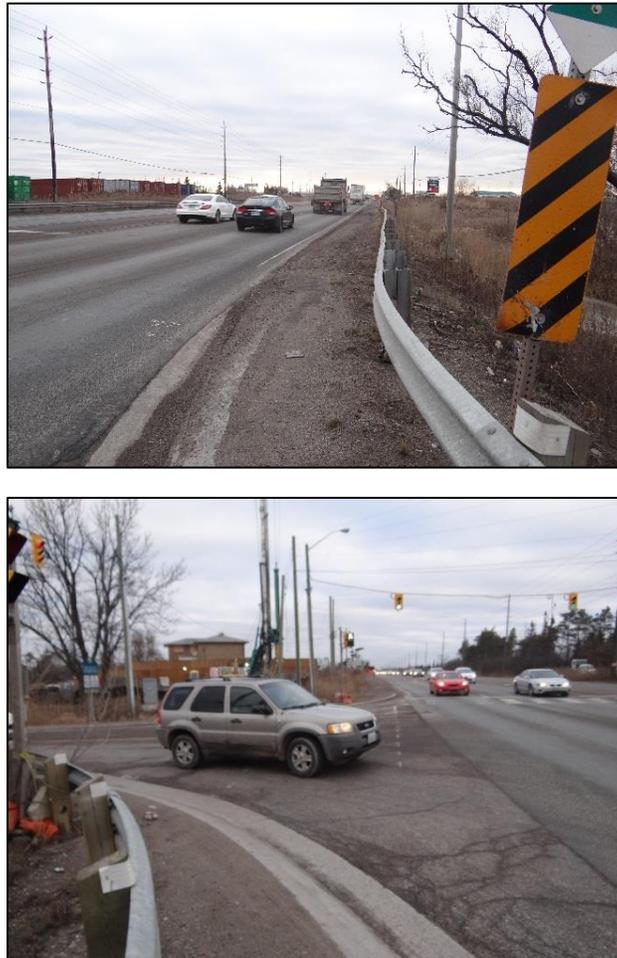
Figure 11: Pedestrian Sidewalks (Coleraine Drive and Regional Road 50)

At the intersection of Coleraine Drive and Regional Road 50, existing pedestrian signal heads and painted crosswalks located on all four approaches of the intersection do not contain any pedestrian sidewalks for accessibility of the intersection and approaches. Existing road shoulders for Regional Road 50 and Colerain Drive are used as sidewalks by pedestrians attempting to cross any of the approaches of the intersection which are approximately 1 meter in width with mountable curbs. The existing geometry of the intersection creates a potential safety hazard for pedestrian at all legs of the intersection attempting to cross. This issue is due to the lack of sidewalks and the possibility of heavy vehicles encroaching the mountable shoulders due to the limited turning radius as demonstrated in Figure 11.

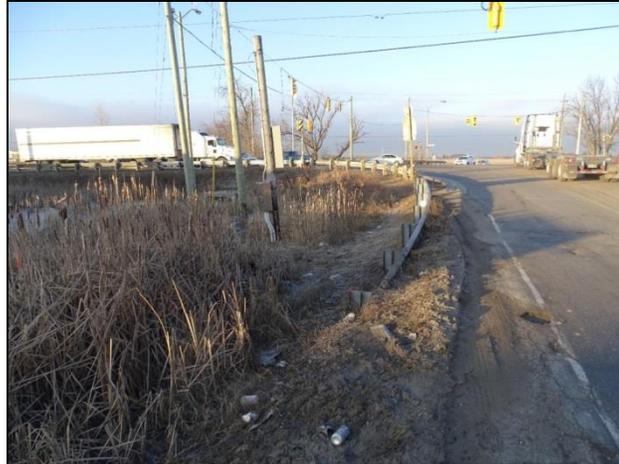
Figure 12: Turned Down Approach Treatment Colerain Drive and Region Road 50

- The culverts and the ditches located on both sides of the Coleraine Drive are protected by steel beam guiderails. The steel beam guiderail on the southeast corner has a turned down approach end which can become a vaulting hazard to errant vehicle; and

At the intersection of Coleraine Drive and Region Road 50, the culverts and the corresponding ditch located on both sides of the roadway are protected by steel beam guide rails. The steel beam guide rail on the southeast corner has a turned down approach end, as illustrated in Figure 12, which can become a vaulting hazard to errant vehicles.

The field investigation noted some existing steel beam guide rail without energy attenuators at approach and/or leaving-ends. Energy attenuators should be provided to reduce the severity of potential collisions with the guide rail ends, which may result in spearing or vaulting the vehicles.

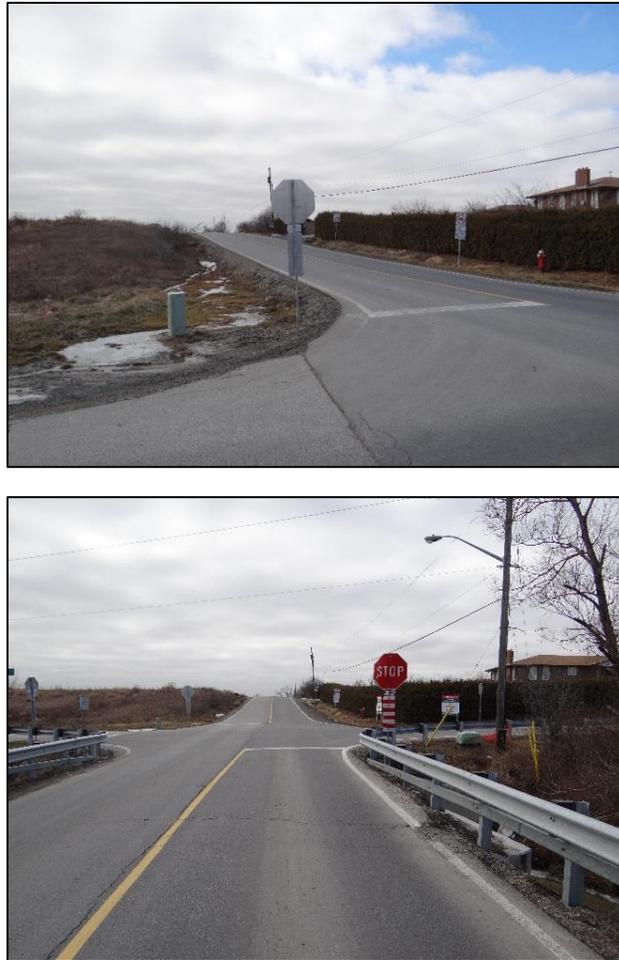
Figure 13: Intersection at Clarkway Drive and Countryside Drive

The northbound, southbound and eastbound directions at the intersection of Clarkway Drive at Countryside Drive present a downgrade on approaches to the intersection. The presence of downgrade on approaches to the intersection could be a potential contributing factor to rear end and angle collisions due to potentially higher speeds. Also, the presence of the crest vertical curve in the north and south legs could restrict the sightlines to upcoming traffic or stopping vehicles while departing the intersection. The intersection is demonstrated in Figure 13. It should be noted that the collision history review indicated one rear-end and one angle collision at this intersection.

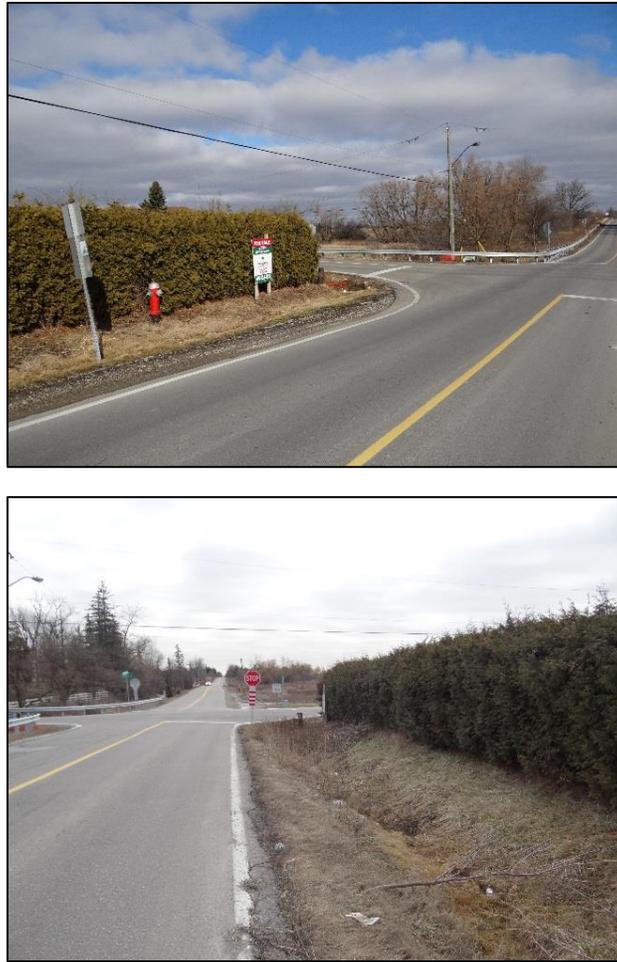
Figure 14: Limited Sight Triangles (Clarkway Drive and Countryside Drive)

Existing vegetation located on the northwest corner of Clarkway Drive and Countryside Drive reduces sight triangles for motorists travelling in the southbound and eastbound directions as shown in Figure 14. It should be noted that the subject intersection is all-way stop control and the requirement for clear sight triangles is not applicable for this type of intersection.

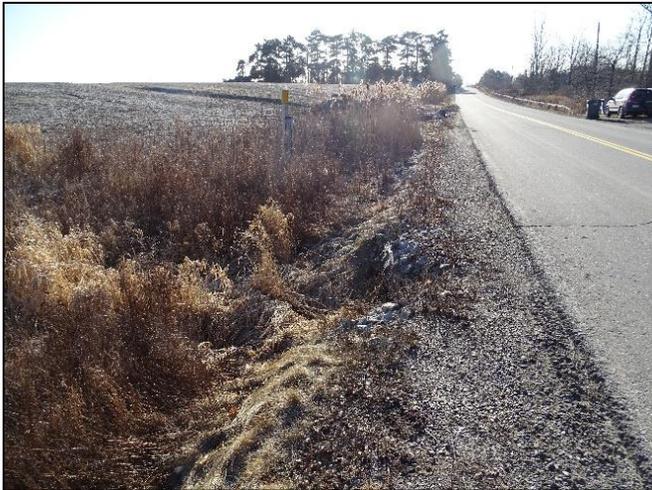
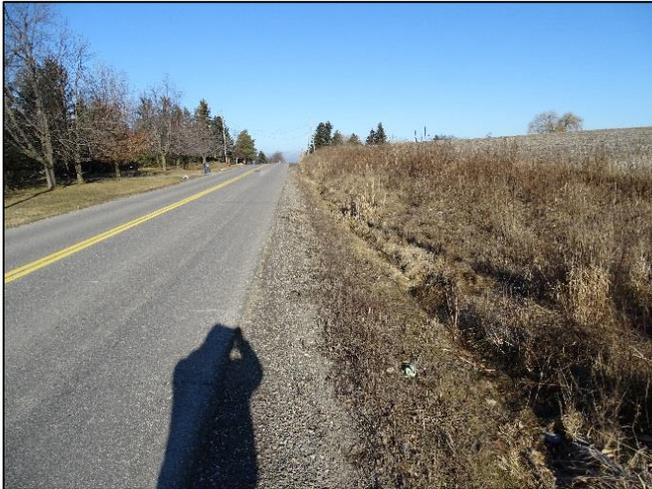
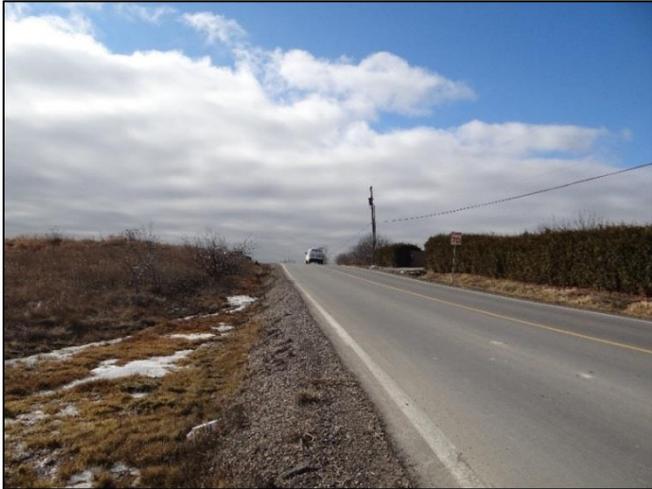
Figure 15: Narrow Shoulders along the Clarkway Drive Corridor

³ 1999 TAC Geometric Design Guide for Canadian Roads, Table 2.2.4.1, Shoulder Widths for Rural Roads

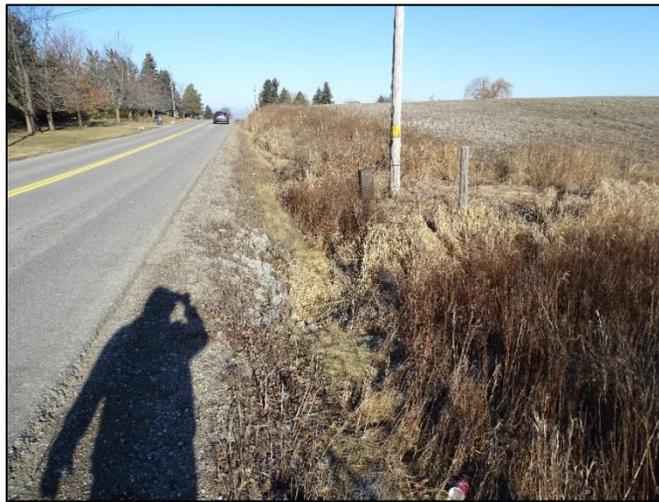
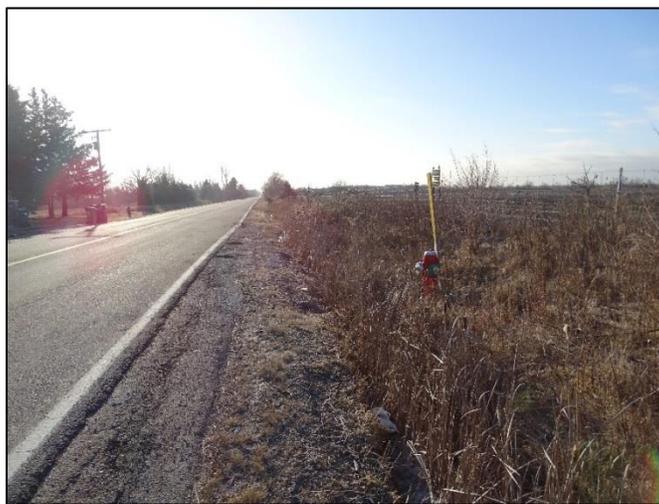
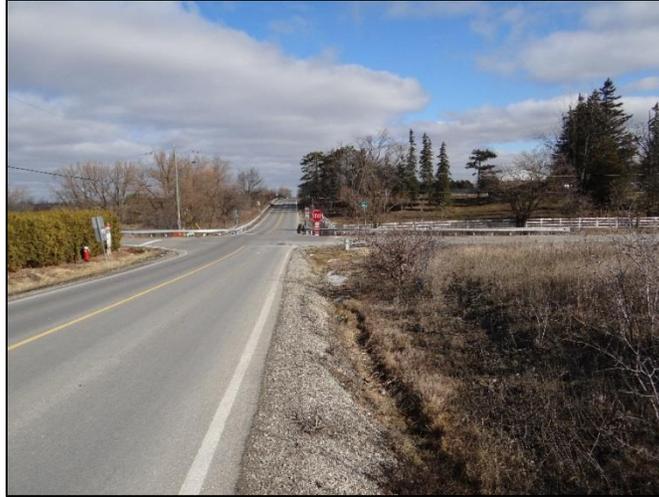
Figure 16: Side Slopes along the Clarkway Drive Corridor

- + **Side Slopes:** The side slopes of the roadway generally were found to be irregular. Slopes appeared to be steep and unrecoverable within clear zone at some locations. Vehicles encroaching on these slopes may not be able to recover and at some locations are likely to overturn. Recoverable slopes are generally the slopes flatter than 4:1 on which a driver can retain or regain the control of the vehicle in a run-off the road event. Non recoverable slopes are generally the slopes from 4:1 to 3:1. These slopes may be traversable, but the vehicle will continue to the bottom. Slopes steeper than 3:1 are known as critical slopes and are considered outside of the recovery zone. Vehicles encroaching on these slopes are likely to overturn. TAC notes that if critical slopes begin within the clear zone distance, a traffic barrier may be warranted if the slope cannot be readily flattened⁴. A typical roadside slope within the clear zone is illustrated in Figure 16.

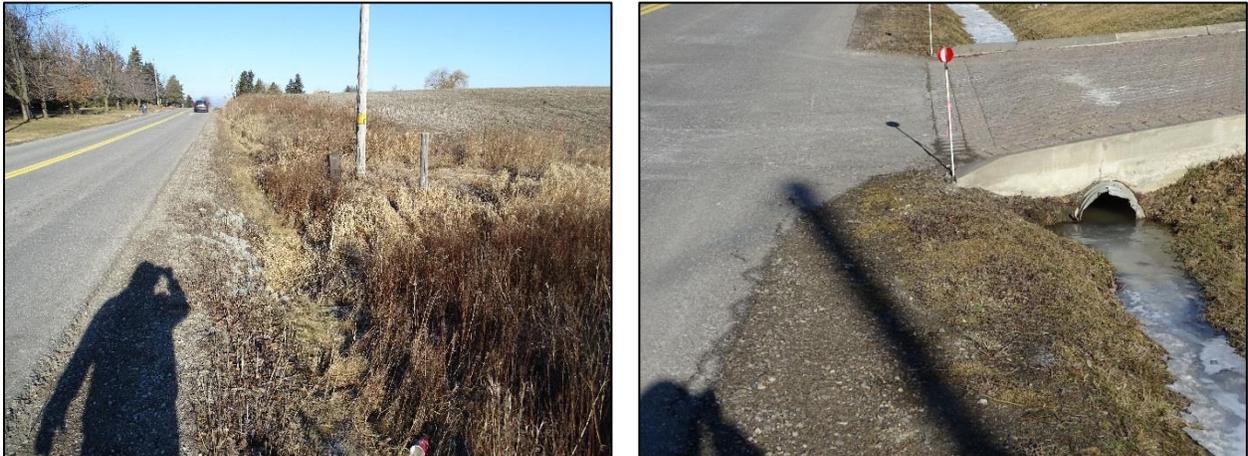
Figure 17: Fixed Objects along the Clarkway Drive Corridor

- + **Fixed Objects:** CIMA examined fixed objects along the roadside and found that a significant number of non-breakaway utility poles that do not meet the clear zone requirement. Additionally, other objects such as a culvert headwalls of private driveways and some breakaway fire hydrant were found to be located within the clear zone. A non-breakaway wood pole, a culvert headwall, and fire hydrant within the clear zone is illustrated in Figure 17.

The field review identified a significant number of non-breakaway utility poles and fire hydrants within the clear zone. The possible options to treat the fixed objects include replacing the poles with a breakaway base pole, relocating the poles and fire hydrants outside the clear zone, or protecting them with a roadside barrier. Given that the review of the collision history does not reveal any collisions involving fixed objects, we do not recommend any treatment in the short term. However,

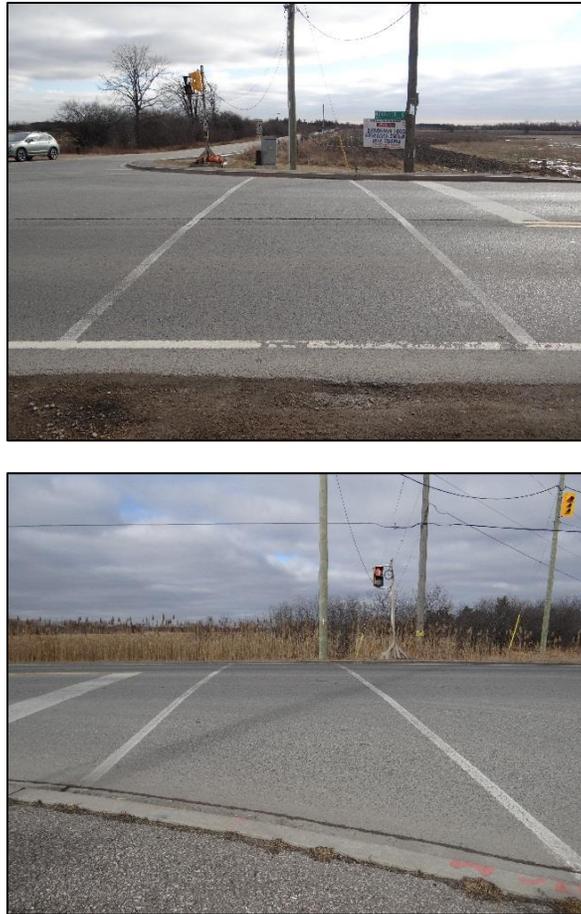
Figure 18: Offset Signal Heads (Clarkway Drive and Mayfield Road)

Existing pedestrian signal heads on all approaches located at Clarkway Drive and Mayfield Road are not properly aligned with the existing pedestrian crosswalks and sidewalks as demonstrated in Figure 18.

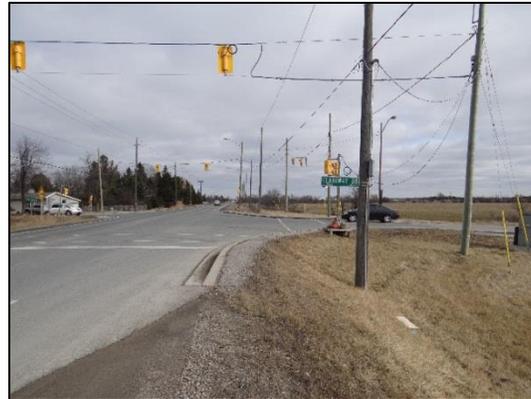
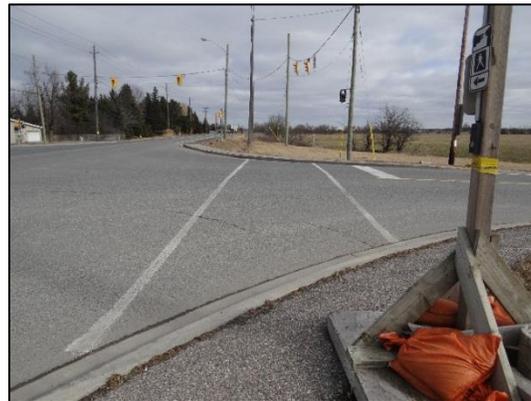
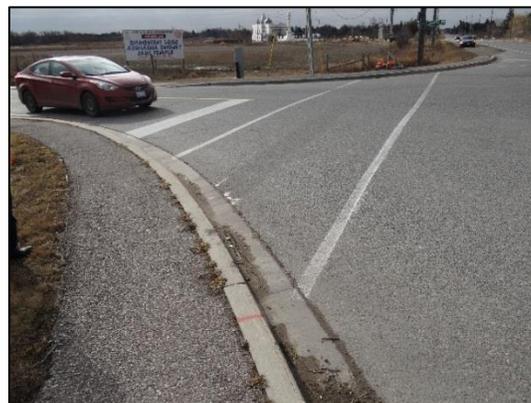
Figure 19: Lack of Pedestrian Infrastructure (Clarkway Drive and Mayfield Road)

Existing pedestrian sidewalks do not have a mountable curb to assist pedestrians with disabilities to access the sidewalks and painted pedestrian crosswalks, and therefore do not meet the Accessibility for Ontarians with Disabilities Act (AODA) as demonstrated in Figure 19.

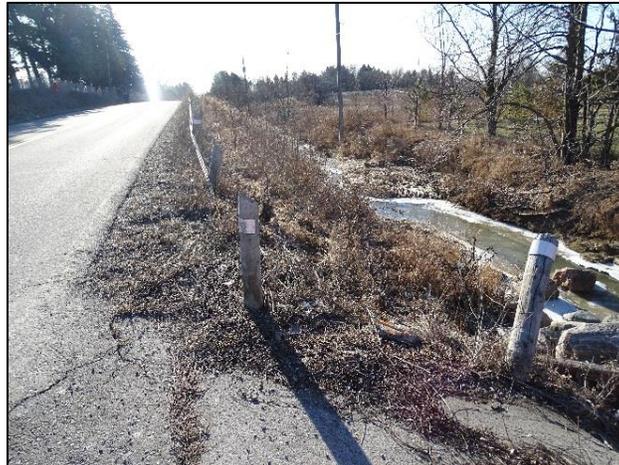
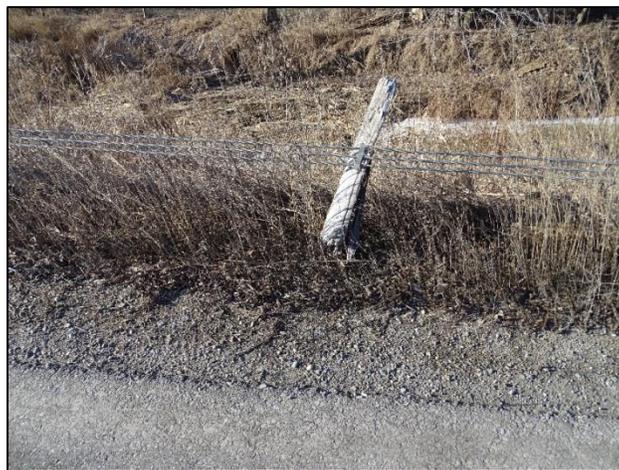
Figure 20: Damaged Cable Guide Rail along the Clarkway Drive

Sections of 3-Cable guide rail systems were found to be installed within the corridor. Most 3-Cable guide rail systems present within the corridor appeared to be old and damaged. The 3-Cable was installed to protect vehicles from the water body hazards and the deep slope. The damaged 3-cable is illustrated in Figure 20.

The field investigation noted the presence of some 3-cable guide rail system. These systems are outdated and should be replaced, where possible, by steel beam guide rails.

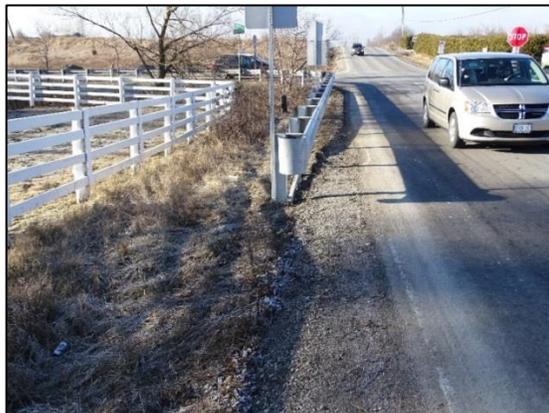
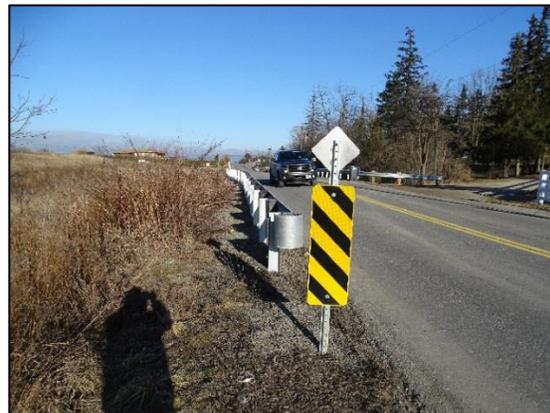
Figure 21: Steel Guide Rail Leaving-End (Clarkway Drive and Countryside Drive)

The leaving-end of the existing steel beam guide rail is located within the clear zone for vehicles in the opposite direction of travel. The leaving-end is missing an energy attenuator, as illustrated in Figure 21. An improper end treatment may pose a spearing hazard in the event of a head-on collision with the guide rail.

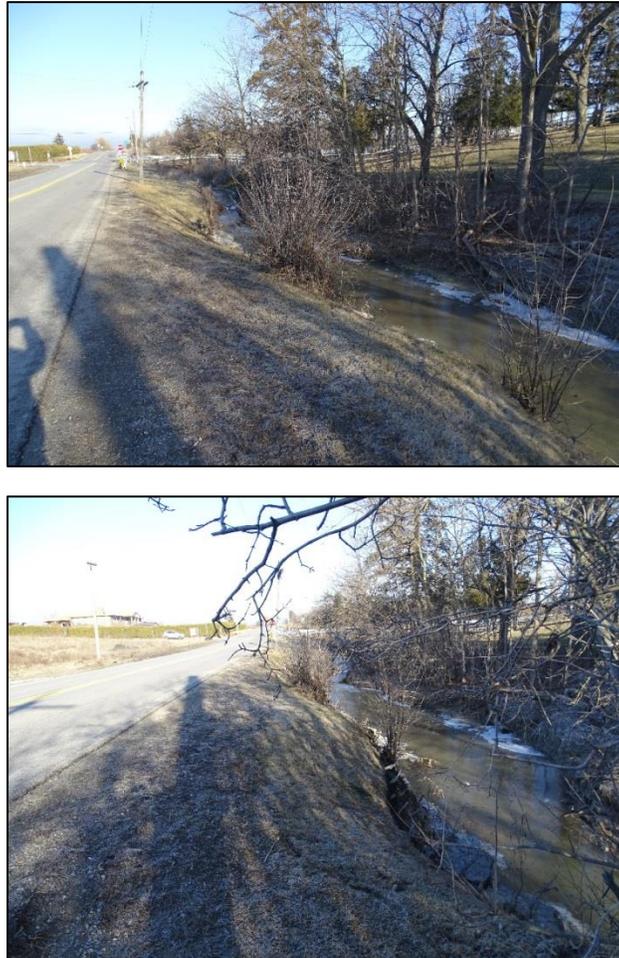
Figure 22: Inadequate Steel Beam Length along the Clarkway Drive

The steel beam guide rail is lacking in length of need (LON) as shown in Figure 22. According to the MTO standard⁵ for protection of water body hazards with barrier, the installation length of the barrier shall be the maximum encroachment distance.

The field review revealed that the length of need (LON) for existing steel beam guide rails are not adequate. The guide rail should be extended during the upcoming road widening to protect the vehicles from the water body hazards. It is noted that the need for guide rails in the long term should be evaluated during the design stages of the upcoming road widening. By widening the road, clear zones will be laterally shifted and may include new hazards requiring protection, or currently existing hazards may be eliminated, either by removal or by introducing proper cross section design.

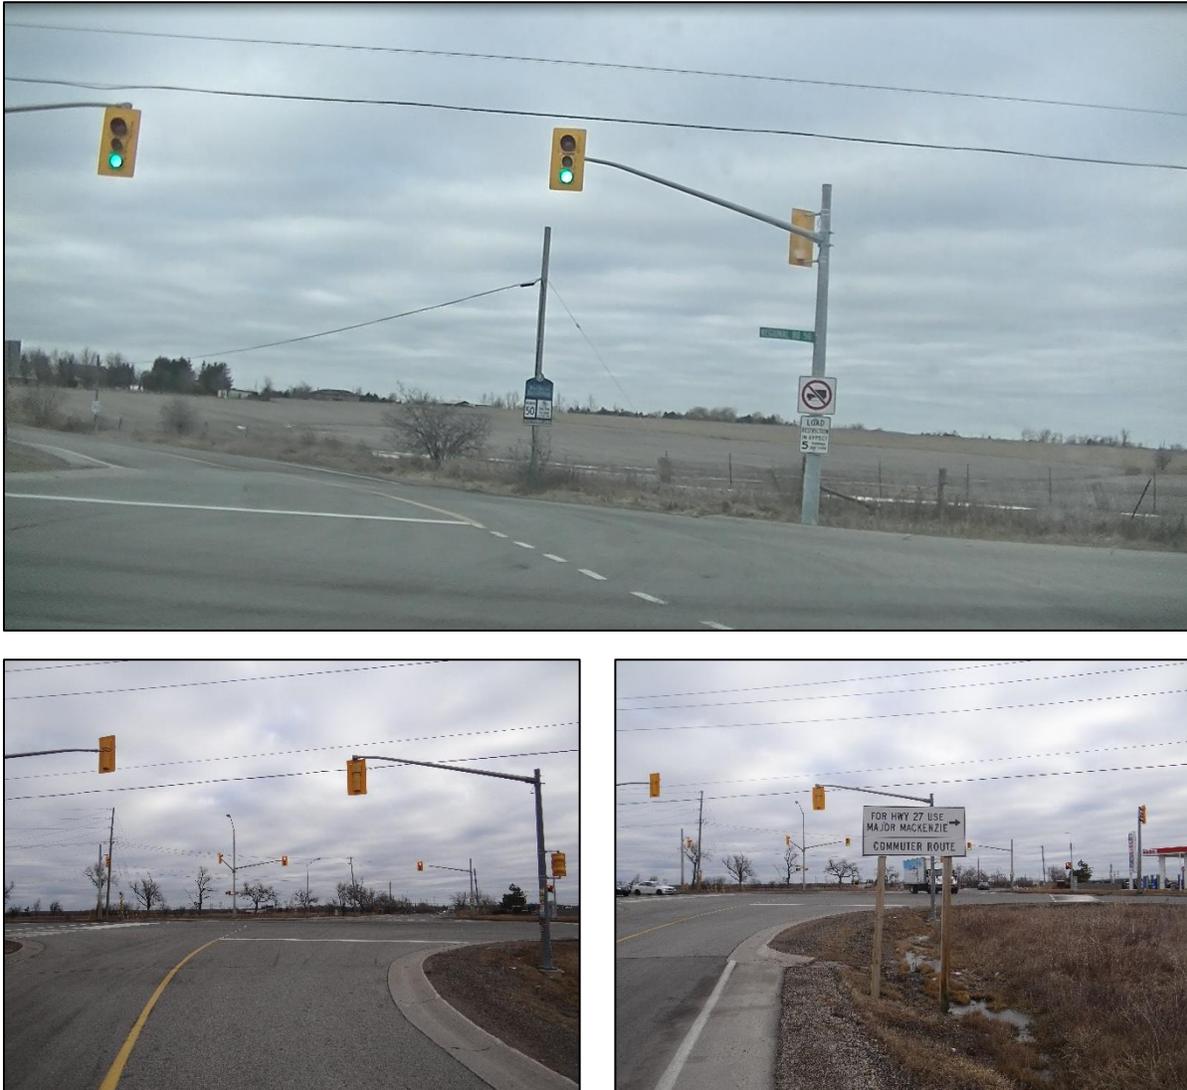
Figure 23: Skewed Intersection Approach (Countryside Drive and Regional Road 50)

receiving lane downstream of the intersection. This situation creates a potential safety hazard for motorists who are unfamiliar with the approach due to the sudden change in road alignment. In addition, the existing configuration can create visibility restrictions to drivers attempting to turn left or right during the permissive phase when drivers in the opposite direction are attempting to perform the same maneuver. This is aggravated when large vehicles, such as trucks, or in some cases large pick-up trucks, are in the opposing left-turn lanes as demonstrated in Figure 23. This may be a potential contributing factor to turning movement collision located at this intersection.

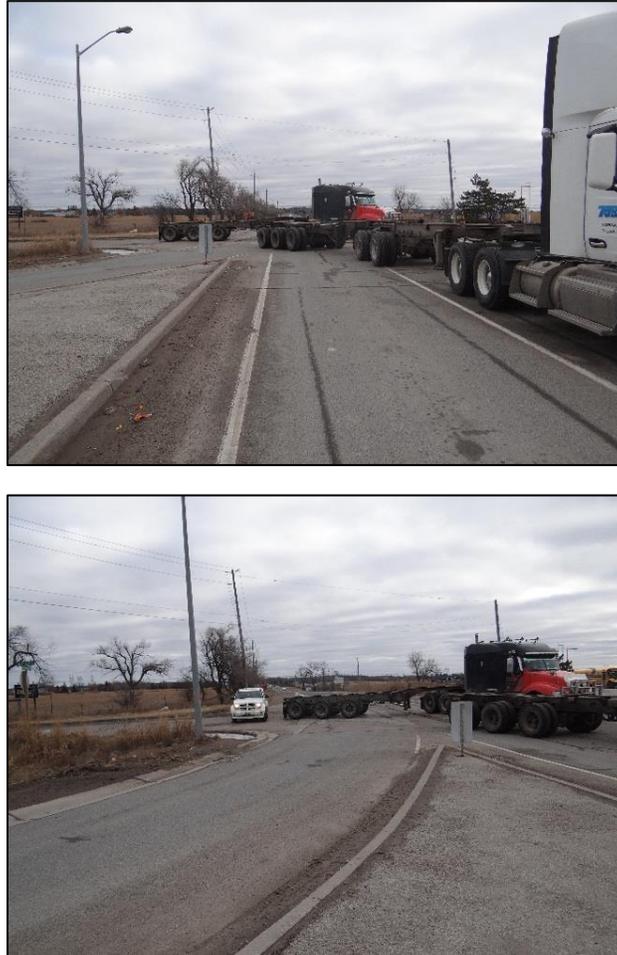
Figure 24: Proximity of the Two Intersections (Cold Creek Drive at Nashville Road and Countryside Drive at Regional Drive 50)

of Countryside Drive and Regional Road 50. The through and right turn vehicles will use the shoulder and/or the north leg of Cold Creek Drive intersection to make the maneuvers around the trucks. This may be a potential safety concern due to the reduced sightlines created by heavy vehicles blocking the through and right turn lanes and impatient motorists stuck behind the heavy vehicles as shown in Figure 24.

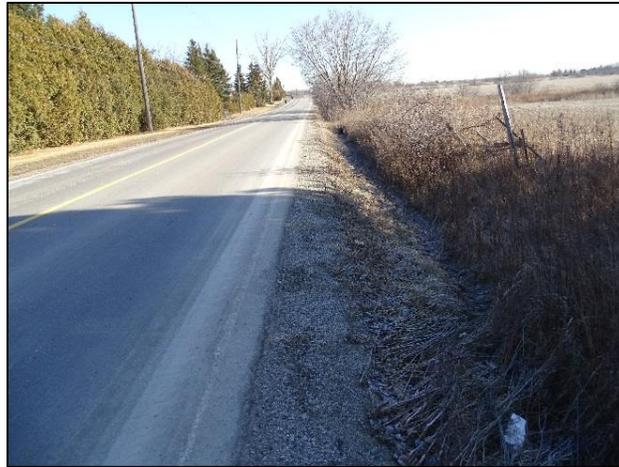
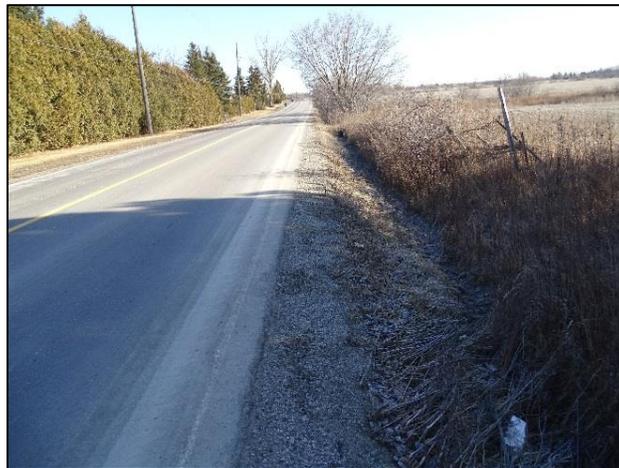
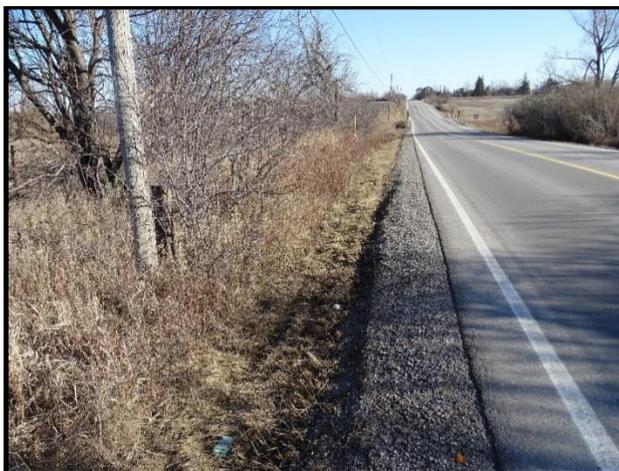
Figure 25: Narrow Shoulders along Countryside Drive

⁶ 1999 TAC Geometric Design Guide for Canadian Roads, Table 2.2.4.1, Shoulder Widths for Rural Roads

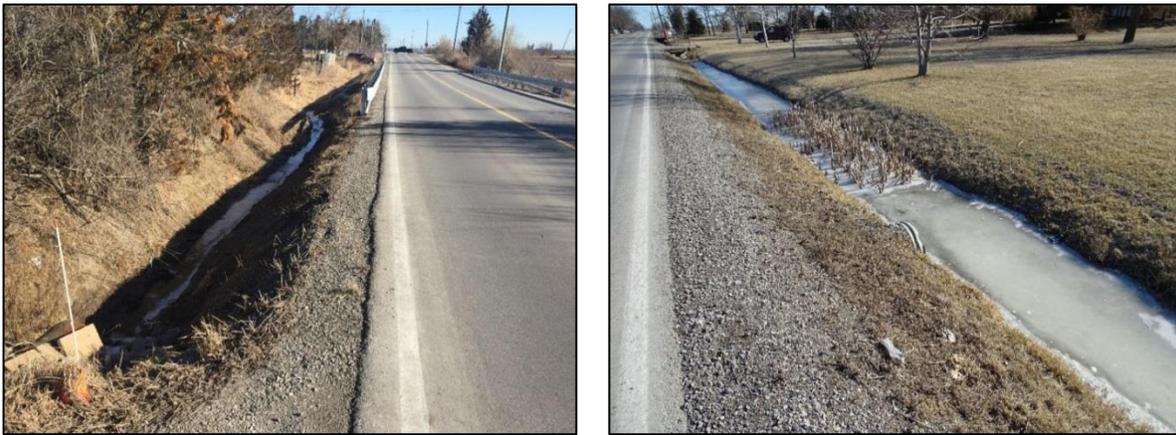
Figure 26: Side Slopes along Countryside Drive

- Side Slopes:** The side slopes of the roadway generally were found to be irregular. Slopes appeared to be steep and unrecoverable within clear zone at some locations. Vehicles encroaching on these slopes may not be able to recover and at some locations are likely to overturn. Recoverable slopes are generally the slopes flatter than 4:1 on which a driver can retain or regain the control of the vehicle in a run-off the road event. Non recoverable slopes are generally the slopes from 4:1 to 3:1. These slopes may be traversable, but the vehicle will continue to the bottom. Slopes steeper than 3:1 are known as critical slopes and are considered outside of the recovery zone. Vehicles encroaching on these slopes are likely to overturn. TAC notes that if critical slopes begin within the clear zone distance, a traffic barrier may be warranted if the slope cannot be readily flattened⁷. A typical roadside slope within the clear zone is illustrated in Figure 26.

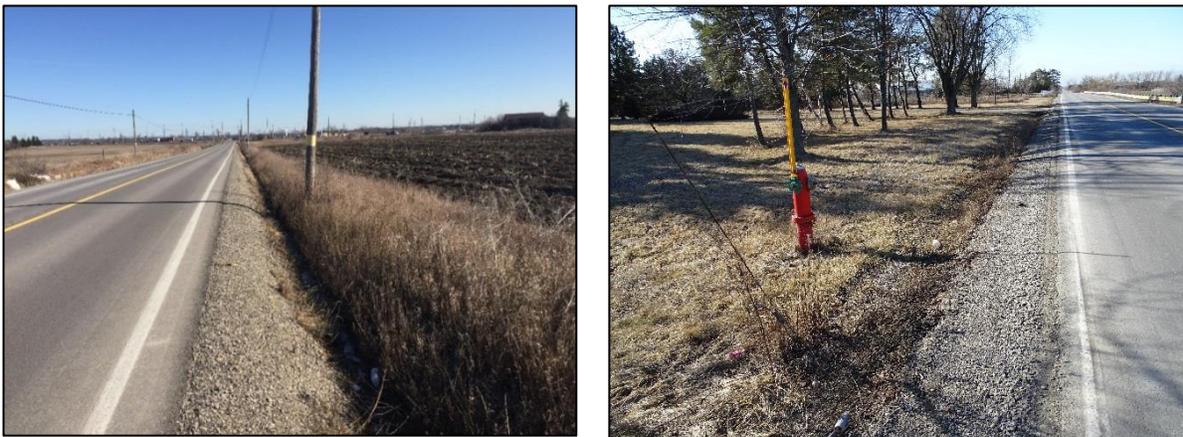
Figure 27: Fixed Objects along Countryside Drive

- Fixed Objects:** CIMA examined fixed objects along the roadside and found that a significant number of non-breakaway utility poles that do not meet the clear zone requirement. Additionally, other objects such as a culvert headwalls of private driveways and breakaway fire hydrant were found to be located within the clear zone. A non-breakaway wood pole, a culvert headwall, and fire hydrant within the clear zone is illustrated in Figure 27.

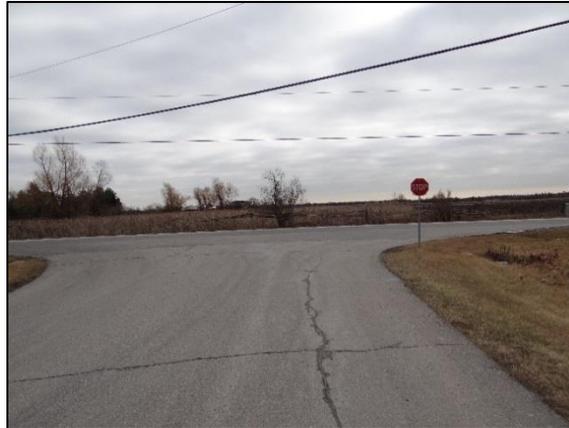
Figure 28: Missing Checkerboard Sign (Countryside Drive and St. Johns Road)

The intersection of Countryside Drive and St. Johns Road is missing a Checkerboard sign (Wa-8LR) for motorists travelling southbound on St. Johns Road. The checkerboard sign must be used where a road terminates, and there is no option to proceed straight ahead, but there are options to proceed to the left or to the right as illustrated in Figure 28. The sign should be used where posted speed is 60 km/h or less.

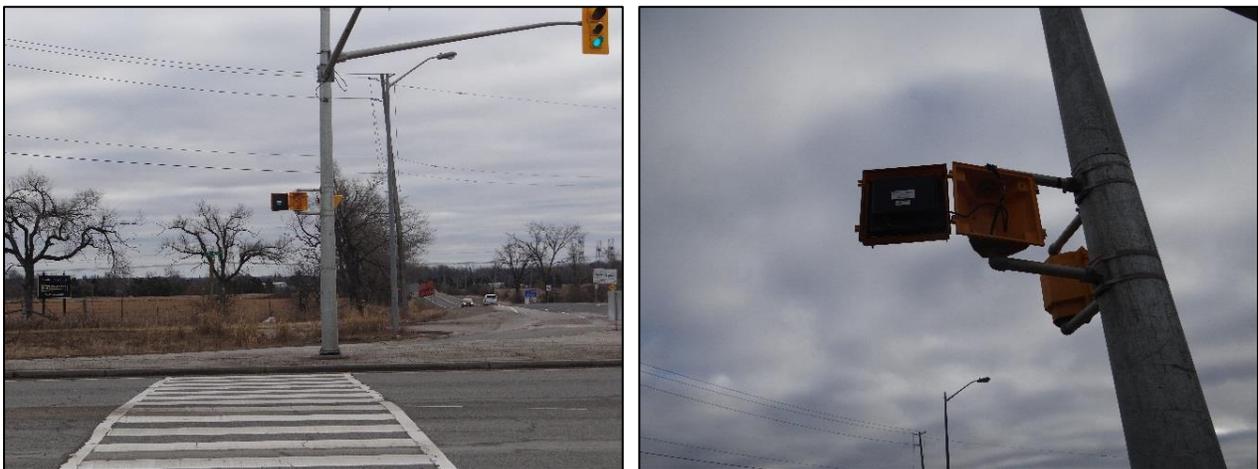
Figure 29: Broken Pedestrian Signal Head (Countryside Drive and Regional Road 50)
