D-3 SAFETY REVIEW OF EXISTING CONDITIONS

**Environmental
Assessment Study of
Arterial Roads Within
Highway 427 Industrial
Secondary Plan Area
(Area 47)
Safety Review of Existing
Conditions**

March 2016

CIMA
Partners in excellence

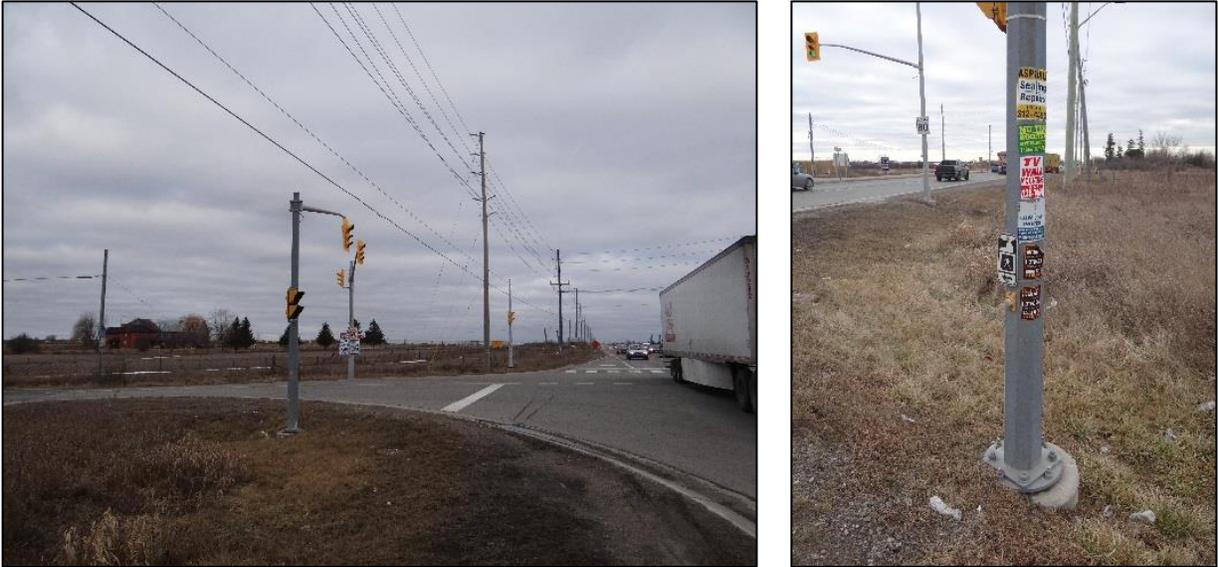
Figure 30: Accessibility of Pedestrian Push Button (Countryside Drive and Regional Road)

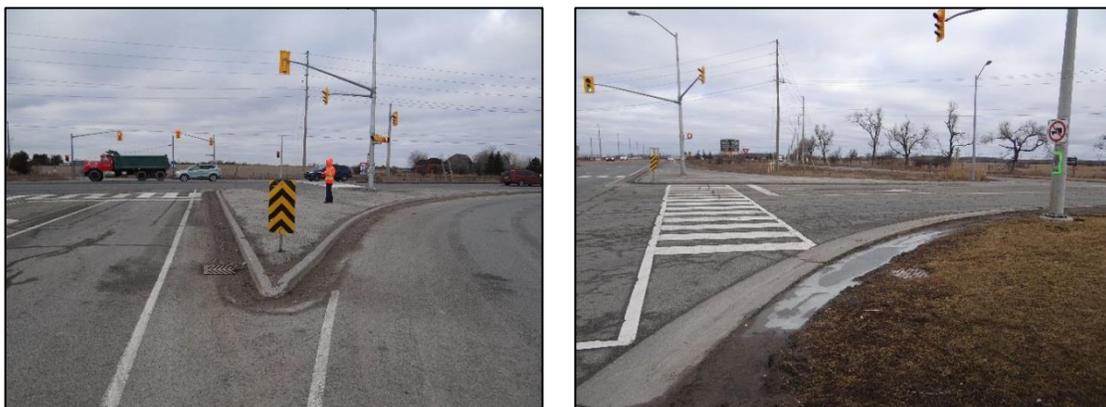
Figure 31: Lack of Pedestrian Infrastructure (Countryside Drive and Regional Road 50)

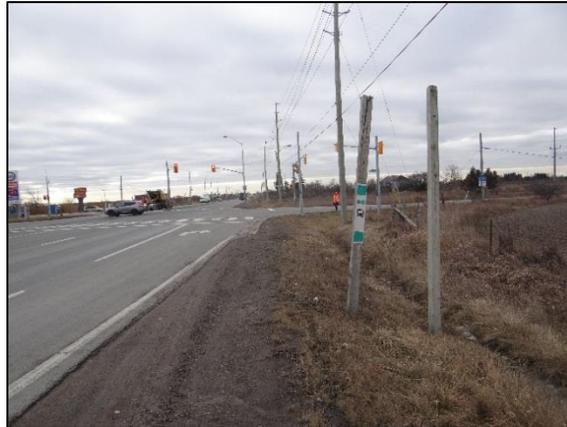
Figure 32: Limited Bus Stop Access (Countryside Drive and Regional Road 50)

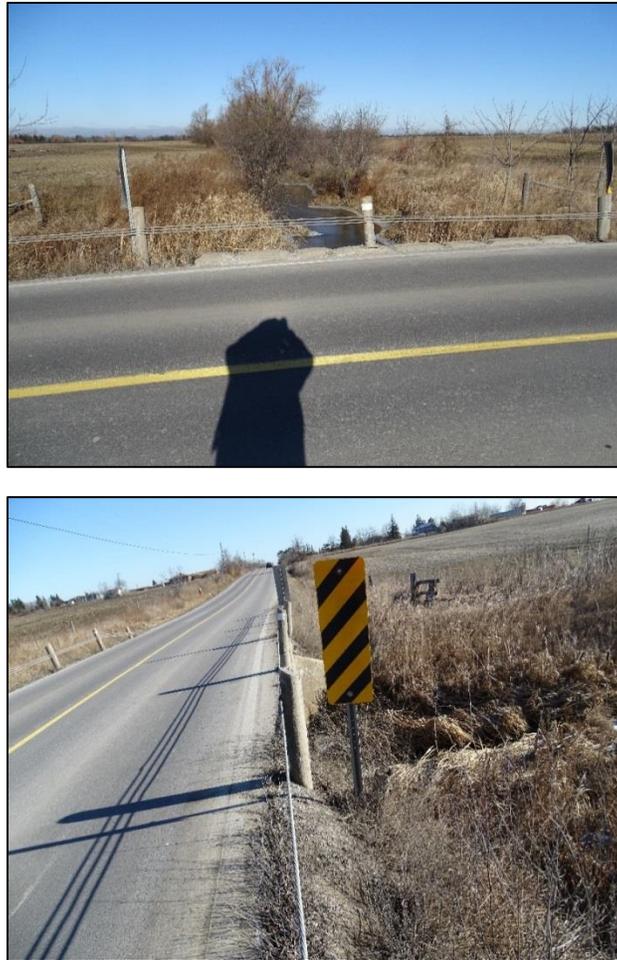
Figure 33: 3-Cable Guide Rail along Countryside Drive

The field investigation noted the presence of some 3-cable guide rail system. These systems are outdated and should be replaced, where possible, by steel beam guide rails.

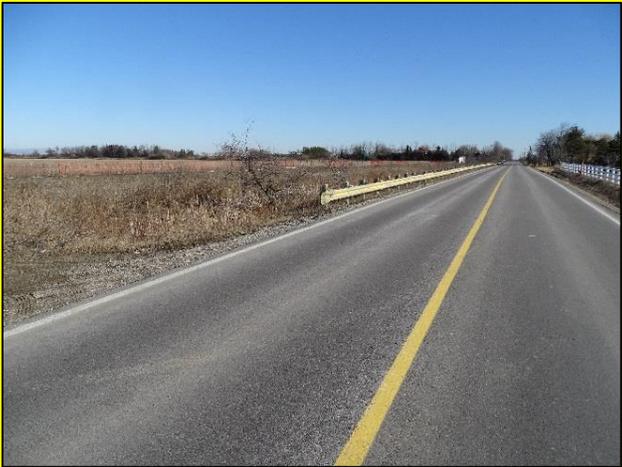
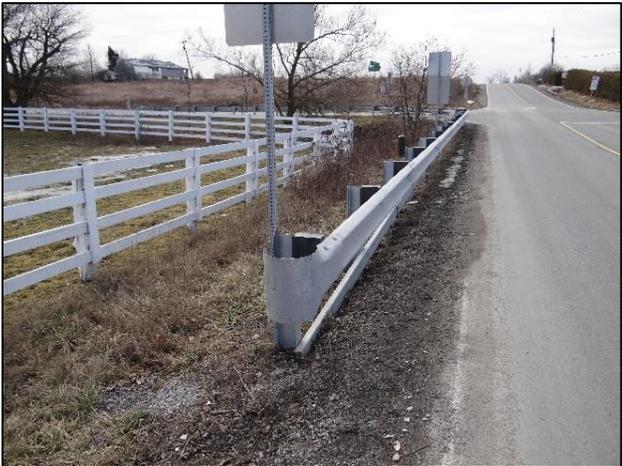
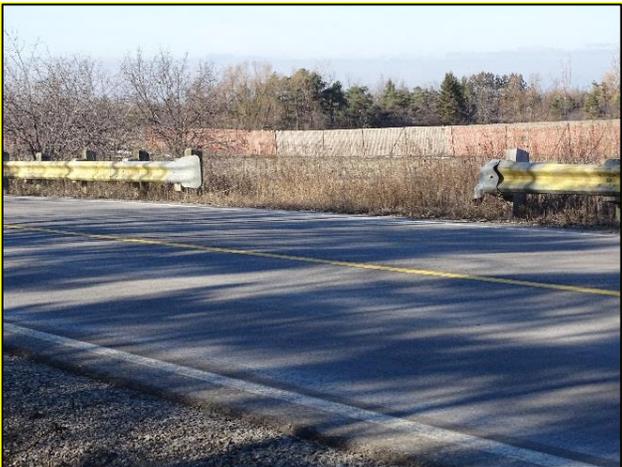
Figure 34: Steel Guide Rail Leaving-End along Countryside Drive

The field investigation noted some existing steel beam guide rail without energy attenuators at approach and/or leaving-ends. Energy attenuators should be provided to reduce the severity of potential collisions with the guide rail ends, which may result in spearing or vaulting the vehicles.

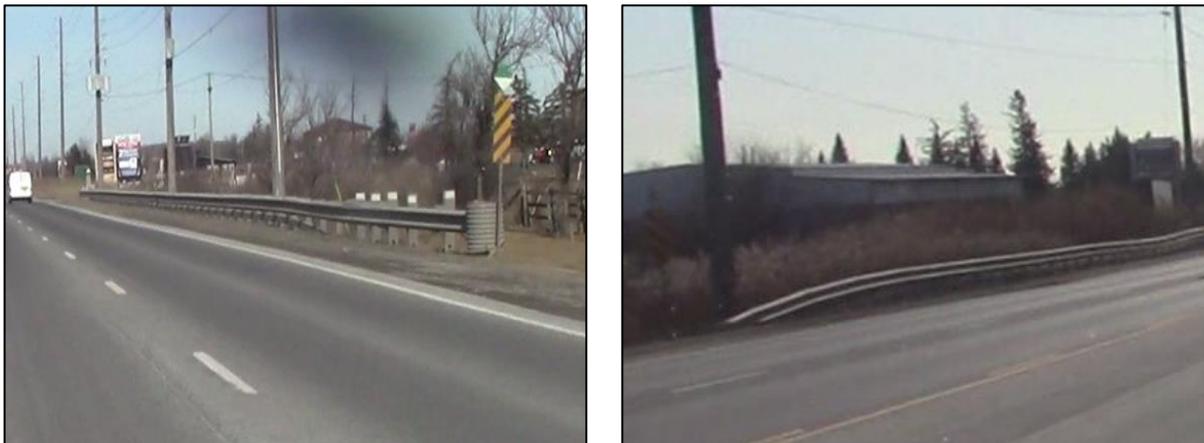
Figure 35: Missing Crash Cushion along Regional Road 50
