Appendix E.6
Geotechnical Report

**Preliminary Geotechnical Investigation
Highway 50 from Castlemore to Mayfield Road
Mayfield Road from Highway 50 to Coleraine Drive
Town of Caledon and City of Vaughn, Region of Peel, Ontario**

Trow Associates Inc.

brge00392733A
July 16, 2010

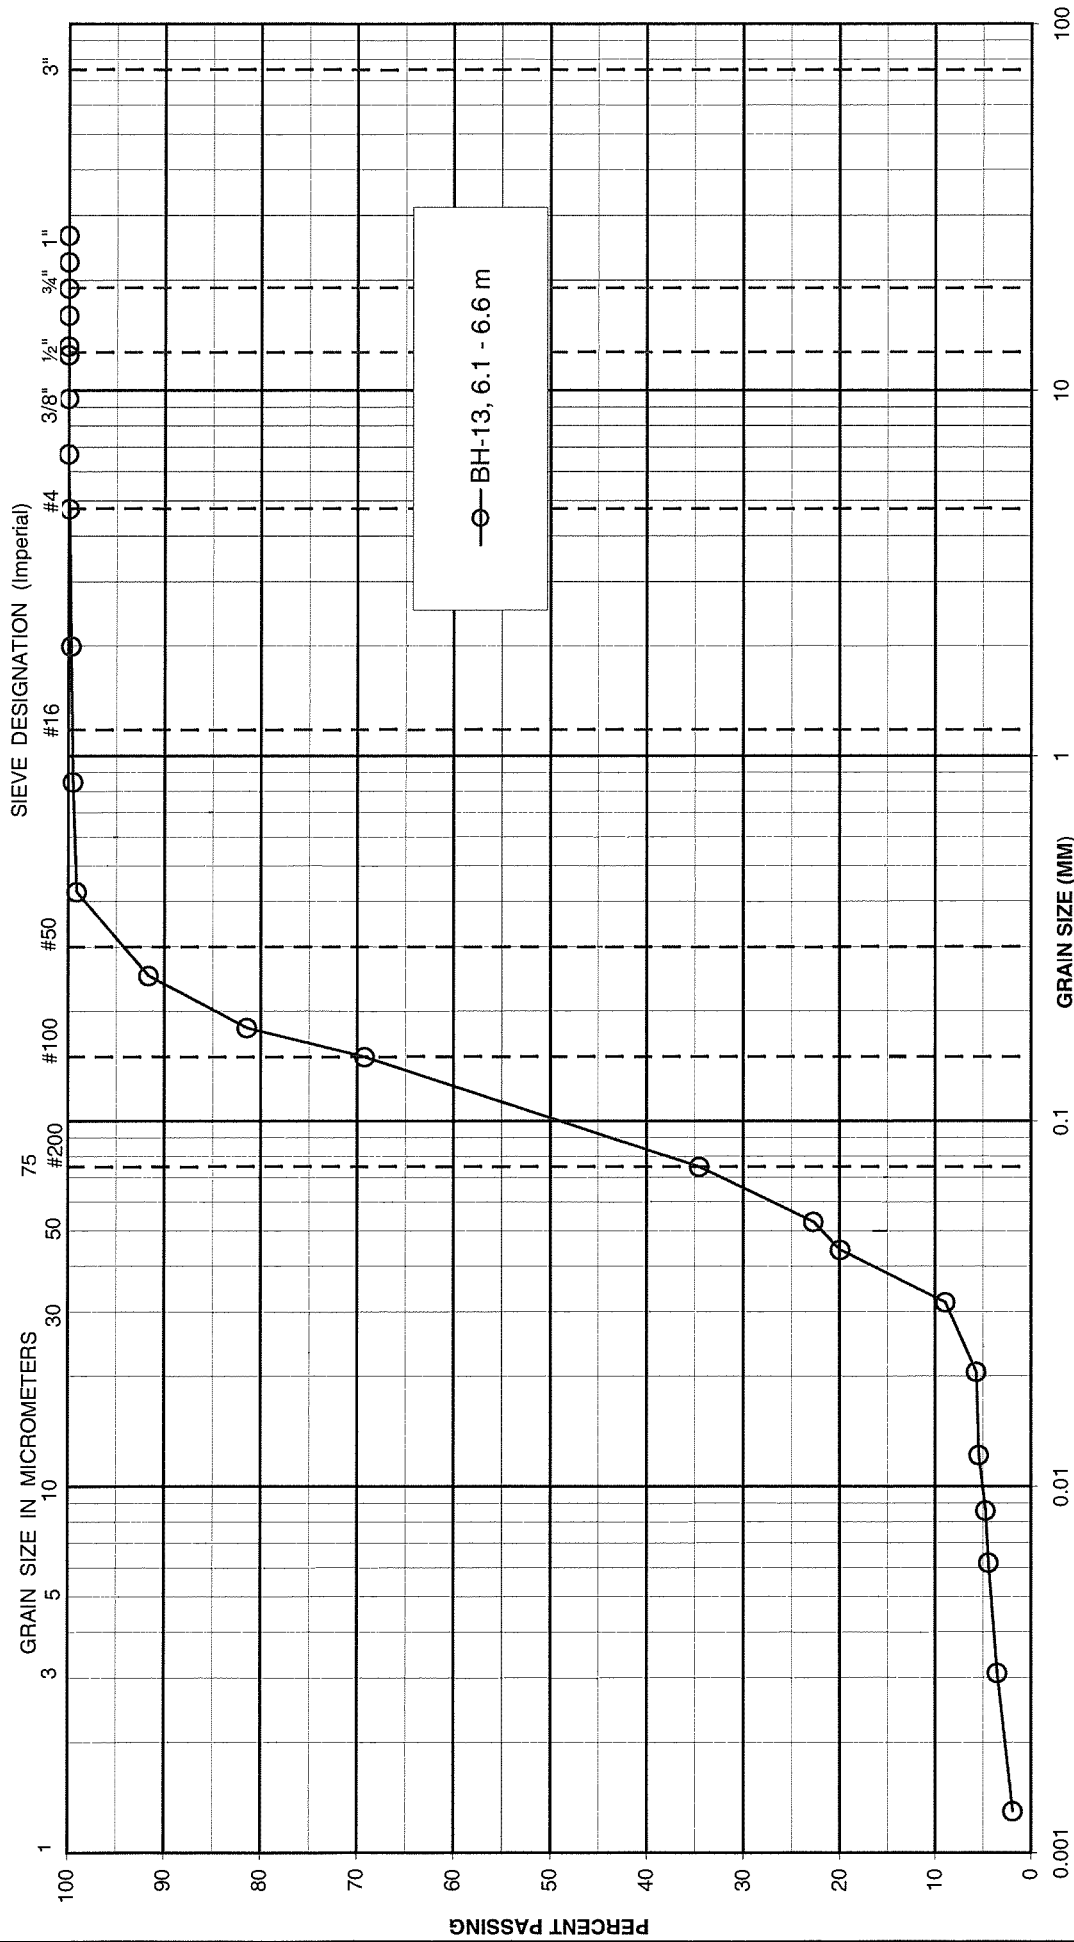
GEO. & ENV. INVESTIGATIONS, HIGHWAY 50 AND MAYFIELD
GRAIN SIZE DISTRIBUTION
 SILTY SAND

Silty sand was identified in 3 Boreholes (Nos. 12 to 14) on Highway 50. Silty sand underlies the sandy silt till and extends to the full depth of all three boreholes. Silty sands have natural moistures of 11 to 17%. SPT 'N' values recorded in the silty sandy range from 13 to over 100 blows per 0.3 m, which indicate compact to very dense conditions. One sample of silty sand from Borehole 13 analyzed for grain size distribution (Figure 3, Appendix 'B') indicated approximately 65% sand, 32% silt and 3% clay.
