Final Report

**Bovaird Drive Class EA
Stream Crossing Geomorphological
Assessment**

Date: July 2012

Ref: 01-10-34

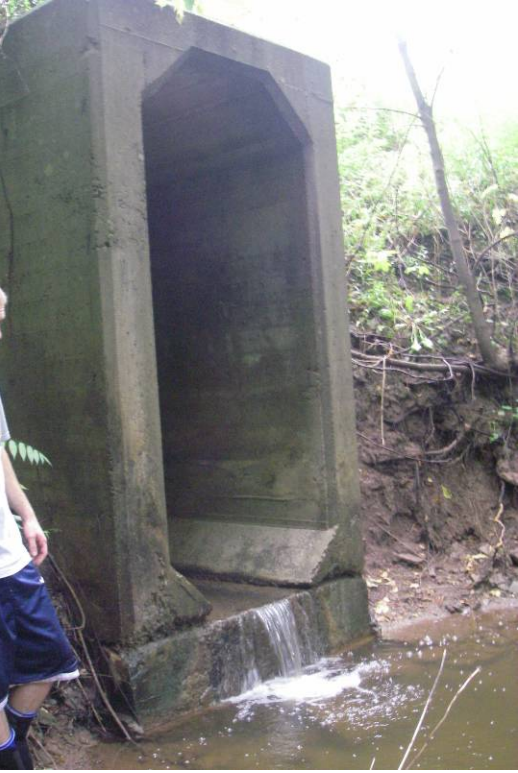
Crossing and Photograph	Description	RGA / RSAT	Management Considerations
<p>Crossing A</p>

<p>Structure</p> <ul style="list-style-type: none"> • Pre-cast concrete box culvert, closed bottom, • Dimensions: 1.20m (w) x 2.80m (h) x 65m (l) • Condition : Culvert intact but heavily eroded around the structure downstream, where a scour pool has developed (0.6m deep). <p>Overall stream character :</p> <ul style="list-style-type: none"> • u/s – defined channel in ravine setting with valley wall contact and good pool-riffle sequencing. • d/s – geomorphologically active channel degrading into bedrock. Valley wall contact in ravine setting • Riparian zone 100m, deciduous forest. <p>Issues / Disturbance:</p> <ul style="list-style-type: none"> • Channel width > Opening • Major pooling and erosion downstream • Culvert perched • Concerns regarding fish passage 	<p>BV-A1</p> <p>RGA: In regime</p> <p>RSAT: Moderate habitat quality</p> <p>BV-A2</p> <p>RGA: Transitional</p> <p>RSAT: Moderate habitat quality</p>	<ul style="list-style-type: none"> • Culvert currently does not take into account channel width or the meander belt width and is causing major pooling and erosion downstream. • Key opportunity for improvement through culvert widening and regrading. Some rehabilitation work likely to be required. • Improvement of fish passage.

RGA Score: The upstream reach, BV-A1, has an RGA score of 0.19, indicating the reach is in a state of dynamic equilibrium and is “In Regime”. Planform adjustment was identified as being the most prominent form of adjustment, with the formation of chutes and islands observed in the field. Reach BV-A2, downstream, has an RGA score of 0.36, which indicates that the reach is “Transitional/Stressed”. Widening was identified as the most prominent form of adjustment with degradation as the secondary mode of adjustment. Fallen and leaning trees, large organic debris, and basal scour through more than 50% of the reach were observed as evidence of widening. Degradation was observed through channel incision into the undisturbed bedrock, headcutting due to knick point migration, elevated tree roots and a suspended armour layer visible in the bank.

The existing culvert at crossing A is 1.2 m wide by 2.8 m high. Upstream of Bovaird Drive, a catchbasin drains a road side ditch and empties into the culvert, adding additional flow and exacerbating erosion downstream. Upstream and downstream of Bovaird Drive the bankfull widths are larger than the existing culvert. During high flow events, water is forced through the narrow opening, increasing velocities and causing a large scour pool to form at the downstream end. It is recommended that the existing crossing structure be replaced and widened in order to, at minimum, convey the bankfull flow and to minimize potential impacts on stream morphology. The recommended preliminary structure size of 10 m is based

on meander amplitudes measured in vicinity of the crossing at the upstream end. A 2 m factor of safety was deemed appropriate, as discussed below, resulting in a final recommended structure size of 12 m.

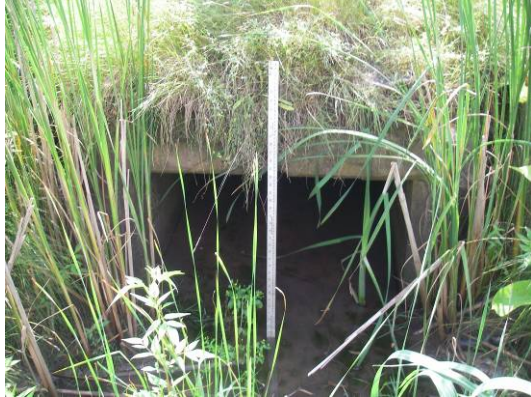
Crossing and Photograph	Description	RGA / RSAT	Management Considerations
<p>Crossing B</p>

<p>Upstream looking downstream</p>	<p>Structure</p> <ul style="list-style-type: none"> • Pre-cast concrete box culvert, closed bottom, • Dimensions: 0.95m (w) x 0.68m (h) x 36m (l) • Condition : Good <p>Overall stream character :</p> <ul style="list-style-type: none"> • u/s – channel undefined, drains road ditch • d/s – undefined within area colonized by cattails. • Riparian zone 30-40m, cattails, dense herbs. <p>Issues / Disturbance:</p> <ul style="list-style-type: none"> • Channel width > Opening • Agricultural practices upstream. • Minor pooling downstream 	<p>BV-B</p> <p>RGA: In regime</p> <p>RSAT: Channel definition limited too</p>	<ul style="list-style-type: none"> • Reduction of the impact of agricultural practices upstream. • Culvert currently does not take into account channel width or the meander belt width and is causing minor pooling.

RGA Score: The RGA score determined for reach BV-B is 0.12, indicating the channel is in a state of dynamic equilibrium. Aggradation was found to be the most prominent mode of adjustment with evidence observed through the poor sorting of bed material, a soft, unconsolidated bed, and deposition occurring in and around structures.

The existing culvert at Crossing B is 0.95 m wide by 0.68 m high. Currently, wetted widths upstream and downstream of the crossing are wider than the structure causing minor pooling to occur. The existing structure is performing well, however minor pooling and wetted widths larger than the culvert are of concern. It is recommended that that existing structure be replaced with a 2.5 m structure.

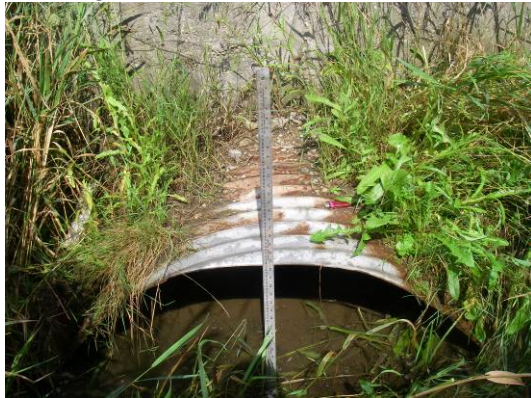
<p>Crossing C</p>

<p>Downstream looking upstream</p>	<p>Structure</p> <ul style="list-style-type: none"> • Pre-cast concrete box culvert with corrugated steel pipe downstream, • Dimensions: u/s 1.30m (w) x 0.90m (h) x 30m (l) d/s 0.5m diameter pipe • Condition : Good <p>Overall stream character :</p> <ul style="list-style-type: none"> • u/s – heavily vegetated with minimal channel definition. • d/s – channel widens with riffle substrate but becomes less defined d/s of Heritage Road crossing. • Riparian zone 15m, herbaceous plants & willow. <p>Issues / Disturbance:</p> <ul style="list-style-type: none"> • Channel width > Opening • Fencing along RHB berm downstream 	<p>BVC1 & G2</p> <p>RGA: In regime</p> <p>RSAT: Moderate habitat quality</p>	<ul style="list-style-type: none"> • Culvert currently does not take into account channel width or the meander belt width.

RGA Score: The RGA score for crossing C is 0.09 and is in a state of dynamic equilibrium. Aggradation was noted as the most dominant form of adjustment with observations of mid-channel bars, and poor longitudinal sorting of bed materials.

The existing crossing structure at crossing C consists of a 1.3 m wide and 0.9 m high box culvert at the upstream end and a 0.5 m diameter CSP in the downstream end. Upstream, the bankfull channel is slightly wider than the crossing structure. Currently the crossing appears to convey flows well with little evidence of pooling or erosion occurring upstream or downstream. However, in order to provide a geomorphologically functional structure, it is recommended that the current crossing be replaced. Based on meander amplitudes measured upstream of the crossing a minimum of 2.3 m is required from a geomorphic perspective.

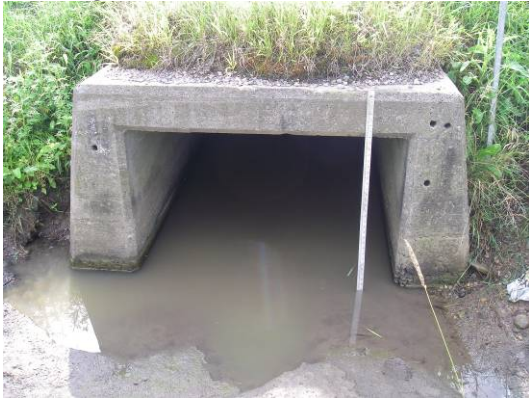
Crossing and Photograph	Description	RGA / RSAT	Management Considerations
<p>Crossing D</p>

<p>Upstream looking downstream</p>	<p>Structure</p> <ul style="list-style-type: none"> • Pre-cast concrete box culvert, open bottom, • Dimensions: 1.25m (w) x 0.80m (h) x 23m (l) • Condition : Good <p>Overall stream character :</p> <ul style="list-style-type: none"> • u/s – agricultural swale • d/s – agricultural swale, • Evidence of some erosion, patches of vegetation in channel. • Riparian zone 10-15m, herbaceous plants. <p>Issues / Disturbance:</p> <ul style="list-style-type: none"> • Channel width > Opening • Minor pooling upstream and downstream 	<p>BV-D</p> <p>RGA: In regime</p> <p>RSAT: Low habitat quality</p>	<ul style="list-style-type: none"> • Reduction of the impact of agricultural practices. • Culvert currently does not take into account channel width or the meander belt width and is causing pooling upstream and downstream.

RGA Score: The RGA score for reaches BV-D1 and BV-D2 is 0.15 and “In Regime”. Widening was found to be the most prominent mode of adjustment. Evidence of widening was observed through steep bank angles and basal scour through more than 50% of the reach length.

Currently, the crossing structure at crossing D is 1.25 m wide and 0.80 m high, which is larger than the measured bankfull width for reaches BV-D1 and BV-D2. Minor pooling and erosion are occurring immediately upstream and downstream of the crossing structure resulting in wetted widths 1.3 to 1.5 m. It is therefore recommended that the crossing structure be replaced and widened in order to prevent further exacerbation of erosion and pooling at the upstream and downstream end, and to ensure conveyance of the watercourse. The recommended structure size of 6 m, six times the average bankfull width, was deemed appropriate to convey the watercourse.

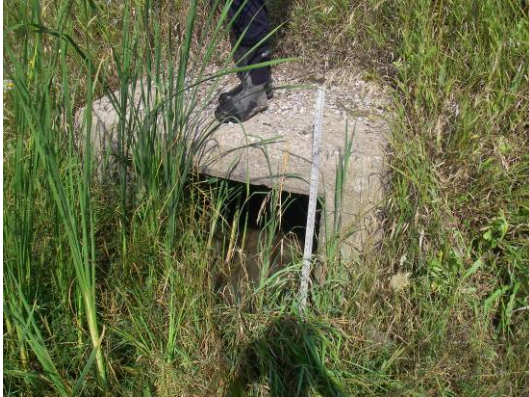
<p>Crossing E</p>

<p>Downstream looking upstream</p>	<p>Structure</p> <ul style="list-style-type: none"> • Pre-cast concrete box culvert, open bottom, • Dimensions: 0.90m (w) x 1.10m (h) x 33m (l) • Condition : Good <p>Overall stream character :</p> <ul style="list-style-type: none"> • u/s – agricultural swale • d/s – agricultural swale, bounded by driving range. • Riparian zone 6m, cattails, tall herbs. <p>Issues / Disturbance:</p> <ul style="list-style-type: none"> • Channel width > Opening • Driving range berm and fence 	<p>BV-E</p> <p>RGA: In regime</p> <p>RSAT: Moderate habitat quality</p>	<ul style="list-style-type: none"> • Reduction of the impact of agricultural practices. • Reduction of riparian pressures along the driving range would improve riparian conditions. • Culvert currently does not take into account channel width or the meander belt width.

The existing structure at crossing E is 0.9 m wide and 1.10 m high, which is larger than the measured bankfull width for reach BV-E. No evidence was found of pooling or erosion upstream or downstream of the crossing and the reach is “In Regime” with some evidence of aggradation noted. The existing structure seems to be conveying channel flow well.

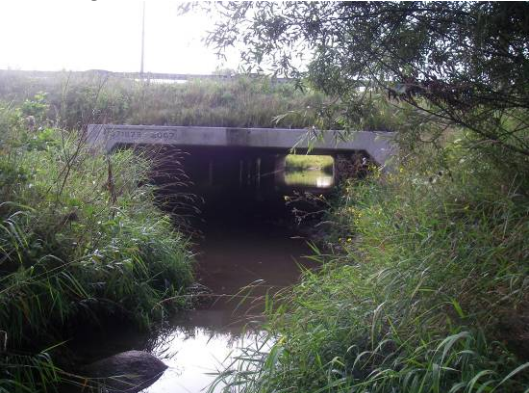
Crossing and Photograph	Description	RGA / RSAT	Management Considerations
<p>Crossing F</p>

<p>Upstream looking downstream</p>	<p>Structure</p> <ul style="list-style-type: none"> • Pre-cast concrete box culvert, open bottom • Dimensions: 5.0m (w) x 1.5m (h) x 60.00m (l) • Condition : Good <p>Overall stream character :</p> <ul style="list-style-type: none"> • Identified as Redside Dace habitat. • u/s defined channel has pool-riffle sequence, bank scouring and channel rehabilitation evident. • d/s large pool (width of culvert) prior to narrowing. • Riparian zone 20-25m, herbaceous plants with trees. <p>Issues / Disturbance:</p> <ul style="list-style-type: none"> • Channel width > Opening • Pooling occurring upstream and downstream, with erosion noted upstream. • Riprap and siltation upstream and through culvert 	<p>BV-F1 & F2 RGA: In regime</p> <p>RSAT: Moderate habitat quality</p>	<ul style="list-style-type: none"> • Redside Dace habitat protected under Endangered Species Act. • Culvert currently does not take into account channel width or the meander belt width and is causing erosion and pooling. • Key opportunity for improvement through culvert widening.

The existing culvert under Bovaird Drive is approximately 5m wide. This width is wider than the reach-average bankfull channel width of 3.5m but is narrower than the bankfull channel width at the crossing itself, where backwater conditions during peak events have resulted in localized over-widening of the channel. This indicates a lack of crossing capacity and it is therefore recommended that the replacement structure be wider to minimize any potential impacts on stream morphology.

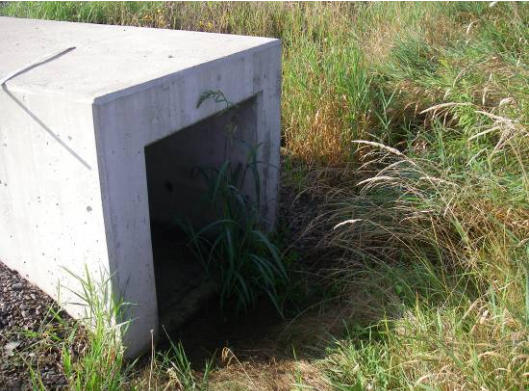
<p>Crossing G*</p>

<p>Upstream looking downstream</p>	<p>Structure</p> <ul style="list-style-type: none"> • Pre-cast concrete box culvert, closed bottom, • Dimensions: 0.94m (w) x 0.92m (h) x 33m (l) • Condition : Good <p>Overall stream character :</p> <ul style="list-style-type: none"> • u/s – no channel, culvert drains from ditch • d/s – agricultural swale, sections of wetland vegetation where channel becomes undefined. • Riparian zone 5m, herbaceous plants & crops. <p>Issues / Disturbance:</p> <ul style="list-style-type: none"> • Channel width > Opening • Agricultural practices. 	<p>BV-G RGA: In regime</p> <p>RSAT: Low habitat quality</p>	<ul style="list-style-type: none"> • Reduction of the impact of agricultural practices. • Culvert currently does not take into account channel width or the meander belt width.

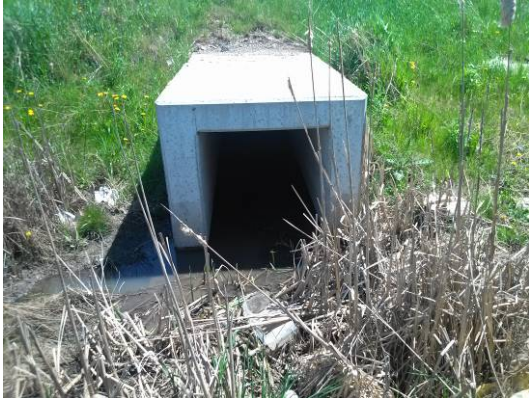
Crossing and Photograph	Description	RGA / RSAT	Management Considerations
<p>Crossing H</p>

<p>Upstream looking downstream</p>	<p>Structure</p> <ul style="list-style-type: none"> • Pre-cast concrete box culvert with corrugated steel pipe downstream, • Dimensions: u/s 0.94 (w) x 0.92m (h) x 30m (l) d/s 0.9 m diameter pipe • Condition: Good, <p>Overall stream character :</p> <ul style="list-style-type: none"> • u/s – defined channel for 100 m u/s that becomes undefined • d/s – channel is road side ditch with cattails growing in stream. • Riparian zone 250 m at u/s end, herbaceous plants and cattails; d/s 5 m, herbaceous plants, grasses and cattails. <p>Issues / Disturbance:</p> <ul style="list-style-type: none"> • Channel width > Opening • Channel drains GO station parking lot and Bovaird Drive. 	<p>BV-H RGA: Transitional</p> <p>RSAT: Low habitat quality</p>	<ul style="list-style-type: none"> • Mitigation for surface runoff from GO station parking lot would improve channel conditions • Culvert currently does not take into account channel width or the meander belt width .
