**Winston Churchill Boulevard
Mississauga, ON**

**Fluvial Geomorphological
Assessment
and
Meander Beltwidth
Assessment**

May 10, 2016

**RE: Winston Churchill Blvd, Region of Peel, ON
Fluvial Geomorphological Assessment and Meander Beltwidth Assessment**

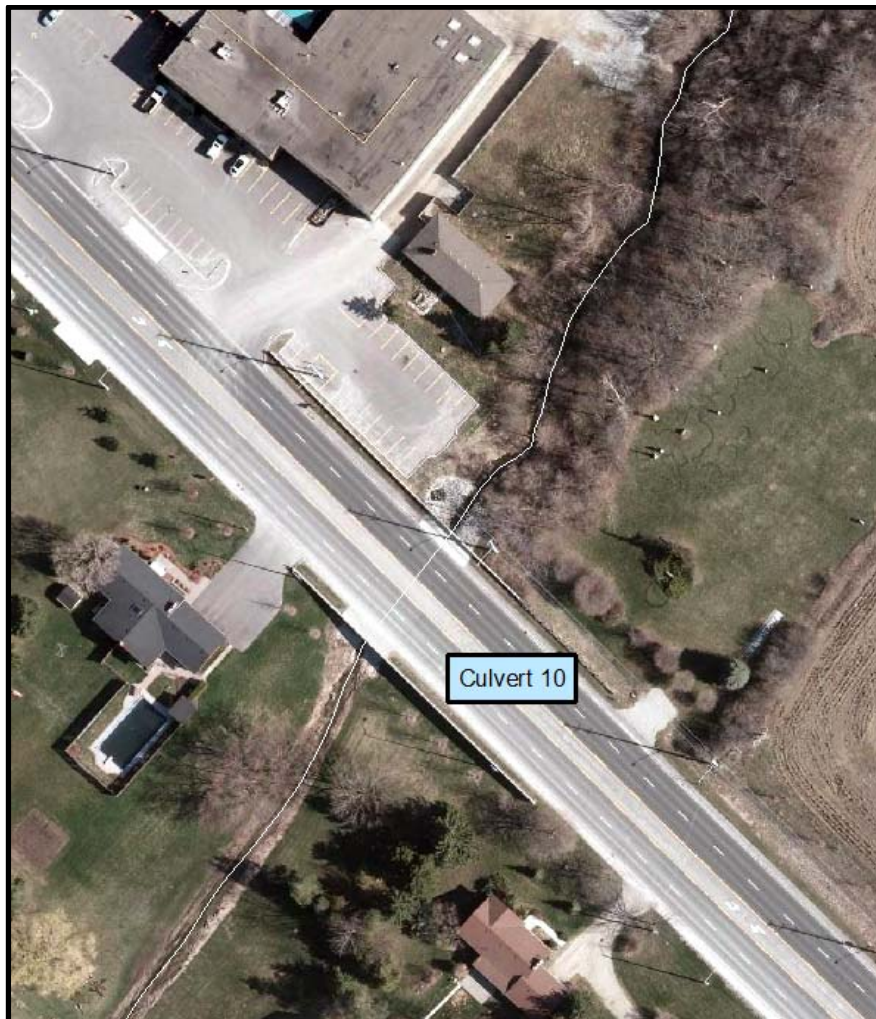
Figure 5: Aerial View of Cu-10 on Mullet Creek

This crossing is the closest crossing to Steeles Ave. and is the southernmost crossing of the three. This culvert conveys Mullet Creek through Winston Churchill Blvd. The reach is similar to crossing Cu-8 in how it has a grassed upstream end (west side) and a forested downstream end (east side). The downstream end has some erosion occurring and also contains a fair amount of large woody debris. The majority of the banks and channel are stabilized only by the roots from the riparian grasses.

Approximately 215 metres of the channel at this crossing was surveyed for this study. Four cross sections were also surveyed in this reach, two on the east side and two on the west side. The channel has a high width-to-depth ratio (>12) and is slightly entrenched. The average bankfull slope is 0.006 m/m, and the bankfull width and average depth were noted to be 1.37 m and 0.12 m. The substrate in this reach contains sands and small gravels but also contains a larger percentage of cobbles. A sieve sample was completed for the reach and the results show 8% sands and 19% gravels and 72% cobbles. A Rosgen classification of B4 has been given to this channel. Survey results can be seen in Table 1.

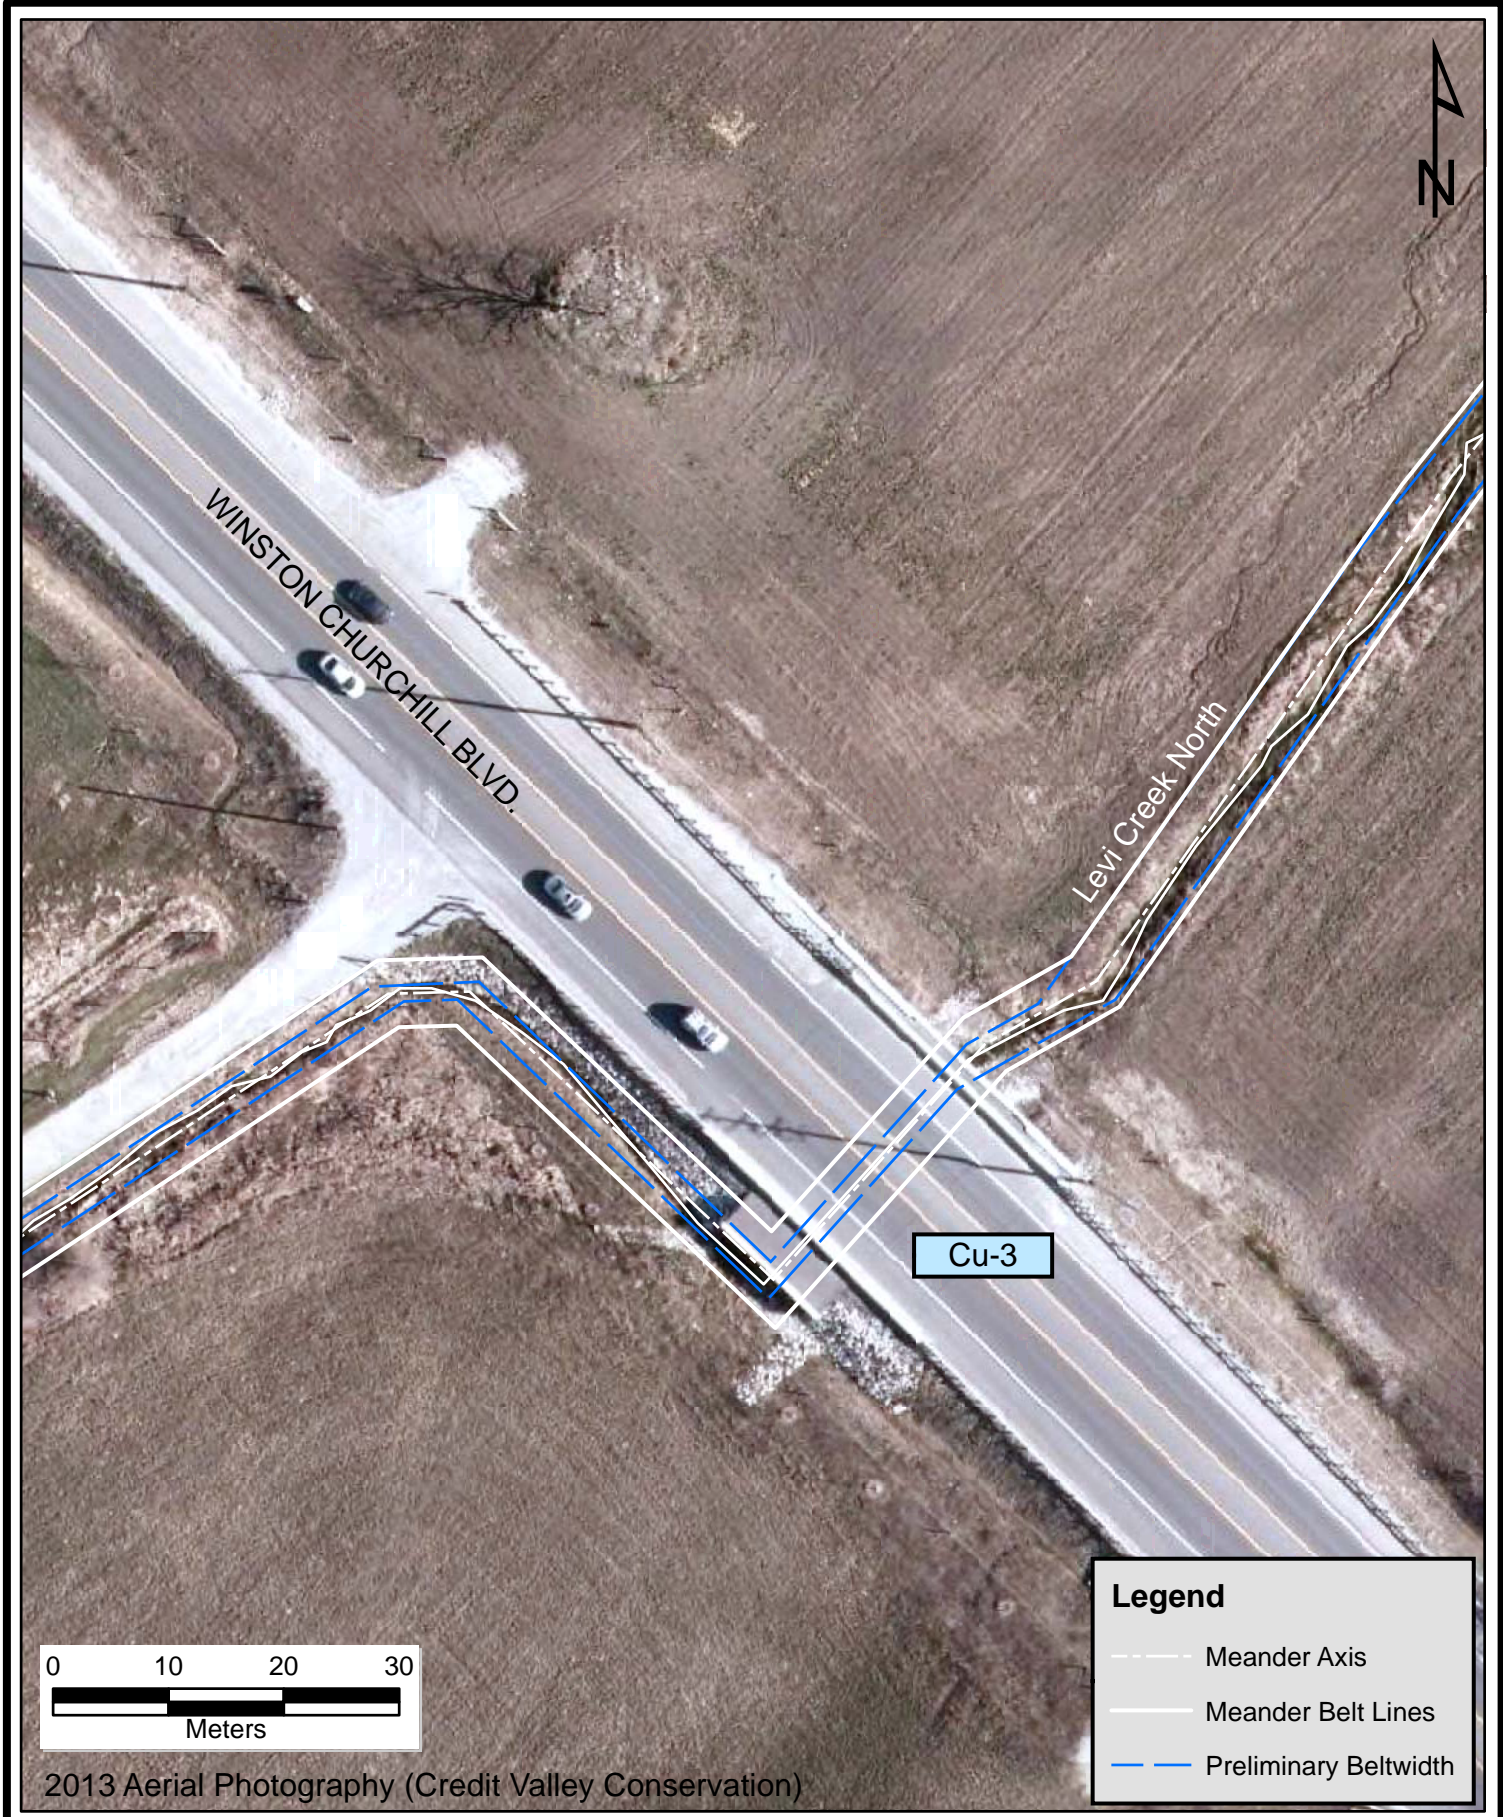
Figure No.:
10

calculated. As mentioned in the previous sub-section, the regime equations based on cross sectional width provided the most reliable estimate of meander beltwidth as they corroborated with the measured beltwidths. To provide a conservative estimate, the largest of the available beltwidths (measured or calculated) for a reach was chosen as the final beltwidth. Figures 10, 11 and 12 show the preliminary and final beltwidths for the channels.

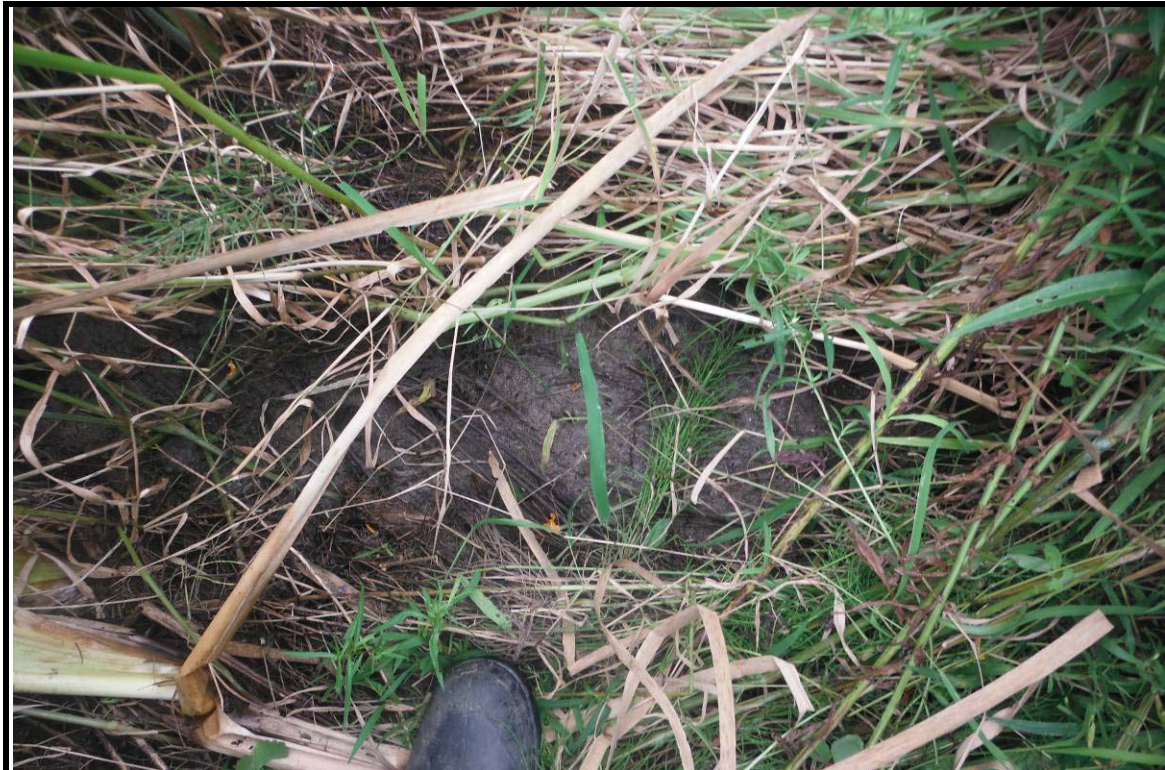
PHOTOGRAPH NO.: 3 - Culvert 3
FROM: In channel
LOOKING: At channel bed
COMMENT: Note lack of flows
