Structural Memo

OSIM Inspection Forms

For the Bridge on Winston Churchill Blvd
Located 2.70 km North of Steeles Avenue
Structure No. 19-1196390 BR01

Hatch Mott MacDonald
2800 Speakman Drive
Mississauga, ON, Canada L5K 2R7
T: 905 403 4455 F: 905 855 2607
Project Number: 336921

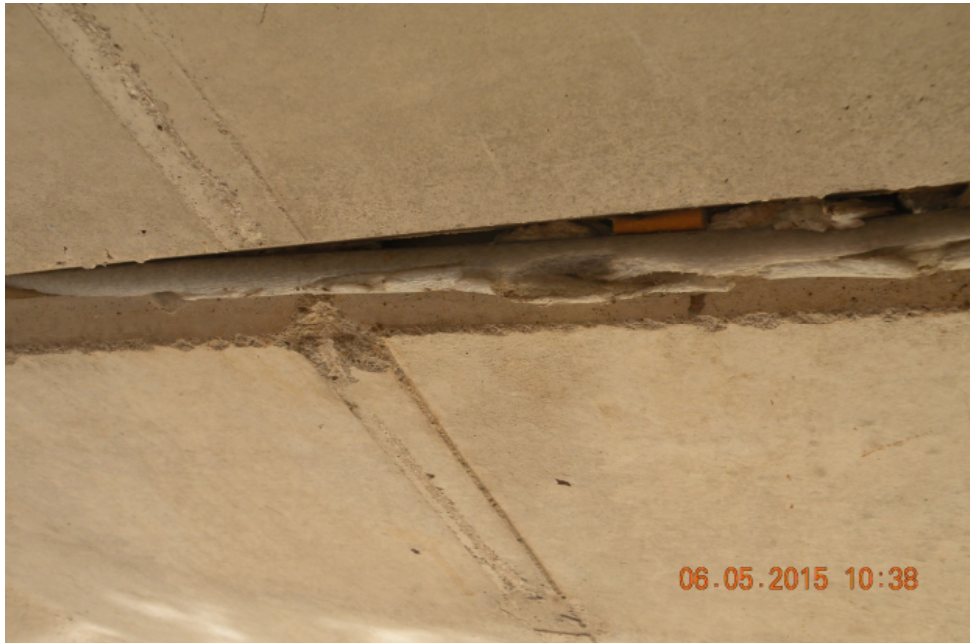
- 3rd box from West End, 2.5 m from South Abutment Wall: 300mmx500mm delaminated piece of concrete
 - Some joints have light spalling and light scaling
 - foam has been forced out from between some joints (East Side)

Form at Joint (several joints near East End)

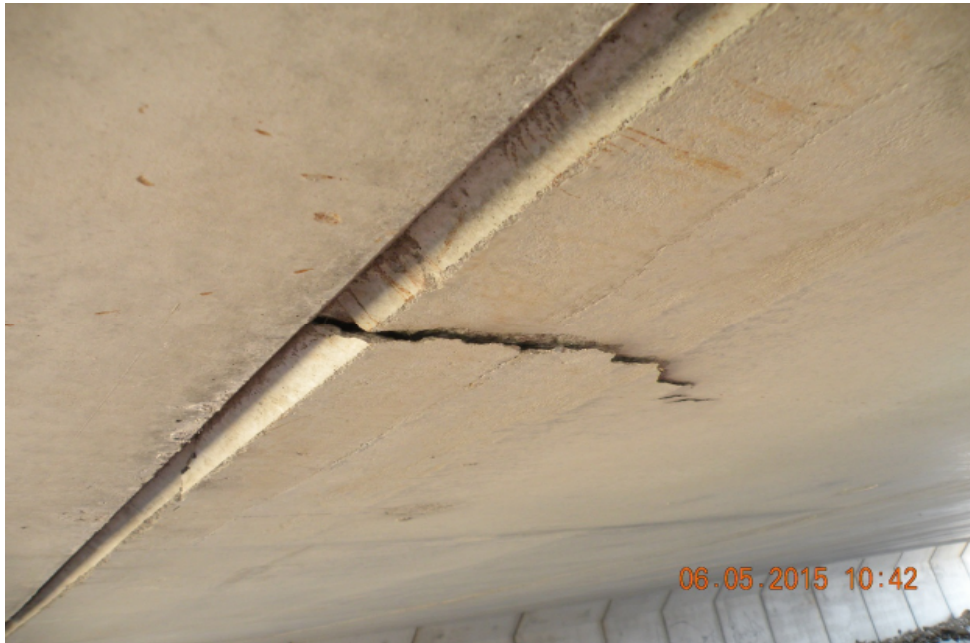
Delamination in third panel from West End

Rehab/Rehabilitation Recommendations	Priority	Cost	Comments
Minor Rehabilitation	1-5 yrs	\$3,500	Removal and patch repair concrete

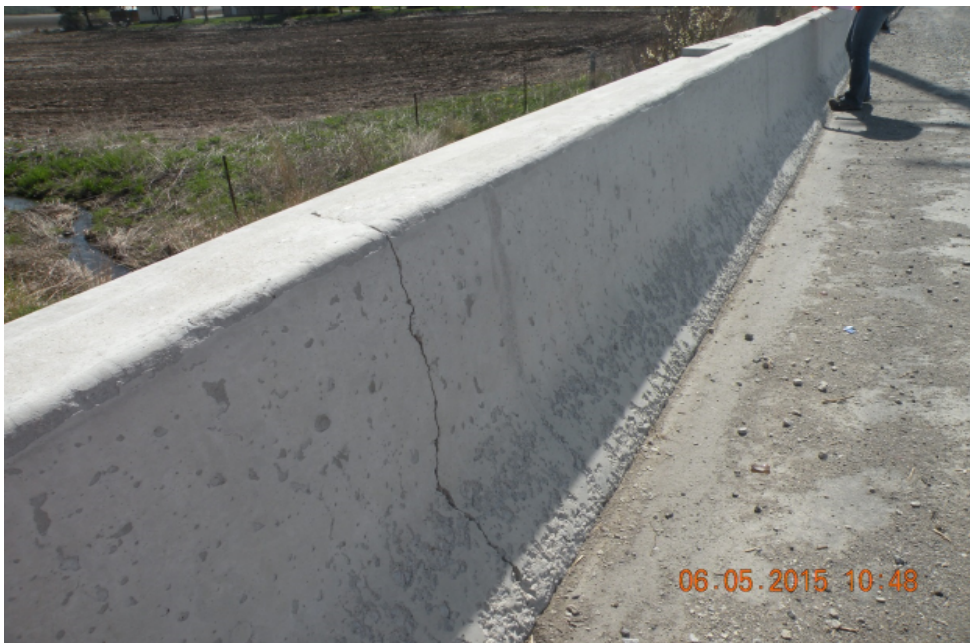
- Wide crack on west barrier - 10.5m and 16.7m from South end of barrier
 - Wide crack on east barrier - 10.5m and 16.5m from south end of barrier
 - Light/medium scaling, more concentrated on bottom leg of barrier

Comments
 - Wide crack on west barrier - 10.5m and 16.7m from South end of barrier
 - Wide crack on east barrier East - 10.5m and 16.5m from south end of barrier
 - Light scaling

Wide Crack and Scaling on Barrier Wall (typical both sides)

Rehab/Rehabilitation Recommendations	Priority	Cost	Comments
Minor Rehabilitation	6-10 yrs.	\$2,500	Seal cracks

Rehab/Rehabilitation Recommendations	Priority	Cost	Comments
Minor Rehabilitation	6-10 yrs.	\$2,500	Seal cracks.

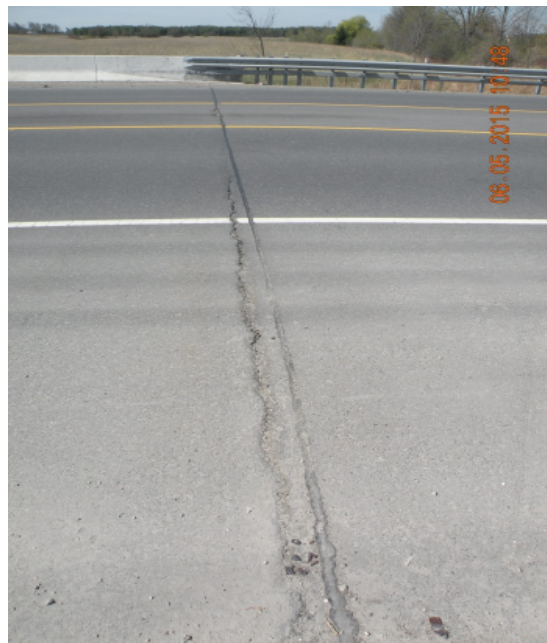
- Crack along both approach joints

Crack on Approach Wearing Surface

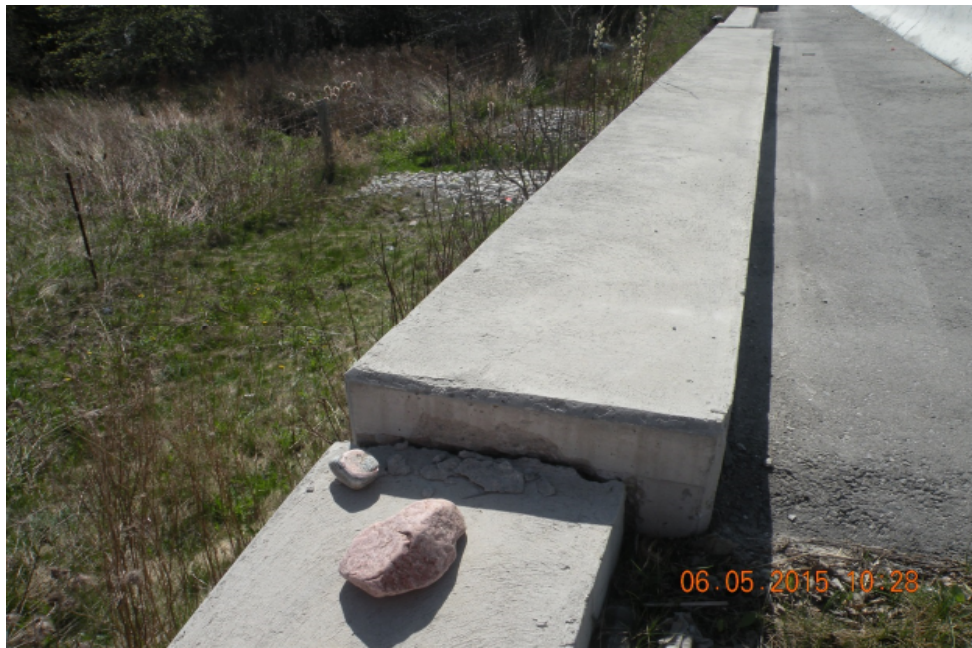
Disintegrated Concrete at RSS Connection

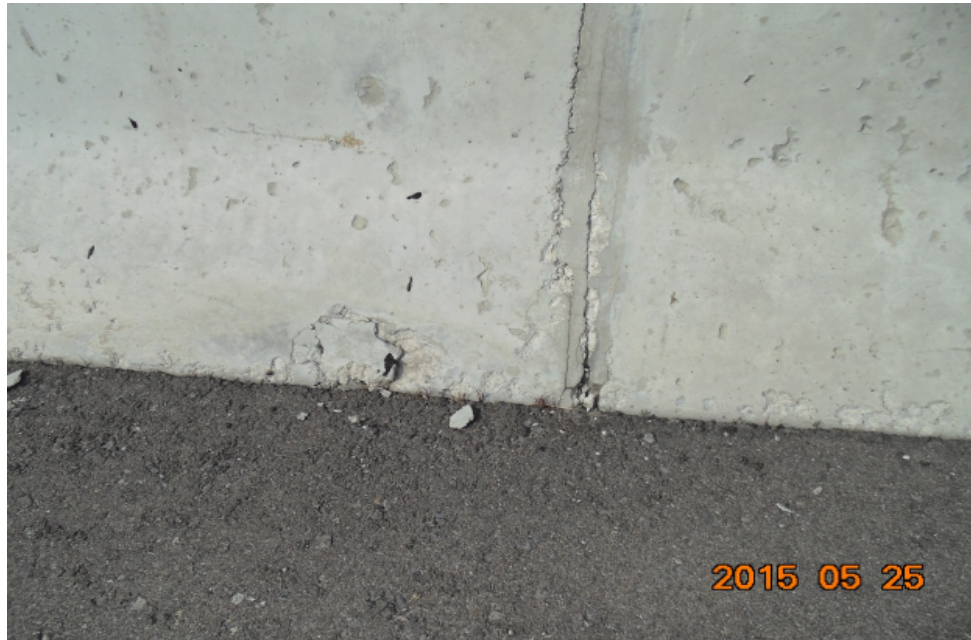
Typical Scaling on Barrier Wall

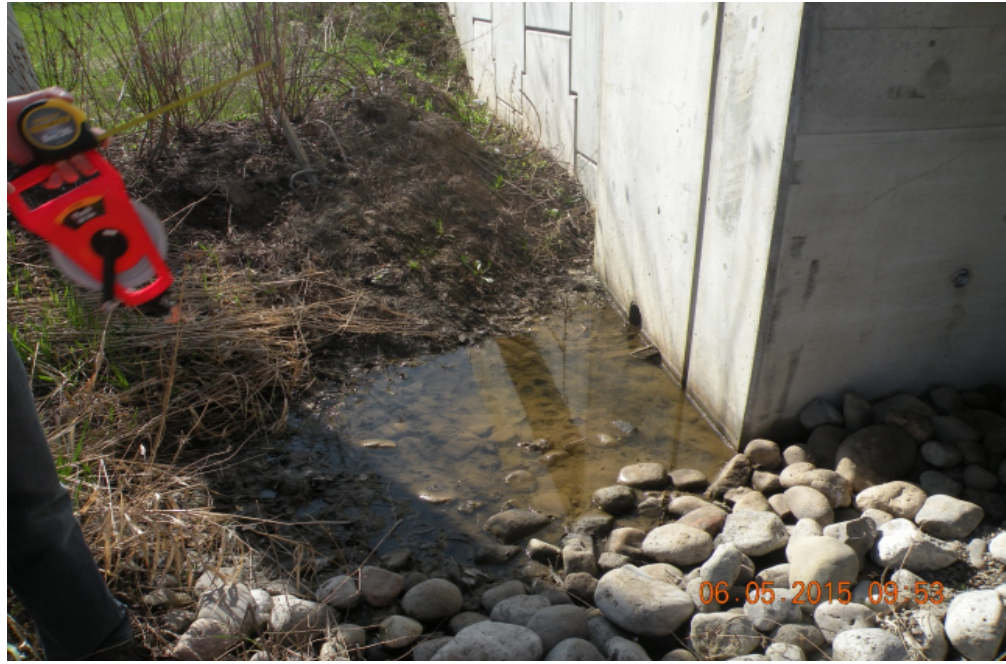
Typical Ponding at Abutment Corners

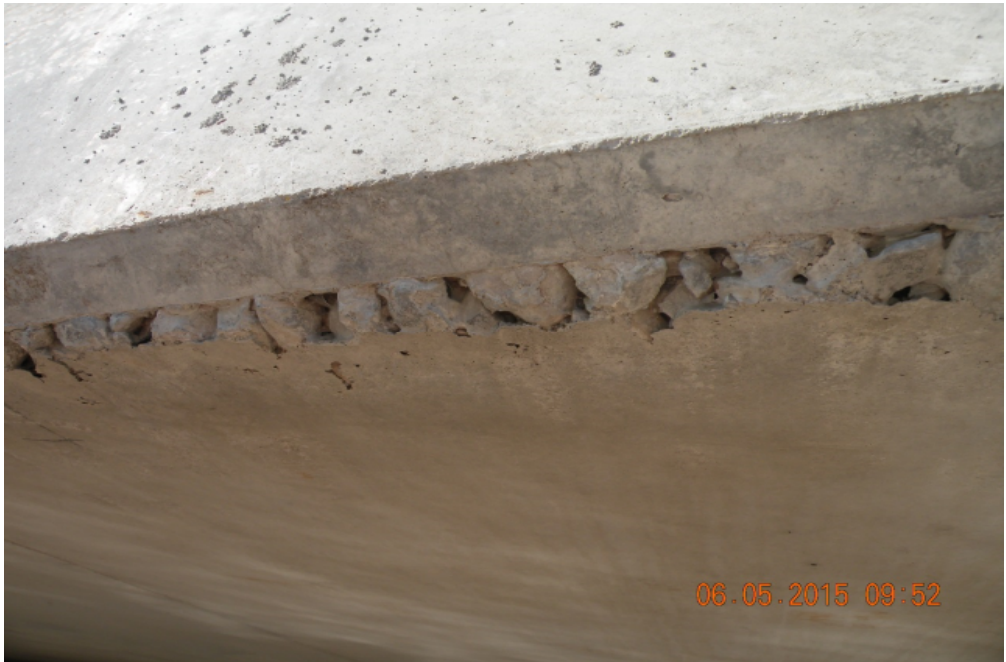
Honeycombing at Soffit

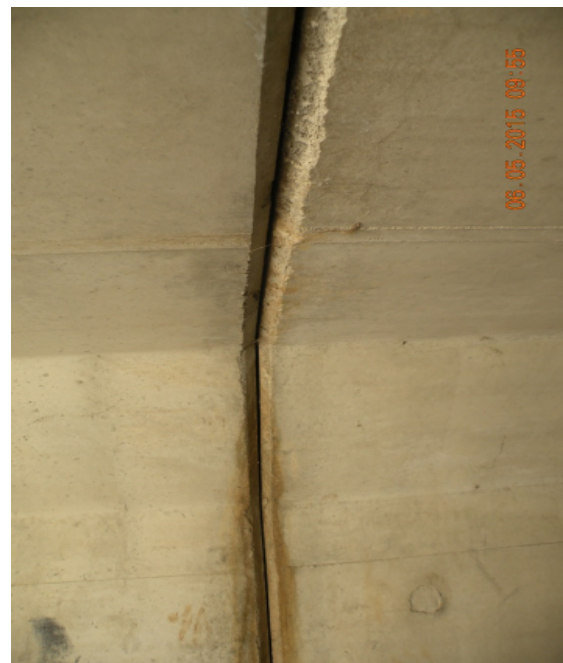
Joint with Staining and Scaling

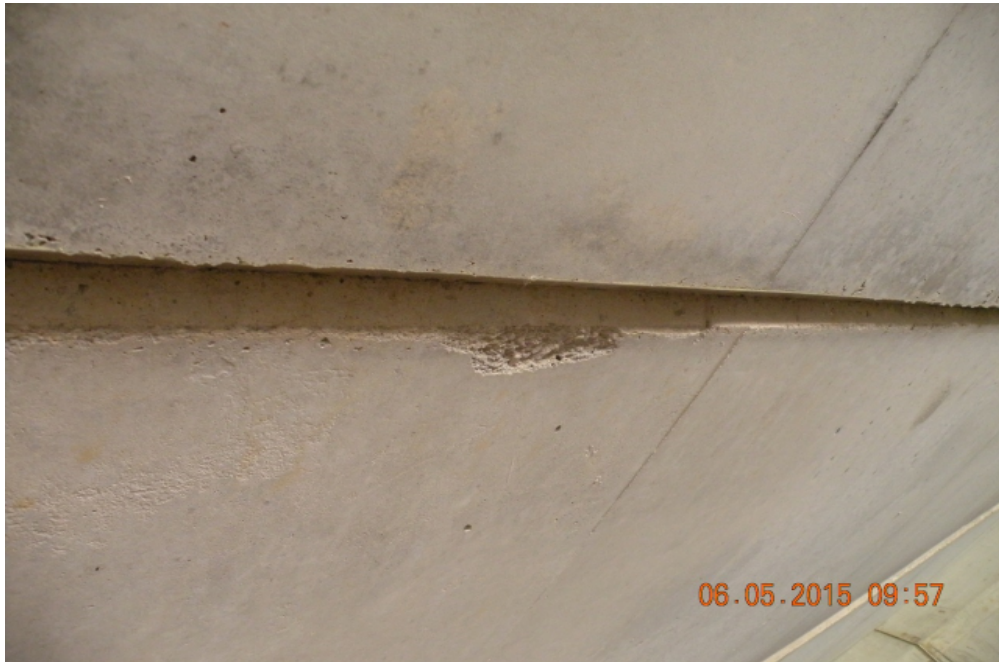
Spall at Soffit Joint

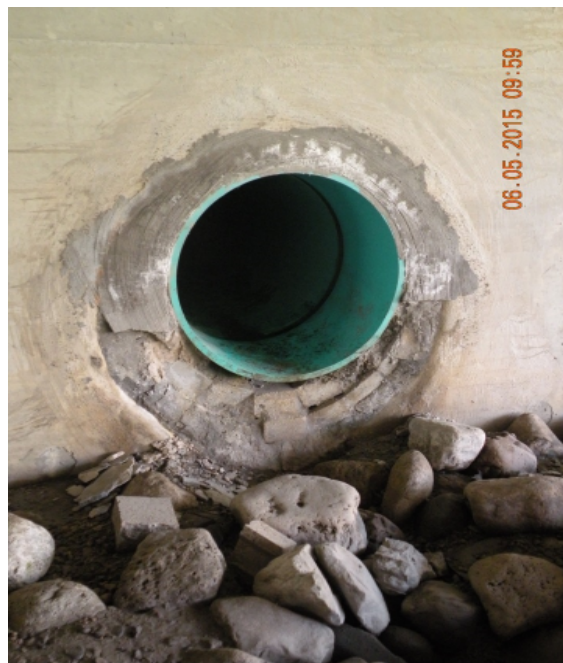
Spalling around PVC Inlet

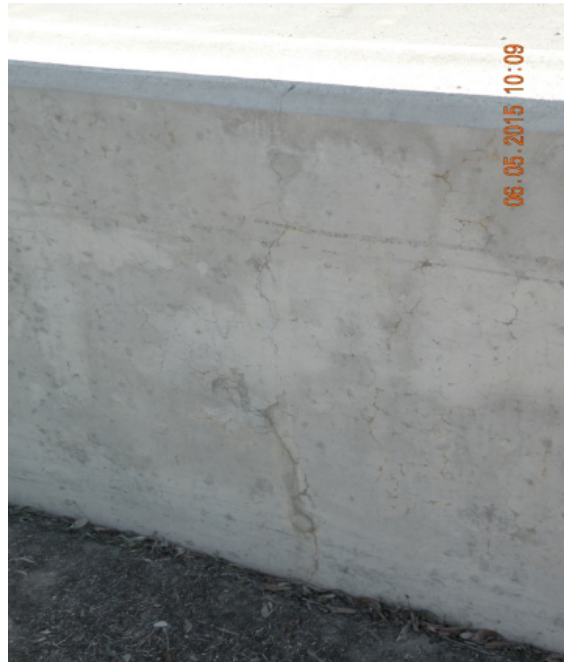
Narrow Crack on Interior Parapet Wall

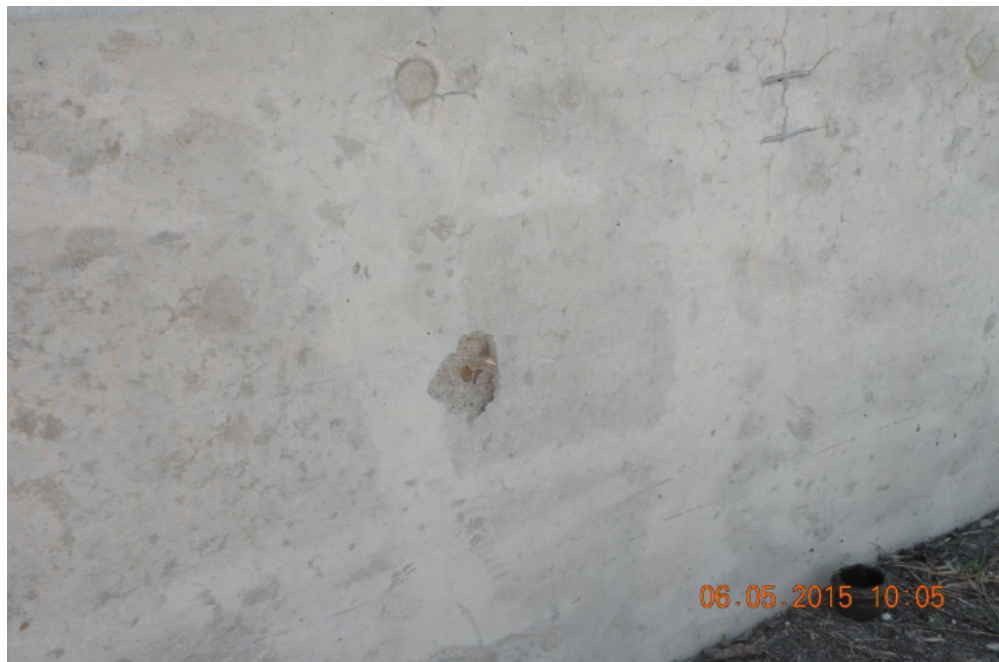
Spall on Interior Parapet Wall
