Culvert Assessment

Minor Culvert Condition Survey along Bush Street, Mississauga Road,
Old Base Line Road and Winston Churchill Boulevard, Belfountain, ON
GEOTETOB21649AA

02 April 2014

**RE: SUMMARY OF FINDINGS (final)
Minor Culvert Condition Survey along Bush Street, Mississauga Road, Olde Baseline Road
and Winston Churchill Boulevard, Belfountain, ON**

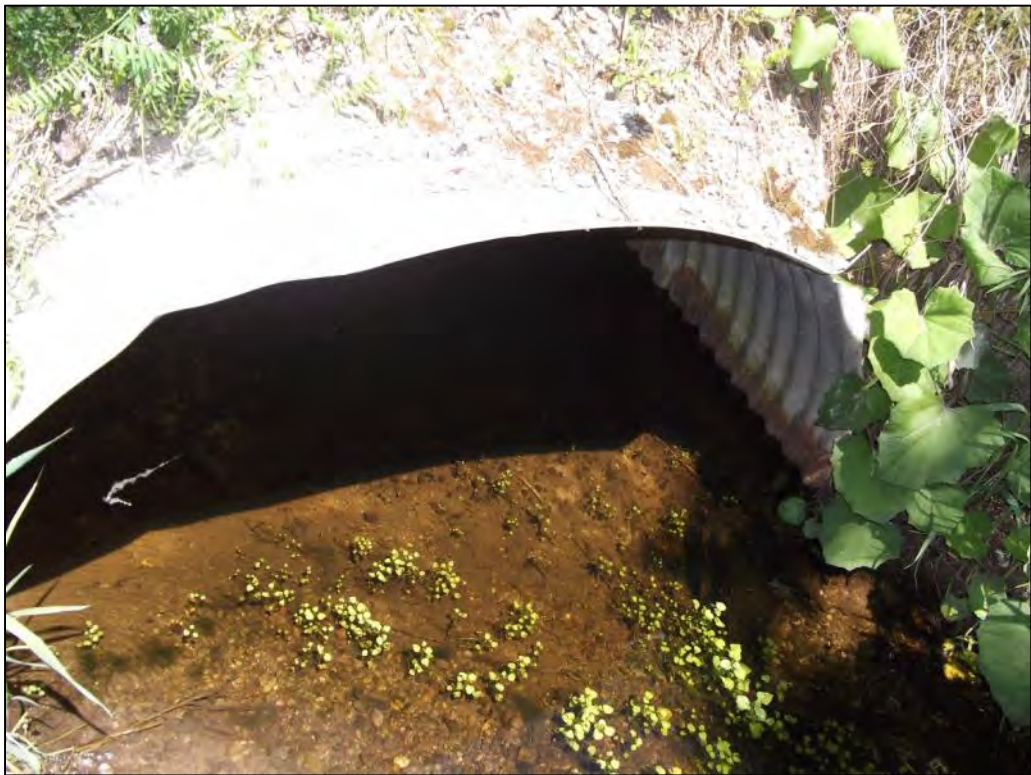
Photo P15 – CUL-019-344

CUL-019-344	CUL-CC	P15-P16		WINSTON CHURCHILL BLVD	118 M NORTH OF 16065 TO THE WEST SIDE OF OUTLAND END	5TH SRD -- THE GRANGE SRD	CENTRE	Looks 1000	CS	O	N	15.30	580631.74	4845305.19	23-Sep-2011	F	20% filled with accumulated debris	May needs flushing
CUL-019-345	CUL-CC	P17-P18		WINSTON CHURCHILL BLVD	J/O 5TH SRD	5TH SRD -- THE GRANGE SRD	CENTRE	600	P	R	N	13.60	580841.19	4845092.50	23-Sep-2011	G		Do nothing
CUL-019-346	CUL-CC	P19-P20		WINSTON CHURCHILL BLVD	286 M NORTH OF 5072	OLDE BASELINE RD -- 5TH SRD	CENTRE	400	CS	R	N	12.35	580974.61	4844956.58	23-Sep-2011	P	60% Blocked, rusted and damaged. Needs flushing	Repair, flushing
CUL-019-347	CUL-CC	P21-P22		WINSTON CHURCHILL BLVD	AT SOUTH ENTRAQNC OF 5072	OLDE BASELINE RD -- 5TH SRD	CENTRE	660	CS	R	N	11.00	581181.47	4844747.54	23-Sep-2011	F	30 - 40% filled with accumulated debris	Needs flushing
CUL-019-348	CUL-CC	P23-P24		WINSTON CHURCHILL BLVD	50 M NORTH OF 15739	OLDE BASELINE RD -- 5TH SRD	CENTRE	400	CS	R	N	12.80	581389.23	4844538.44	23-Sep-2011	F	Rusted , damaged at west end	West end needs to be repaired

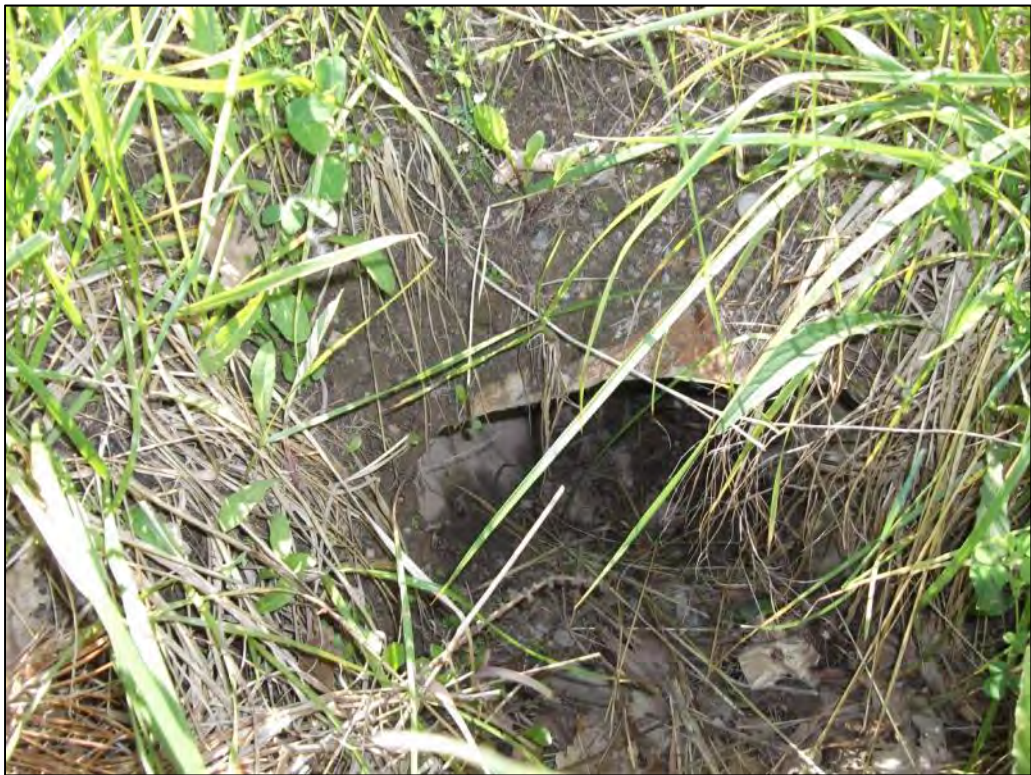
Photo P73 – CUL-019-387

CUL-019-387	CUL-EC	P73-P74		WINSTON CHURCHILL BLVD	5262	THE GRANGE SRD -- 10TH SRD	SOUTH BOUND	400	CS	R	N	6.30	579079.00	4846885.00	23-Sep-2011	F	Rusted and a bit damaged at south end	South end needs to be repaired
CUL-019-388	CUL-EC	P75-P76		WINSTON CHURCHILL BLVD	5252	THE GRANGE SRD -- 10TH SRD	CENTRE	400	CS	R	N	16.00 (App.)	579217.33	4846724.90	23-Sep-2011	P	East end rusted with 60% filled with accumulated debris. West end is not accessible	Repair, flushing
CUL-019-389	CUL-EC	P77-P78		WINSTON CHURCHILL BLVD	5192	THE GRANGE SRD -- 10TH SRD	SOUTH BOUND	400	CS	R	N	18.40	579635.63	4846296.96	23-Sep-2011	G		Do nothing
CUL-019-390	CUL-CC			WINSTON CHURCHILL BLVD		10TH SRD -- BUSH ST	CENTRE	900	CS	R	N	23.00	578046.66	4847917.84	23-Sep-2011	G	COULD NOT LOCATE	
CUL-019-391	CUL-CC	P79-P80		WINSTON CHURCHILL BLVD	22 M SOUTH OF 17049	10TH SRD -- BUSH ST	CENTRE	900	CS	R	N	15.00	578589.14	4847369.10	23-Sep-2011	G		Do nothing

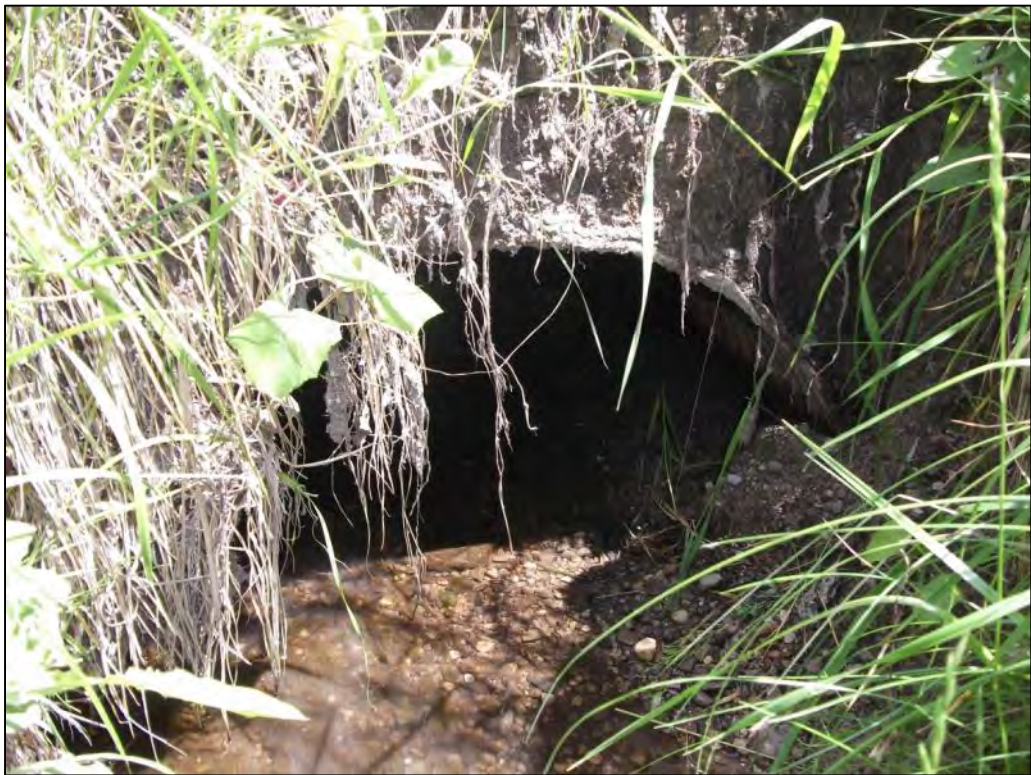
Photo P81 – CUL-019-392

CUL-019-392	CUL-CC	P81-P82		WINSTON CHURCHILL BLVD	17 M SOUTH OF SIDEROAD 10	THE GRANGE SRD -- 10TH SRD	CENTRE	550	CS	R	N	14.90	578668.87	4847267.84	23-Sep-2011	F	25% filled with accumulated debris and rusted. Access to east end with difficulty	Repair, flushing
CUL-019-393	CUL-CC	P83-P84		WINSTON CHURCHILL BLVD	29 M NORTH OF 5274	THE GRANGE SRD -- 10TH SRD	CENTRE	460	CS	R	N	18.20	578924.60	4847034.70	23-Sep-2011	F-G	Rusted, damaged at west end	West end needs to be repaired
CUL-019-394	CUL-CC	P85-P86		WINSTON CHURCHILL BLVD	10 M SOUTH OF 5258	THE GRANGE SRD -- 10TH SRD	CENTRE	460	CS	R	N	22.20	579142.55	4846816.77	23-Sep-2011	F-P	Rusted and damaged at both ends	To be replaced
CUL-019-397	CUL-CC	P89-P90		WINSTON CHURCHILL BLVD	5 M NORTH OF THE GRANGE SIDE RD	THE GRANGE SRD -- 10TH SRD	CENTRE	400	CS	R	N	15.50	579970.15	4845977.14	23-Sep-2011	F-P	Rusted, damaged and 50% filled with accumulated debris at east end, west end is fine	East end needs to be repaired and flushing

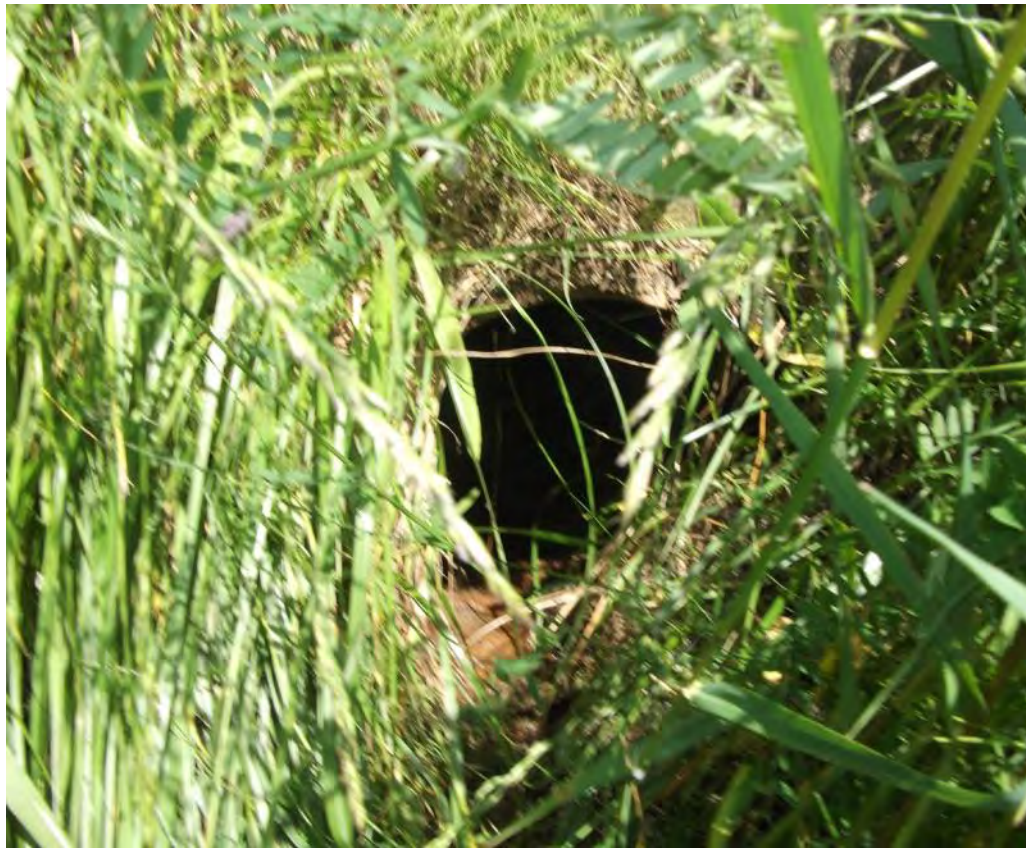
Photo P91 – CUL-019-398

CUL-019-398	CUL-EC	P91-P92		WINSTON CHURCHILL BLVD	16927	THE GRANGE SRD -- 10TH SRD	NORTH BOUND	460	CS	R	N	8.50	578883.49	4847087.55	23-Sep-2011	F-G	Rusted inside	Repair
CUL-019-399	CUL-FE	P93-P94		WINSTON CHURCHILL BLVD	140 M NORTH OF 16927	THE GRANGE SRD -- 10TH SRD	NORTH BOUND	460	CS	R	N	6.30	578780.51	4847190.53	23-Sep-2011	P	Rusted and badly damaged at north end	To be replaced
CUL-019-400	CUL-EC	P95-P96		WINSTON CHURCHILL BLVD	17353	10TH SRD -- BUSH ST	NORTH BOUND	400	CS	R	N	10.00	577990.85	4848003.06	23-Sep-2011	G	Does not exist, visually appears that owner may have burried it	
CUL-019-401	CUL-EC	P97-P98		WINSTON CHURCHILL BLVD	65 M NORTH OF 5342	10TH SRD -- BUSH ST	SOUTH BOUND	900	CS	R	N	5.90	578149.20	4847799.15	23-Sep-2011	F	Damaged at north end	To be repaired
CUL-019-402	CUL-EC	P99-P100		WINSTON CHURCHILL BLVD	5342	10TH SRD -- BUSH ST	SOUTH BOUND	600	CS	R	N	7.00	578215.35	4847735.83	23-Sep-2011	G		Do nothing
