**FLUVIAL GEOMORPHOLOGY AND HYDRAULIC ASSESSMENTS
ENVIRONMENTAL ASSESSMENT (EA) AND PRELIMINARY DESIGN
FOR DRAINAGE IMPROVEMENTS OF HIGHWAY 50 FROM
MAYFIELD ROAD TO HEALEY ROAD
REGION OF PEEL, CALEDON, ONTARIO**

Prepared for:
R.V. ANDERSON ASSOCIATES LIMITED

Prepared by:
MATRIX SOLUTIONS INC.

Version 1.1
November 2021
Mississauga, Ontario

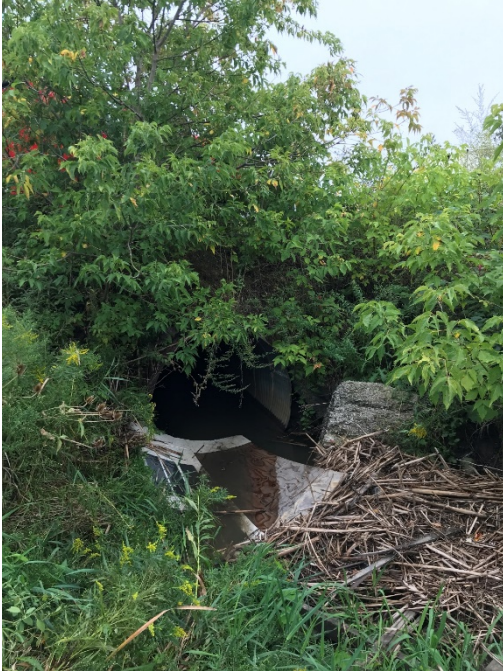
FIGURE 5 Culvert 2 Upstream End

Notably, this structure was not appraised as part of the Region of Peel condition assessments provided to Matrix, likely because of its location being situated on private property.

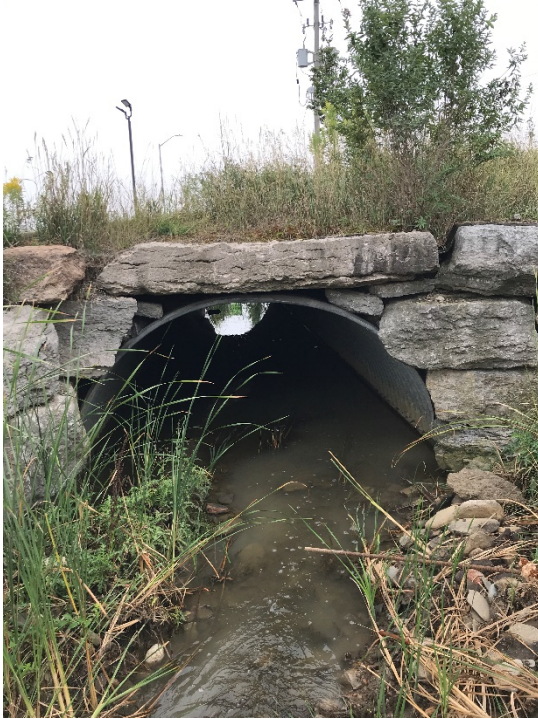
FIGURE 7 Culvert 3 Upstream End

Notably, this structure was appraised as “Fair Condition” by the structure condition assessments completed by Region of Peel. The corresponding Region of Peel structure ID is: “FROM - RR050-0215 TO - RR050-0216.”

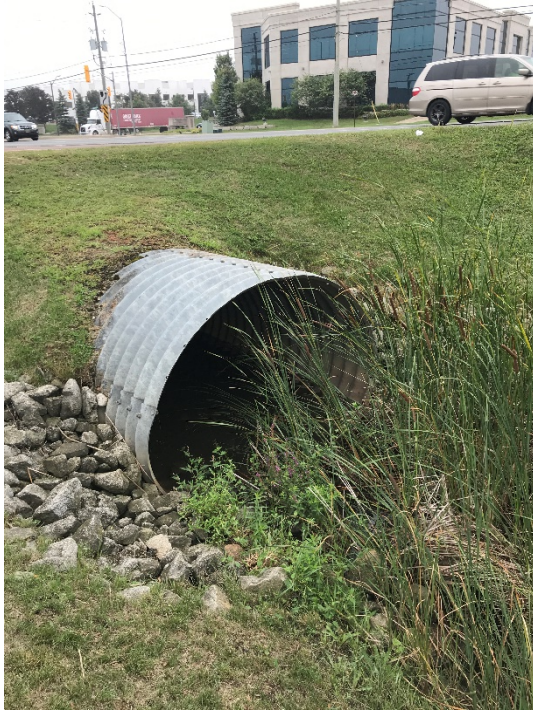
FIGURE 9 Culvert 4 Upstream End

Notably, this structure was appraised as “Fair Condition” by the structure condition assessments completed by Region of Peel. The corresponding Region of Peel structure ID is: “FROM - RR050-0213 TO - RR050-0214.”

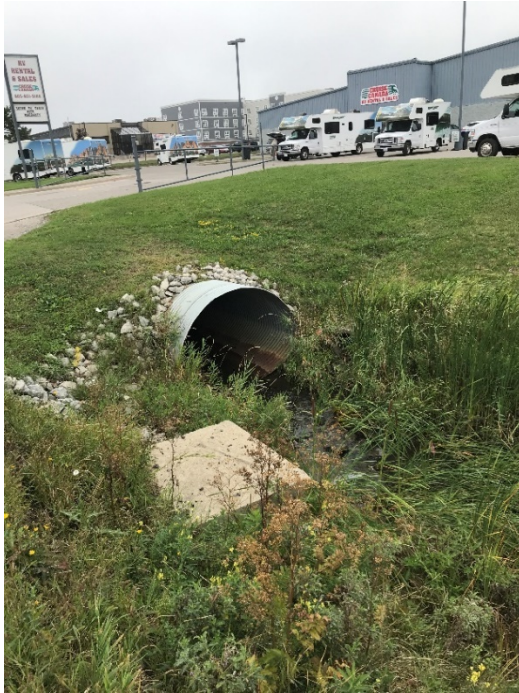
FIGURE 11 Culvert 5 Downstream End

Notably, this structure was appraised as “Fair Condition” by the structure condition assessments completed by Region of Peel. The corresponding Region of Peel structure ID is: “FROM - RR050-0211 TO - RR050-0212.”

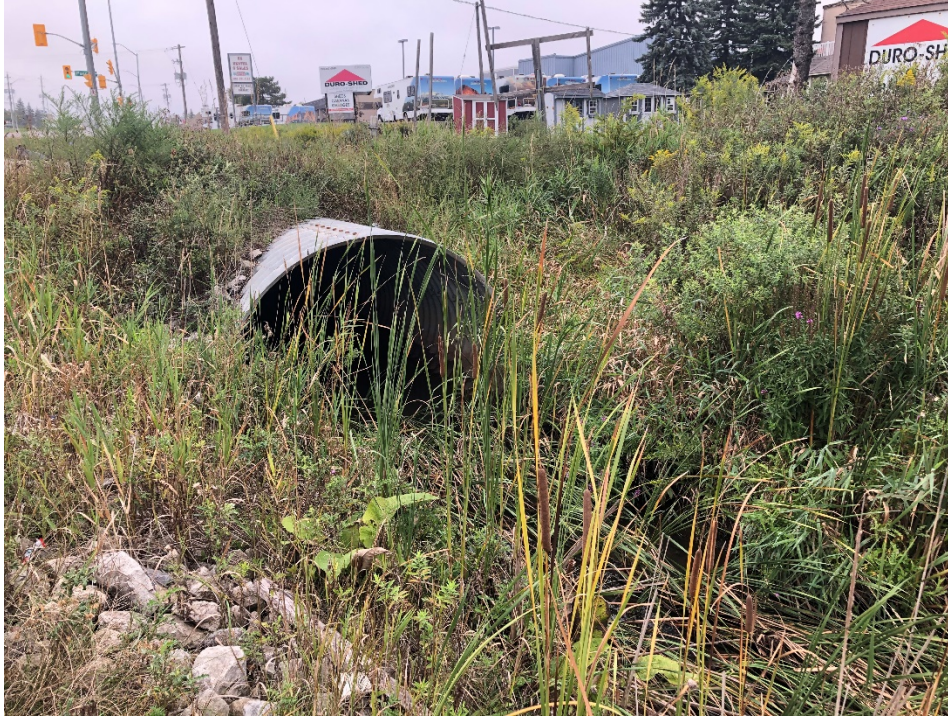
FIGURE 13 Culvert 6 Downstream End

Notably, this structure was appraised as “Fair Condition” by the structure condition assessments completed by Region of Peel. The corresponding Region of Peel structure ID is: “FROM - RR050-0209 TO - RR050-0210.”

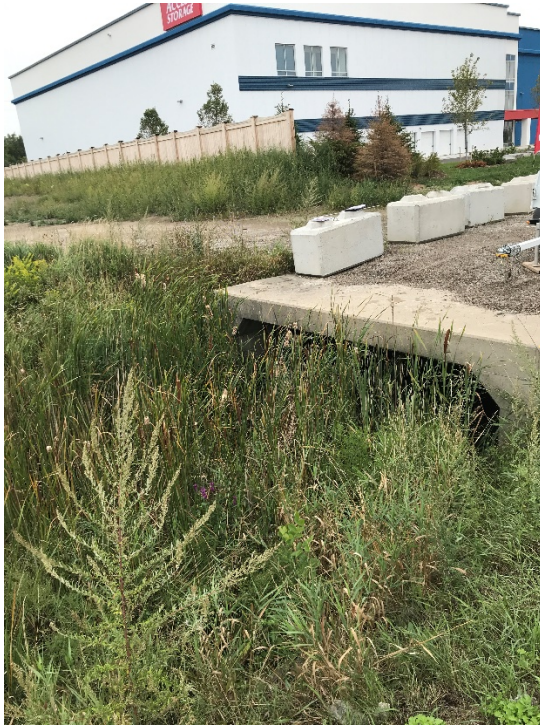
FIGURE 14 Culvert 7 Upstream End

Notably, this structure was appraised as “Very Good Condition” by the structure condition assessments completed by Region of Peel. The corresponding Region of Peel structure ID is: “501227.”

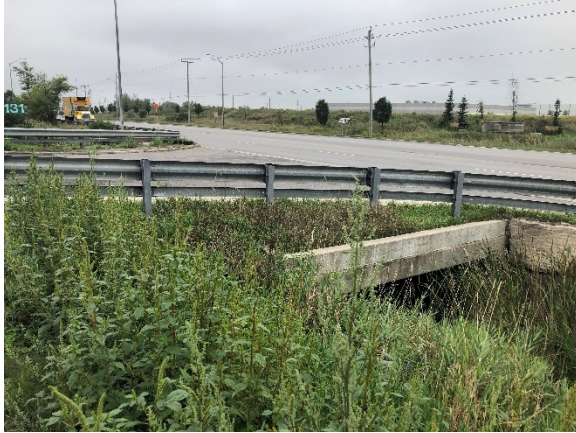
FIGURE 16 Culvert 8 Upstream End

Notably, this structure was appraised as “Very Good Condition” by the structure condition assessments completed by Region of Peel. The corresponding Region of Peel structure ID is: “501220.”

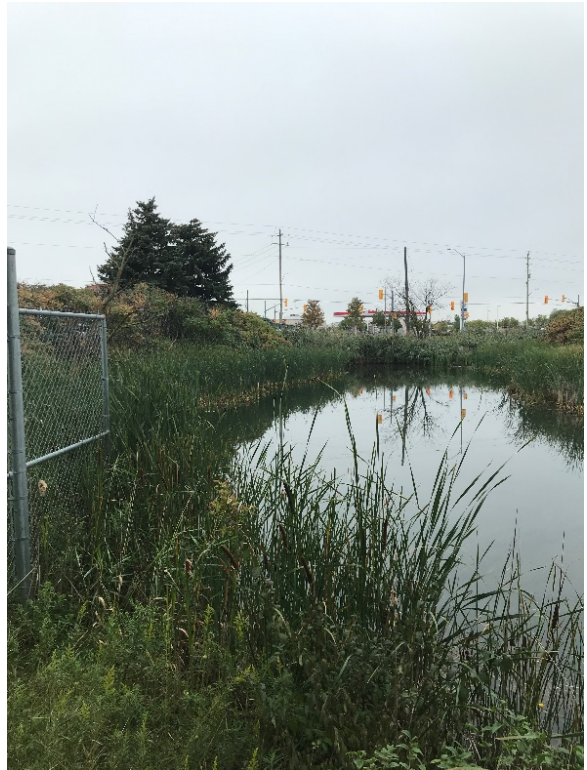
FIGURE 18 Existing Pond Looking Upstream

An online pond exists immediately downstream of Culvert 1. The pond appears to have no formalized inlet/outlet controls and appears largely unmaintained, with heavy siltation and overgrown invasive vegetation (Figure 18). Although the pond is not delineated by security fence along the RR50 boundary, the pond appears to be situated largely beyond the RR50 RoW. In addition to the upstream watercourse areas contributing to the pond, one small diameter inlet from the eastern side was located, presumed to provide some function of stormwater servicing to the adjacent private Ontario Provincial Police property.

It is recommended that better understanding of the ownership/jurisdiction, form/function and maintenance/operation of the pond be further understood by the EA project team, as it pertains to ramifications of the assessed alternatives for improvement. It is understood there is a future easterly extension of George Bolton Parkway, which will require due consideration for Culvert 1 and the pond downstream.

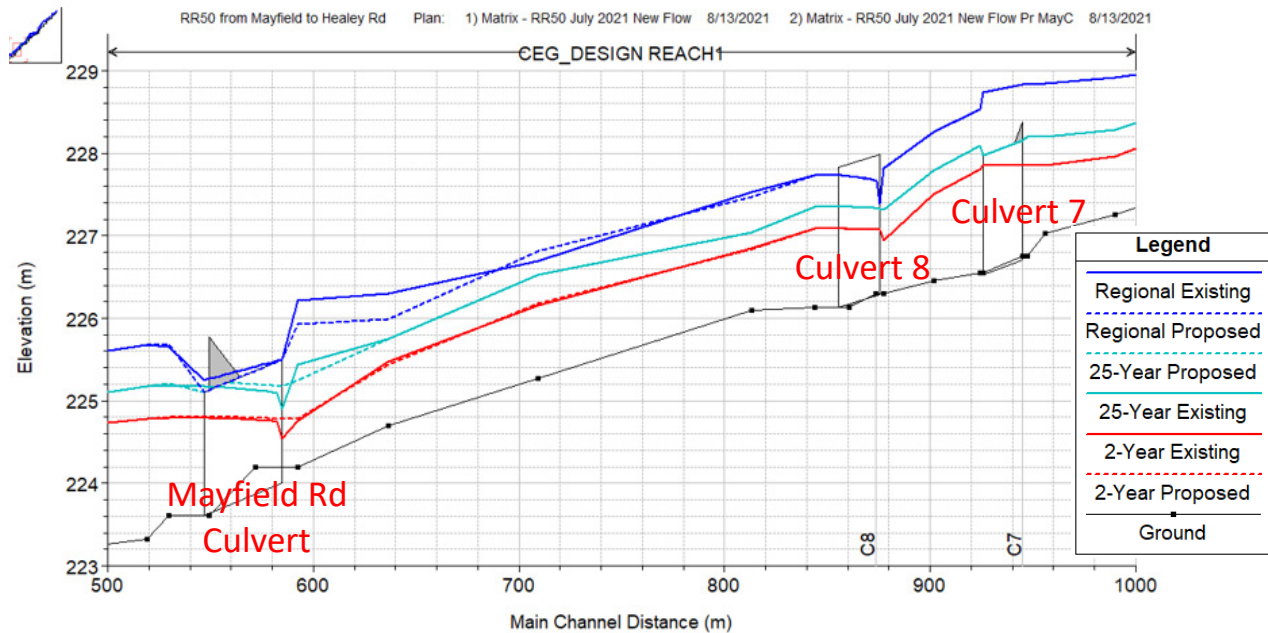
FIGURE 29 Water Level Profile for Existing Mayfield Road Culvert and Proposed Mayfield Road Culvert During the 2-year, 25-year, and the Regional events

Figure 29 shows water level profiles for existing and proposed conditions during three storm events including the 2-year, 25-year, and the Regional events. The results show that the proposed twin culverts lower water levels immediately upstream, but the improvements do not extend as far upstream as Culvert 8 for any of the events. Near Mayfield Road, the increased capacity of proposed twin culverts leads water level decrease compared with the existing water level. Table 12 shows the water levels and differences between the existing and proposed conditions at the upstream end of Mayfield Road. It is found that water levels are decreased on the proposed conditions from 2-year through the Regional event. Overall, the proposed Mayfield Road twin culverts do not alter the hydraulic performance of Culvert 8 and do not alter spill conditions on RR50 during all modelled events.
