March 7, 2024

Arcadis  
8133 Warden Ave, Unit 300  
Markham, Ontario  
L6G 1B3

**Re: Fluvial Geomorphology Assessment at subject reach of Cooksville Creek  
Detailed Design and Schedule 'B' Class EA Services for the 525-mm Sanitary  
Sewer - Kirwin Avenue (Cooksville Creek) Project 23-2129  
City of Mississauga, Region of Peel  
GEO Morphix Ltd. Project No. PN23123**

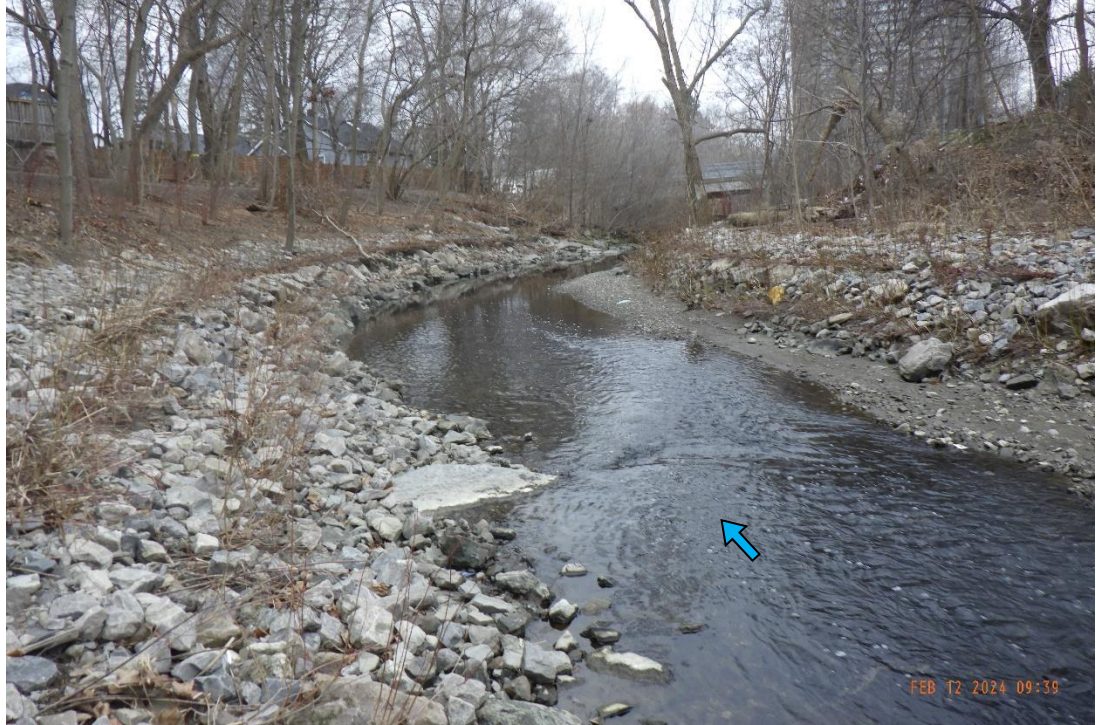
Photo 1

Upstream of Kirwin Drive and the subject sewer crossing location, Cooksville Creek was armoured with riprap and armourstone grade controls. The arrow denotes flow direction.

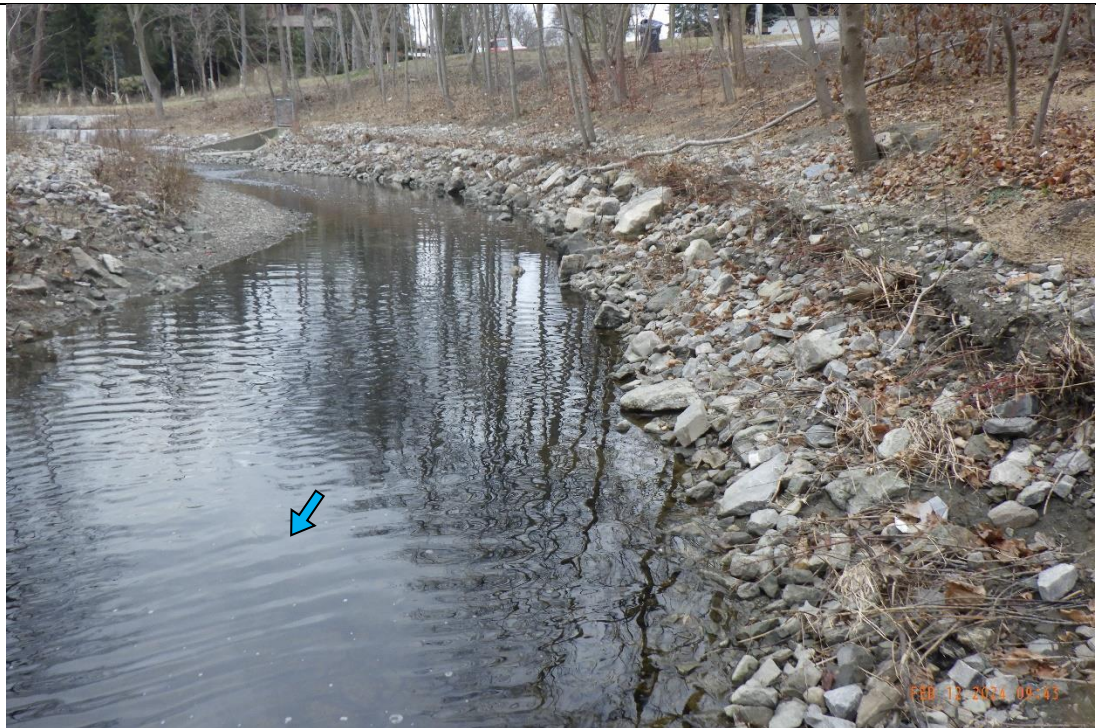
Photo 2

Sections of the treatment were in poor condition. For example, riprap had become detached and displaced in-channel. Till exposure was also documented along the channel bed.

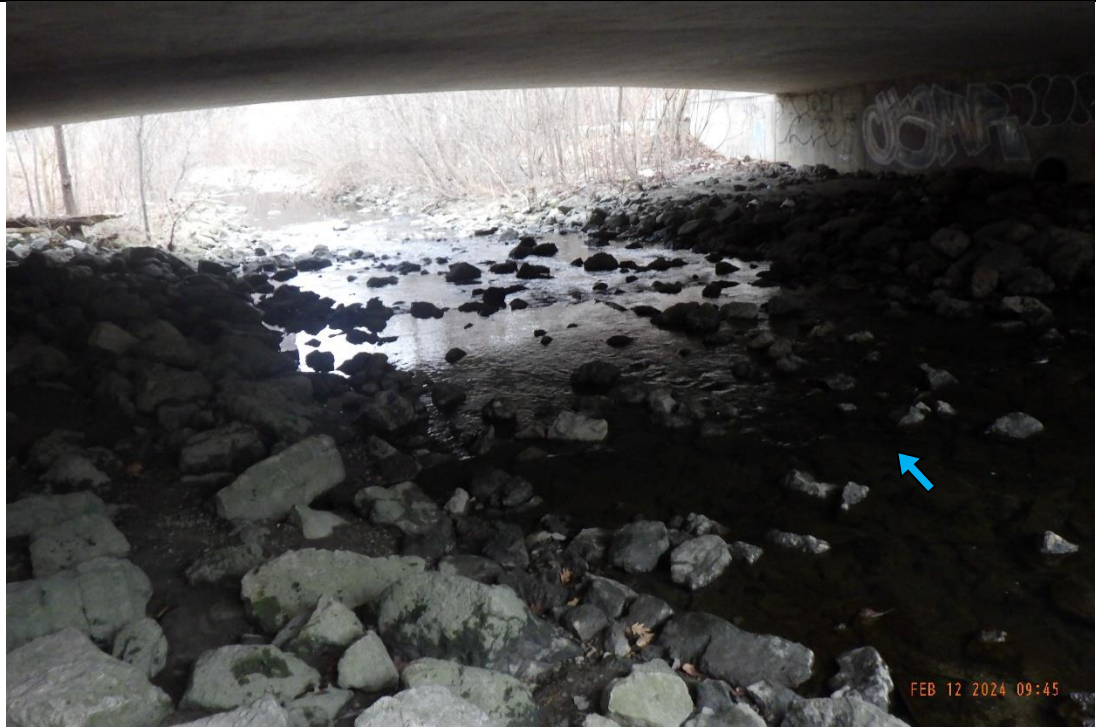
Photo 3

The channel was historically reinforced with riprap within and downstream of the Kirwin Drive stream crossing.

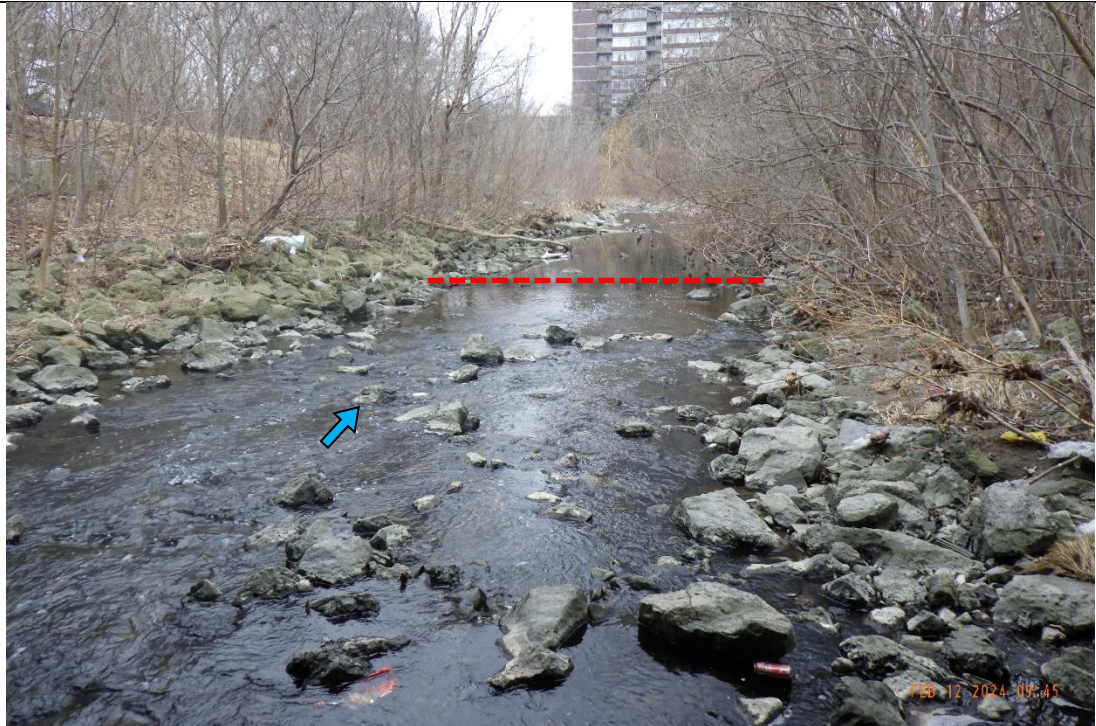
Photo 4

The riprap treatment extended downstream of Kirwin Drive. The treatment was in moderately stable condition. There was limited evidence of scouring and channel banks were well vegetated. The approximate proposed sewer crossing is delineated in red.

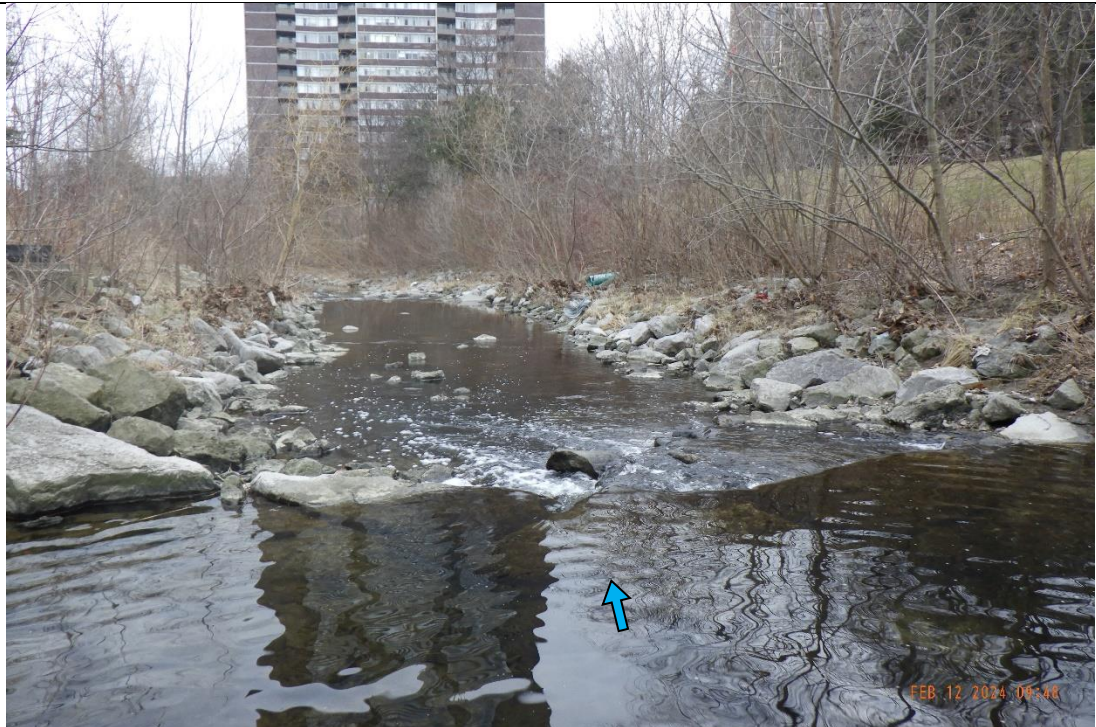
Photo 5

The channel was realigned/armoured by 2015 downstream of the proposed sewer crossing to Dundas Street. An armourstone weir located 18 m downstream would provide upstream grade control to the new sewer.

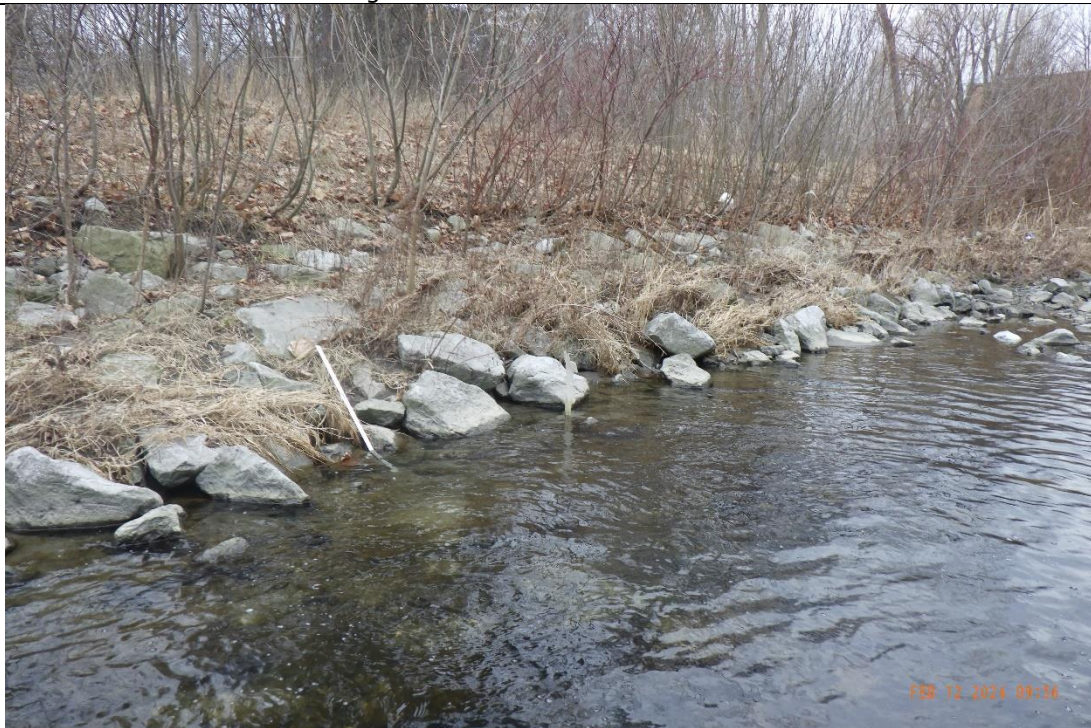
Photo 6

Channel banks were vegetated and protected with riprap. The treatment was in good condition at the time of assessment.

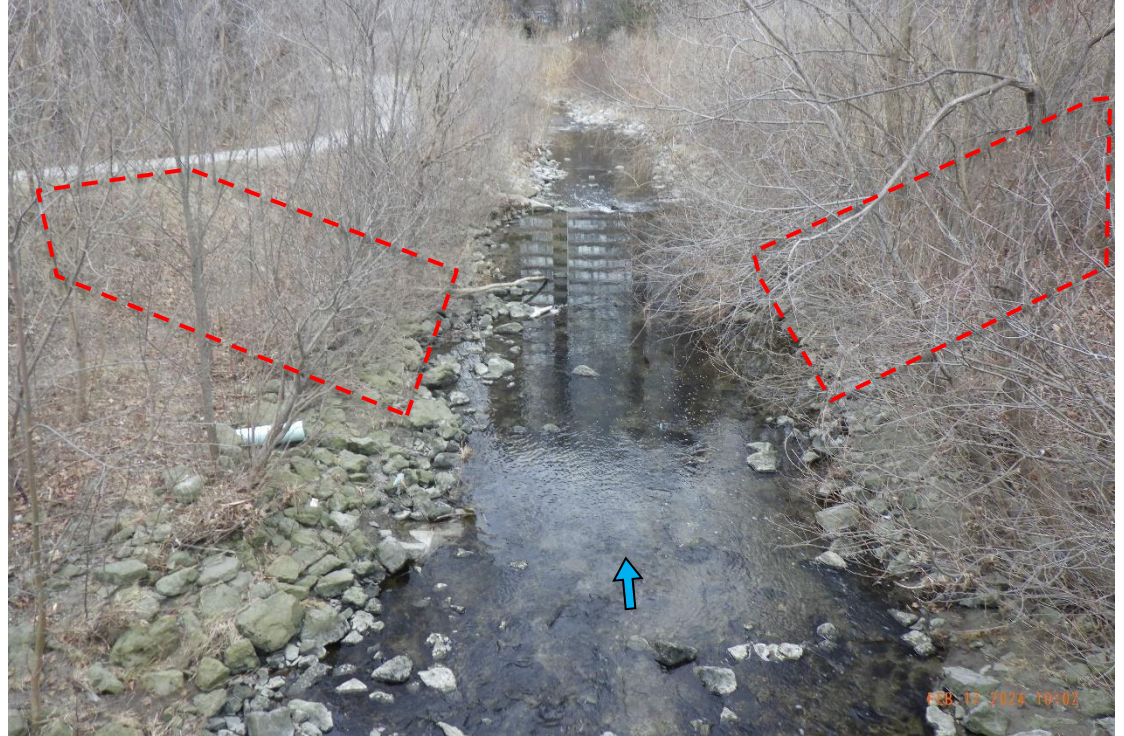
**Photo 7**

Overview of sewer crossing location. The anticipated area of disturbance is roughly outlined in red.

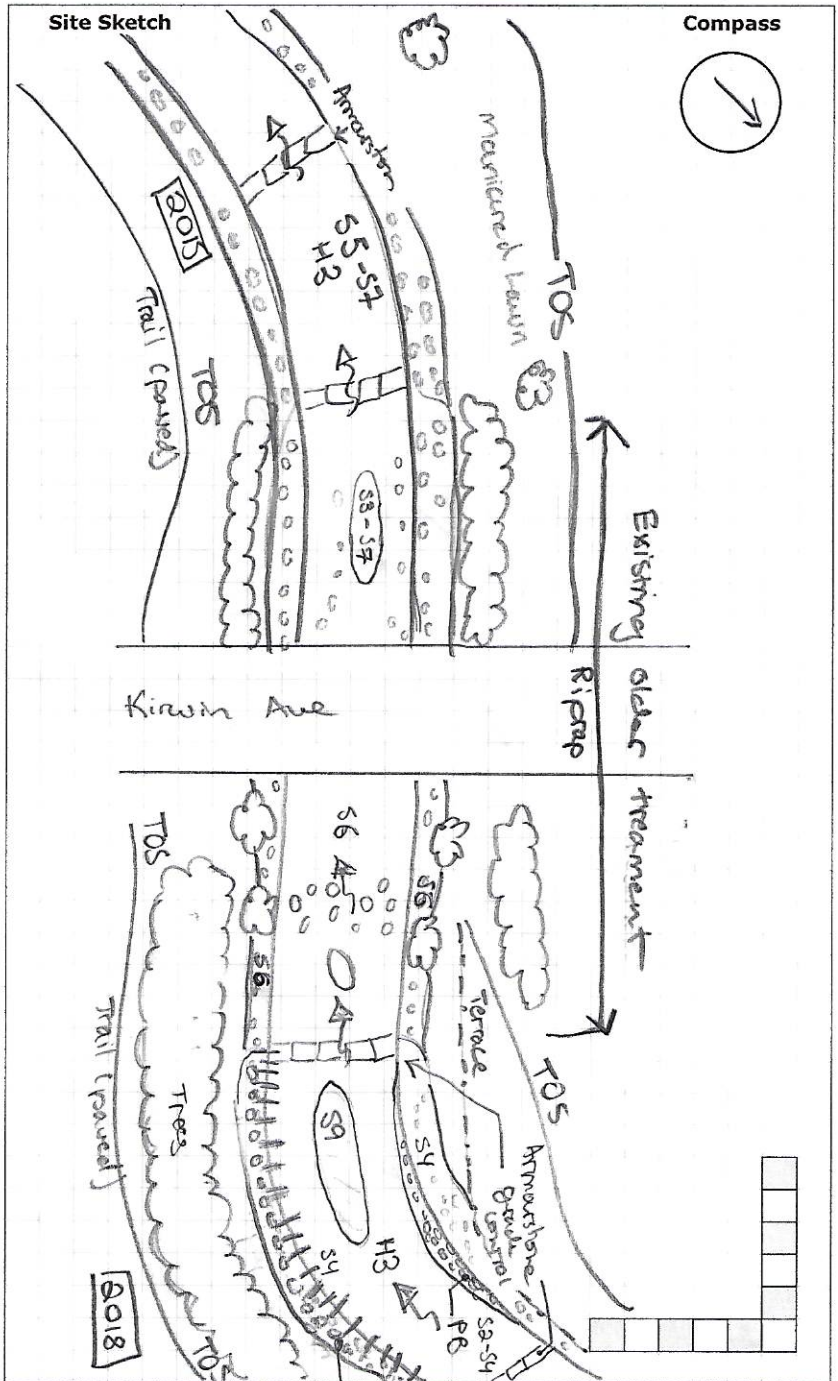
2018 US treatment in poor condition. Seawing observed. Transitions to older riprap based treatment (moderate condition) then to 2018 cascade. (goal)
