**Winston Churchill Boulevard
Mississauga, ON**

**Fluvial Geomorphological
Assessment
and
Meander Beltwidth
Assessment**

May 10, 2016

**RE: Winston Churchill Blvd, Region of Peel, ON
Fluvial Geomorphological Assessment and Meander Beltwidth Assessment**

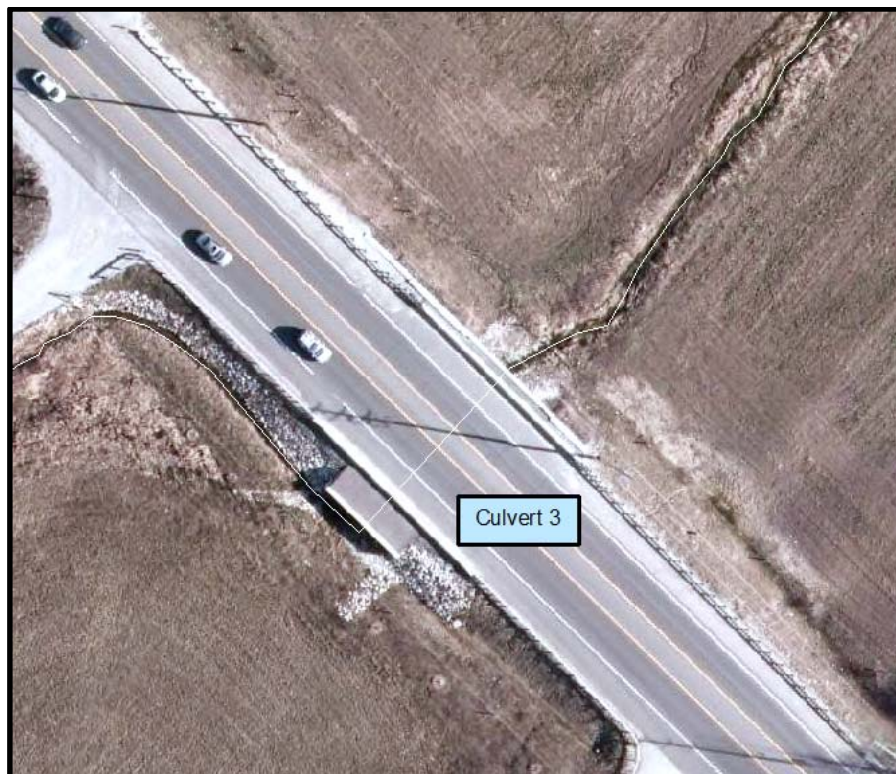
Figure 3: Aerial View of Cu-3 on Levi Creek North

This crossing is the closest crossing to Embleton Rd. and is the northern most crossing of the three. This culvert conveys Levi Creek North through Winston Churchill Blvd. The reach has little instream cover as the riparian buffer is comprised of tall grasses and no trees or shrubs. Some undercut banks were observed in this reach although flow appears to typically be low or intermittent. The majority of the banks and channel are stabilized only by the roots from the riparian grasses.

Approximately 200 metres were surveyed for this study. Four cross sections were surveyed in this reach, two on the east side and two on the west side. The channel showed low width-to-depth ratio (<12) and is slightly entrenched. The average bankfull slope is 0.015 m/m, and the bankfull width and average depth were noted to be 0.89 m and 0.09 m. The substrate in this reach is focused on sands and small gravels. A sieve sample was completed for the reach and the results show 96% sands and 3.5% gravels. No Rosgen classification will be given to this channel as 'field drainage' should suffice in conveying its general characteristics. Survey results can be seen in Table 1.

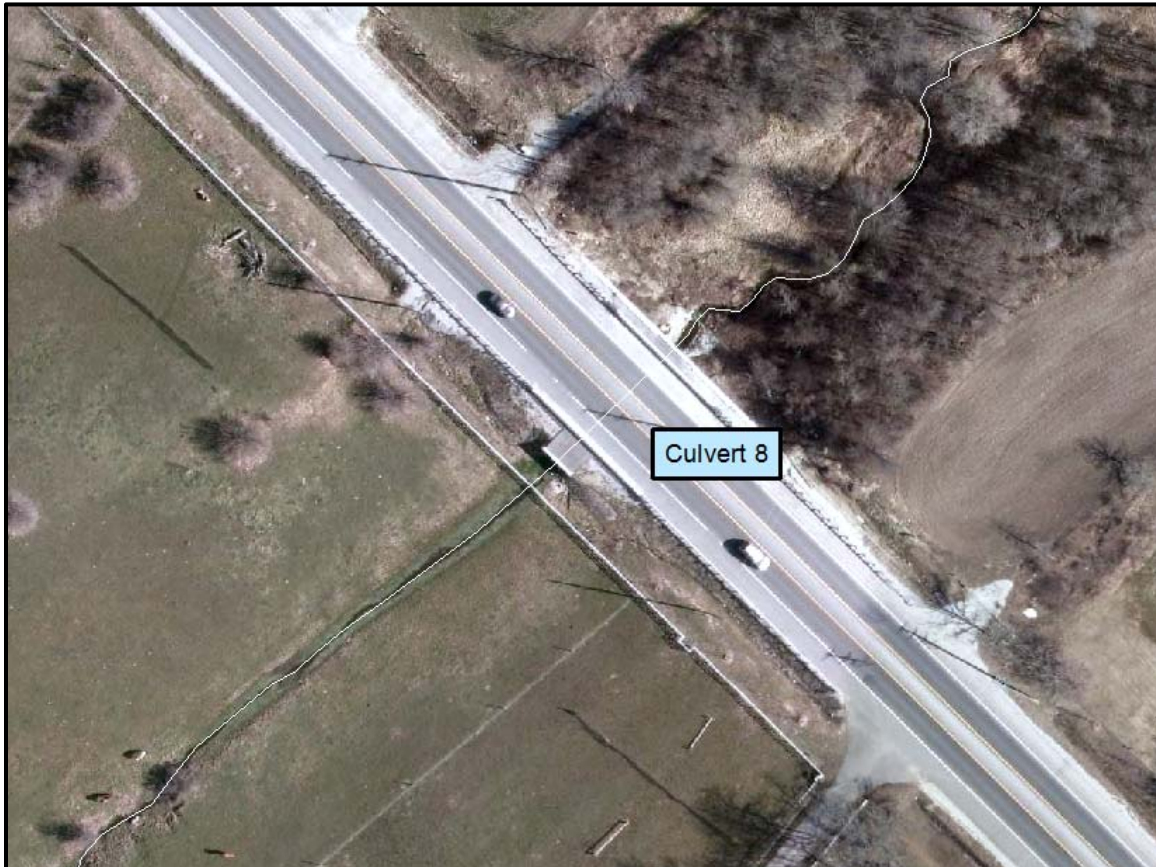
Figure 4: Aerial View of Cu-8 on Levi Creek South

This crossing and reach are between Cu-3 and Cu-10 with approximately 1km separating each crossing. This culvert conveys Levi Creek South through Winston Churchill Blvd. The upstream and downstream sides of this reach are very different from one another. The upstream end (west side) is straightened grass channel with a small riparian buffer. The downstream end (east side) is a sinuous channel that has proper channel features and a wide riparian with large trees and shrubs.

Approximately 200 metres of channel were surveyed along with five cross sections to determine the typical channel geometry. The overall channel has a moderate width-to-depth ratio and is not entrenched. The average bankfull slope through the whole study area is 0.007 m/m, and the average bankfull width and depth were noted to be 1.37 m and 0.13 m.

The substrate in this reach ranges from silt to cobbles with small gravels and sand the dominant substrates. The sieve sample for this reach reveals that 85% of the substrate is gravel while 15% is sand. The banks are typically made up of highly erodible soils. Rosgen classification for this reach is determined to be an E4 channel type. Survey results can be seen in Table 1.

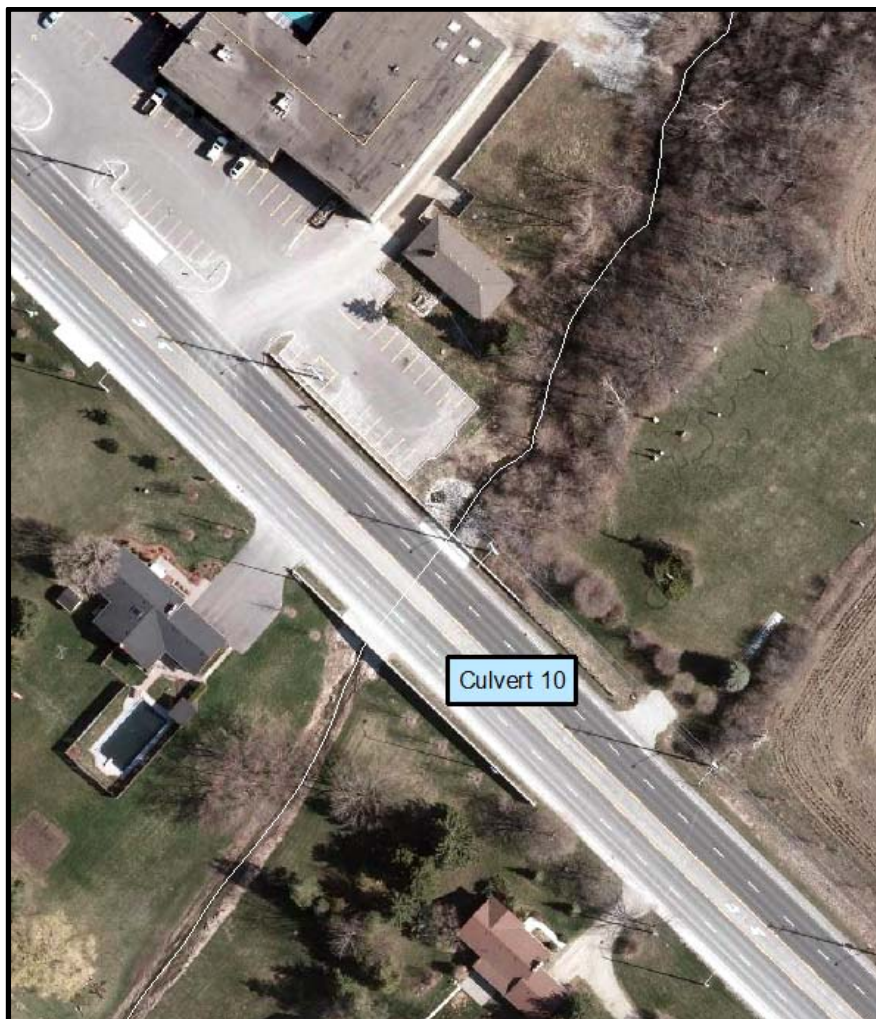
Figure 5: Aerial View of Cu-10 on Mullet Creek

This crossing is the closest crossing to Steeles Ave. and is the southernmost crossing of the three. This culvert conveys Mullet Creek through Winston Churchill Blvd. The reach is similar to crossing Cu-8 in how it has a grassed upstream end (west side) and a forested downstream end (east side). The downstream end has some erosion occurring and also contains a fair amount of large woody debris. The majority of the banks and channel are stabilized only by the roots from the riparian grasses.

Approximately 215 metres of the channel at this crossing was surveyed for this study. Four cross sections were also surveyed in this reach, two on the east side and two on the west side. The channel has a high width-to-depth ratio (>12) and is slightly entrenched. The average bankfull slope is 0.006 m/m, and the bankfull width and average depth were noted to be 1.37 m and 0.12 m. The substrate in this reach contains sands and small gravels but also contains a larger percentage of cobbles. A sieve sample was completed for the reach and the results show 8% sands and 19% gravels and 72% cobbles. A Rosgen classification of B4 has been given to this channel. Survey results can be seen in Table 1.
