Appendix O

Structural Memo

Region of Halton

For the Bridge on Winston Churchill Blvd
 Located 2.70 km North of Steeles Avenue
 Structure No. 19-1196390 BR01

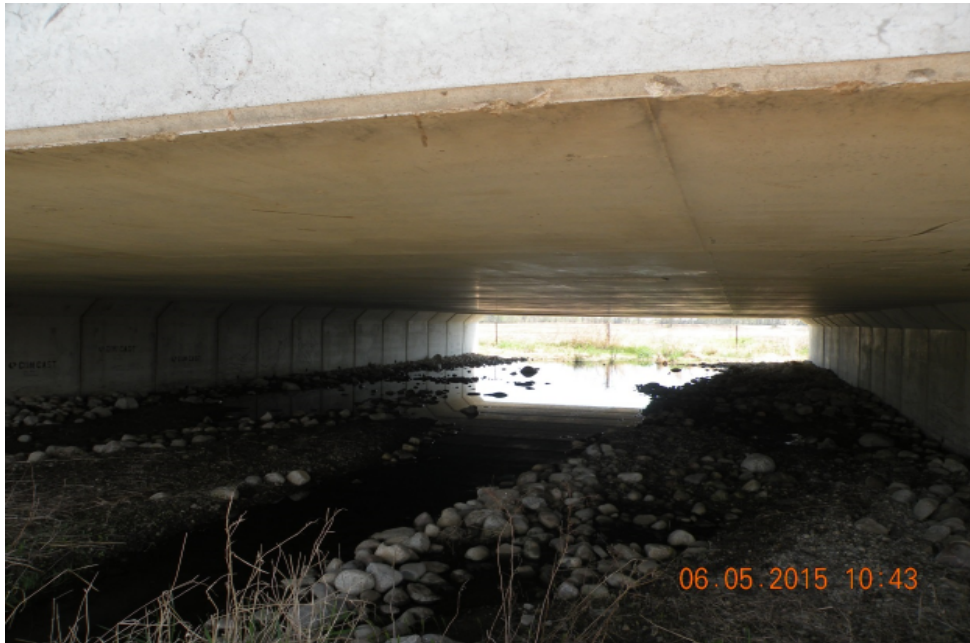
Looking East (Note Scaling on Exterior Soffit)

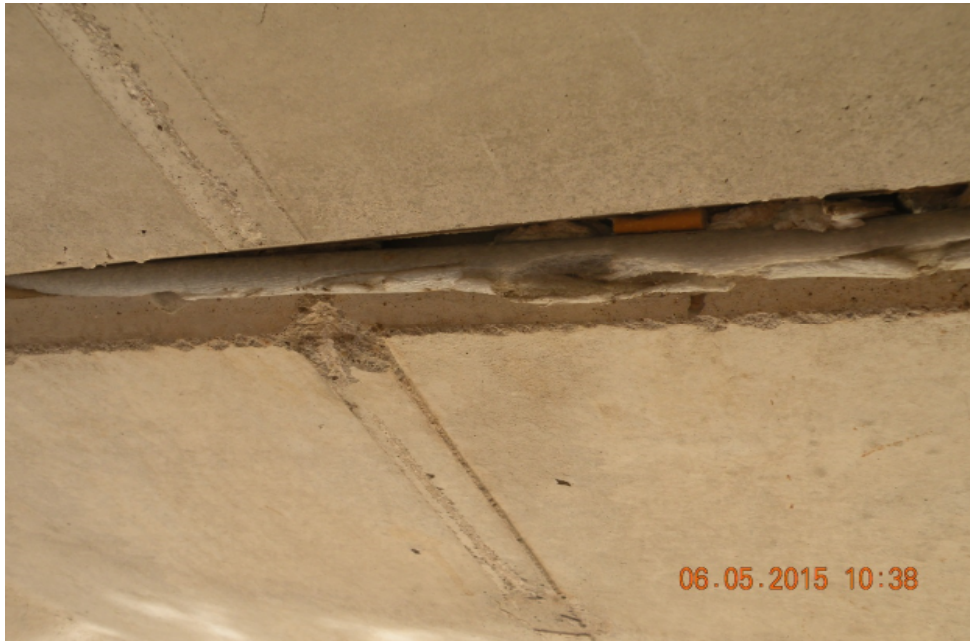
Form at Joint (several joints near East End)

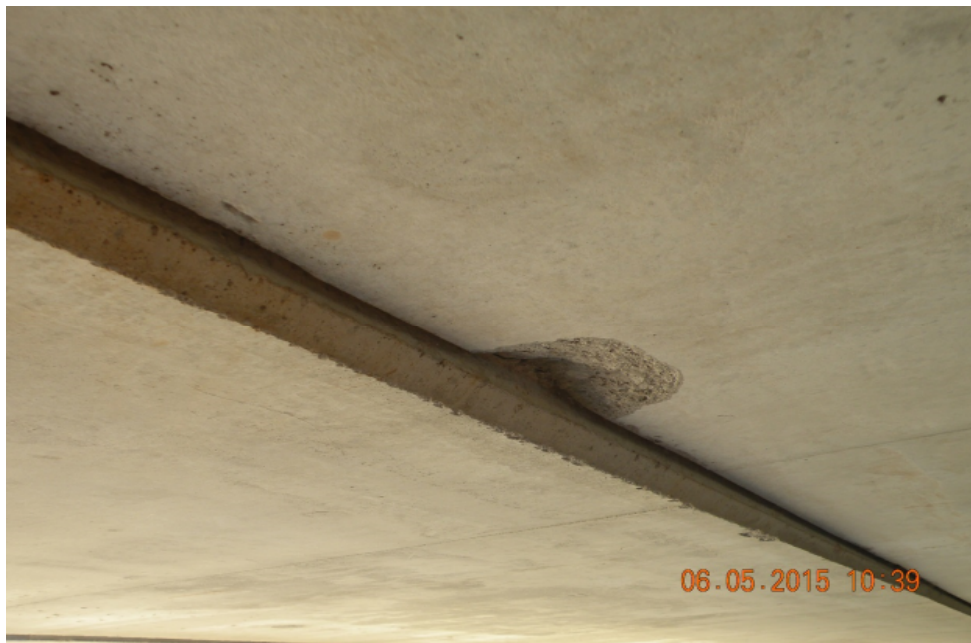
- 3rd box from West End, 2.5 m from South Abutment Wall: 300mmx500mm delaminated piece of concrete
 - Some joints have light spalling and light scaling
 - foam has been forced out from between some joints (East Side)

Spall at Second Joint from East End

Performance Deficiencies	Maintenance Needs	Priority	Comments
None	None		
Rehab/Rehabilitation Recommendations	Priority	Cost	Comments
Minor Rehabilitation	1-5 yrs	\$3,500	Removal and patch repair concrete

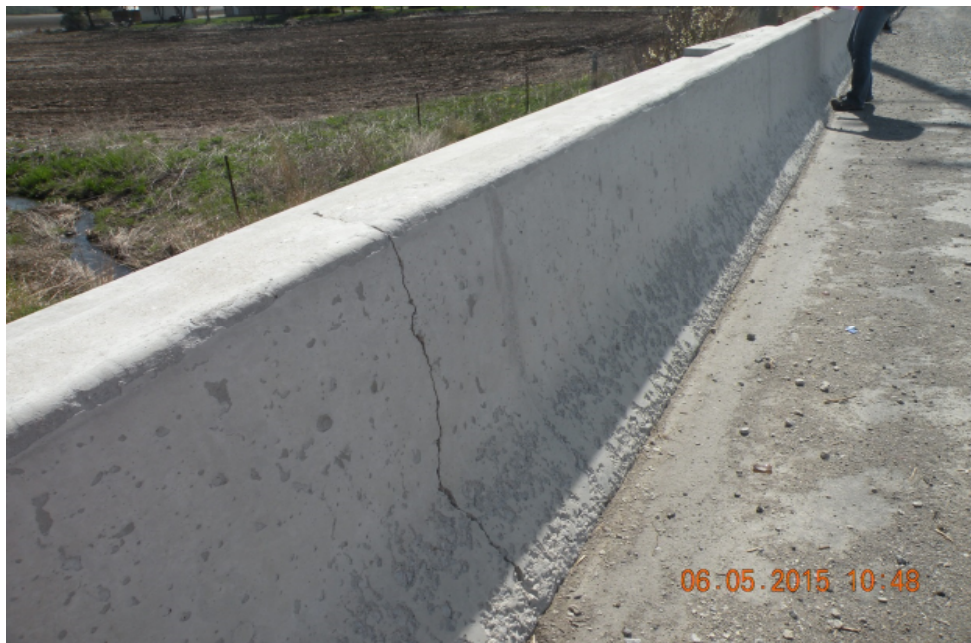
Comments
 - Wide crack on west barrier - 10.5m and 16.7m from South end of barrier
 - Wide crack on east barrier - 10.5m and 16.5m from south end of barrier
 - Light/medium scaling, more concentrated on bottom leg of barrier

Comments
 - Wide crack on west barrier - 10.5m and 16.7m from South end of barrier
 - Wide crack on east barrier East - 10.5m and 16.5m from south end of barrier
 - Light scaling

Wide Crack and Scaling on Barrier Wall (typical both sides)

Rehab/Rehabilitation Recommendations	Priority	Cost	Comments
Minor Rehabilitation	6-10 yrs.	\$2,500	Seal cracks

Rehab/Rehabilitation Recommendations	Priority	Cost	Comments
Minor Rehabilitation	6-10 yrs.	\$2,500	Seal cracks.

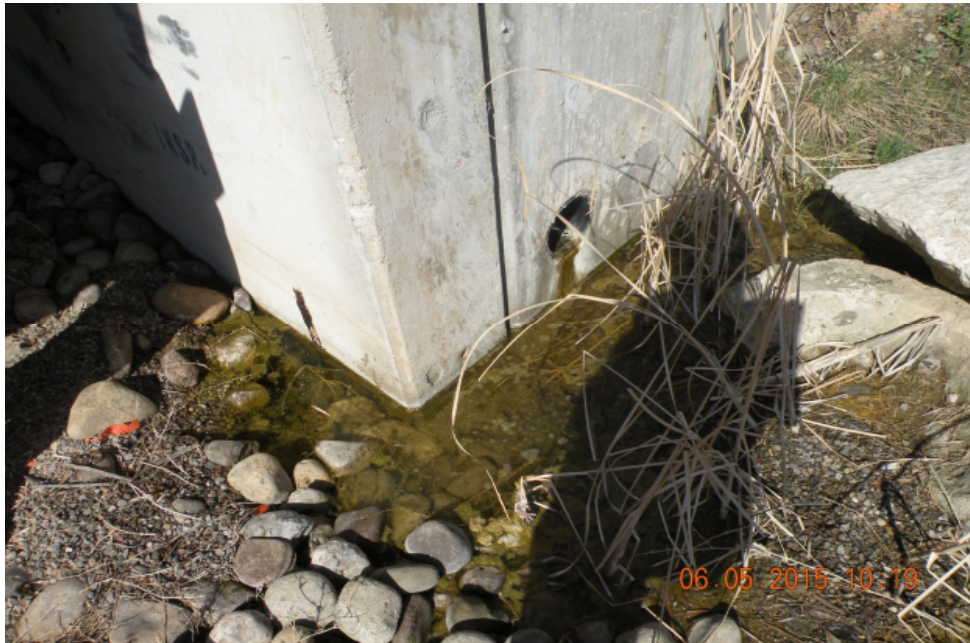
Pounding (Typical on East Side)

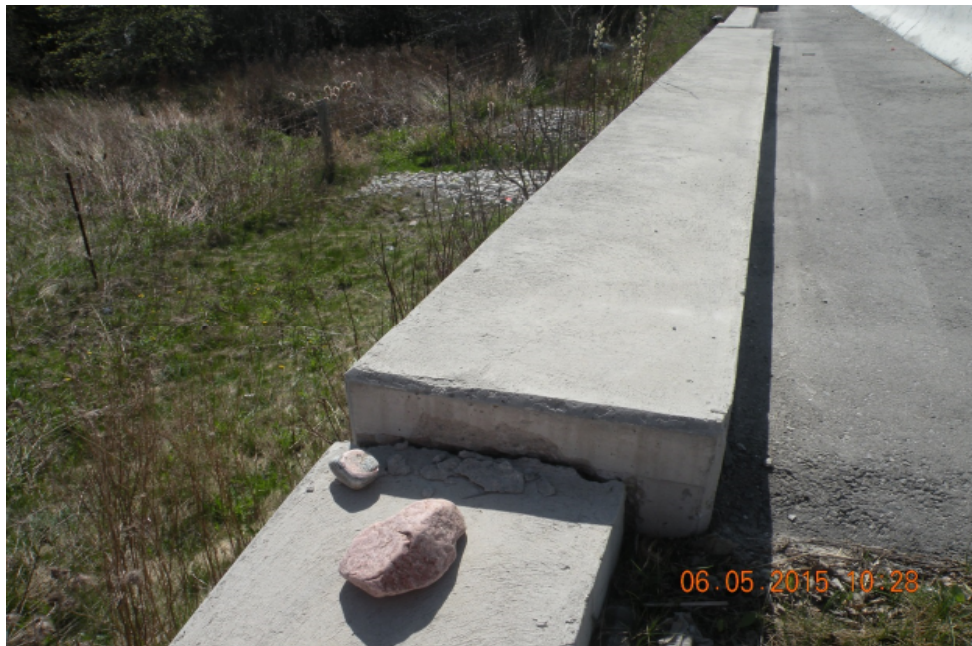
Disintegrated Concrete at RSS Connection

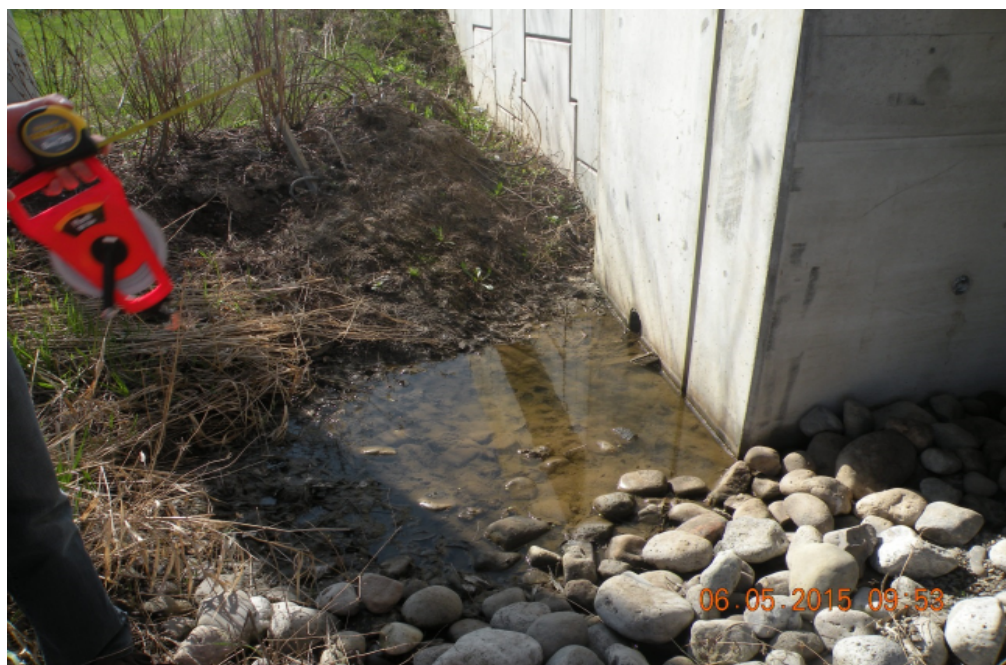
Typical Ponding at Abutment Corners

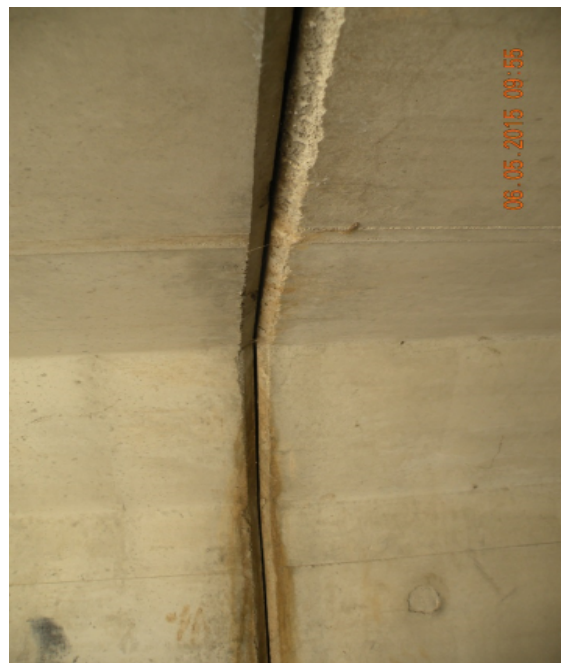
Joint with Staining and Scaling

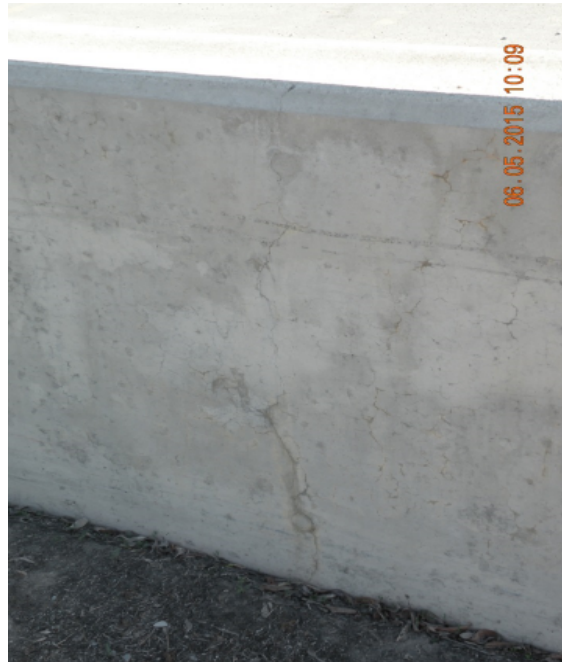
Narrow Crack on Interior Parapet Wall

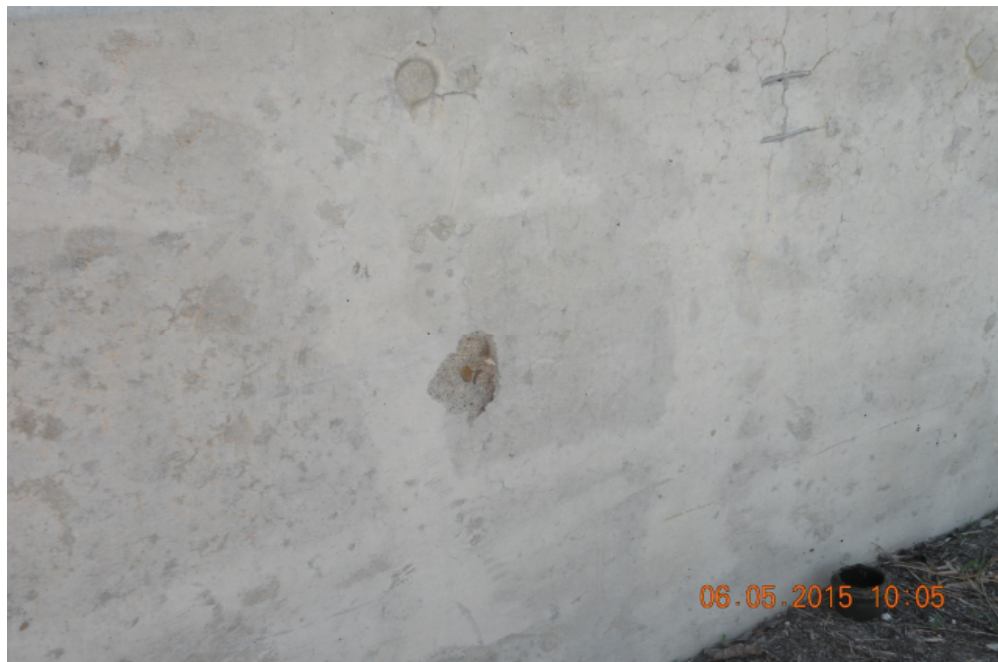
Spall on Interior Parapet Wall
