Region of Peel

In-service Road Safety Review

Dixie Road Complete Corridor Study

September 2024

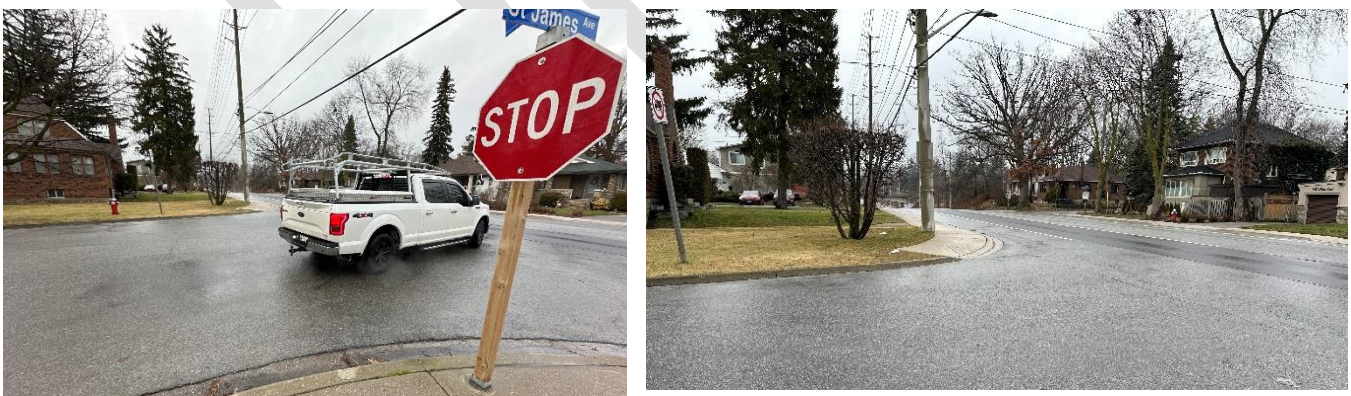
Photo Location: on the eastbound approach of the intersection, looking north

St. James Avenue and Dixie Road Intersection: *Sightlines for vehicles turning from St. James Avenue into Dixie Road are obstructed by utility poles, vegetation, and the vertical grade change on Dixie Road south of the railway underpass.*

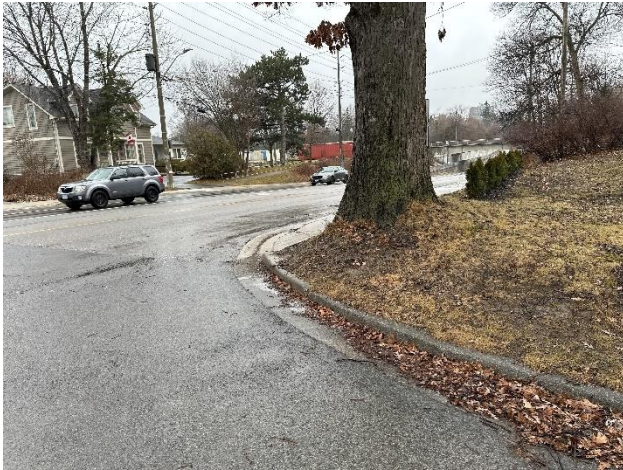
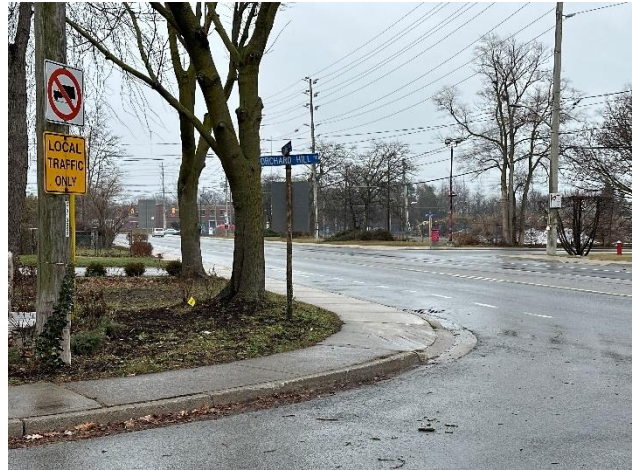
Orchard Hill Road and Dixie Road Intersection: *Sightlines for vehicles turning from Orchard Hill Road into Dixie Road are partially obstructed by large trees on both sides and the vertical grade change on Dixie Road south of the railway underpass (for vehicles making a right turn).*

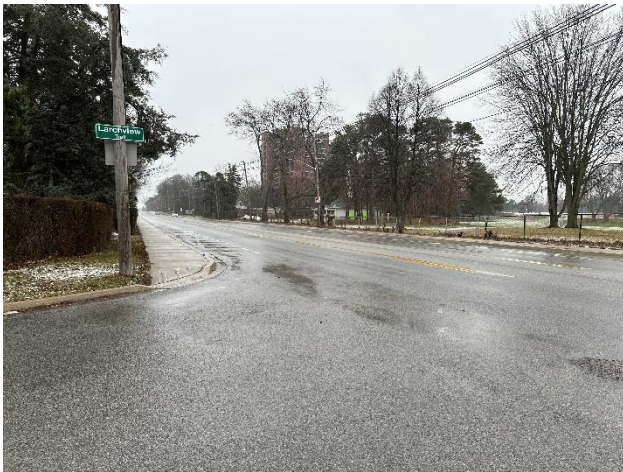
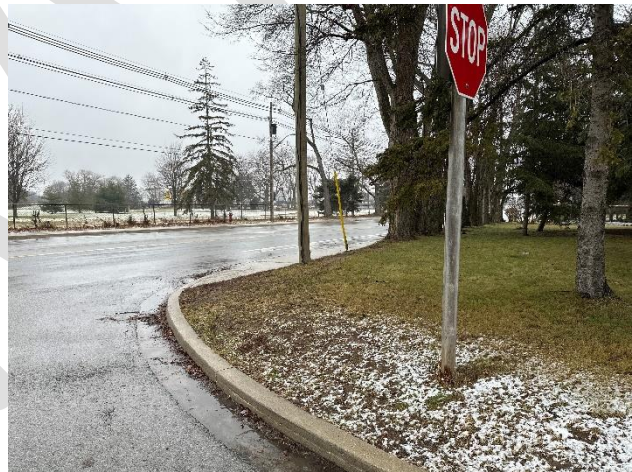
Larchview Trail and Dixie Road Intersection: *Sightlines for vehicles turning from Larchview Trail into Dixie Road are obstructed by vegetation and hydro poles.*

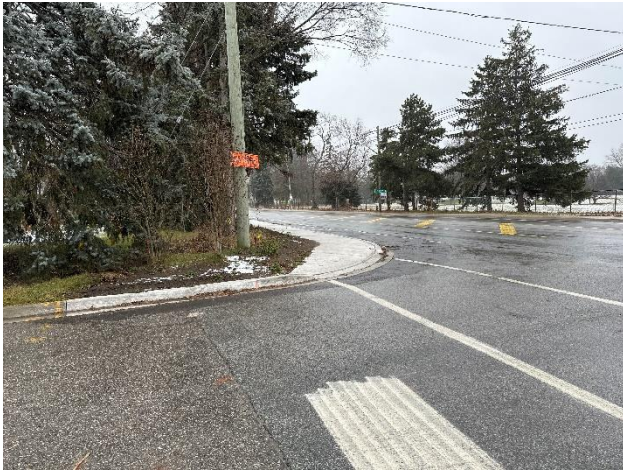
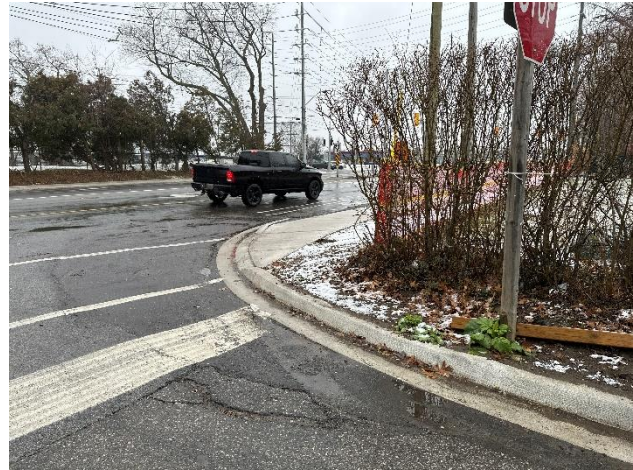
Londonderry Boulevard and Dixie Road Intersection: *Sightlines for vehicles turning from Londonderry Boulevard into Dixie Road are obstructed by vegetation and hydro poles.*

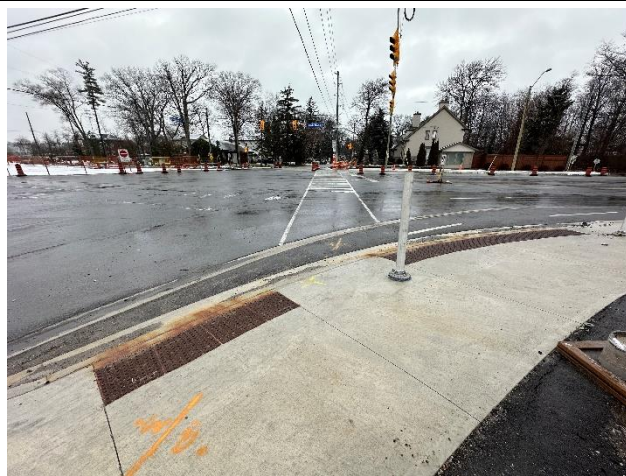
Photo Location: Dixie Road at Rometown Drive, Southwest corner, looking east

- Dixie Road at Lakeshore Road East: Northwest and northeast corners
- Dixie Road at Rometown Drive: TWSIs are missing on the southeast corner. Additionally, on the southwest corner, TWSIs are not aligned with the crosswalks. Furthermore, it seems that the southeast sidewalk has recently been widened, with a new depressed curb and TWSI located far from the intersection.

TWSIs are not aligned with crosswalks

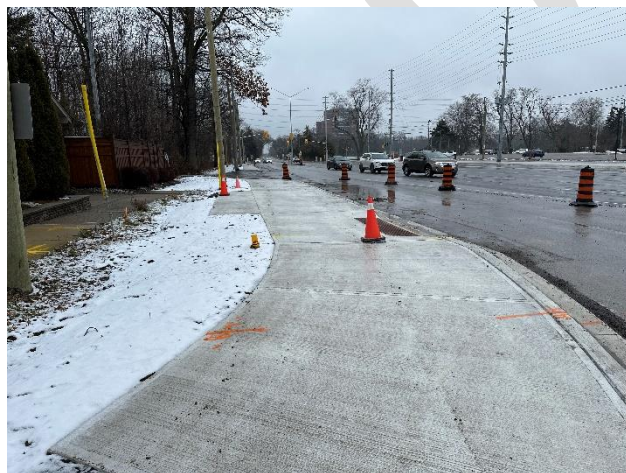
Photo Location: Dixie Road at Rometown Drive, Southeast corner, looking south

TWSI in the southeast corner located far from the intersection

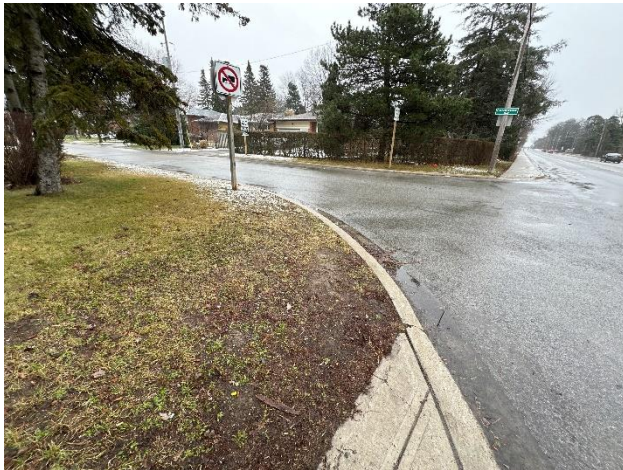
Photo Location: Dixie Road at Larchview Trail, Northeast corner, looking south

Absence of crosswalk on Larchview Trail & Presence of pedestrian pathway marks showing pedestrian desire line on the east side of Dixie Road

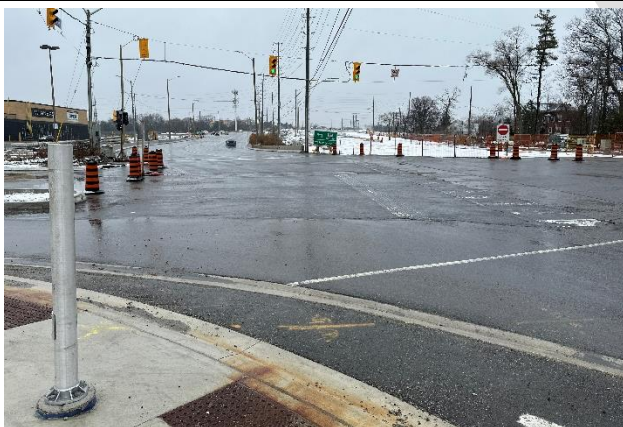
Photo Location: Dixie Road at Rometown Drive, Southwest corner, looking north

Absence of a painted crosswalk on the west leg

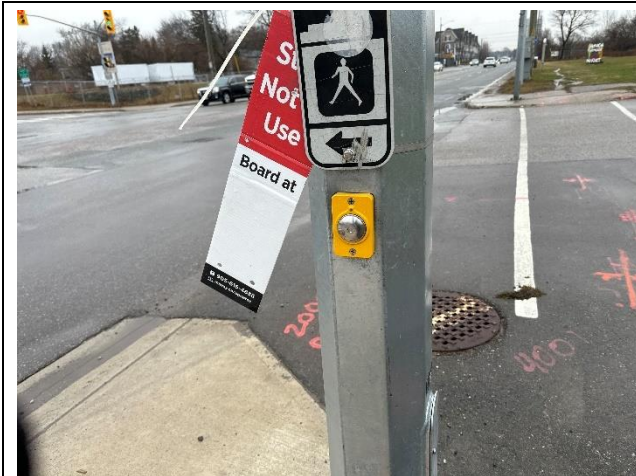
Photo Location: Dixie Road at Lakeshore Road East, Southwest corner, looking east

All pedestrian crossings along the corridor lack accessible pedestrian signals. An illustrative example of missing accessible pedestrian signals at Lakeshore Road East is provided in **Exhibit 21**.

Absence of Accessible Pedestrian Signals (standard pushbuttons are used)

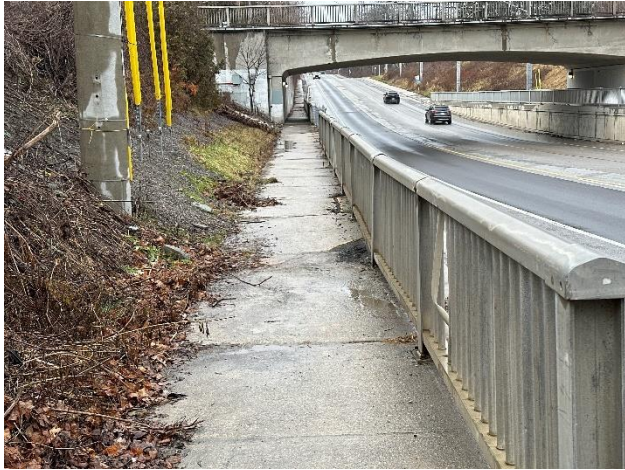
Photo Location: West side, ~45 m from underpass, looking north

Uneven and damaged sidewalk near the railing on the west side of Dixie Road

1. The following issues were noted at the rail underpass (**Exhibit 22**). The pedestrian facilities will be upgraded in Summer 2024 through upcoming rail underpass construction.
 - Sidewalks are generally poor, narrow, damaged at some locations, and uneven, which represents a tripping safety hazard.
 - Parts of the railings are missing, with water pooling.
 - Low-hanging tree branches above the retaining wall encroach on the right-of-way and require pedestrians to duck under or dodge branches while walking this section, occasionally forcing pedestrians into the clear zone, reducing their safety and increasing the risk of collisions.

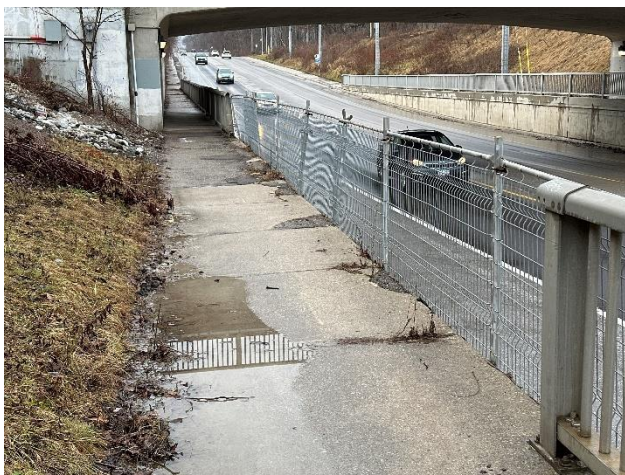
Photo Location: West side, adjacent to underpass, looking north

Missing railing sections on the west side of Dixie Road, with multiple instances of pooling

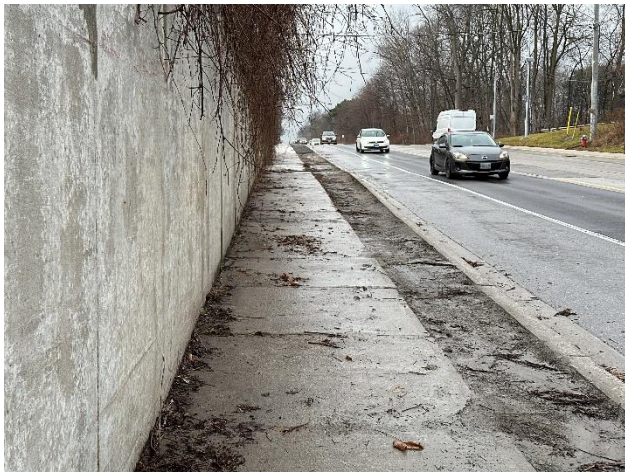
Photo Location: West side, ~50 m downstream of underpass, looking north

Low-hanging branches

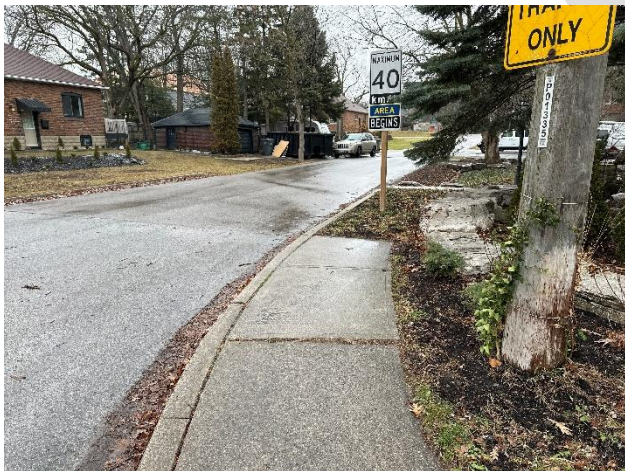
Photo Location: Dixie Road at Orchard Hill Road, southeast corner, looking east

2. The sidewalk on the southeast side of the intersection of Dixie Road at Orchard Hill Road abruptly ends creating a safety hazard for pedestrians (**Exhibit 23**).

Southeast sidewalk abruptly ends

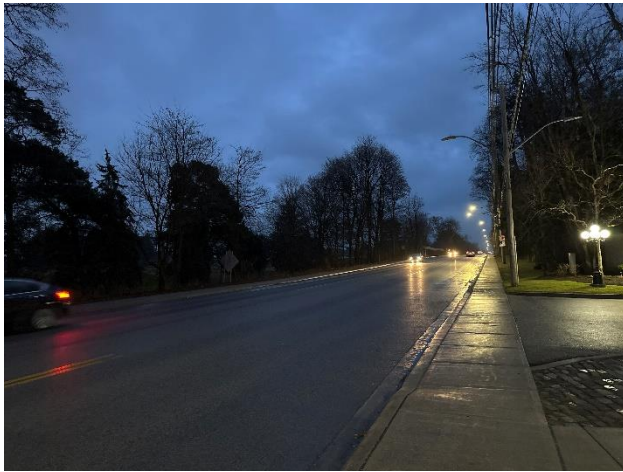
Photo location: North side of intersection, looking south

3. Low visibility (dark conditions) was observed at Fairways Condo (1400 Dixie Road). As shown below, there is no streetlighting on the east side of the intersection where this access meets Dixie Road.

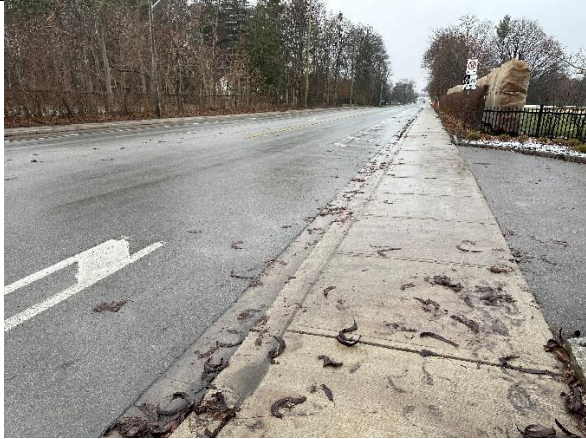
Bicycle lane markings are discontinued through the intersection
Photo Location: Dixie Road at Toronto Golf Club Access, south side of the intersection, looking north

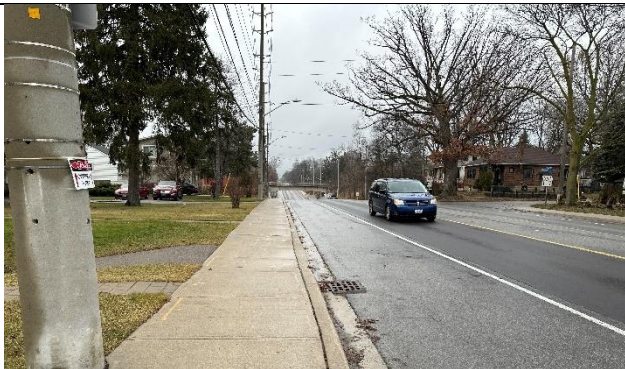
Bicycle lane buffer is missing for southbound traffic approaching the intersection
Photo Location: Dixie Road at St. James Avenue, northwest corner, looking north

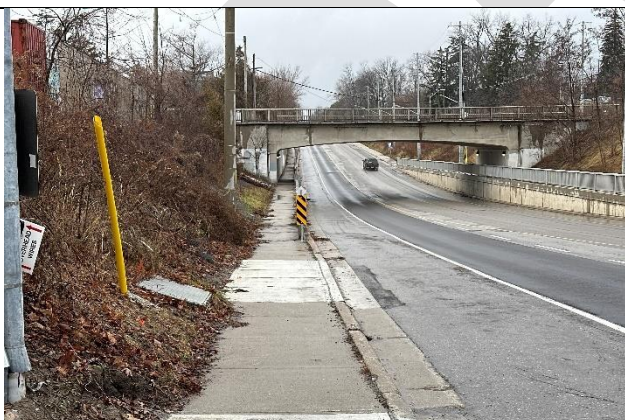
Bicycle lane buffer is missing on both sides between Orchard Hill Road and Lakeview Golf Course Access
Photo Location: West side of Dixie Road, approximately 50m from the underpass, looking north

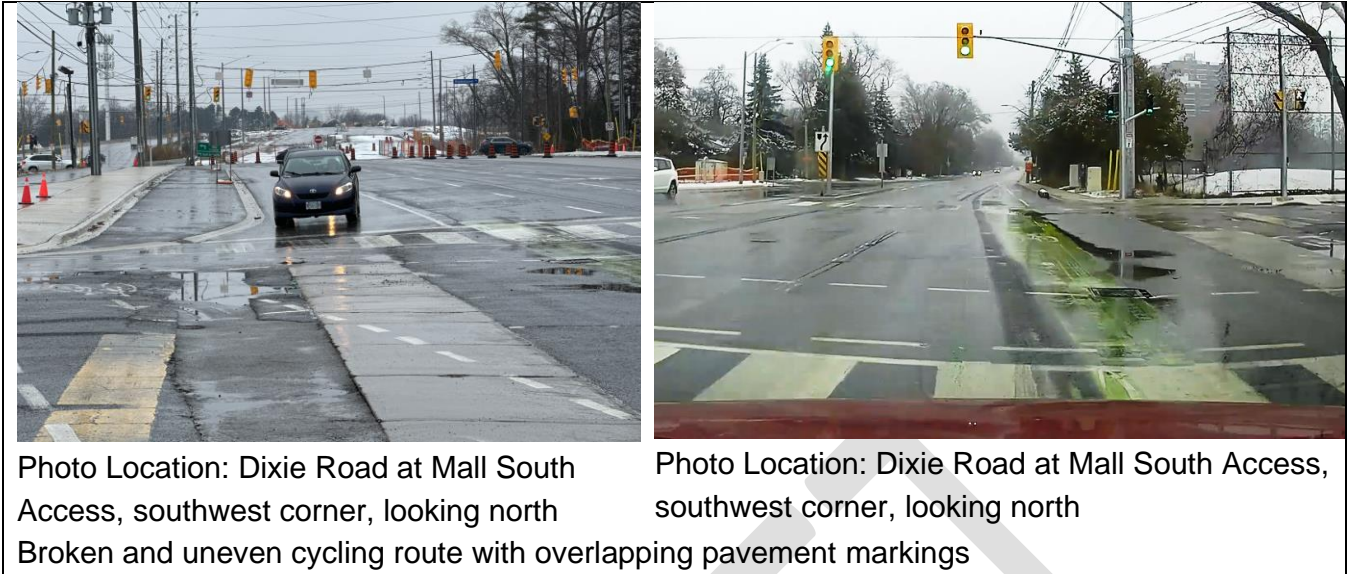
Exhibit 26: Issues with Cyclist Facilities at Dixie Road at Mall South Access

- At some locations, bicycle lane markings are discontinued, or the bicycle lane buffer is missing or faded (**Exhibit 25**).
- At Dixie Road at Mall South Access, the cycling route on the west side of Dixie Road is broken and uneven as it crosses over a decommissioned sidewalk, with the presence of confusing or overlapping pavement markings, where the pre-Dixie Mall Outlet redevelopment bicycle lane tie-in directly straddles the vehicle path of travel (**Exhibit 26**).

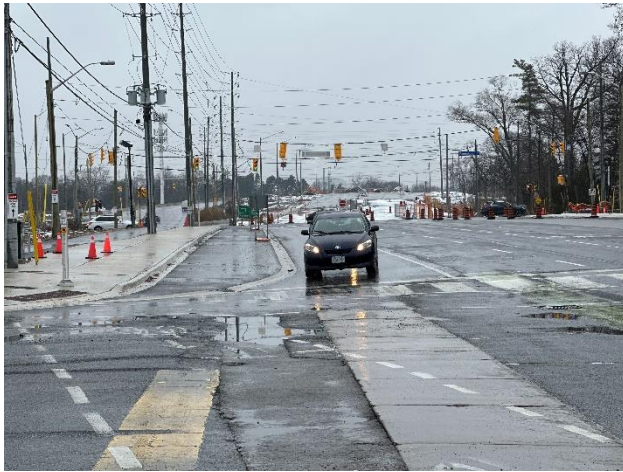
Photo Location: Dixie Road at Mall South Access, Southwest corner, looking north

- Some drivers were observed making southbound right turns without stopping on a red signal or yielding to pedestrians;
- Some drivers were observed making eastbound left-turning without yielding to pedestrians crossing Dixie Road until their vehicles reached the crosswalk.

Aggressive turning behaviour (southbound right turning vehicles)

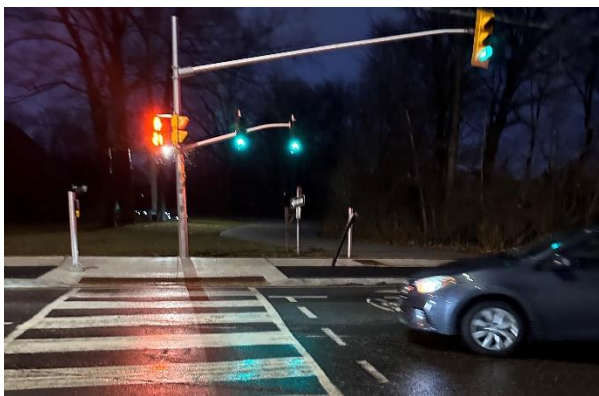
Photo Location: Dixie Road at Mall South Access, North side crosswalk, looking east

Aggressive turning behaviour (eastbound left turning vehicles)

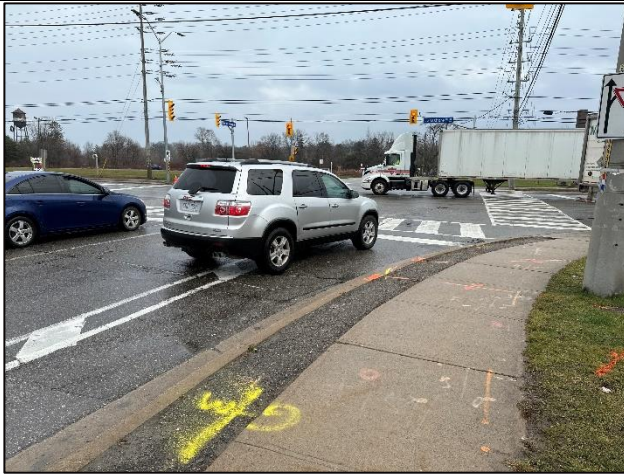
Photo location: Dixie Road at Lakeshore Road East, Northwest corner, looking south

Southbound drivers encroaching the bicycle lane while turning right
