Region of Peel

# Study Area Profile

## Dixie Road Complete Corridor Study

March 2024 – Memorandum

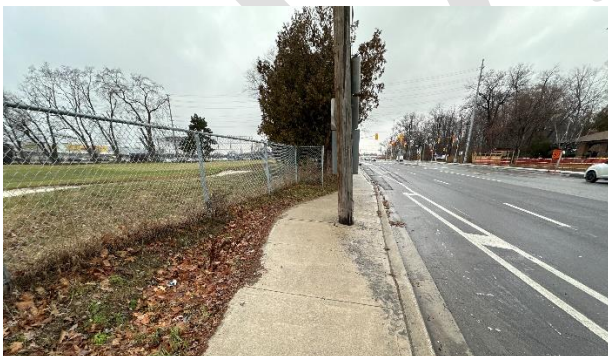
**Facility widths accommodate up to 2 people walking side-by-side**, with some

pinch points observed throughout the corridor.

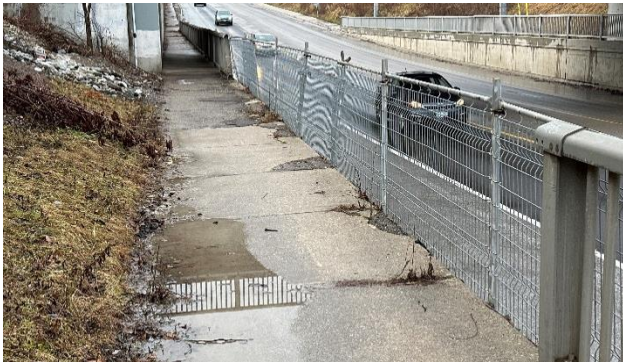
Photo Location: Dixie Road, west side adjacent to CN Rail Underpass, looking north

**Facilities are generally in state of good repair**, except for the west side around the rail underpass where poor pavement conditions, damaged or missing railings, and pooling were noted.

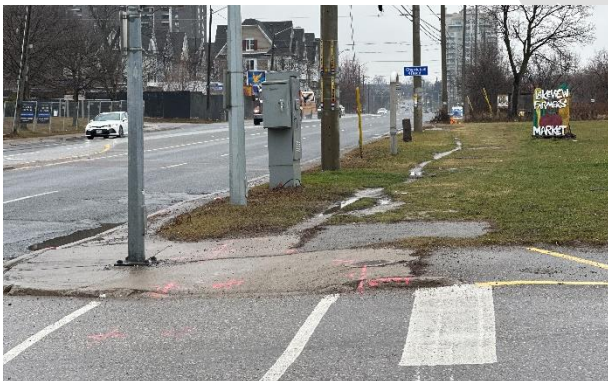
**Desire paths are present along multiple side streets intersecting with the corridor.**

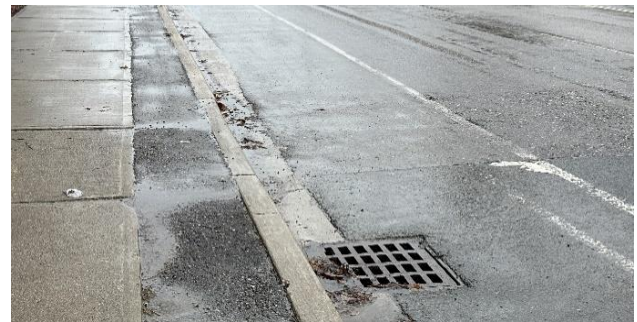
**Bicycle lane buffer is missing in some locations, notably around the CN Rail underpass.**

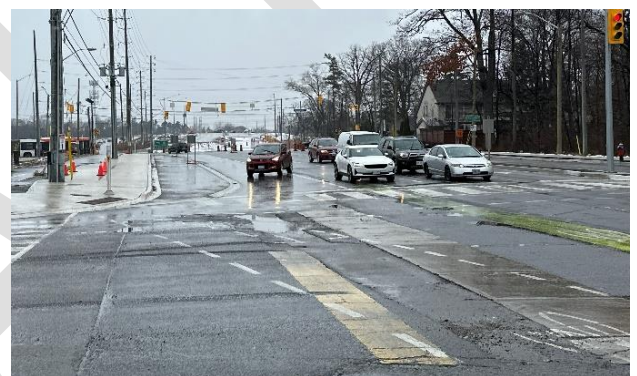
**Cycling facilities are generally in state of good repair, except through the Dixie Mall South Access, where the cyclist path of travel is uneven as it crosses over a decommissioned sidewalk.**

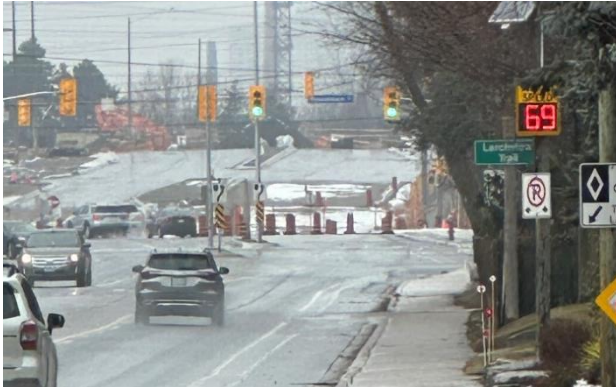
**Speeding is common.** Based on the on-site speed radar speed sign, a large portion (~70%) of vehicles were observed driving 10-20 km/h over the 50 km/h speed limit.

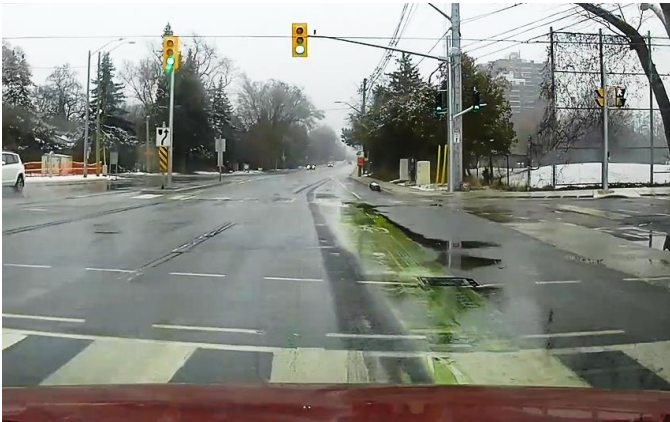
Driving facilities are generally in state of good repair, except at the Dixie Mall South Access, where the pre-Dixie Mall Redevelopment bicycle lane tie-in directly straddles the vehicle path of travel.

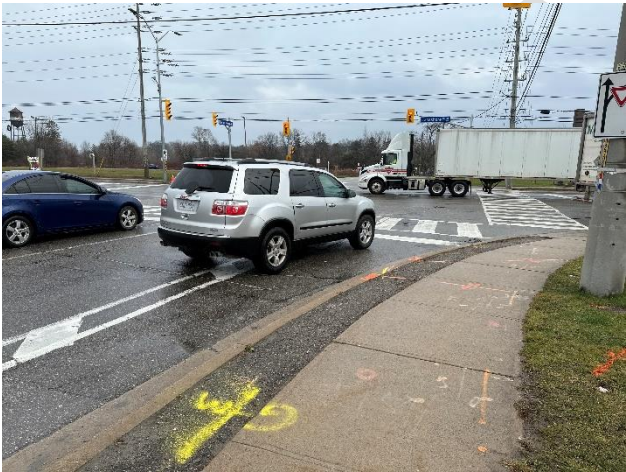
**Geometrics:** The radius at the southbound right approach is large and encourages drivers to encroach the bicycle lane while turning on both red and green indication.  
Photo location: NW corner, looking south

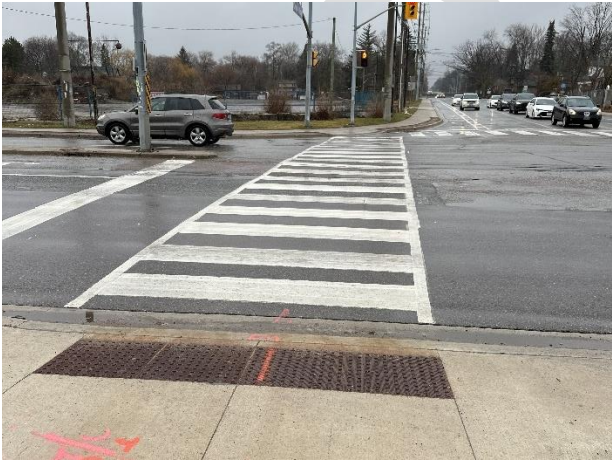
**Pedestrian Facilities:** TWSIs are present on the southwest corner, but not on the northwest corner.

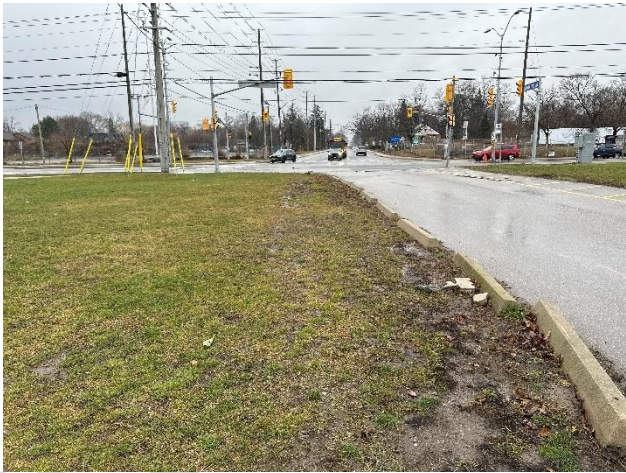
**Pedestrian Facilities:** Potential desire path heading northbound into intersection

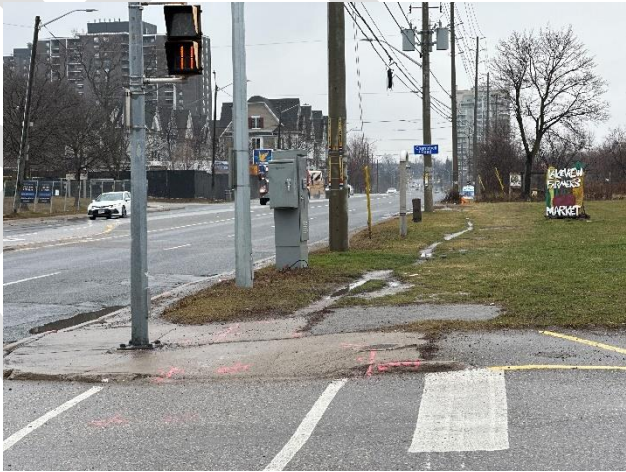
**Pedestrian Facilities:** Desire path on southeast side heading westbound into intersection

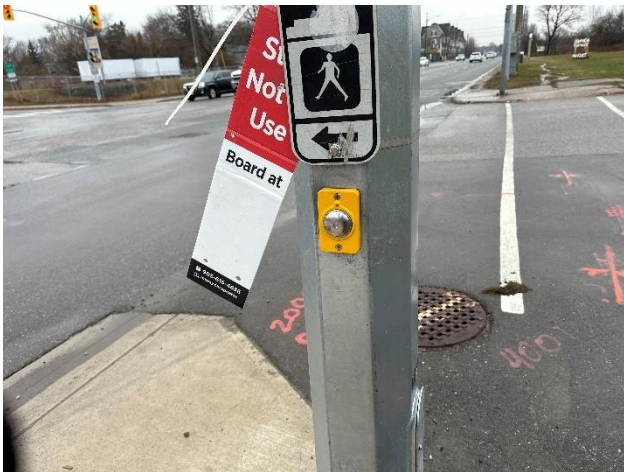
**Pedestrian Facilities:** No Accessible Pedestrian Signals present on all corners. Standard pushbuttons are used.

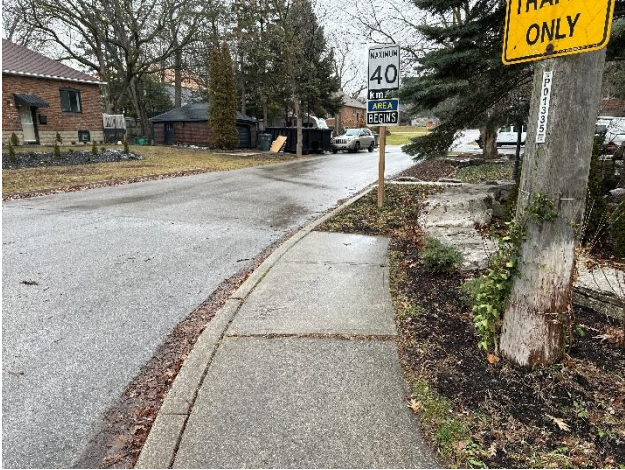
**Pedestrian Facilities:** Southeast sidewalk ends after the curb return.  
Photo Location: Southeast corner, looking east

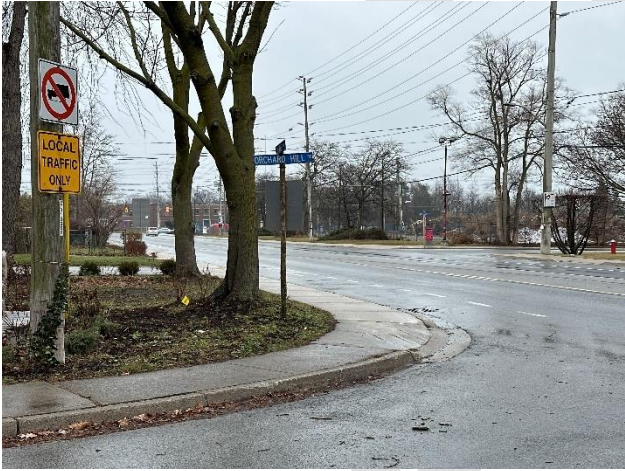
**Motor Vehicle Facilities:** Sightlines facing south are partially obstructed by trees and signage, requiring drivers to encroach the pedestrian right-of-way for a clear sightline.  
Photo Location: On westbound approach, looking south

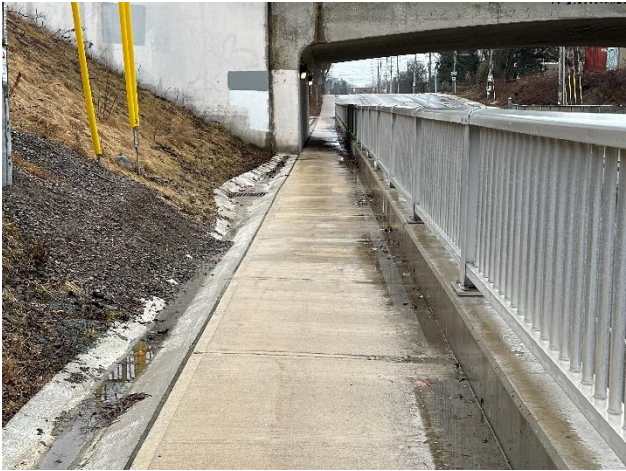
**Pedestrian Facilities:** Condition on the east side heading into the underpass is generally adequate, but water pools near the railing.

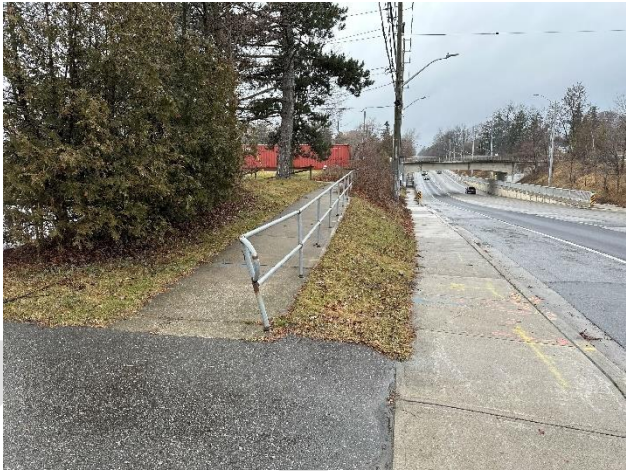
**Pedestrian Facilities:** Railing on the west side headed into the underpass leading to St. Marys Avenue is bent.

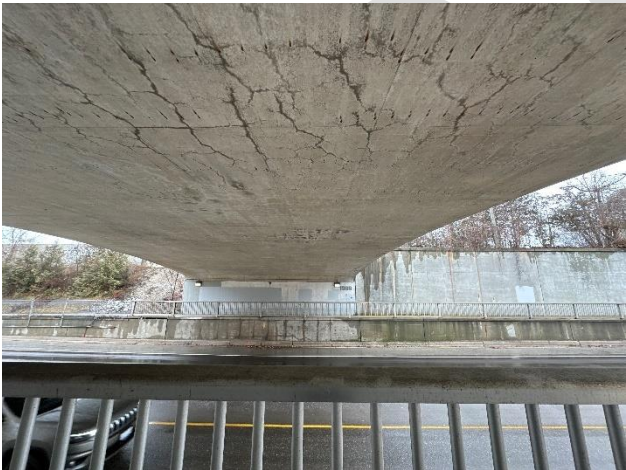
**Pedestrian Facilities:** Minor cracking is observed on the underpass but no major spalling is present.

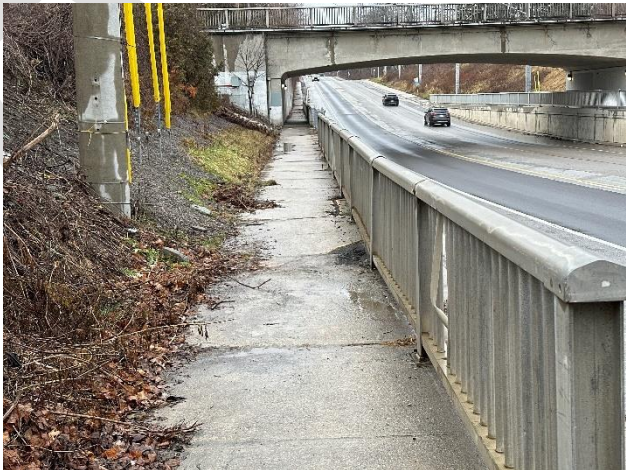
**Pedestrian Facilities:** Condition of west sidewalk is poor. Sidewalk is uneven and damaged near the railing.

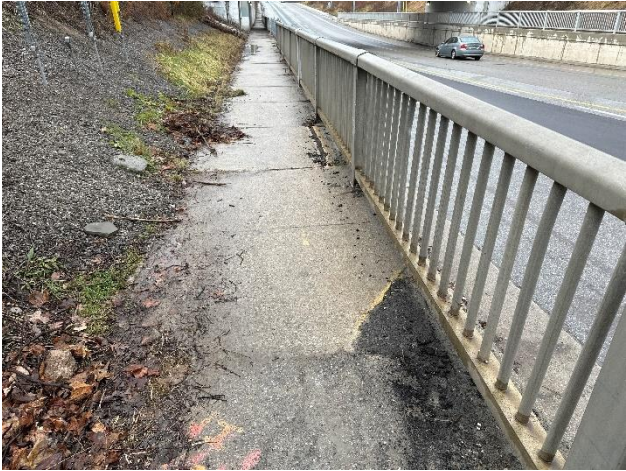
**Pedestrian Facilities:** Recently patched sidewalk near the railing on the west side.

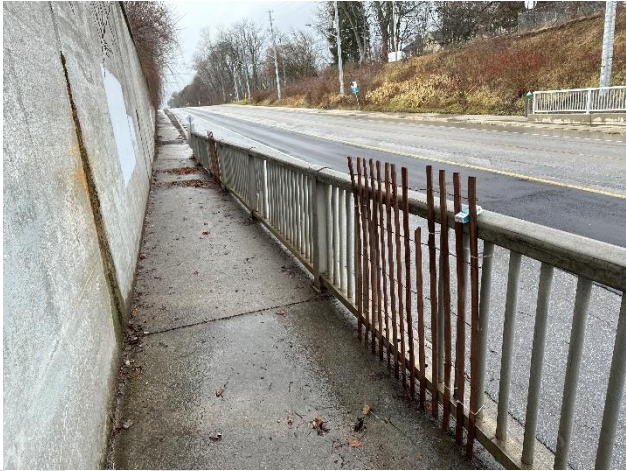
**Pedestrian Facilities:** Sections of railings are missing on the west side, north of the underpass.

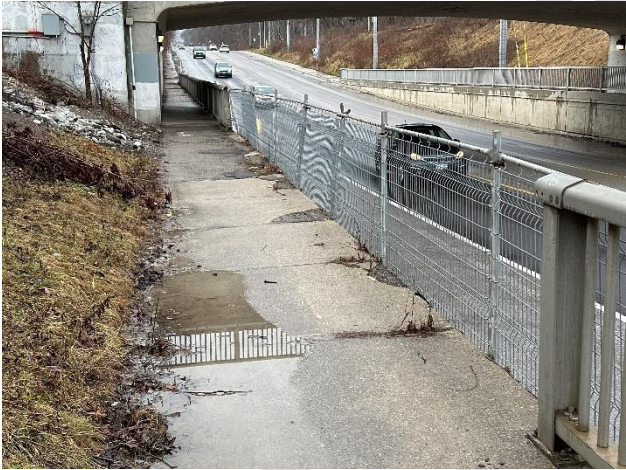
**Pedestrian Facilities:** West side railing section near the underpass is missing, with some pooling.

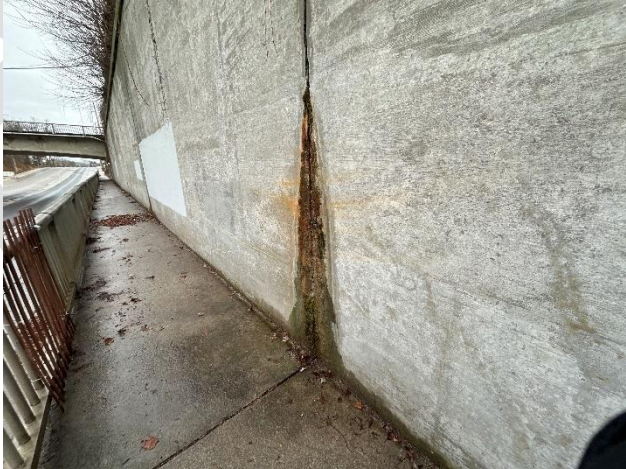
**Pedestrian Facilities:** Potential water seepage is present in west side retaining wall.

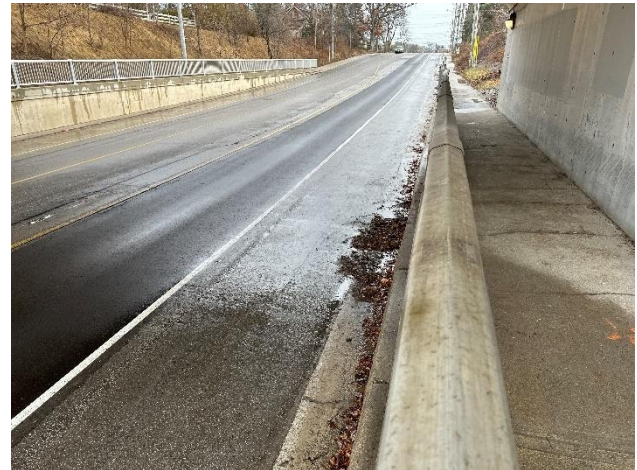
**Cycling Facilities:** On the west side, debris is noted in the cycling facility.

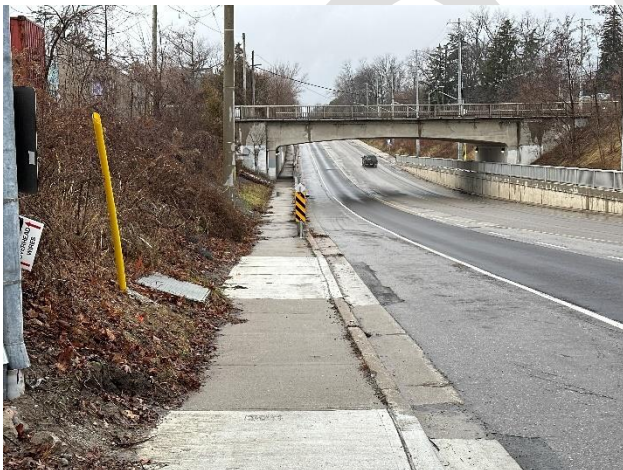
**Cycling Facilities:** Buffer missing on both sides between Orchard Hill Road to the Lakeview Golf Course Access.

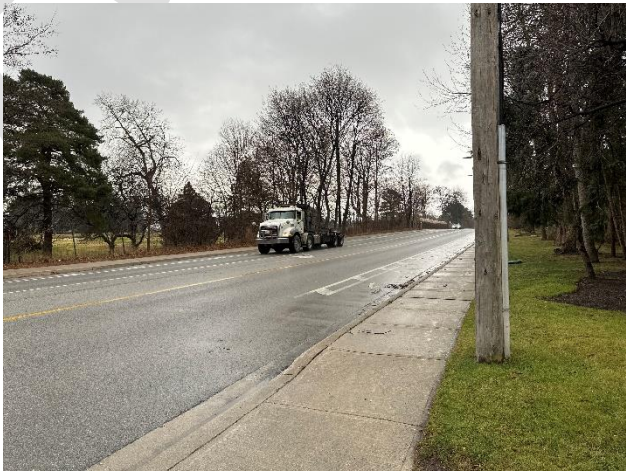
**Motor Vehicle Facilities:** Sightlines are generally adequate, but it should be noted that visibility looking south is slightly diminished by a roadway crest.

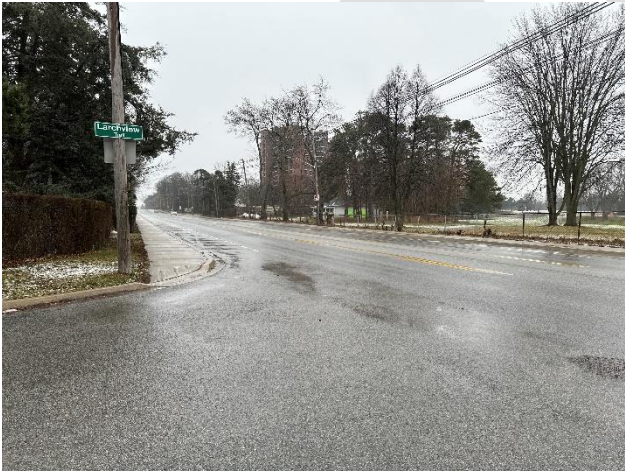
**Motor Vehicle Facilities:** Sightlines looking south are partially obstructed by vegetation and require drivers to encroach the pedestrian right-of-way for a clear sightline.

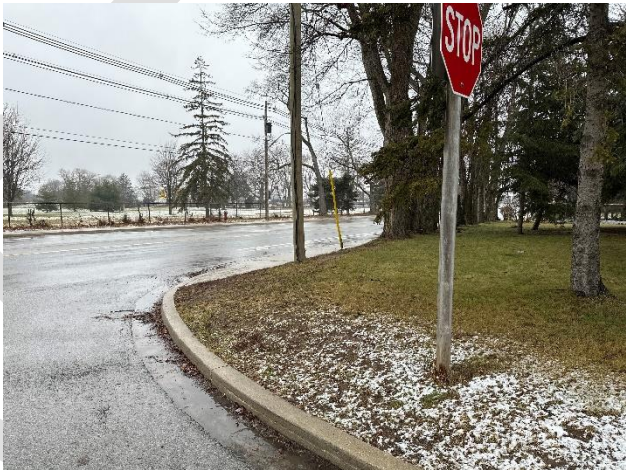
**Motor Vehicle Facilities:** Sightlines looking north are partially obstructed by vegetation and hydro poles and require drivers to encroach the pedestrian right-of-way for a clear sightline.

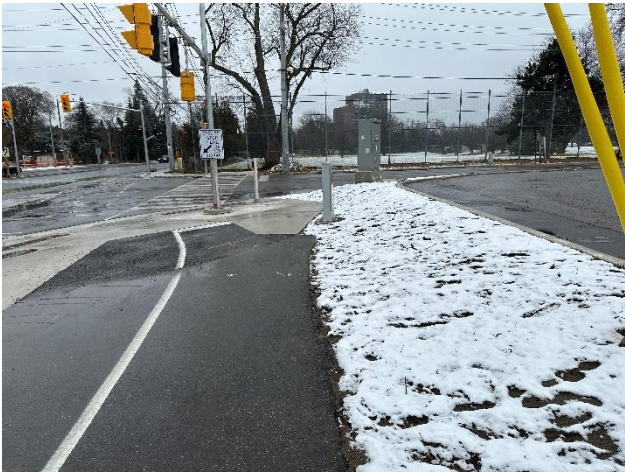
**Pedestrian Facilities:** Multiple desire lines from the Dixie Mall parking lot lead to the sidewalk.

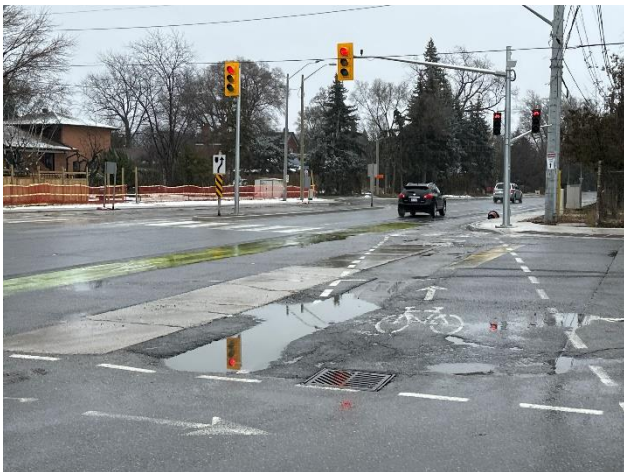
**Cycling Facilities:** Facilities on west side required refreshing.

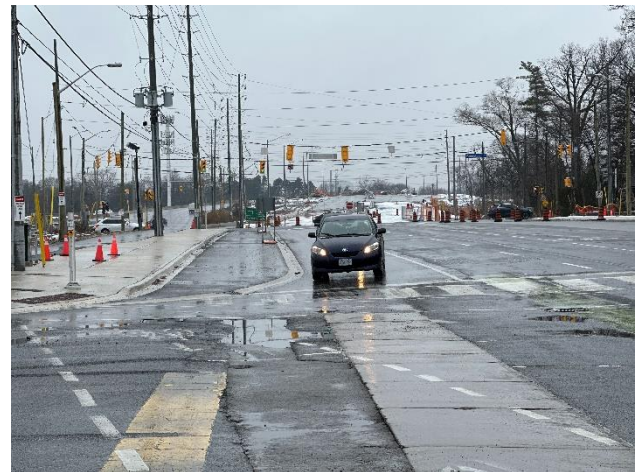
**Driving Behaviour:** Despite the large curb extension, drivers in both general vehicles and MiWay buses perform southbound right turns very aggressively, often not stopping on red or yielding to pedestrians.

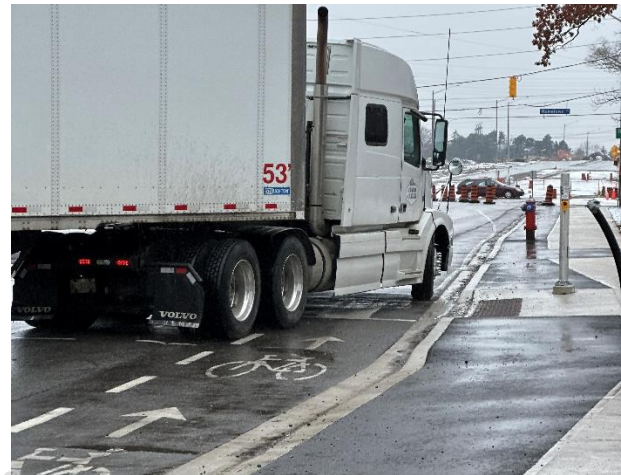
**Driving Behaviour:** Large vehicles turning eastbound left encroach the corner of the cycling facility transition.

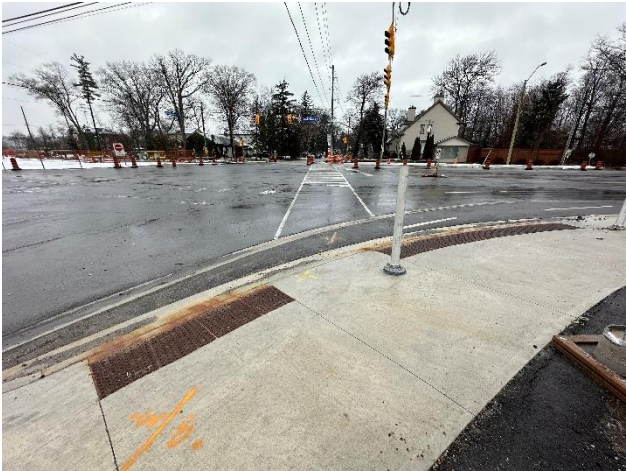
**Pedestrian Facilities:** TWSIs are not aligned with crosswalks.
