**Fish and Fish Habitat Assessment for Bovaird Drive Class Environmental
Assessment from Lake Louise Drive/Worthington Avenue to 1.45 km west of
Heritage Road**

Prepared by: Cam Portt
C. Portt and Associates
56 Waterloo Avenue
Guelph, ON
N1H 3H5
cportt@sentex.net

March 26, 2012

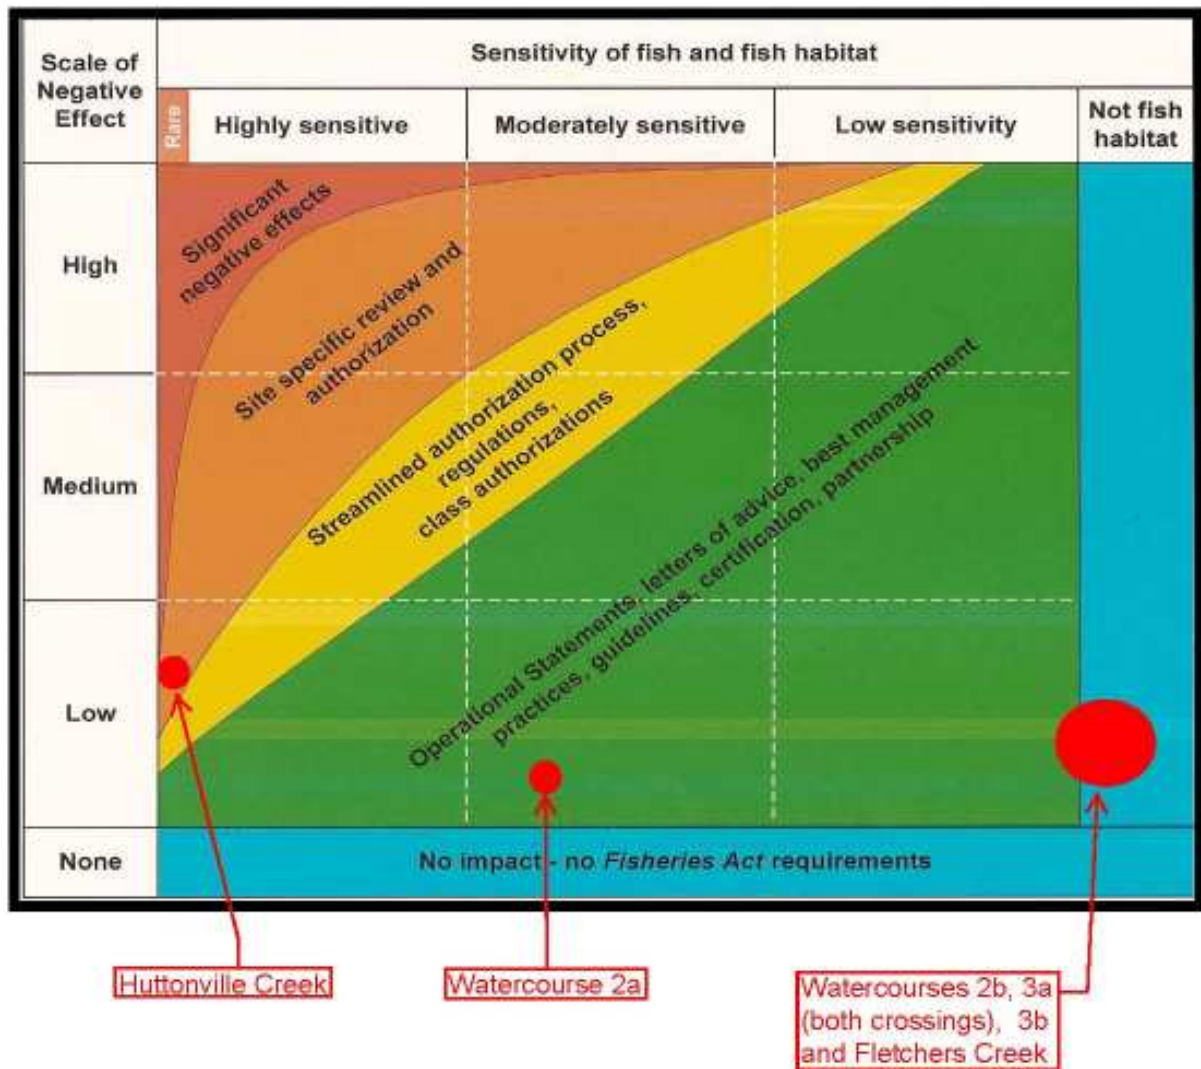
Figure 2. Risk management assessment for the proposed watercourse crossings.

The assessment for each evaluation criteria, is presented for each crossing where works are proposed in Table 3. The overall risk management assessments are illustrated in Figure 2. The sensitivity of fish and fish habitat is low, except for watercourse 2a where it is medium and for Huttonville Creek, where it is high due to the presence of the endangered redbside dace. In all cases the scale of negative effects is low. With the exception of Huttonville Creek, based on this assessment, and provided that best management practices (i.e. for sediment controls, timing restrictions, revegetation guidelines) are followed, the proposed works can be carried out under a letter of advice, or perhaps, in some cases, by following guidance in operational statements (Figure 2). These practices, which are subject to change over time, should be clearly described during detailed design.

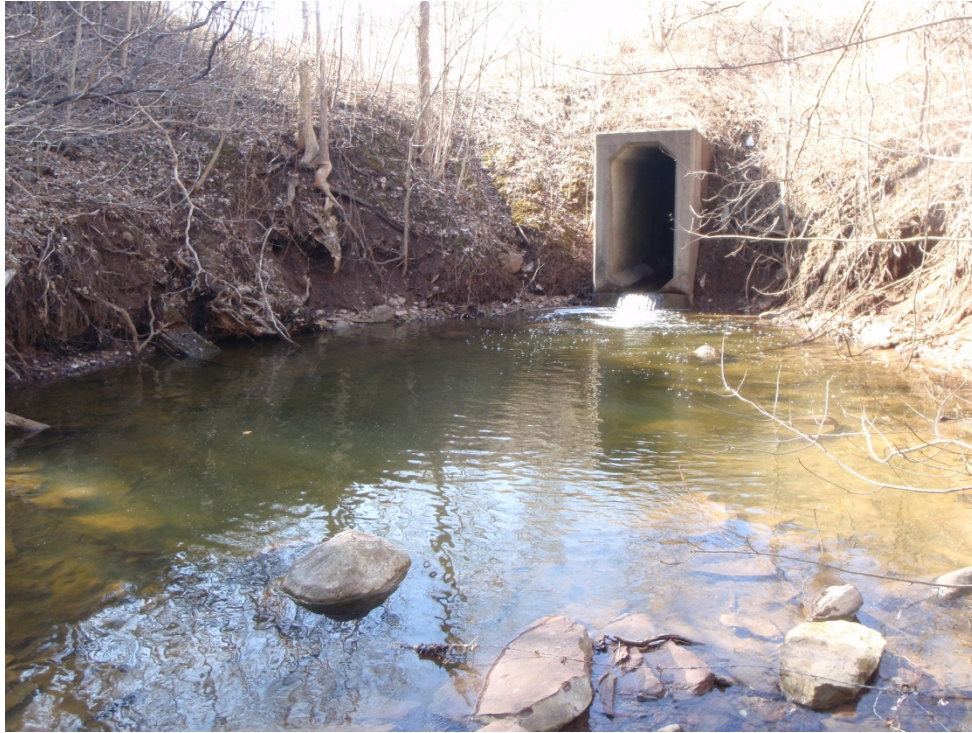
The 1.2 m concrete box culvert under Bovaird Drive is 95 m long. It is perched at normal flows, so non-jumping fish species would not be able to move upstream under any flow conditions, and the culvert itself is probably a barrier due to shallow water during low flows and high velocities during high flows (Photograph 1). In addition, although the upstream end was obscured by debris (Photograph 2), the sound of water falling into the culvert indicated that there is currently a vertical drop into the culvert at its upstream end. There appears to have been a substantial amount of sediment deposition in the valley immediately upstream from the culvert. On the south side of Bovaird Drive, and the east side of the watercourse, the steep ditch descent into the valley has been stabilized with stone.

Photograph 1. Downstream end of culvert at watercourse 2a. March 30, 2010.

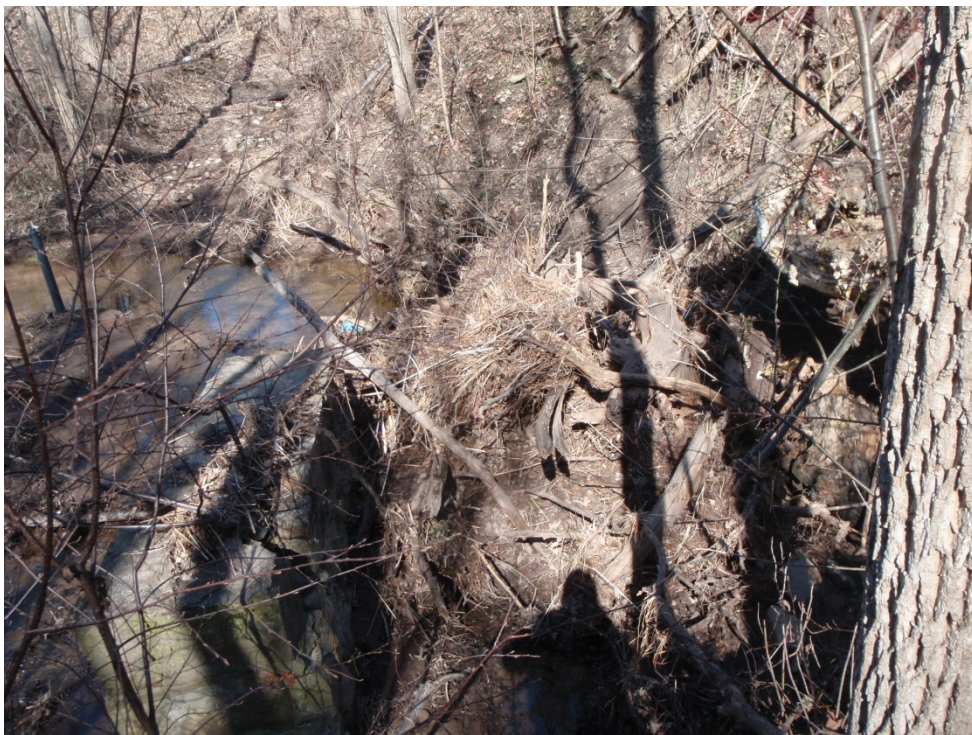
Photograph 2. Debris jam at upstream end of culvert at watercourse 2a. March 30, 2010.

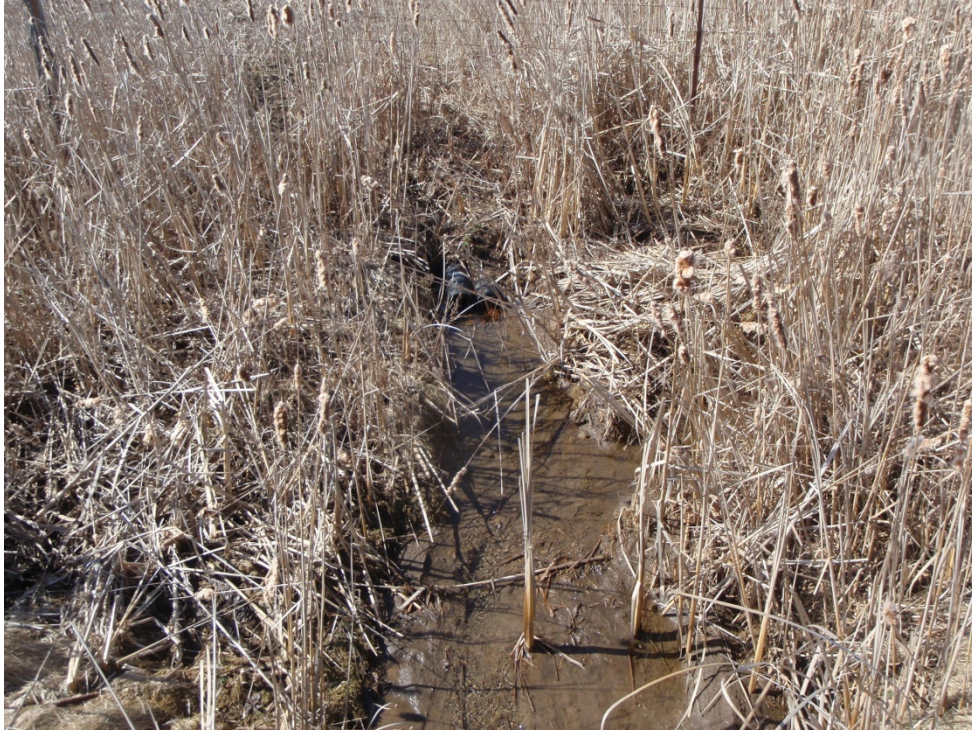
This small drainage feature passes beneath Bovaird Drive in a 35 m long, 0.91 m open footing concrete culvert. On March 30, 2010, flow originated from field tiles that discharge at the edge of the right-of-way (Photograph 3). The culvert is partially filled with fine sediment (Photograph 4). Downstream from Bovaird Drive the channel is wide and undefined for approximately 100 metres, and vegetated with cattails (Photograph 5).

As indicated above, the main source of flow in this watercourse in March, 2010, was field tiles that drain to the Bovaird Drive right-of-way (Photograph 3). The watercourse itself was dry upstream and downstream from the pond in the fall of 2003. There was standing water, but no discernable flow, immediately upstream and downstream of the Bovaird Road culvert on June 6, 2011. As this watercourse is dry during the summer of most

Photograph 3. Field tiles that are source of upstream flow at watercourse 2b. March 30, 2010.

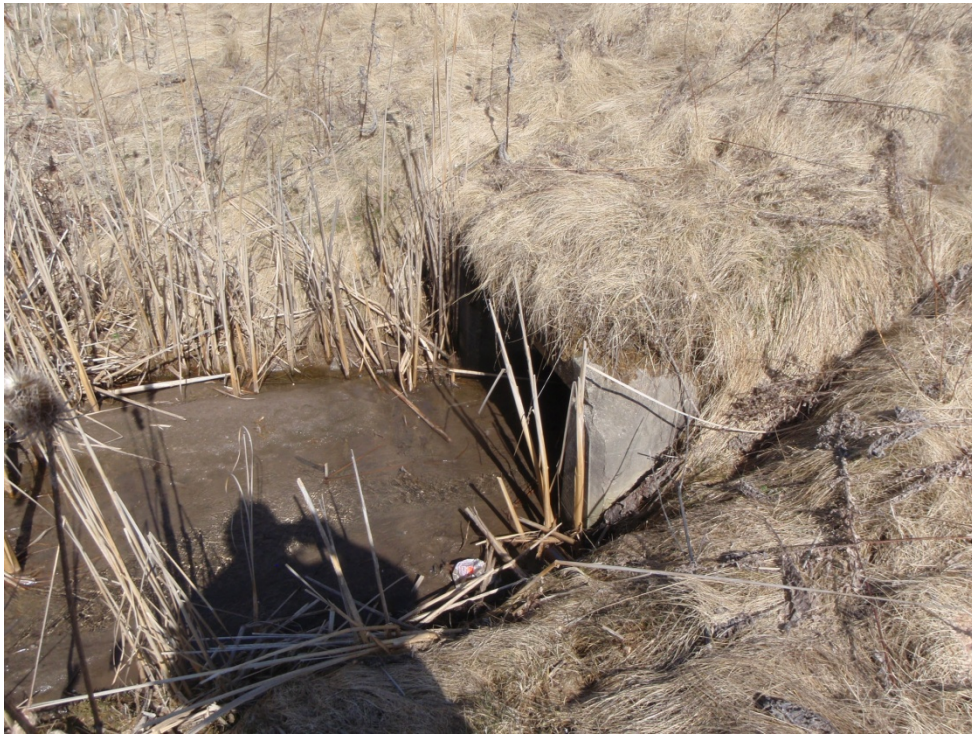
Photograph 4. Upstream end of Bovaird Drive culvert at watercourse 2b. March 30, 2010.

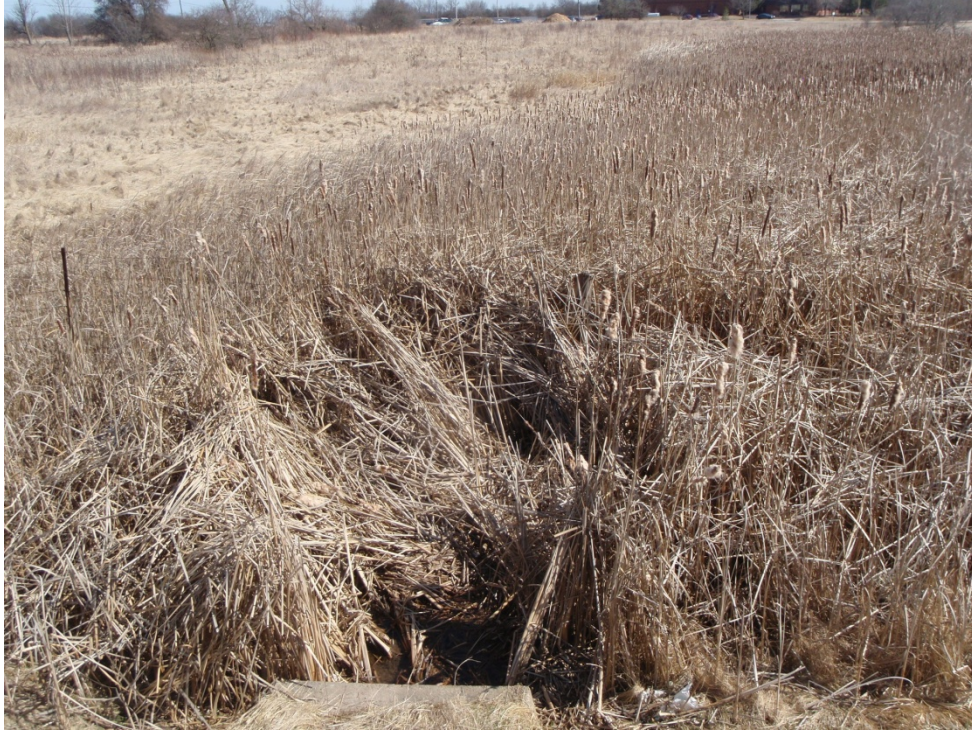
Photograph 5. Looking downstream at watercourse 2b. March 30, 2010.

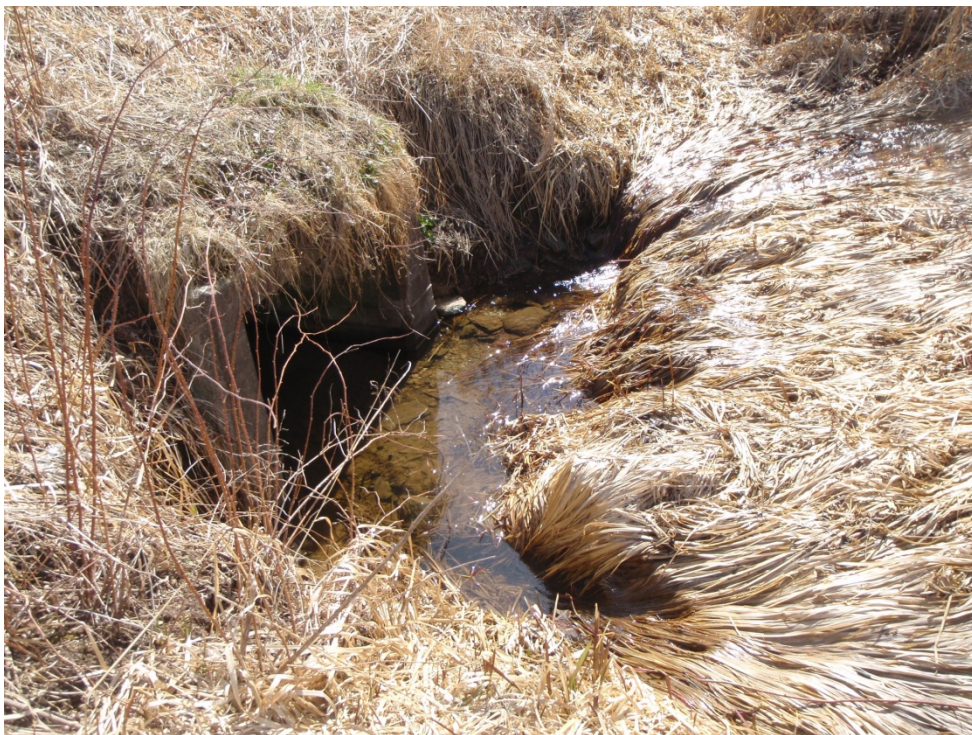
This watercourse is conveyed under Bovaird Drive just west of Heritage Road in a 1.2 m open footing culvert that has been extended on the downstream side with a corrugated steel pipe (Photographs 6 and 7), resulting in a total culvert length of 30 m. The road embankment has been stabilized with gabions on the downstream side of Bovaird Drive (Photograph 7). The watercourse flows along Heritage Road for approximately 35 metres (Photograph 8) and then is conveyed beneath Heritage Road in a 0.9 m diameter, 14 m long, corrugated steel pipe (Photograph 9).

Photograph 6. Upstream end of Bovaird Drive culvert at watercourse 3a. March 30, 2010.

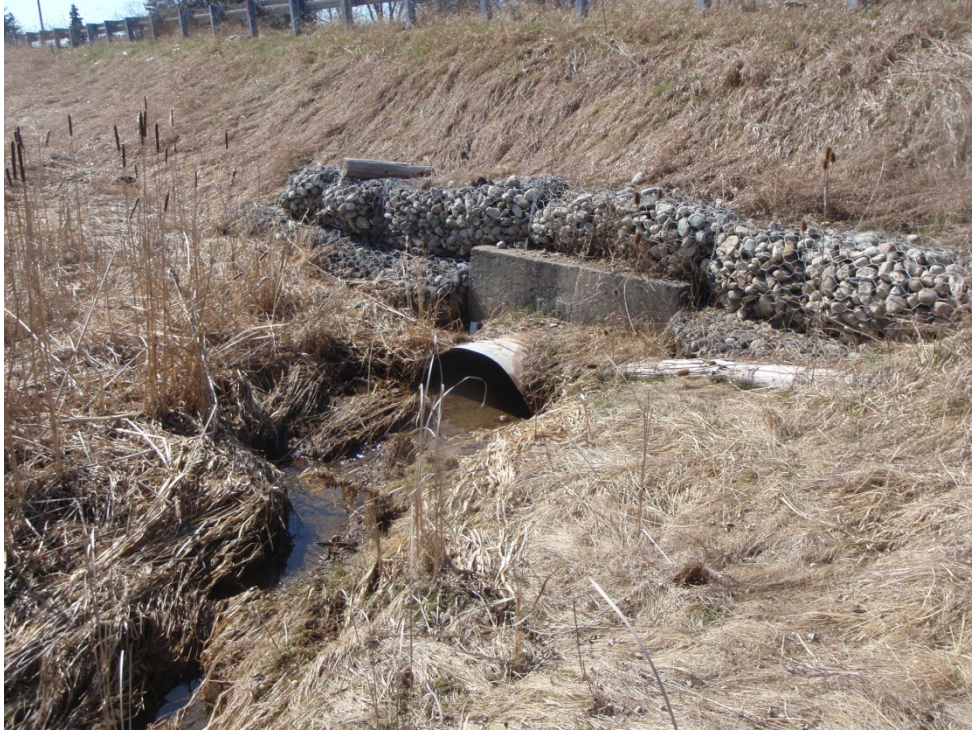
Photograph 7. Downstream end of Bovaird Drive culvert at watercourse 3a. March 30, 2010.

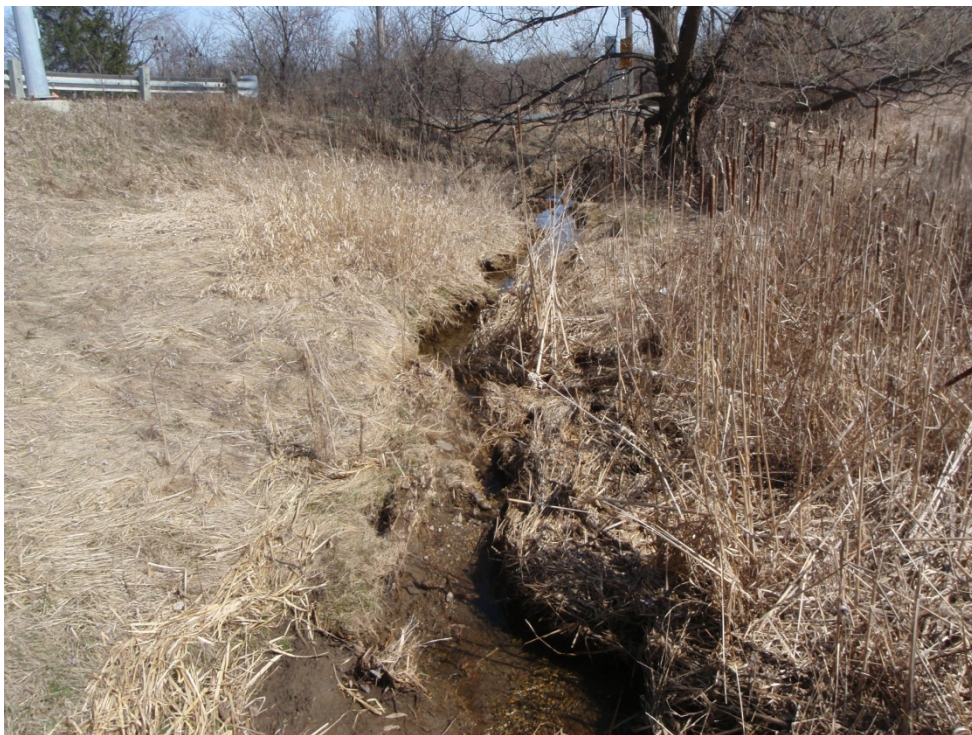
Photograph 8. Watercourse 3a downstream from Bovaird Drive culvert. March 30, 2010.

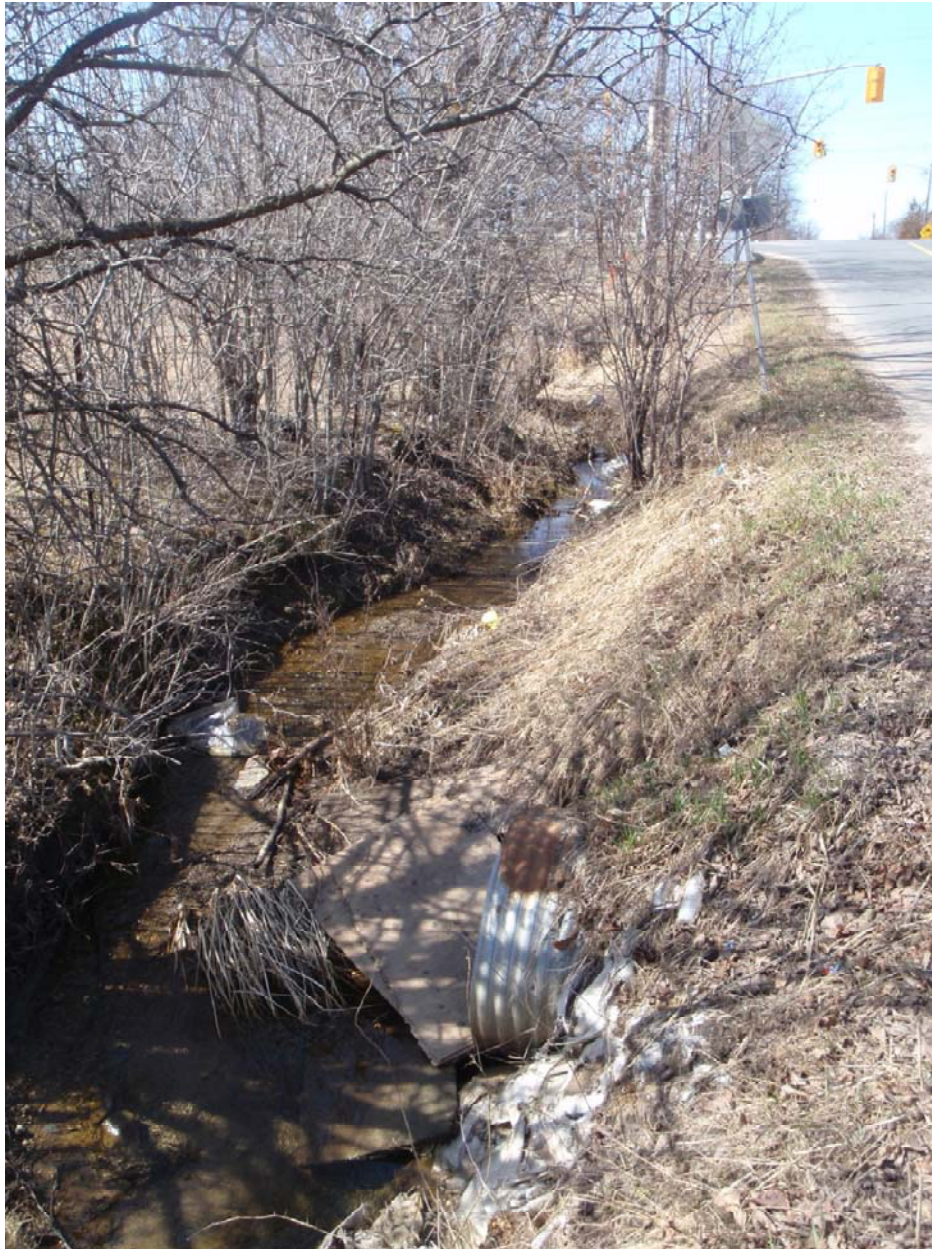
Photograph 9. Watercourse 3a, flowing along Heritage Road and the upstream end of the Heritage Road culvert. March 30, 2010.

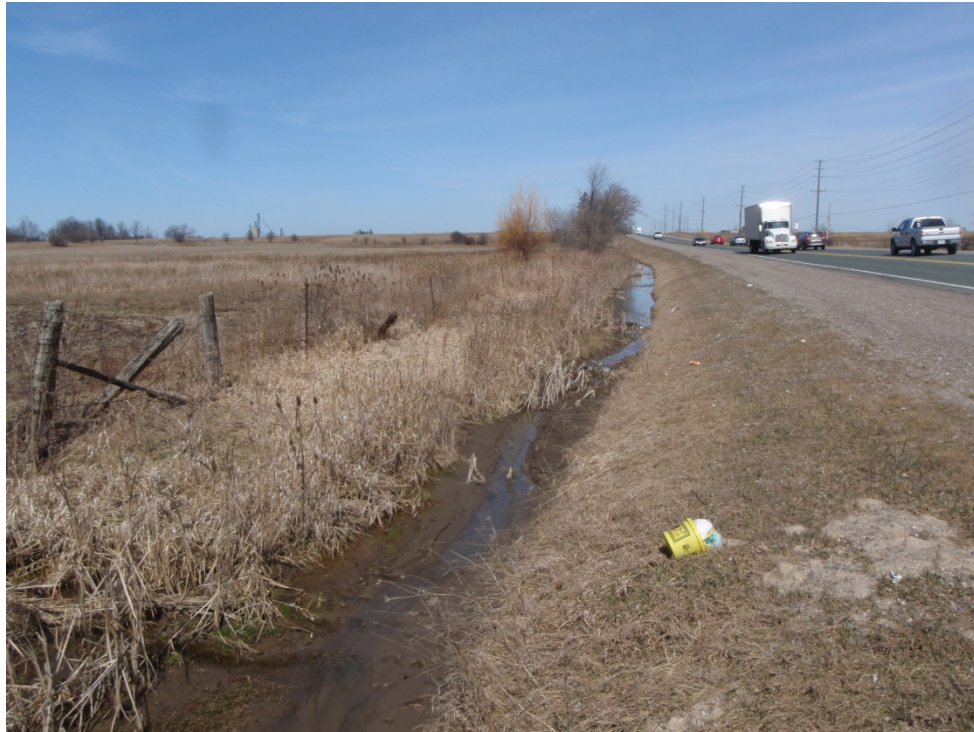
Photograph 10. Ditch flowing westerly to watercourse 3b on upstream side of Bovaird Drive. March 30, 2010.

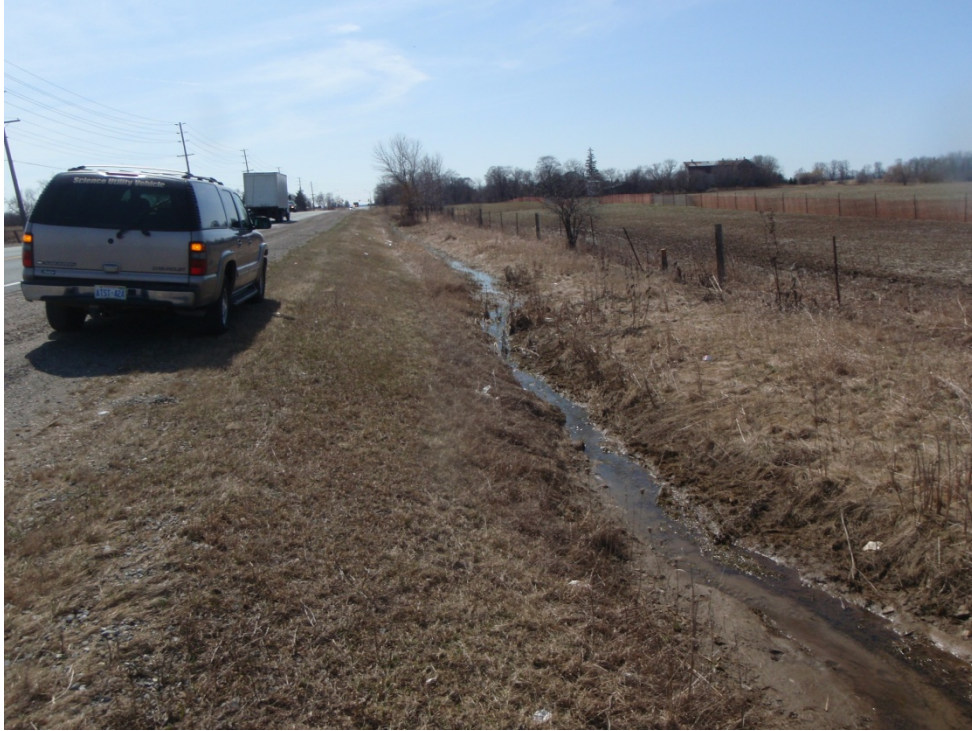
Photograph 11. Ditch flowing easterly to watercourse 3b on upstream side of Bovaird Drive. March 30, 2010.

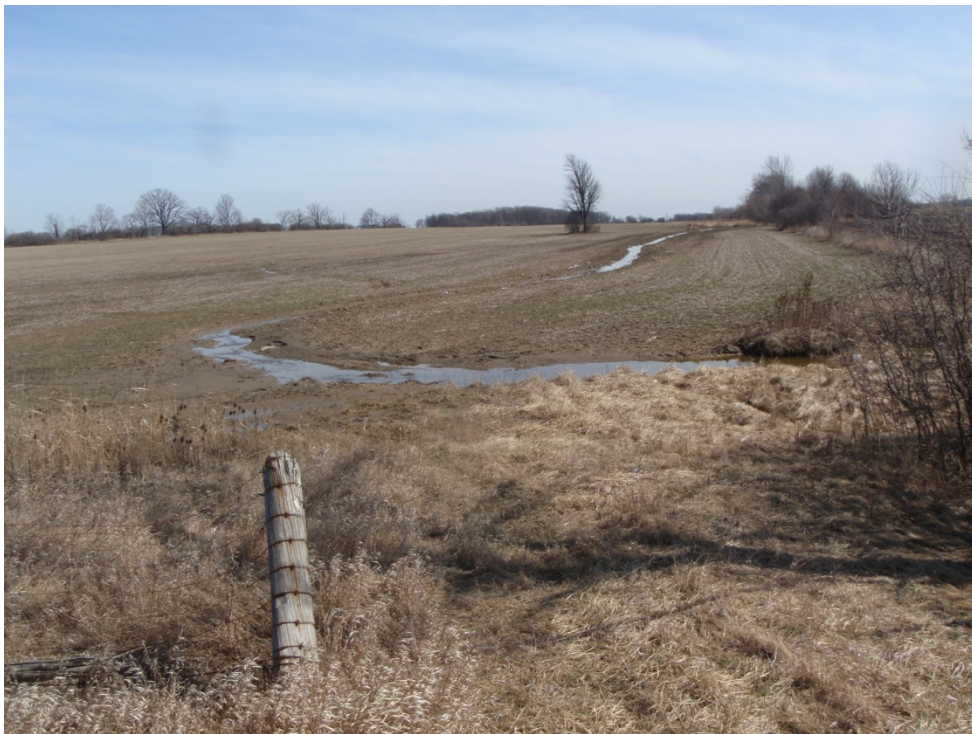
The surface drainage features in upper reaches of this subwatershed were dry when examined in the late summer of 2003. On March 30, 2010, and on June 6, 2011, water was flowing from three main drainage features from the agricultural land upstream from Bovaird Drive. One of these was approximately in line with the Bovaird Drive culvert, but water from the others flowed for some distance along the north Bovaird Drive ditch to the culvert (Photographs 10 and 11). The existing 45 m long, 1.2 m open footing concrete culvert under Bovaird Drive is partially filled with sediment. Downstream from Bovaird Drive the drainage feature flowed across a cultivated field (Photograph 12). There is an online pond approximately 1.2 km downstream from Bovaird Drive.

Photograph 12. Watercourse 3b flowing across cultivated field downstream from Bovaird Drive. March 30, 2010.

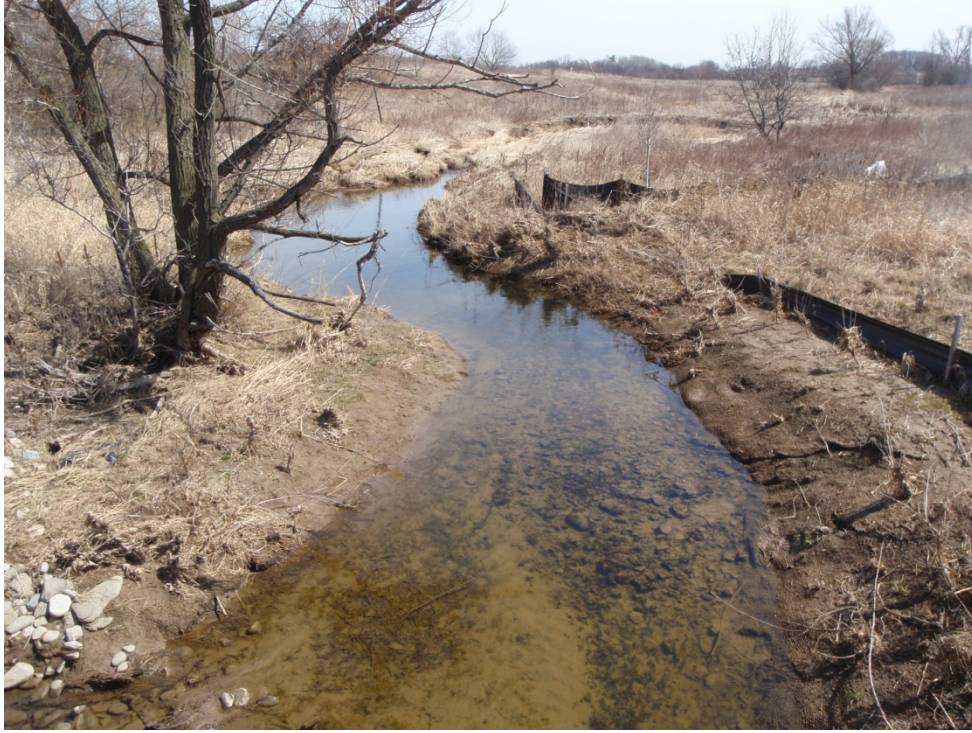
Characterization Report; AMEC and others, 2008). The Bovaird Drive culvert has been recently replaced and extended at this location and coir cloth is visible along the banks, upstream and downstream from Bovaird Drive (Photographs 13 and 14).

Photograph 13. Huttonville Creek looking downstream from Bovaird Drive culvert. March 30, 2010.

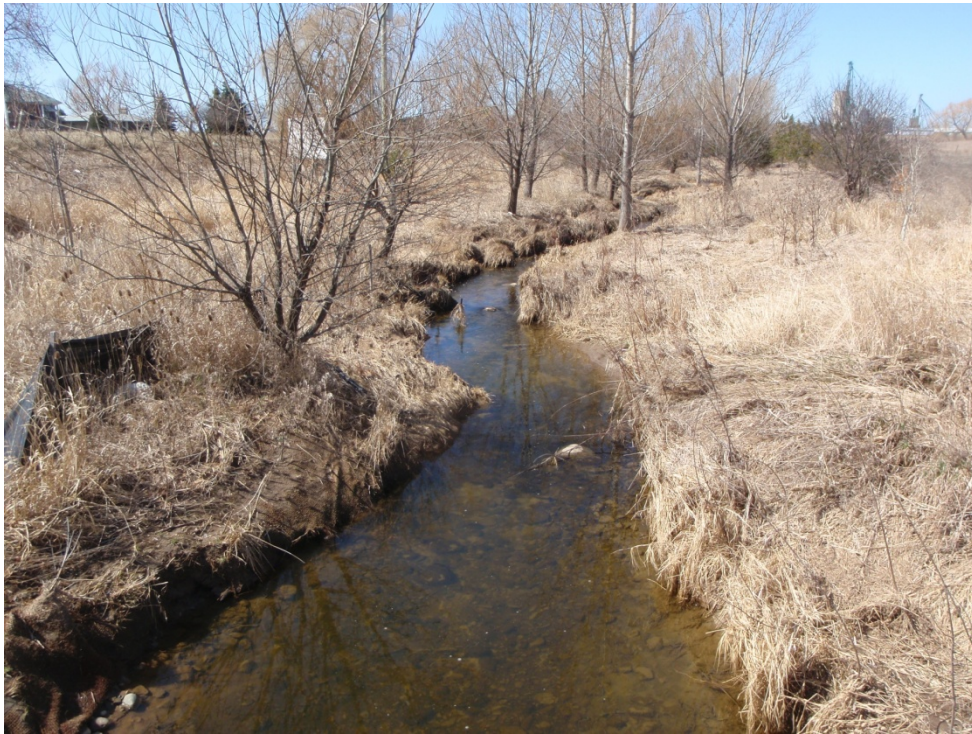
Photograph 14. Huttonville Creek looking upstream from Bovaird Drive culvert. March 30, 2010.

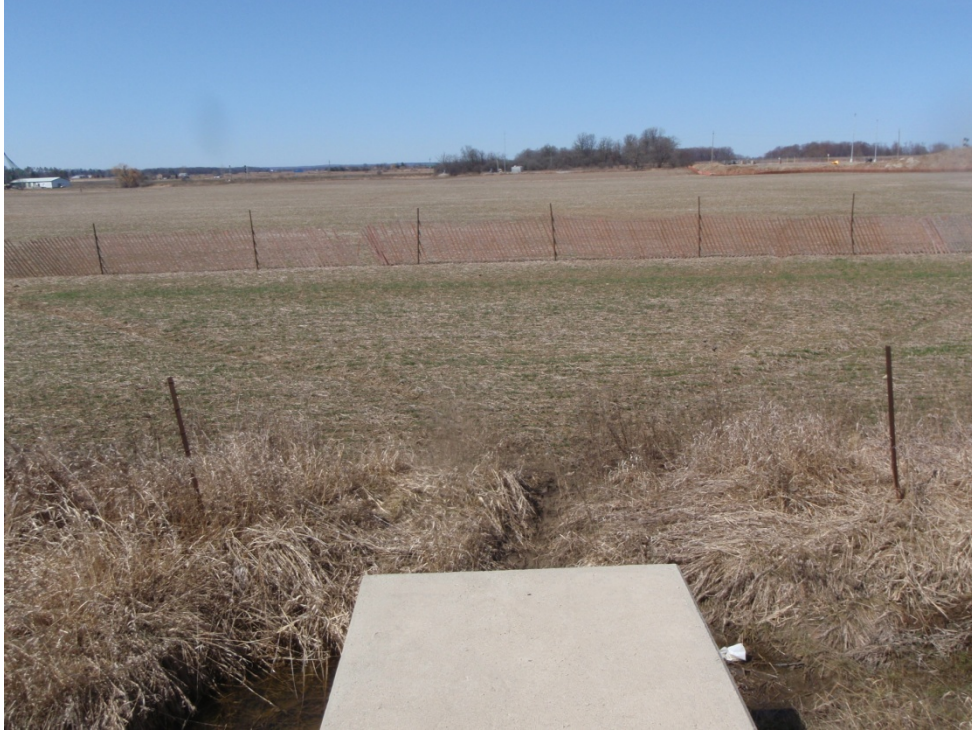
There is one Bovaird Drive culvert, a 33 m long, 0.9 m x 1.0 m concrete box, within the Springbrook Creek subwatershed. There is no defined drainage feature upstream from Bovaird Drive and there was no flow at this location on March 30, 2010 (Photograph 15). There was standing water present in the roadside ditch and the drainage feature upstream from Bovaird Drive and at some locations in the watercourse immediately downstream from Bovaird Drive (Photograph 16). On June 6, 2011, this feature was dry except for a puddle at the upstream end of the Bovaird Drive culvert. The sensitivity of this watercourse is considered to be low, although the presence of redbside dace in the lower reaches of Springbrook Creek must be considered during mitigation development.

Photograph 15. Upstream from Bovaird Drive culvert at Springbrook Creek headwater drainage feature. March 30, 2010.

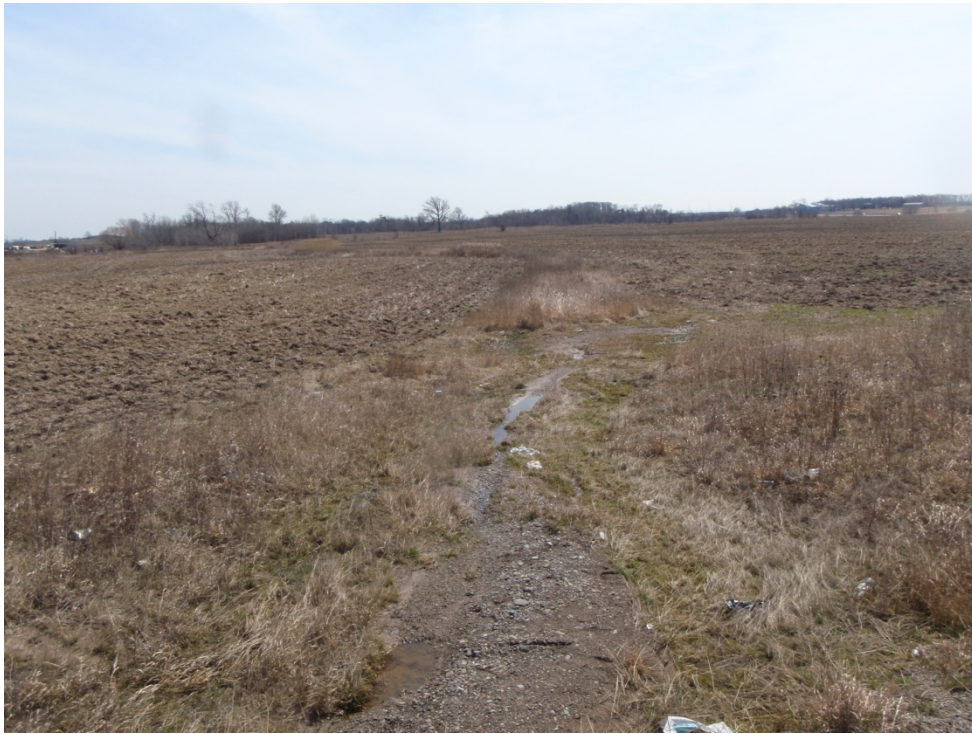
Photograph 16. Downstream from Bovaird Drive culvert at Springbrook Creek headwater drainage feature. March 30, 2010.

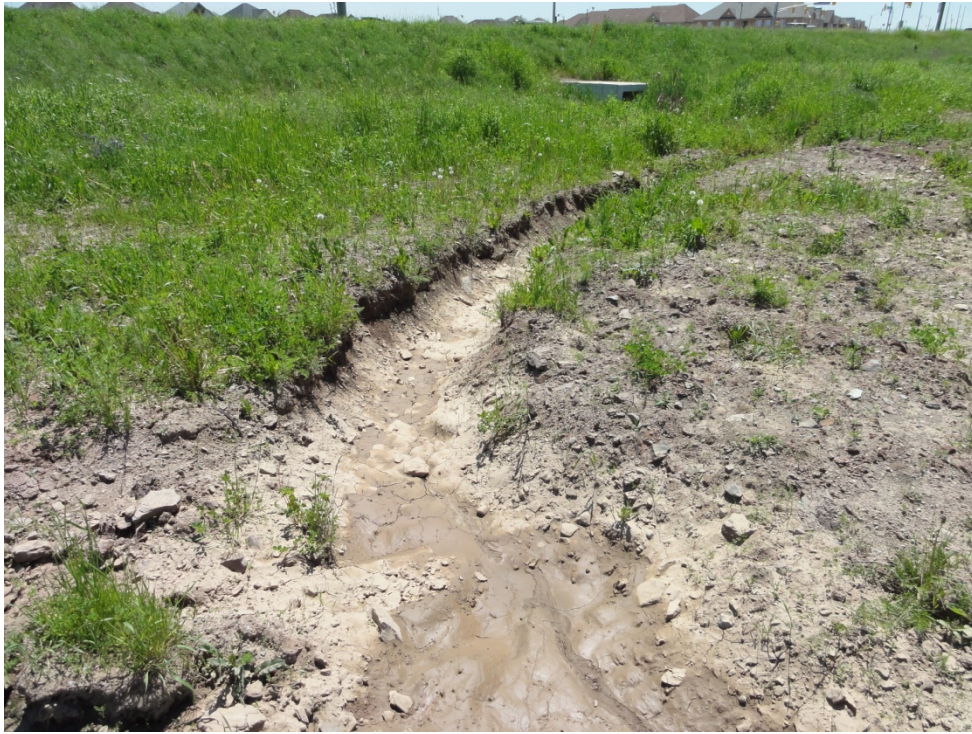
A drainage feature originates from parking lot drainage via a storm sewer outfall at the GO station and flows on the surface for approximately 50 m before entering a concrete box culvert (Photograph 17) that conveys it to the ditch on the south side of Bovaird Drive. That ditch drains east to a 2400x1500mm concrete box culvert extends through the Creview Development and discharges to a stormwater management facility south of James Potter Road. There was standing water present here on March 30, 2010, and this feature was dry on June 6, 2011. This drainage feature is considered to have low sensitivity.

Photograph 17. Drainage feature in Fletcher's Creek watershed upstream from Bovaird Drive. June 6, 2011.
