**ENVIRONMENTAL ASSESSMENT STUDY OF ARTERIAL ROADS WITHIN
HIGHWAY 427 INDUSTRIAL SECONDARY PLAN AREA (AREA 47) - PART B
CITY OF BRAMPTON
FLUVIAL GEOMORPHIC COMPONENT**

Version 1.0
November 2022
Mississauga, Ontario

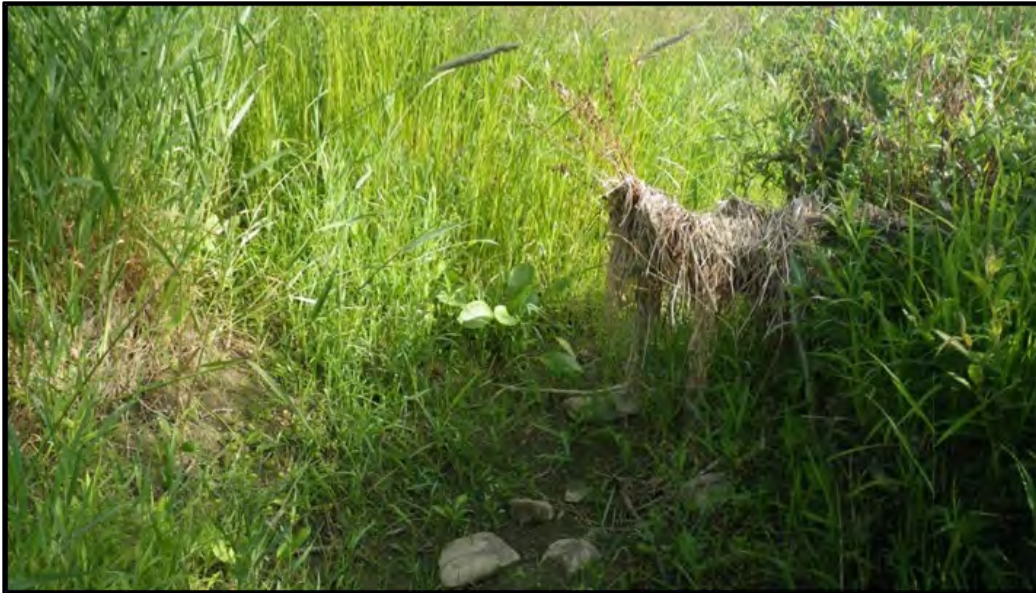
1. Reach G-1D: evidence of high flow above bed

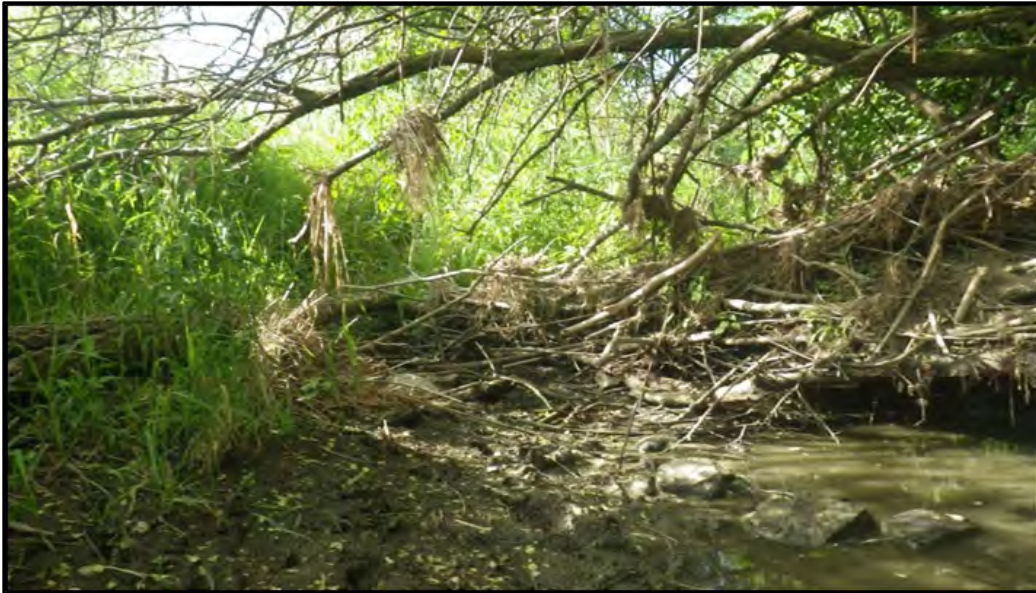
3. Reach G-1D: woody debris jam and high-water marks

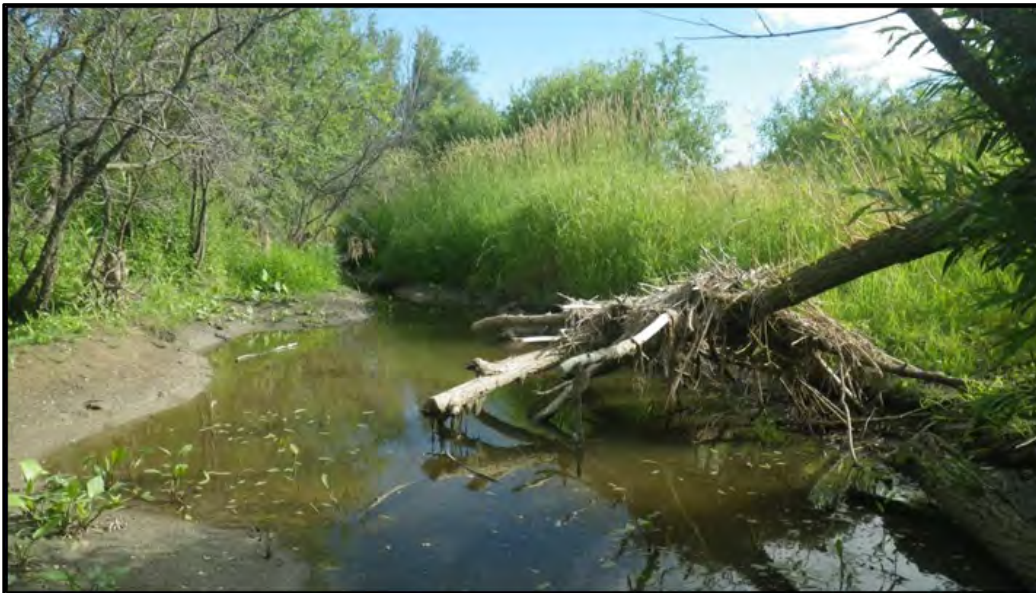
4. Reach G-1D: pool cross-section with high-water marks

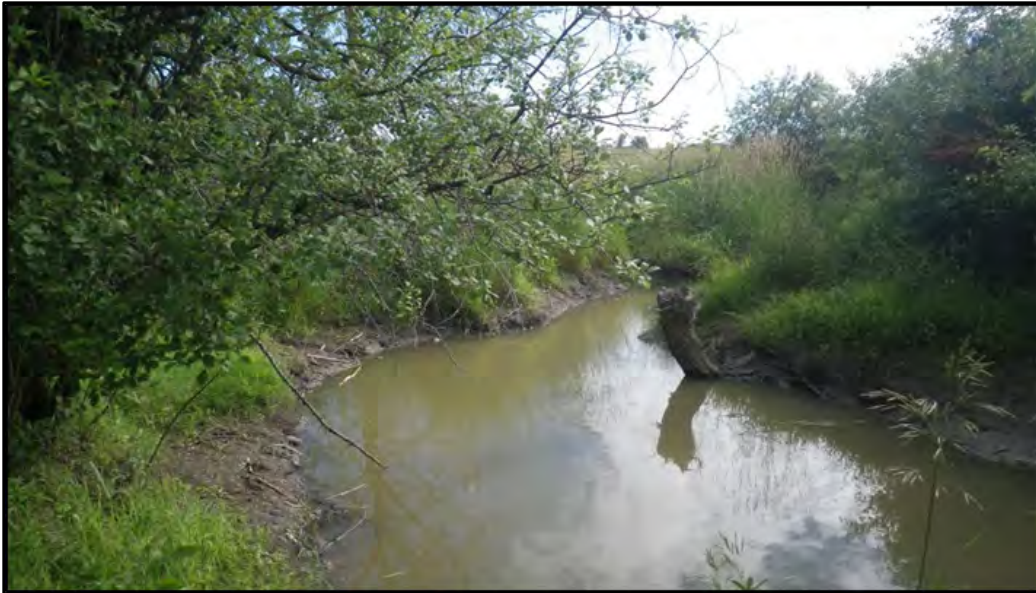
5. Reach G-1D: extensive ponding upstream from beaver dam

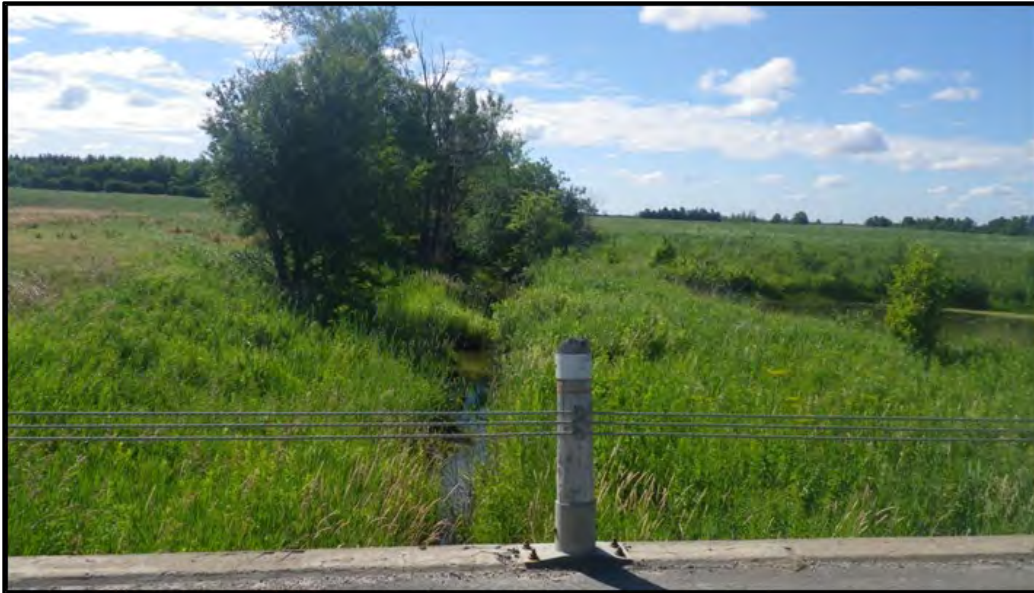
7. Reach G-2D: offline pond downstream from Countryside Drive crossing; channel is entrenched below floodplain and surrounding agricultural fields

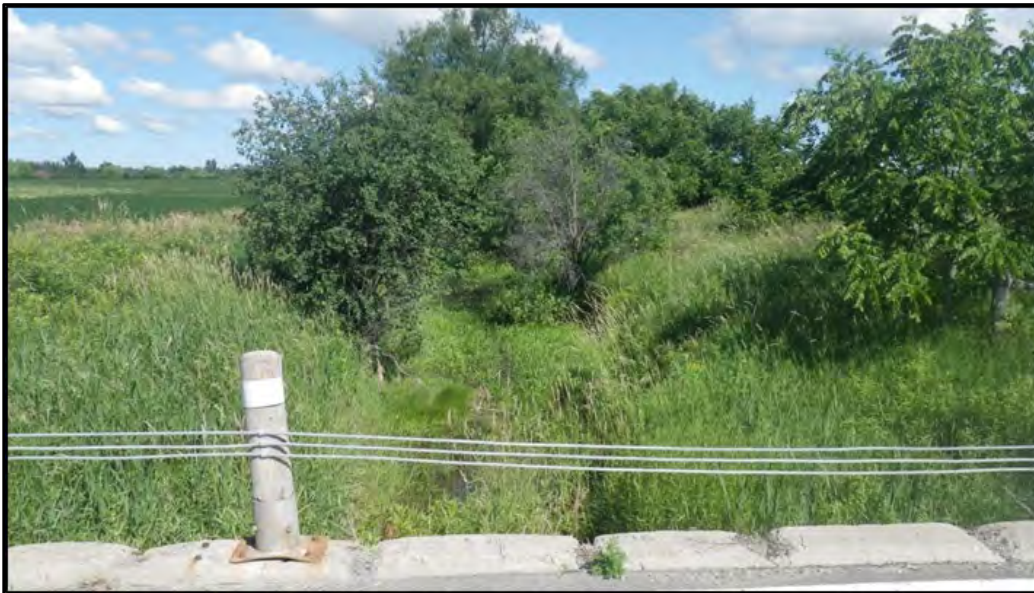
8. Reach G-3: upstream from Countryside Drive crossing; channel is entrenched; ponding is occurring upstream and widens flow pathway but creates shallower channel; vegetation dominated along the bed

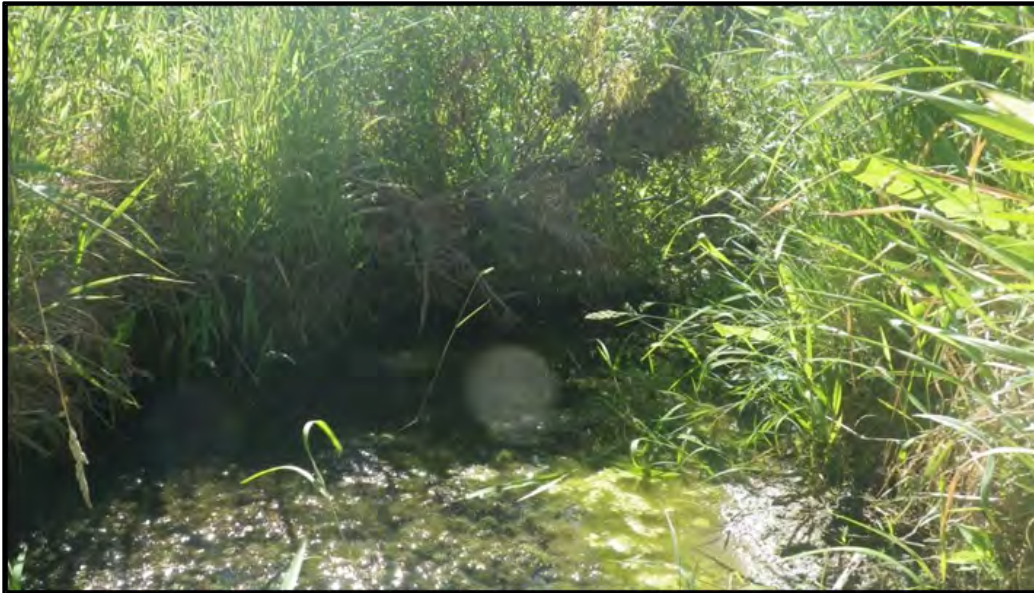
9. Reach G-3: stagnant water due to ponding upstream from Countryside Drive crossing

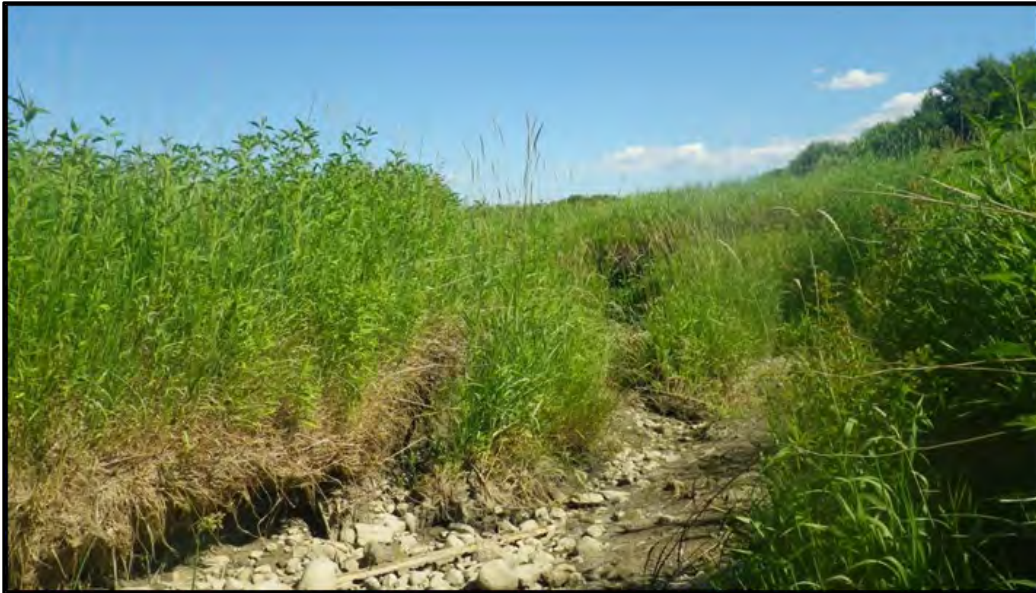
11. Reach C-3: undercutting and detached channel banks are common throughout the reach

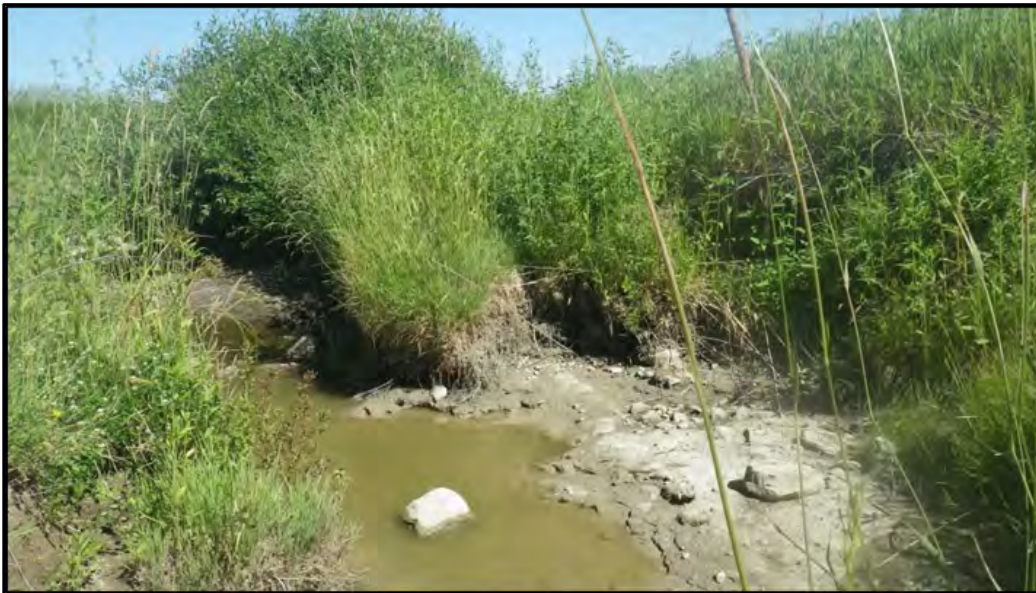
12. Reach C-3: multiple detached banks along outside meander belt

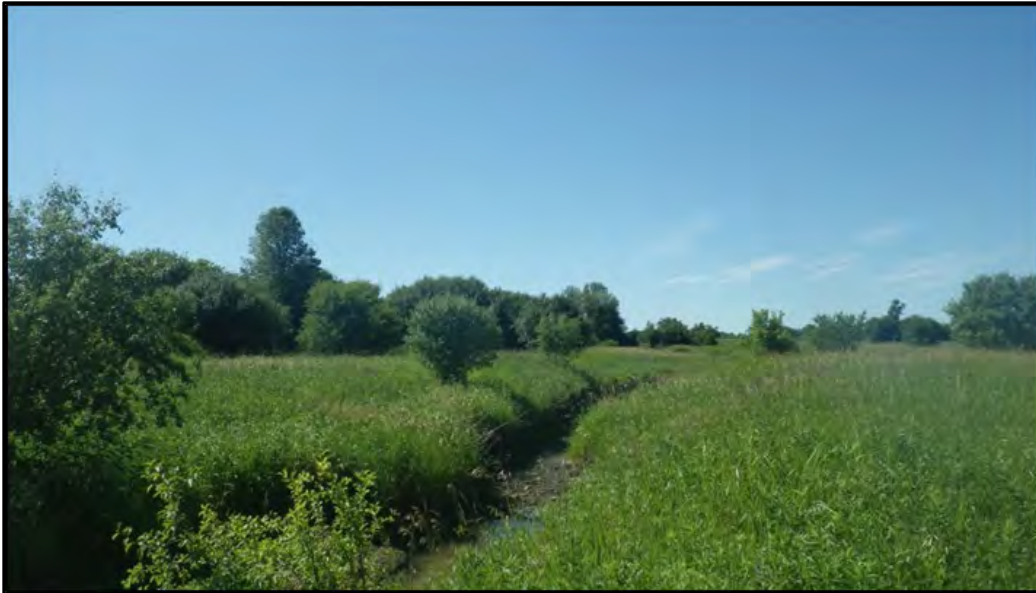
15. Reach C-3: looking upstream along channel from floodplain vantage point; wide riparian corridor and channel entrenchment apparent

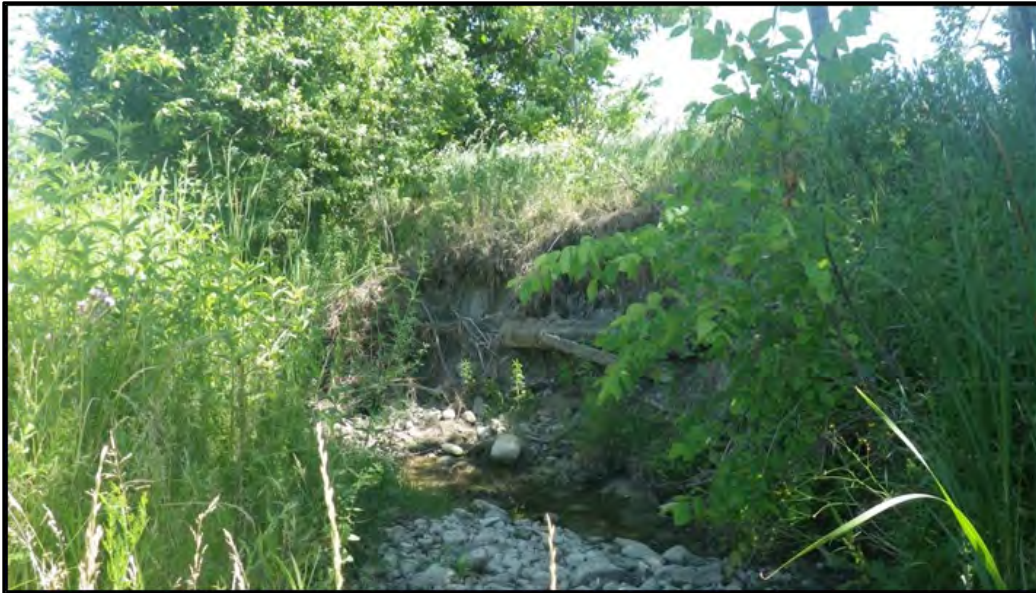
17. Reach C-5B: sharp meander bend at upstream extent of reach; extensive erosion of outer bank; bank height >2 m

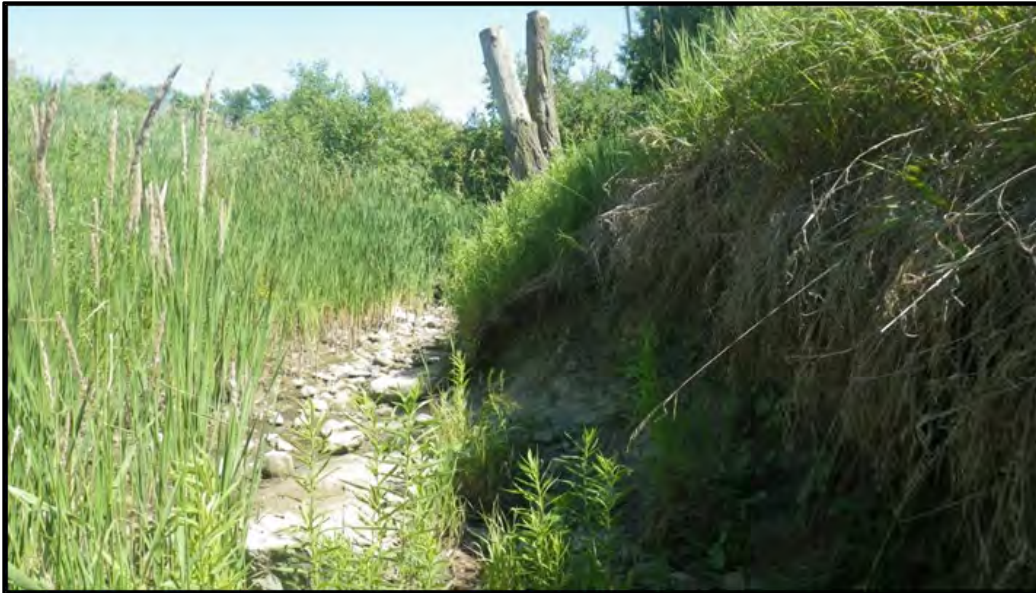
19. Reach C-5B: local erosion and undercutting of bank adjacent to road

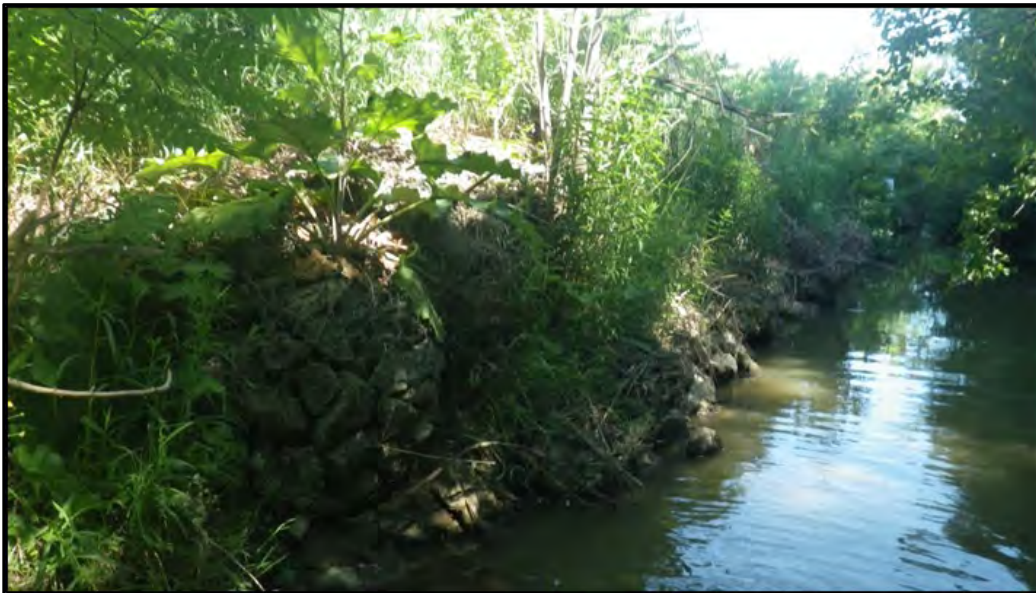
20. Reach C-5B: gabion baskets protect road embankment at the downstream extent of the reach; the gabion baskets are in poor condition with undercutting and failure of netting

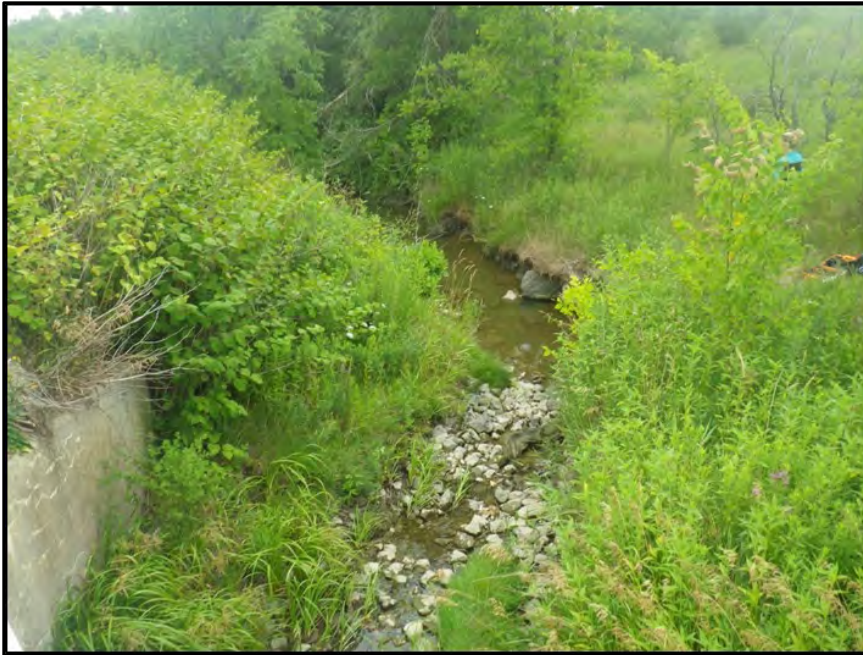
21. Reach C-6: view of reach from Clarkway Drive crossing; bank erosion and undercutting are visible on the outside meander bend

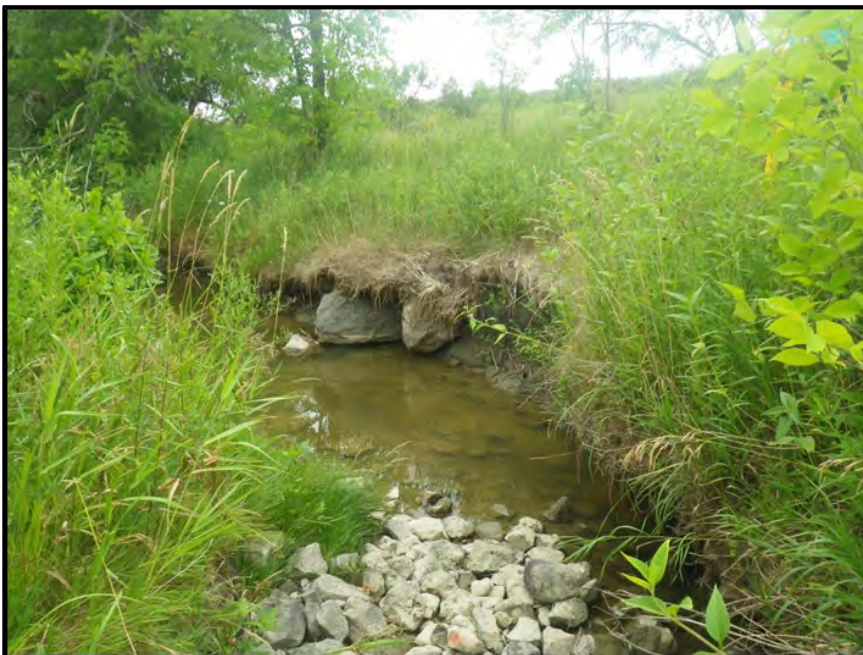
22. Reach C-6: boulder bank protection along outside meander bend; erosion and undercutting still occurring

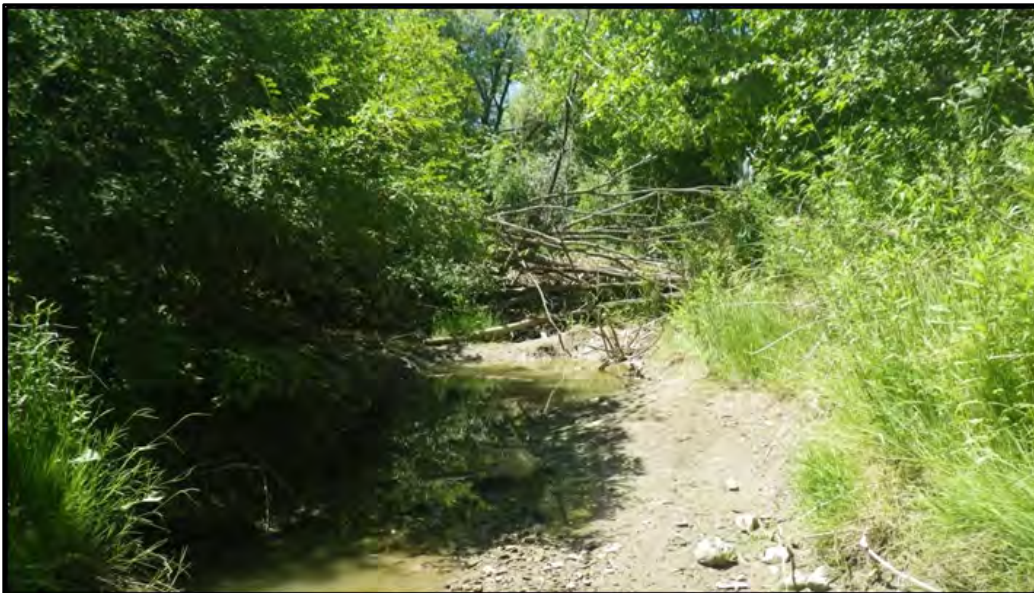
24. Reach C-6: wood debris common within channel and on banks

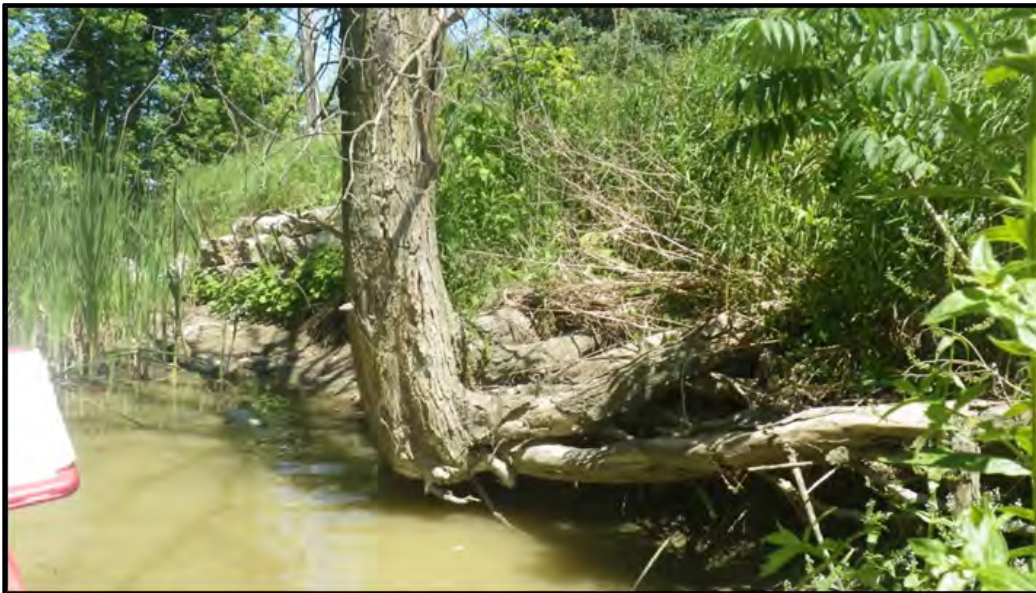
26. Reach C-6: exposed and elevated tree roots along outside meander bend toward downstream extent of the reach

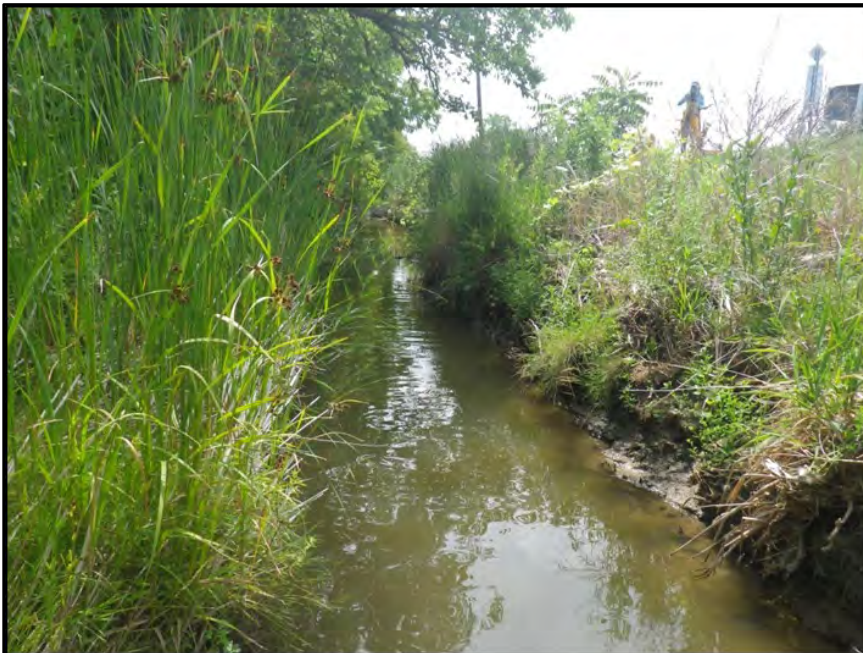
28. Reach C-7: looking downstream along channel; bank erosion along south bank is common throughout the reach

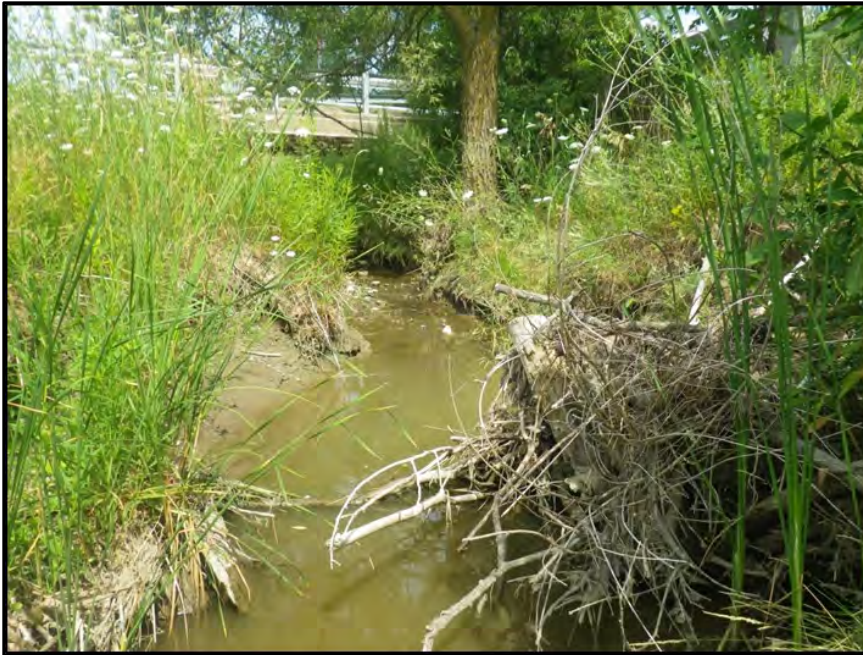
29. Reach C-7: woody debris has caused constriction of flow and local increase in erosion

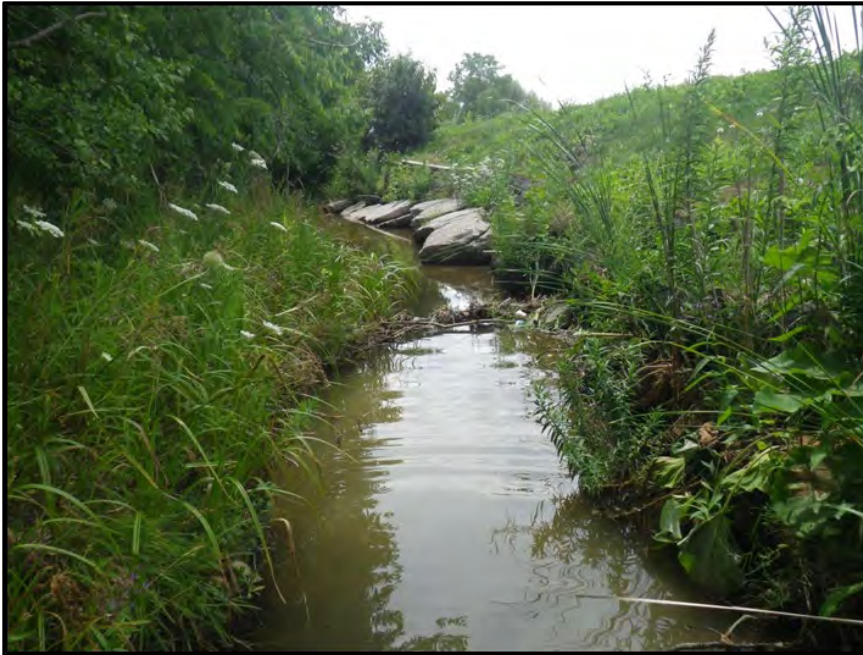
31. Reach C-7: ponding upstream from armourstone bank protection

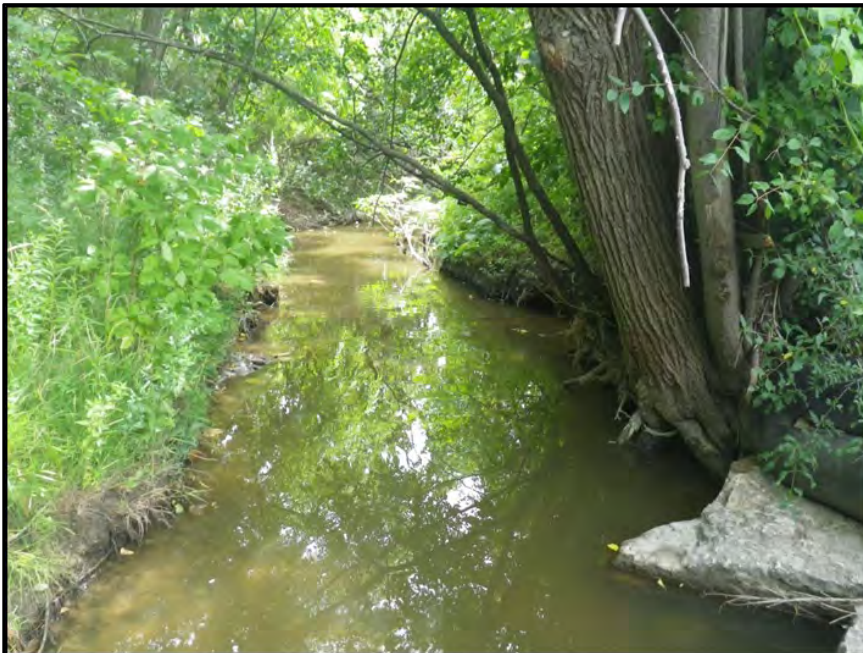
32. Reach C-7: exposed and undercut tree roots are evidence of channel widening

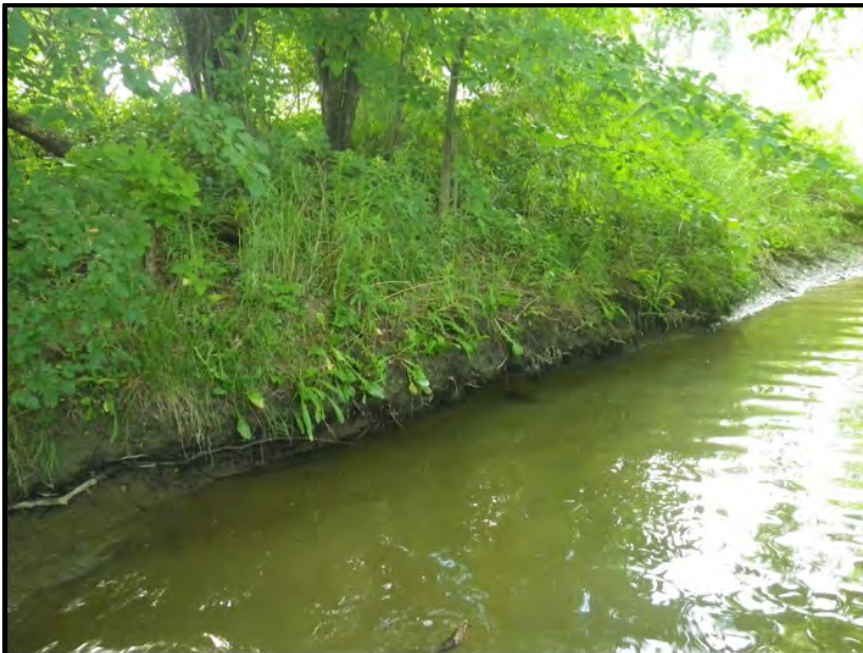
34. Reach C-8: bank undercutting along typical pool cross-section

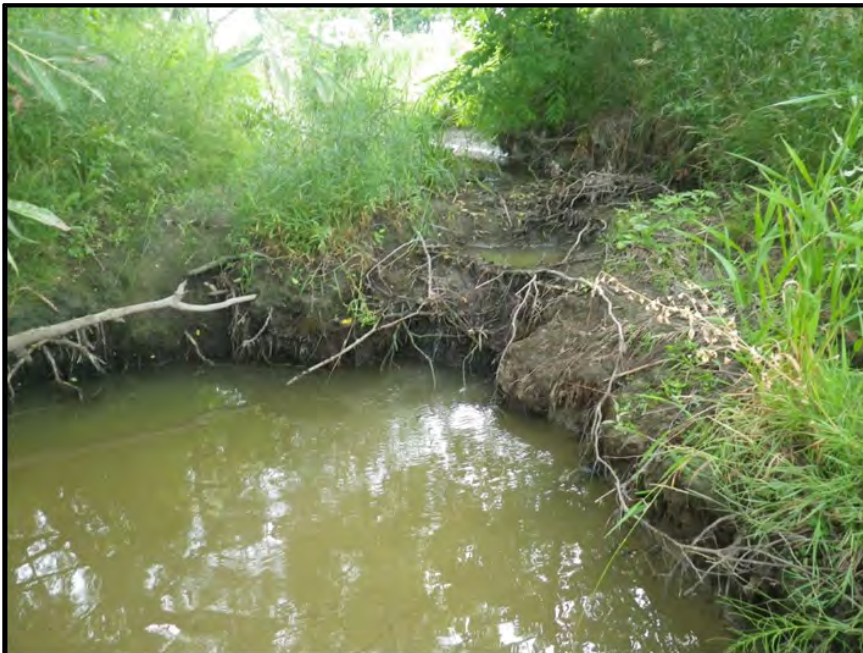
36. Reach C-8: knick-point and scour pool formation adjacent to Countryside Drive

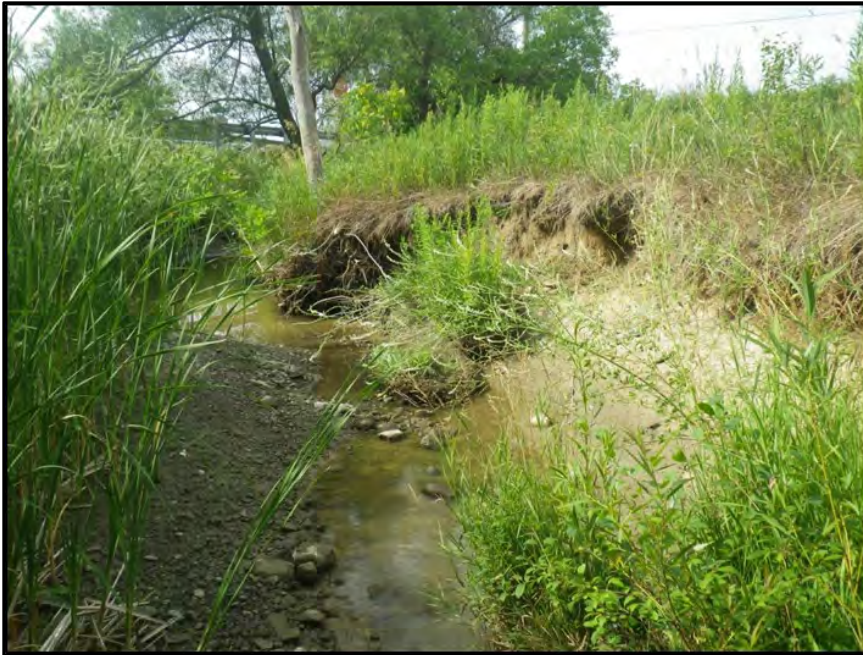
37. Reach C-8: vertical eroding bank and detached bank along outside meander bend; gravel point bar formation along inside meander bend

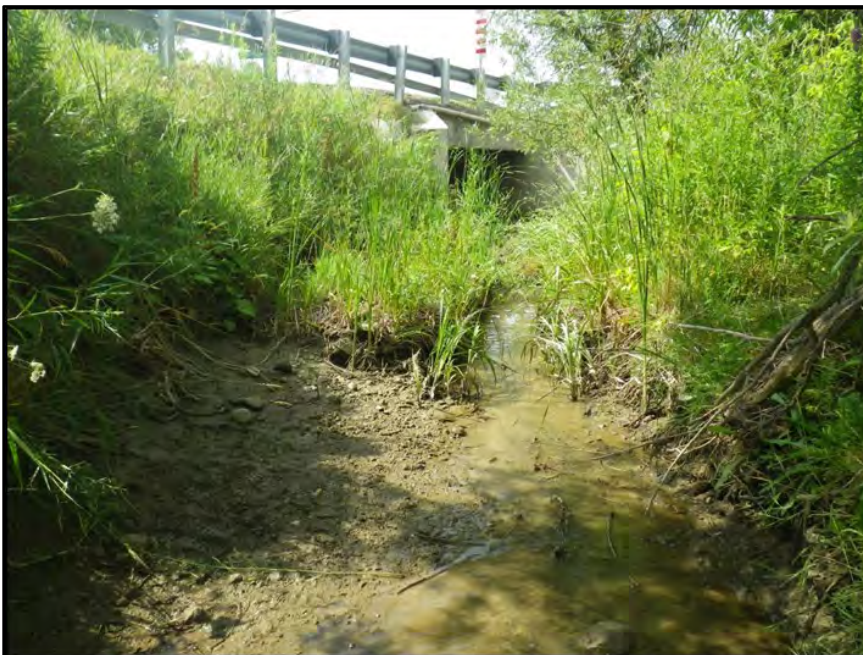
38. Reach C-8: detached bank constricts pathway approaching Countryside Drive crossing

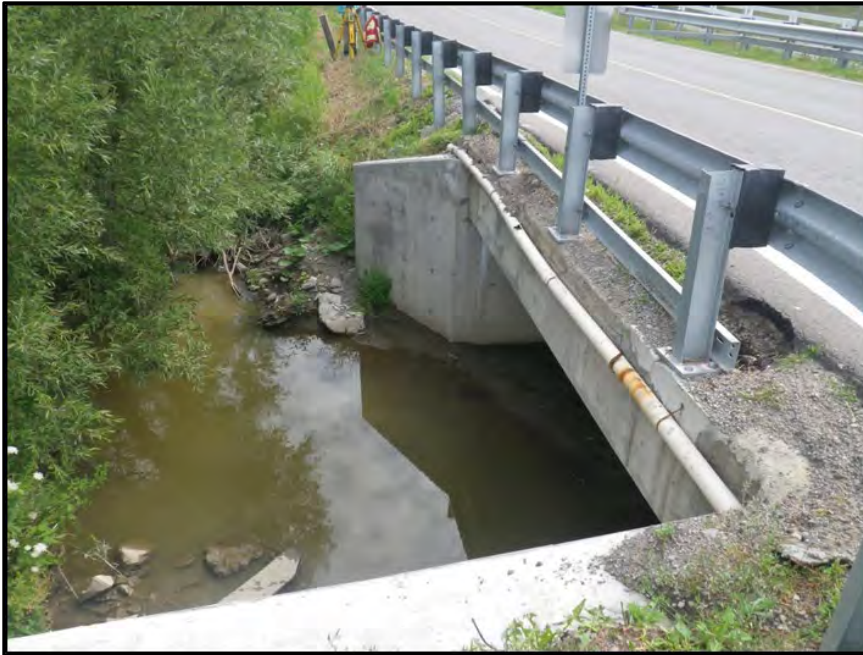
39. Reach C-8: view of Countryside Drive crossing from Clarkway Drive; approach angle of channel causes erosion and scour

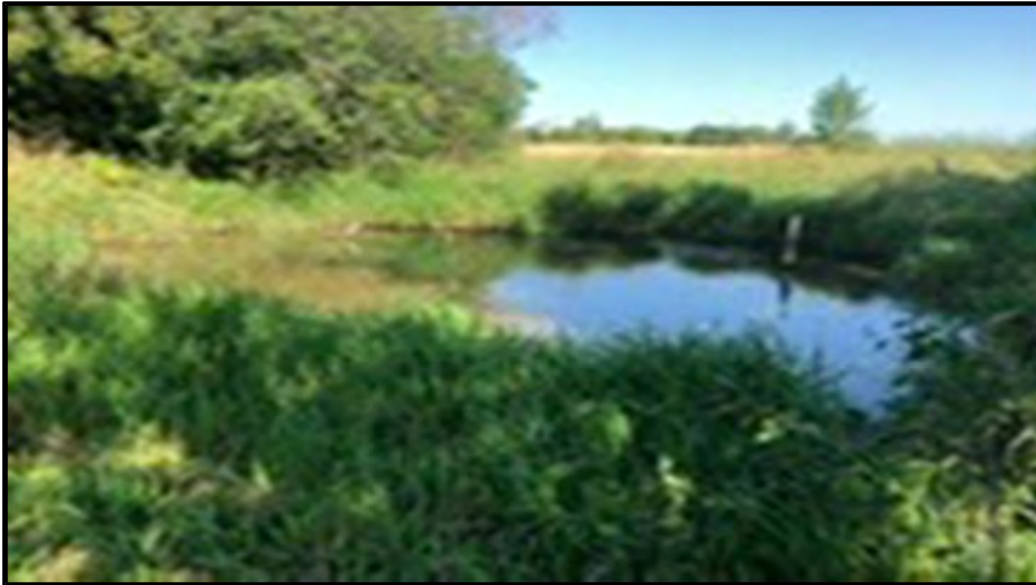
41. Reach R-5: online pond upstream from Countryside Drive; a low berm controls downstream flow
