## TECHNICAL MEMORANDUM

**DATE** September 10, 2019

**Project No.** 1665649

### **FLUVIAL GEOMORPHIC ASSESSMENT IN SUPPORT OF THE SCHEDULE C MUNICIPAL CLASS ENVIRONMENTAL ASSESSMENT, COLERAINE DRIVE, TOWN OF CALEDON, ONTARIO**

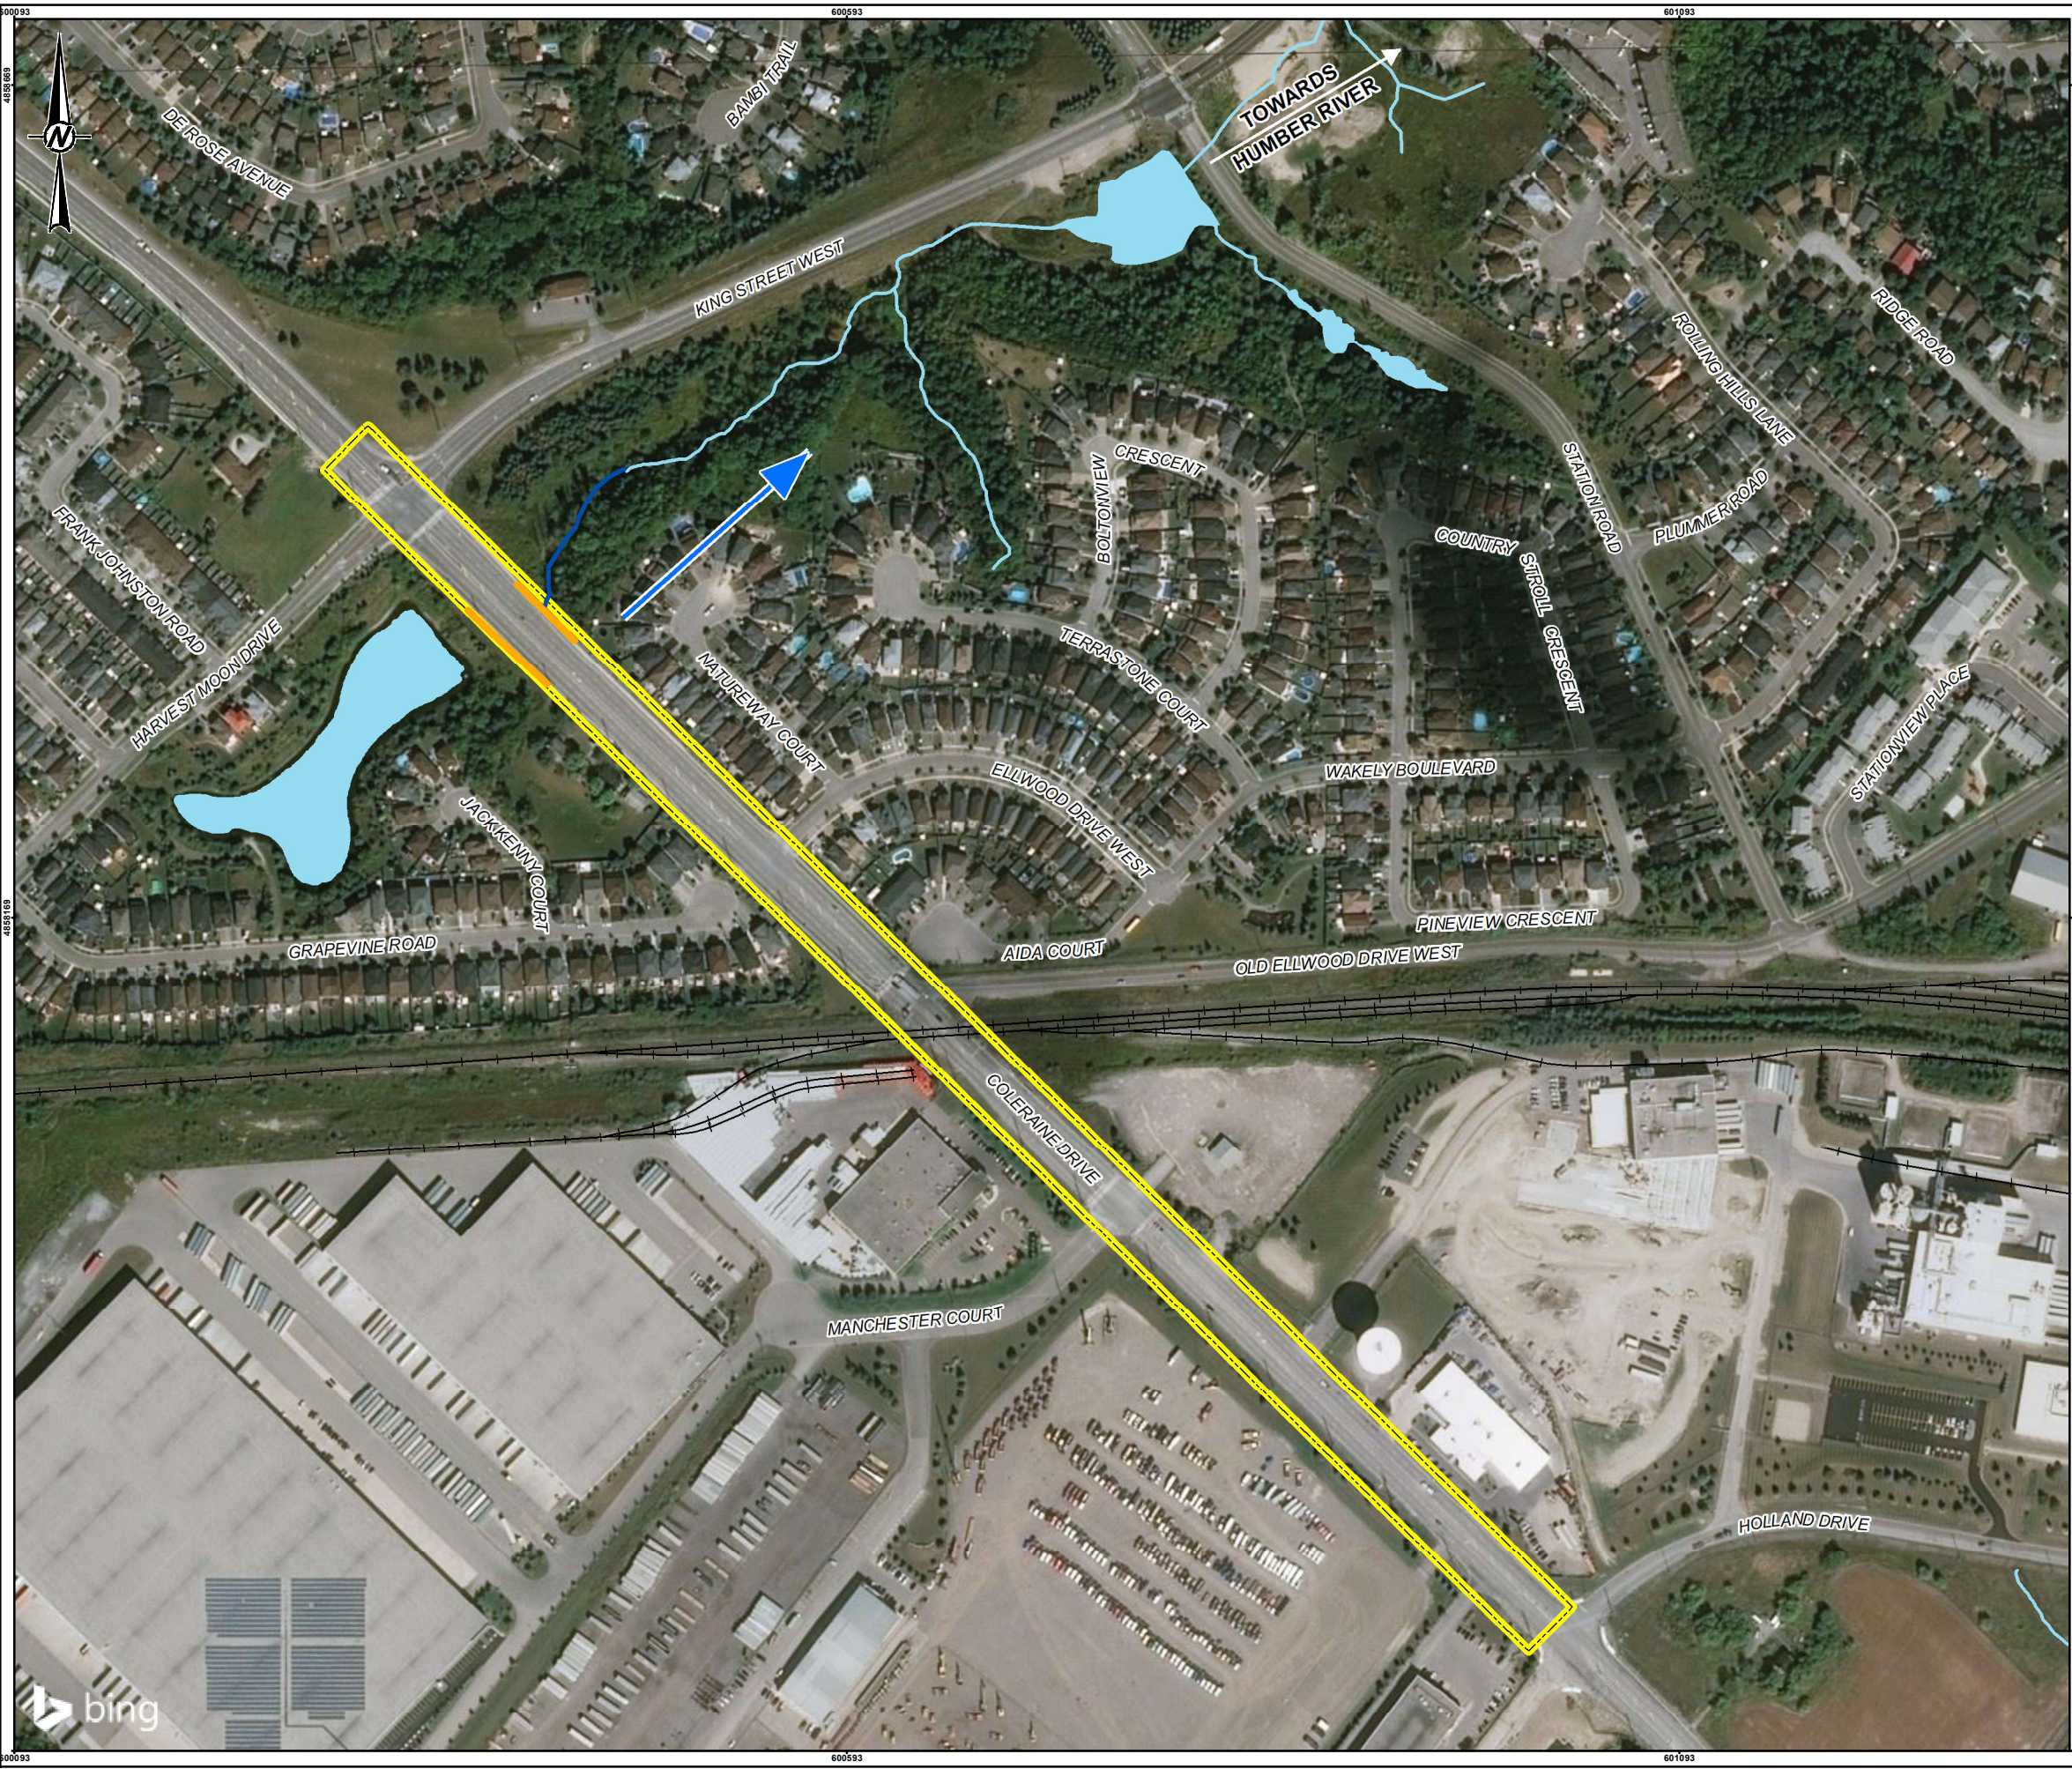
TITLE  
**SITE OVERVIEW AND FIELD OBSERVED WATERCOURSE CROSSING AT COLERAINE DRIVE FOR UT-01**

To account for changes in fluvial geomorphologic characteristics along a channel, watercourses are typically separated into reaches that display similar physical characteristics and controls on channel morphology. With reference to Figure 1, field observations in combination with a review of available base mapping and air photographs identified one reach length at the unnamed tributary (described herein as UT-01). The delineation of the reach breaks for UT-01 (i.e., upstream and downstream boundaries of the reach length) were based on observed changes in hydrology and hydraulics, recognizing that the upstream reach is located immediately downstream of the upstream SWM Pond (located to the immediate west of Coleraine Drive), while the downstream reach break is located immediately upstream of the downstream SWM Pond.

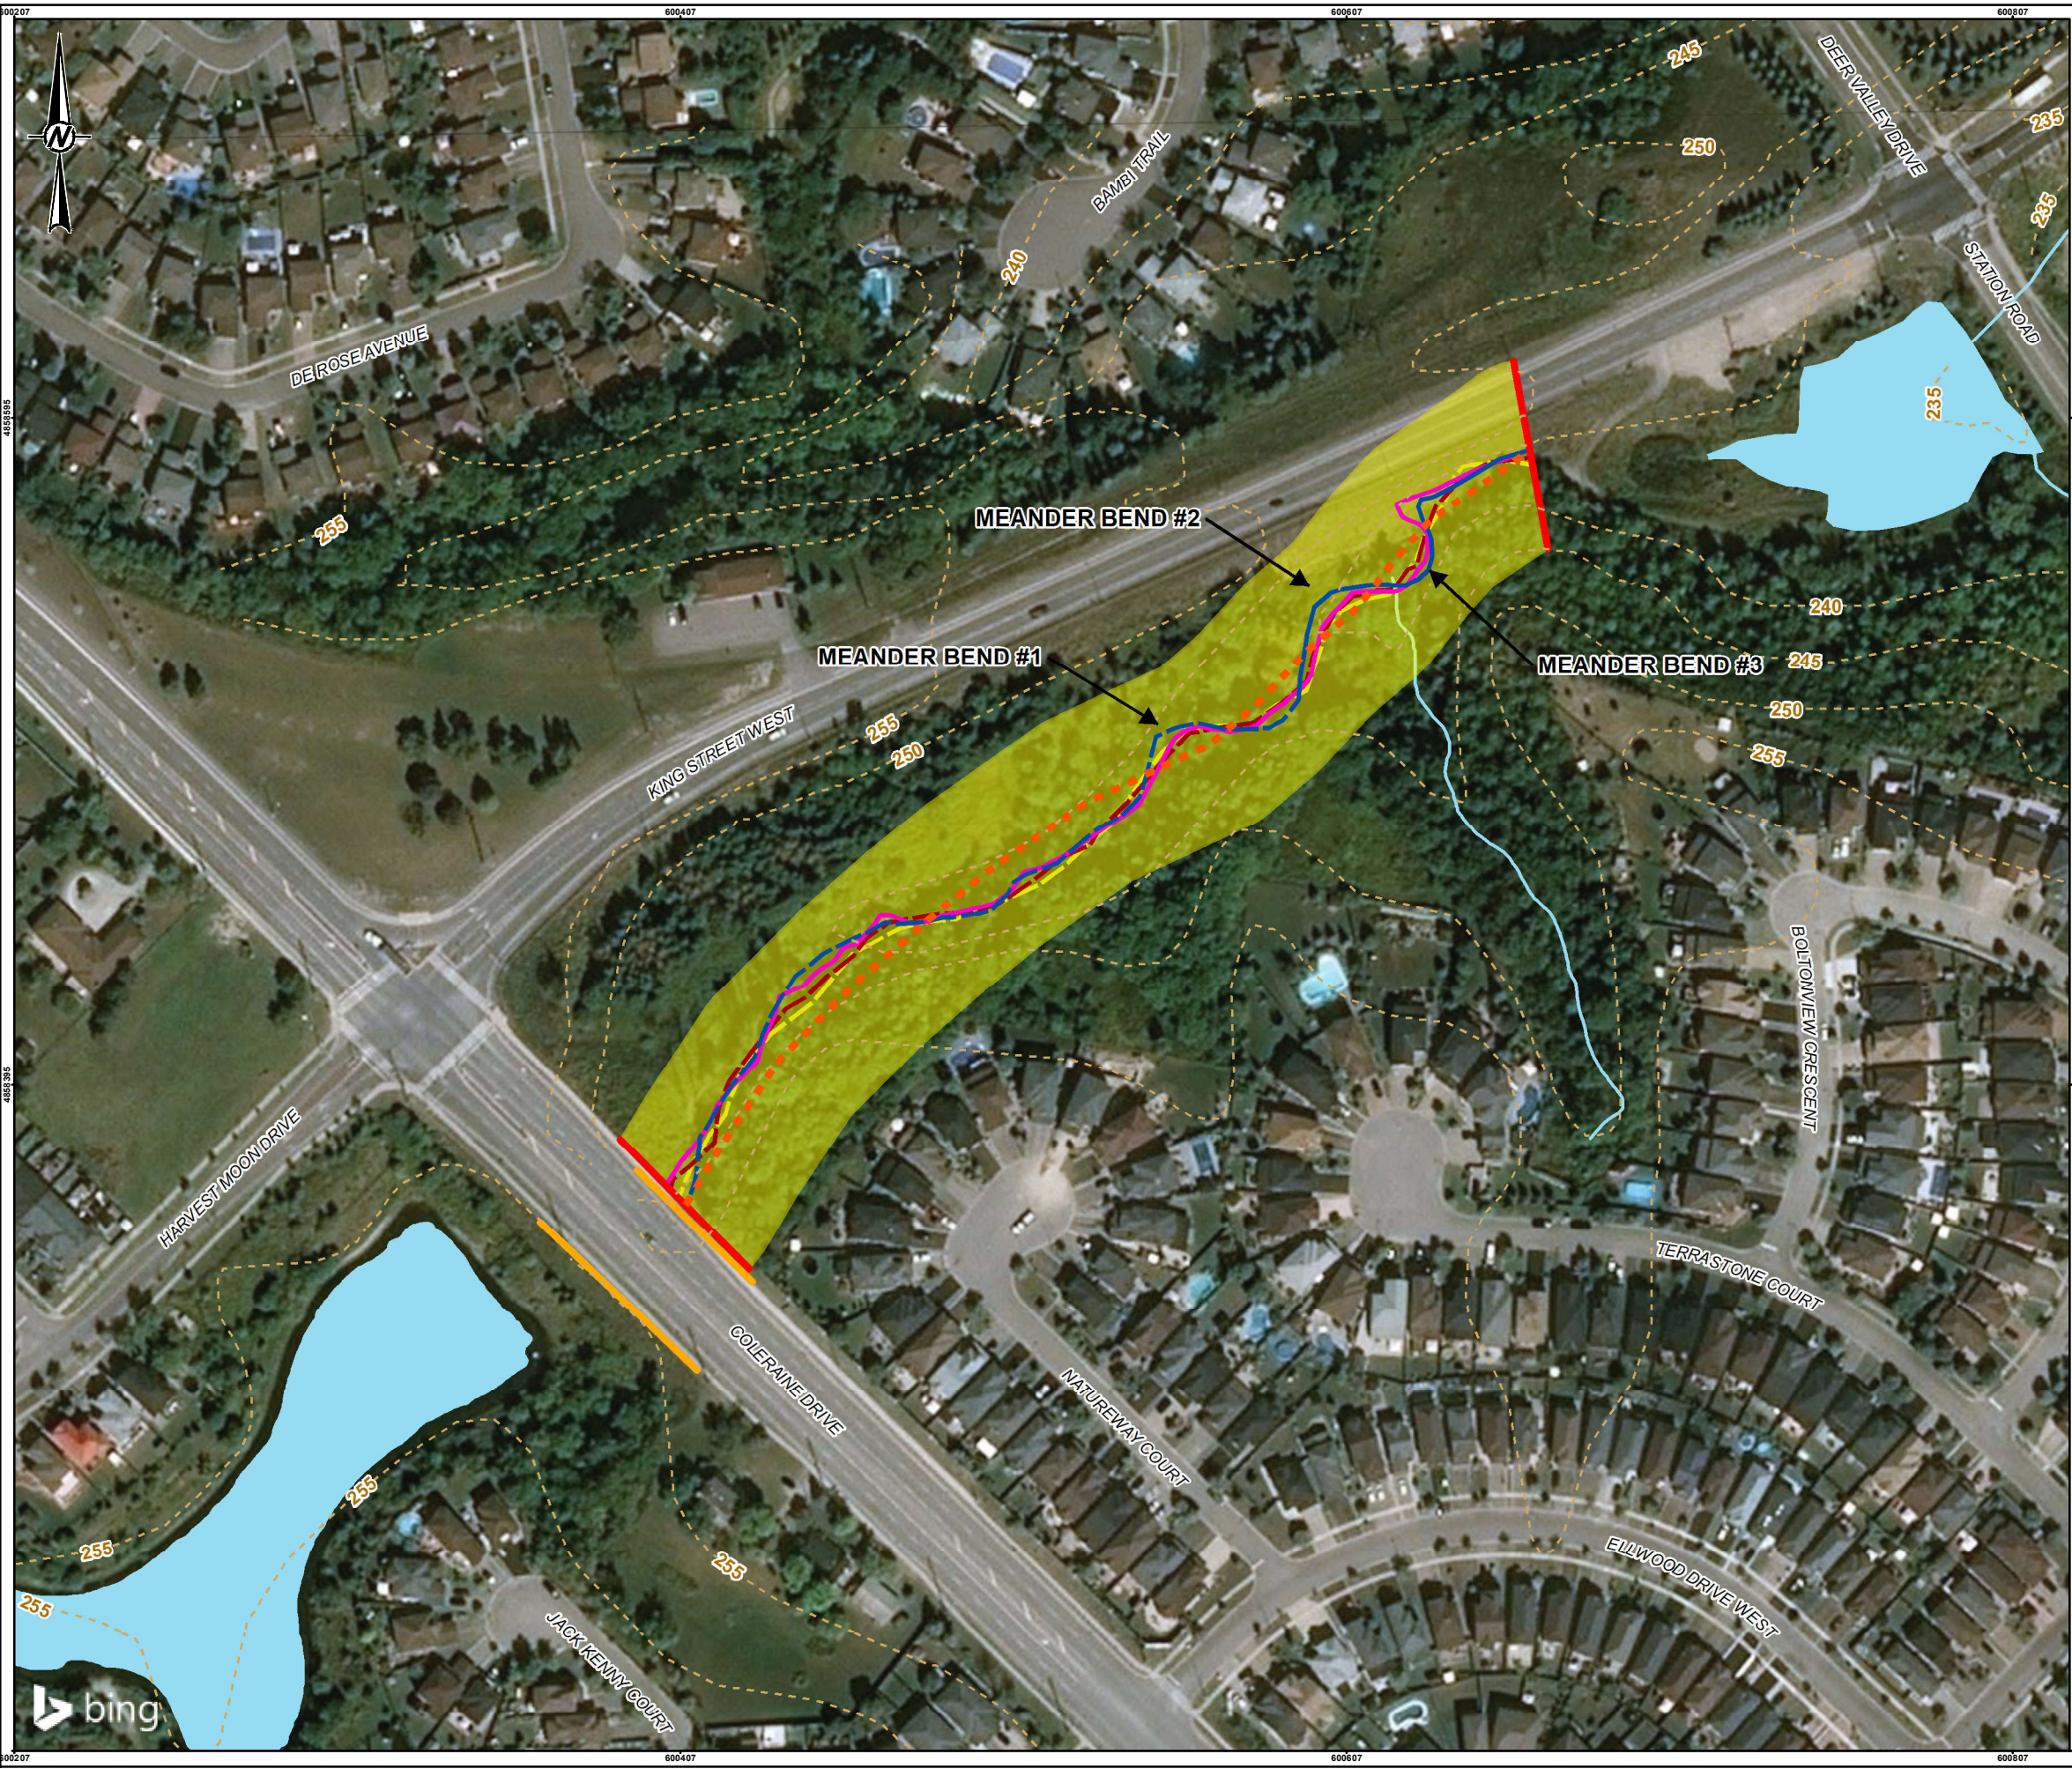
**TITLE**  
 ESTIMATED MEANDER BELT WIDTH AT COLERAINE DRIVE FOR UT-01

The meander belt width estimate at the unnamed tributary (UT-01) is illustrated on Figure 3, recognizing that the assessment assumed no further changes in the hydrologic regime for the long term (i.e., flow duration and frequency). The methodology for the meander belt width estimate relies on interpreting whether hydrologic change would be expected under future conditions, with recognition that the fluvial processes (i.e. characteristic flow patterns, hydrological regime, etc.) are major drivers on channel size and associated meander development. Given that the upstream catchment area has been largely developed since the mid-1970s, any potential changes to the hydrological regime at the channel has likely already been realized. A summary of the meander belt width estimates is provided below.

- A preliminary belt width was measured to be approximately 30 m. The preliminary meander belt width represents the measured width between the outer-most meander bends based on historical imagery from 1946 through 2015.

- The existing meander belt width was estimated to be approximately 37 m. The calculation of the existing belt width combines the preliminary meander belt width with the average bankfull width of the channel (approximately 7 m), as estimated in the field ( $30\text{ m} + 7\text{ m} = 37\text{ m}$ ).
- The final meander belt was estimated to be approximately 48 m. This final belt width combines the estimated existing meander belt width (37 m) with the estimated 100 year migration distance (11 m) (i.e., average rate of channel migration based on the historical air photo record – refer to Section 3.3).

The 100-year erosion limit at the reach length of the UT-01 was assessed based on the average rate of channel migration at the following meander bends (refer to Figure 3):

- Meander Bend #1 (located 230 m downstream from the crossing) – average migration rate of 10 cm/yr.
- Meander Bend #2 (located 300 m downstream from the crossing) – average migration rate of 15 cm/yr.
- Meander Bend #3 (located 330 m downstream from the crossing) – average migration rate of 7 cm/yr.

Based on the historical analysis, the 100-year erosion limit was estimated to be approximately 37 m. This 100-year erosion limit was determined by extending the average rate of migration at the most active meander bend over a 100-year time span ( $0.15\text{ m/yr} * 100 = 15\text{ m}$ ), and then applying this distance to either side of the average width of the bankfull channel ( $15\text{ m} * 2 + 7\text{ m} = 37\text{ m}$ ).

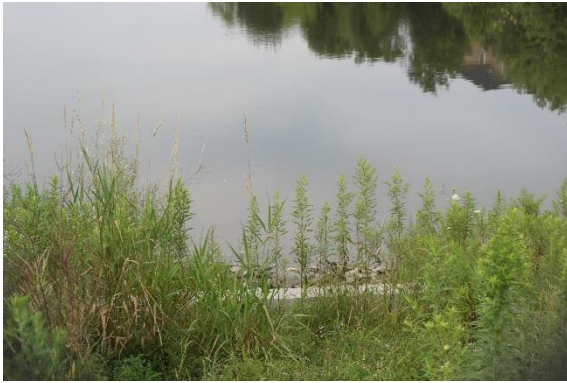
**Photograph 1: Upstream SWM Pond (located immediately west of Coleraine Drive); looking upstream from road crossing on August 10, 2017.**

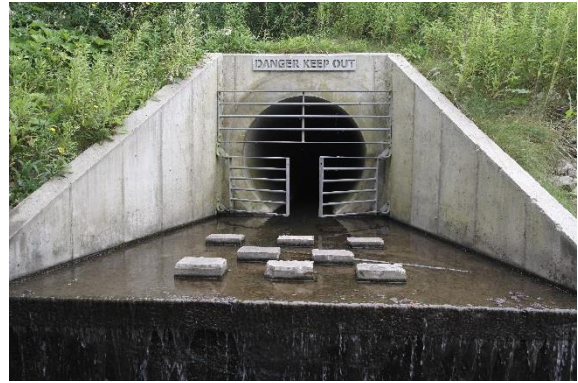
**Photograph 2: Outlet of crossing structure at Coleraine Drive; looking upstream on August 10, 2017.**

It is understood that roadway improvements at Coleraine Drive may involve upgrades or replacement of the existing crossing structure at the unnamed tributary (i.e., circular concrete culvert with concrete end section, and energy dissipater). According to TRCA protocols, crossing structures should be constructed outside of the meander belt width of a watercourse to the extent possible, or, alternatively, the features should be designed to match or exceed the 100-year erosion limit of the channel. However, for the study reach at the unnamed tributary, it is recognized that spanning a crossing structure the length of the estimated belt width or 100-year erosion limit of the channel would not be practical from an engineering perspective, given that the existing crossing structure (located within the boundaries of the estimated belt width and 100-year erosion limit of the study reach) serves as the outlet control for the upstream SWM Pond (located to the immediate west of Coleraine Drive). Furthermore, Golder is of the opinion that a strategy to match the crossing span to the estimated belt width or 100-year erosion limit is unnecessary from a fluvial geomorphic perspective, recognizing that there is little to no channel morphology to accommodate in the area upstream of the crossing (i.e., the upstream reach has been heavily modified relative to the period of the historical air photo record and is comprised entirely of the SWM Pond and associated inflow and outflow structures). Instead, any proposed modifications to the existing circular concrete culvert should be designed to enhance flow and/or sediment conveyance at UT-01. In addition, the incorporation of bank and bed treatments (e.g., flow dissipation pool, bank revetments, bed armouring, etc.) should be considered at the outlet of the culvert to mitigate any increased opportunity for scour and erosion in the local area or further downstream.

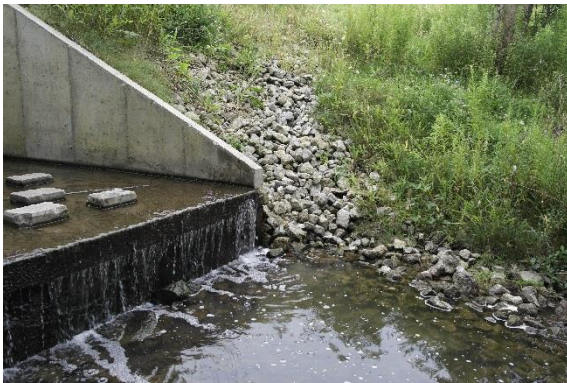
**Photograph 3: Outlet of crossing structure at Coleraine Drive; looking at left bank on August 10, 2017**

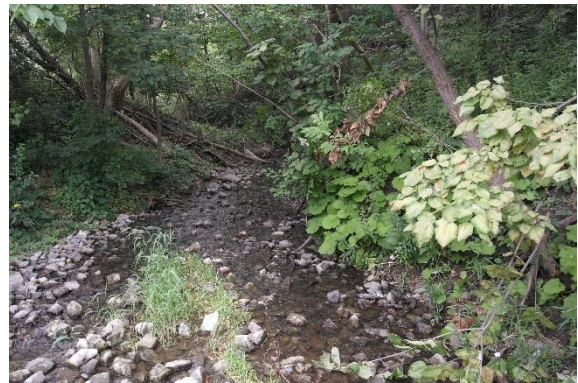
**Photograph 4: Unnamed Tributary immediately downstream of crossing structure; looking downstream on August 10, 2017.**

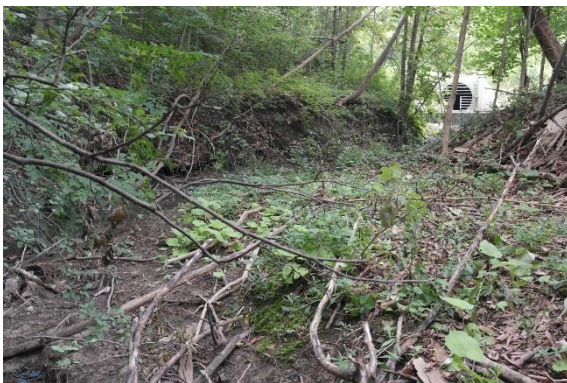
**Photograph 5: Unnamed Tributary 25 m downstream of crossing structure; looking upstream on August 10, 2017.**

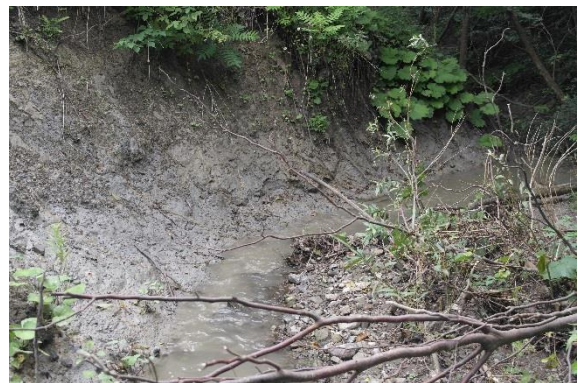
**Photograph 6: Unnamed Tributary 75 m downstream of crossing structure; looking downstream on August 10, 2017.**
