D.2 – Tree Evaluation Report

Schedule “C” Class Environmental Assessment for Airport
Road from Braydon Boulevard / Stonecrest Drive to
Countryside Drive

Tree Evaluation Report

Project No. 1905 | February 2021

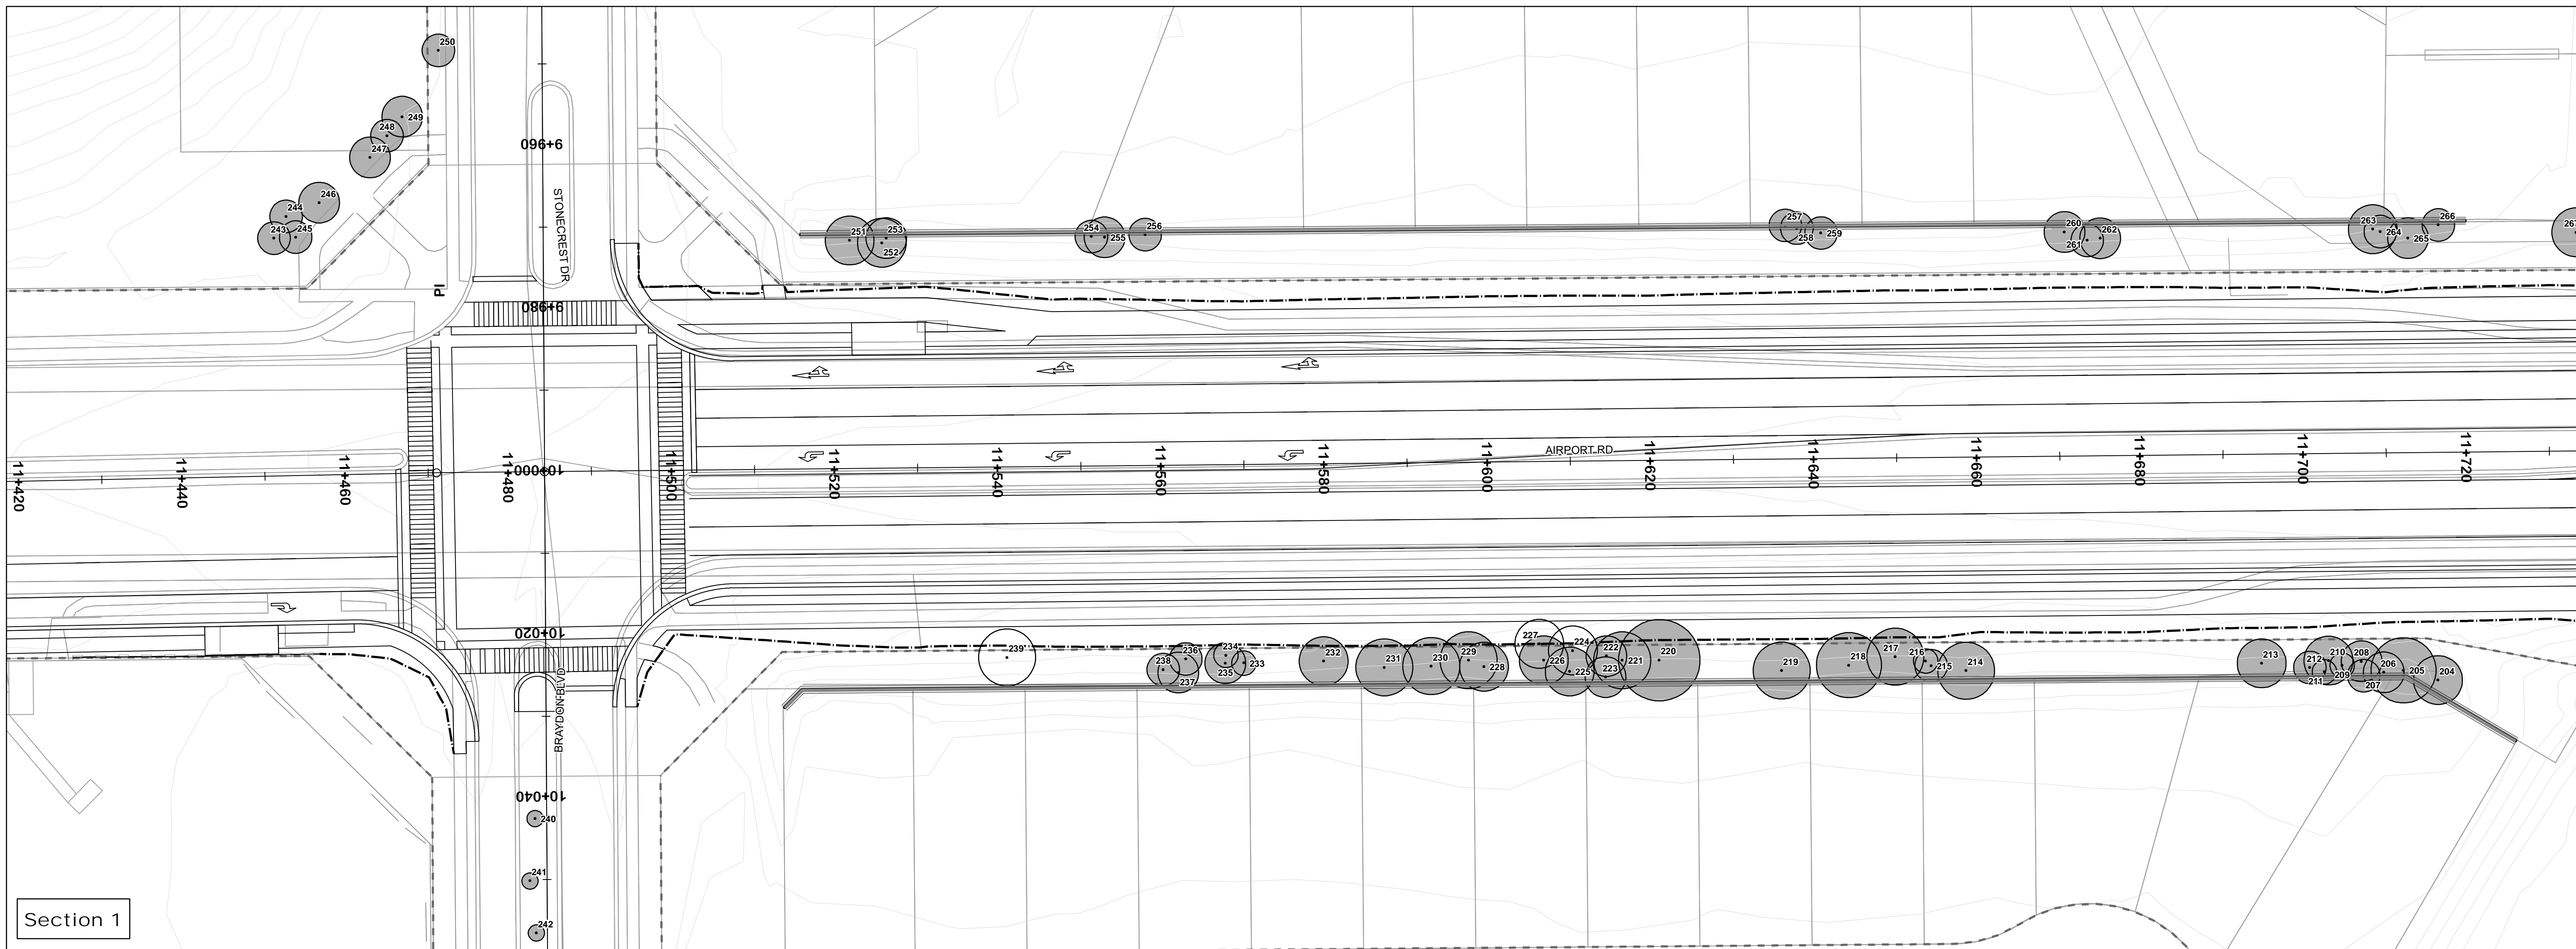
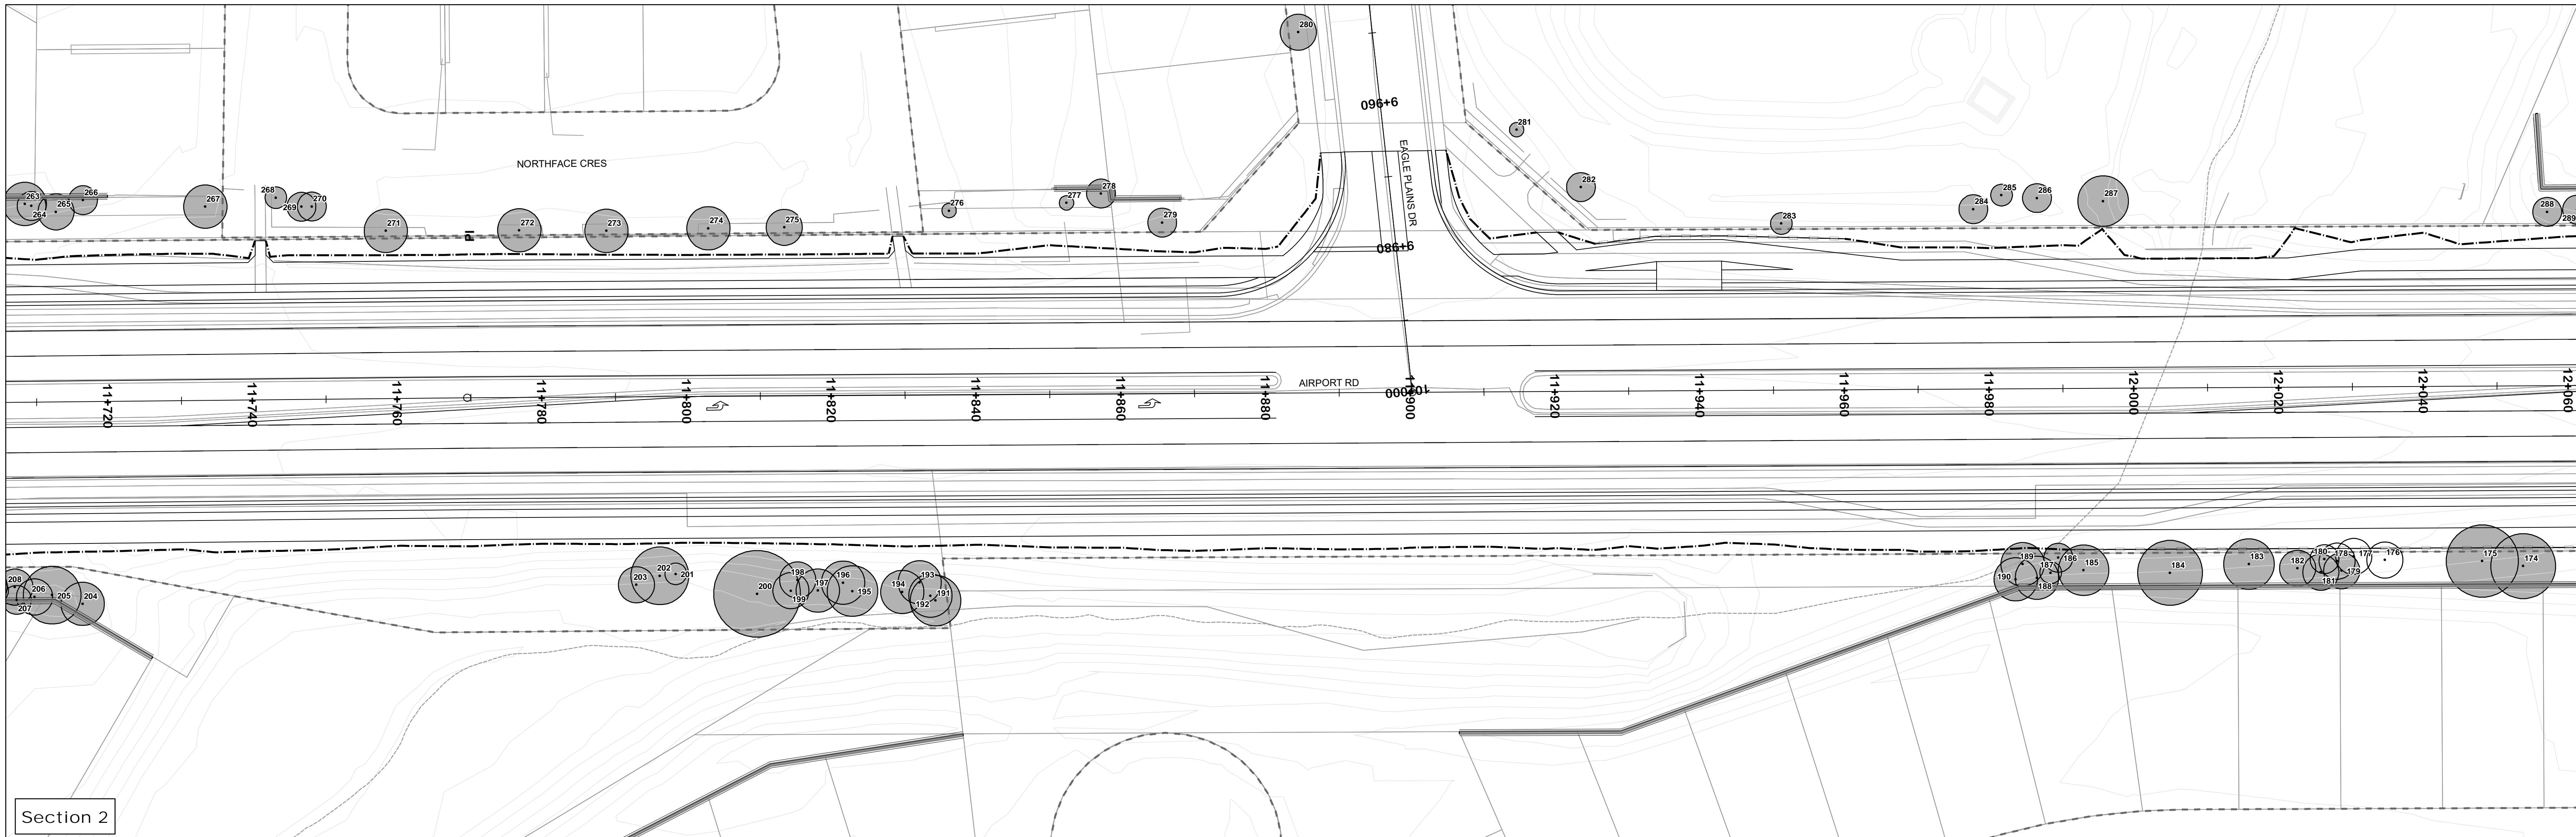
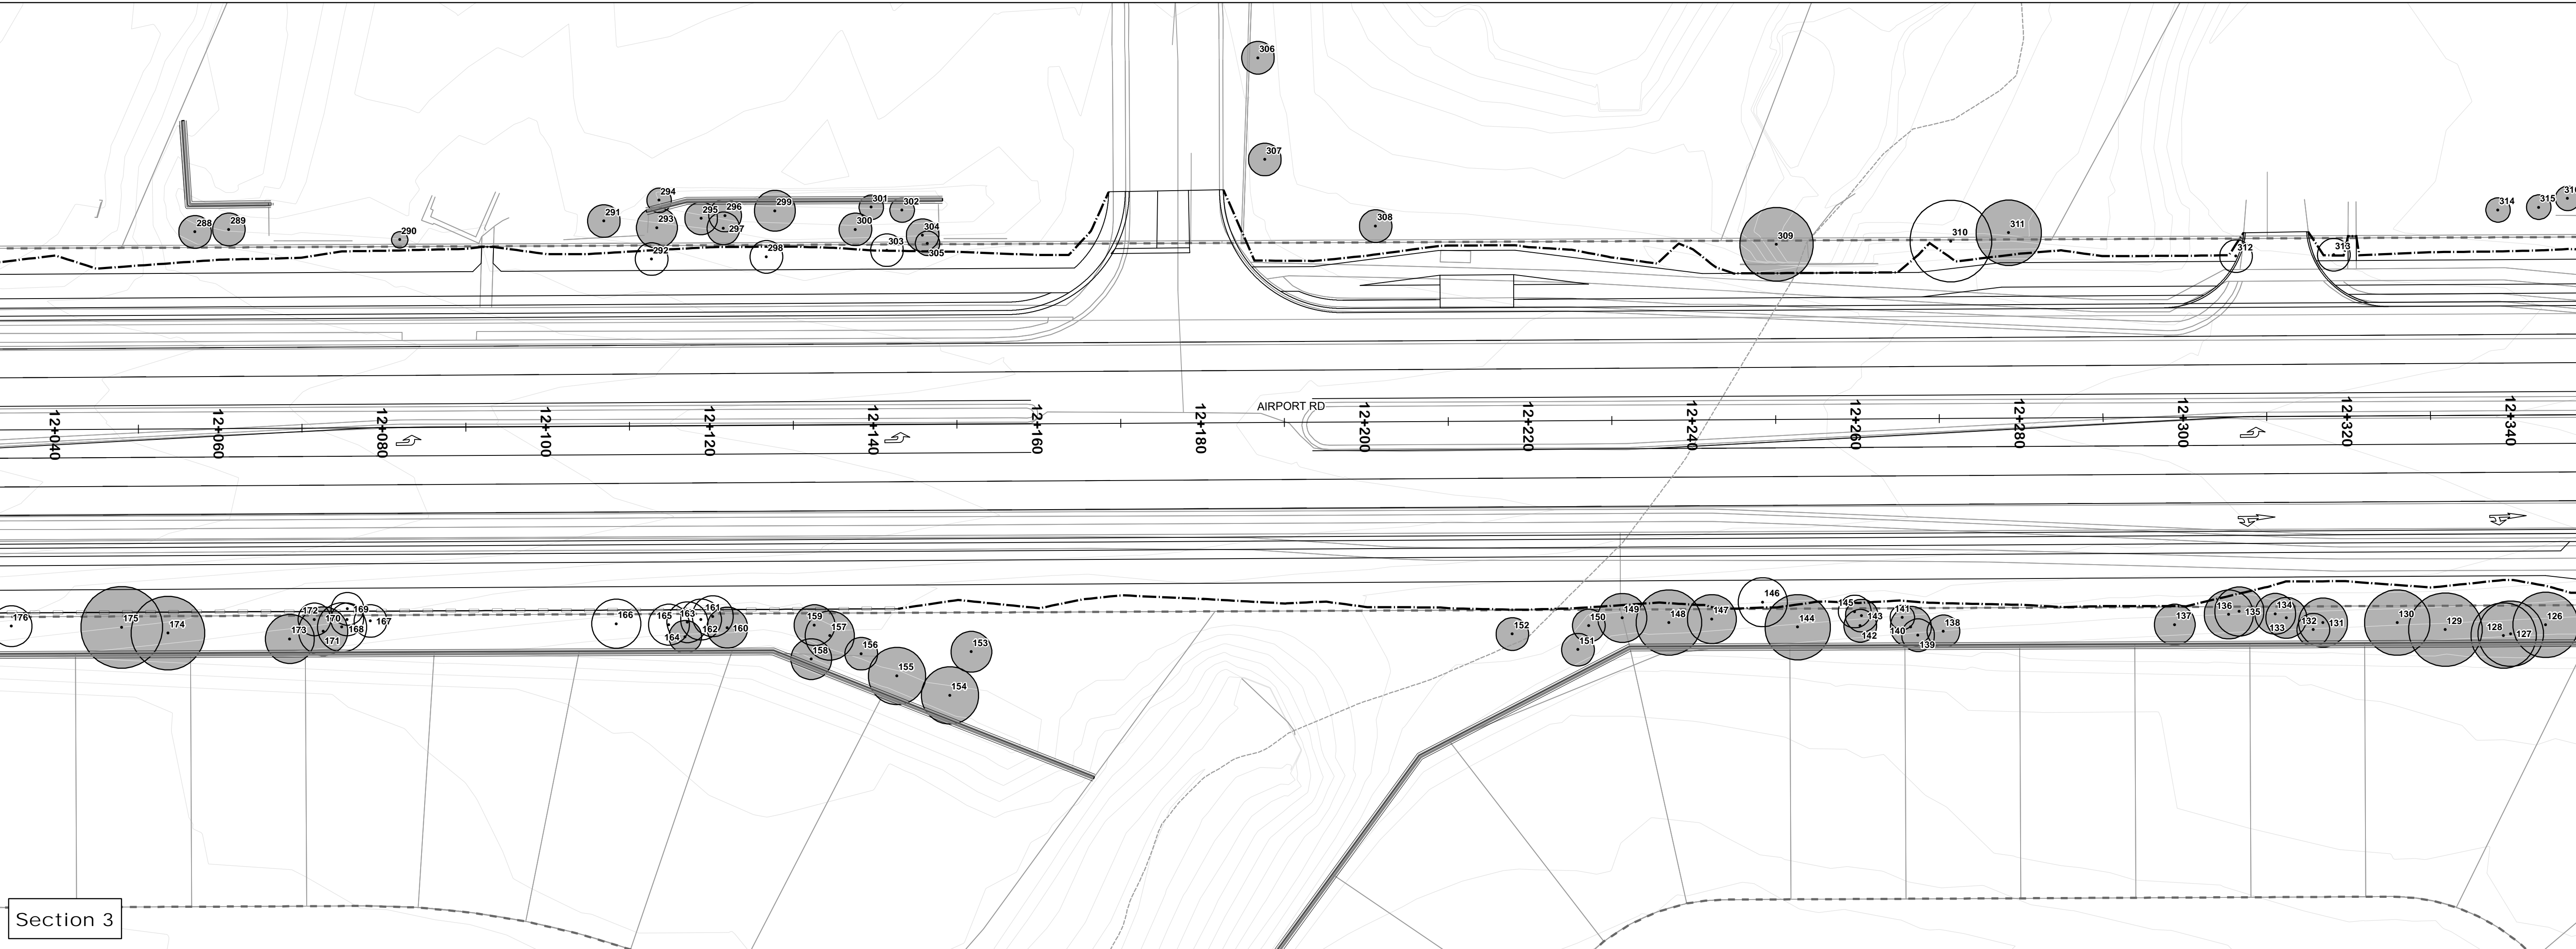
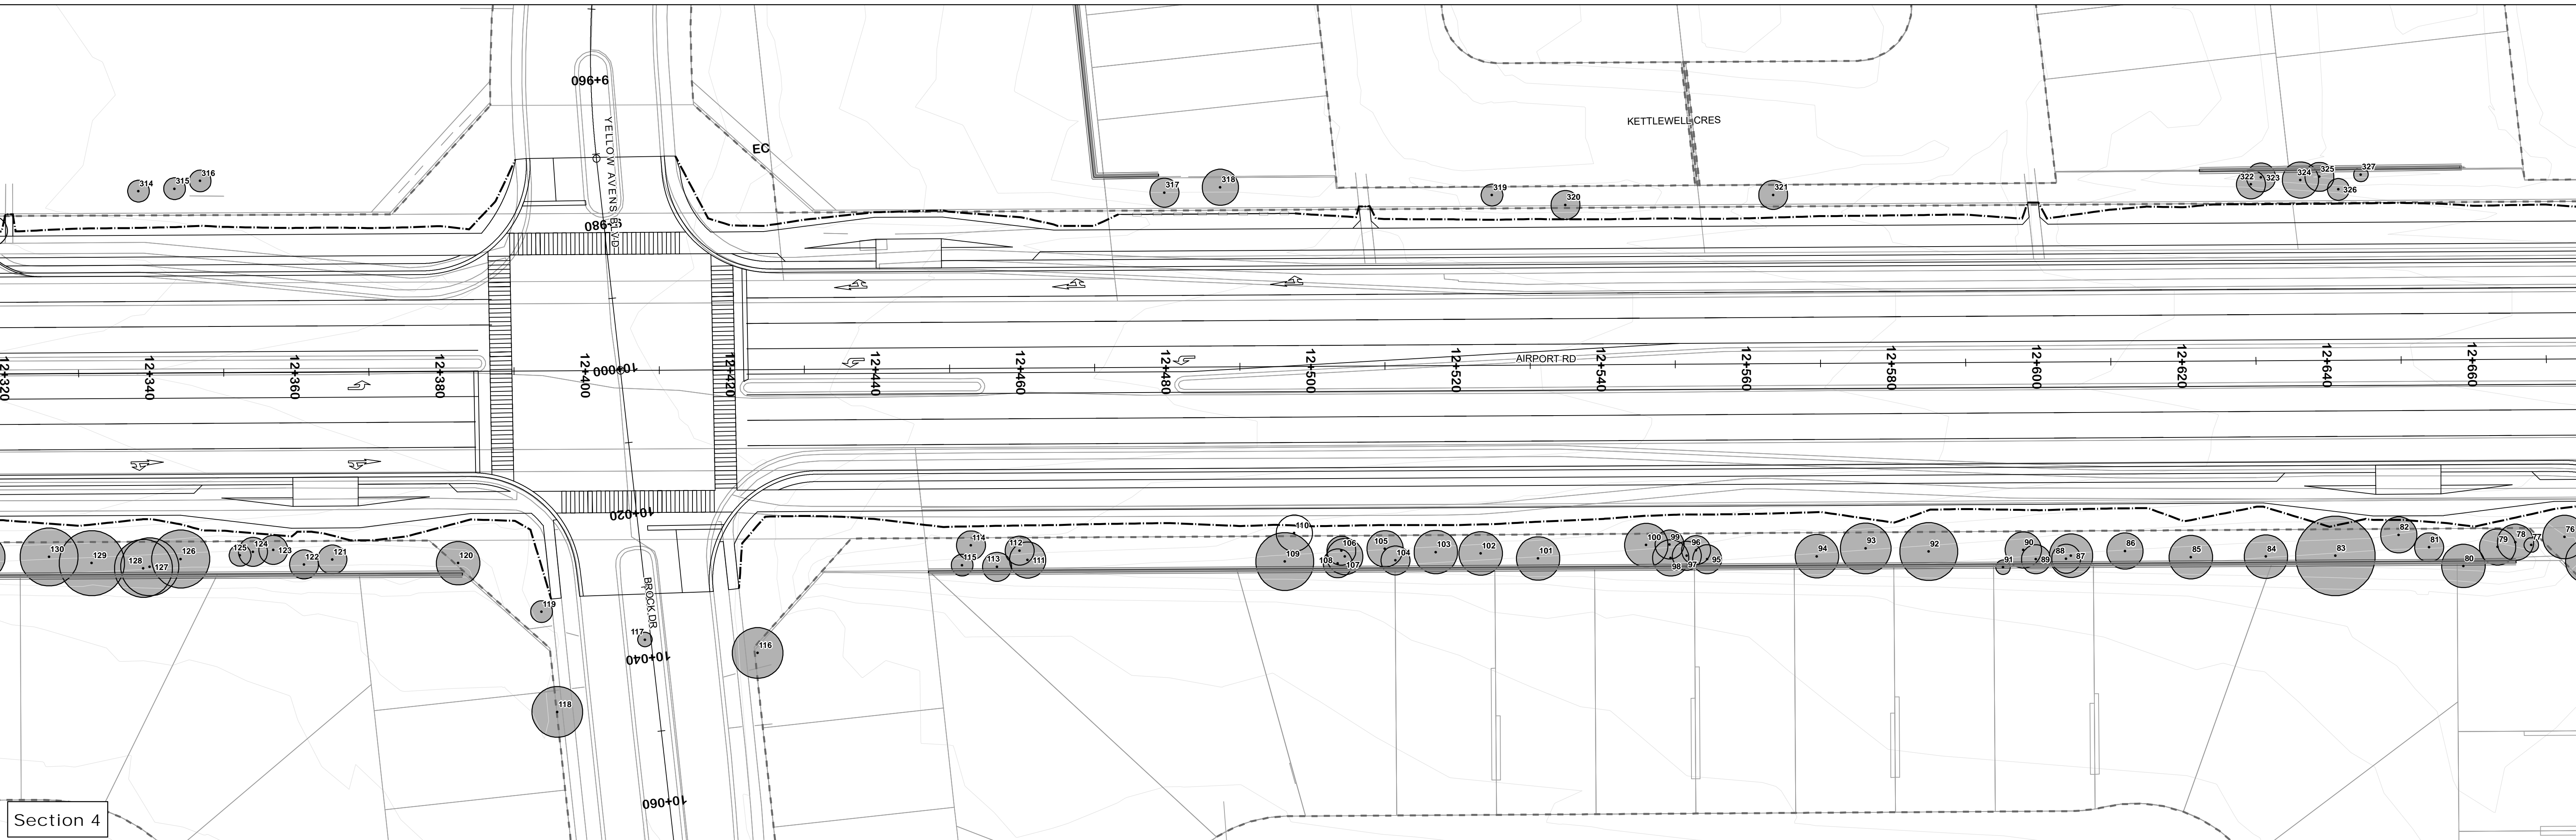
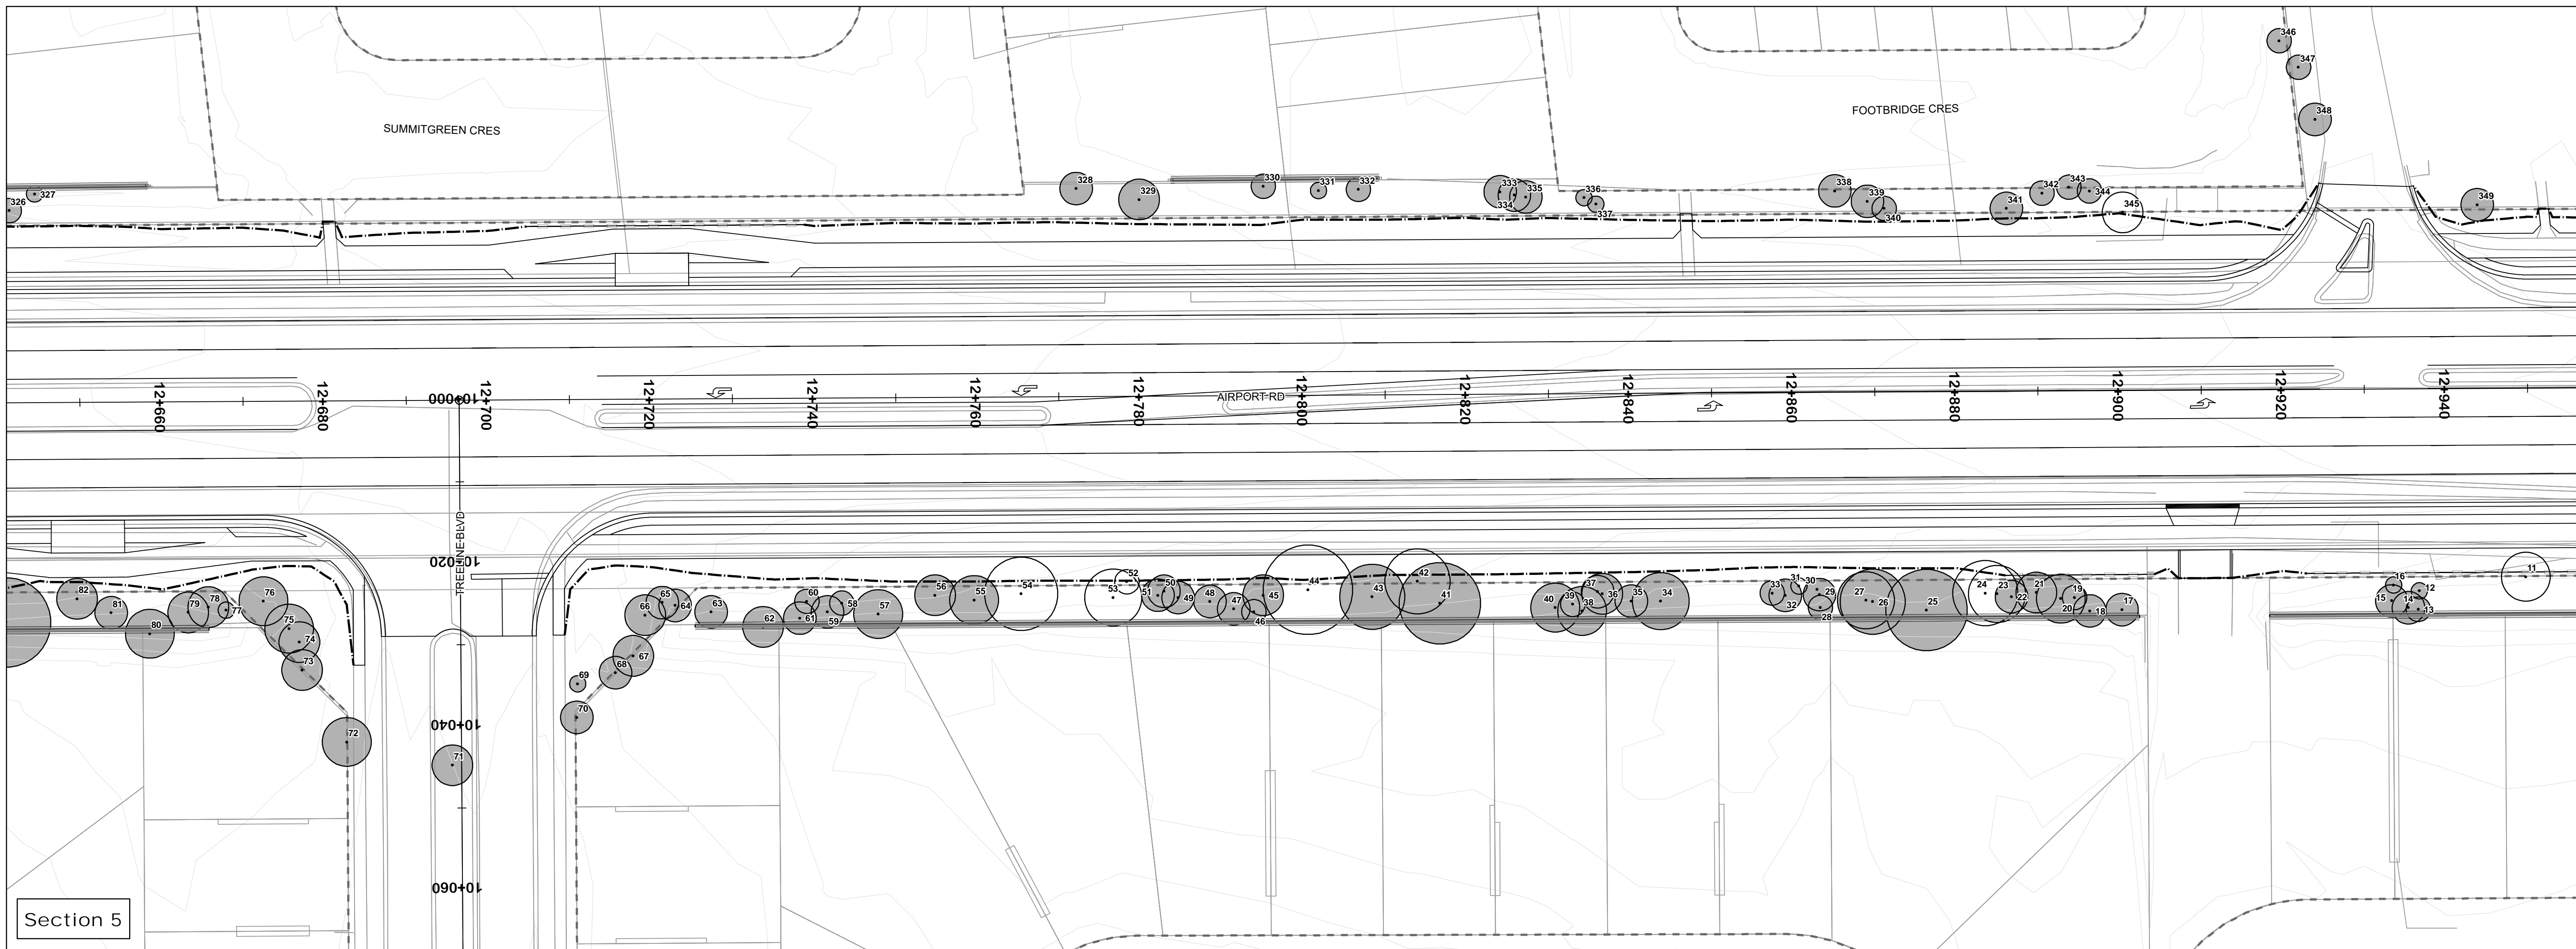
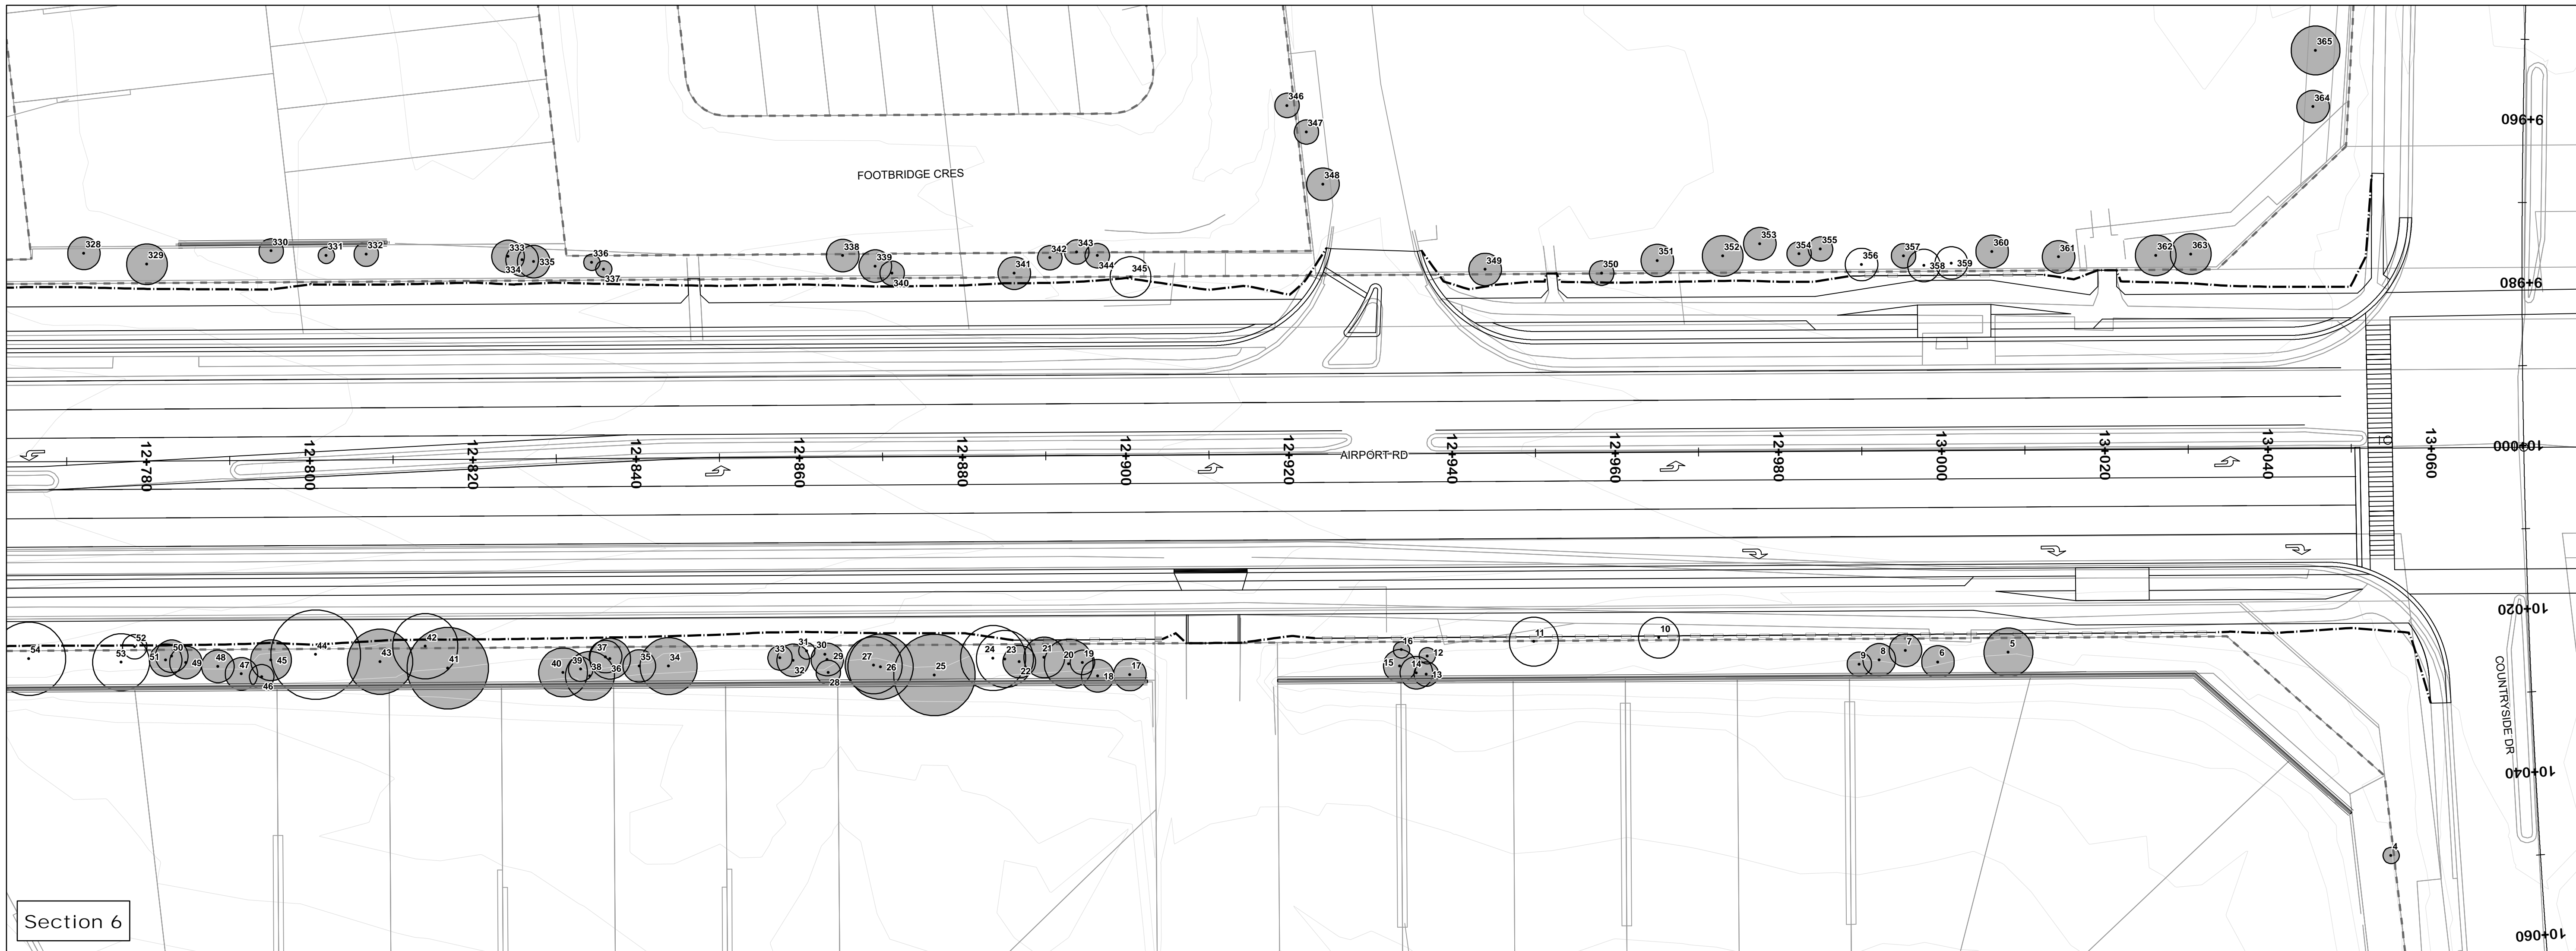
Tree Inventory & Preservation Plan

Of the 368 trees inventoried, 42 are anticipated to be removed. Of the 42 anticipated to be removed, 5 are recommended for removal as a result of their condition and position which may pose a public hazard.

The remaining 37 trees require removal based on the extent of the proposed site grading within the ROW. The stems of most of these trees are not in direct conflict with the undertaking but are trees situated along the grading limit or in close proximity that may incur severe root damage as a result of grading. Most of these trees are in good to fair health with an improbable potential for structural failure, and range in size from 10.2cm DBH to 26.9cm DBH.
