# Appendix K:

# Municipal Class Environmental Assessment Airport Road Between King Street and Huntsmill Drive, Town of Caledon

## Fluvial Geomorphological Assessment Centreville Creek and East Credit River Tributary

August 20, 2020  
Project No. 17101

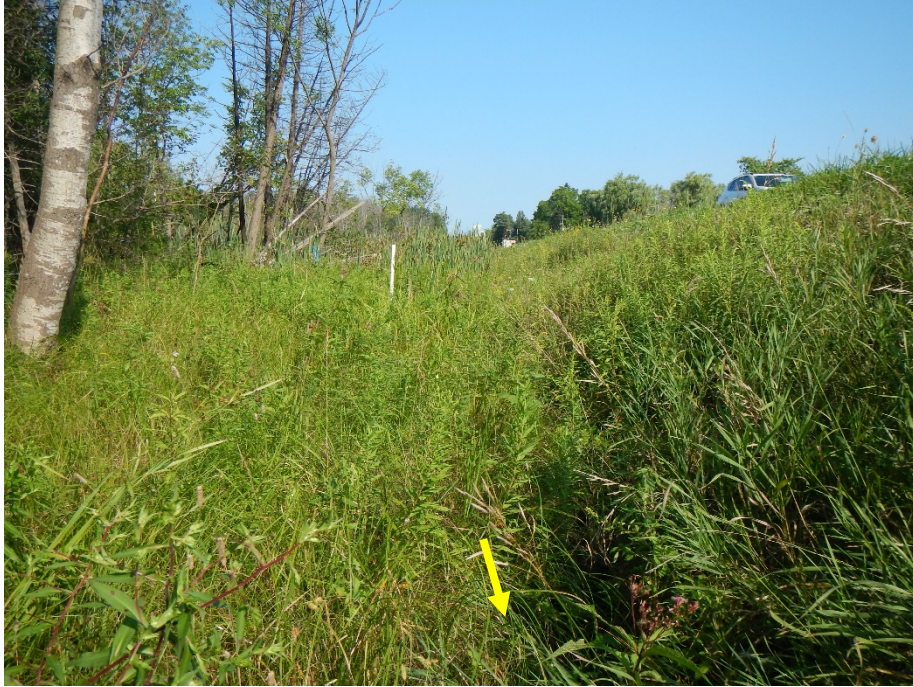
Photo 1  
Boyce' s Creek - Reach BC-1

Upstream of Crossing 1, flows travelled undefined through a marsh consisting of grasses, cattails and phragmites. Yellow arrow indicates flow direction.

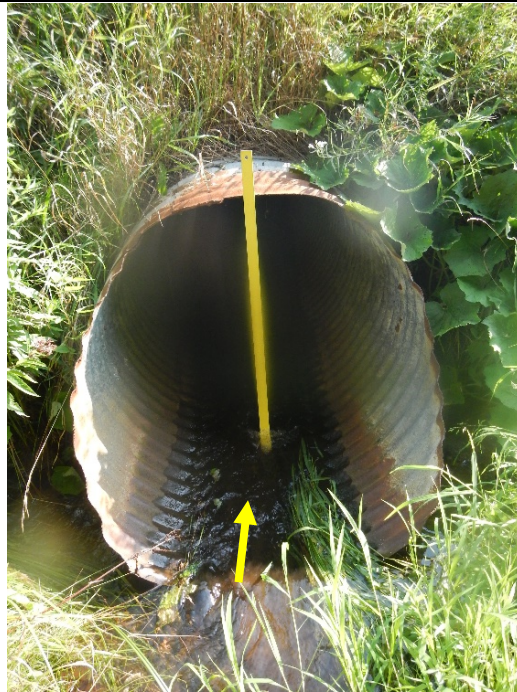
Photo 2  
Boyce' s Creek - Reach BC-1

Crossing 1 is a 0.9 m diameter corrugated steel pipe (CSP) culvert. The culvert was perched 8 cm above the channel bed.

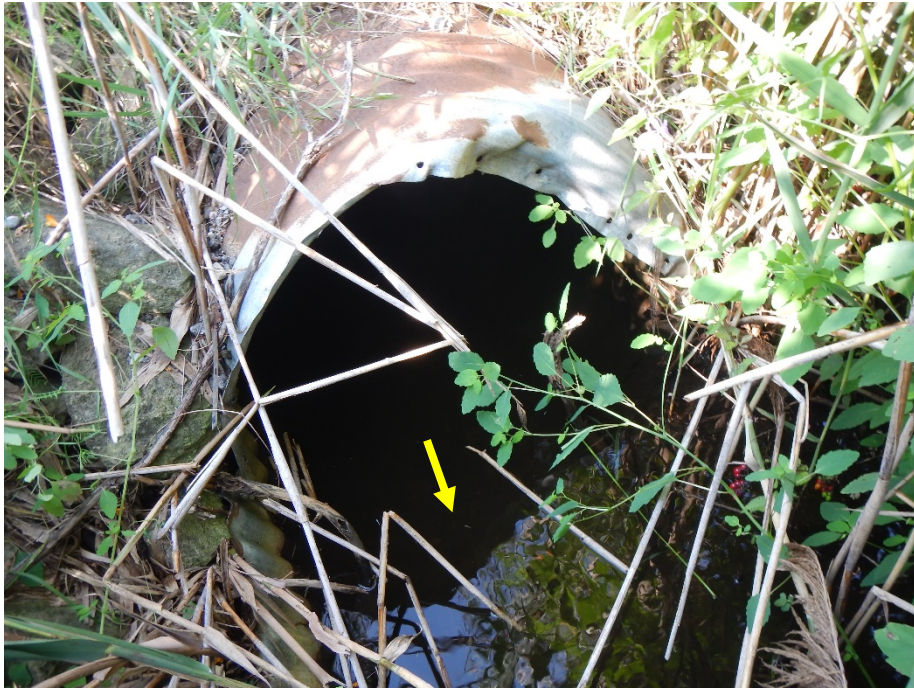
Photo 3  
Boyce' s Creek - Reach BC-1

The downstream end of Crossing 1 on the east side of Airport Road was free of debris.

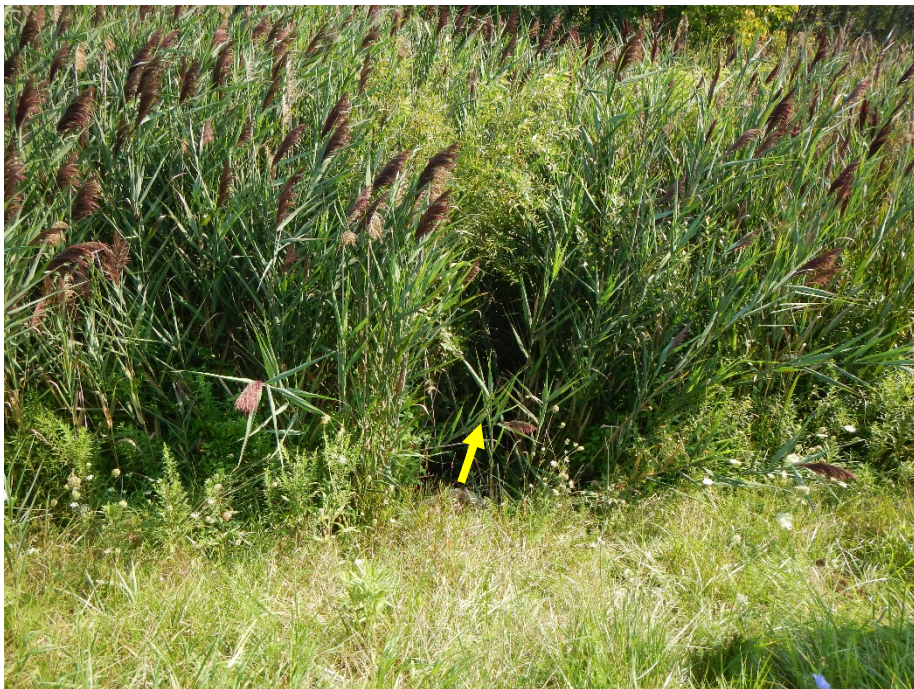
Photo 4  
Boyce' s Creek - Reach BC-1

Downstream of Crossing 1, flows entered a grass and phragmites-dominated marsh with no defined channel.

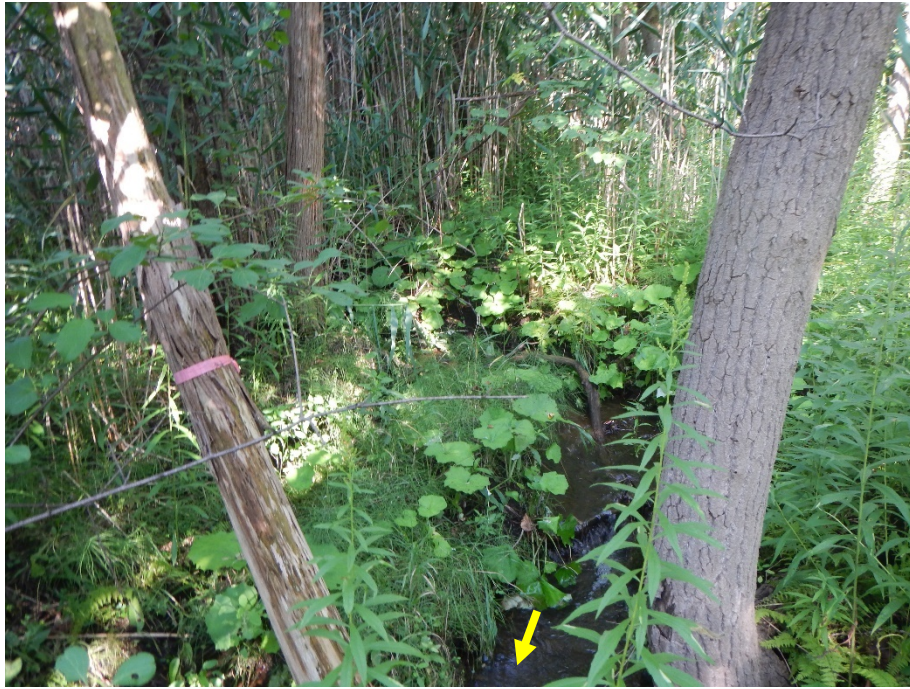
Photo 5  
Boyce's Creek - Downstream of BC-1

Approximately 12 m downstream of Crossing 1 the watercourse became defined in a forest. The channel's substrate consisted of cobbles with several large boulders.

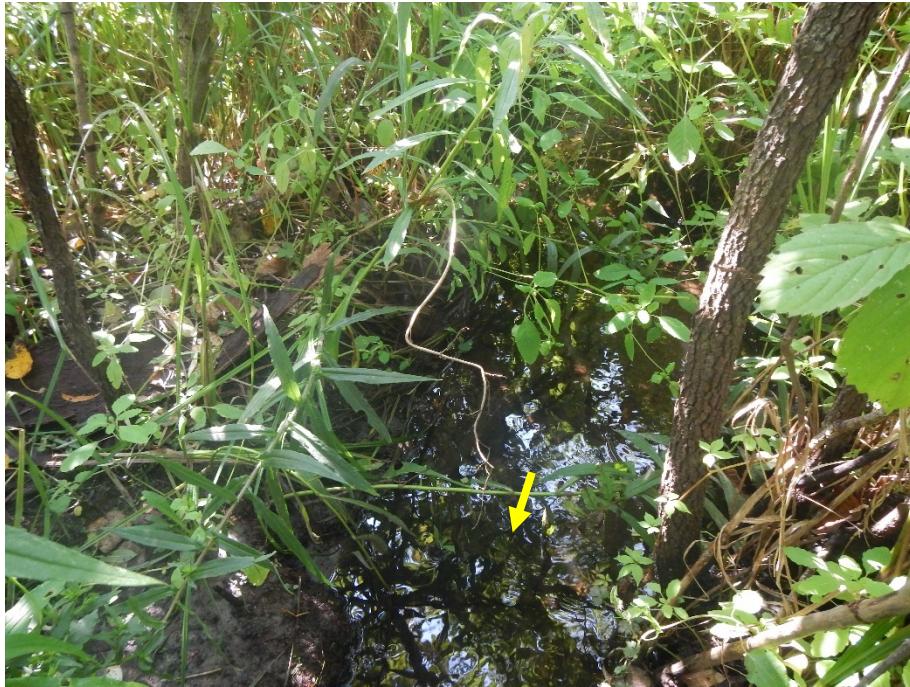
Photo 7  
Centreville Creek Tributary - Reach CCT-1

The substrate within the reach consisted largely of silt, clay and sand. The channel had an average maximum bank full depth of 0.37 m and average bankfull width of 1m.

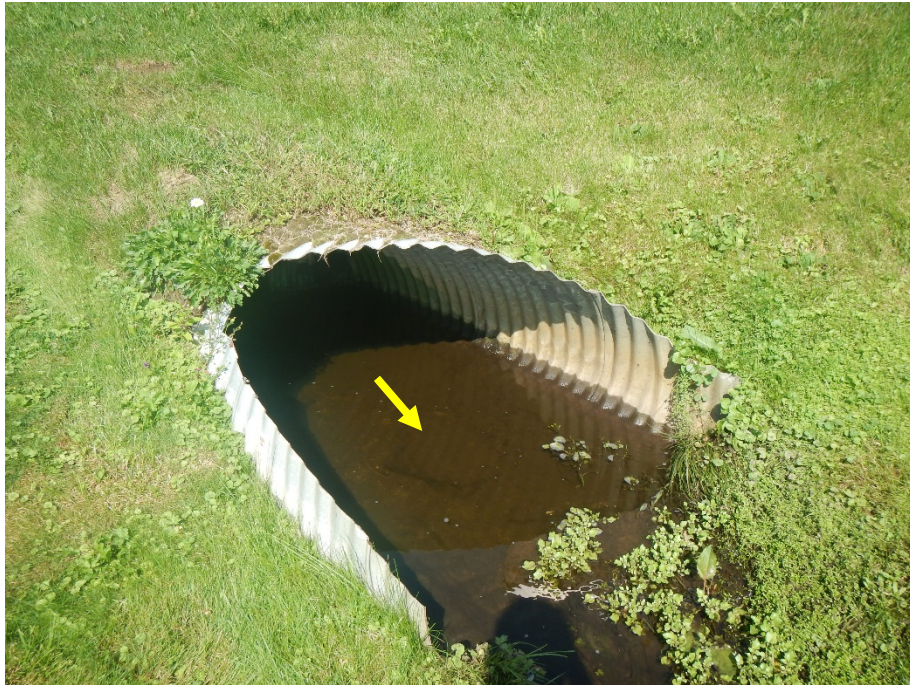
Photo 8  
Centreville Creek Tributary - Reach CCT-1

An elliptical culvert directed flows from the upstream forest reach (CVT-1) into a short, open channel to the west of Airport Road. Water seepage was observed at the upstream extent of the segment, evidence of a possible groundwater upwelling.

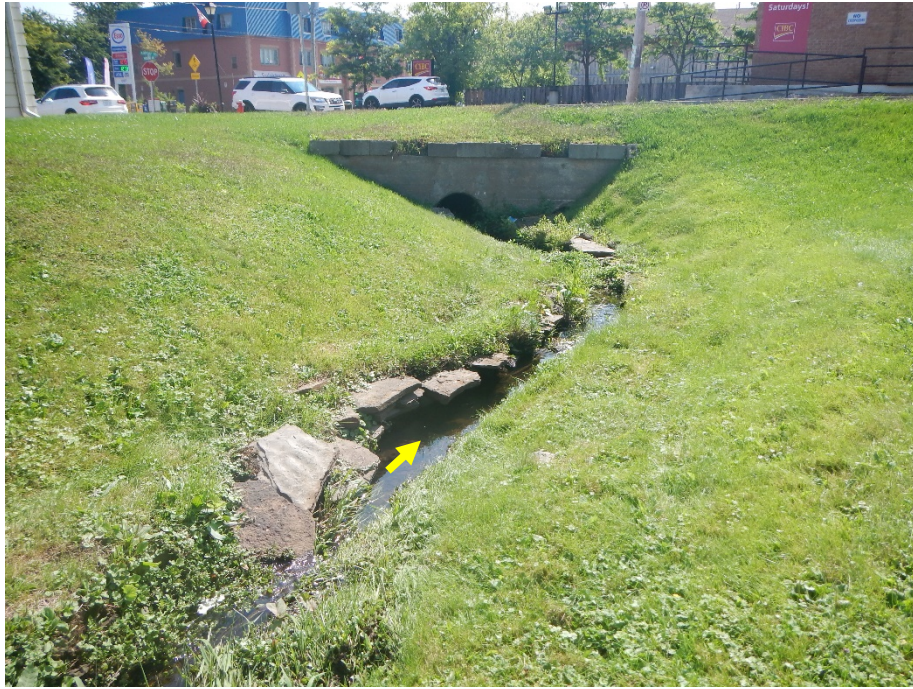
Photo 9  
Centreville Creek Tributary - Reach CCT-1

The watercourse was bounded by manicured grass. One bank was largely armoured with flagstone.

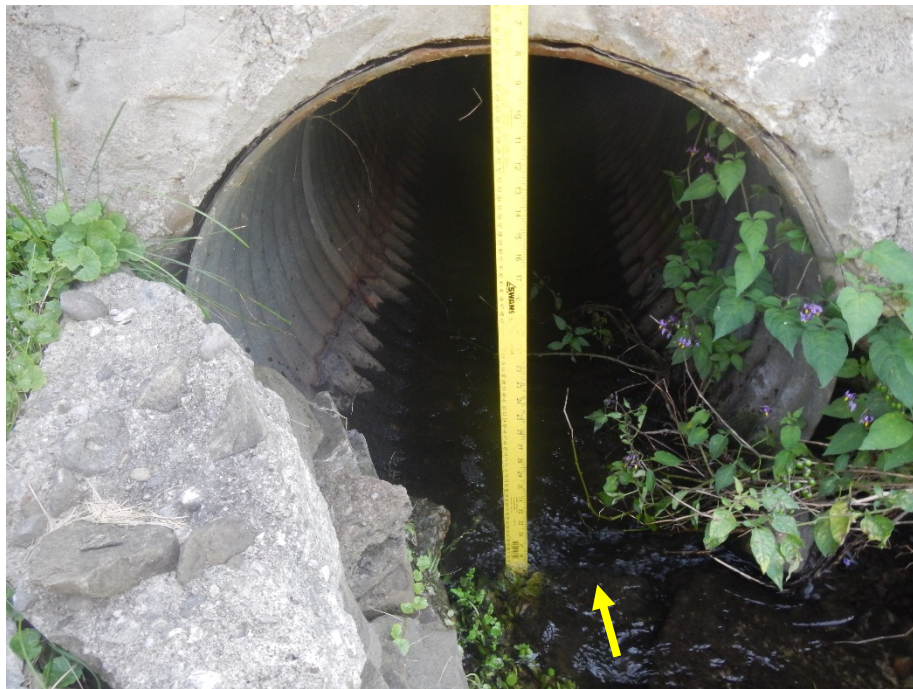
Photo 10  
Centreville Creek k Tributary - Reach CCT-1

Crossing 2 is a 0.8 m diameter CSP culvert.

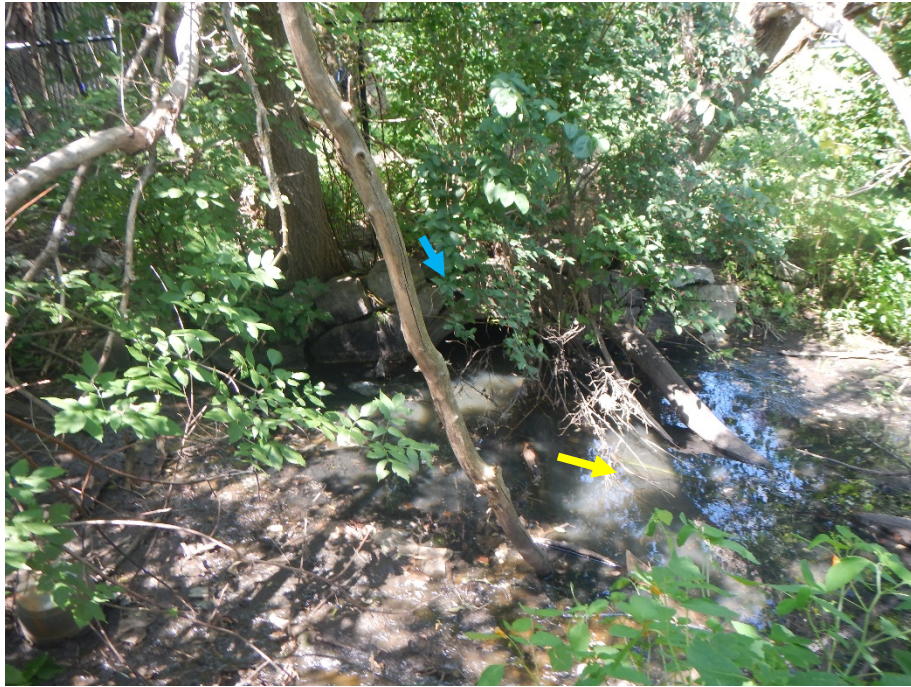
Photo 11  
Centreville Creek Tributary - Reach CCT-2

The downstream end of Crossing 2 (blue arrow) was backwatered, with standing water present within the culvert itself and downstream for approximately 10 m.

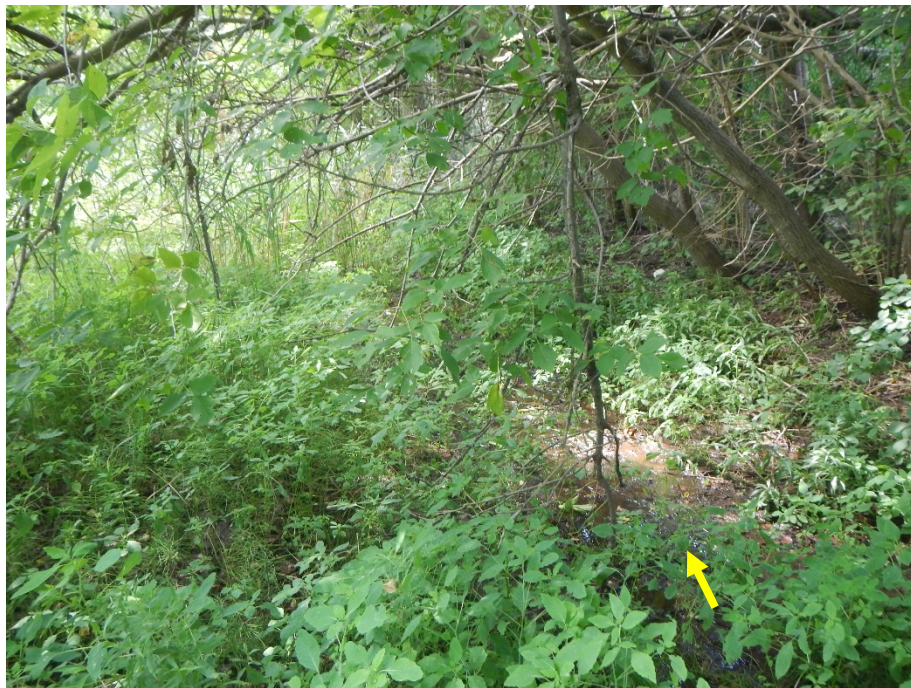
Photo 12  
Centreville Creek Tributary - Reach CCT-2

Downstream of the backwatered area the watercourse was poorly defined and was encroached by riparian vegetation. This vegetation consisted of established deciduous trees, herbaceous plants and shrubs.

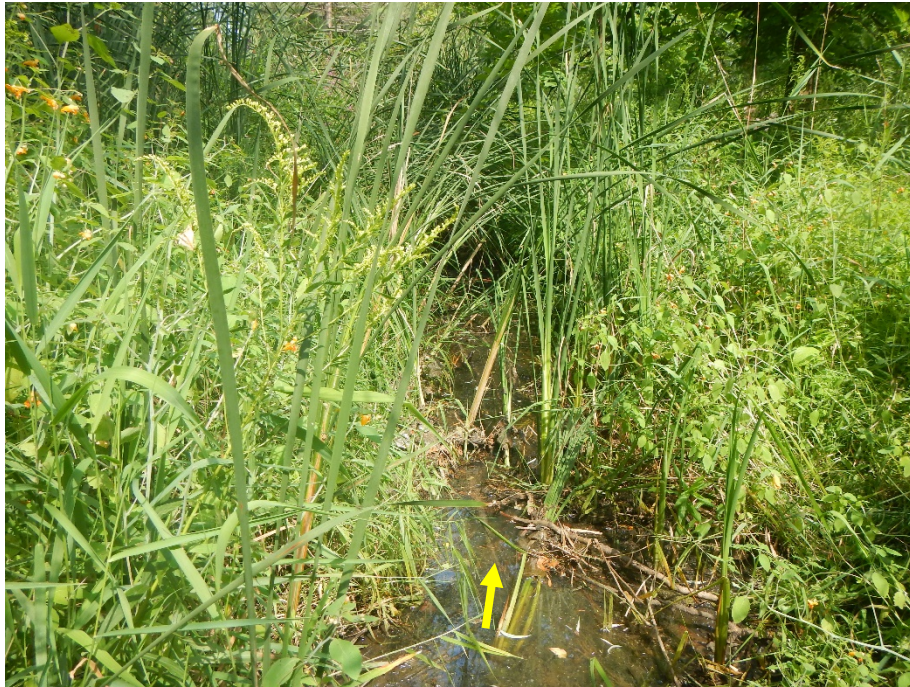
Photo 13  
Centreville Creek Tributary - Reach CCT-2

Rooted emergent vegetation including reed canary grass and cattails were found throughout most of the channel downstream of Crossing 2.

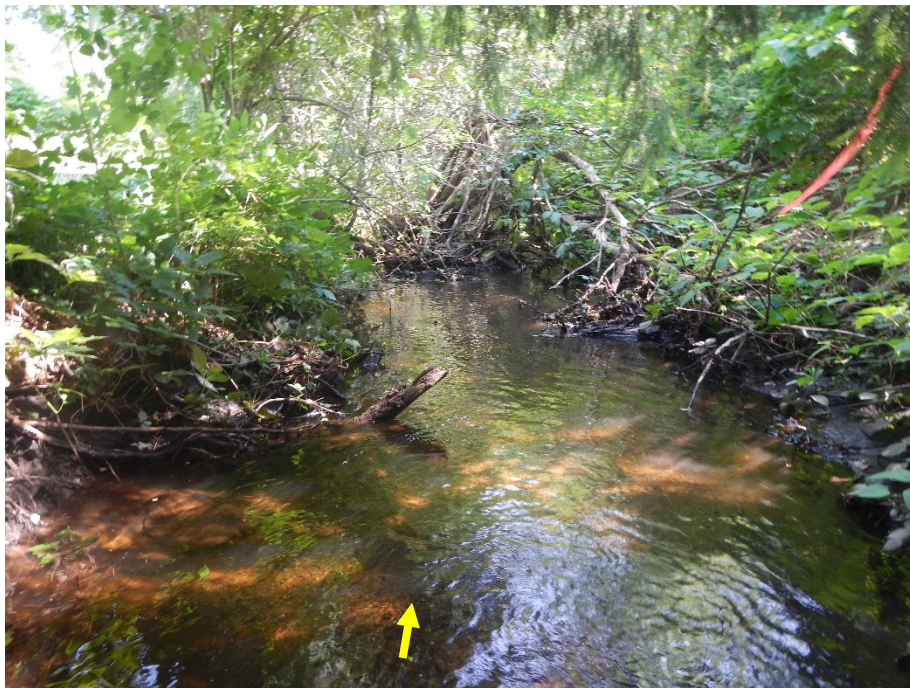
Photo 14  
Centreville Creek - Reach CC-1

Upstream extent of Centreville Creek observations. The channel was well-defined with a riparian buffer dominated by shrubs and mature trees. Riffles and pools were scarce within the reach, and the predominant substrates were sand and gravel.

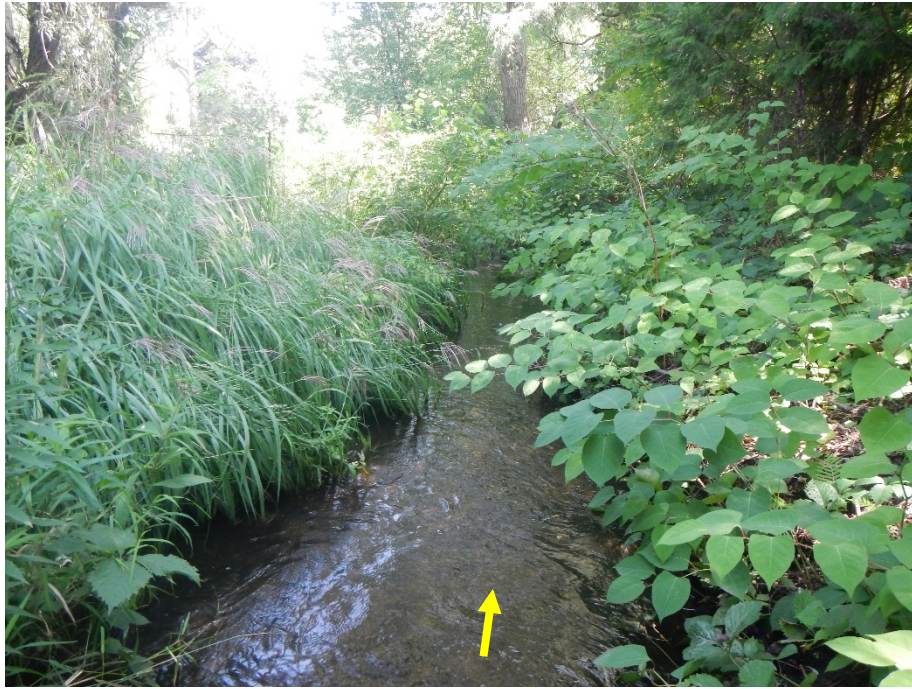
Photo 15  
Centreville Creek - Reach CC-1

Channel banks within the reach were generally well vegetated and stable.

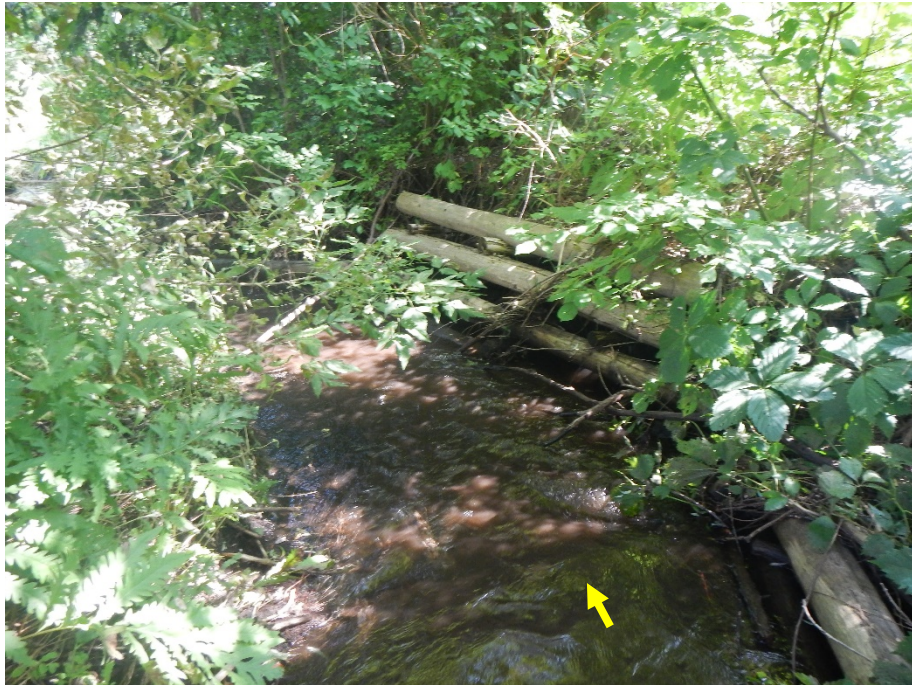
Photo 16  
Centreville Creek - Reach CC-1

Crib walls, undermined and in generally poor condition, were observed along the creek at the rear of the properties located along Emma Street. These were previously constructed to prevent erosion and protect pedestrian bridges over the creek. Watercress, an indicator of possible groundwater input, was observed within the channel at several locations and was most abundant immediately downstream of a relatively large meander bend at 4 Emma Street. Downstream of Airport Road, the channel had a higher width-to-depth ratio, and the channel corridor was more akin to a wetland system.

A crib wall was present along the outer bank of a left bend in the channel. There was significant loss of material within and behind the crib wall.

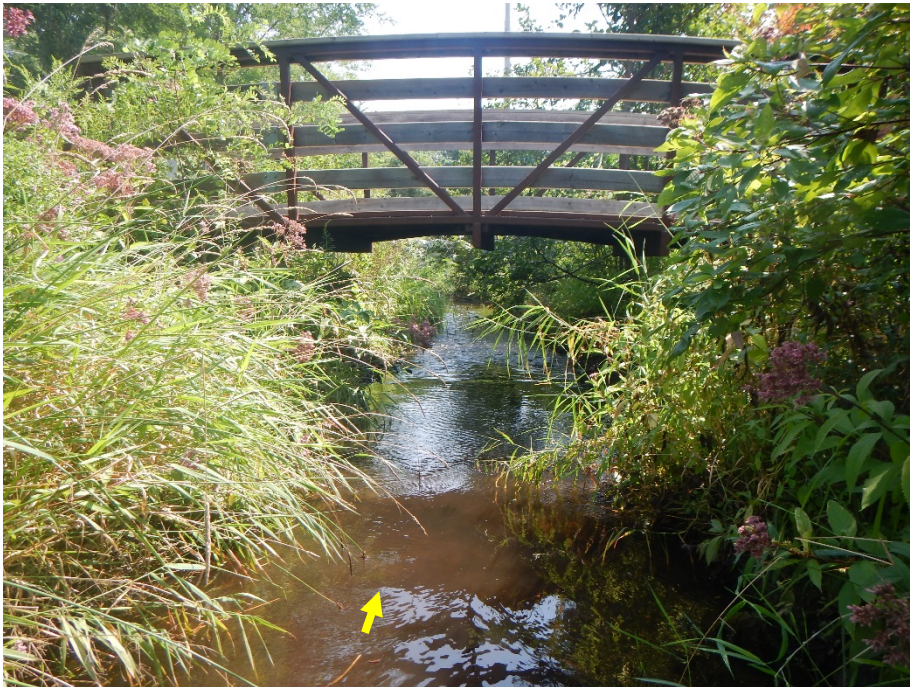
Photo 18  
Centreville Creek - Reach CC-1

The creek passes beneath the Caledon Trailway before crossing Airport Road. An artificial riffle composed of gravel and cobble was present downstream of the bridge.

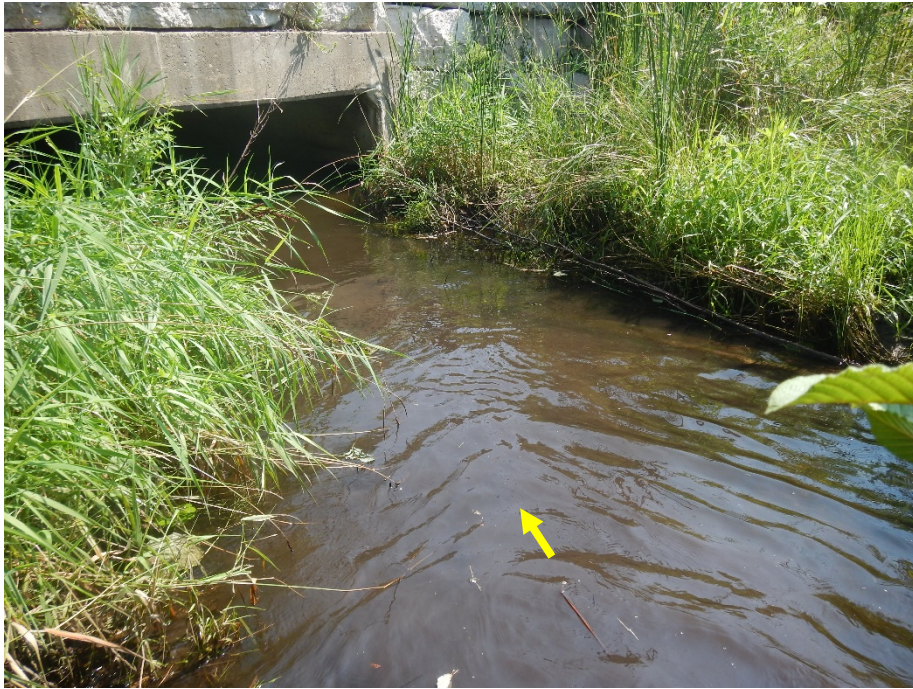
Photo 19  
Centreville Creek - Reach CC-1

Upstream of Crossing 3 (concrete box culvert) on the west side of Airport Road, a shallow pool composed of silt and sand substrates was located downstream of the artificial riffle.

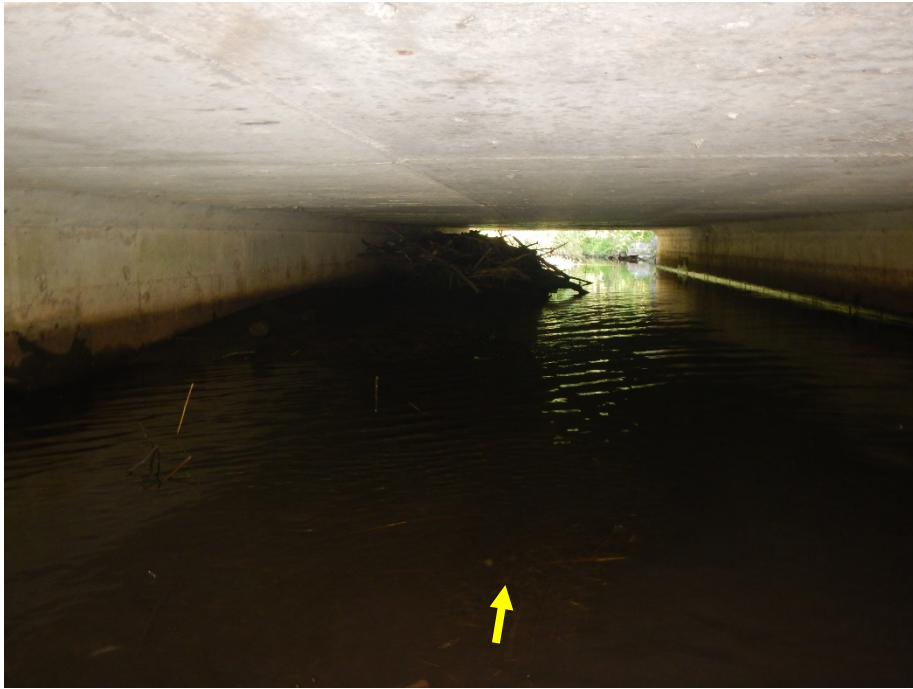
Photo 21  
Centreville Creek - Reach CC-1

A woody debris jam was present which partially impeded flows within Crossing 3 beneath Airport Road.

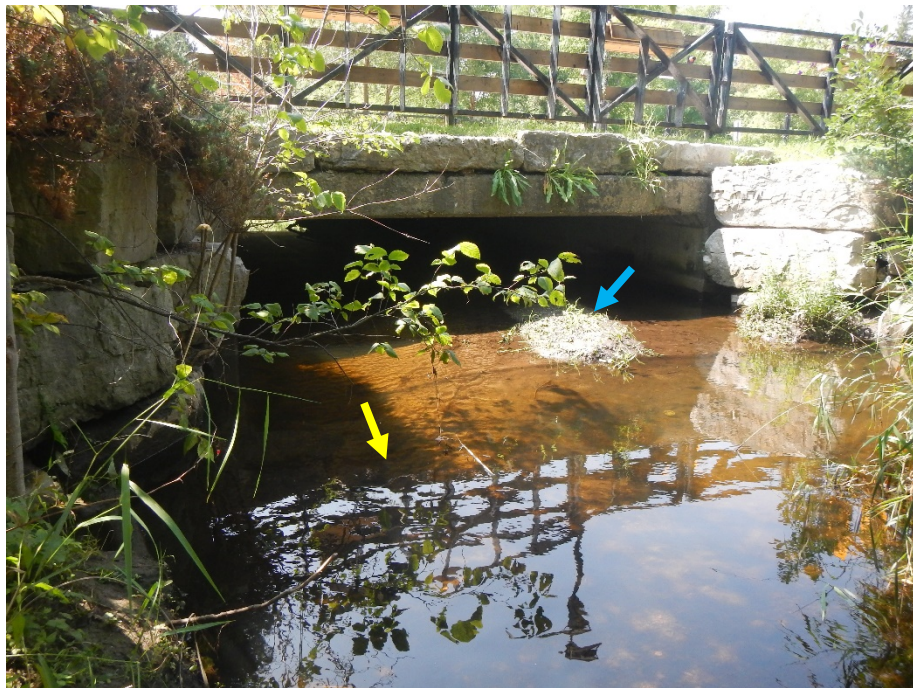
Photo 22  
Centreville Creek - Reach CC-1

A sandy lag deposit (blue arrow) was present downstream of the debris jam within Crossing 3. Downstream of the crossing was a shallow pool with bed material composed of sand and silt.

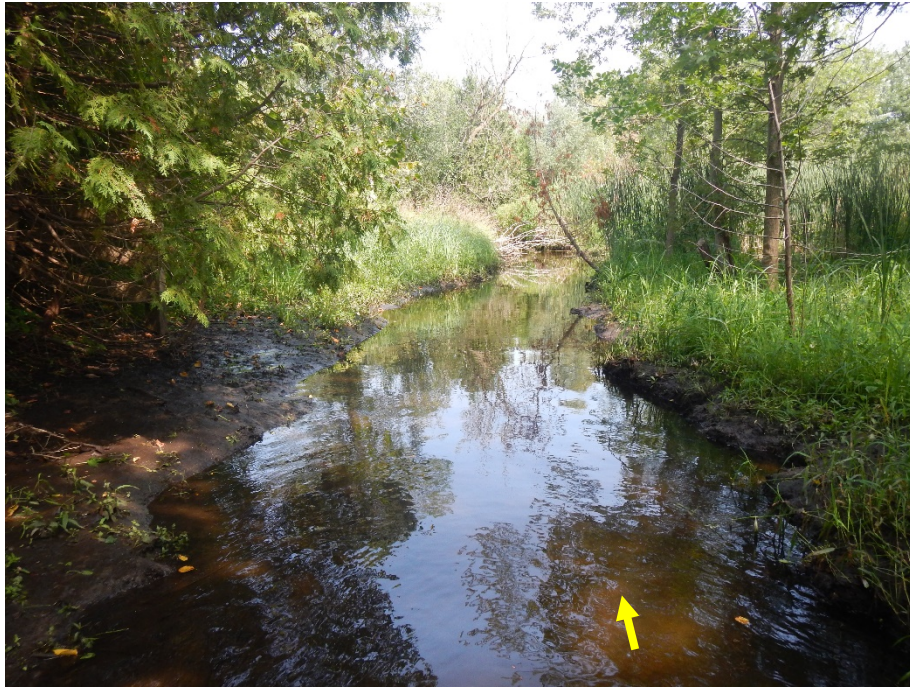
Photo 23  
Centreville Creek - Reach CC-1

Downstream of Crossing 3 the riparian buffer was populated by grasses and deciduous trees. The channel had low entrenchment, and hydrophilic vegetation generally grew adjacent to the channel.

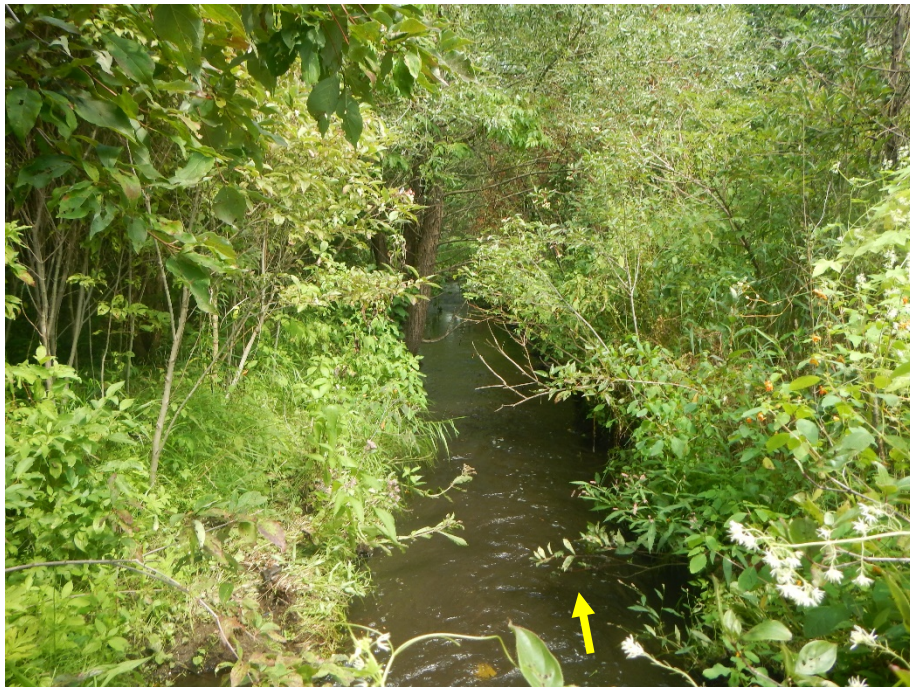
Photo 24  
Centreville Creek - Reach CC-1

Approximately 80 m downstream of Crossing 3, deciduous trees lined both channel banks at a riffle, where the channel was narrower and more entrenched than near the crossing.

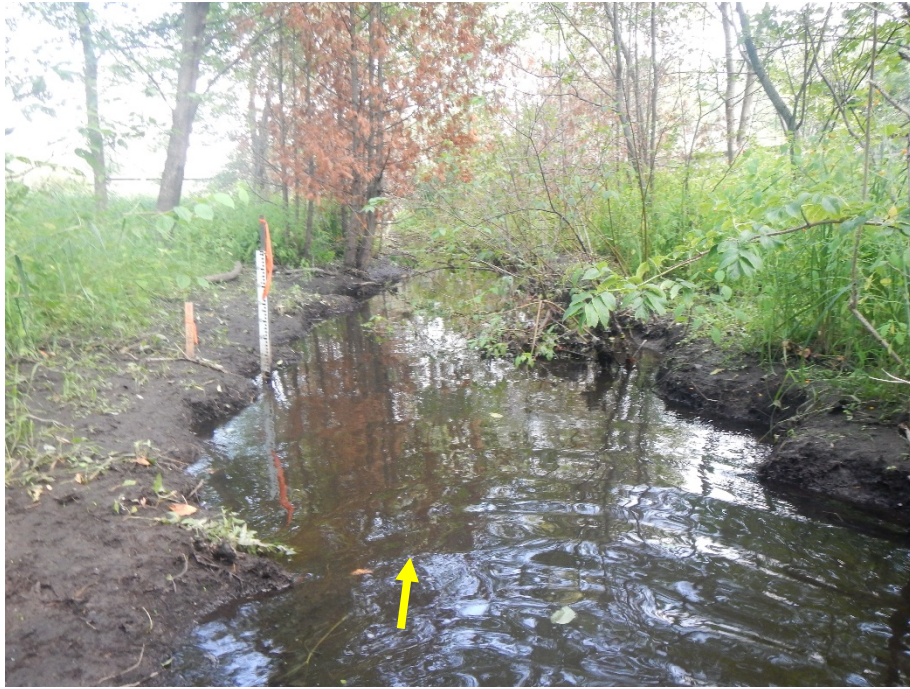
Photo 25  
Centreville Creek - Reach CC-1

Downstream of the forested area, the channel widened and was again less entrenched. Channel banks were composed of mucky soil, with little vegetation to provide stability.

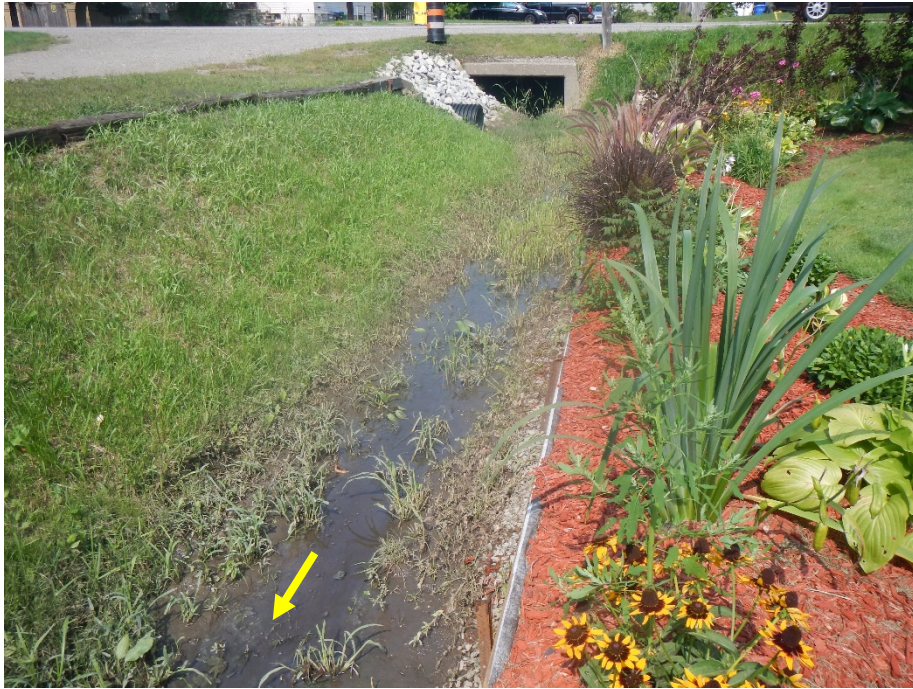
Photo 27  
East Credit River Tributary - Reach ECRT-1

On the west side of Airport Road, the Crossing 7 outlet was partially blocked by rip rap, limiting its capacity to convey flows.

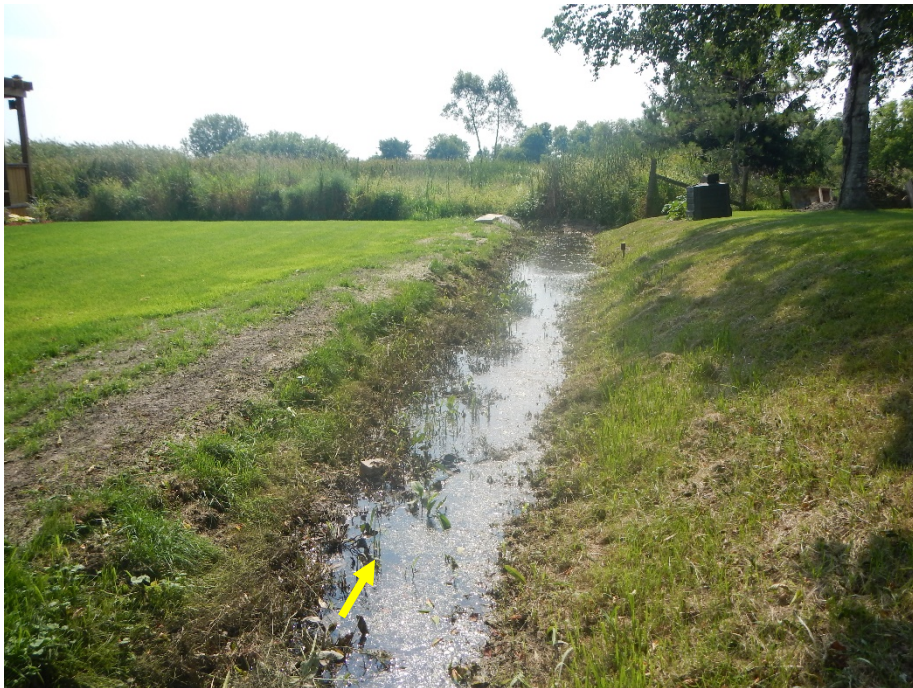
Photo 28  
East Credit River Tributary - Reach ECRT-1

Riparian vegetation consisted of manicured lawns within the residential properties. At the edge of the property material has accumulated against the fence, which spans the channel, and is creating a backwater which extended to Crossing 7.

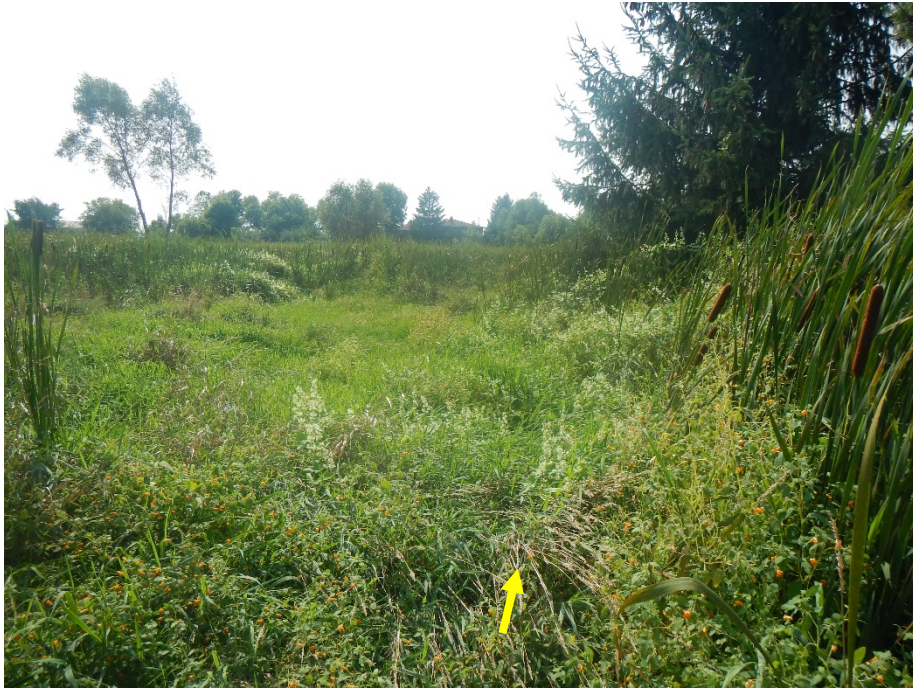
Photo 29  
East Credit River Tributary - Reach ECRT-1

Downstream of the residential properties, the watercourse became poorly-defined and entered a marsh populated with grasses, cattails, and phragmites.

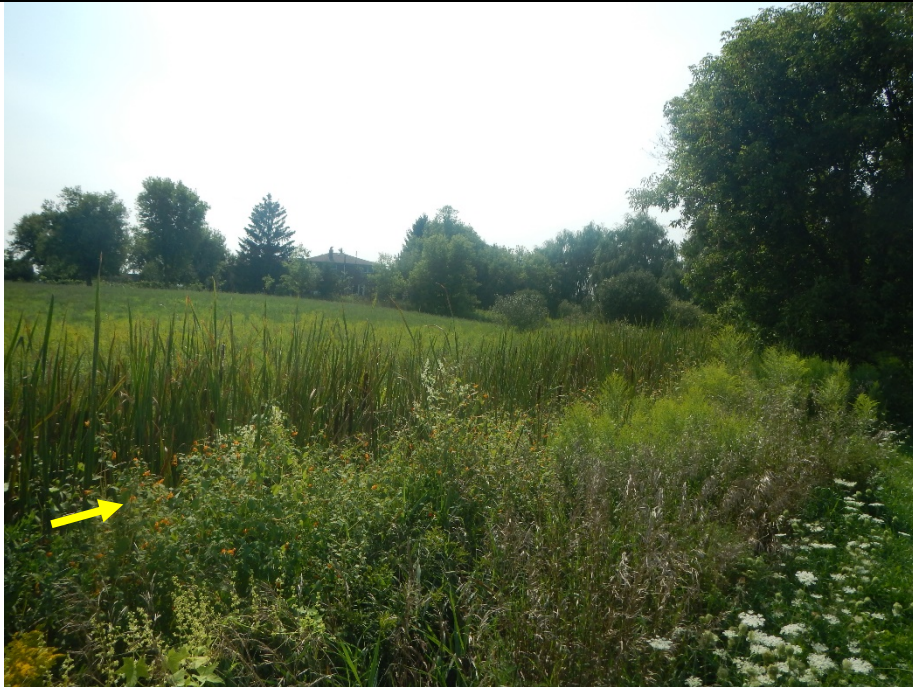
Photo 30  
East Credit River Tributary - Reach ECRT-1

Within the agricultural property the watercourse is a straightened ditch populated by cattails and reeds. On both sides of the ditch, there was a narrow riparian buffer composed of herbaceous vegetation.
