Region of Peel

Addendum to Environmental Study Report

**Improvements to Bovaird Drive, from Lake Louise Drive/Worthington
Avenue to 1.45 km west of Heritage Road in the City of Brampton**

May 2015

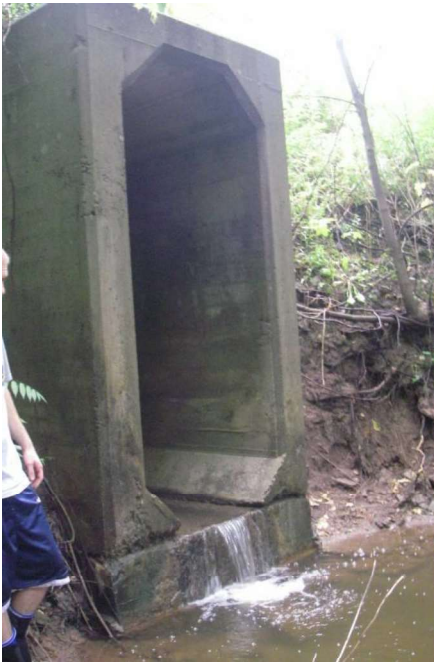
Structure <ul style="list-style-type: none"> Pre-cast concrete box culvert, closed bottom, Dimensions: 1.20m (w) x 2.80m (h) x 65m (l) Condition : Culvert intact but heavily eroded around the structure downstream where a scour pool has developed (0.6m deep). 	BV-A1 RGA: In regime RSAT: Moderate habitat quality	<ul style="list-style-type: none"> Culvert currently does not take into account channel width or the meander belt width and is causing major pooling and erosion downstream. Key opportunity for improvement through culvert widening and regrading. Some rehabilitation work likely to be required.
	Overall stream character : <ul style="list-style-type: none"> US – defined channel in ravine setting with evidence of widening and good pool-riffle sequencing. DS – geomorphologically active, widening, channel degrading into bedrock. Valley wall contact in ravine setting Riparian zone 100m, deciduous forest. Issues / Disturbance: <ul style="list-style-type: none"> Channel width > Opening Major pooling and erosion downstream Culvert perched Concerns regarding fish passage 	BV-A2 RGA: Transitional RSAT: Moderate habitat quality	<ul style="list-style-type: none"> Improvement of fish passage.

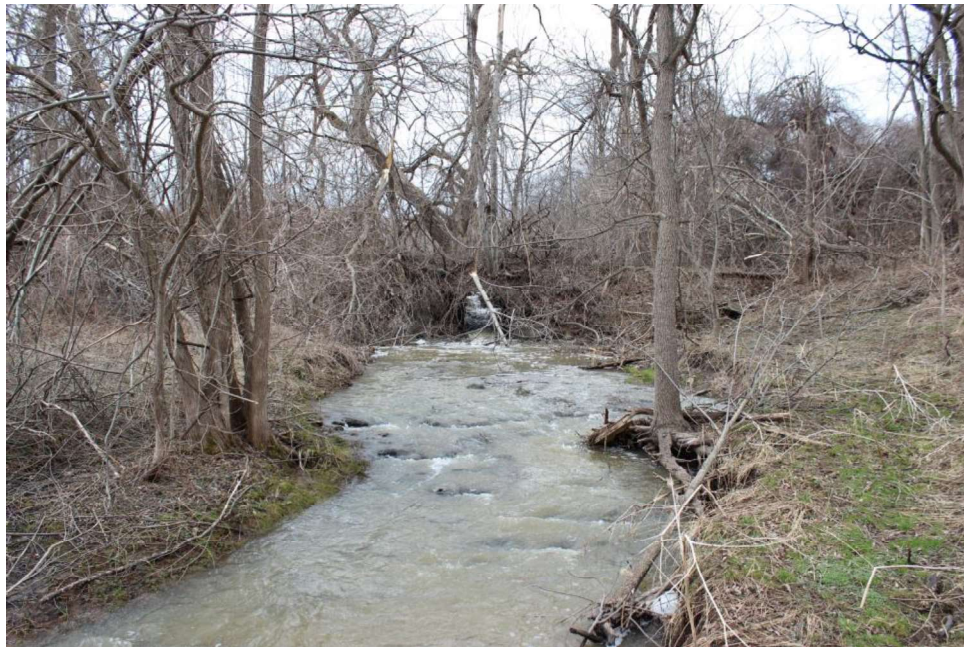
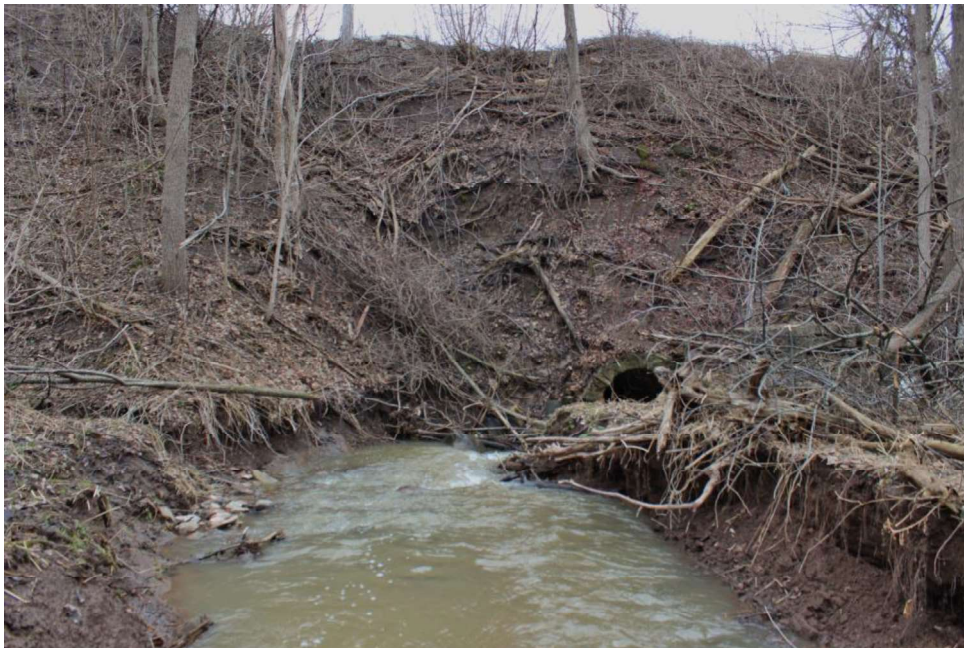
Two culverts were identified within the reach and both were determined to be attributing to instability within the watercourse (**Figure 4.3**). The small culvert located near the upstream end of the reach (250m upstream of Bovaird Drive) is undersized and set at a steeper slope than the natural channel. This has led to the development of a deep scour pool immediately downstream of the outlet and backwatering at the upstream end resulting in aggradation. The second culvert, which conveys flows under Bovaird Drive, has also been identified as a major source of channel disturbance. Based on existing channel dimensions and flows, the culvert is considered to be undersized. The undersized culvert restricts effective conveyance of flows leading

to issues with flow constriction causing channel widening and degradation. Immediately upstream of the culvert, the channel consists of steeply eroding banks which increase in height towards the culvert, evidence of channel widening and degradation. The culvert drains into Reach BV-A2 located south of Bovaird Drive.

Figure 4.3: Photographs of existing culverts within Reach BV-A1, the small culvert approximately 250m US of Bovaird Drive (top) and the US (North) portion of the Bovaird Drive culvert (bottom).

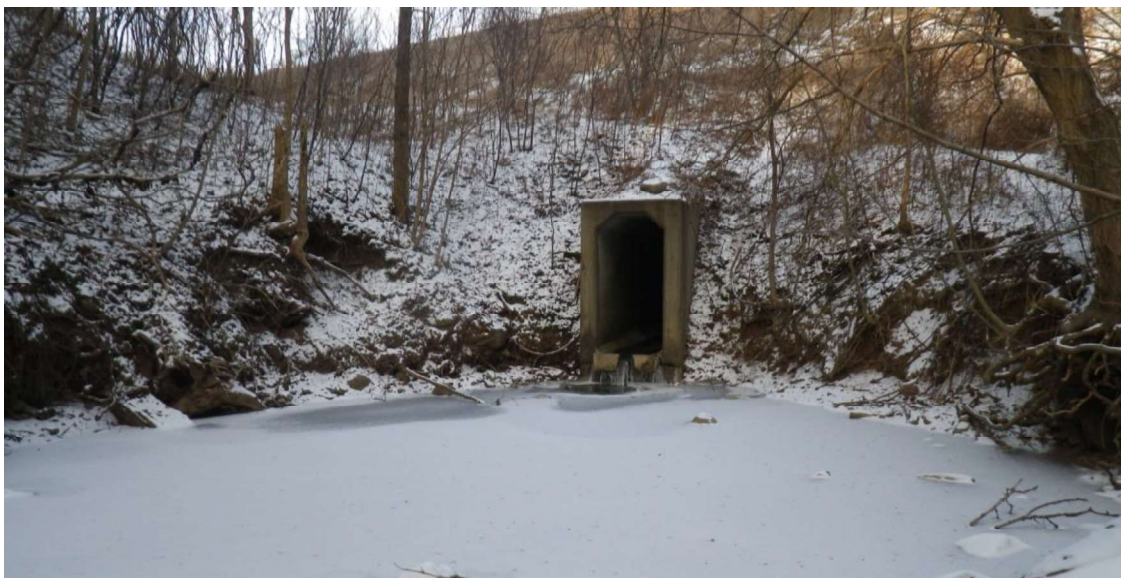
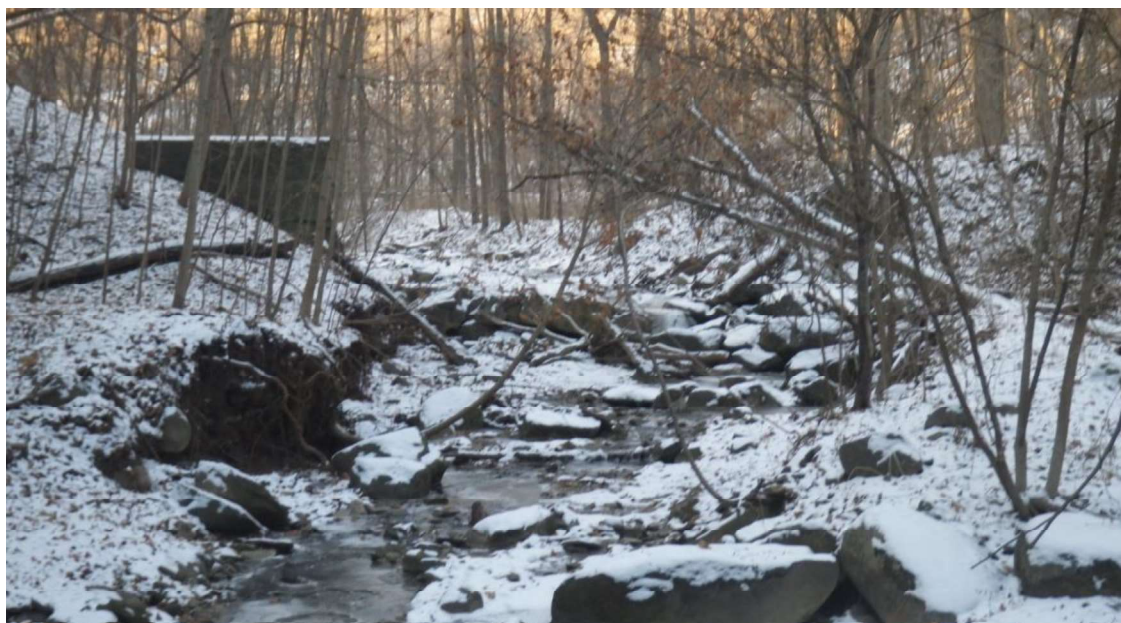
The most significant channel disturbance within the reach is the undersized culvert which conveys flows under Bovaird Drive (**Figure 4.4**). Immediately downstream of the Bovaird Drive culvert, a large scour pool has formed leaving the culvert invert perched creating a barrier for fish passage. Bed and bank scour, resulting from elevated flow velocities released from the culvert during high flows, have caused increases in channel width and depth immediately downstream of the culvert. Approximately 60m downstream of the Bovaird Drive culvert the remnants of a relic weir structure was observed (**Figure 4.4**). At this location, a sudden drop in elevation of approximately 1.2m was recorded with large pieces of concrete present creating a small cascade-like feature. This features impedes fish migration to upstream areas potentially reducing available habitat for fish species. Additional channel disturbances noted include, valley wall contacts which confine the channel and restrict lateral migration at various locations, and accumulations of large woody debris which were a common occurrence within the reach.

Figure 4.4: Photographs of existing fish barriers within Reach BV-A2, the perched culvert immediately DS of Bovaird Drive (top) and the relic weir approximately 60m DS of Bovaird Drive (bottom).

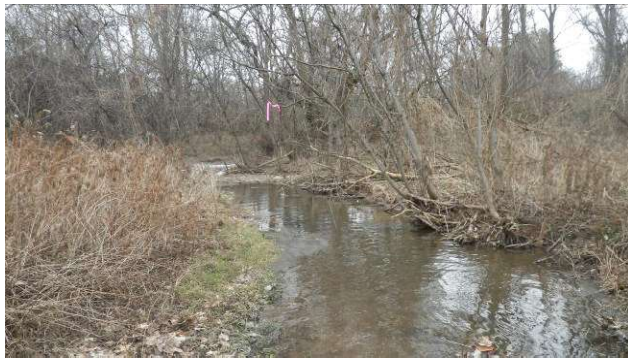
XS 10: View facing downstream. Note bank erosion along outside meander bend (left bank). Right bank has gradual slope.

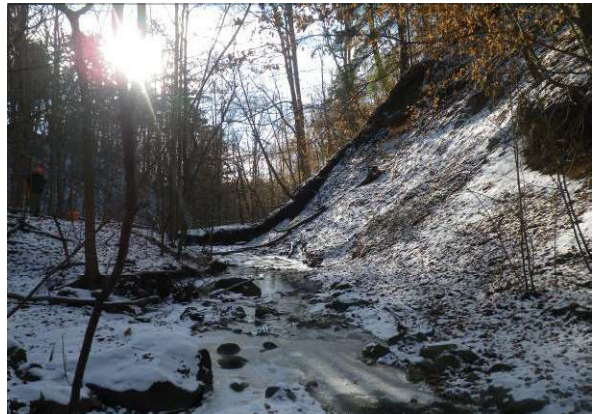
XS 4: View facing upstream. Exposed roots present along banks with overhanging vegetation observed on right bank (valley wall contact).

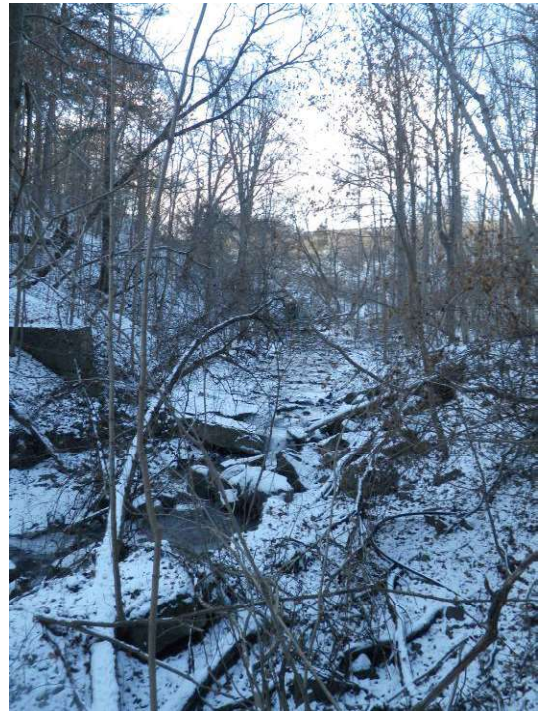
View facing upstream at remnants of an old weir located approximately 60m from the upstream reach extent. A sudden drop in bed elevation was observed at this location along with the inclusion of large boulders within the channel.
