#### Mississauga Road, Old Main Street, Bush Street, Olde Base Line Road, and Winston Churchill Boulevard Class EA

#### Public Information Centre #2

Wednesday, November 20, 2013 Caledon Country Club, 2121 Olde Base Line Road, Caledon

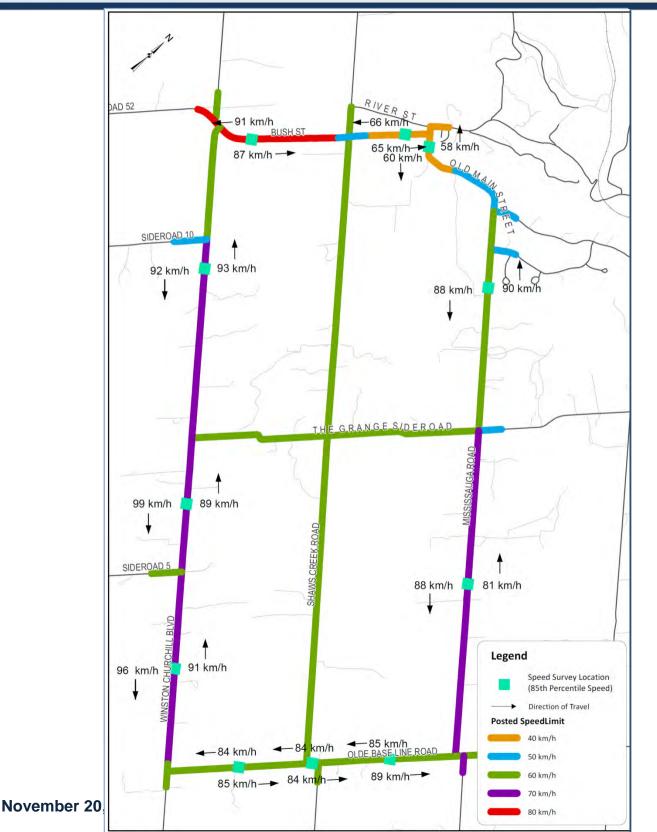
# **Traffic Speeds**

Speed surveys indicate that traffic generally travels at higher speeds than the posted speed limits.

Road segments where the 85<sup>th</sup> percentile speeds are more than 20 km/h over the posted speed limits include:

- Olde Base Line Road
- Mississauga Road between The Grange Sideroad and Woodlands Court
- Winston Churchill Boulevard
- Bush Street in the Village of Belfountain

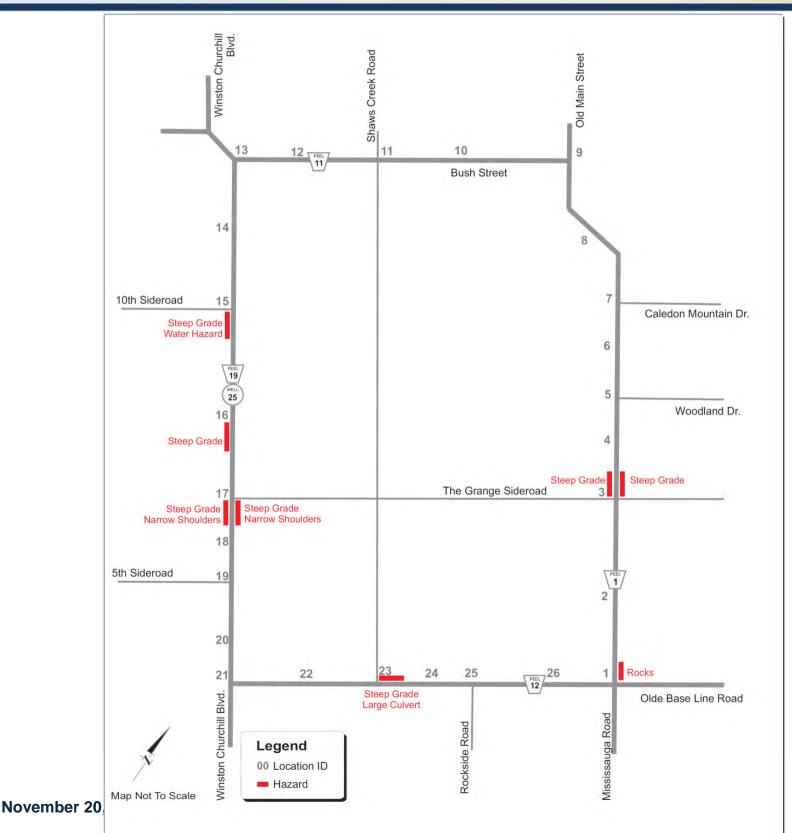
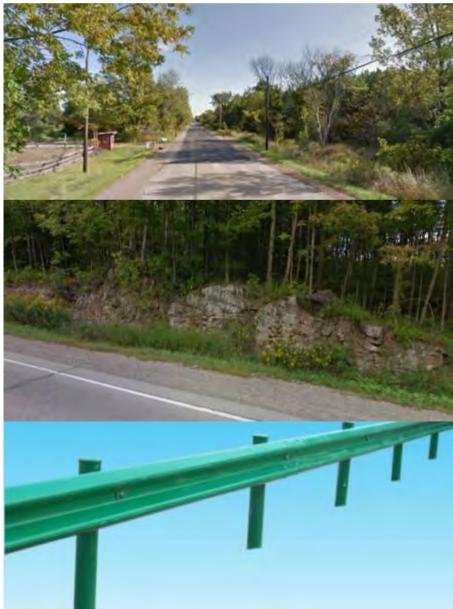
### **Roadside Hazards**

Roadside hazards include hydro poles, steep slopes, and rock cuts. The Study will consider options to improve safety at roadside hazard locations.

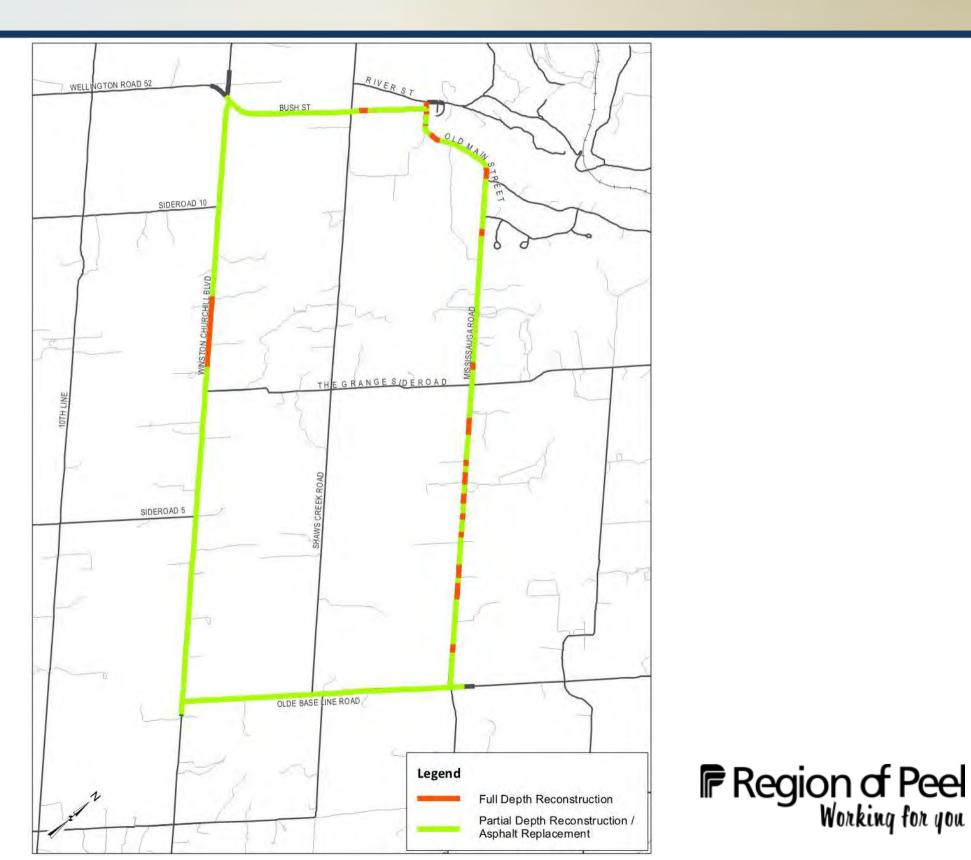
#### **Geotechnical Recommendations**

### **Recommended Pavement Structures**

Geotechnical Investigations completed to date have recommended the following typical pavement structure to address the deficient pavement conditions:

40-50 mm (1.6-2 in.)	Surface Course
60-100mm (2.4-4 in.)	Binder Course
150 - 300 mm (6-12 in.)	Granular A Base
400 mm (16 in.)	Granular B Sub-base
subgrade

\* Note: The pavement recommendations will be confirmed in the subsequent phases of this study.

Pavement structure granular materials must conform to OPSS (Ontario Provincial Standard Specification) specifications.

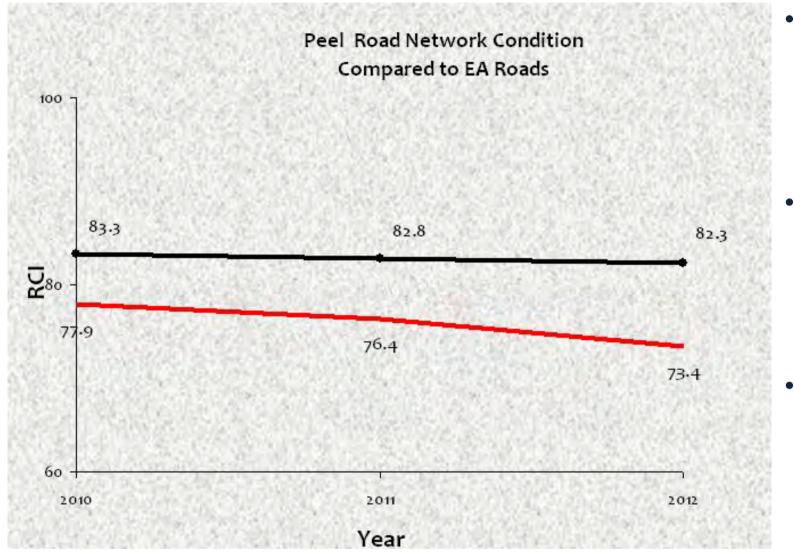
## Ride Condition Index (RCI)

- Black line represents projected network RCI for all Regional Roads.
- Red line represents projected RCI for the roads in the study area.

- The Ride Condition Index (RCI) is a quantitative number that represents the overall condition and quality of a Regional road network.
- The RCI aggregates the rating of many types of road defects including cracking, rutting, potholes and surface quality into one measurable number.
- Study area roads are below the network average and are deteriorating faster than the network average and will likely be below the level of service (72) for roads in the next 3- 5 years.

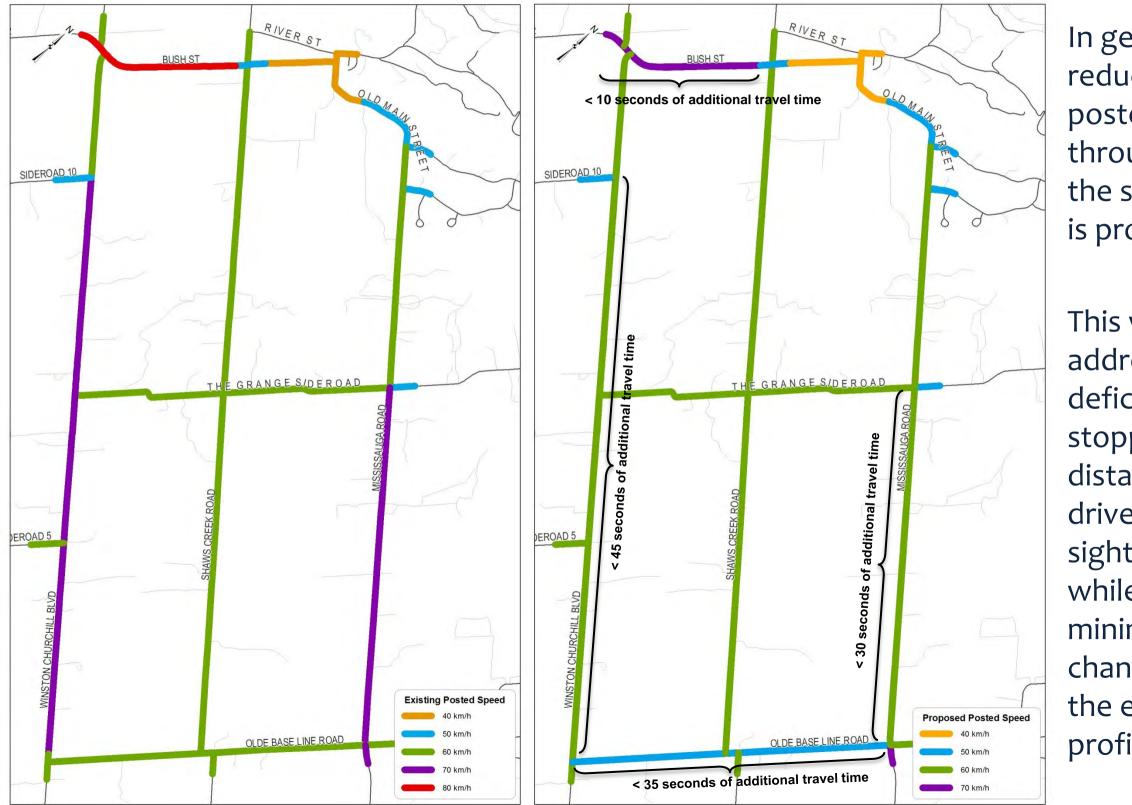
### **Existing and Proposed Posted Speeds**

In general, a reduction in posted speeds throughout the study area is proposed.

This will address deficient stopping sight distance and driveway sightlines, while minimizing changes to the existing profiles.

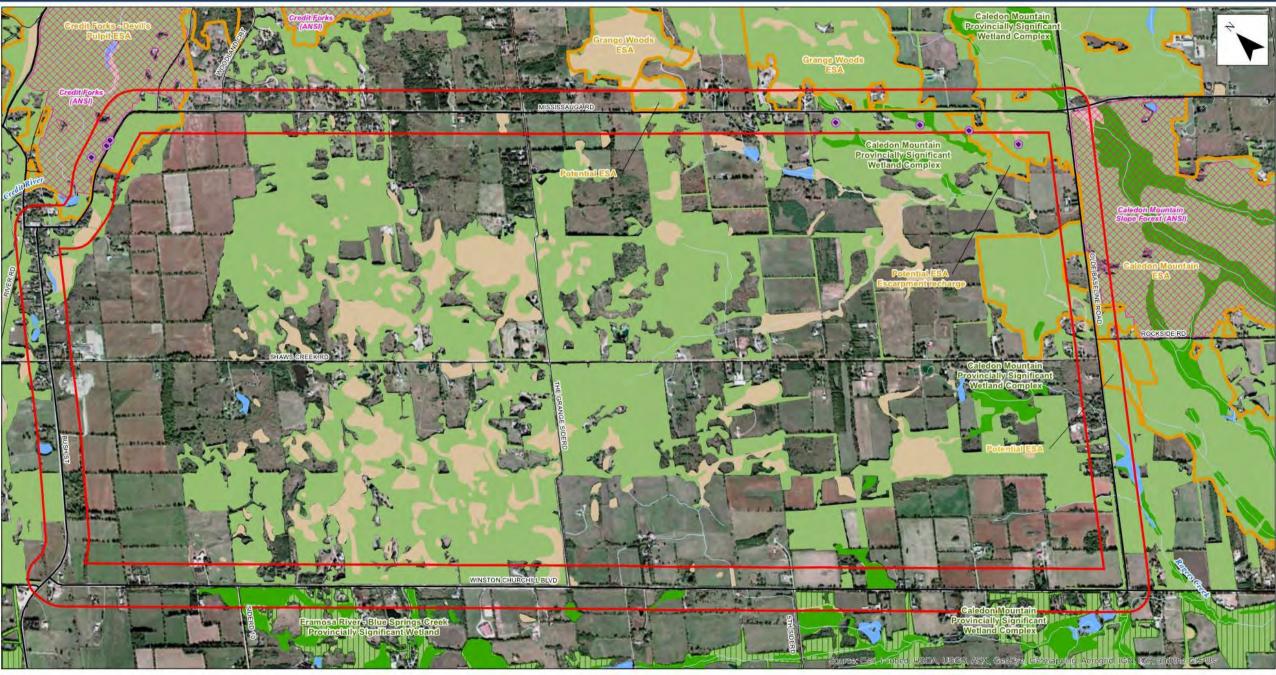
#### Figure 5a

Natural Feature Constraints - Woodlands, Wetlands and Designated Policy Areas

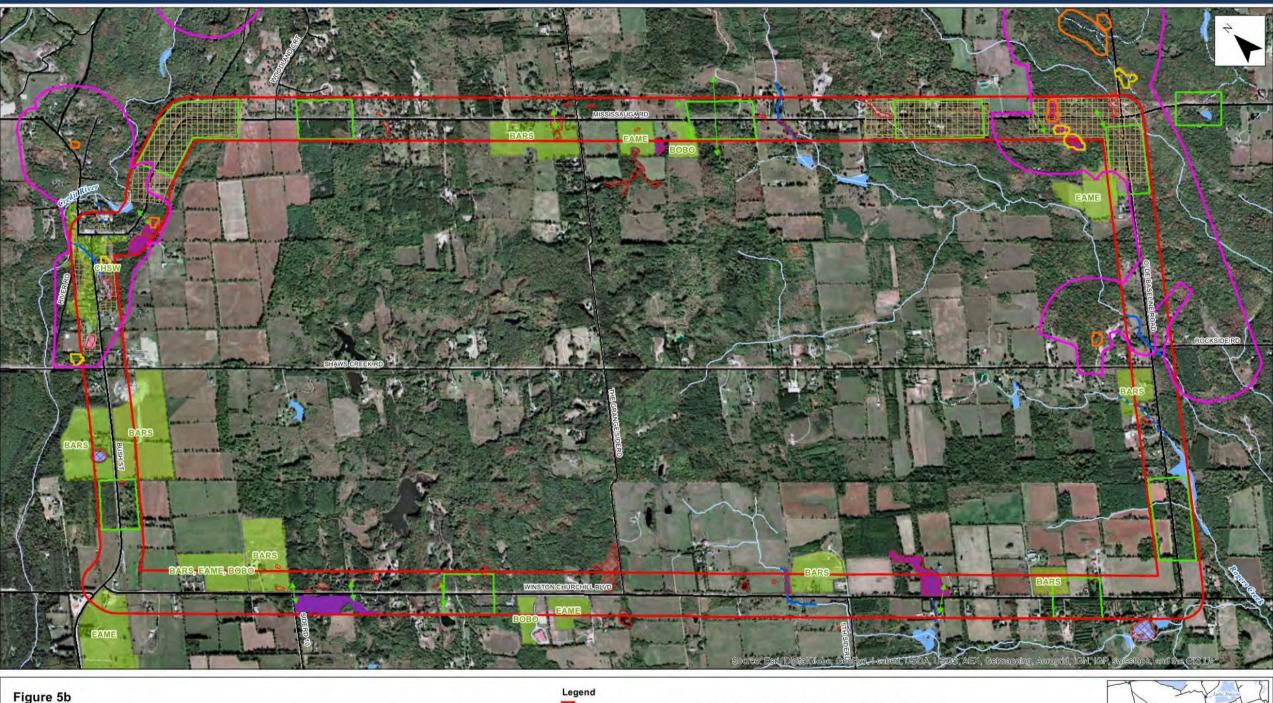
#### Natural Feature Constraints - Fish and Wildlife Habitat

#### **Natural Feature Constraints - Fish and** Wildlife Habitat

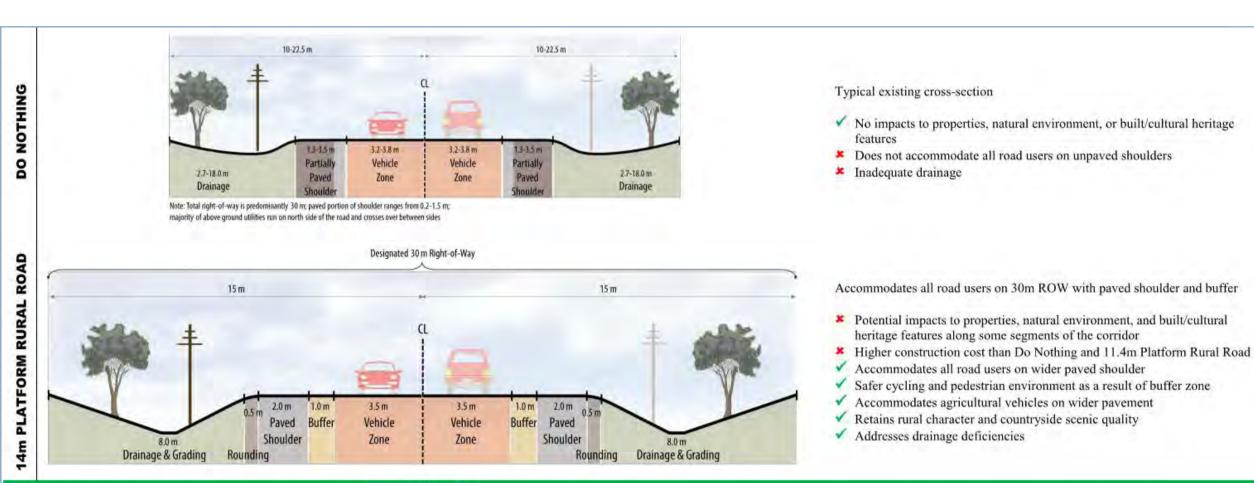
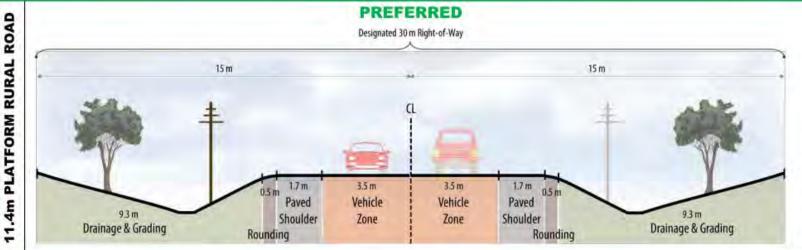
## **Bush Street Cross-Sections**

Accommodates all road users on 30m ROW with narrow shoulder (no buffer) and allows for more extensive grading within ROW

- Some potential impacts to properties, natural environment, and built/cultural heritage features along some segments of the corridor, but minimized where possible
- Lower construction cost than 14m Platform Rural Road
- Accommodates all road users on paved shoulder
- Safer cycling and pedestrian environment from paved shoulder
- Accommodates agricultural vehicles on wider pavement
- Retains rural character and countryside scenic quality
- Addresses drainage deficiencies

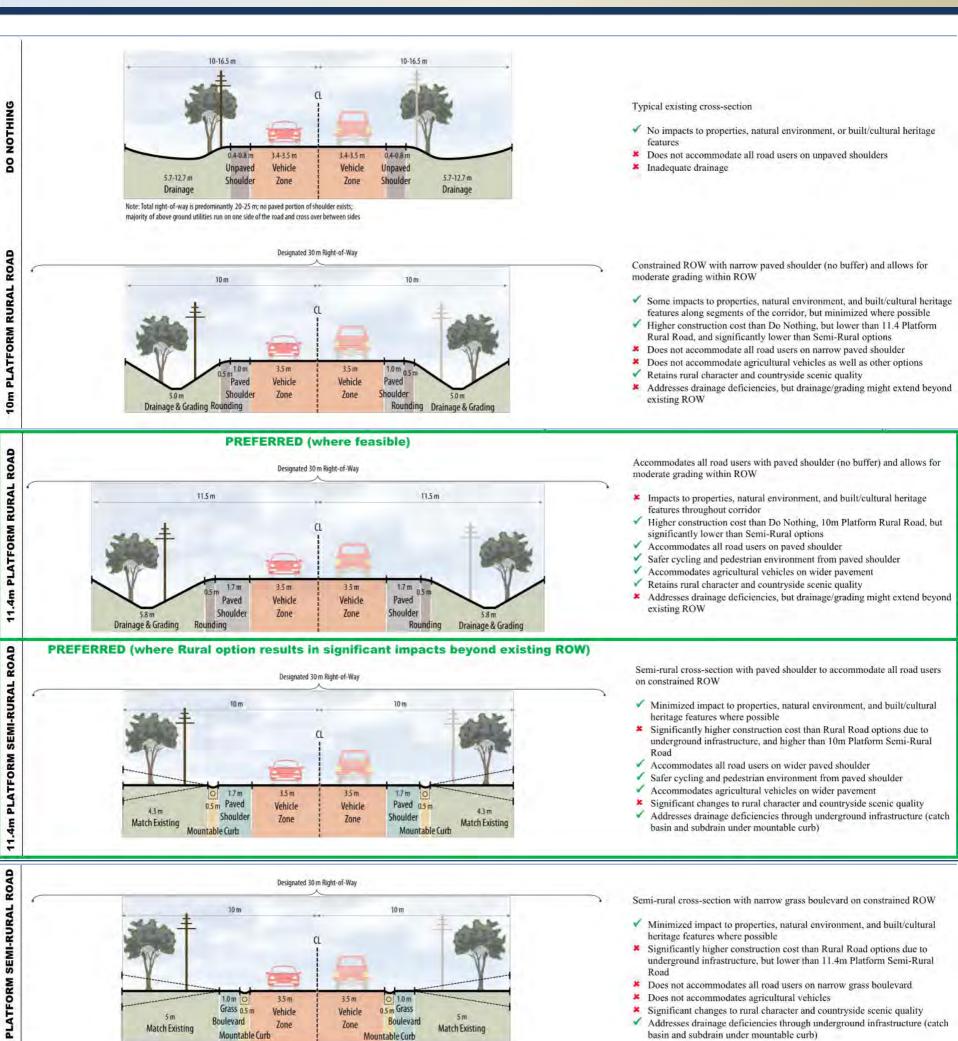
#### **Olde Base Line Road Cross-Sections**

Addresses drainage deficiencies through underground infrastructure (catch basin and subdrain under mountable curb)
