**MISSISSAUGA ROAD ENVIRONMENTAL ASSESSMENT
FLUVIAL GEOMORPHIC ASSESSMENT**

144162-22380-522

Report Prepared for:
AMEC FOSTER WHEELER

Prepared by:
MATRIX SOLUTIONS INC.

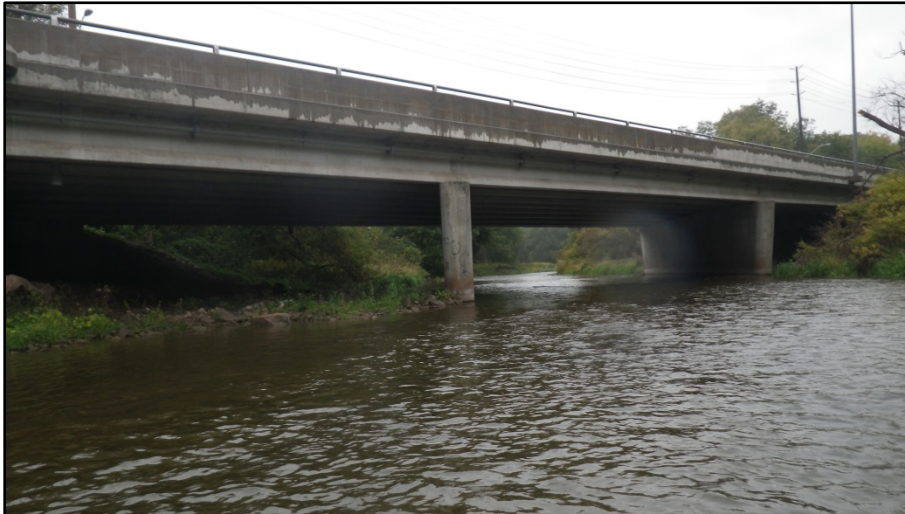
1. Looking upstream towards Mississauga Road— flow limited to flow within the 16 m wide gap between two piers.

The existing bridge crossing at Mississauga Road constricts active flow to a 16 m wide corridor. This width is less than the reach average bankfull channel width of 25 m. At the crossing, backwater and ponding are located to either side of the bridge piers away from active flow. This indicates a lack of crossing capacity and it is therefore recommended that the replacement structure be wider to minimize any potential impacts on stream morphology.

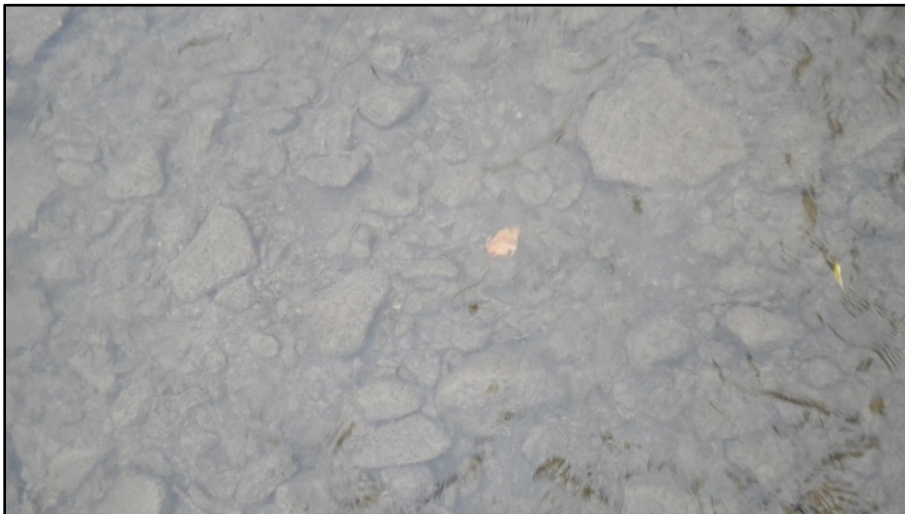
2. Downstream of Credit River Bridge – bed composed primarily of partially embedded cobble with some clay and boulders.

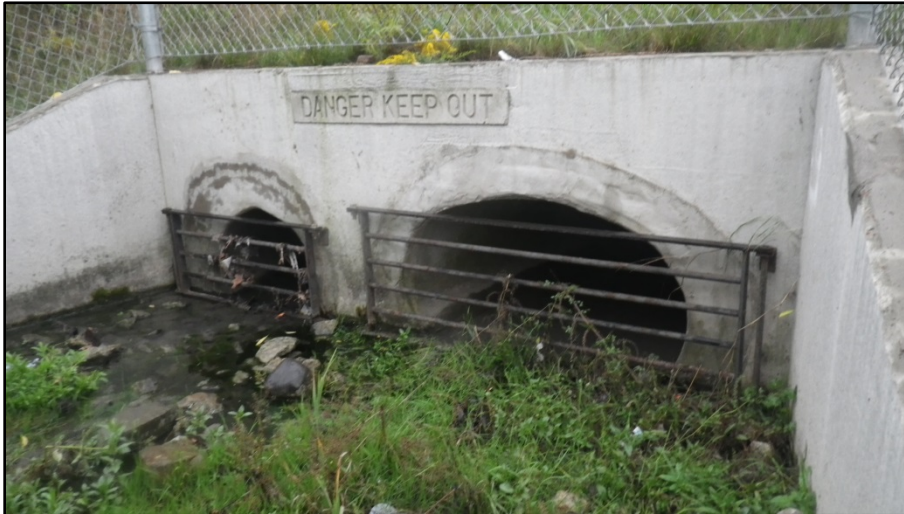
3. Downstream of Credit River Bridge – double outlet oval shaped concrete pipe with grates; rip rap lined outlet channel.

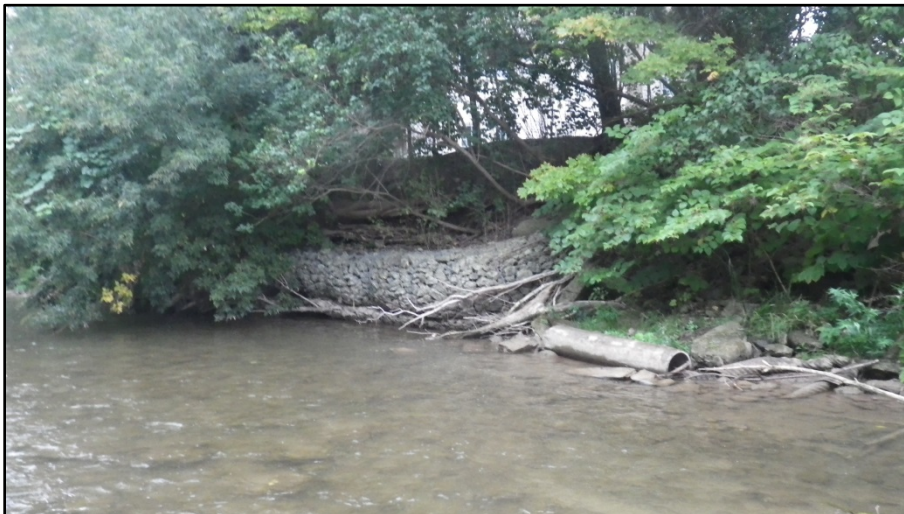
4. Downstream of Credit River Bridge – channel hardening with gabion baskets along residential properties.

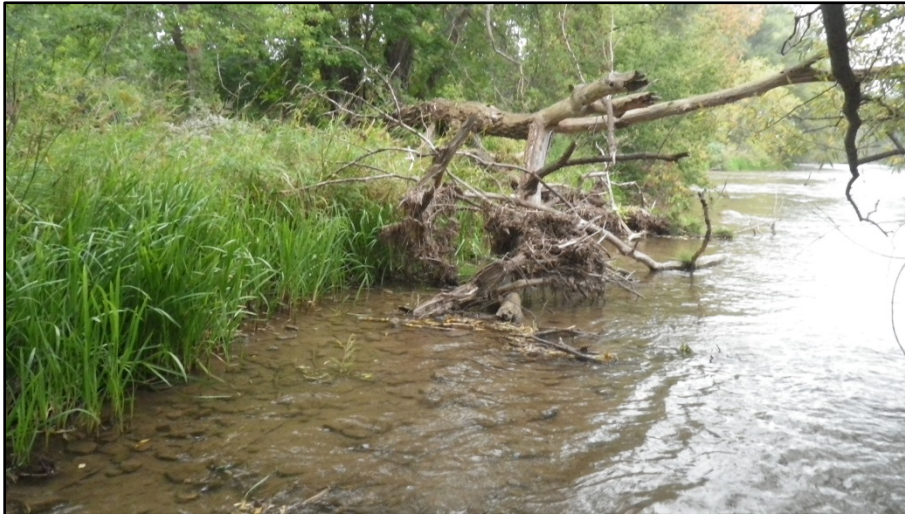
5. Downstream of Credit River Bridge – minor debris jam with evidence of high flow.

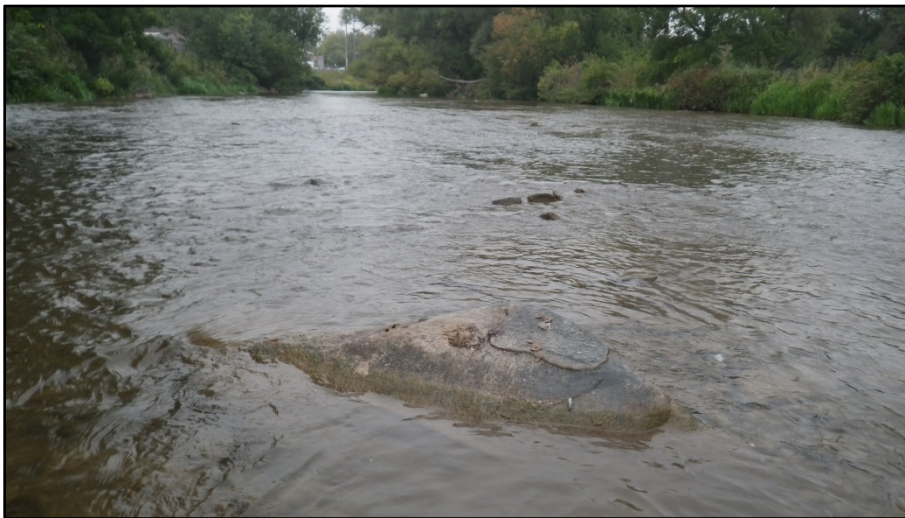
6. Downstream of Credit River Bridge – large boulder with downstream scour depth of 0.57 m.

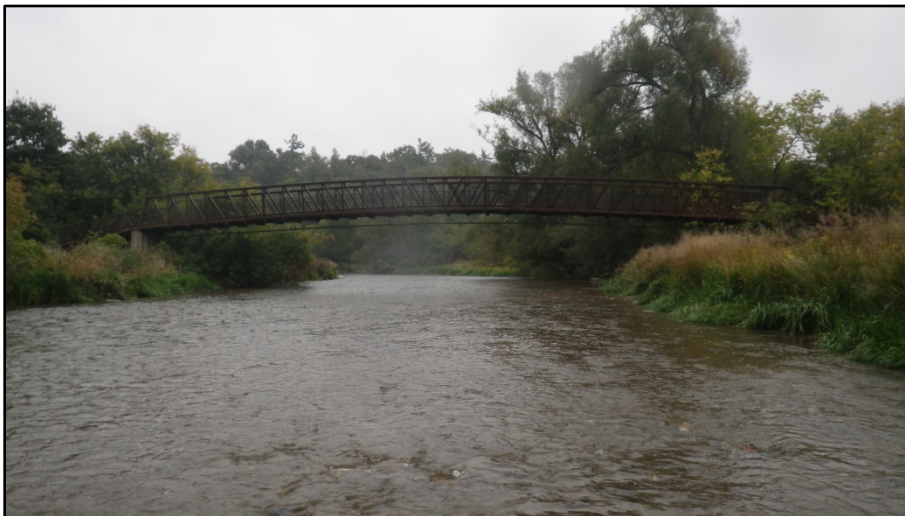
8. Downstream of Credit River Bridge – golf car bridge spanning the watercourse.

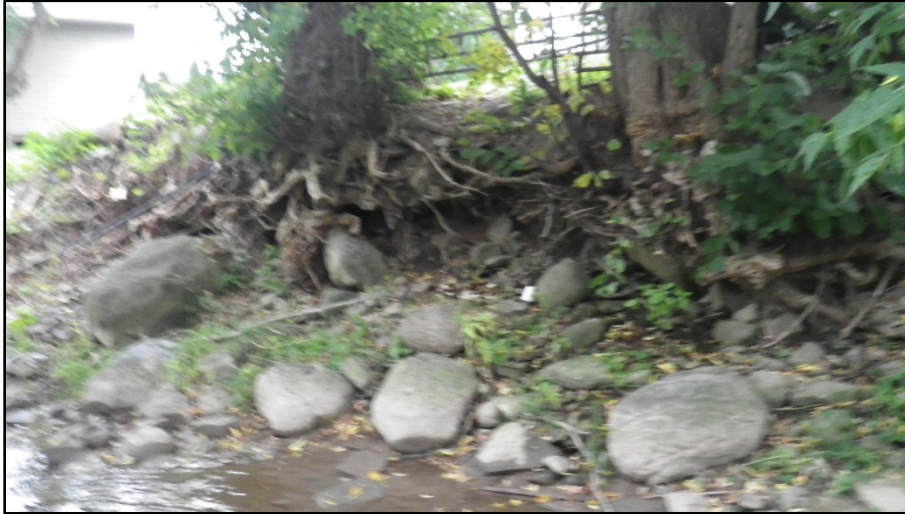
9. Downstream of Credit River Bridge – undercutting of trees and large boulders on right bank

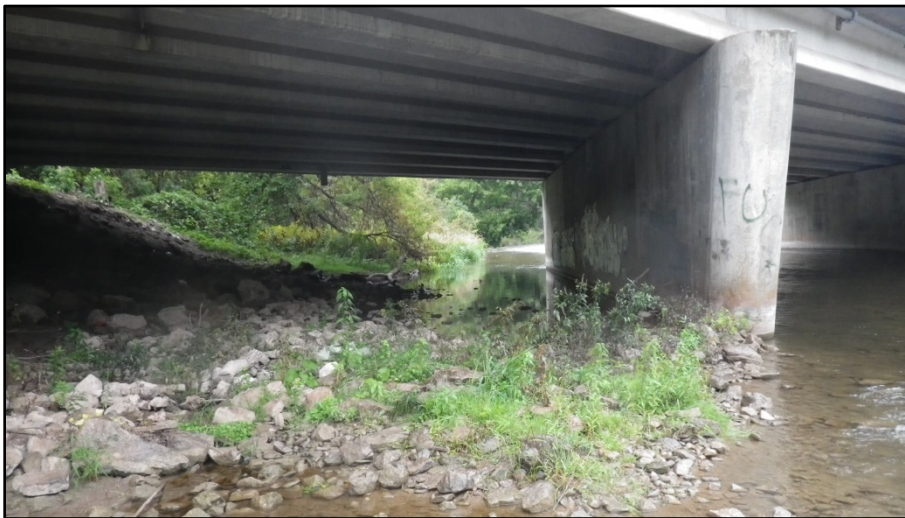
10. Credit River Bridge – channel over widens just downstream of the bridge to compensate for 16 m wide main opening.

The current crossing span is restricting flow of the channel. To reduce the possibility of increased channel widening on the downstream end of the crossing as well as limit additional bed scour, it is recommended the pier structures be removed and the crossing spans the width of the channel plus a factor of safety for future migration of the river.

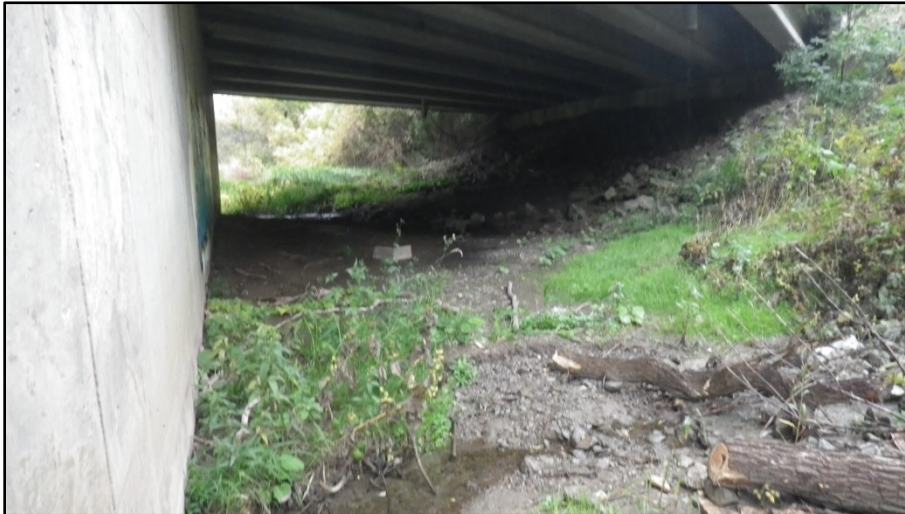
11. Credit River Bridge – left bank side of bridge pier shows no flow.

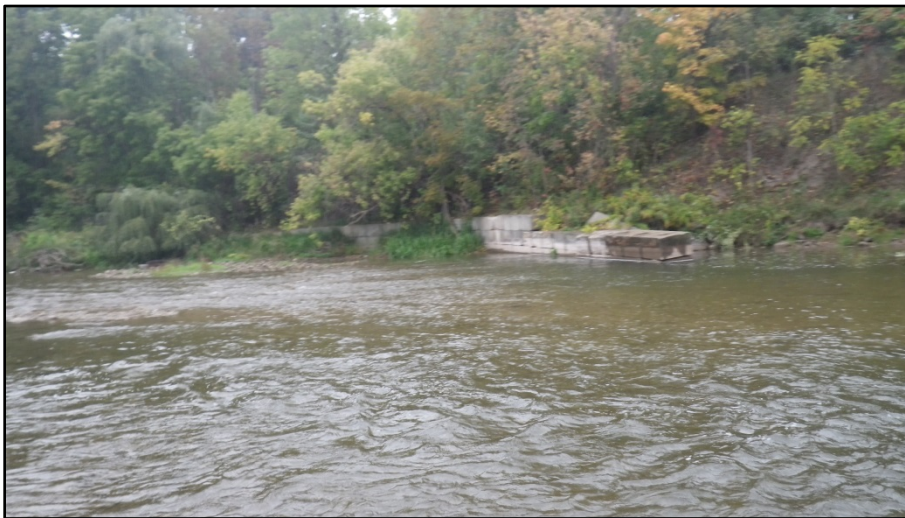
12. Upstream of Credit River Bridge – channel hardening along left bank adjacent to River Road.

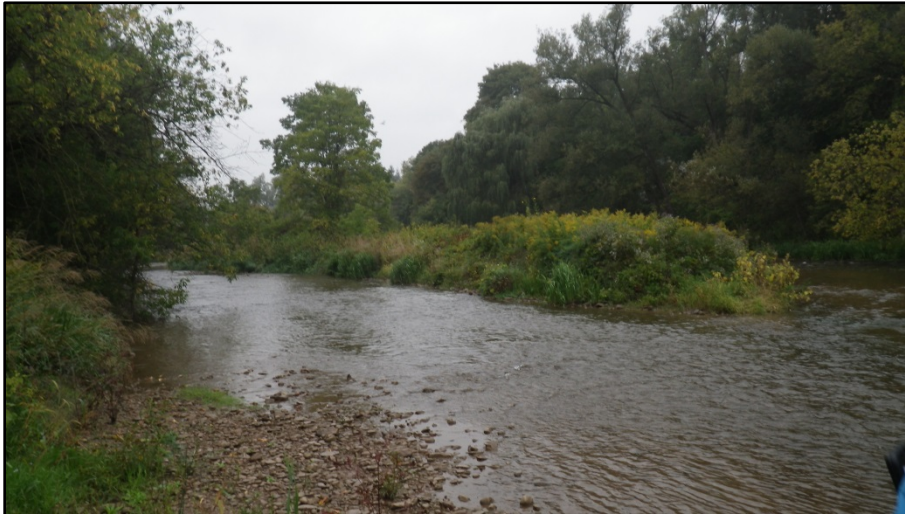
13. Upstream of Credit River Bridge – island formation downstream of decommissioned dam.

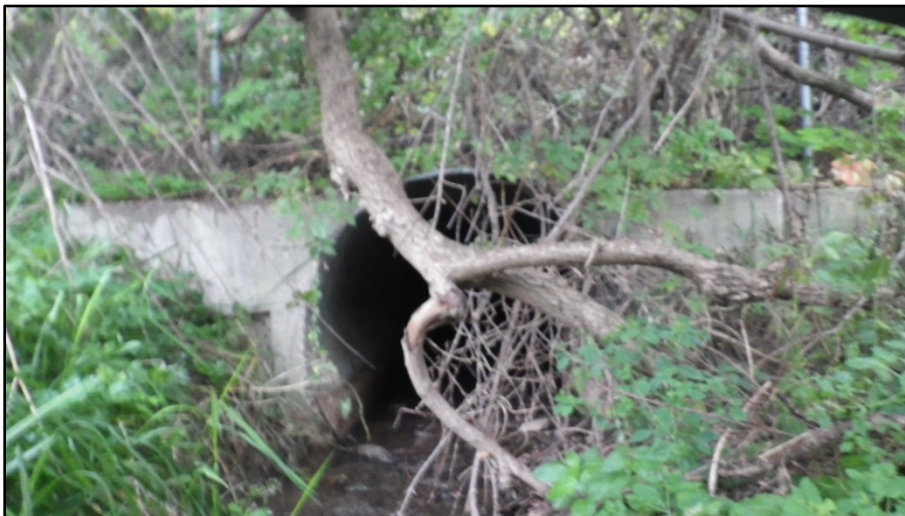
14. Unnamed Credit Trib – outlet of corrugated steel pipe to Credit River.

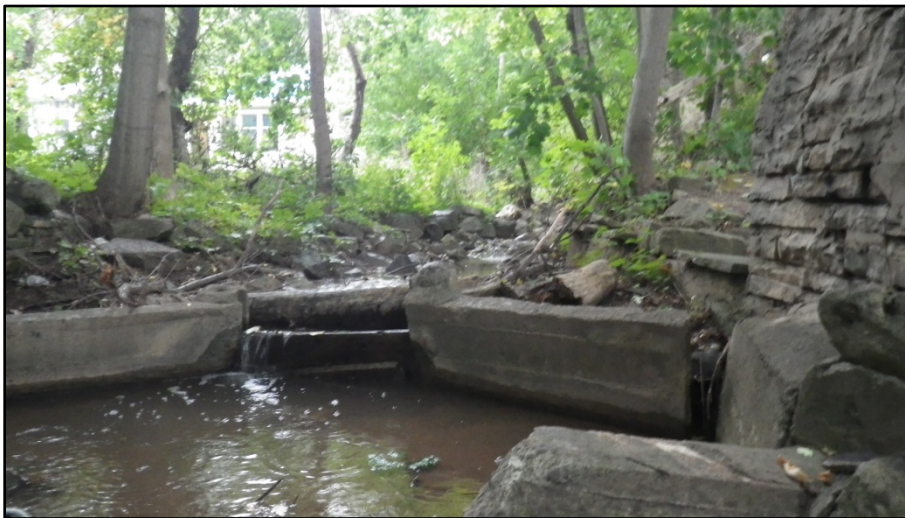
16. Unnamed Credit Trib – old weir with 35-40 cm drop.

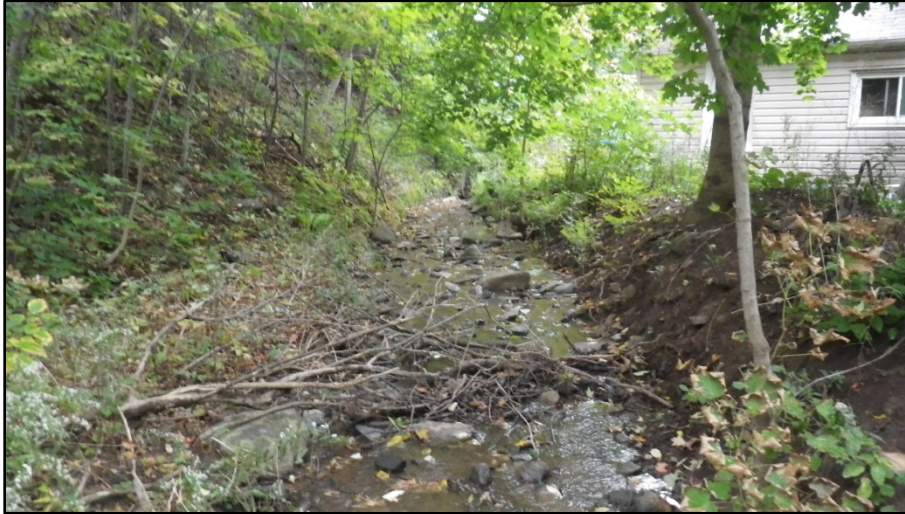
17. Unnamed Credit Trib – low flow channel with cobble and pebble substrate.

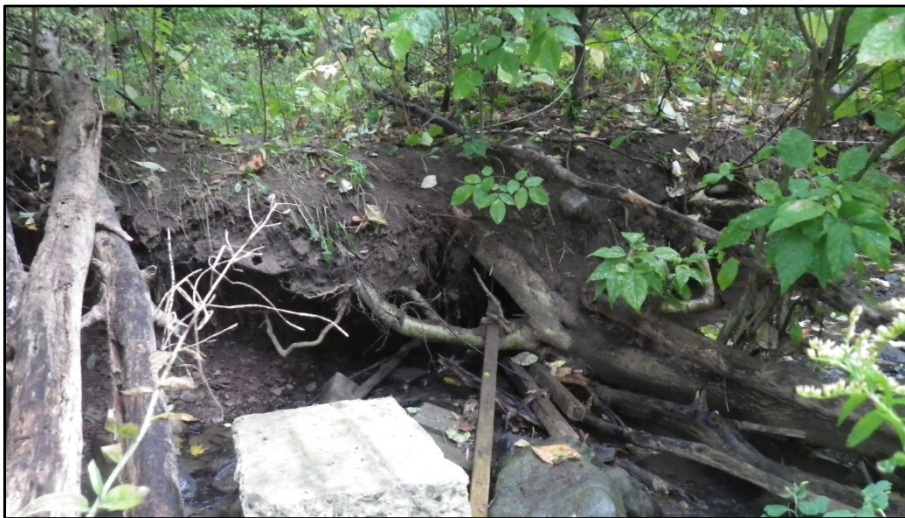
18. Unnamed Credit Trib – approximately 20 cm of undercutting and minor debris jam.

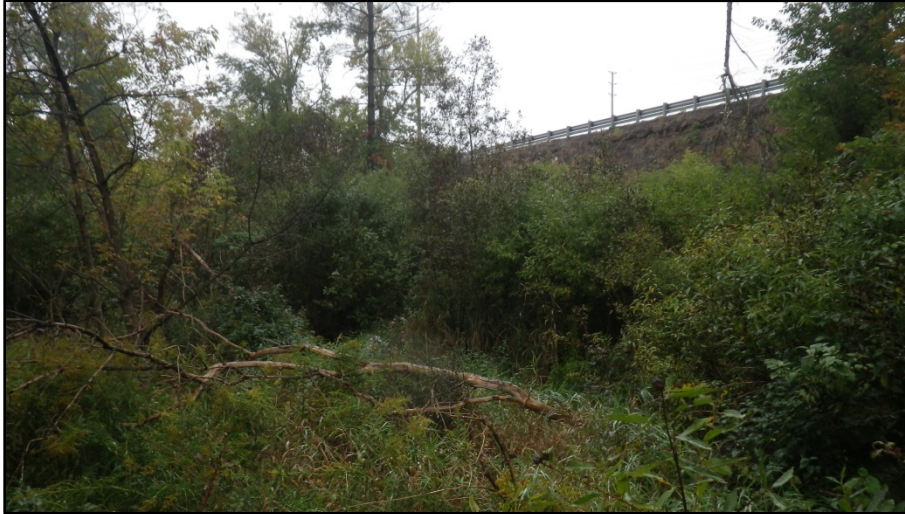
19. Unnamed Credit Trib – steep (>70°) embankment slope leading to Mississauga Road northeast of creek.

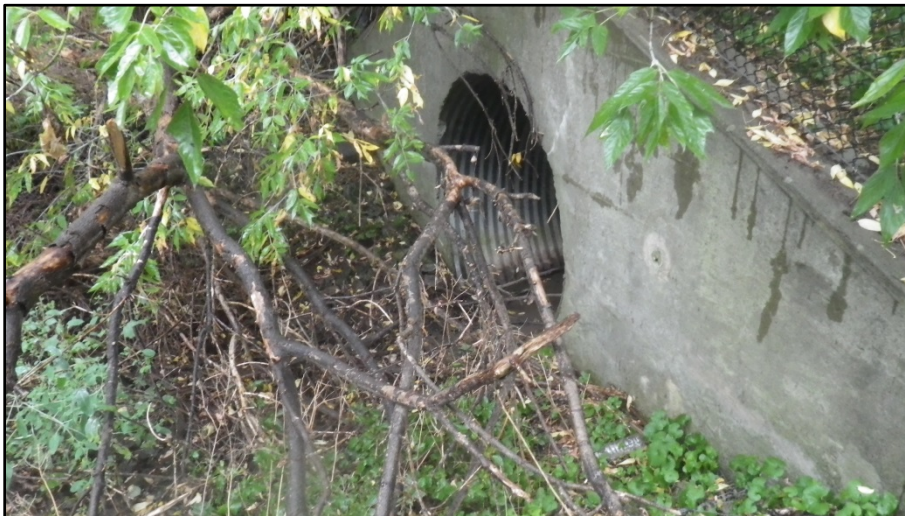
20. Unnamed Credit Trib at Ostrander Boulevard – outlet of culvert.

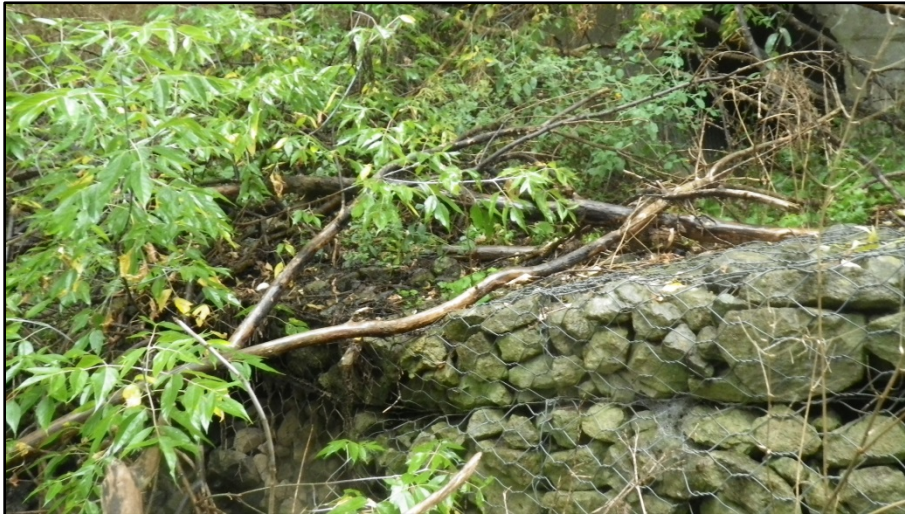
21. Unnamed Credit Trib at Ostrander Boulevard – channel is lined with gabion baskets and scour pad present.

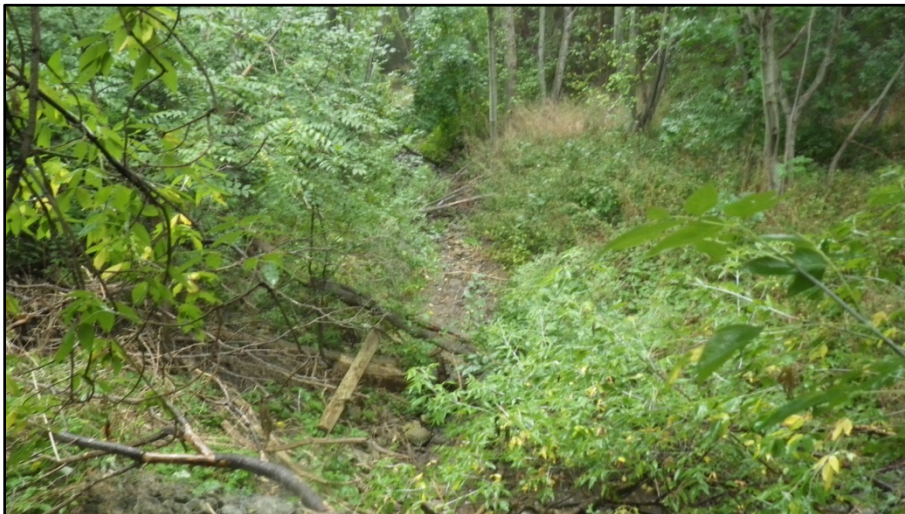
22. Unnamed Credit Trib at Ostrander Boulevard – dry channel downstream of culvert outlet.

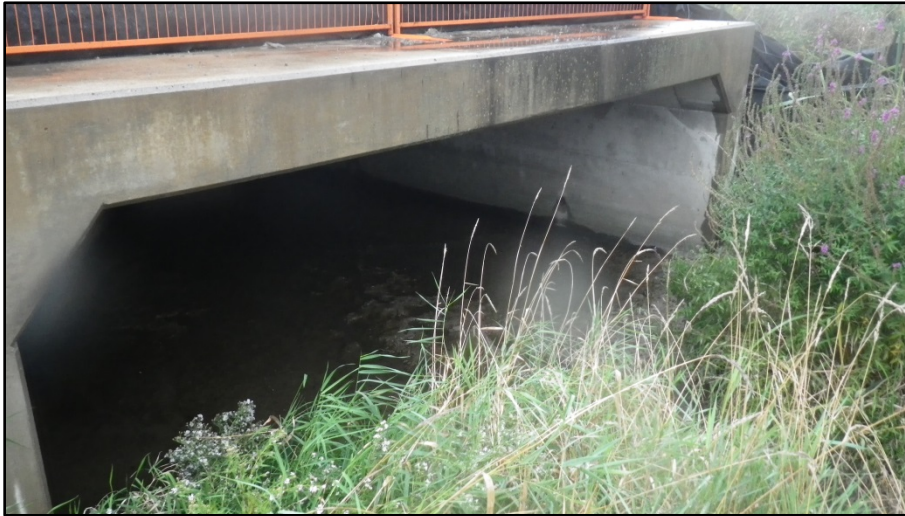
23. Huttonville Creek - box culvert outlet at Bovaird Drive W.

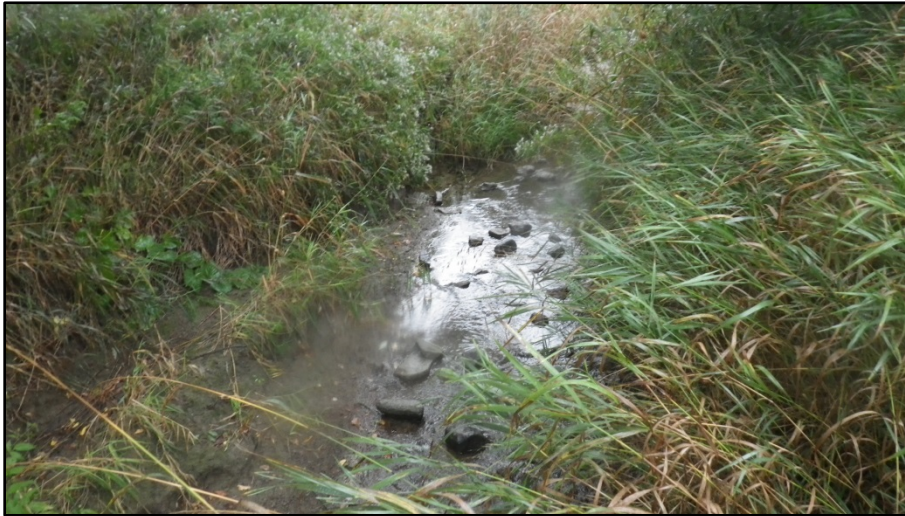
25. Huttonville Creek – sediment composed predominantly of gravels with some cobbles and pebbles and silt.

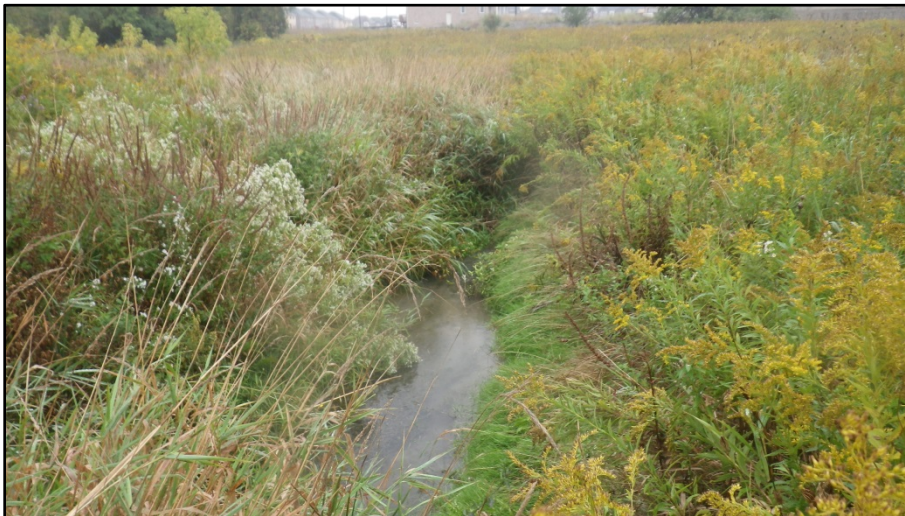
26. Huttonville Creek – wider section of channel with higher bank heights of approximately 0.6 m.

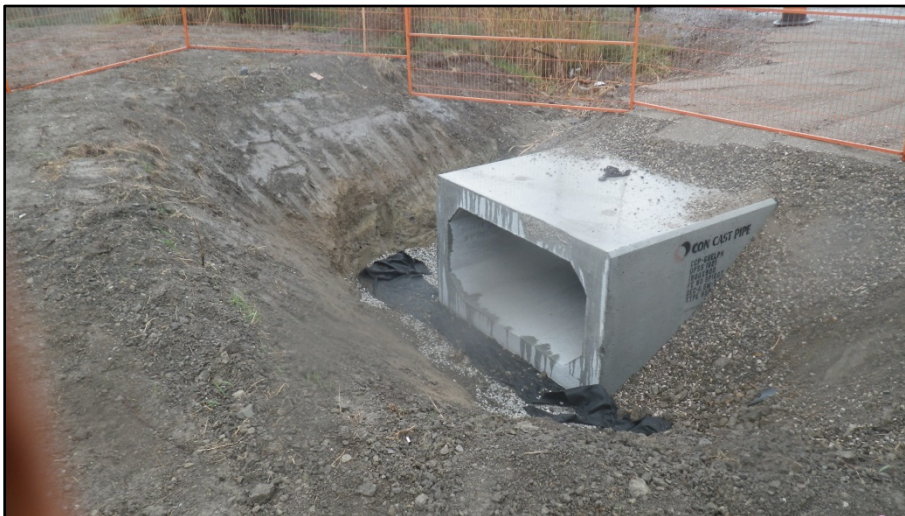
28. Huttonville Creek unnamed tributary – box culvert under construction at the time of field investigations.
