**DATE** September 23, 2019**PROJECT No.** 1664178**TO** Jaime Garcia (CIMA+)**CC** Sandra McGaghran (Golder)**FROM** Andrew Forbes and Justin Lim**EMAIL** aforbes@golder.com**FLUVIAL GEOMORPHIC ASSESSMENT IN SUPPORT OF THE SCHEDULE B MUNICIPAL CLASS ENVIRONMENTAL ASSESSMENT, ALBION VAUGHAN ROAD AND KING STREET EAST, TOWN OF CALEDON, ONTARIO**

**1.0 INTRODUCTION**

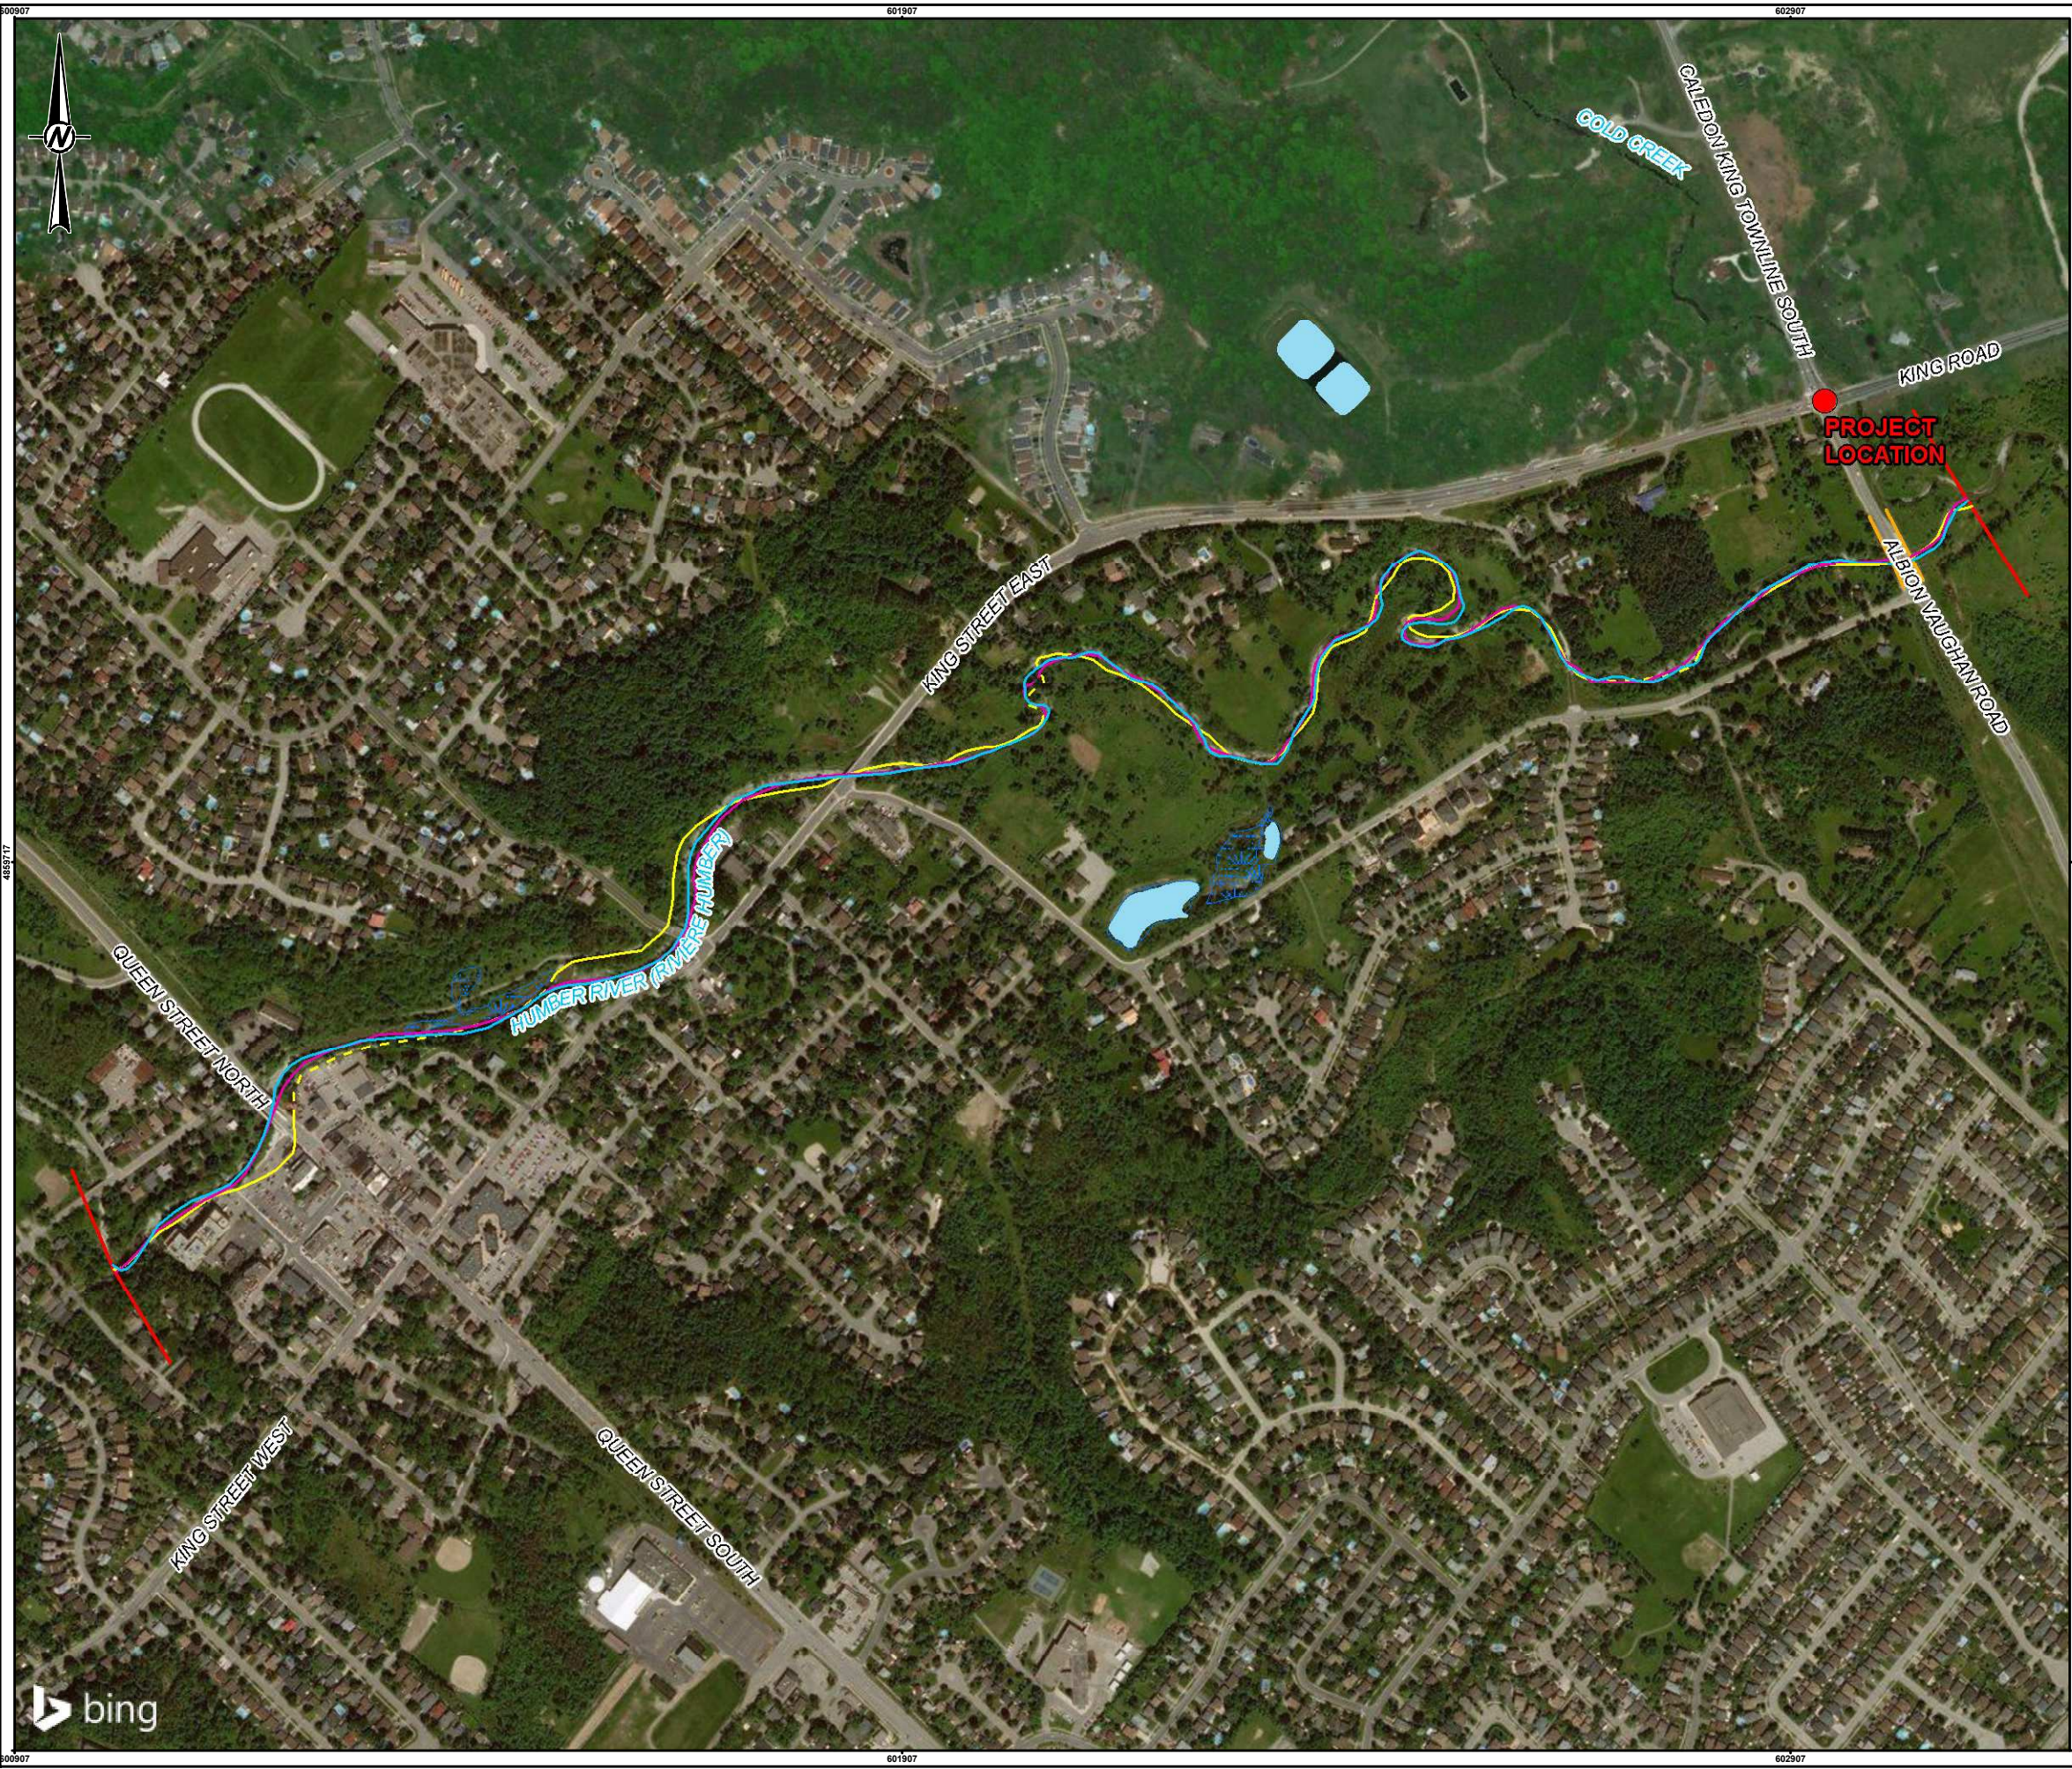
A historical air photograph analysis was completed in support of the meander belt assessment, and relied on aerial photography and orthoimagery from 1951, 1981, and 2016. These photographs were used to evaluate changes in channel patterns and surrounding land use over time for the reach lengths Cold Creek and the Main Humber River (CC-01 and HR-01). The results of the historical air photograph analysis are illustrated on Figures 2 and 3, and described below.

The results of the historical air photo analysis demonstrated that channel patterns at CC-01 in the area upstream of the King Street East crossing have been characterized by low to moderate sinuosity for the duration of the air photo record, noting that the channel has included only minor adjustments over time (e.g., downstream shift/migration of the channel in a few locations). In comparison, the channel pattern downstream of the King Street East crossing was shown to be characterized by a prominent meander pattern. As described in Section 3.1, the channel at this location follows a broad sweeping shape (along a north-south axis – trending first toward the east and then to the west) for a full meander length before it joins the Main Humber River. A review of the historical air photos shows that the meander pattern downstream of the King Street East crossing has included marked examples of lateral and downstream migration over time. The outer meander bend on the eastern side of the valley has exhibited lateral migration toward the valley wall, especially prominent between 1951 and 1981, while the outer meander bend on the western side of valley has displayed downstream migration and rotation toward the Main Humber River (and, to a lesser extent, lateral migration toward Albion Vaughan Road). These observed patterns of channel migration are likely indicative of the location of the meander bends relative to the valley and local infrastructure, recognizing that the outer meander bend on the eastern side of the valley is largely unconfined (i.e., no visible constraint to adjust laterally), while the outer meander bend on the western side of the valley is located within 5 m of Albion Vaughan Road (i.e., potential constraint to lateral migration).

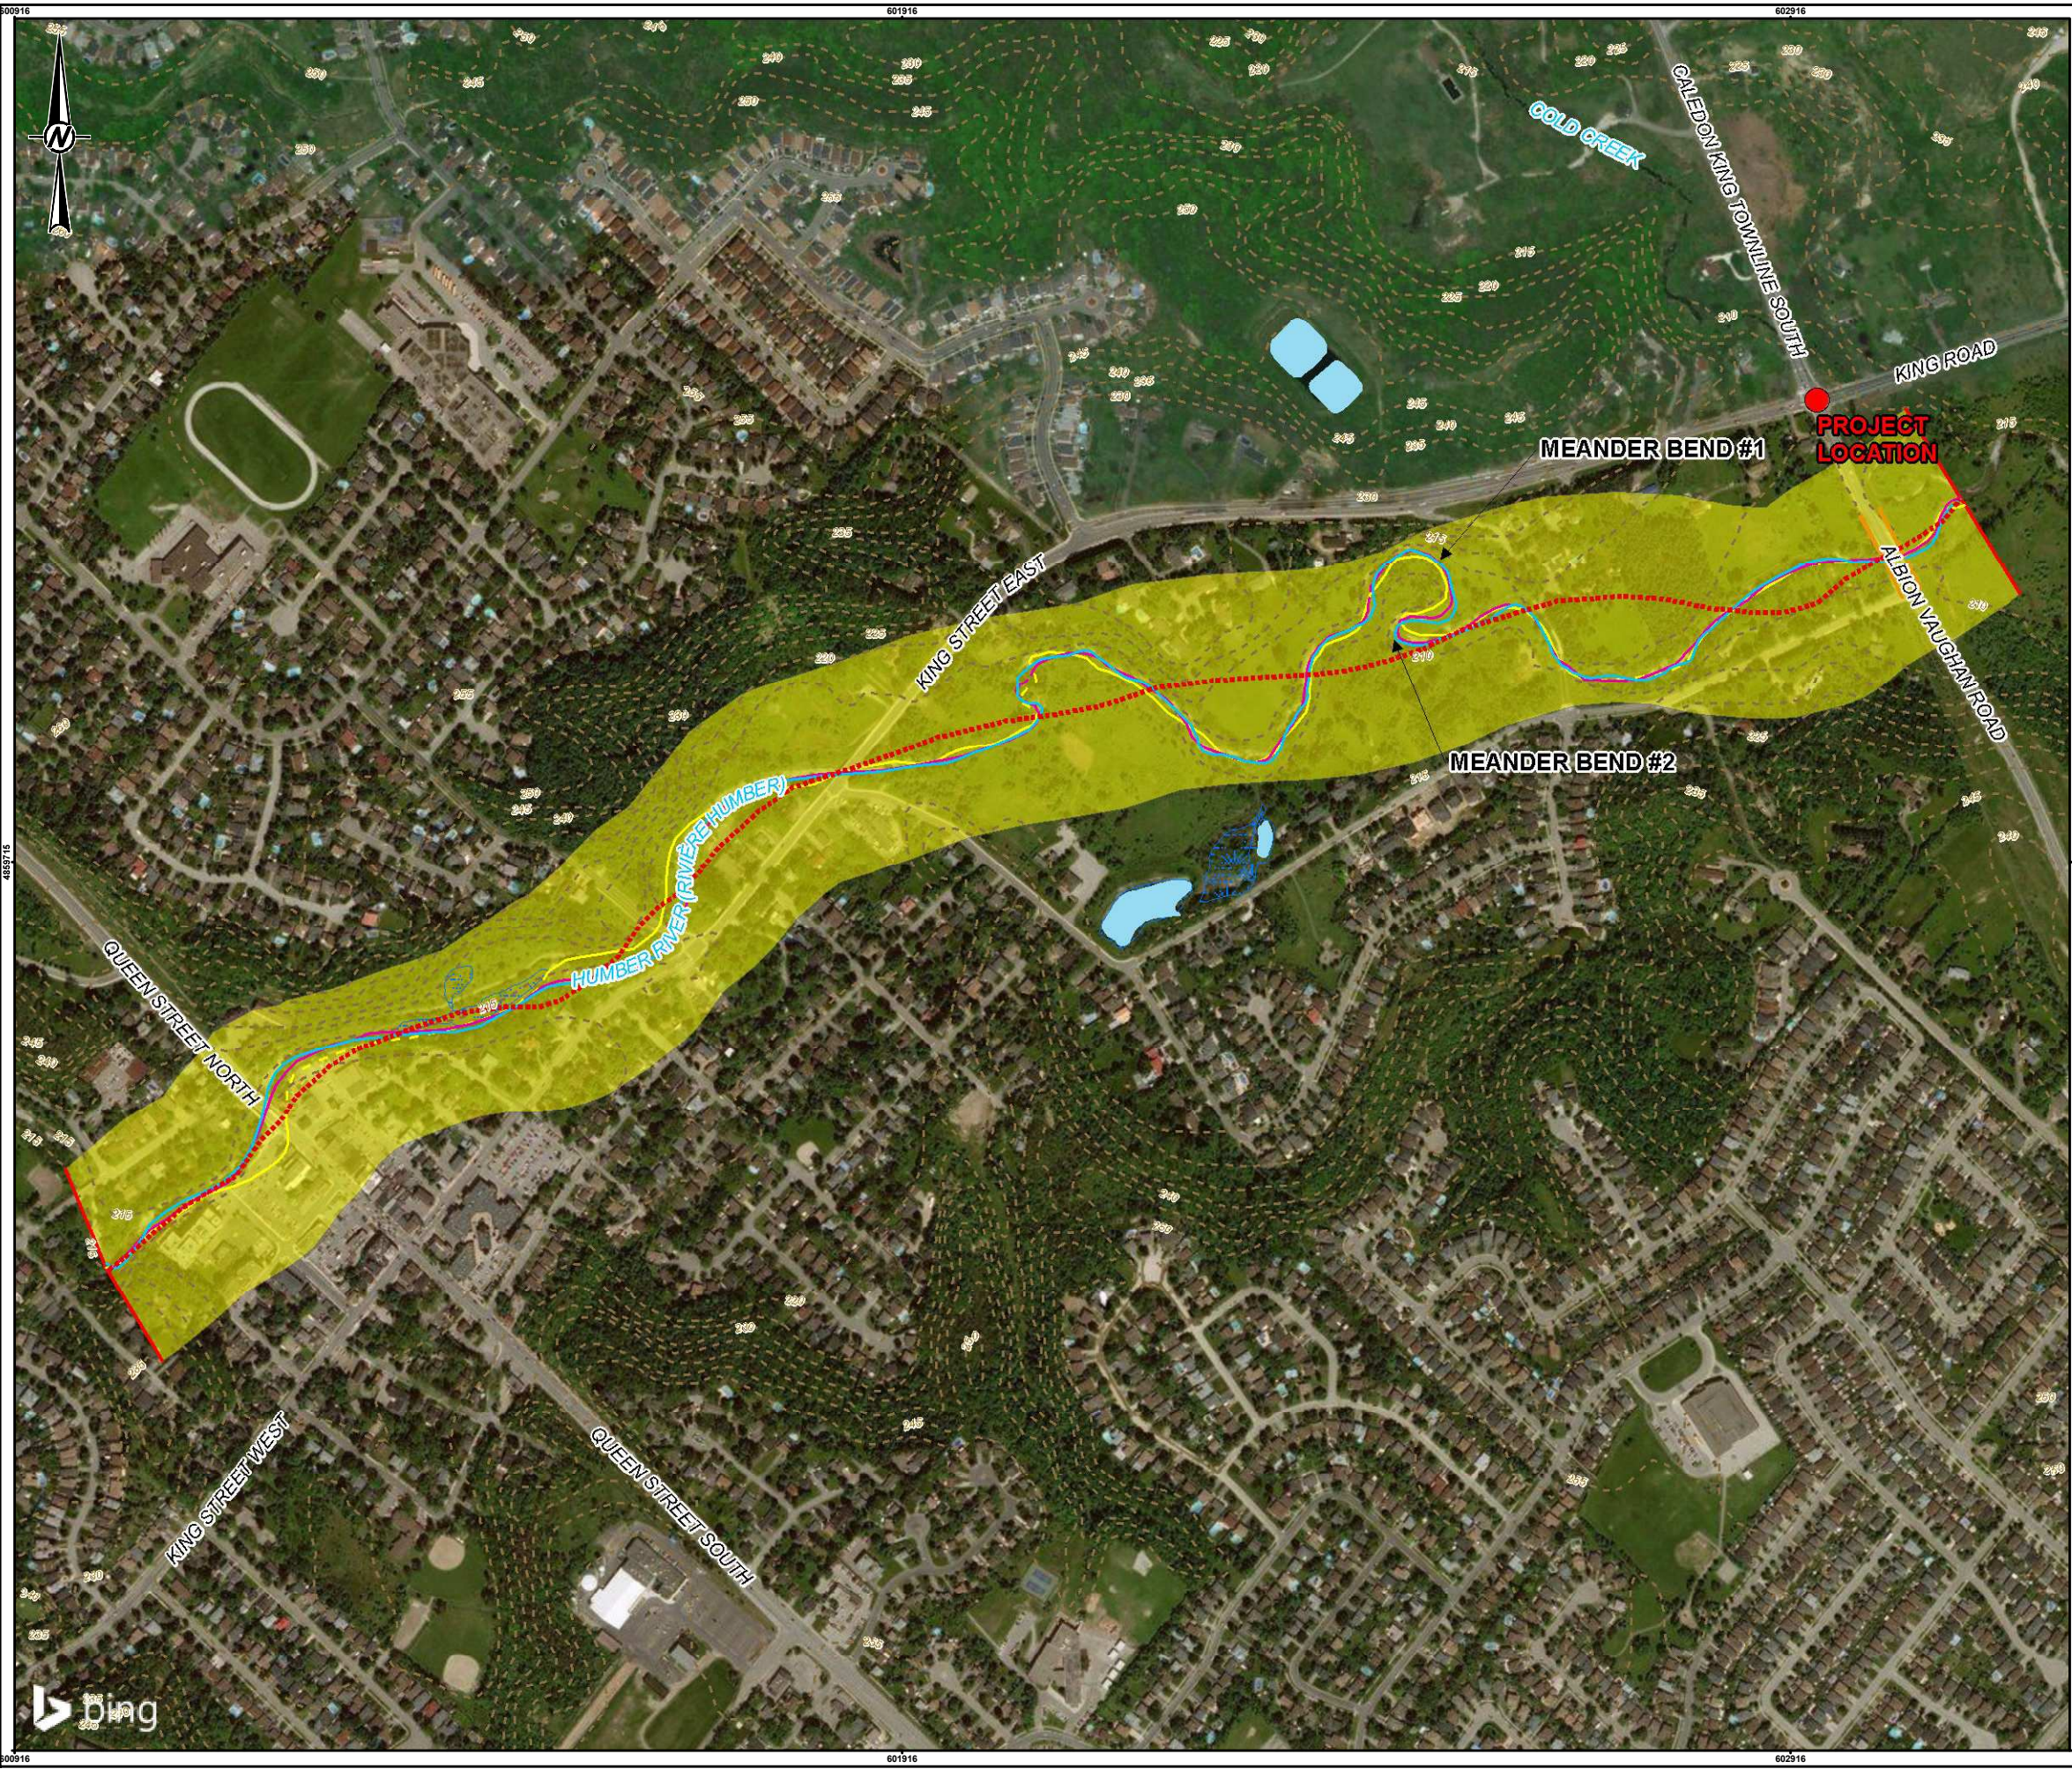
The meander belt width estimates at Cold Creek (CC-01) and Humber River (HR-01) are illustrated on Figures 4 and 5, respectively, recognizing that the assessment assumed no major long term changes in the hydrologic regime (i.e., flow duration and frequency). A summary of the meander belt width estimates is provided below.

- A preliminary meander belt width was measured to be approximately 110 m. This estimate of the preliminary belt width considered the following:
  - The meander pattern at the study reach was observed to be largely confined by valley walls along both sides of the planform. As such and in accordance with TRCA guidelines, the meander belt width was aligned with the average distance between the top and bottom of the valley walls for the full extent of the study reach. The available topographic data was used to infer the top of valley wall along both sides of the planform (estimated to be at an average elevation of roughly 210 to 215 m asl), recognizing that a detailed topographic survey should be completed to refine this estimate.

- The existing meander belt width was estimated to be approximately 122 m. The calculation of the existing belt width combines the preliminary meander belt width with the average bankfull width of the channel (12 m), as estimated in the field (e.g., 110 m + 12 m = 122 m).

- A final meander belt width was estimated to be approximately 134 m. This final belt width combines the estimated existing belt width with a safety factor of 1.1 in order to account for anticipated local changes in upstream hydrology and potential channel movement.

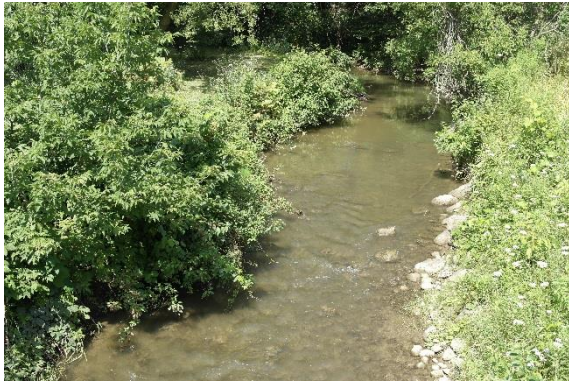
*Photograph 1: Cold Creek (CC-01) at Albion Vaughan Road crossing; looking upstream from the bridge at Albion Vaughan Road.*

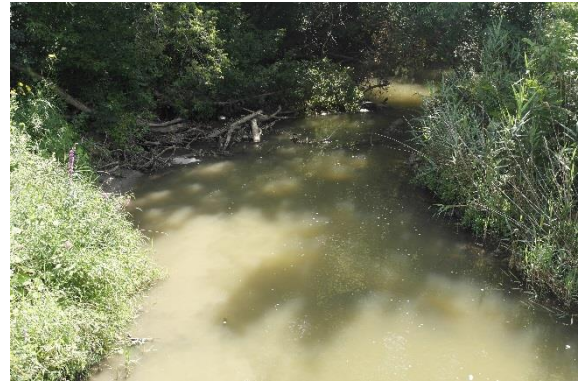
*Photograph 2: Cold Creek (CC-01) at Albion Vaughan Road crossing; looking downstream from the bridge at Albion Vaughan Road.*

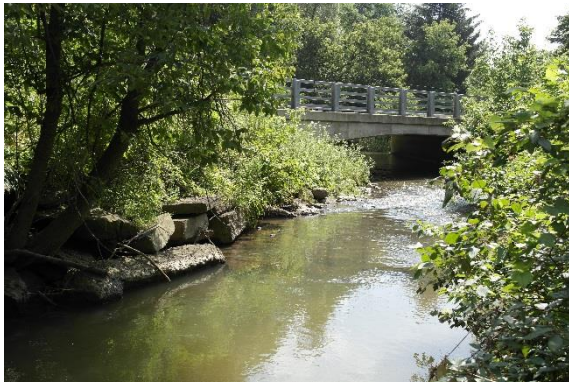
*Photograph 3: Cold Creek (CC-01) 25 m upstream from Albion Vaughan Road crossing; looking downstream at the bridge at Albion Vaughan Road.*

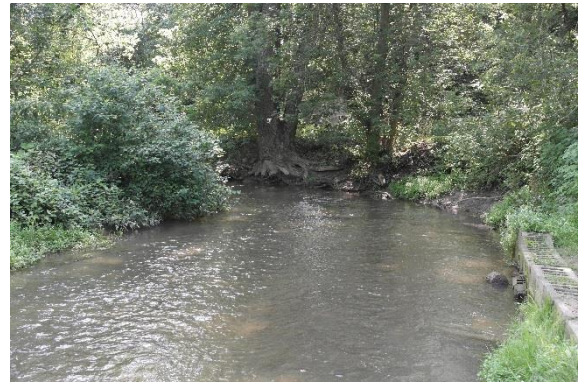
*Photograph 4: Cold Creek (CC-01) 75 m upstream from Albion Vaughan Road crossing; looking downstream.*

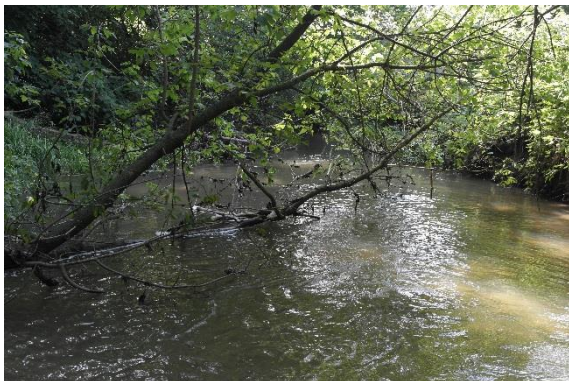
*Photograph 5: Cold Creek (CC-01) 25 m downstream from Albion Vaughan Road crossing; looking downstream.*

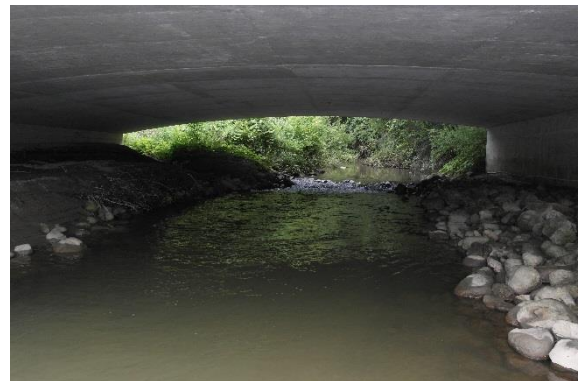
*Photograph 6: Cold Creek (CC-01) at King Street East crossing; looking upstream.*

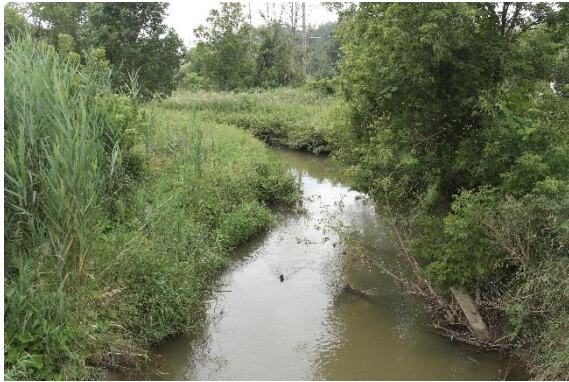
*Photograph 7: Cold Creek (CC-01) at King Street East crossing; looking downstream from the bridge at King Street East.*

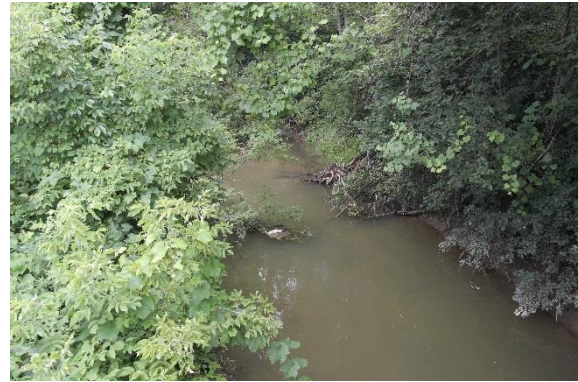
*Photograph 8: Cold Creek (CC-01) at King Street East crossing; looking upstream from the bridge at King Street East.*

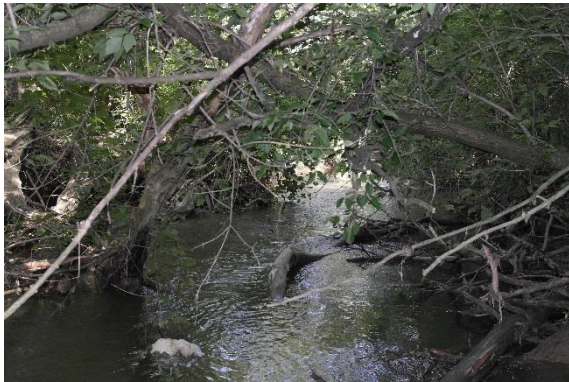
*Photograph 9: Cold Creek (CC-01) 25 m upstream from King Street East crossing; looking upstream.*

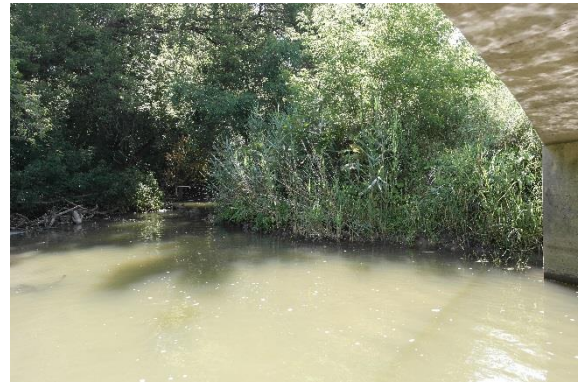
*Photograph 10: Cold Creek (CC-01) 75 m upstream from King Street East crossing (at the location of the Albion Vaughan Road crossing); looking downstream.*

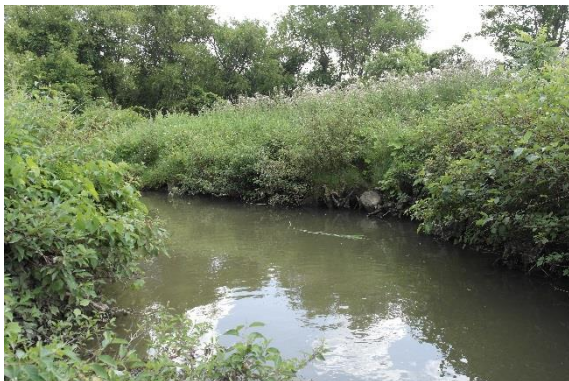
*Photograph 11: Cold Creek (CC-01) 25 m downstream from King Street East crossing; looking downstream.*

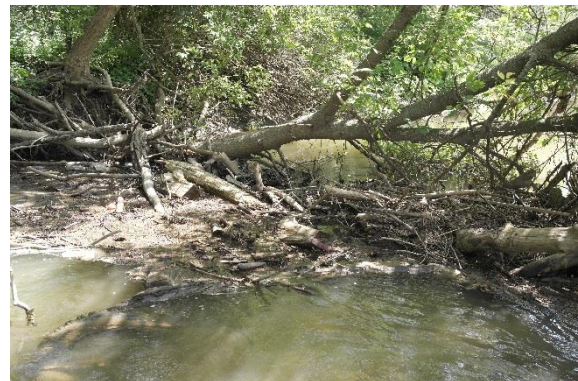
*Photograph 12: Cold Creek (CC-01) 75 m downstream from King Street East crossing; looking downstream at the outer meander bend on the eastern side of the valley.*

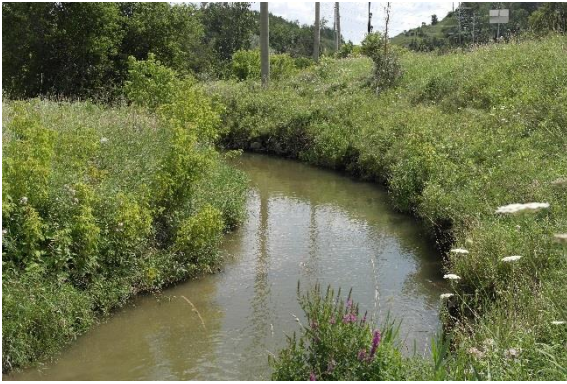
*Photograph 13: Cold Creek (CC-01) approx. 125 m downstream from King Street East crossing; looking downstream at the outer meander bend on the western side of the valley.*

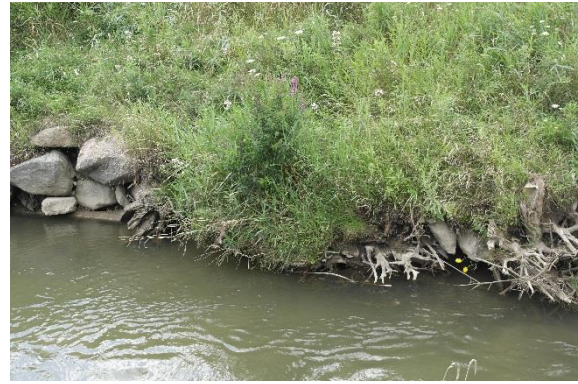
*Photograph 14: Cold Creek (CC-01) approx. 150 m downstream from King Street East crossing; looking downstream at left bank of the outer meander bend on the western side of the valley.*

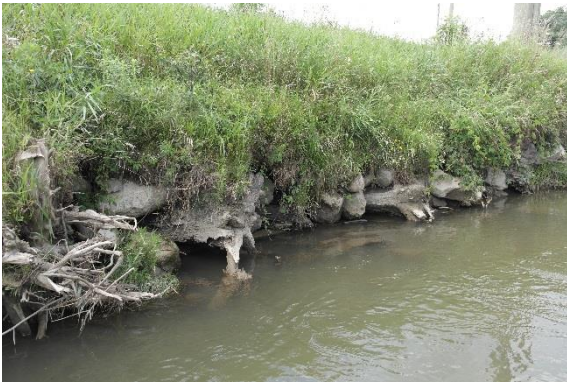
*Photograph 15: Cold Creek (CC-01) approx. 150 m downstream from King Street East crossing; looking downstream at right bank of the outer meander bend on the western side of the valley.*

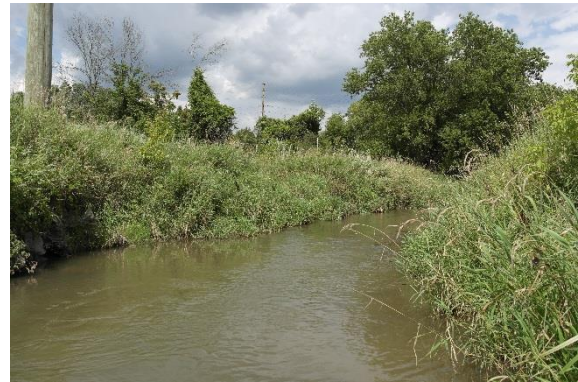
*Photograph 16: Cold Creek (CC-01) approx. 150 m downstream from King Street East crossing; looking upstream at the outer meander bend on the western side of the valley.*

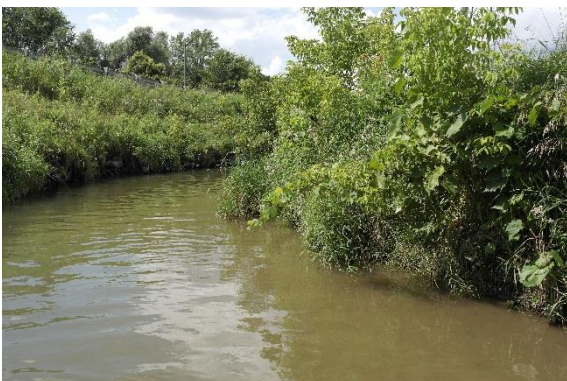
*Photograph 17: Cold Creek (CC-01) approx. 175 m downstream from King Street East crossing; looking upstream at the outer meander bend on the western side of the valley.*

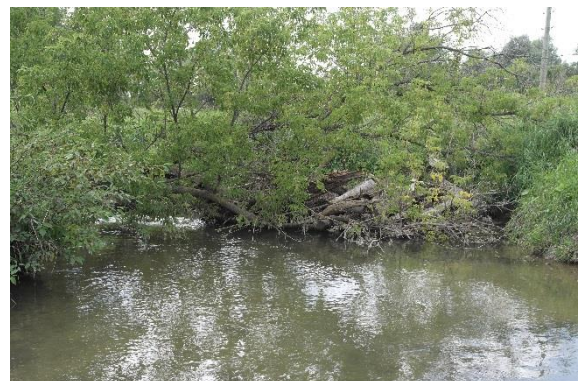
*Photograph 18: Cold Creek (CC-01) approx. 225 m downstream from King Street East crossing; looking upstream at debris jam.*

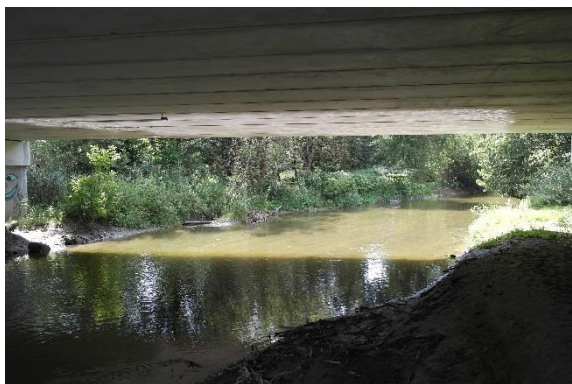
Photograph 19: **Humber River (HR-01) at Albion Vaughan Road crossing**; looking upstream from under the bridge at Albion Vaughan Road.

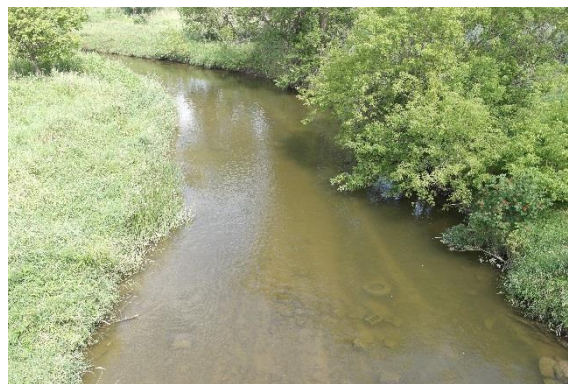
Photograph 20: **Humber River (HR-01) at Albion Vaughan Road crossing**; looking upstream from the bridge at Albion Vaughan Road.

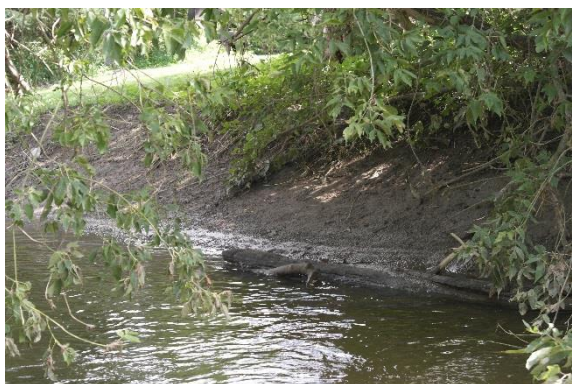
Photograph 21: **Humber River (HR-01) 25 m upstream from Albion Vaughan Road crossing**; looking downstream at right bank.

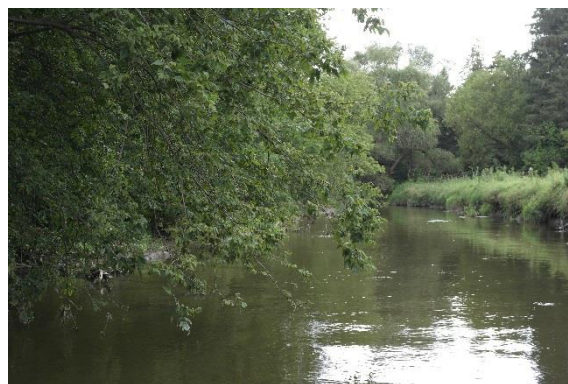
Photograph 22: **Humber River (HR-01) 75 m upstream from Albion Vaughan Road crossing**; looking upstream.

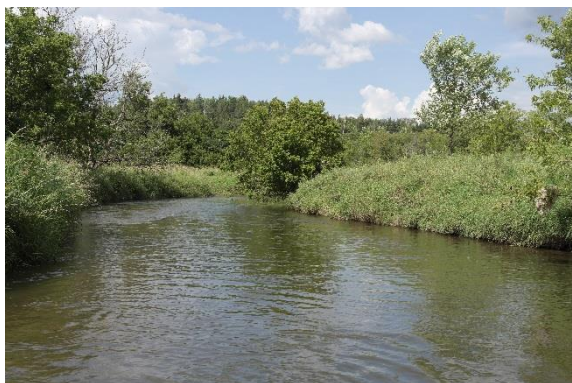
Photograph 23: **Humber River (HR-01) 25 m downstream from Albion Vaughan Road crossing**; looking downstream.

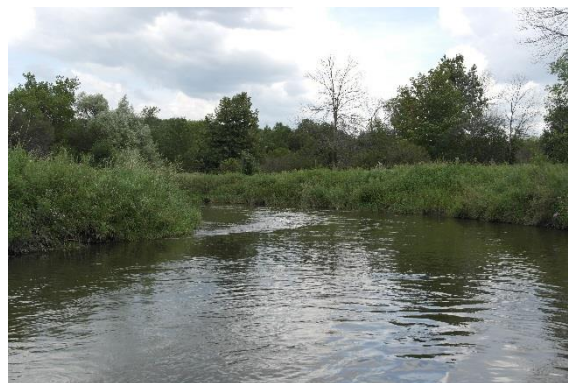
Photograph 24: **Humber River (HR-01) 75 m downstream from Albion Vaughan Road crossing**; looking downstream.
