**ENVIRONMENTAL ASSESSMENT STUDY OF ARTERIAL ROADS WITHIN  
HIGHWAY 427 INDUSTRIAL SECONDARY PLAN AREA (AREA 47) – PART A  
CITY OF BRAMPTON  
FLUVIAL GEOMORPHIC COMPONENT**

Prepared for:  
**WOOD ENVIRONMENT & INFRASTRUCTURE SOLUTIONS**

Prepared by:  
**MATRIX SOLUTIONS INC.**

Version 1.0  
May 2021  
Mississauga, Ontario

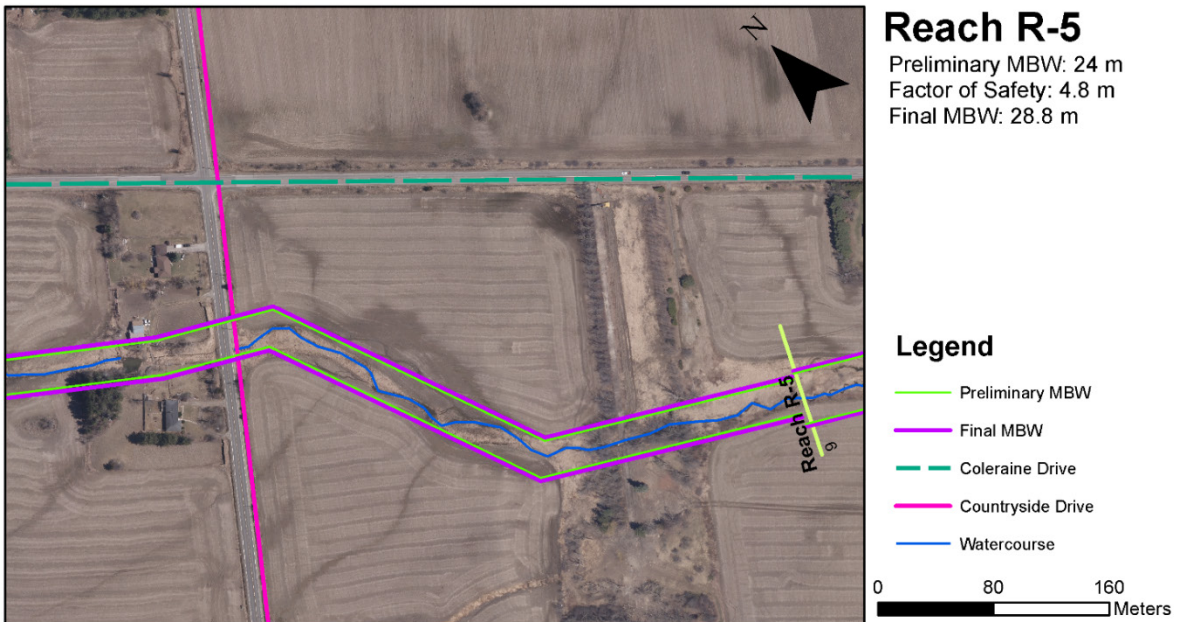
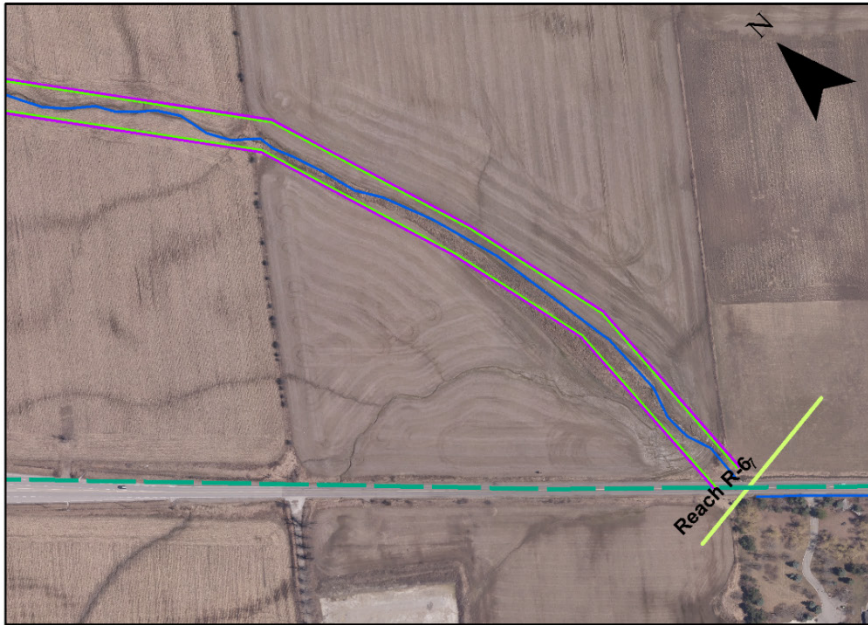
**Reach R-6**  
Preliminary MBW: 20 m  
Factor of Safety: 2 m  
Final MBW: 22 m

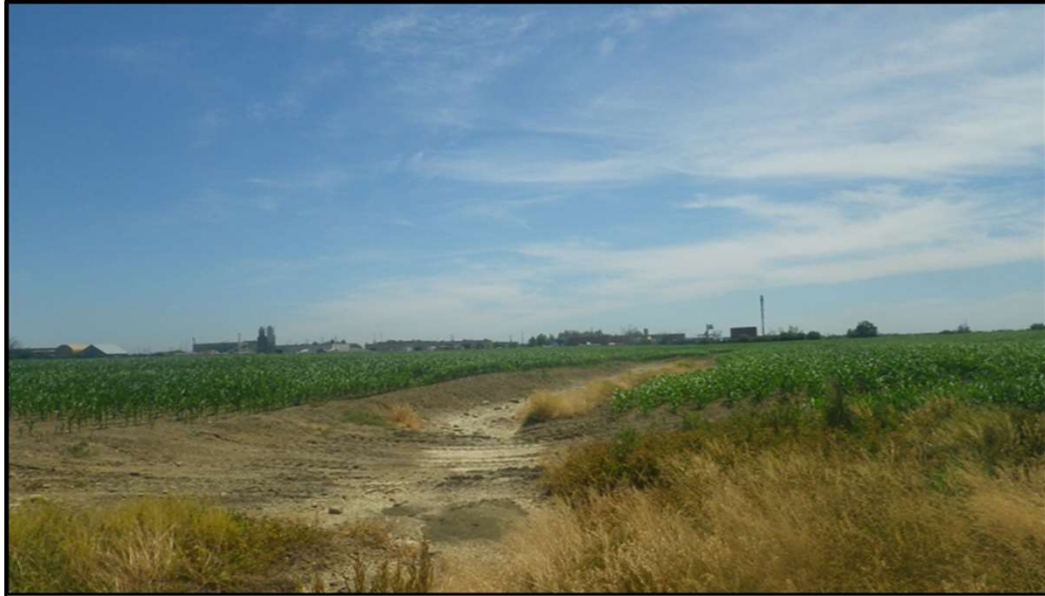
1. Reach R-4: topographic low within agricultural field appears seasonally ploughed by remains void of crops; distinct thalweg alternated between edges of the feature.

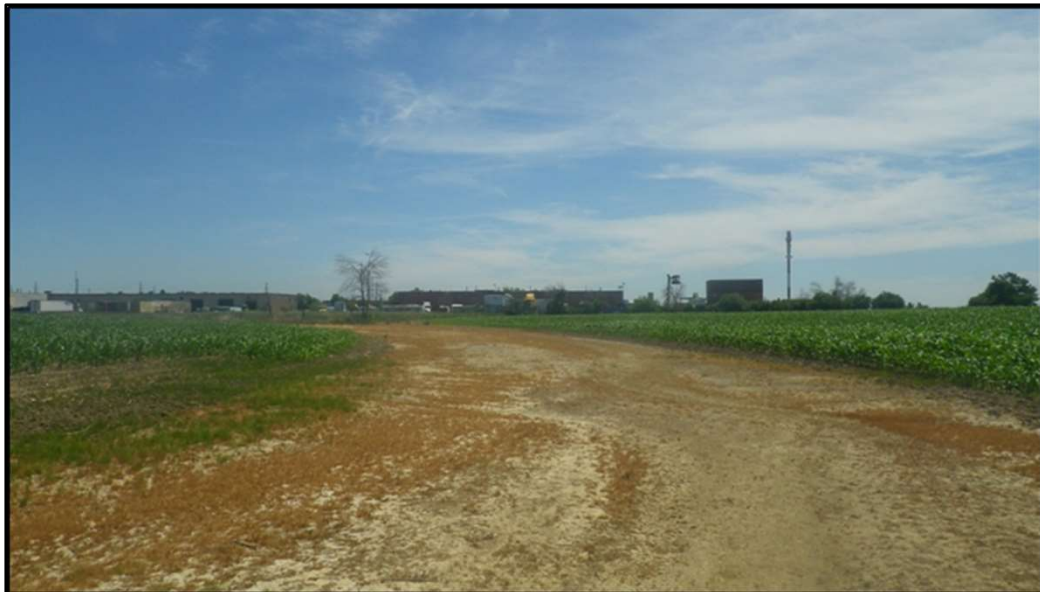
2. Reach R-4: downstream extent of the reach approaching industrial land use area.

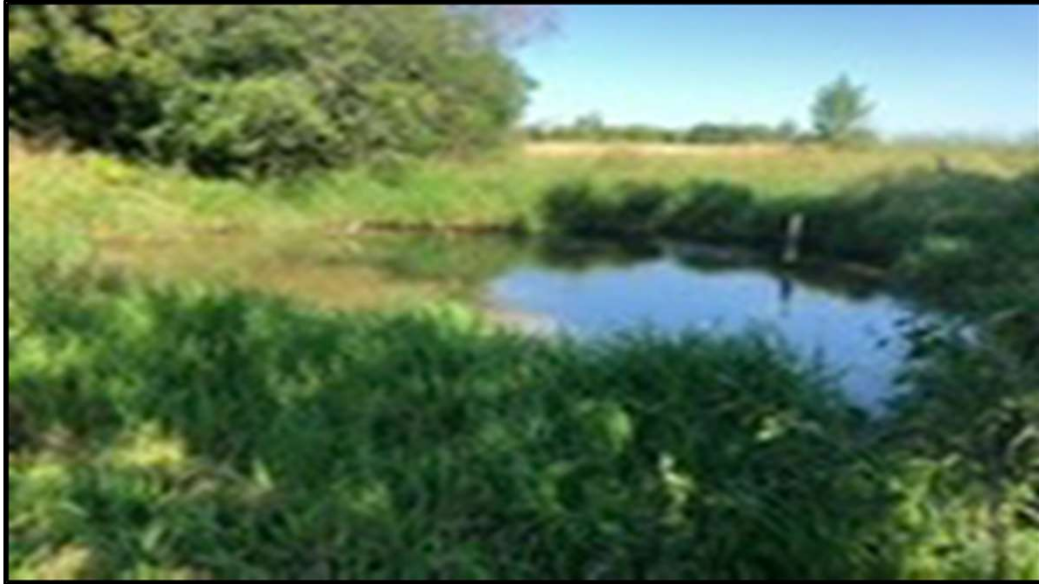
3. Reach R-5: online pond upstream from Countryside Drive; a low berm controls downstream flow.

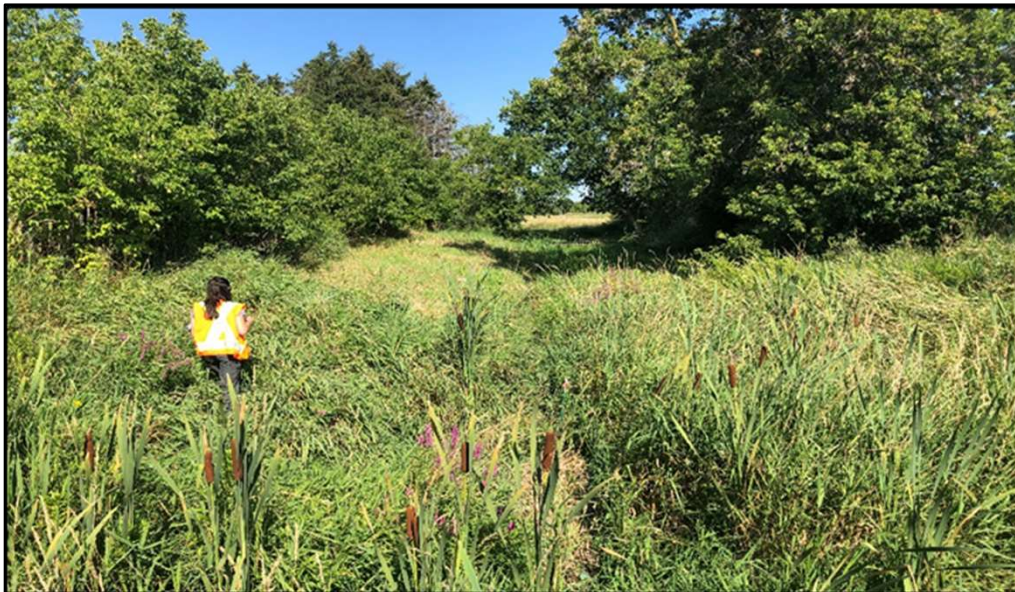
4. Reach R-5: planform view upstream of Countryside Drive crossing; channel is narrow and floodplain is well vegetated with long grasses and cattails.

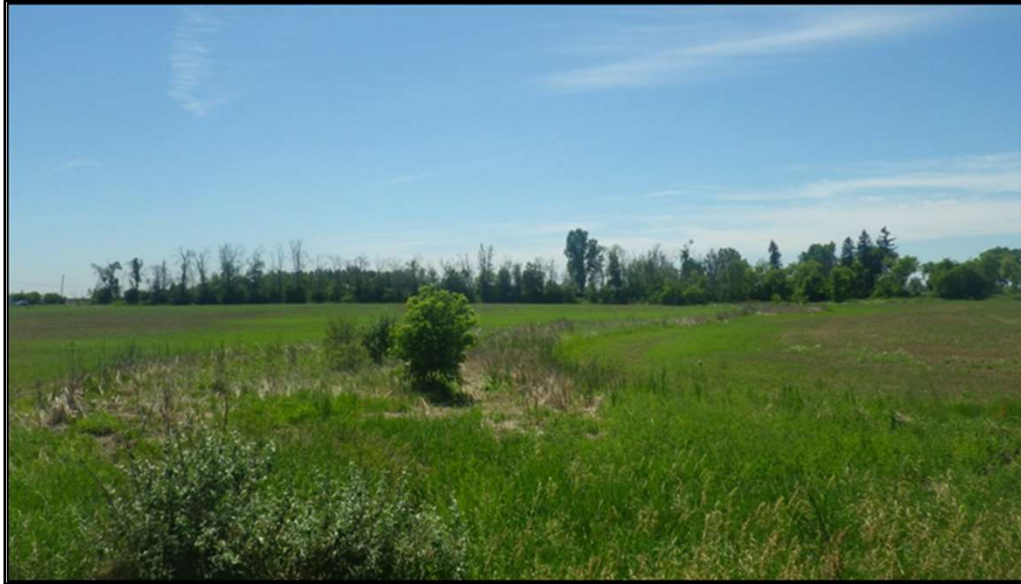
5. Reach R-5: looking downstream from Countryside Drive; channel flows between farm fields and is sinuous; overall channel banks and floodplain are well vegetated; standing water present at field visit.

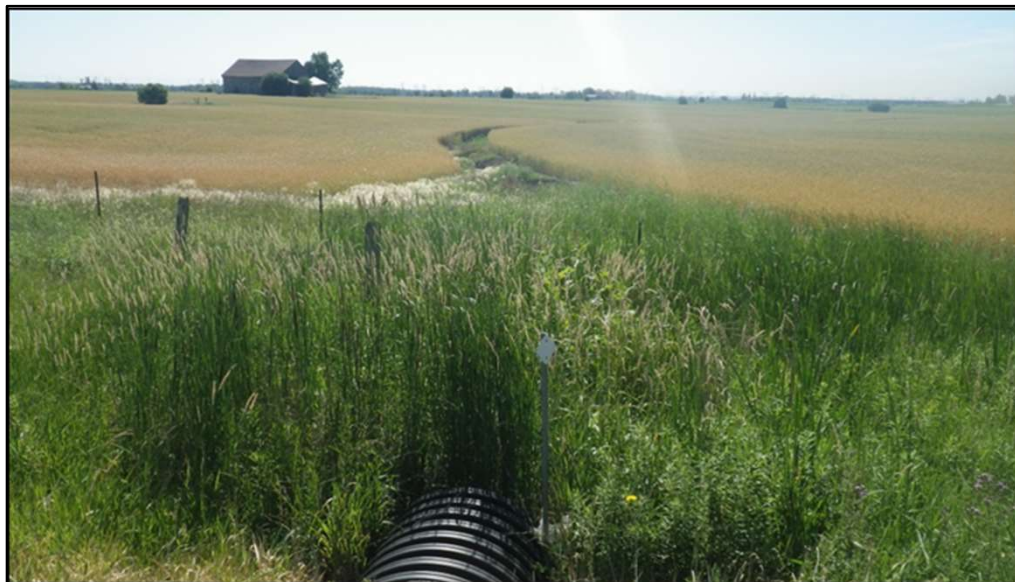
6. Reach R-6: looking downstream from Mayfield Road; feature is defined through topographic low in agricultural field; long grasses abundant along channel banks and bed.

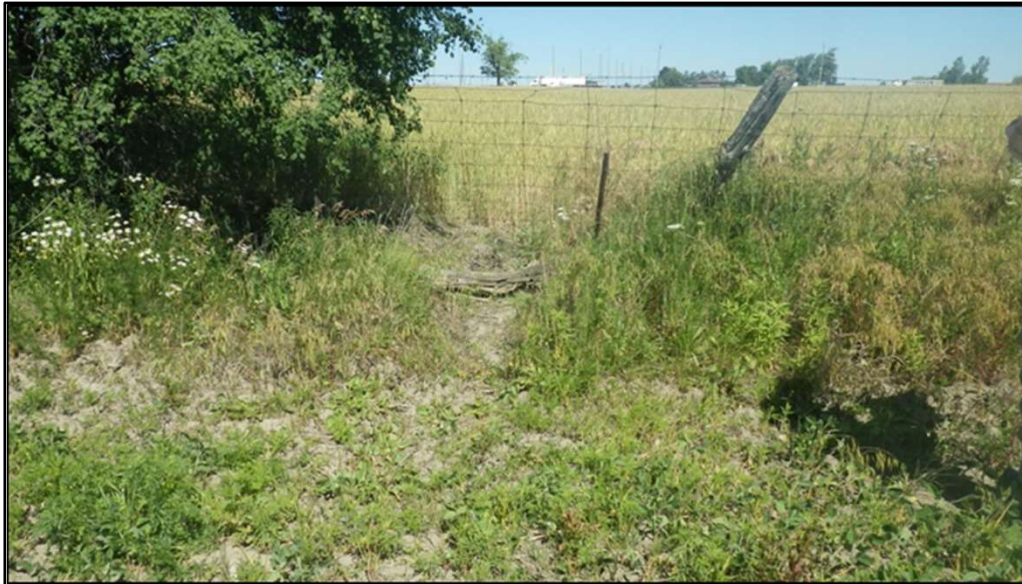
7. Reach R-6: feature crosses through hedge row between agricultural fields.

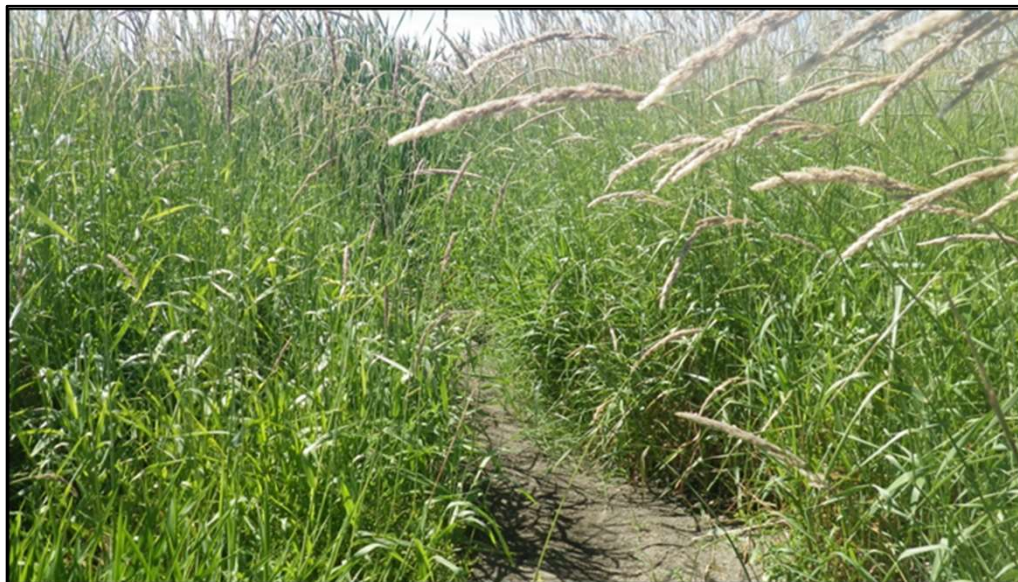
8. Reach R-6: feature enters zone of cattails and long grasses; multiple potential flow paths have developed.

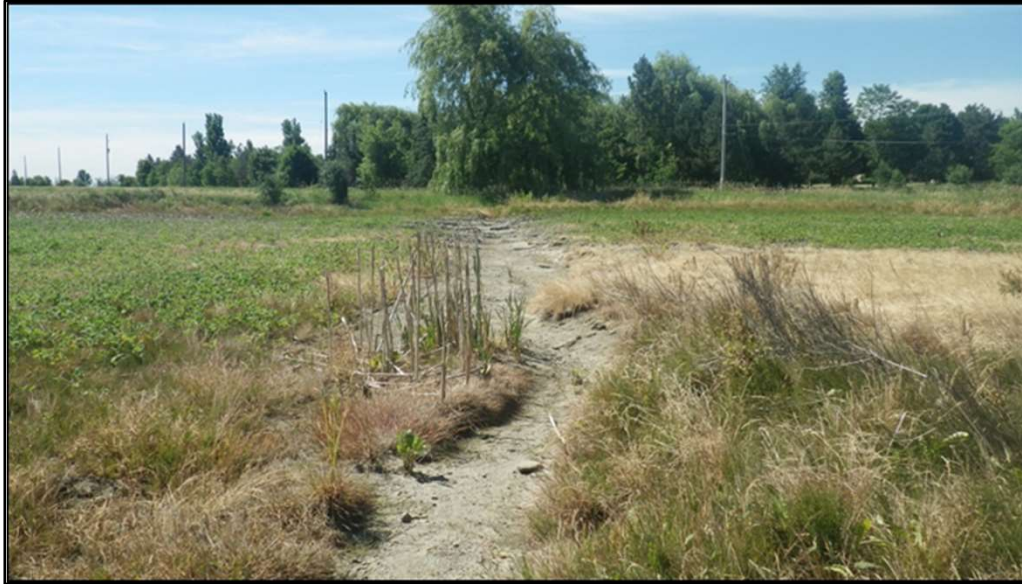
9. Reach R-6: view downstream toward Coleraine Road crossing; channel banks poorly defined.

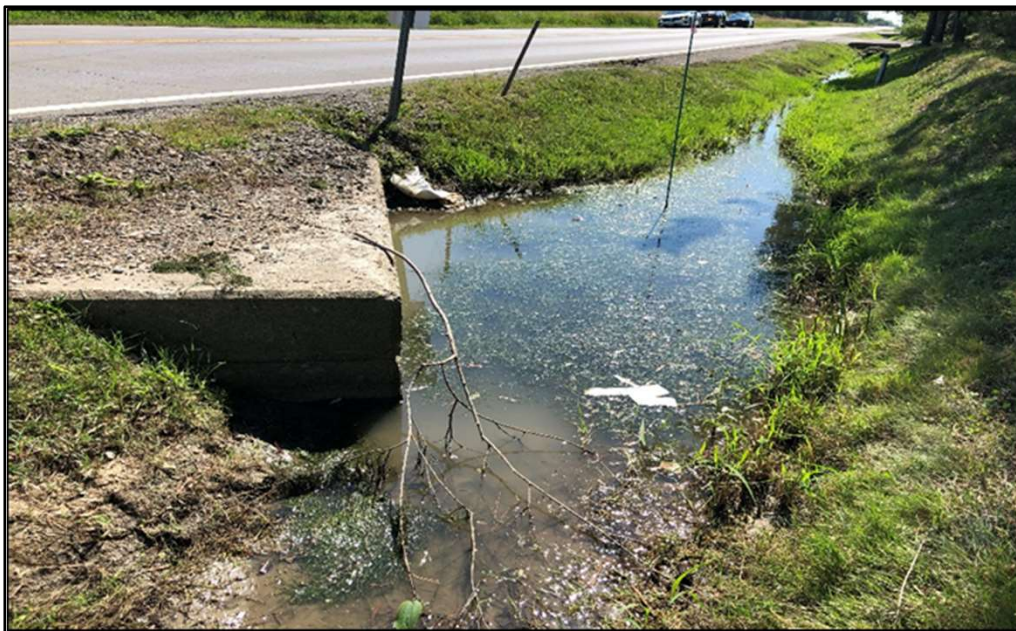
10. Reach R-6: Coleraine Drive culvert; extensive sedimentation and culvert backwatering along south side of Coleraine Drive.

During the field assessment, it was noted that the existing 3.0 m span concrete box culvert is undersized, and erosion is occurring against the road embankment upstream of the crossing. Due to the degrading nature of the culvert, it is recommended during road improvements that the culvert be replaced and more appropriately sized to accommodate channel processes. Based on an average bankfull width of 1.5 m, a crossing span with a minimum opening of 4.5 m, or three times the bankfull width, is recommended. A crossing span comparable to the upstream meander amplitude (10 m) was deemed not necessary as the channel is straight within the vicinity of the road crossing and there was no evidence of lateral migration to suggest this meander will migrate towards the crossing and place infrastructure at risk. Upstream of the crossing, the channel banks are less defined, and the channel is dry most of the year. Overall, the planform of the stream appears rather inactive and often gets infilled with vegetation upstream of the crossing as it is within the headwaters of the system. The proposed preferred crossing design (by Wood) consists of a 17 m wide, single-span bridge allowing for channel adjustment and wildlife passage. A span of 17 m is considered appropriate from a fluvial geomorphic perspective and is beyond our recommendation of a 4.5 m span. For further details regarding the justification for the 17 m bridge span, the reader is referred to the *Part A: Stormwater Drainage Assessment – Arterial Roads within Highway 427 Industrial Secondary Plan Area (Area 47)* (Wood 2020).
