C1. Natural Environmental Report

SITE REVIEW REPORT

Re: **Class Environmental Assessment Study for Dixie Road (Regional Road 4) from Mayfield Road Southerly to Queen Street, Brampton, Region of Peel Natural Environment Review**

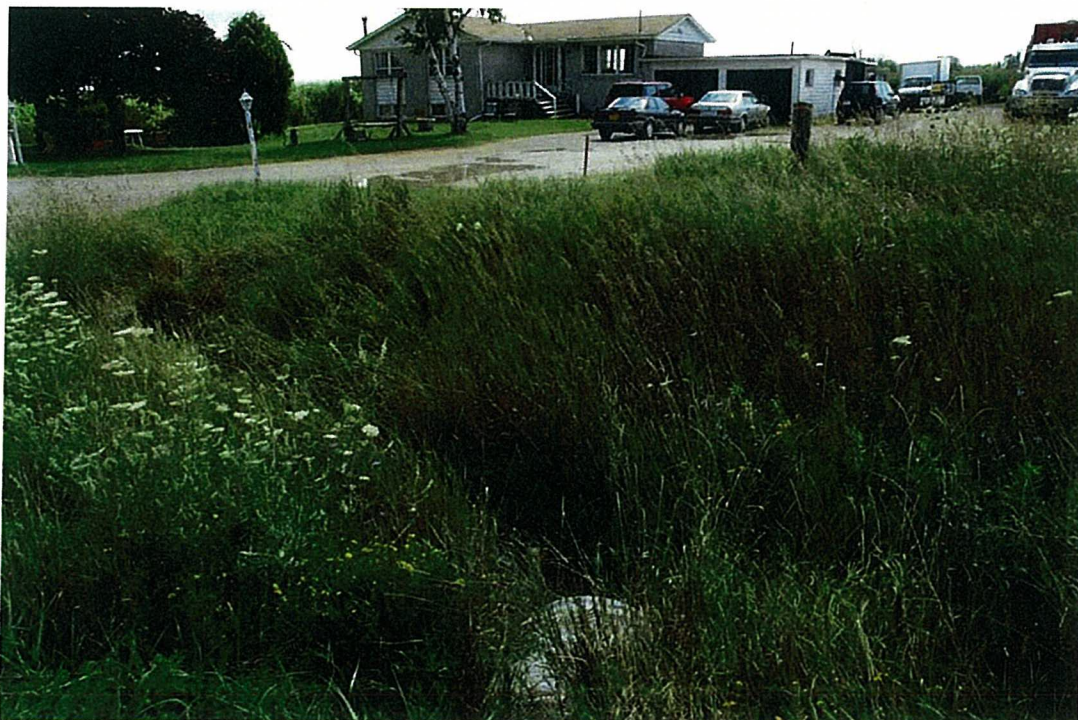
A 0.6 m diameter CSP crosses under Dixie Road south of Mayfield Road conveying a headwater tributary of Etobicoke Creek to the southeast

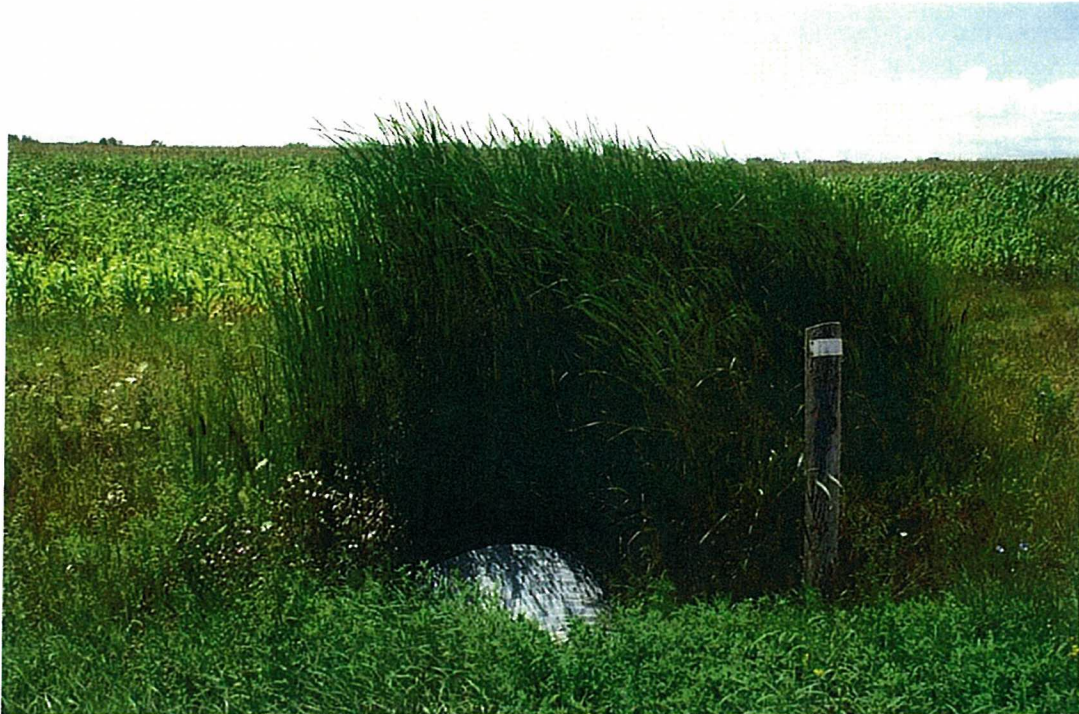
Another Etobicoke Creek tributary crosses Dixie Road north of Countryside Drive via a 1.8 m diameter CSP

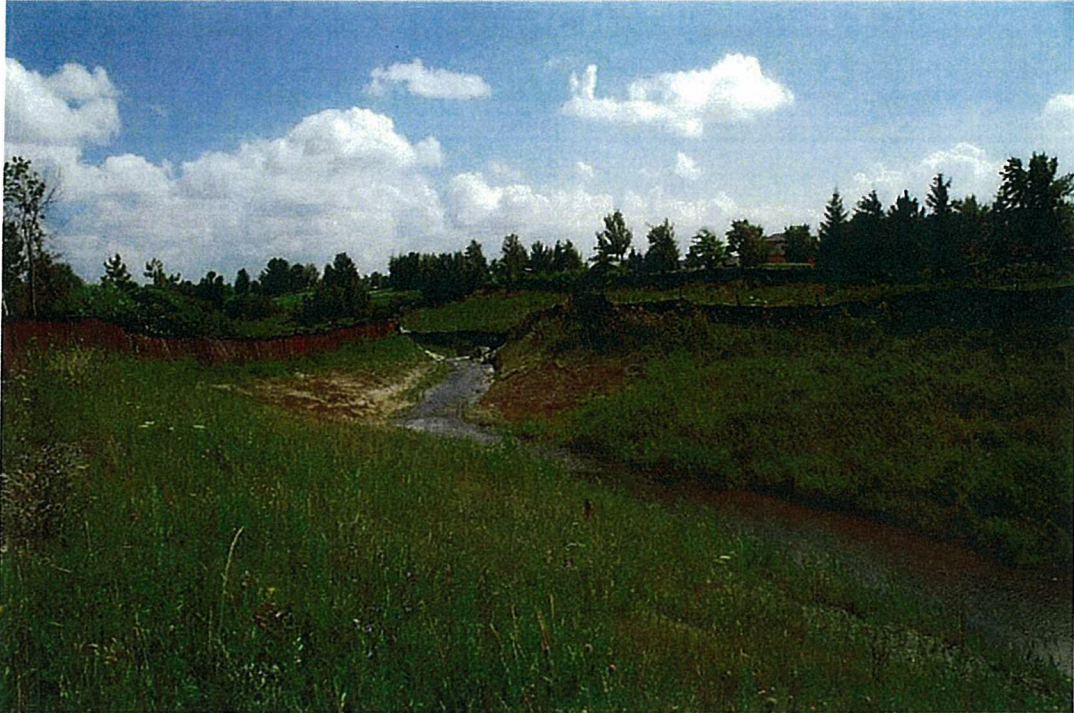
Another Etobicoke Creek tributary has been recently diverted south and west of Dixie Road

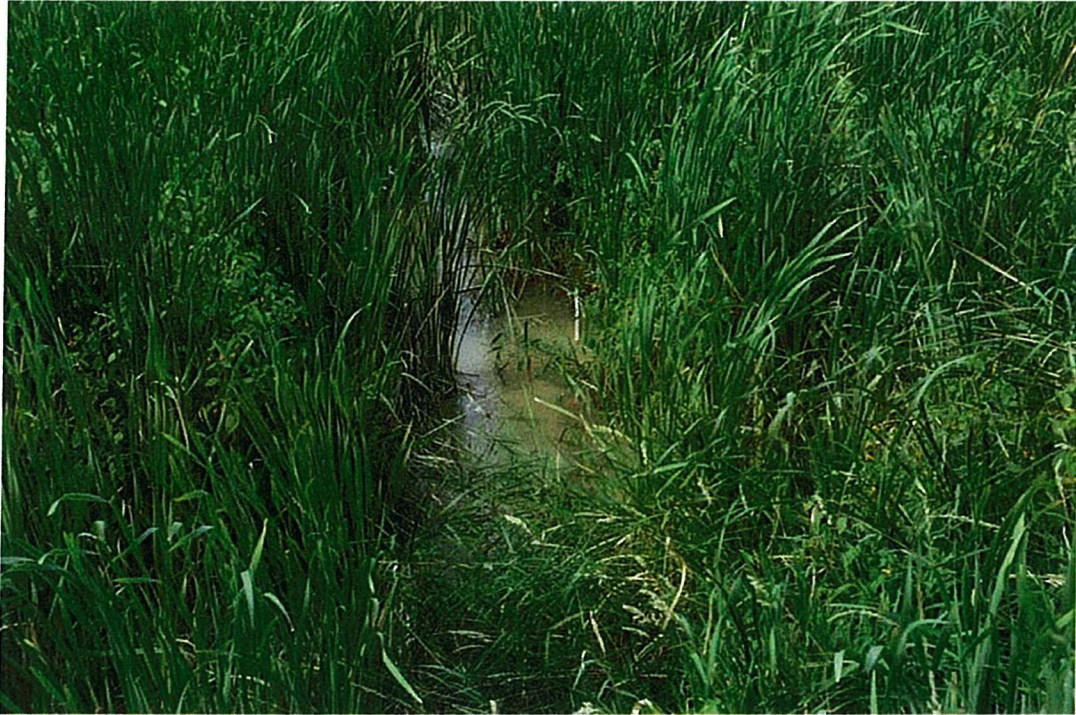
Sections of the channel are cattail filled while other areas are open.
The water was quite turbid/brown above the reservoir

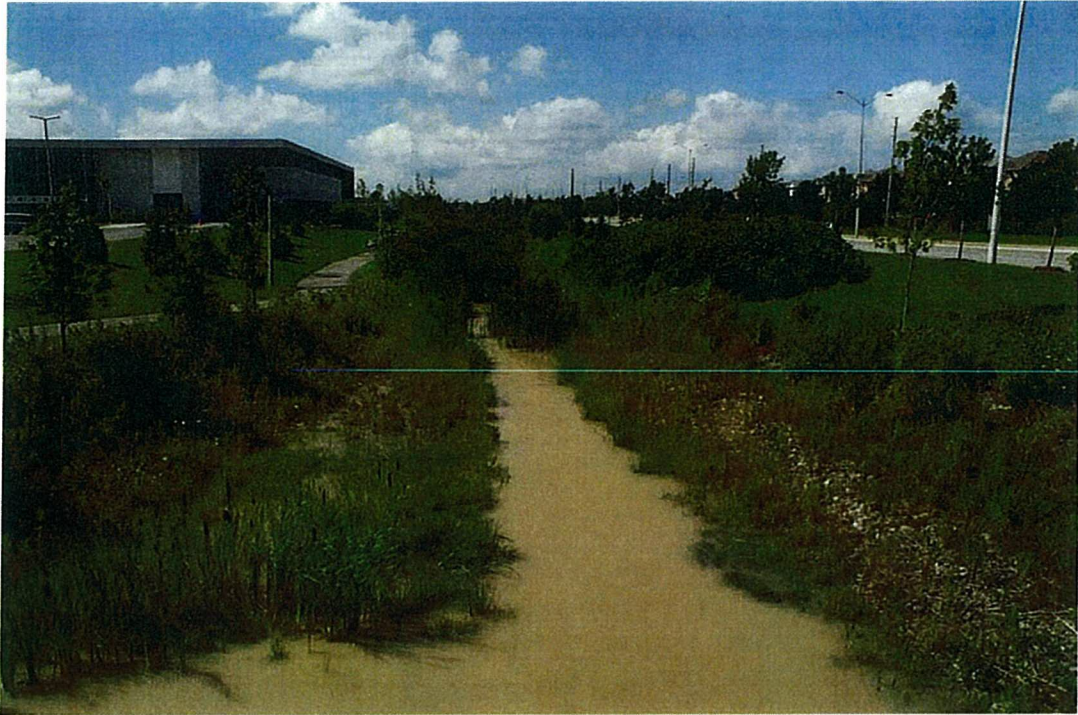
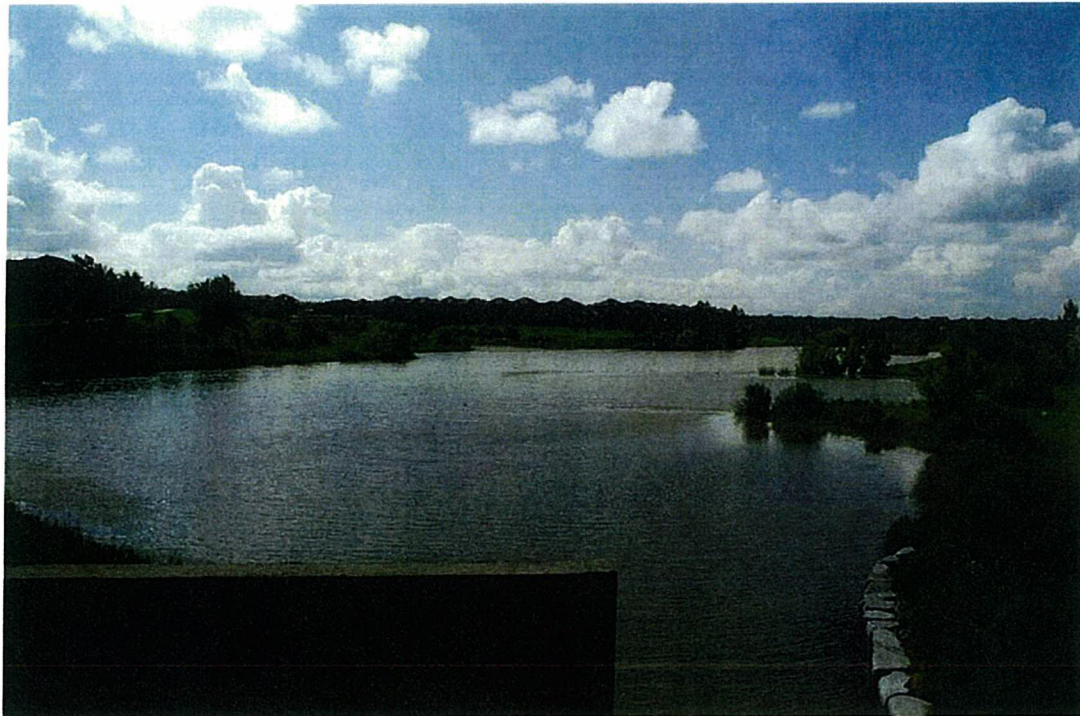
South of Sandalwood at the Soccer Centre the channel remains turbid (above) while it has cleared somewhat at the lower end of the reservoir at Bovaird Drive (below)

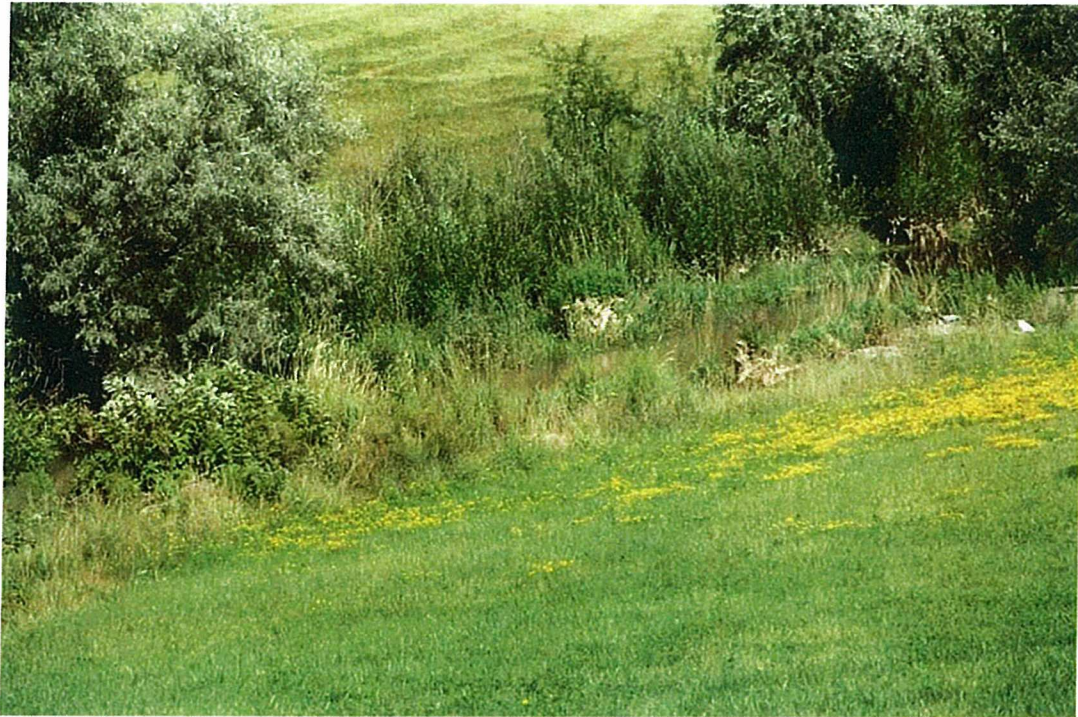
The watercourse enters more-or-less a natural channel through Manitou Park southeast of the Bovaird/Dixie Road intersection. Water colour remains murky.

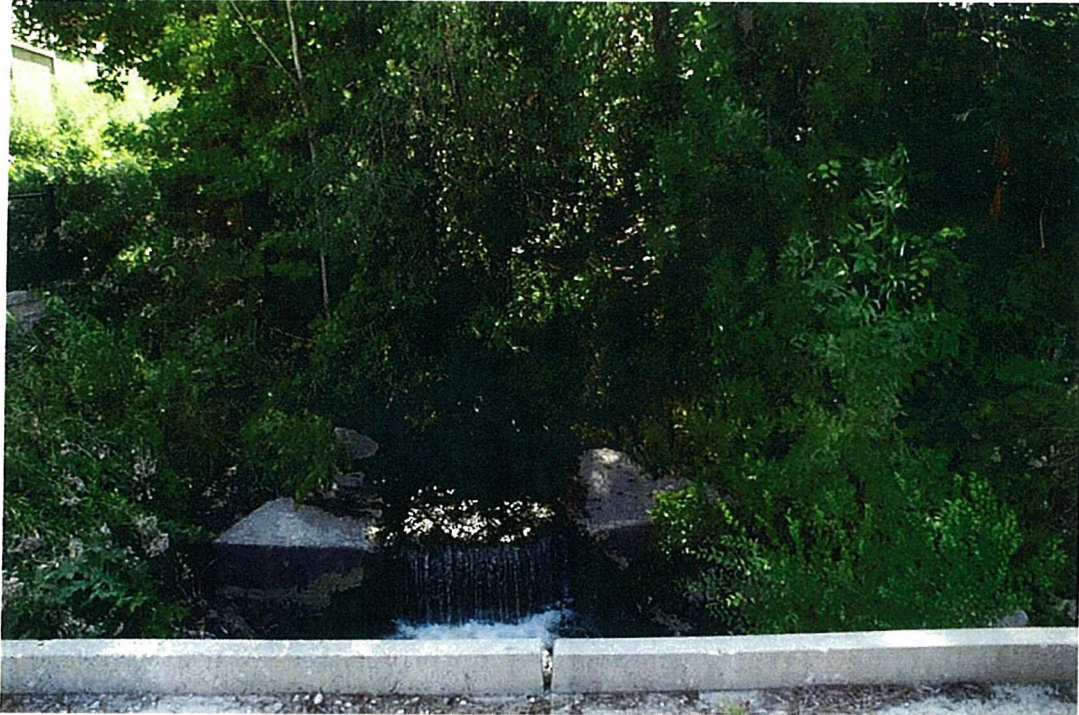
An additional Etobicoke Creek tributary crosses Dixie Road above Queen Street.
A major concrete channel obstruction is immediately upstream (west)

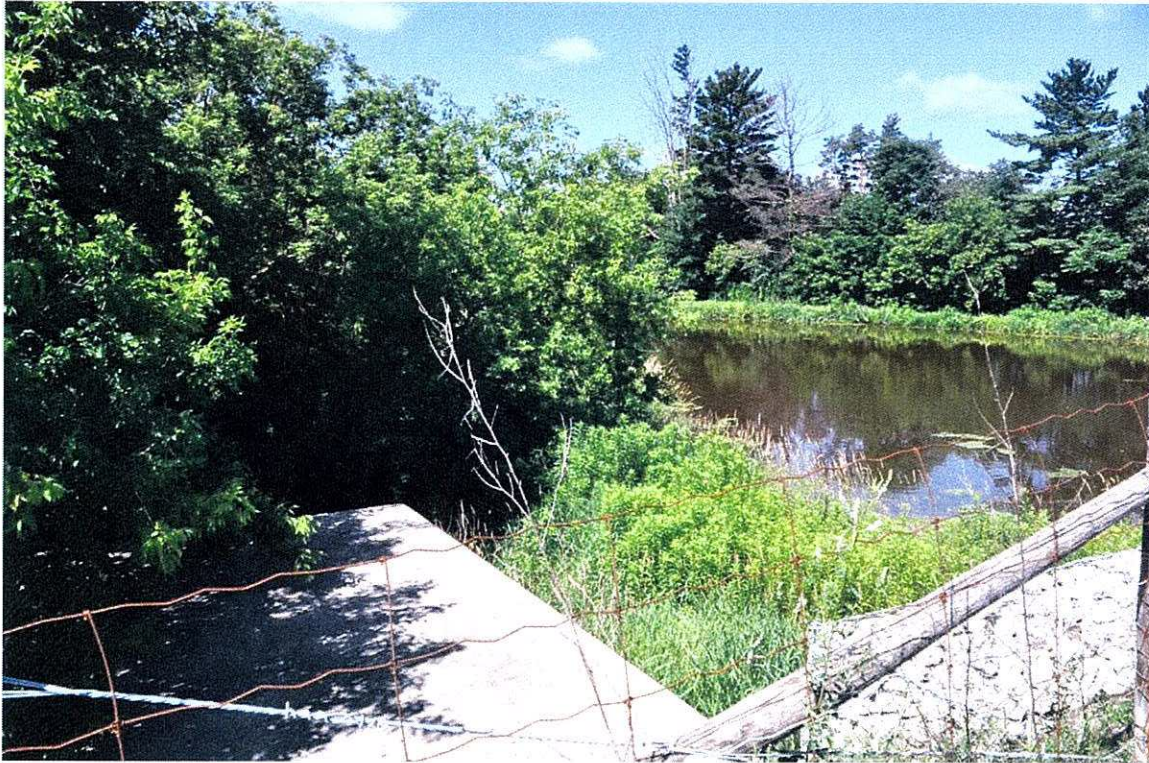
Crossing 1 – Campbell's Cross Tributary/Kilmanagh Creek (Station 16+420)

Box culvert inlet (above) and stagnant bypass pond (below) on Campbell's Cross tributary

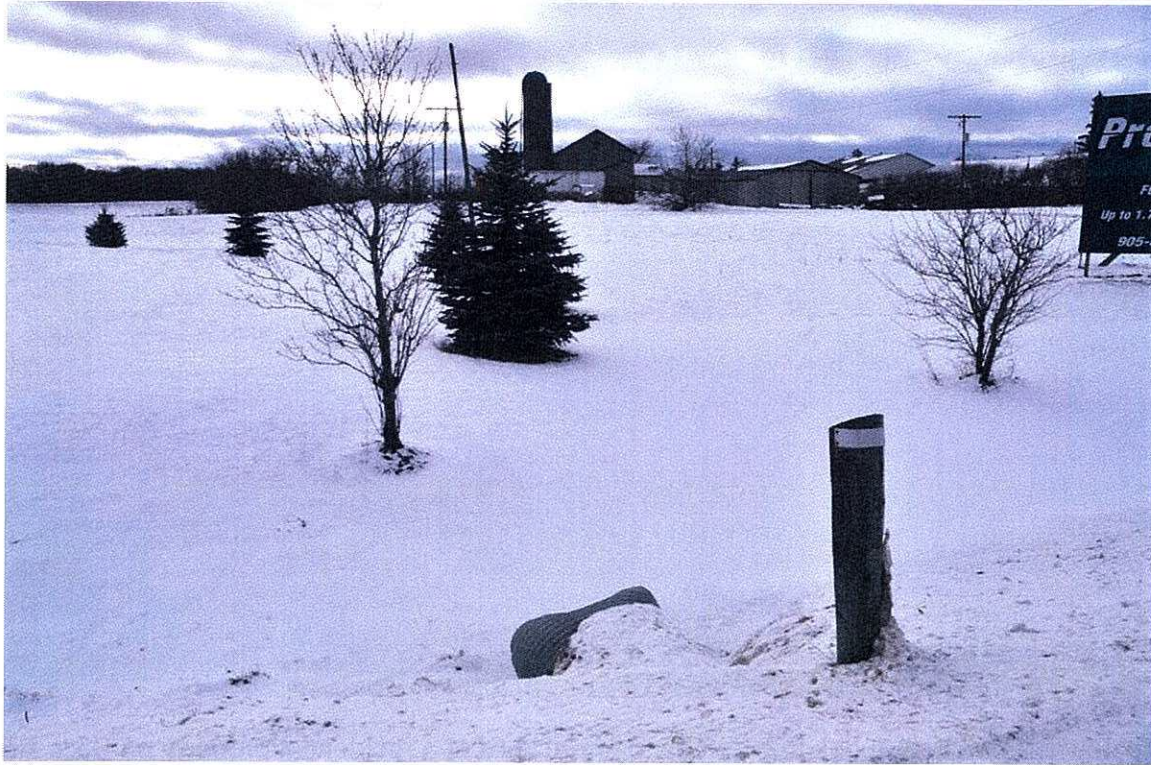
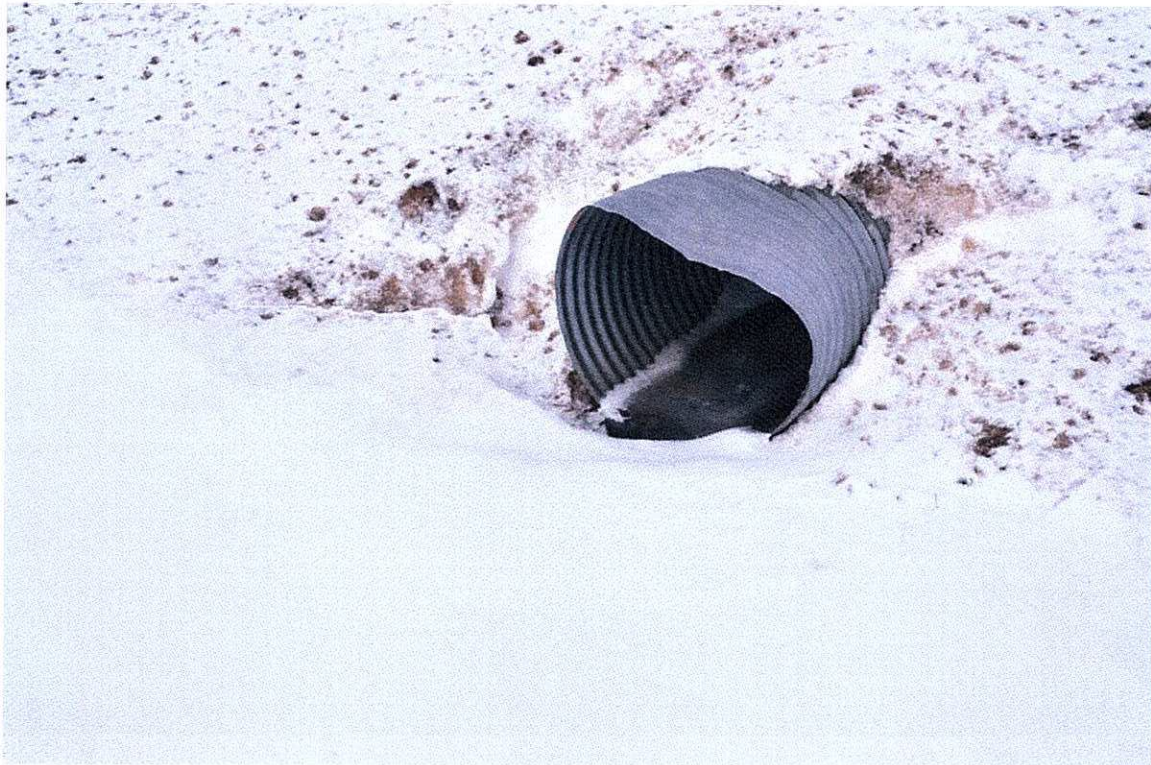
Crossing 2 – Kilmanagh Creek Tributary (Station 16+280)

The upstream area for this culvert (entrance below) is a landscaped yard in front of this farm.

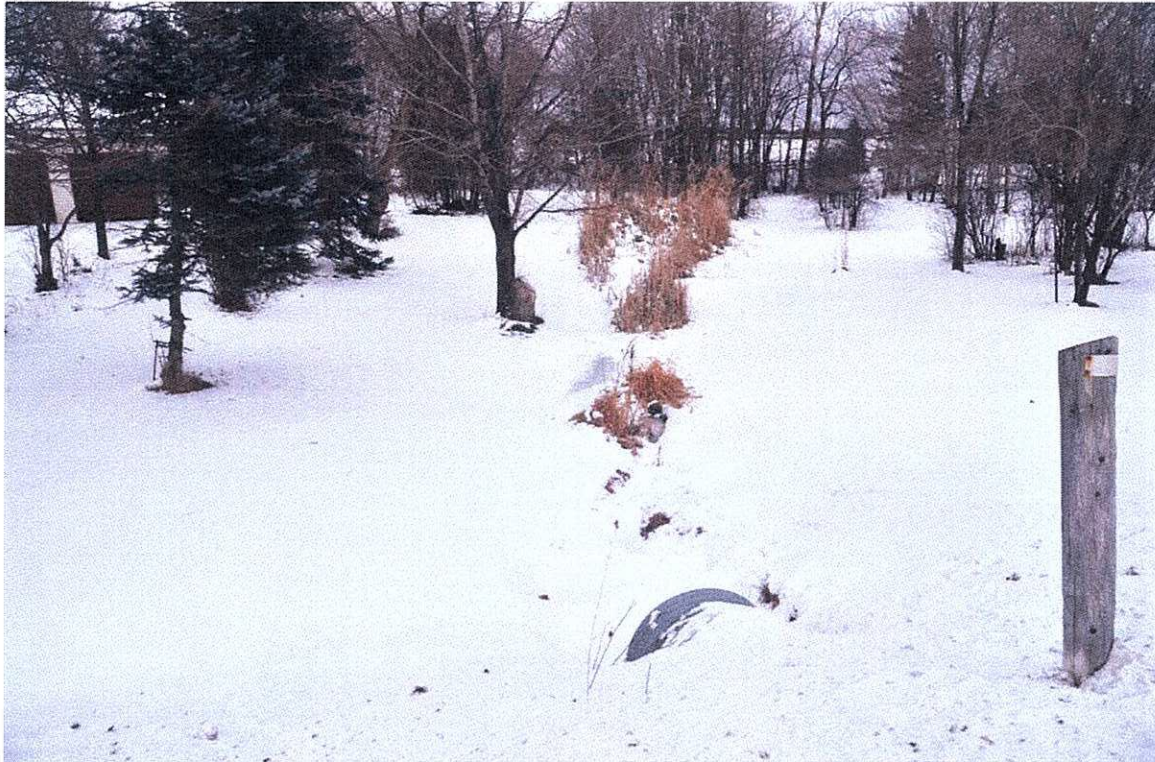
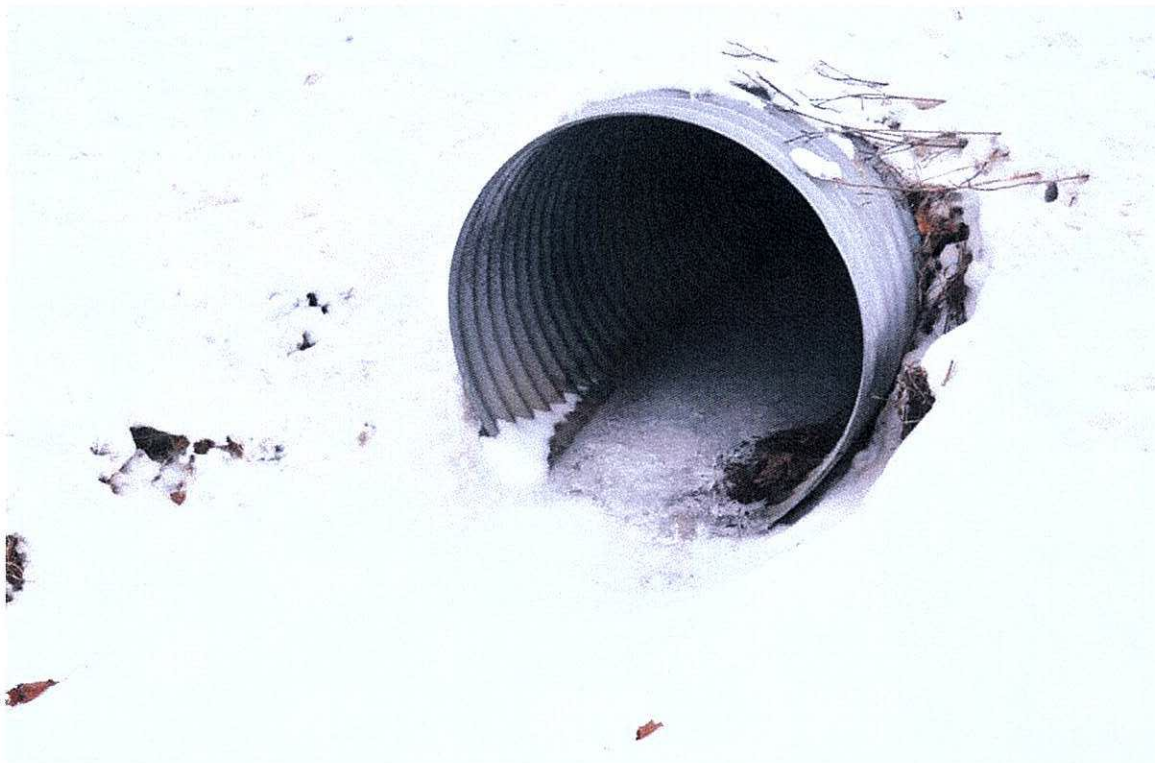
The downstream flow is directed across the front yard of a residential property on Dixie Road. Cattails occupy the downstream channel. The slightly perched culvert outlet is below

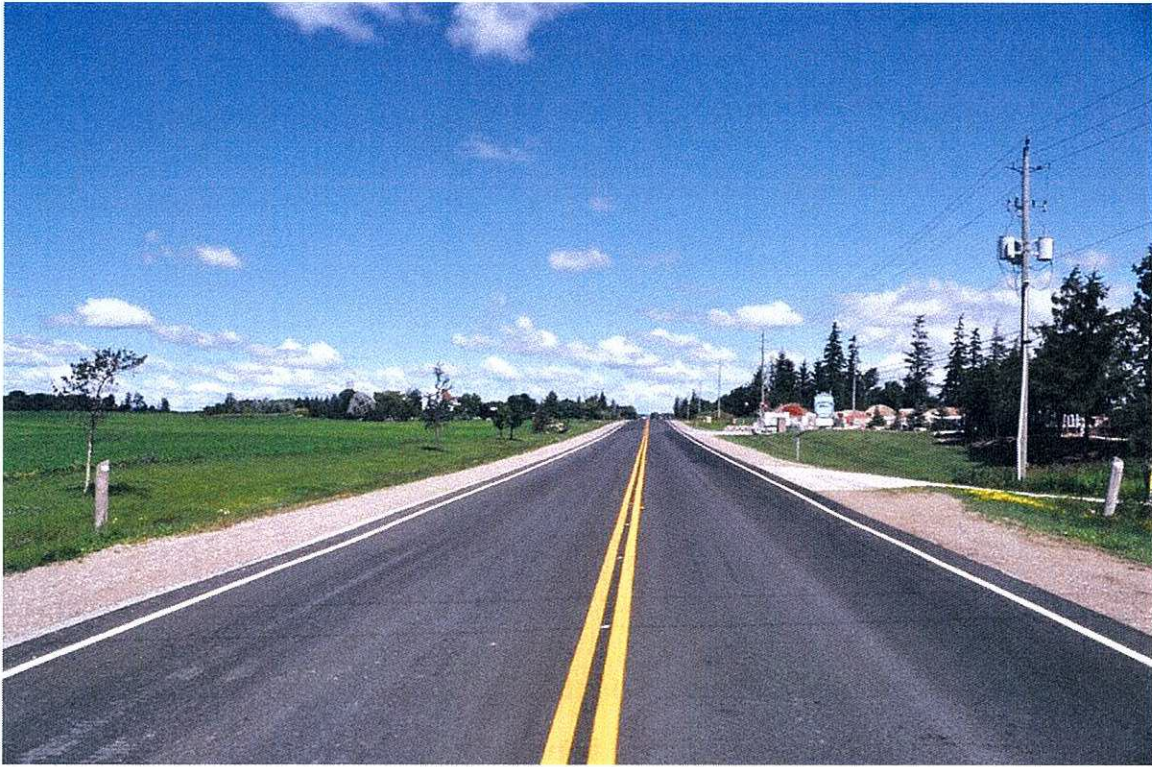
Crossing 3 – West Humber River Tributary (Station 15+910)

View north (above) and south (below) on Dixie Road approximately mid-way along the study area at watercourse crossing 3. A twin 1.2 m diameter CSP crosses under the roadway at this location

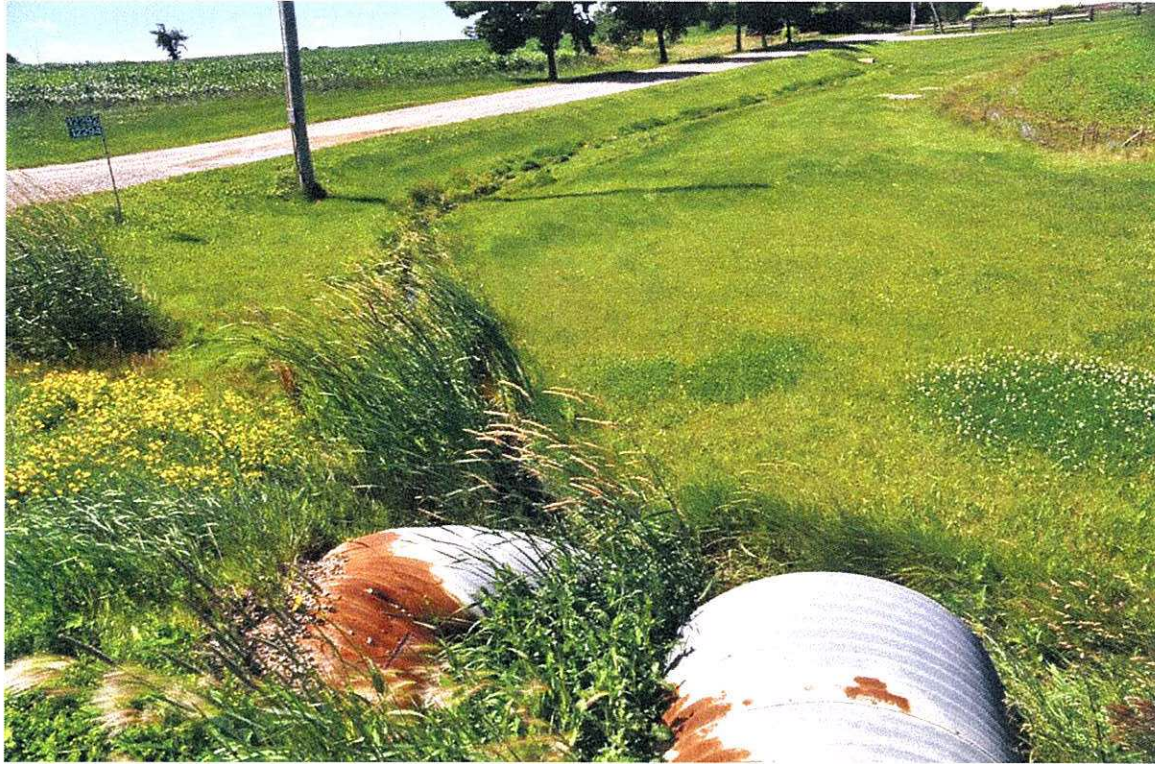
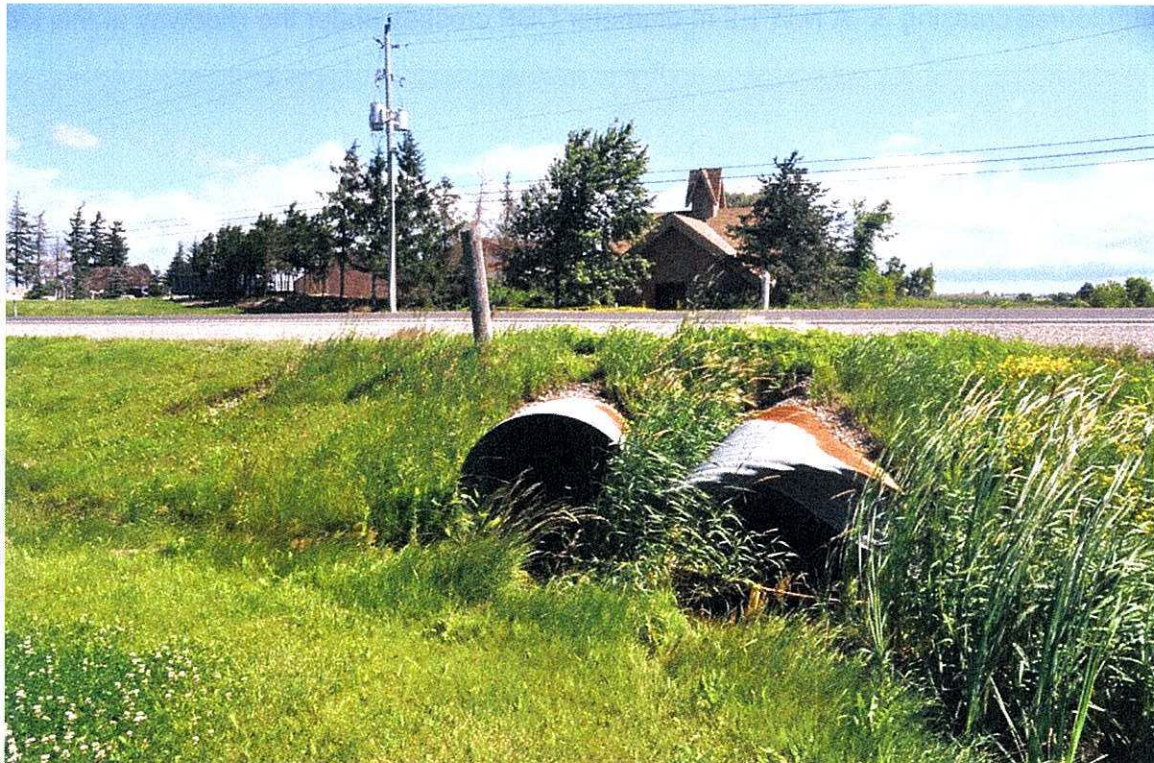
Several hundred metres further south and approximately 0.9 km north of Mayfield Road at 15 +910 another West Humber River tributary (Crossing 3) crosses diagonally under Dixie Road via twin 1.2 m diameter CSPs. There was some stagnant water in each of the culvert barrels but no fish were observed on the June site visit. Adjacent vegetation filled channels were dry with no observable streambed. Upstream, a 2 m wide area of uncut grass paralleled a farm entrance driveway with adjacent mowed lawn. Downstream, the channel extended southeast through a hay field. Adjacent vegetation included purple loosestrife, long grasses, goldenrod and a cattail patch at the culvert outlet. It was not considered fish habitat.

View upstream (above) at the West Humber tributary crossing and at damaged twin culvert inlet (below)

At Crossing 3 the roadway is widened to six lanes with the majority of widening to the west. The West Humber Tributary twin culvert will require extension to the east and west or full replacement (likely due to pipe damage). It appears all roadside vegetation to the north and south on the west side will be lost. An environmental management plan with an emphasis on erosion and sediment controls will be essential at this location.

West Humber Tributary Crossing 3* (Station 15+910)	Twin CSPs	1.2 m diameter	<ul style="list-style-type: none"> Culvert replacement / extension to east and west (3.6 m x 1.2 m) 	<ul style="list-style-type: none"> No net impacts to fish and fish habitat 	<ul style="list-style-type: none"> Implement environmental protection plan with emphasis on erosion and sediment control
Etobicoke Creek Tributary Crossing 4* (East of Dixie Rd on Mayfield Rd)	Culvert	600 mm diameter	<ul style="list-style-type: none"> Culvert extension to north and south (600 mm diameter) 	<ul style="list-style-type: none"> No net impacts to fish and fish habitat 	<ul style="list-style-type: none"> Implement environmental protection plan with emphasis on erosion and sediment control
Etobicoke Creek Tributary Crossing 5* (West of Dixie Rd on Mayfield Rd)	Culvert	750 mm diameter	<ul style="list-style-type: none"> No changes 	<ul style="list-style-type: none"> None 	<ul style="list-style-type: none"> Standard erosion and sediment controls for adjacent road improvement work

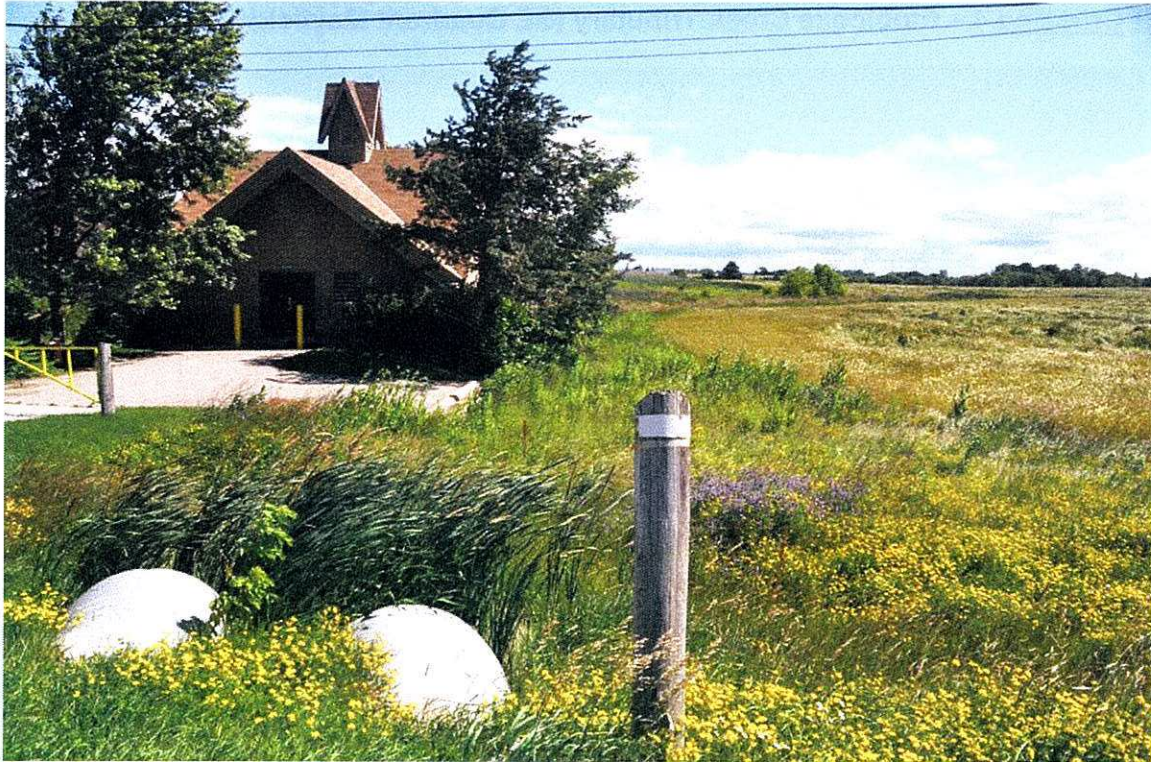
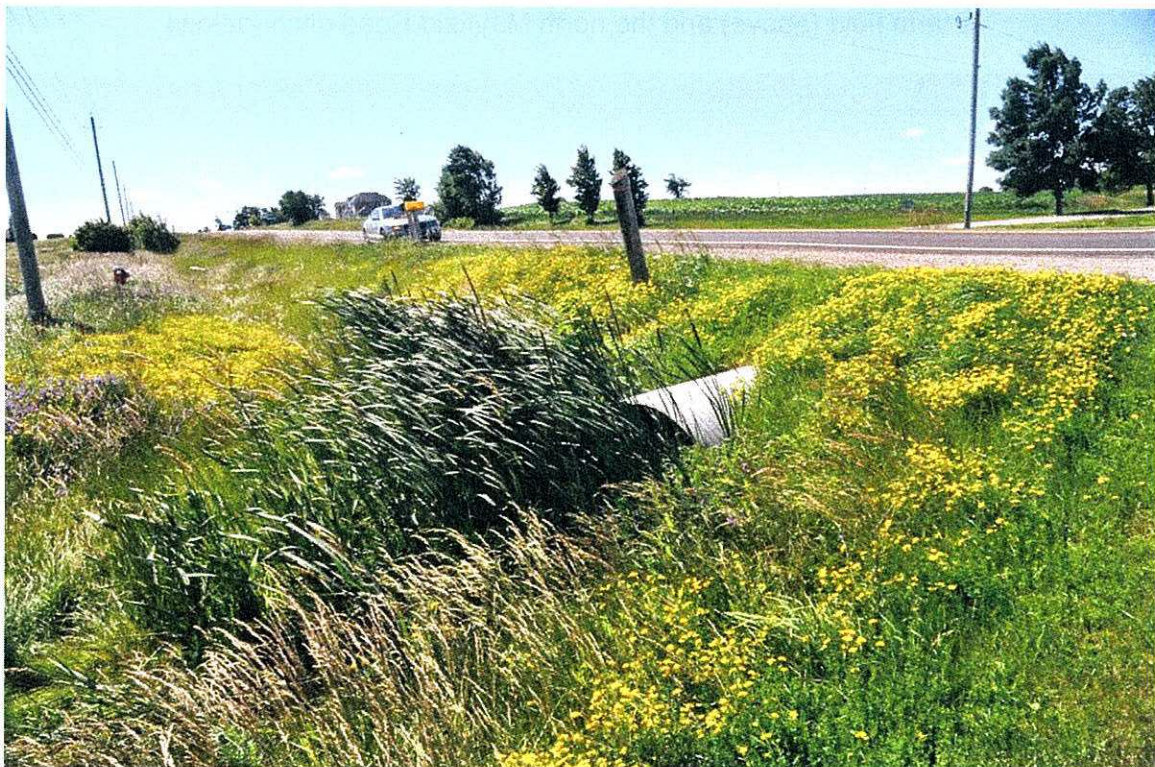
View downstream at the West Humber tributary channel (above)
and partially obstructed culvert outlet (below)

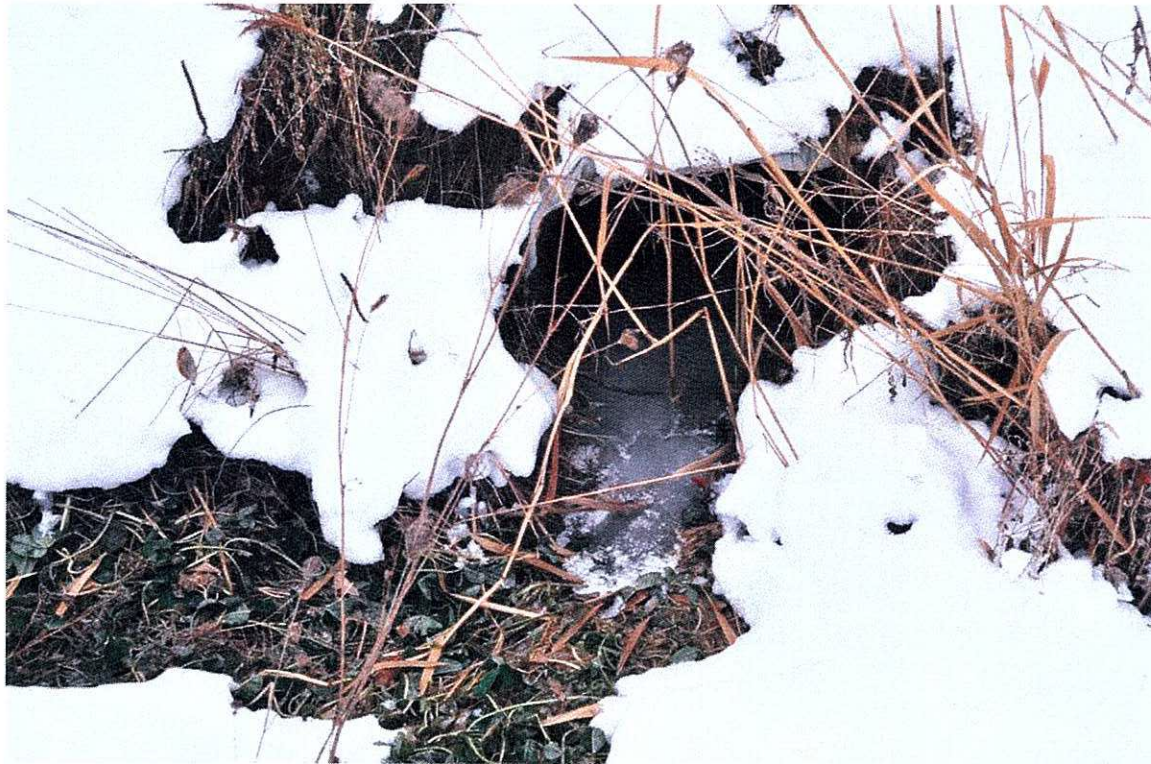
The culvert inlet at the northeast quadrant of Mayfield/Dixie is almost obscured by vegetation

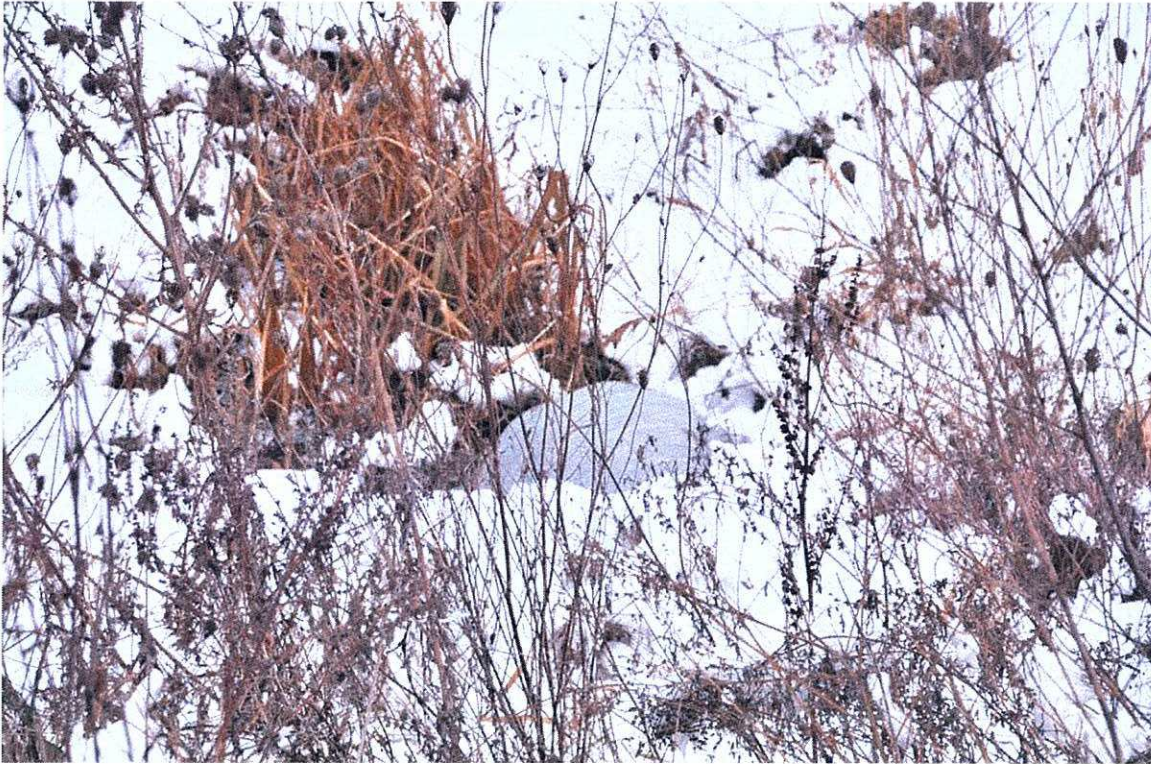
Again, the culvert outlet is almost obscured by vegetation

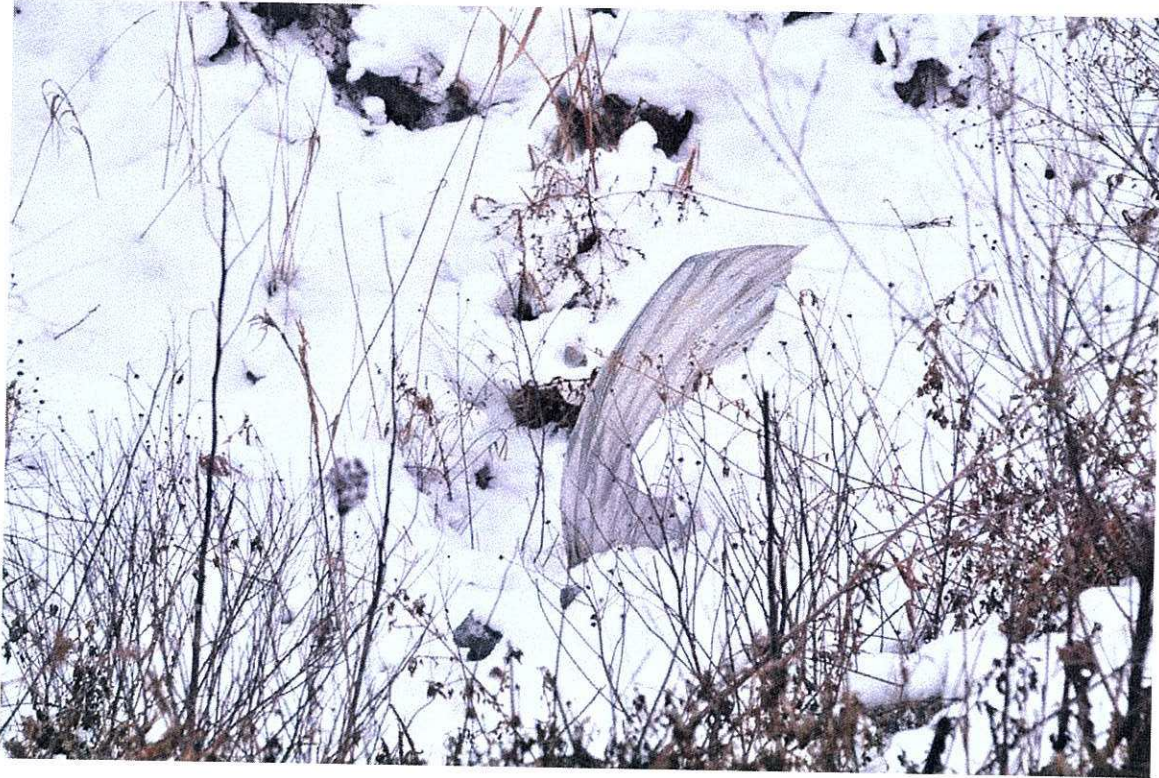
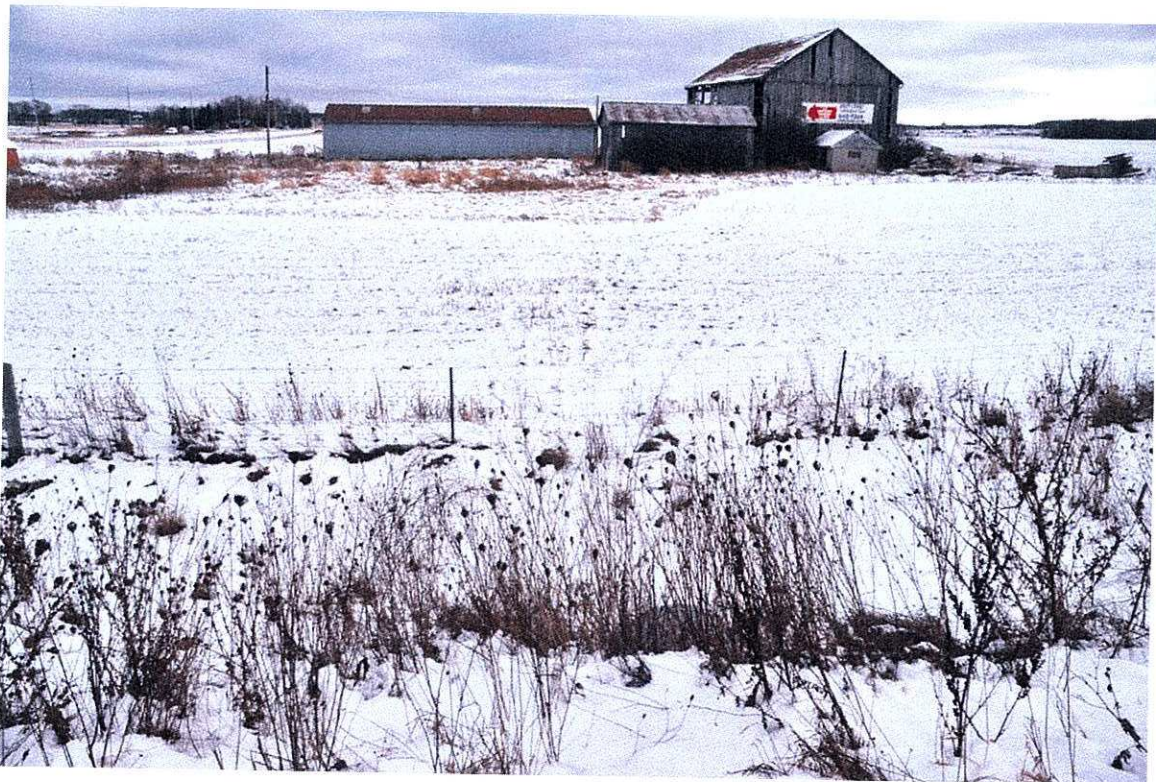
The culvert inlet is in the northwest quadrant in the north Mayfield Road ditch (above).
Outlet drainage is directed across a low area of farm field towards the barn (below)
