Environmental Assessment

Airport Road from King Street to Huntsmill Drive

Public Information Centre No. 2

Summary of Technical Study Findings

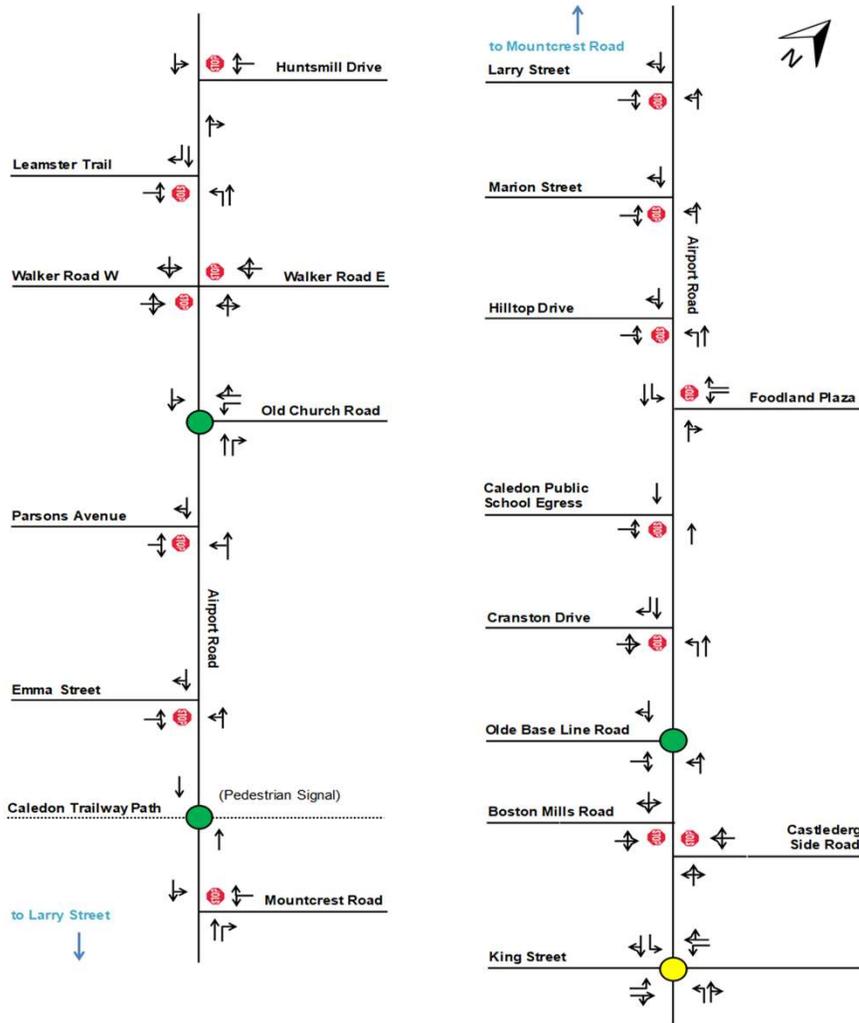
Level-of-Service (LOS) Map (afternoon peak hour)

What is Level-of-Service?

Level-of-service is a measure of performance based on average delay at each intersection:

- LOS 'A' means drivers experience little or no delay
- LOS 'E' or 'F' signifies long delays, which can be in excess of 1 minute

Existing Traffic Operations

- Airport Road currently operates well overall
- Some delay is incurred for traffic turning onto Airport Road during busy periods
- No locations with collisions that are of high-frequency or common type
- Heavy trucks frequently use Airport Road

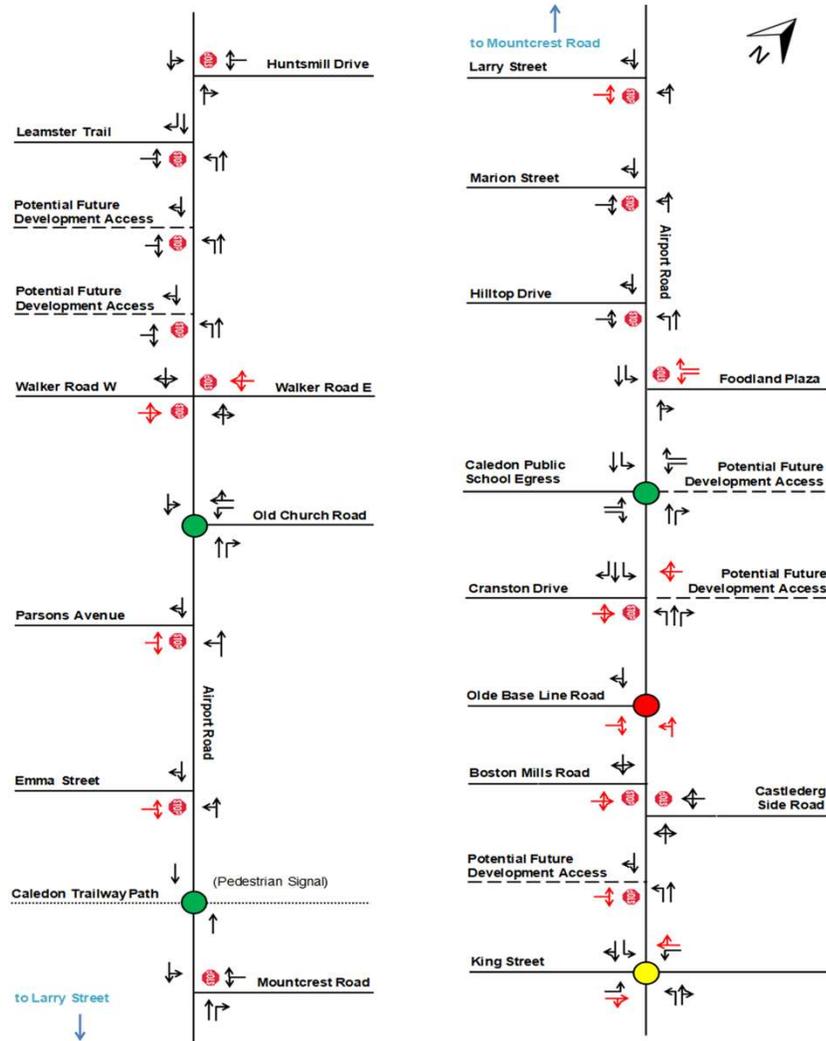
Level of Service (LOS) Map (afternoon peak hour)

Future Constraints

Traffic growth will introduce new operational constraints:

- Turning left and right onto Airport Road incurs long delays in the peak hours:
 - Walker Road
 - Parsons Avenue
 - Emma Street
 - Larry Street
 - Foodland Plaza
 - Cranston Drive
 - Olde Base Line Road
 - Boston Mills Road
- Some intersections may warrant improvements, signals or a roundabout:
 - Walker Road
 - Cranston Drive
 - Olde Base Line Road
 - Boston Mills Road / Castleberg Side Road

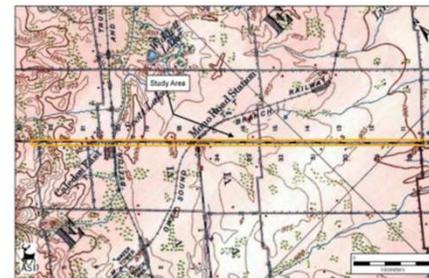
Study area overlaid on 1919 Bolton National Topographic System (NTS) map

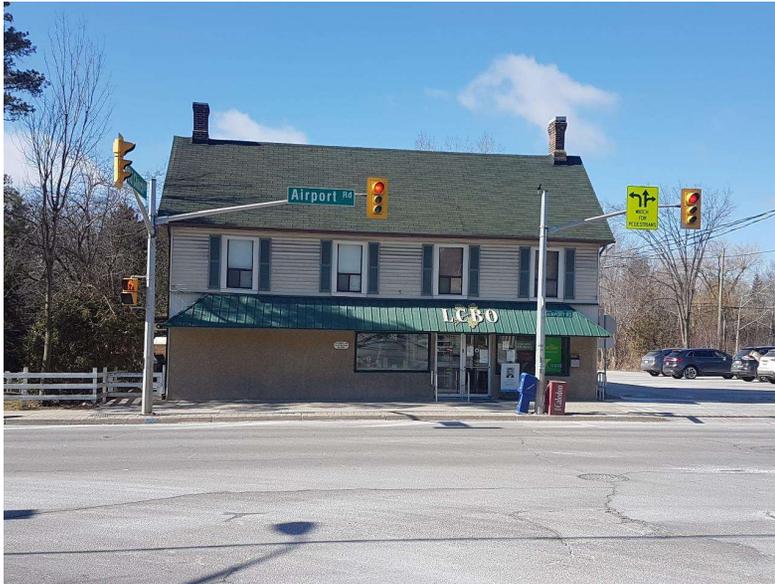
16000 Airport Road

- Retains cultural heritage value (eligible for designation)
- Realignment of proposed extension to avoid heritage attributes not technically feasible
- Options to mitigate heritage impact:
 1. Relocate structure, or
 2. Remove building, and
 - i. Salvage or document heritage attributes
 - ii. Consider a commemorative plaque nearby

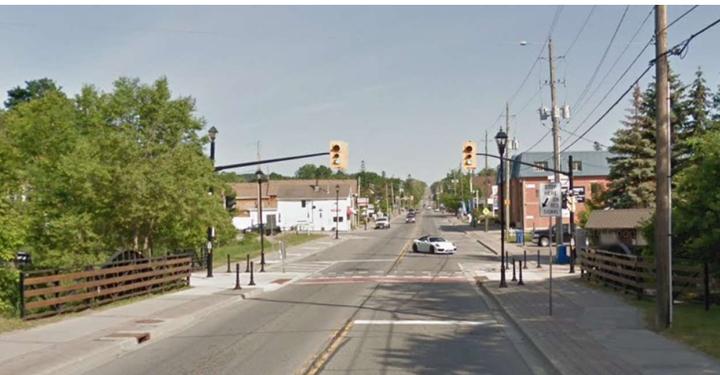
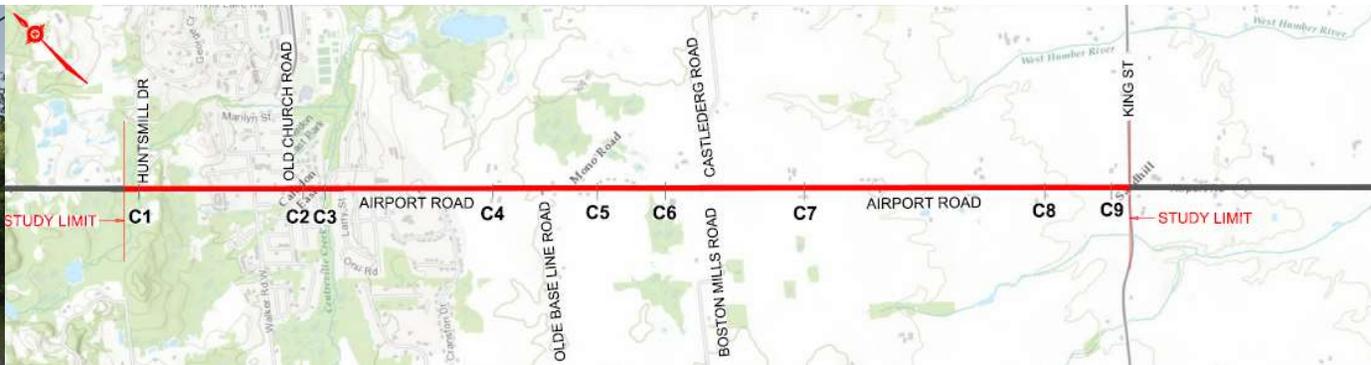
C3 / Centreville Creek
9/17/2020

Culverts:

- All culverts will be replaced, with the exception of C2 and C5.
 - C1, C3, C4, C7, C8 and C9 will be replaced due to inadequate hydraulic capacity.
 - C6 will be replaced to improve structural integrity.
- C1, C3 and C7 to be replaced with Concrete Box Culverts
- **C3 / Centreville Creek in Caledon East is considered a major replacement (~12 m wide culvert).**
- C4, C6, C8, C9 to be replaced with Concrete Pipes.

- A fluvial geomorphological assessment was completed for 4 regulated watercourse crossings (1, 2, 3 and 7).
- Boyce's Creek has a meander belt width of 15.1 m. Recommended culvert replacement span is 3.67 m.
- Centreville Creek has a meander belt width of 20 m. Recommended culvert replacement span is 10.35 m.
- The meander belt width of Centreville Creek Tributary (Crossing 2) was not determined since there is no open channel within the road allowance, and the likelihood of daylighting the creek within the road allowance is low.
- The meander belt width of East Credit River Tributary (Crossing 7) was not determined as the culvert inlet was located in a private property well outside of the road allowance.
