In-service Road Safety Review

Bovaird Drive (Regional Road 107) Lake Louise Drive/Worthington Avenue to the Peel/Halton Boundary City of Brampton, Ontario

Peel Project No. 09-4360

Intus Road Safety Engineering Inc.

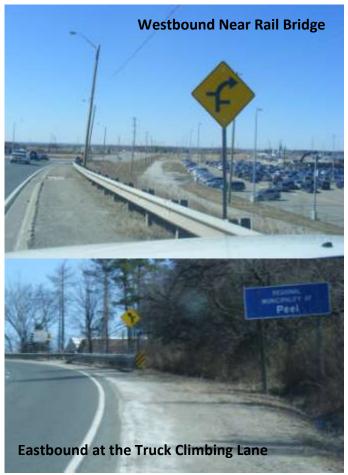
- Westbound on Bovaird Drive immediately west of the rail bridge, there is an intersection warning sign that is not required (see Figure 4.1). Similarly, there is an eastbound intersection warning sign vicinal to the truck climbing lane that appears unnecessary (see Figure 4.1).

FIGURE 4.1: Unnecessary Intersection Warning Signs

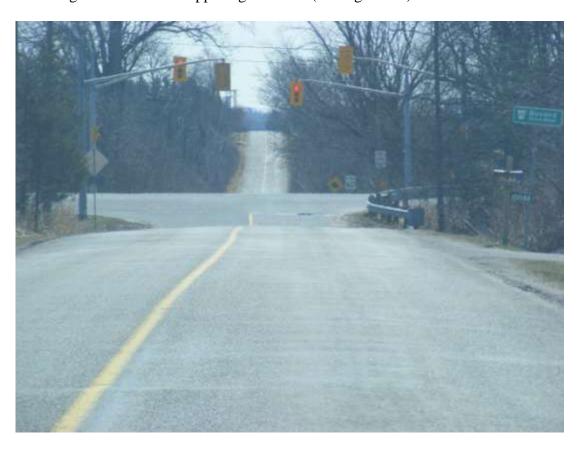
- The separation between the signal head for the southbound approach to the intersection of Bovaird Drive and Mississauga Road were not measured but appear to be very close together.
- During the site visit (midday during a weekday) the westbound advance left-turn phase was activated even when there was no traffic in the westbound left-turn lane⁸.
- Overall, the placement of the signal heads in the study area requires review. In many instances the lenses of some heads are temporarily blocked from view by the mast arms or signal heads for the opposing direction (see Figure 4.2).

FIGURE 4.2: Signal Head Obstructed by Mast Arm at Heritage Road

- 6.2.8 The benefits achieved from any operational efficiencies in traffic have not been accounted for in this analysis.
- 6.2.9 With respect to short-term measures, the available options for addressing the angle collisions are to revise the signal timing to improve the level of service, or to improve conspicuity of the signal heads through larger lenses, converting from span wire to mast arms, reflective tape on the backboards, conversion from incandescent to LED lamps, and/or additional signal heads.
