Tree Inventory Report

July 23, 2019
RS# 2017-066

**SUBJECT: Tree Inventory and Preservation Plan
Airport Road Improvements, King Street to Huntmill Drive
Regional Municipality of Peel**

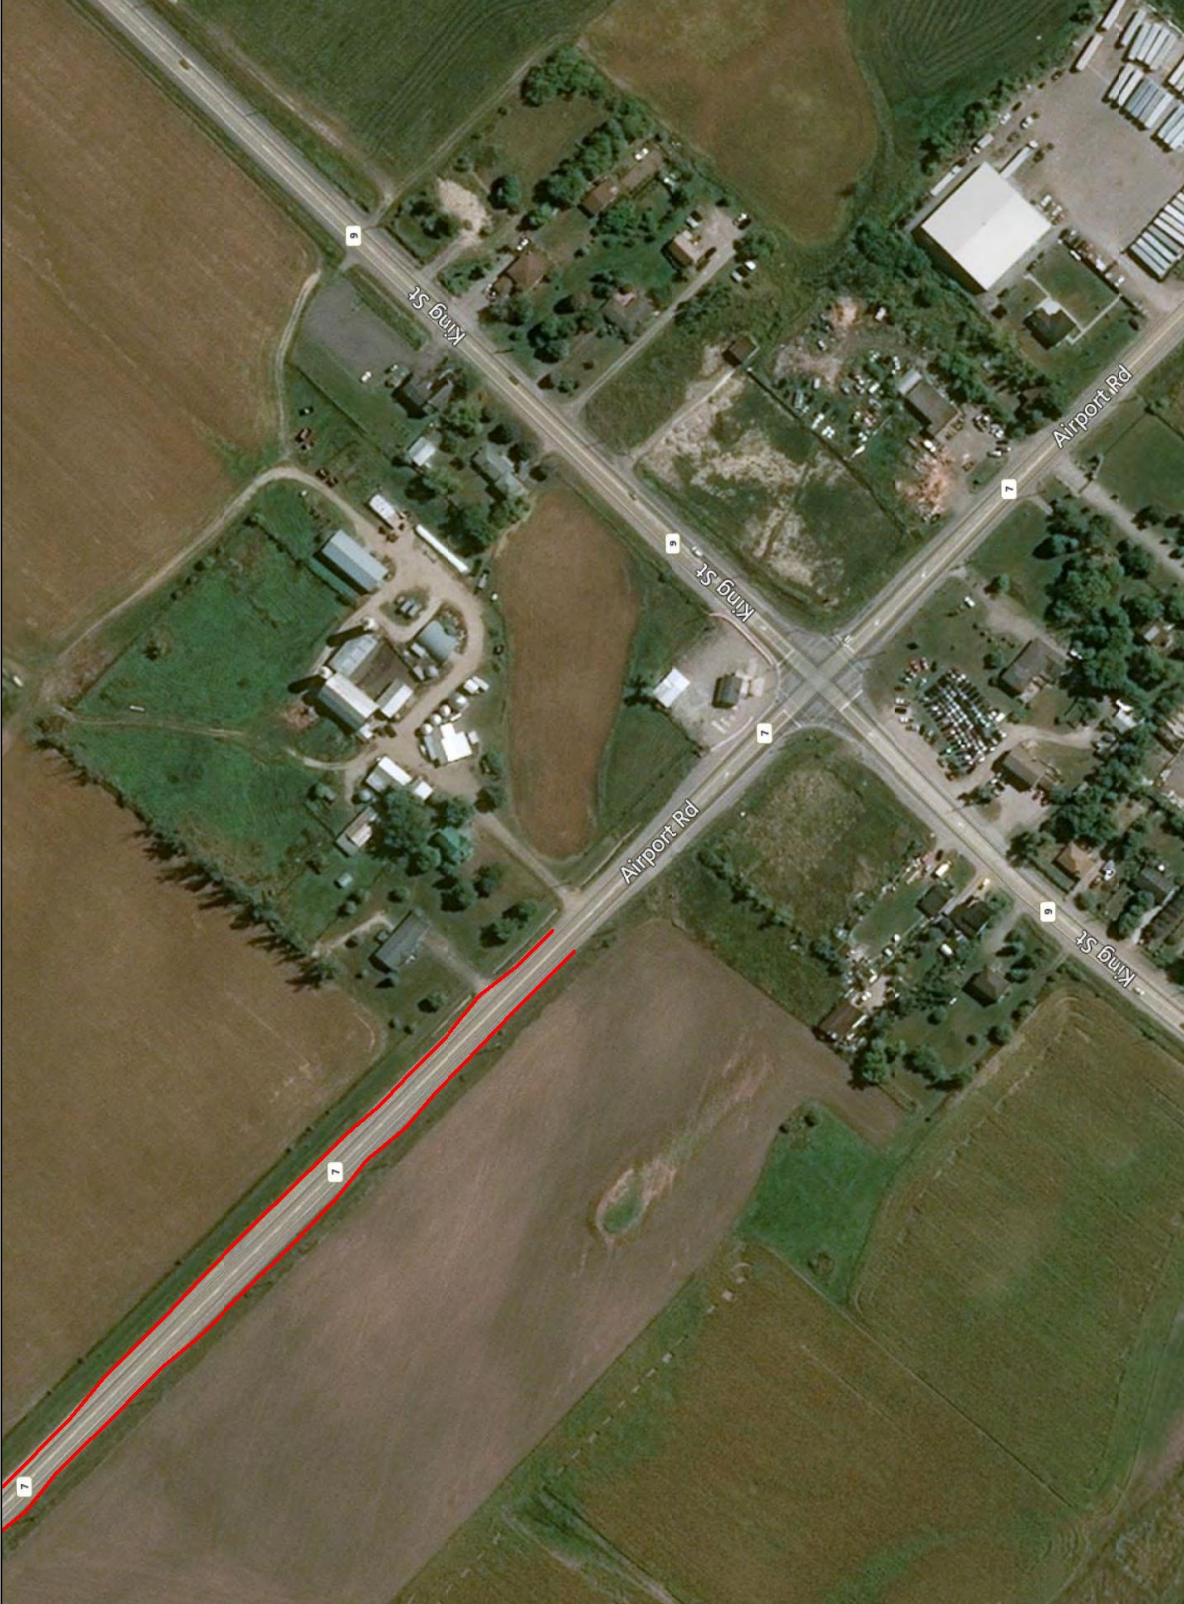
Figure 21. Tree Inventory and Impact Assessment.
 Impact assessment is based on the limit of grading associated with the preferred alternative - Airport Road between Huntmill Drive and King St., Region of Peel

As outlined in **Appendix 1** and shown on **Figure 2**, a total of ninety-two (92) trees require removal to implement the construction alternatives proposed along Airport Road and Old Church Road, this does not include dead trees that are presumed to require removal due to safety issues. In addition, one-hundred and forty-seven (147) trees are outside of the proposed construction alternatives and have been noted in **Appendix 1** as having either poor health or structure and require additional assessment by Municipal or Regional staff to determine if removal is required. Minor impact/disturbance to the root system of trees recommended for retention that occur within proximity to the proposed road improvements may also occur given their proximity to the area of disturbance.

As a means to protect trees located outside the grading limit of the proposed alternative, and recommended for retention as shown on **Figure 2**, RiverStone recommends the following measures:

- **Tree protection fencing should be installed along the edge of disturbance (Figure 2) adjacent to selected construction activities to protect retainable trees from soil disturbance, root damage, and other physical impacts. Tree protection fencing is to be aligned in a way that will protect the critical root zone of the assessed retainable trees. No site alteration activities (e.g., grading, etc.), machinery movement, or storage of any equipment or materials is to occur within the tree protection fencing.**
