Mayfield Road Improvements

**Municipal Class
Environmental Assessment
Chinguacousy Road to
Winston Churchill Boulevard**

**HYDROGEOLOGY INVESTIGATION
MAYFIELD ROAD
WINSTON CHURCHILL BOULEVARD TO CHINGUACOUSY ROAD
BRAMPTON / CALEDON, REGION OF PEEL**

January 27, 2016
File: 19-1605-148

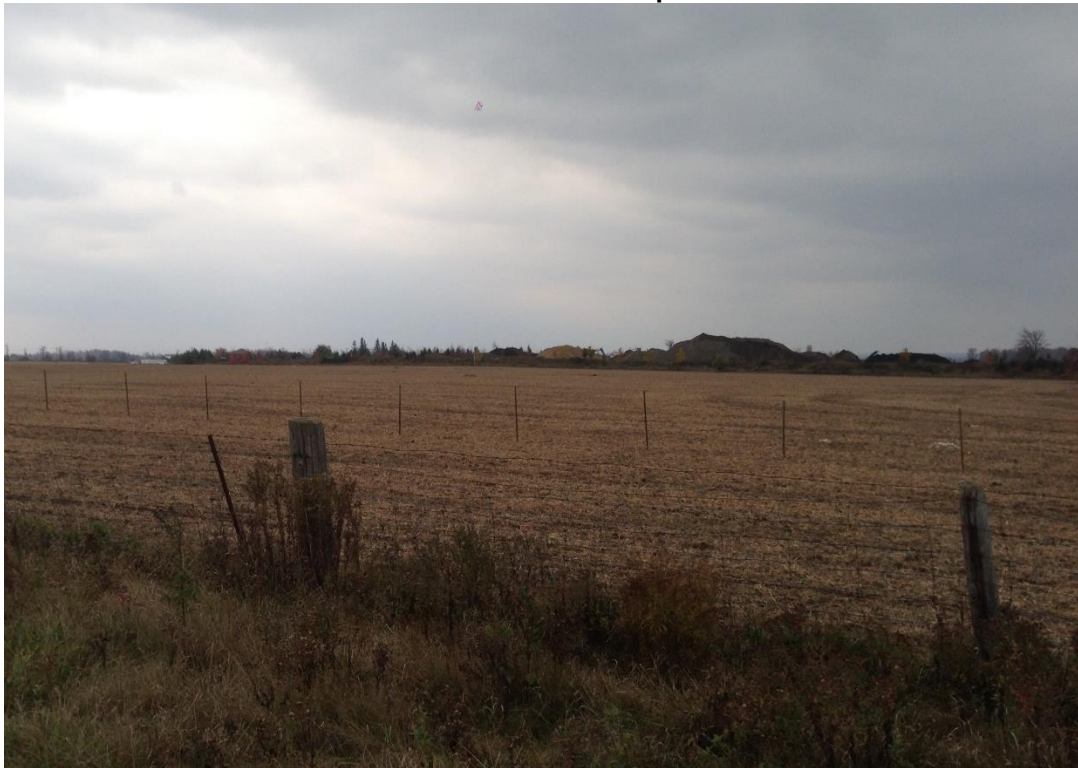
PHOTO 5: Looking west from Mississauga Road towards 816 Mayfield Road (Gro-Bark) at mulch and soil stockpiles.

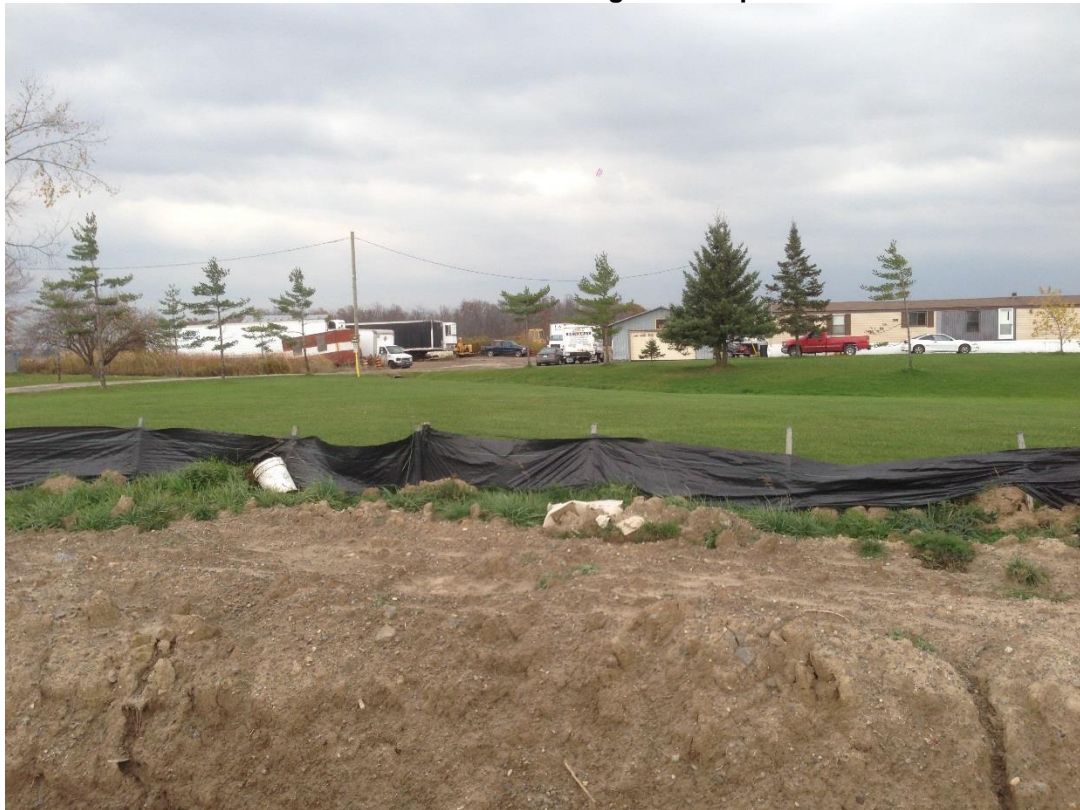
PHOTO 7: Looking south towards 1637 Mayfield Road at truck trailer storage. Recent construction visible in foreground of photo.

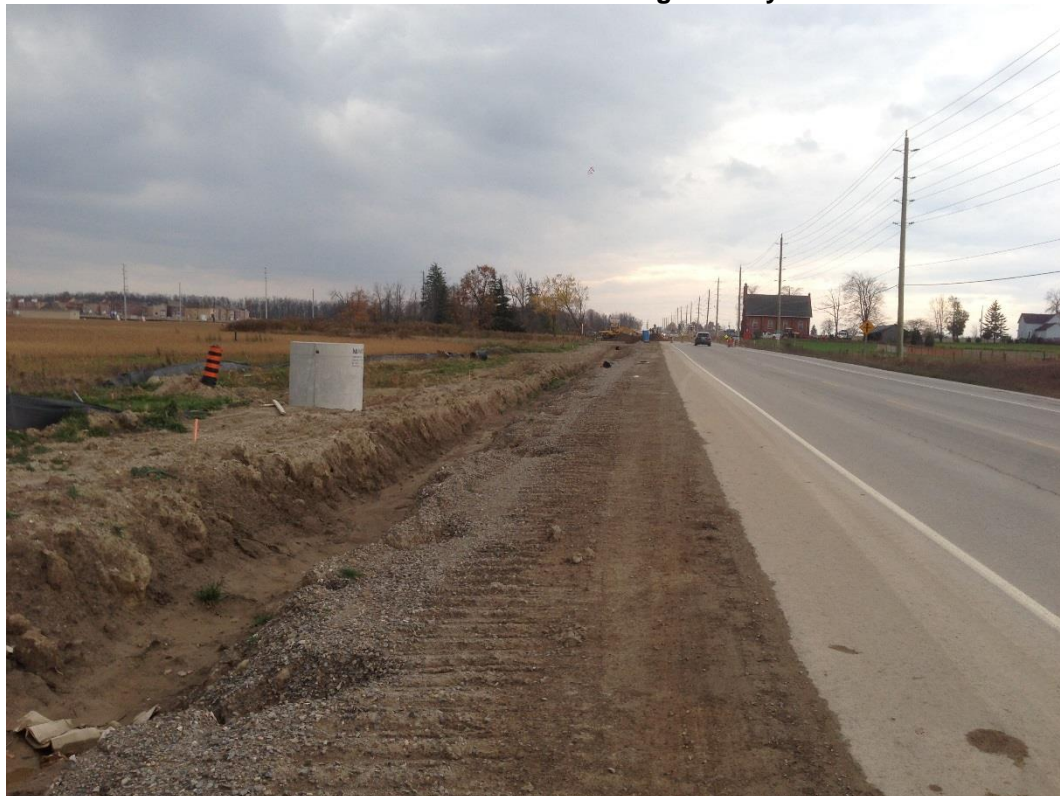
PHOTO 10: Looking west at utility construction along the south side of Mayfield Road between Creditview Road and Chinguacousy Road.

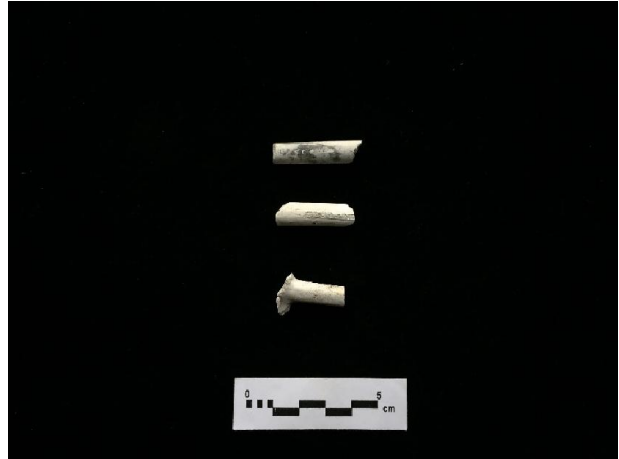
Plate 39: Assorted mid nineteenth-century smoking pipe stems from H3.
Top: impressed mark “[M]URRA_[Y]” “[G]LASGOW.”
Middle: impressed mark “BANN[ERMAN]” “[M]ONTREAL.” Bottom: undecorated stem/bowl junction.

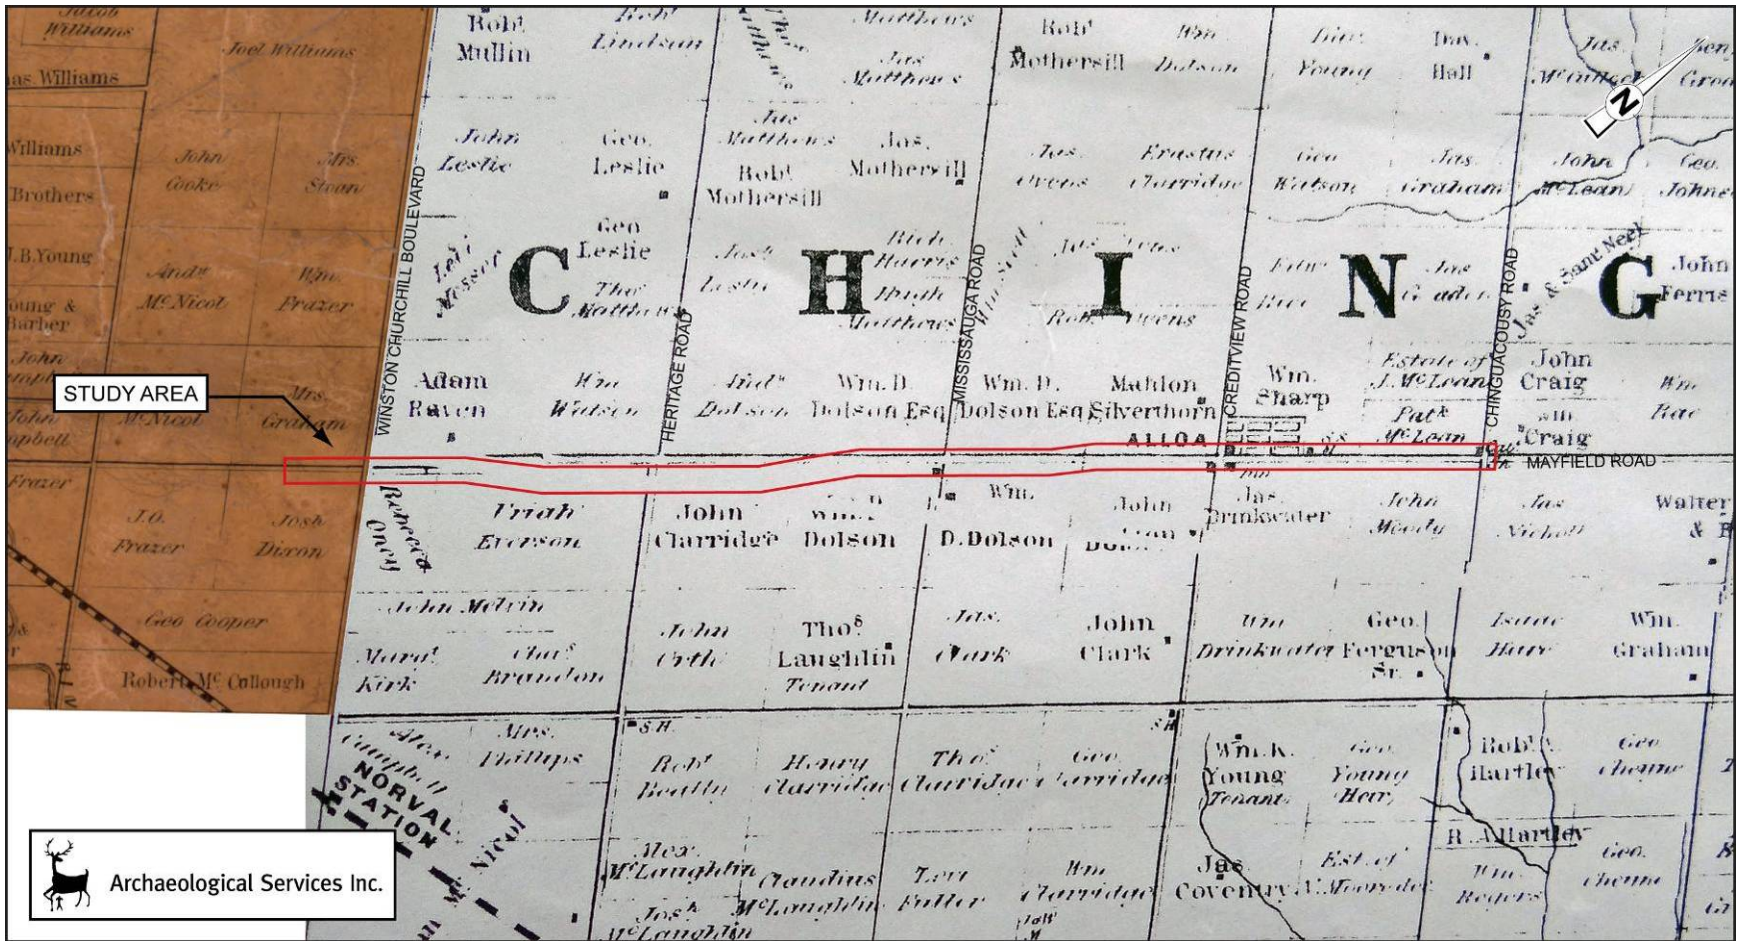
Figure 2: The study area overlaid on the 1859 Tremain map of Peel County and the 1858 Tremain map of Halton County

Base Map: Tremain's Map of Peel County (Tremain 1859) and Tremain's Map of Halton County (Tremain 1858)

The 1859 *Tremaine Map of the County of Peel* and the 1877 *Illustrated Historical Atlas of the Country of Peel* were reviewed to determine the potential for the presence of cultural heritage resources within the study corridor during the nineteenth century (Figures 2 and 3). It should be noted, however, that not all features of interest were mapped systematically in the Ontario series of historical atlases, given that they were financed by subscription, and subscribers were given preference with regard to the level of detail provided on the maps. Moreover, not every feature of interest would have been within the scope of the atlases.

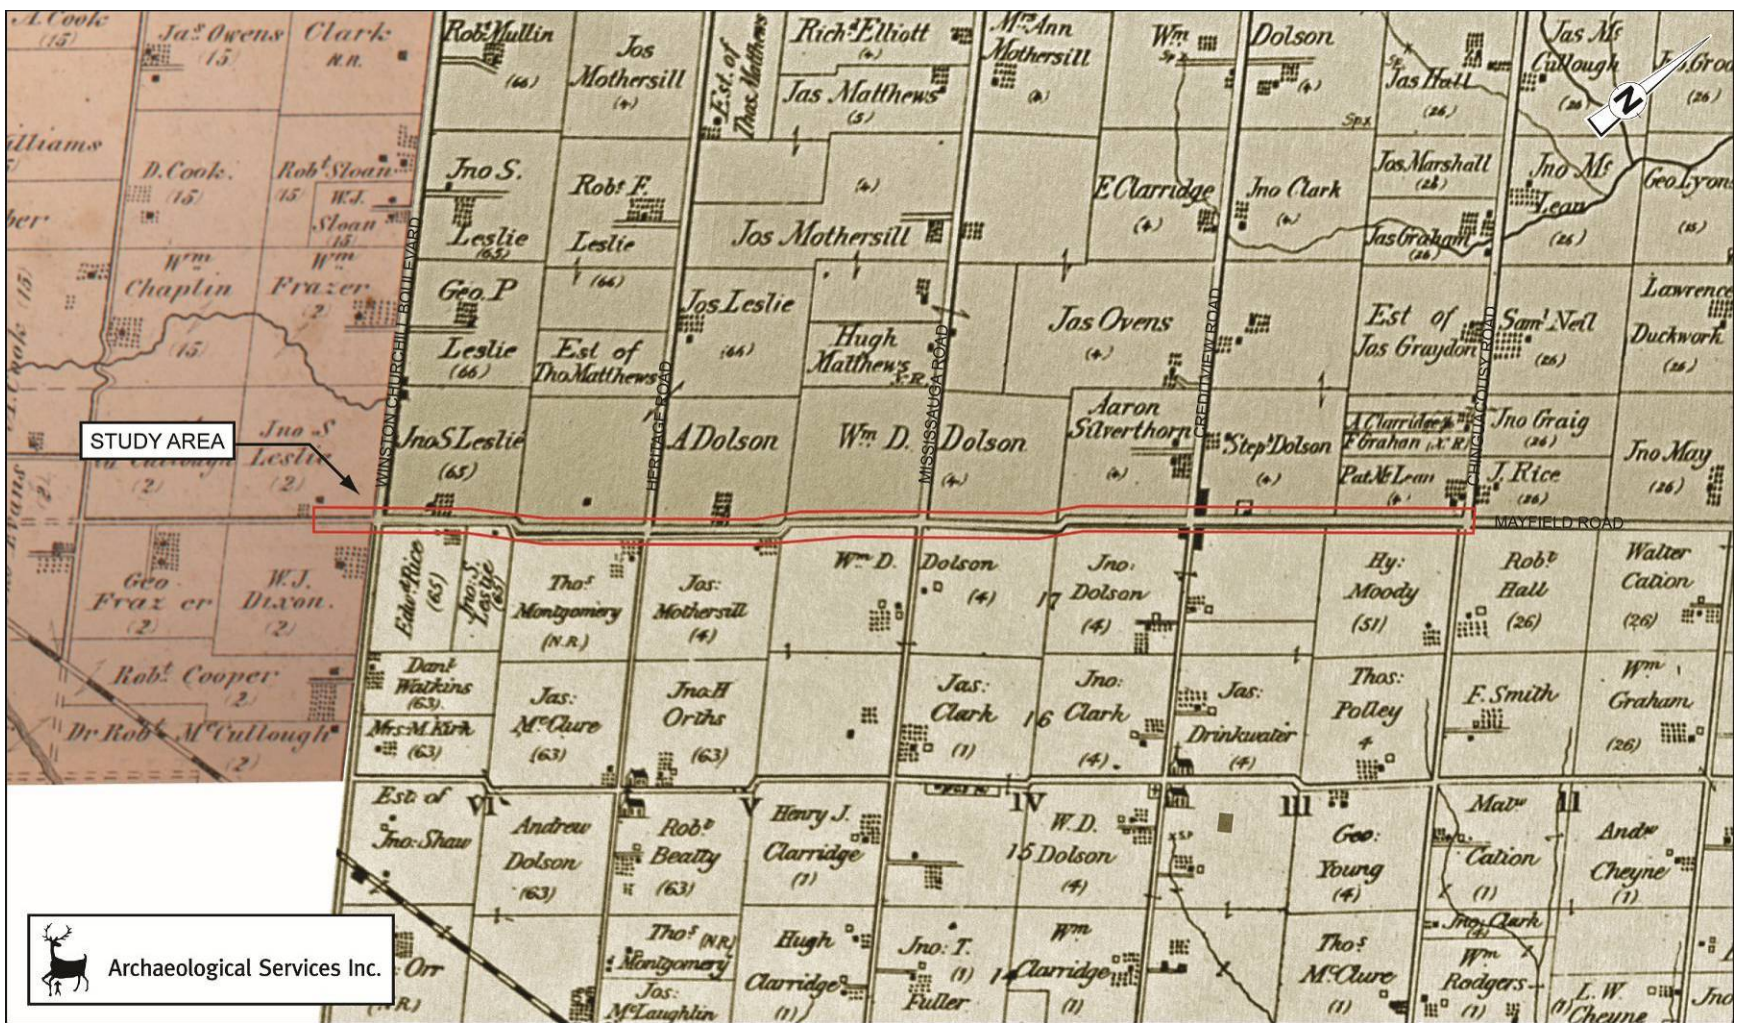
Figure 3: The study area overlaid on the 1877 map of the Townships of Chinguacousy North and South and the 1877 map of the Township of Esquesing

Base Map: Illustrated Historical Atlas of the County of Peel (Walker & Miles 1877) and the Illustrated Historical Atlas of the County of Halton (Walker & Miles 1877)

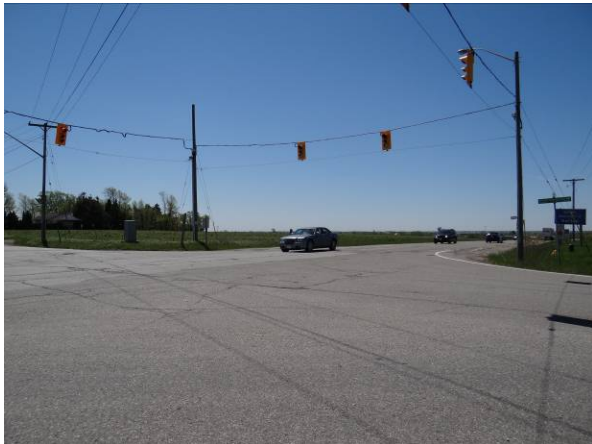
Plate 3: South view across the intersection of Mayfield Road and Winston Churchill Boulevard. Road is at grade and is bounded by agricultural fields.

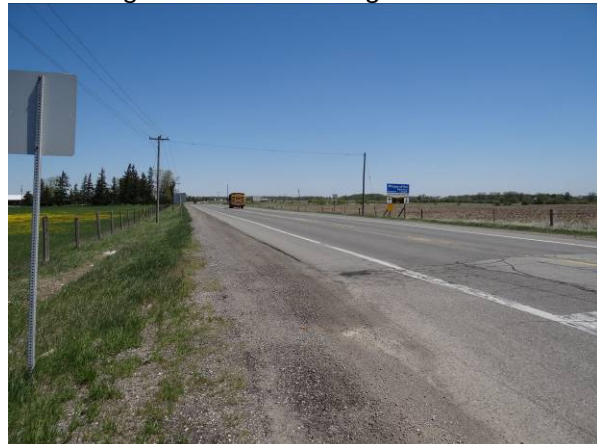
Plate 4: Northeast view along Mayfield Road. Road is at grade and is bounded by agricultural fields.

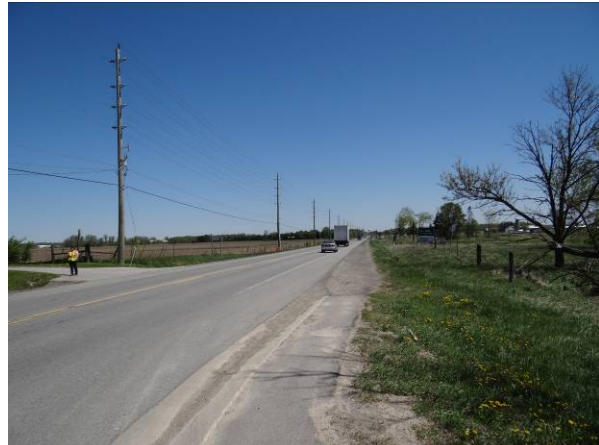
Plate 8: North-northeast view along Mayfield Road. Road is at grade and is bounded by agricultural fields.

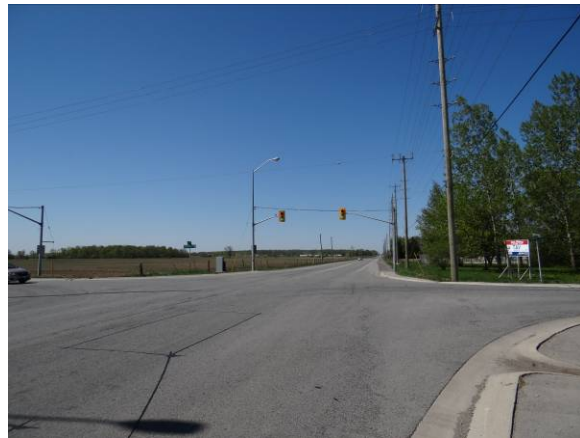
Plate 10: South-southwest view of the intersection of Mayfield Road and Chinguacousy Road. Road is at grade and bordered by agricultural fields and historic farmsteads.

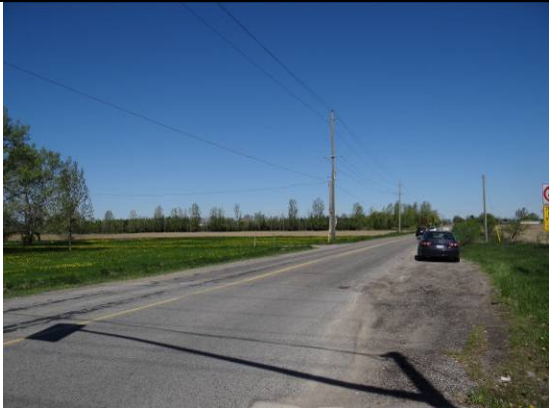
<p>West view along Chinguacousy Road. Road is two lanes and is at grade.</p>

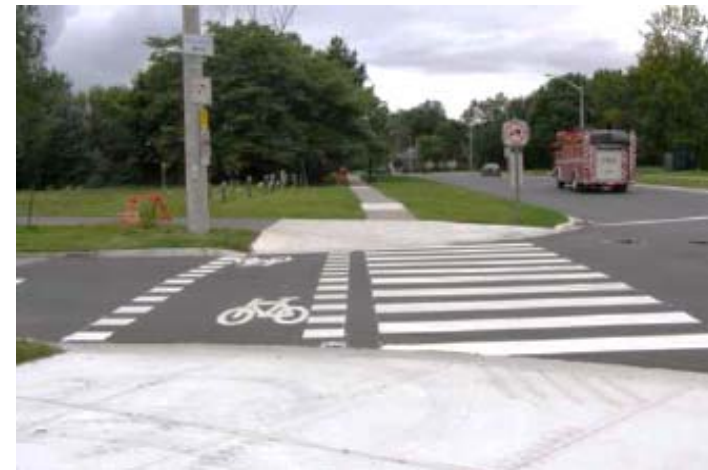
The Ontario Traffic Manual is the design guideline for active transportation facilities and the Ontario Cycling Strategy's vision is to make cycling a viable transportation mode. The Region's Active Transportation Plan recommends a multi-use trail on Mayfield Rd. For more information on the Region's AT program visit:

Bicycle detection systems and cross ride treatments will be evaluated in the detailed design stage.
