Hydrogeology Report

**Re: Mayfield Road Environmental Assessment  
Existing Conditions - Hydrogeology**

Please find attached a hydrogeological assessment of the proposed alternatives for the improvements to Mayfield Road between Chinguacousy Road and Heart Lake Road.

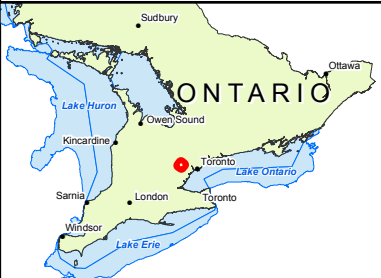
**Surficial Geology**

- 3: Paleozoic bedrock
- 5d: Glaciolacustrine-derived silty to clayey till
- 8b: Interbedded flow till, rainout deposits and silt and clay
- 9c: Foreshore-basinal deposits
- 19: Modern alluvial deposits
- 20: Organic deposits

The study area is located in the South Slope Physiographic Region, which consists of undulating till plains with limited relief. The major surface material is Halton till, which is up to 10 m thick. Recent alluvium consisting of gravel, sand, silt and clay is expected in the vicinity of Little Etobicoke Creek, and organic deposits of muck and peat are found in the wetland complex on the north side of Mayfield Road between Heart Lake Road and Kennedy Road. Groundwater was noted to be near ground surface in the vicinity of the wetlands, and some upwelling into Spring Creek north of Mayfield Road. Private wells are expected to be in use west of McLaughlin Road, which is a rural area. There may be some residences on private wells east of this, however.

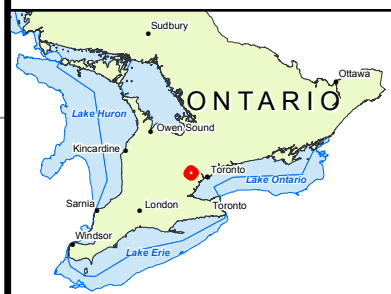
- MOE Water Well
- Roads
- Watercourse
- Study Area
- Water Area, Permanent
- Wetland Area, Permanent
- 500 m from Mayfield Road

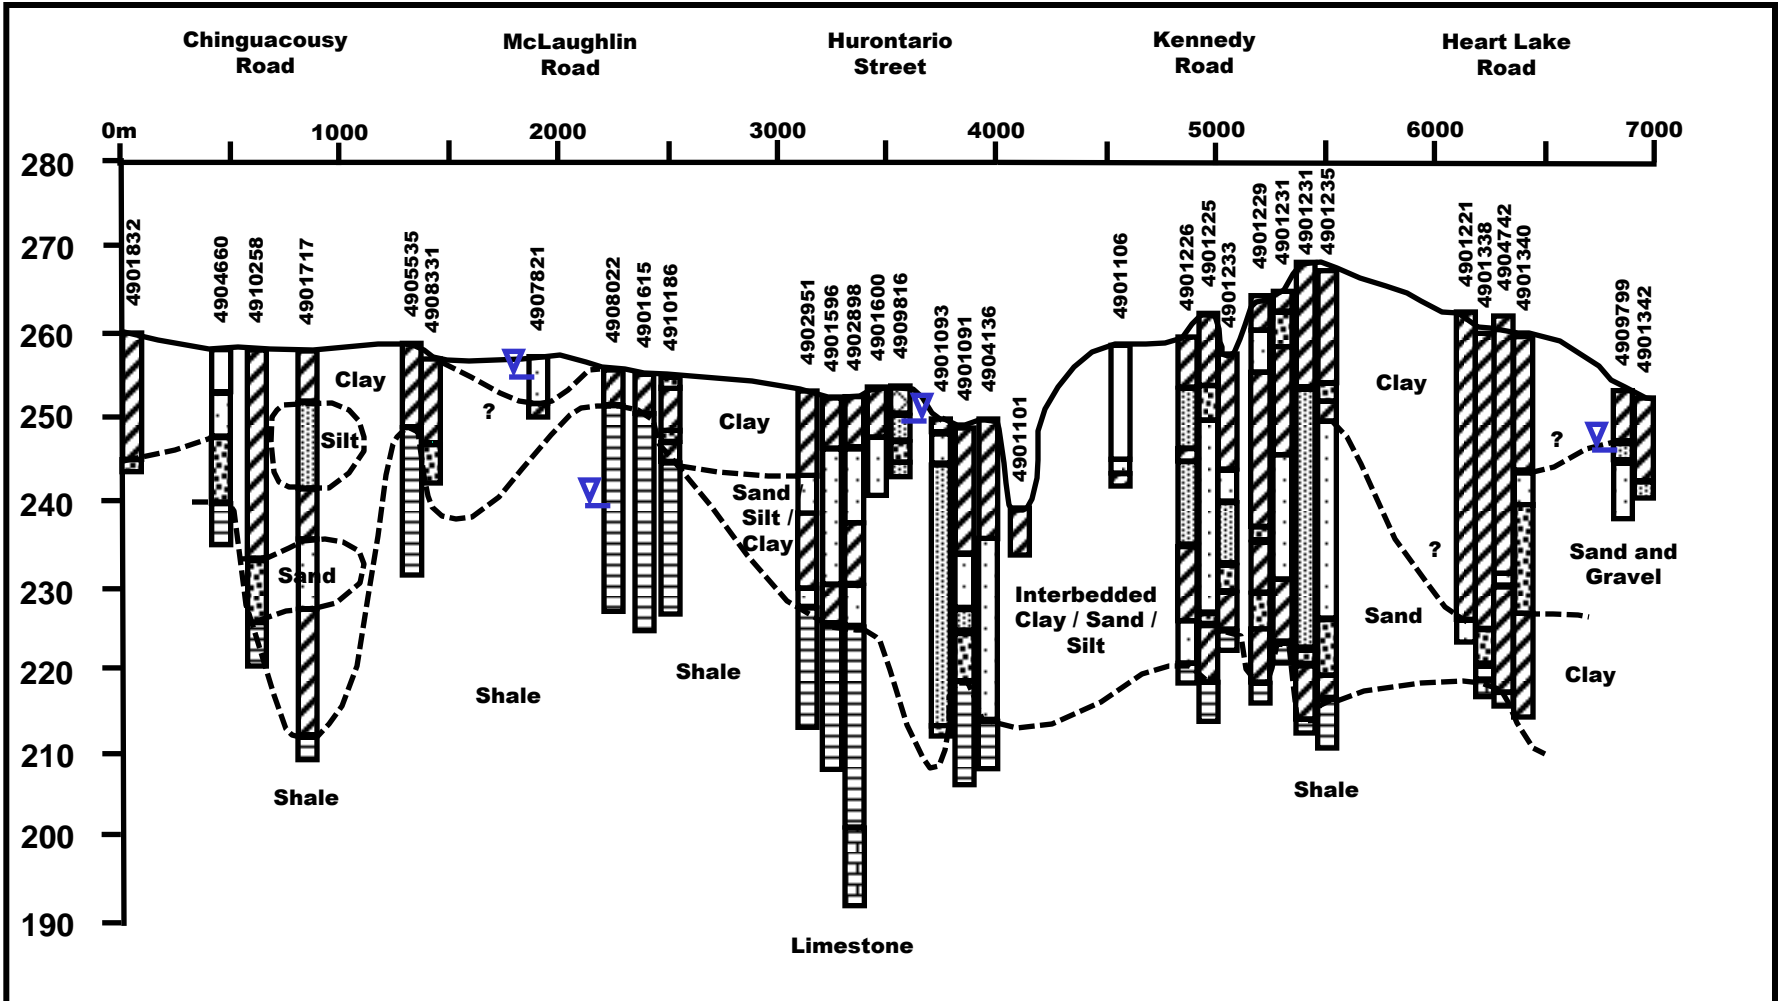
CLIENT	CONSULTANT(S) GENIVAR
PROJECT TITLE	MAYFIELD ROAD EA
DRAWING TITLE	CONCEPTUAL CROSS-SECTION FROM MOE WATER WELL RECORDS
SCALE	DATE OCTOBER 2013
PROJECT NO. 101-17262-00	DRAWING NO. FIGURE 5

Water well records were obtained from MOE within 500 m of the study area (Figure 4). Wells along Mayfield road were selected and plotted on a cross-section (Figure 5). In the western portion of the alignment in the vicinity of Chinguacousy Road, clay is found at ground surface between 5 and 25 m in thickness. The clay contains up to 10 m thick layers of silt, sand and gravel, and overlies bedrock, which ranges between 15 and 50 m bgs. Bedrock rises to 5 – 10 m bgs towards McLaughlin Road, and is overlain by clay. As the alignment approaches Hurontario Street, depth to bedrock increases to approximately 40 – 50 m bgs. The overburden becomes more complex as well. While a thin layer of clay is still found at ground surface (5 – 10 m in thickness), beneath this unit are interbedded layers of sand, silt and clay of varying thicknesses. These conditions persist towards Heart Lake Road, where the surficial clays become much thicker (15 – 40 m) with isolated sand, silt and gravel pockets. Groundwater levels identified in the MOE database were sporadic and typically were located near the bottom of the well. As such, these data are not considered to be a reliable indicator of actual groundwater conditions.

The data found in the MOE water well database was found to be much more complicated than the interpretations provided by the YPDT cross-section. Aside from surficial clays being identified across the entire study area, no specific regional aquifer / aquitard relationships could be determined from the data.
