**Cultural Heritage Assessment Report:
Built Heritage Resources and Cultural Heritage Landscapes**

**Mayfield Road Class Environmental Assessment
Chinguacousy Road to Heart Lake Road
Regional Municipality of Peel, Ontario**

ASI File 10EA-364

July 2011 (Revised November 2013, October 2014)

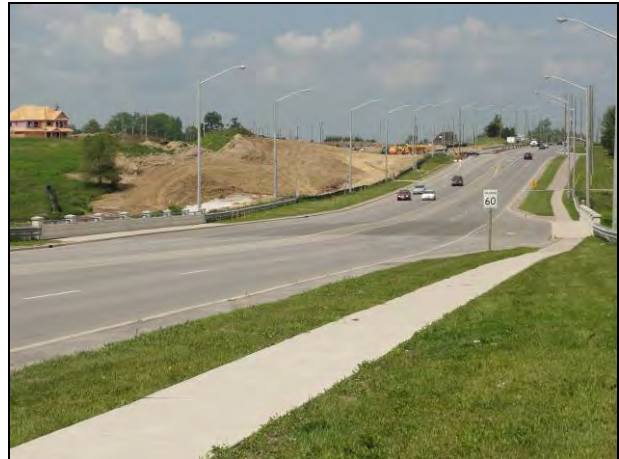
Plate 6: View of the bridge that carries Mayfield Road across Etobicoke Creek and of ongoing construction.

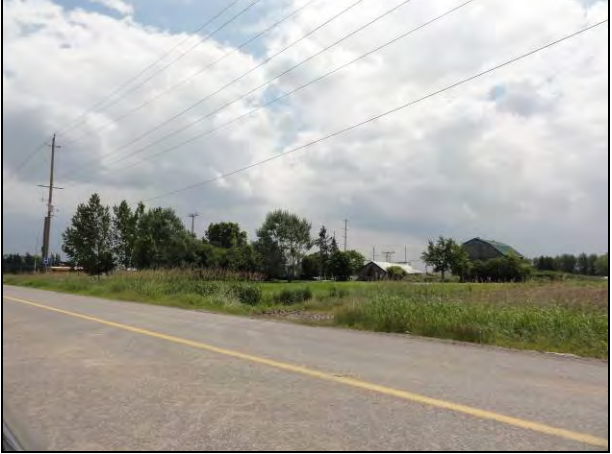
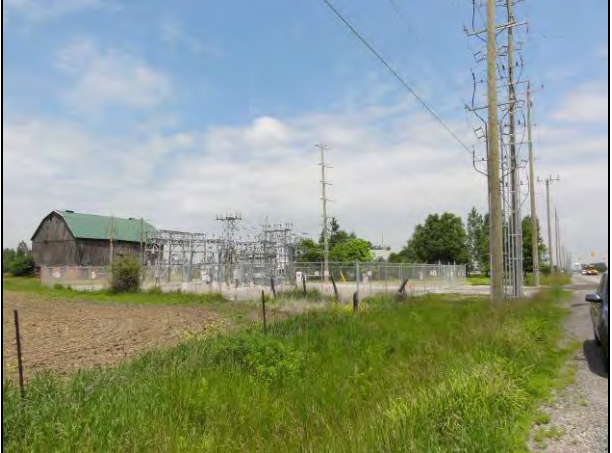
Feature	Inventory Description	Photograph(s)
CHL 1	<p>The farmscape features a one-and-a-half storey residence with a gable roof, an internal brick chimney, and synthetic siding. Agricultural structures include a gambrel barn that sits on a red brick foundation as well as a smaller gable roof outbuilding. Mature vegetation surrounds the residence, which is accessed via Chinguacousy Road. Younger vegetation is found along Mayfield Road. Part of the property along Mayfield Road has been severed by a Hydro One easement.</p> <p>A farmhouse with orchard associated with Pat. McLean is illustrated at this location on the 1877 atlas map.</p>

<p>View of the farmstead property from Chinguacousy Road.</p>

<p>View of the gambrel barn and the Hydro One easement along Mayfield Road.</p>
	Location: 12016 Chinguacousy Road	
	Feature Type: Farmscape	
	Recognition: Heritage Inventory, Town of Caledon

Resource	Potential Impact(s)	Proposed Mitigation Measure(s)
CHL 1	Alteration (III.2) due to encroachment on frontage, and potential removal of trees and vegetation for the construction of a sidewalk within the existing property limits.	<ul style="list-style-type: none"> • Implement tree protection zones to retain existing trees on the property, as feasible; • Landscape documentation should be carried out prior to construction; • Post-construction landscaping to re-establish pre-construction conditions.
CHL 2	No negative impacts anticipated since all heritage attributes are located outside of the affected area.	<ul style="list-style-type: none"> • None
CHL 3	No negative impacts anticipated since all heritage attributes are located outside of the affected area.	<ul style="list-style-type: none"> • None
CHL 4	No negative impacts anticipated	<ul style="list-style-type: none"> • None
CHL 5	Alteration (III.2) due to encroachment on frontage, and potential removal of trees and vegetation for the construction of a sidewalk within the existing property limits.	<ul style="list-style-type: none"> • Implement tree protection zones to retain existing trees on the property, as feasible; • Landscape documentation should be carried out prior to construction; • Post-construction landscaping to re-establish pre-construction conditions.

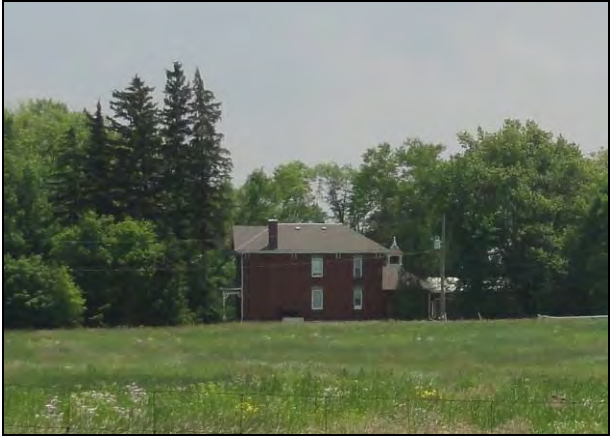
Feature	Inventory Description	Photograph(s)
CHL 2	<p>The farmscape, better known as Beechwood Farm, features a two storey brick residence with a hipped roof and a number of agricultural outbuildings. The structures are located over 300 metres south of Mayfield Road. The residence, which faces Chinguacousy Road, is characterized by a gable dormer on its front façade, a one-storey rear accretion, an external brick chimney, brackets underneath overhanging eaves, and buff-brick flat arches over the windows. Agricultural buildings include one silo, at least two nineteenth-century barns, as well as a number of more modern outbuildings.</p> <p>A farmhouse with orchard associated with Hy. Moody is illustrated at this location on the 1877 atlas map.</p>	  <p>View of the farm property from Mayfield Road.</p>

<p>Close-up view of the farmhouse.</p>
	Location: 11687 Chinguacousy Road	
	Feature Type: Farmstead

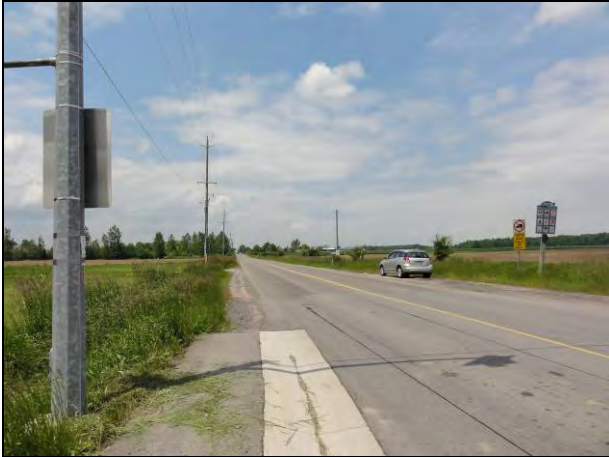
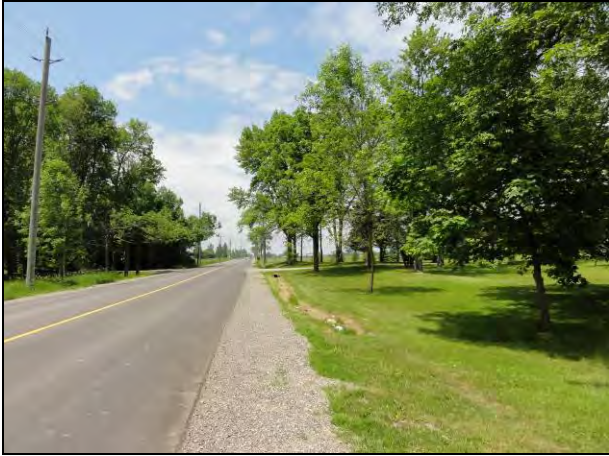
Feature	Inventory Description	Photograph(s)
CHL 4	Historically, Chinguacousy Road forms the road allowance between Concession II West and Concession III West in the Township of Chinguacousy. The roadscape is characterized by a narrow, two-lane paved road with little to no shoulders. It is framed by active farms both north and south of Mayfield Road.

<p data-bbox="820 779 1425 835">Looking north along Chinguacousy Road, north of Mayfield Road.</p>

<p data-bbox="820 1323 1425 1379">Looking north along Chinguacousy Road, south of Mayfield Road.</p>
	Location: Chinguacousy Road	
	Feature Type: Roadscape	
	Recognition: Identified during the field review

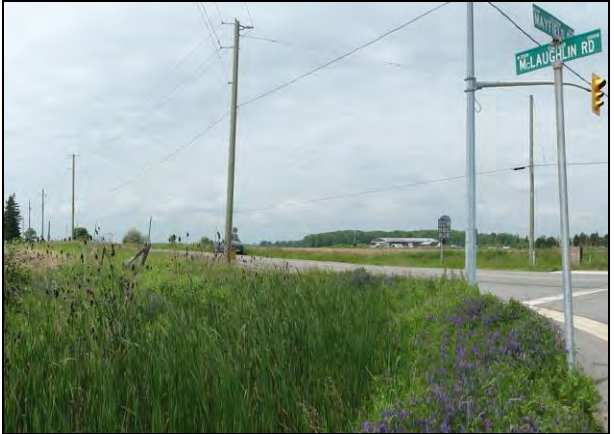
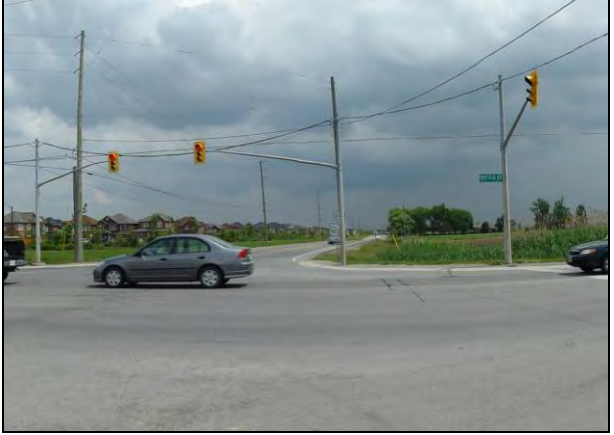
Feature	Inventory Description	Photograph(s)
CHL 6	<p>Historically, McLaughlin Road forms the road allowance between Concession I West and Concession II West in the Township of Chinguacousy. North of Mayfield Road, the roadscape is characterized by a narrow, two-lane paved road with narrow gravel shoulders and shallow ditches. It is framed on both sides by active farms. South of Mayfield Road, however, McLaughlin Road is bordered to the east by a recent subdivision (does not appear on the aerial mapping provided in this report) and as such, it is no longer evocative of its historical agricultural roots.</p>

<p>McLaughlin Road, north of Mayfield Road.</p>
	Location: McLaughlin Road, north of Mayfield Road	
	Feature Type: Roadscape	
	Recognition: Identified during the field review

<p>McLaughlin Road, south of Mayfield Road.</p>

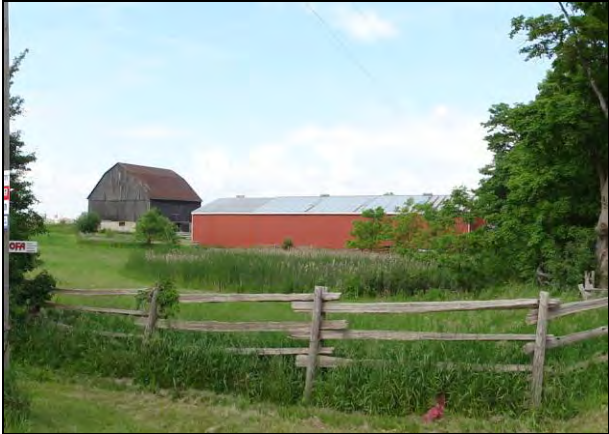
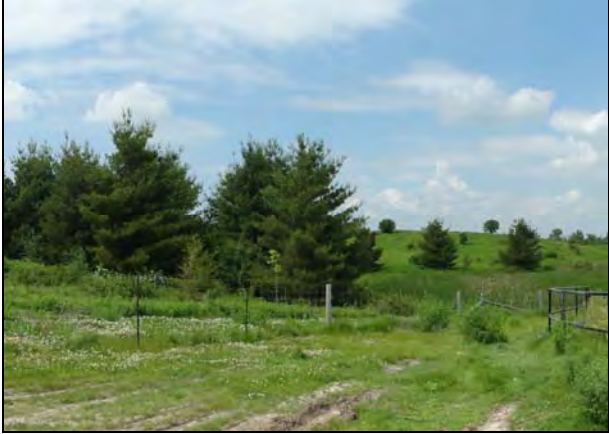
Feature	Inventory Description	Photograph(s)
CHL 7	<p>This farmscape features a modified brick residence, a gambrel roofed barn on repaired stone foundations, and a number of additional modern agricultural outbuildings. Heritage Caledon describes the residence as a Neo-classical farmhouse dating to c. 1840s. The residence is accessible by a gravel driveway leading from Kennedy Road. An older post and rail fence marks the western boundary of the property which is currently for sale. The structures are located over 225 metres north of Mayfield Road.</p> <p>The scenic landscape between the buildings and Mayfield Road retains much of its natural, gently-rolling topography (with the exception of a storm water management pond in the northeast corner of the Mayfield Road and Kennedy Road intersection).</p> <p>A farmhouse associated with Sam Snell is illustrated at this location on the 1859 Tremaine map and a a farmhouse with orchards associated with William Patterson is illustrated on the 1877 atlas map.</p>

<p>View of the agricultural outbuildings.</p>

<p>View of the gently rolling topography just north of Mayfield Road. The storm water management pond is located to the right of this view.</p>

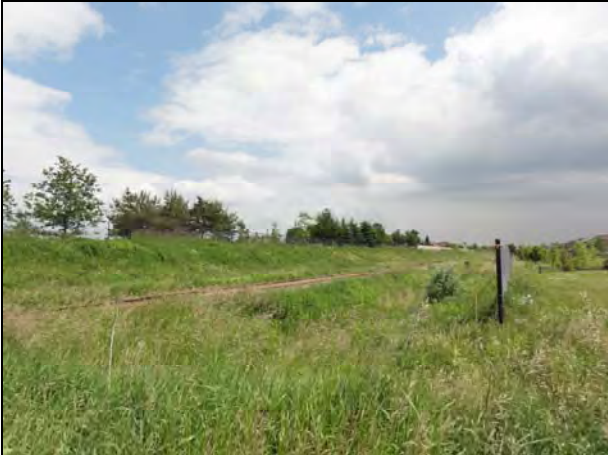
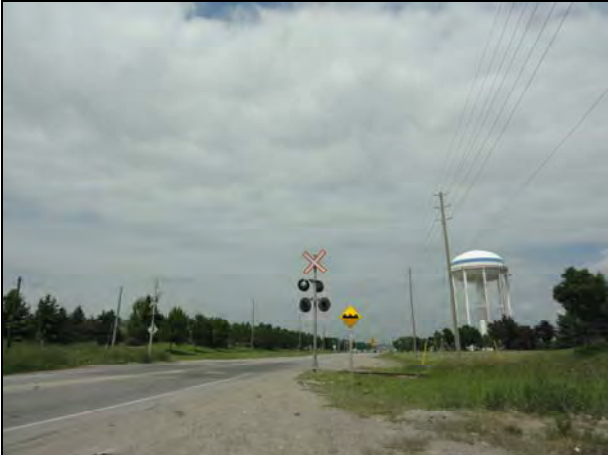
Feature	Inventory Description	Photograph(s)
CHL 8	<p>The former Credit Valley Railway, now CP rail, intersects Mayfield Road approximately halfway between McLaughlin Road and Hurontario Street and consists of a single track. The rail line is illustrated on the 1877 historic atlas map.</p> <p>The Scheinman study determined that the Credit Valley Railway “manifest sufficient cultural value to warrant ongoing consideration for preservation in any future urban boundary expansion or development scheme which might be proposed for the area.” (cited in Town of Caledon 2010: 15-16)</p>

<p>View south along the CP rail line</p>

<p>View east along Mayfield Road at the CP Rail line crossing.</p>
	Location: CP rail	
	Feature Type: Railscape	
	Recognition: Identified as part of the Mayfield West Secondary Plan (Phase 2) study
