**FLUVIAL GEOMORPHOLOGY AND HYDRAULIC ASSESSMENTS
ENVIRONMENTAL ASSESSMENT (EA) AND PRELIMINARY DESIGN
FOR DRAINAGE IMPROVEMENTS OF HIGHWAY 50 FROM
MAYFIELD ROAD TO HEALEY ROAD
REGION OF PEEL, CALEDON, ONTARIO**

Prepared for:
R.V. ANDERSON ASSOCIATES LIMITED

Prepared by:
MATRIX SOLUTIONS INC.

Version 1.1
November 2021
Mississauga, Ontario

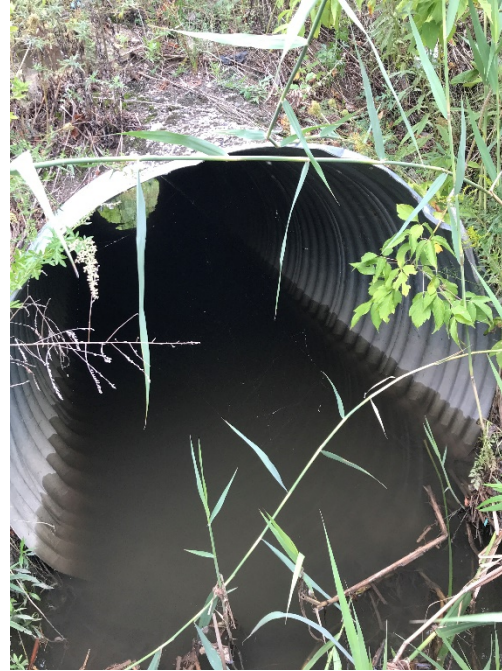
FIGURE 6 Culvert 2 Downstream End

The upstream end is comprised of a protruding culvert barrel; oriented northerly to convey approaching watercourse flows with vegetated embankments and concrete block end walls. The upstream end is partially obstructed by debris (both natural and “urban” debris), slumping slopes, and overhanging vegetation (Figure 5). The downstream end is comprised of a protruding culvert barrel with vegetated embankments and no formalized end treatments (Figure 6).

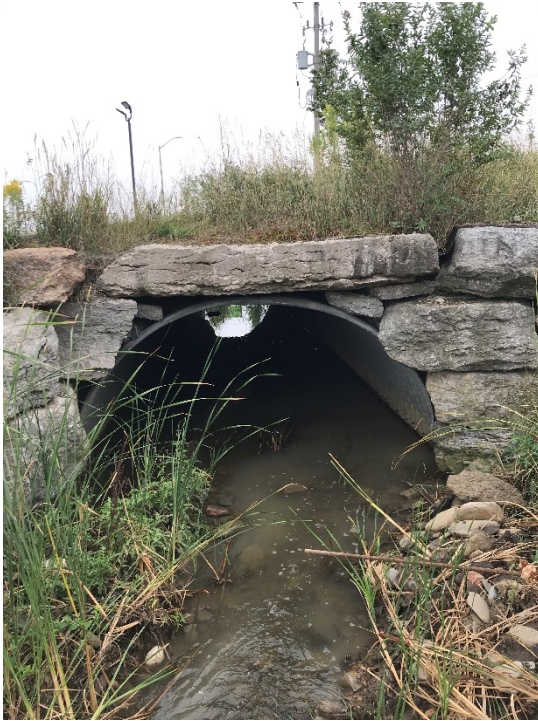
FIGURE 7 Culvert 3 Upstream End

Notably, this structure was appraised as “Fair Condition” by the structure condition assessments completed by Region of Peel. The corresponding Region of Peel structure ID is: “FROM - RR050-0215 TO - RR050-0216.”

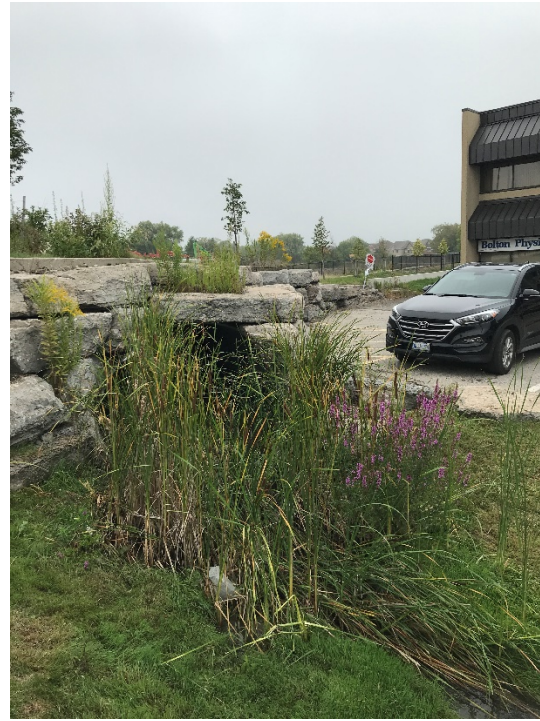
FIGURE 8 Culvert 3 Downstream End

The upstream end is comprised of an open culvert span, oriented northerly to convey approaching watercourse flows with armourstone wingwalls/headwall (Figure 7). The downstream end is comprised of an open culvert span with armourstone wingwalls/headwall (Figure 8).

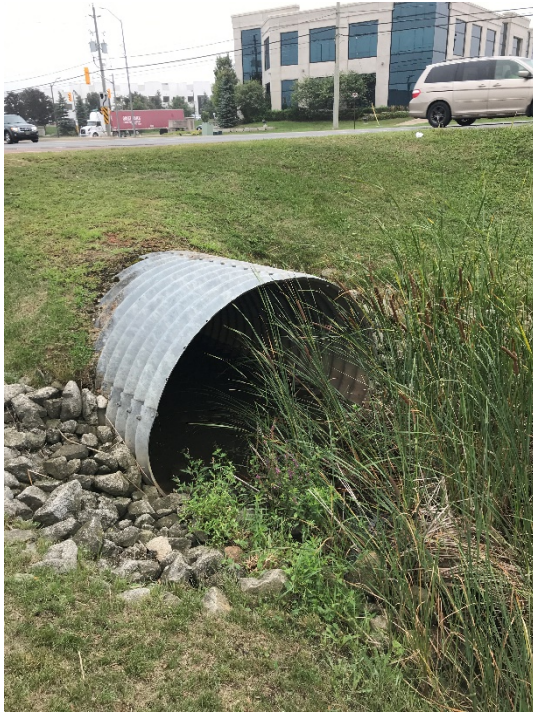
FIGURE 9 Culvert 4 Upstream End

Notably, this structure was appraised as “Fair Condition” by the structure condition assessments completed by Region of Peel. The corresponding Region of Peel structure ID is: “FROM - RR050-0213 TO - RR050-0214.”

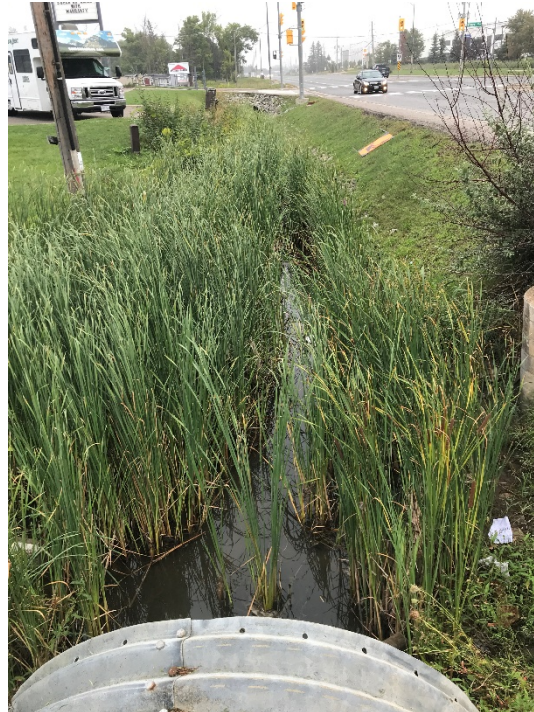
FIGURE 10 Culvert 4 Looking Downstream

The upstream end is comprised of a protruding culvert barrel, oriented northerly to convey approaching watercourse flows with riprap stone/manicured grass embankments and no formalized end treatment (Figure 9). The downstream end is comprised of a protruding culvert barrel with manicured grass embankments and no formalized end treatment (Figure 10).

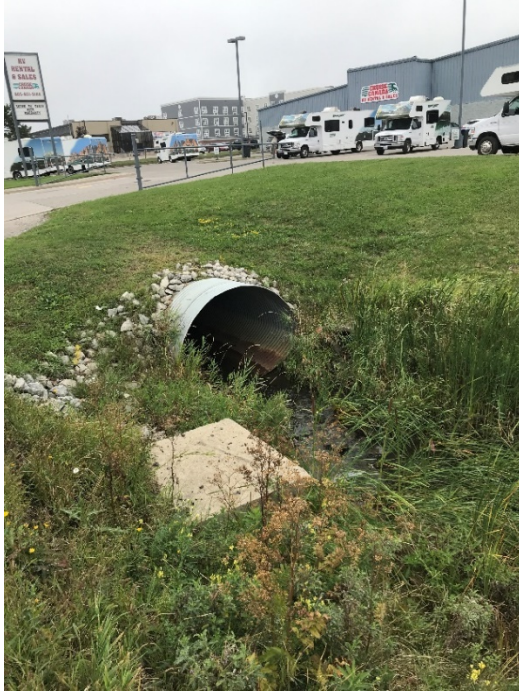
FIGURE 11 Culvert 5 Downstream End

Notably, this structure was appraised as “Fair Condition” by the structure condition assessments completed by Region of Peel. The corresponding Region of Peel structure ID is: “FROM - RR050-0211 TO - RR050-0212.”

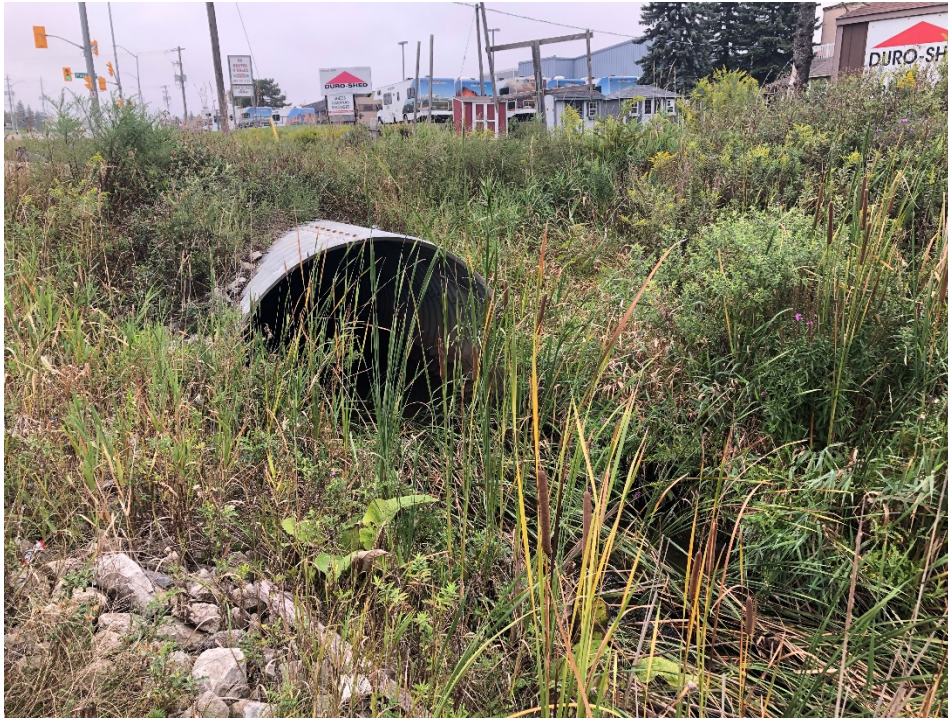
FIGURE 13 Culvert 6 Downstream End

Notably, this structure was appraised as “Fair Condition” by the structure condition assessments completed by Region of Peel. The corresponding Region of Peel structure ID is: “FROM - RR050-0209 TO - RR050-0210.”

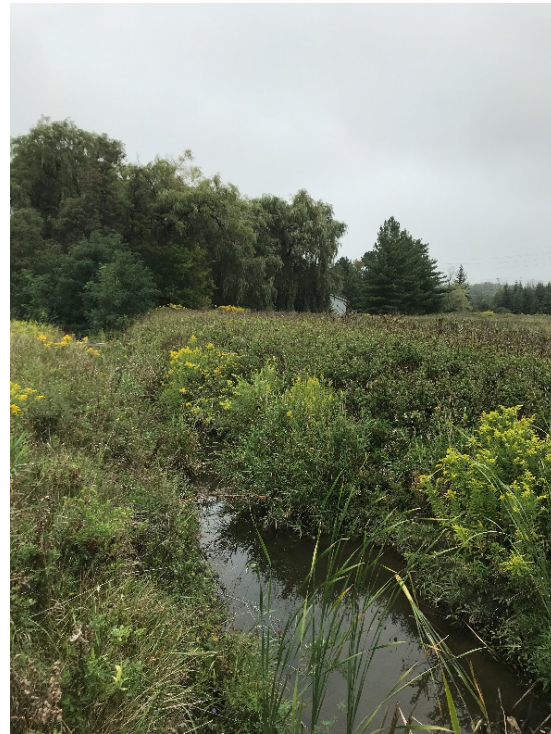
FIGURE 20 Previous Channel Realignment Looking Upstream

In consultation with the project team, it has been identified that an approximate 80 m length of the watercourse upstream of Culvert 7 has been historically realigned by a private landowner (Figure 20), for which TRCA is currently involved and pursuing restitution.

It is recommended that the status of this realignment be further understood by the EA team, as it pertains to ramifications of the assessed alternatives for improvement.

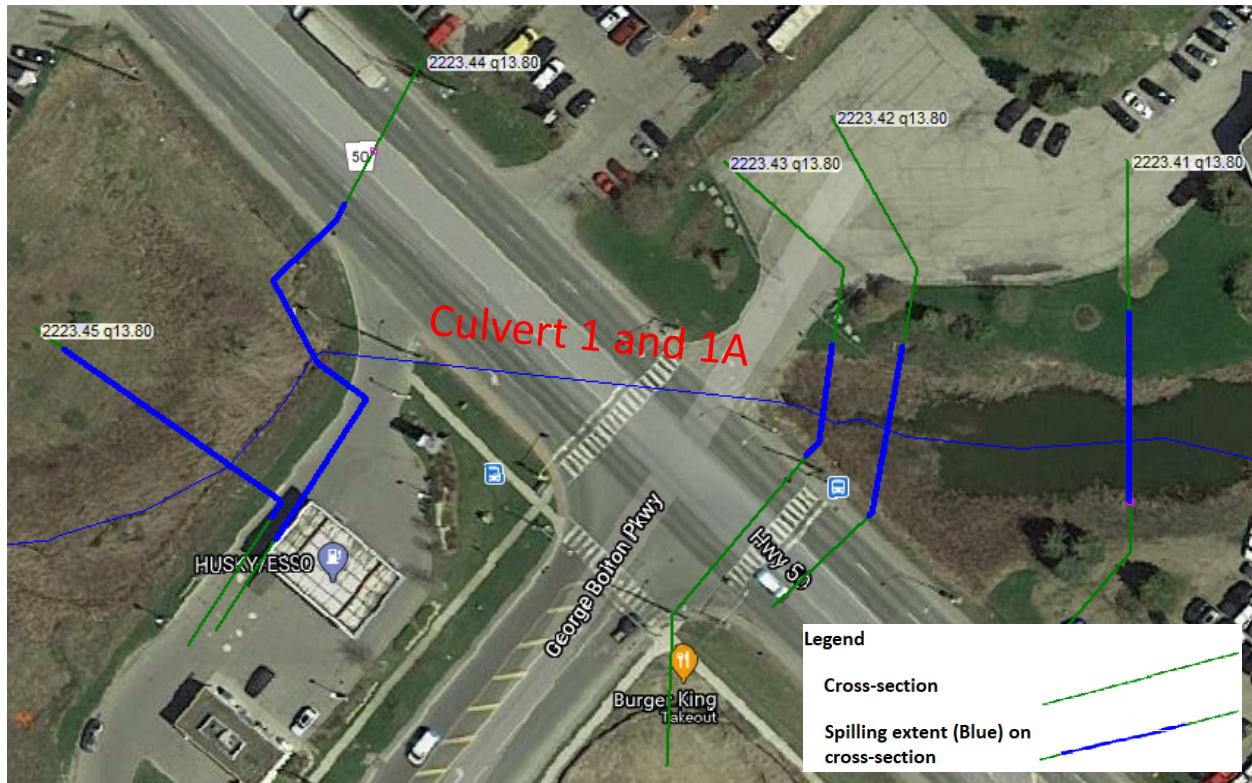
FIGURE 22 Culvert 1 Water Extents on Cross-sections During the Regional Event

Component	Value (m)						
C1 Upstream Invert Elevation	236.76						
C1 Upstream Obvert Elevation	237.36						
C1A Upstream Invert Elevation	236.79						
C1A Upstream Obvert Elevation	237.67						
Driveway Elevation	238.50						
Return Period	2-year	5-year	10-year	25-year	50-year	100-year	Regional
Flow (m ³ /s)	3.11	4.26	5.11	6.18	7.05	7.90	13.80
Water Surface Elevation (m)	238.50	238.54	238.56	238.59	238.61	238.63	238.75
Freeboard to Obvert Elevation on Culvert 1 (m)	-1.14	-1.18	-1.20	-1.23	-1.25	-1.27	-1.39
Culvert Submergence on Culvert 1	Y	Y	Y	Y	Y	Y	Y
Freeboard to Obvert Elevation on Culvert 1A (m)	-0.83	-0.87	-0.89	-0.92	-0.94	-0.96	-1.08
Culvert Submergence on Culvert 1A	Y	Y	Y	Y	Y	Y	Y
Freeboard to Driveway (m)	0.00	-0.04	-0.06	-0.09	-0.11	-0.13	-0.25
Driveway Overtopping	Y	Y	Y	Y	Y	Y	Y

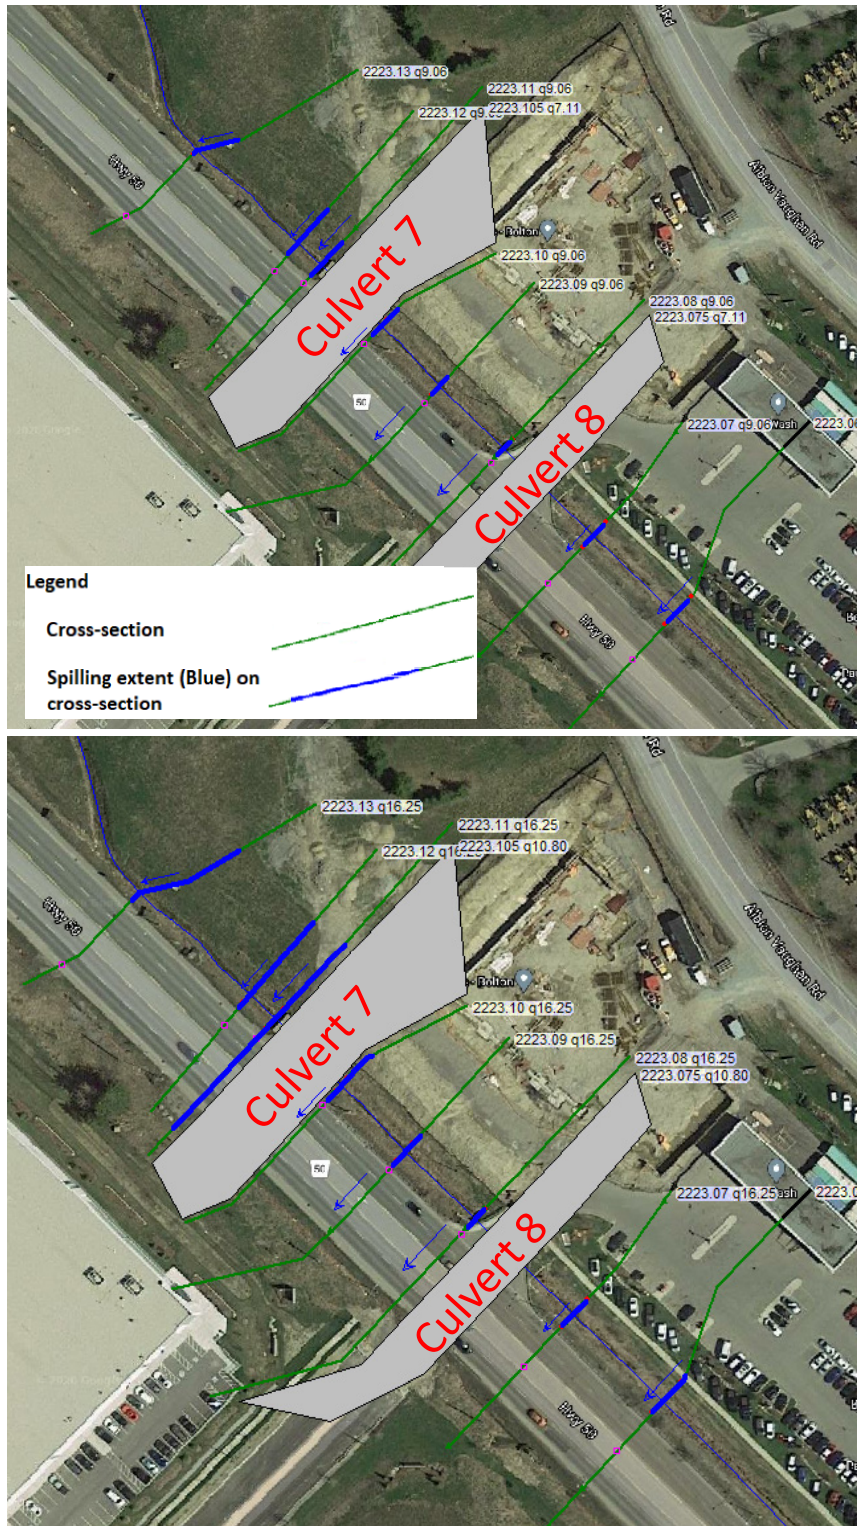
FIGURE 28 Culverts 7 and 8 Water Extents on Cross-sections During the 100-year (Top) and Regional Event (Bottom)

Figure 28 plots water extents on cross-sections adjacent to Culverts 7 and 8 for the Regional event. During the 2-year through 100-year events, water does not encroach RR50 at any adjacent. During the Regional event, the watercourse experiences high water levels from backwater upstream of Culvert 7. In this case, water encroaches RR50 and spills across to the west side of the road. For reaches downstream of Culvert 7 and adjacent to Culvert 8, water is contained in the channel and does not encroach RR50.

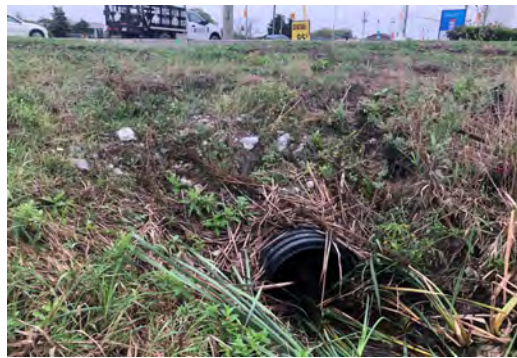
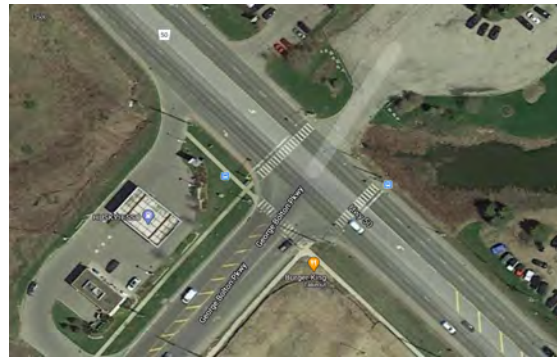
Channel Disturbance Hardened with riprap around culvert at road

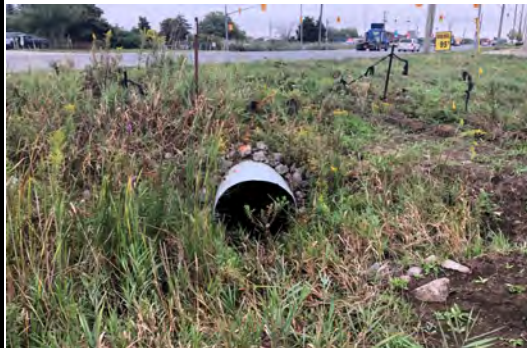
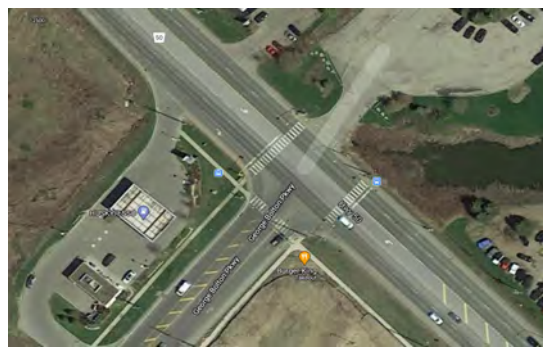
Channel Disturbance Hardened with riprap around culvert at road

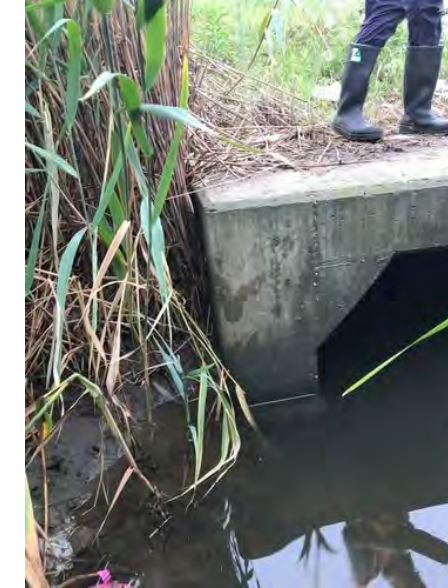
14. Culvert 1 Outlet

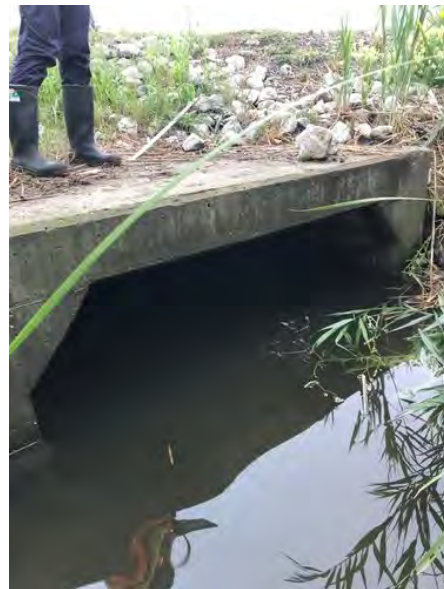
15. Culvert 1 Outlet

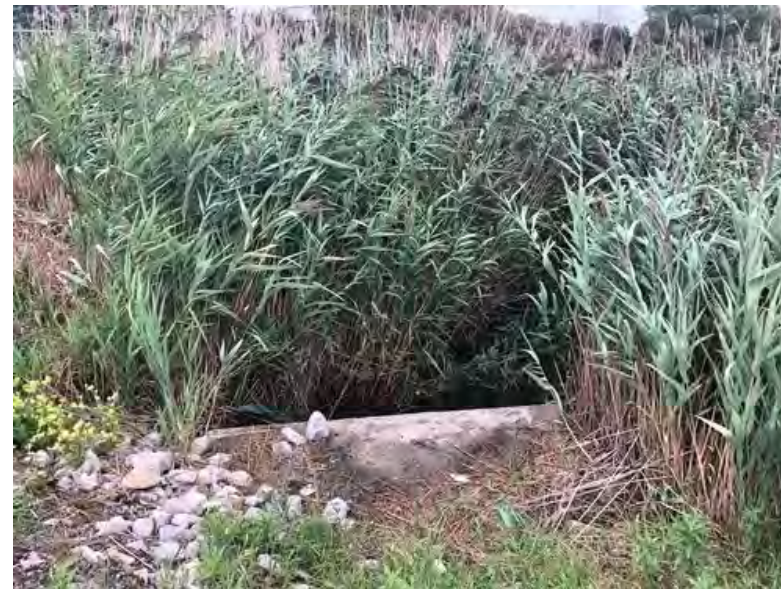
16. Culvert 1 Outlet

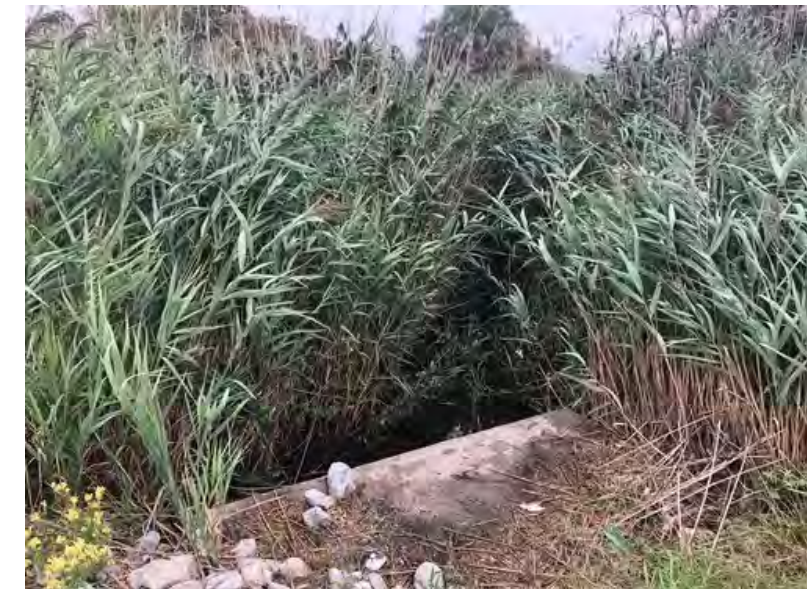
17. Culvert 1 Outlet

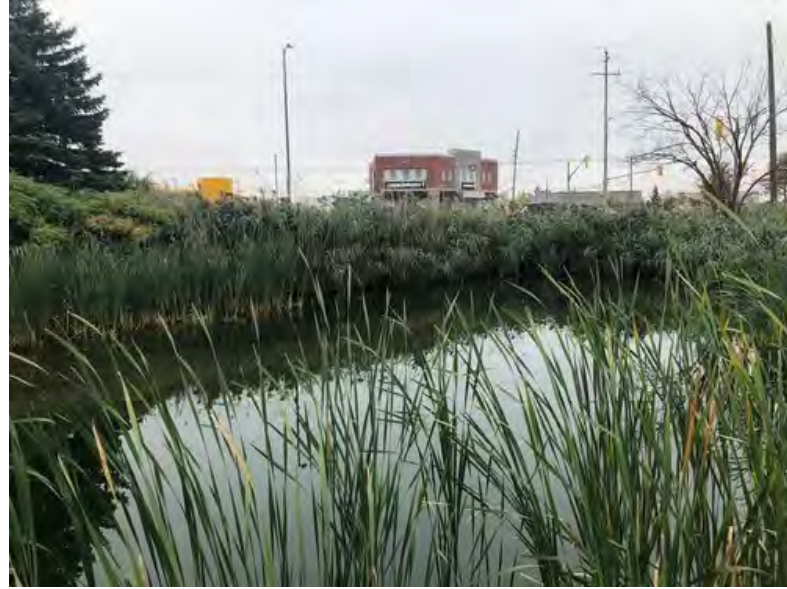
18. Culvert 1 Outlet

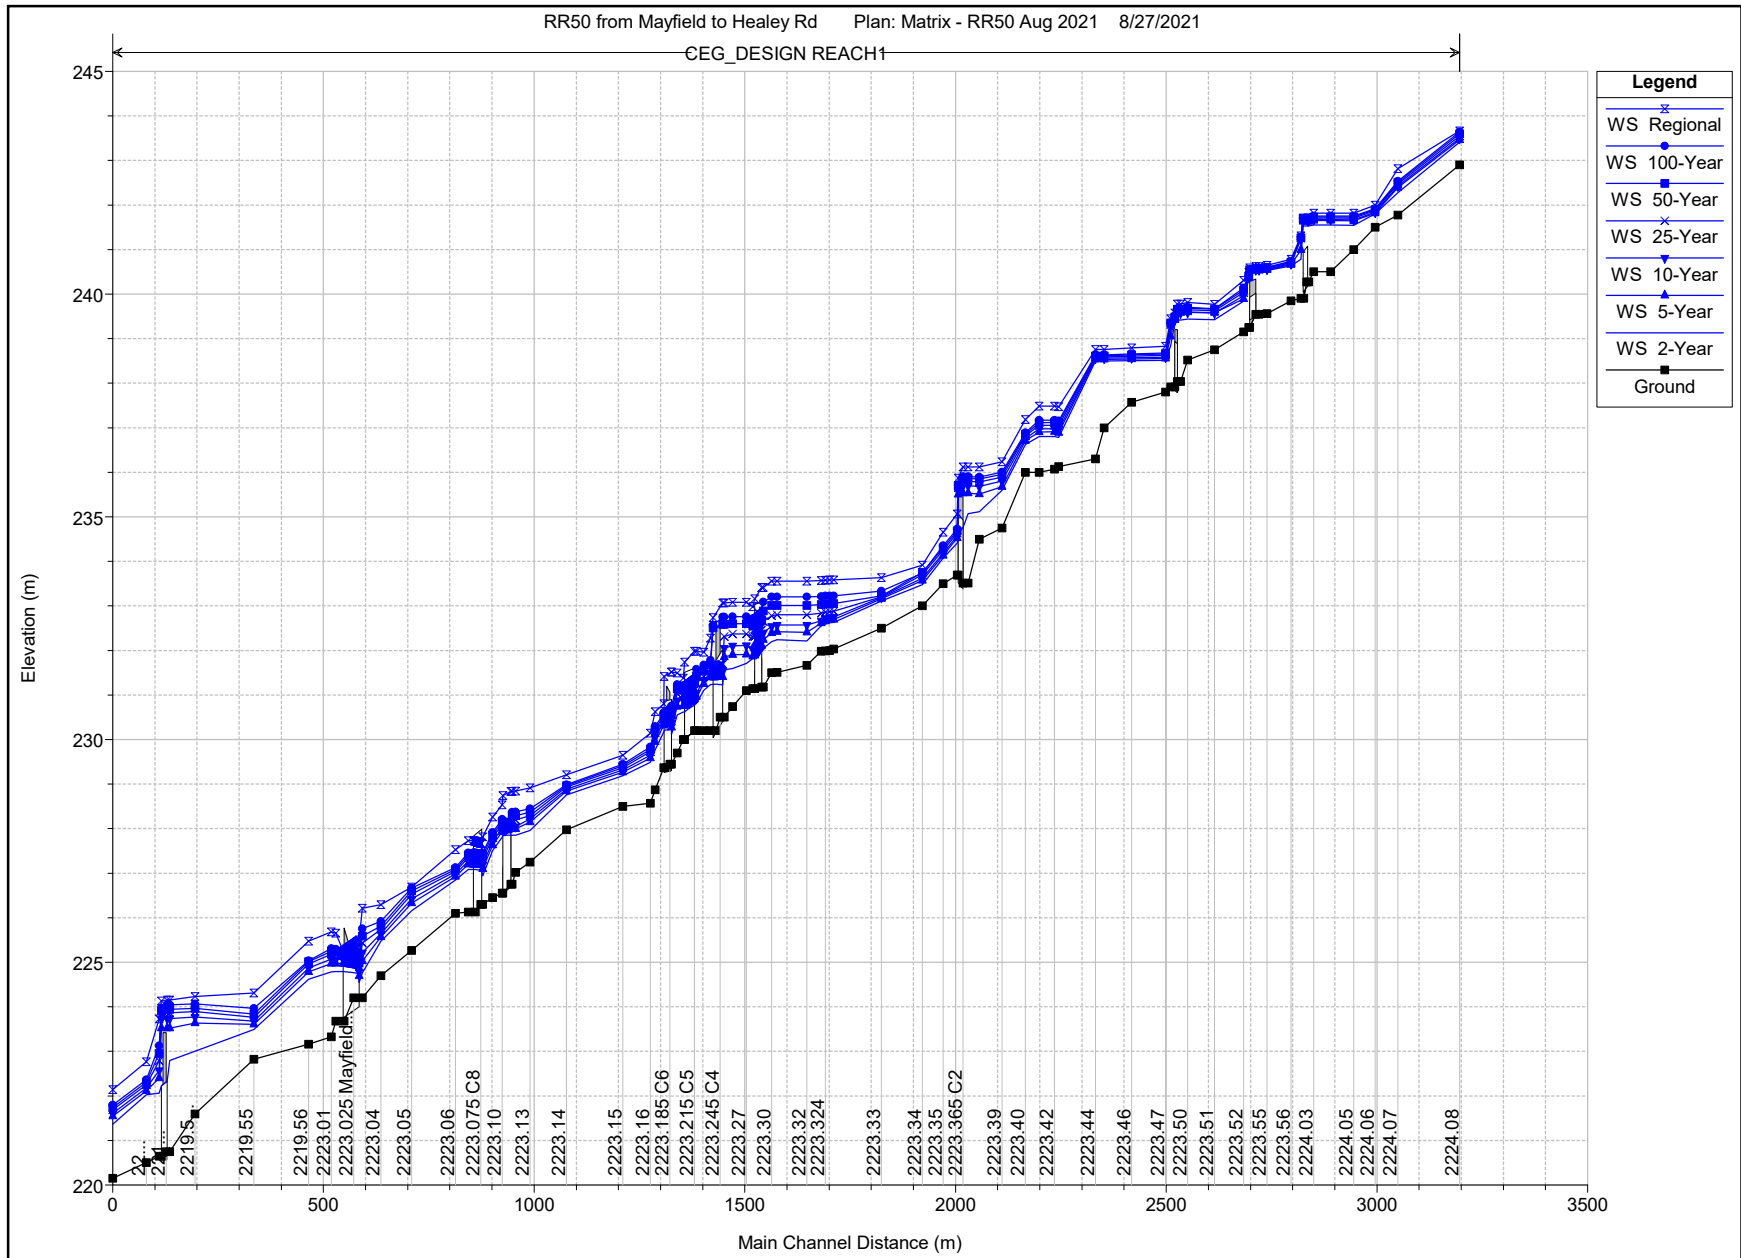
Item 4 – Water Surface Elevation Profile
