Appendix I Contamination Report

FINAL THURBER ENGINEERING REPORTS WINSTON CHURCHILL BOULEVARD CLASS EA STUDY HIGHWAY 401 TO EMBLETON ROAD REGION OF PEEL

WINSTON CHURCHILL **BOULEVARD CLASS EA CONTAMINATED SOIL ASSESSMENT**

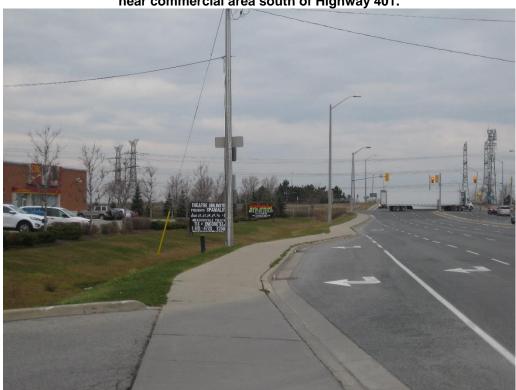
- At the south end of the study area, several commercial properties were observed on both sides of Winston Churchill Boulevard, as part of shopping complexes located on the north side of Argentia Road (Photos 3 and 4). Within the study area, the commercial properties include a Rona Home and Garden Centre, a CIBC Bank, a Best Buy store, and other retail stores. South of the limit of the study area, Shell and Esso gas stations are located at the northwest and southeast corners of the intersection at Argentia Road.

PHOTO 3: Looking north along west side of Winston Churchill Blvd., near commercial area south of Highway 401.

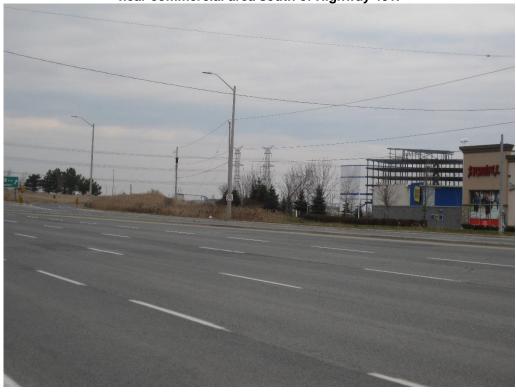
PHOTO 4: Looking northeast at east side of Winston Churchill Blvd., near commercial area south of Highway 401.

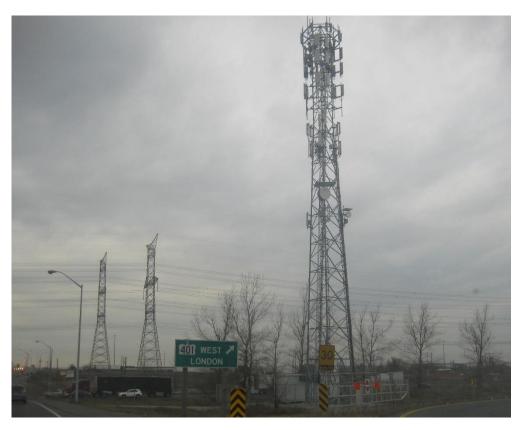
- A cellular tower was observed on the east side of Winston Churchill Boulevard, within the Highway 401 interchange area (Photo 5). The tower was surrounded by a chain-link fence and the site included several electrical components and wiring.

PHOTO 5: Looking northeast at cellular tower at Highway 401 interchange.

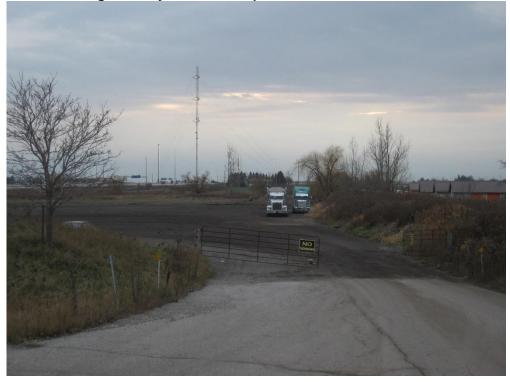
- North of Highway 407, two properties containing gravel yards and transport trucks or other industrial equipment were observed on the west side of the road at 7886 and 7940 Winston Churchill Boulevard (Photos 6 and 7). A self-storage facility, and Clintar landscaping yard are located north and west of these properties respectively. Digital imagery from 2015 shows vehicle and trailer storage at the rear of the self-storage property. The Clintar property is located beyond the limits of the study area.

PHOTO 6: Looking west at yard with transport trucks at 7886 Winston Churchill Blvd.

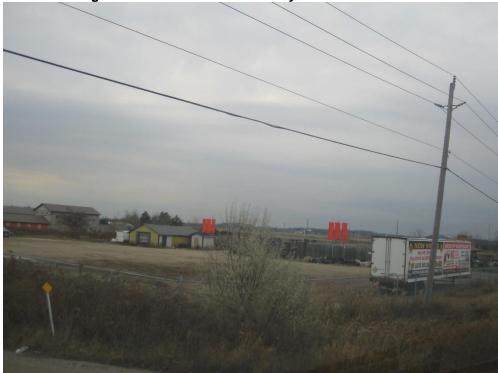
PHOTO 7: Looking northwest towards industrial yard at 7940 Winston Churchill Blvd.

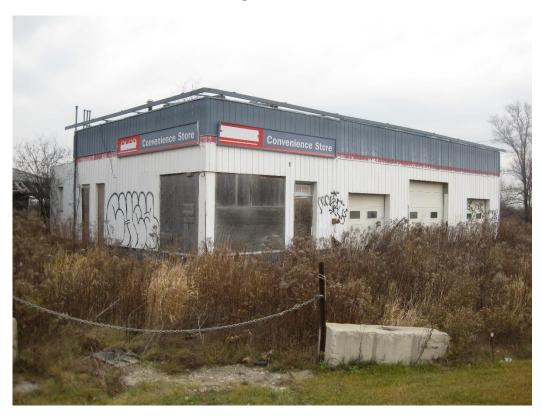
- An abandoned gas station (formerly Olco) was observed at the northeast corner of the Steeles Avenue intersection at 2982 Steeles Avenue East. The property was observed to contain a single-storey building with a former convenience store and three service garage doors. The property grounds were mainly vegetated and surrounded by concrete blocks. No paved areas or fuel pumps were visible. A PVC monitoring well was observed at the southeast corner of the site building. An abandoned single-storey house was observed adjacent to the northwest corner of the gas station building (Photos 10 to 12).

PHOTO 10: Abandoned gas station at 2982 Steeles Ave E.

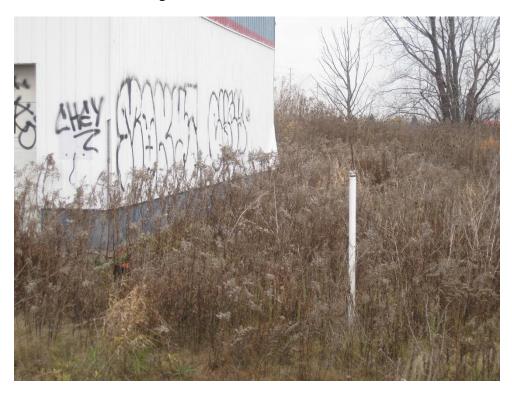
PHOTO 11: PVC monitoring well at southeast corner of 2982 Steeles Ave E building.

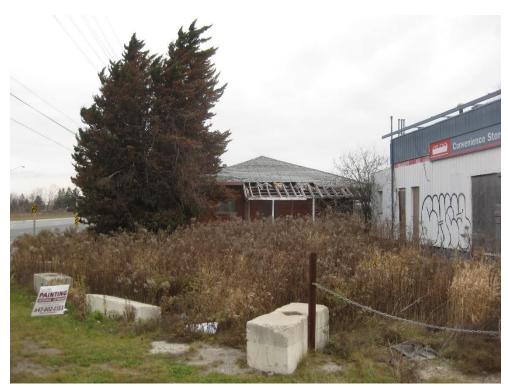
PHOTO 12: Looking north toward abandoned house adjacent to 2982 Steeles Ave E.

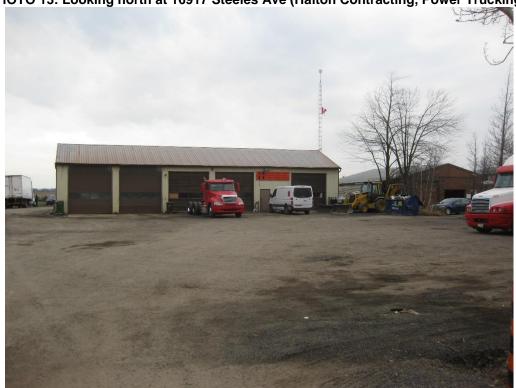
- West of Winston Churchill Boulevard, a contracting company was observed at 16917 Steeles Avenue. Signs were observed on the property for Halton Contracting, as well as Power Trucking Inc. The property contained a gravel yard, garage buildings and several transport trucks and construction equipment (Photo 13). A wood furniture manufacturing company (Halton Homestead) is located west of the contractor property at 16863 Steeles Avenue.

PHOTO 13: Looking north at 16917 Steeles Ave (Halton Contracting, Power Trucking).

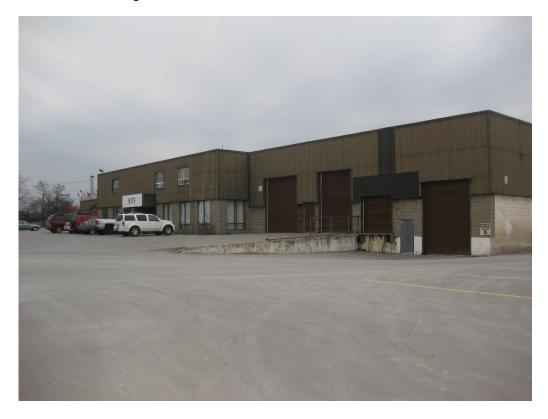
- An industrial warehouse building was observed at 8175 Winston Churchill Boulevard, south of the MLF facility. The north portion of the building was occupied by a Maple Lodge Farms factory outlet chicken shop. Aerial imagery from 2015 shows storage of several transport trucks and metal frames, possibly for sign manufacturing) located behind the building (Photos 14 and 15).

PHOTO 14: Looking northeast towards warehouse at 8175 Winston Churchill Blvd.

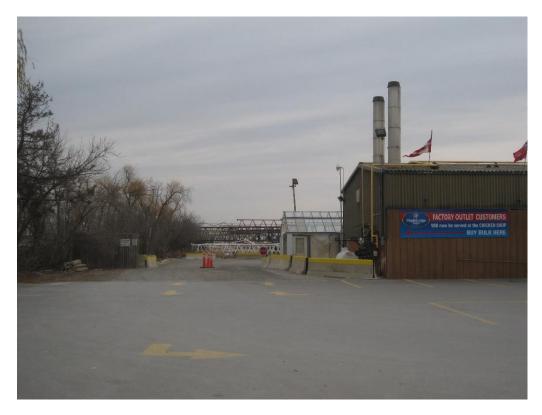
PHOTO 15: Looking east towards metal storage behind Maple Lodge Farms outlet shop at 8175 Winston Churchill Blvd.

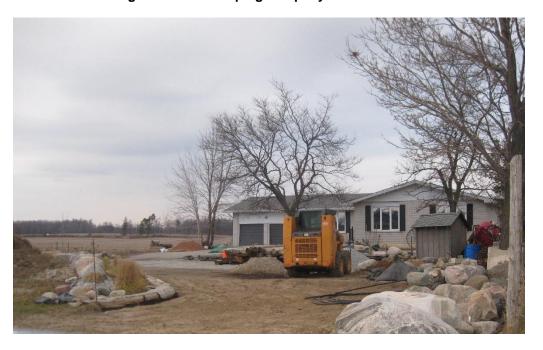
- Several farm properties are located on both sides of Winston Churchill Boulevard between the MLF facility and Embleton Road.
- A landscaping company was observed at 8597 Winston Churchill Boulevard (Mikro Landscaping). The site building appeared to be a residential house, with small excavation equipment and storage of landscaping materials in the front yard area (Photo 20). A garden centre (Lee's Garden Centre and Nursery) is located on the west side of the road at 8564 Winston Churchill Boulevard.
- At the north end of the study area, the land use at the intersection with Embleton Road was observed to be open fields, with some residential properties at the northeast corner (Photos 21 and 22).

PHOTO 20: Looking east at landscaping company at 8597 Winston Churchill Blvd.
