# Airport Road Improvements

Municipal Class Environmental  
Assessment  
Airport Road  
from 1.0km north of Mayfield Road to  
0.6km north of King Street

**PRELIMINARY**  
**FOUNDATION INVESTIGATION AND DESIGN REPORT**  
**SALT CREEK CULVERT, DEANS CULVERT AND NORRIS BRIDGE**  
**AIRPORT ROAD CLASS ENVIRONMENTAL ASSESSMENT (EA)**  
**FROM 930 m NORTH OF MAYFIELD ROAD**  
**TO 244 m NORTH OF KING STREET**  
**REGIONAL MUNICIPALITY OF PEEL, ONTARIO**

File No. 11-12-2096  
December 18, 2014  
©**Terraprobe Inc.**

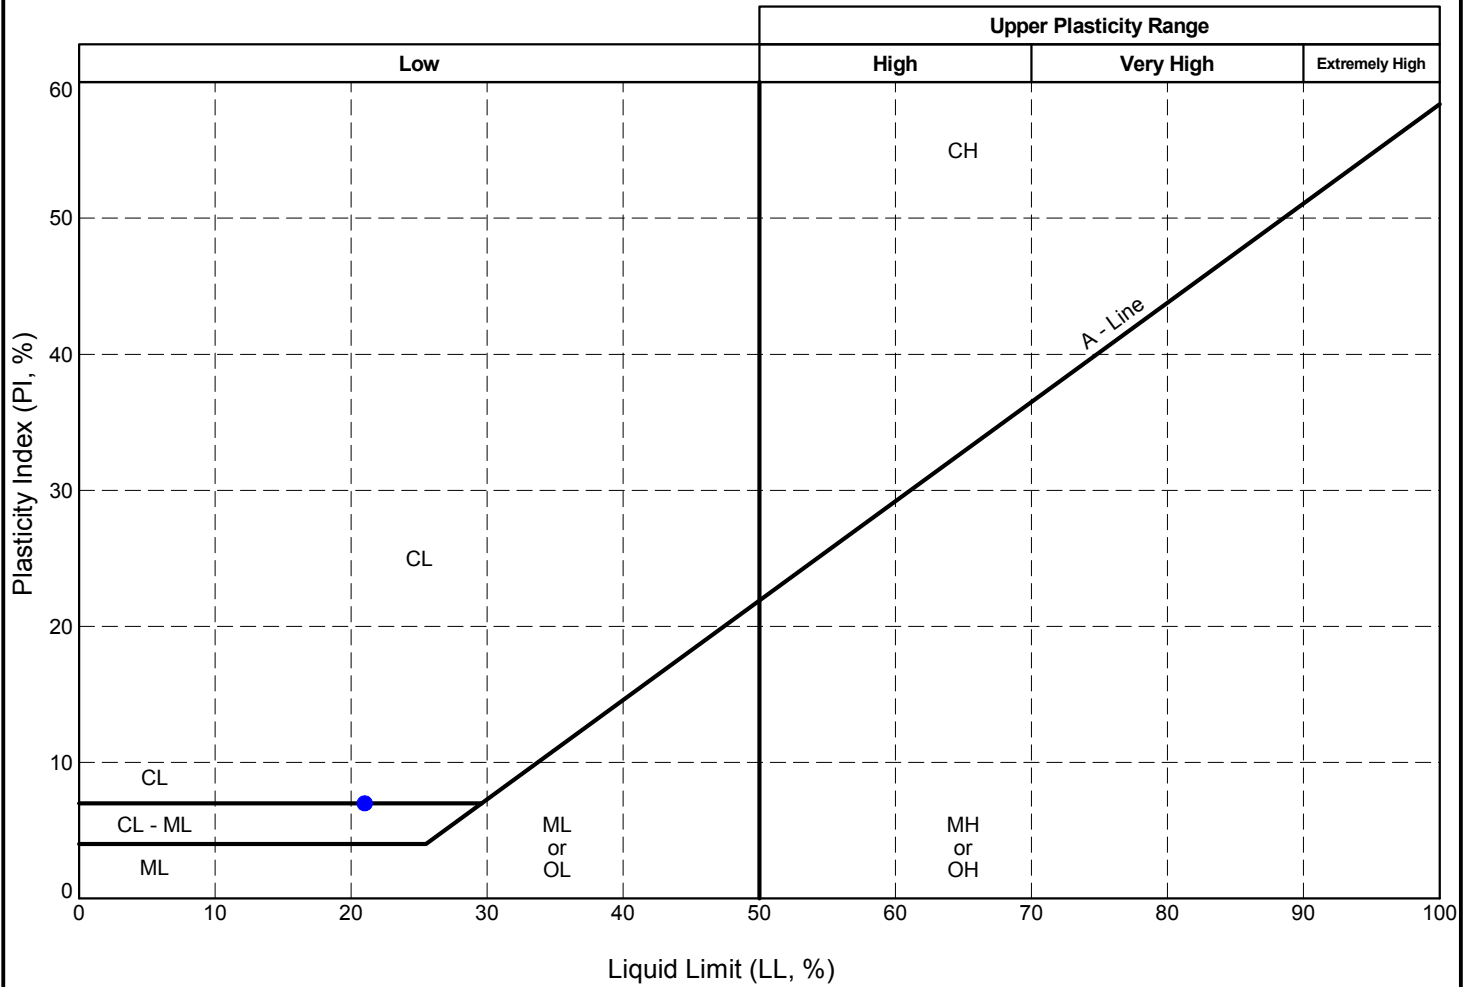
Borehole	Sample	Depth (m)	Elev. (m)	LL (%)	PL (%)	PI (%)	USCS Description
● SC2	SS5	3.3	97.3	21	14	7

Liquid Limit:	21%
Plastic Limit:	14%
Plasticity Index:	7%
Natural Moisture Content:	11%

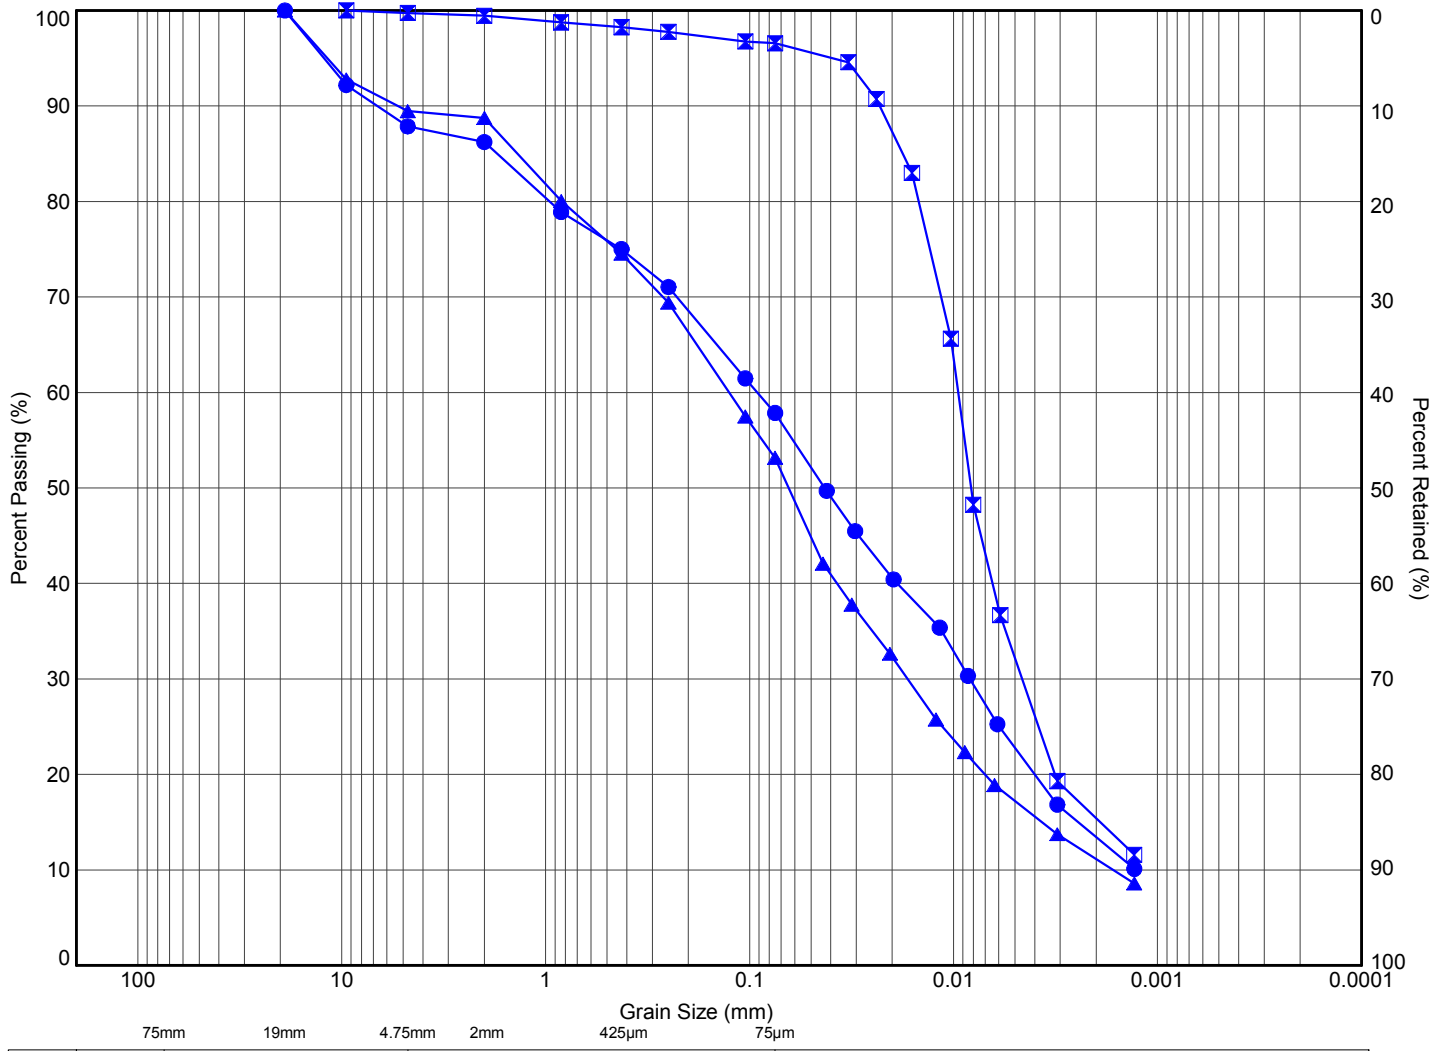
Title: **GRAIN SIZE DISTRIBUTION  
FIGURE B3 - CLAYEY SILT TILL**

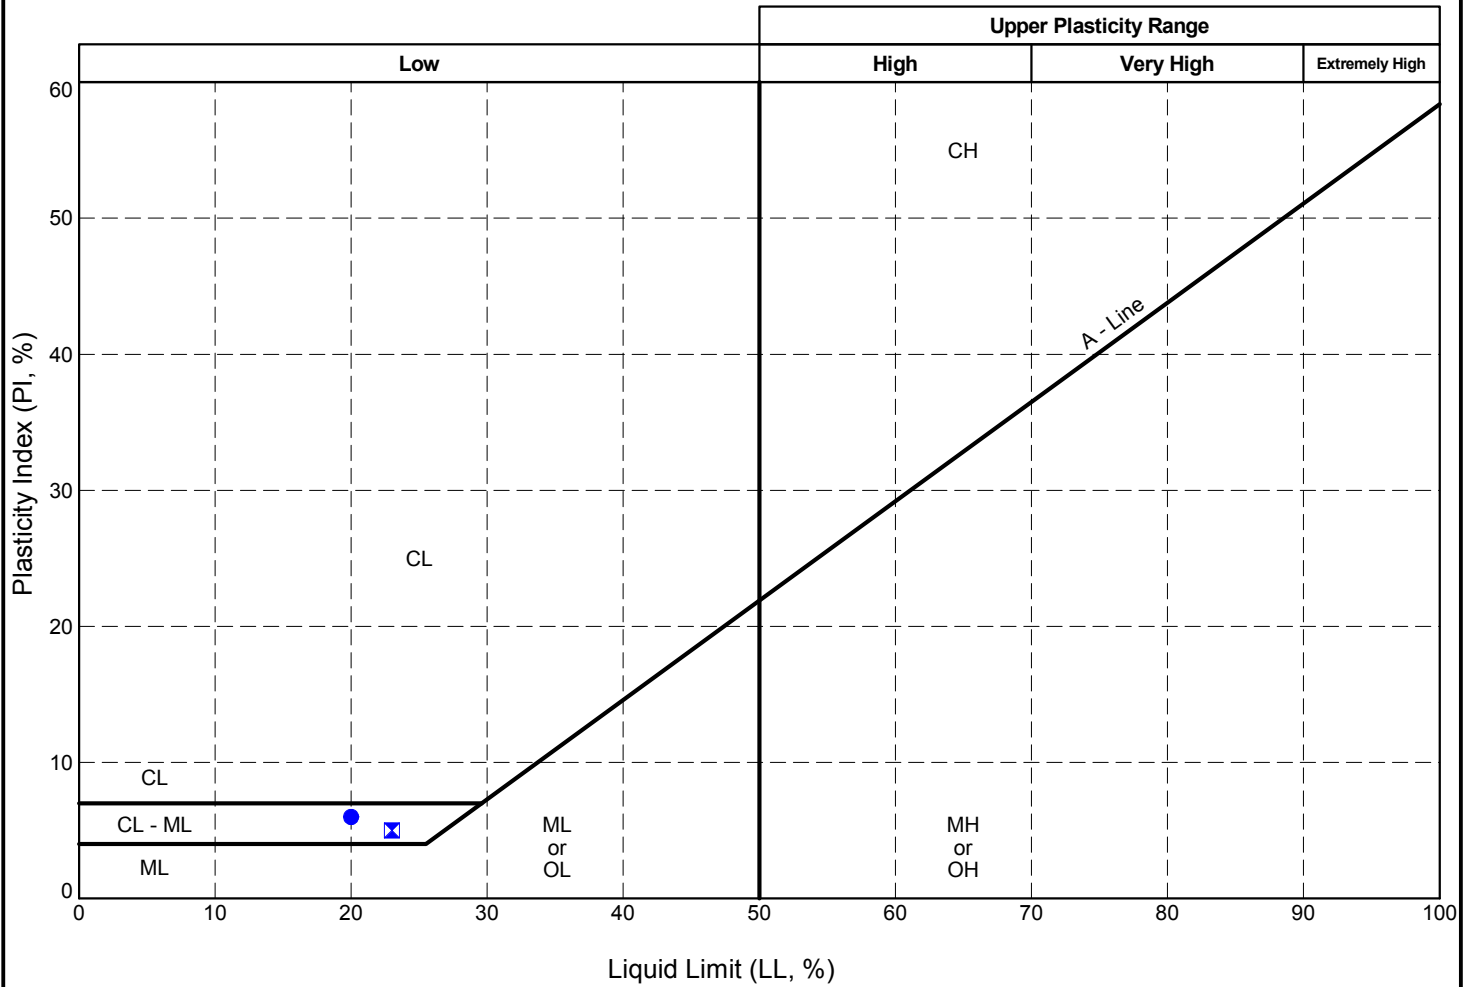
Borehole	Sample	Depth (m)	Elev. (m)	LL (%)	PL (%)	PI (%)	USCS Description
● DC1	SS4	2.5	95.9	20	14	6	
■ DC1	SS8	7.7	90.7	23	18	5

Liquid Limit:	20% and 23%
Plastic Limit:	14% and 18%
Plasticity Index:	5% and 6%
Natural Moisture Content:	9% and 15%

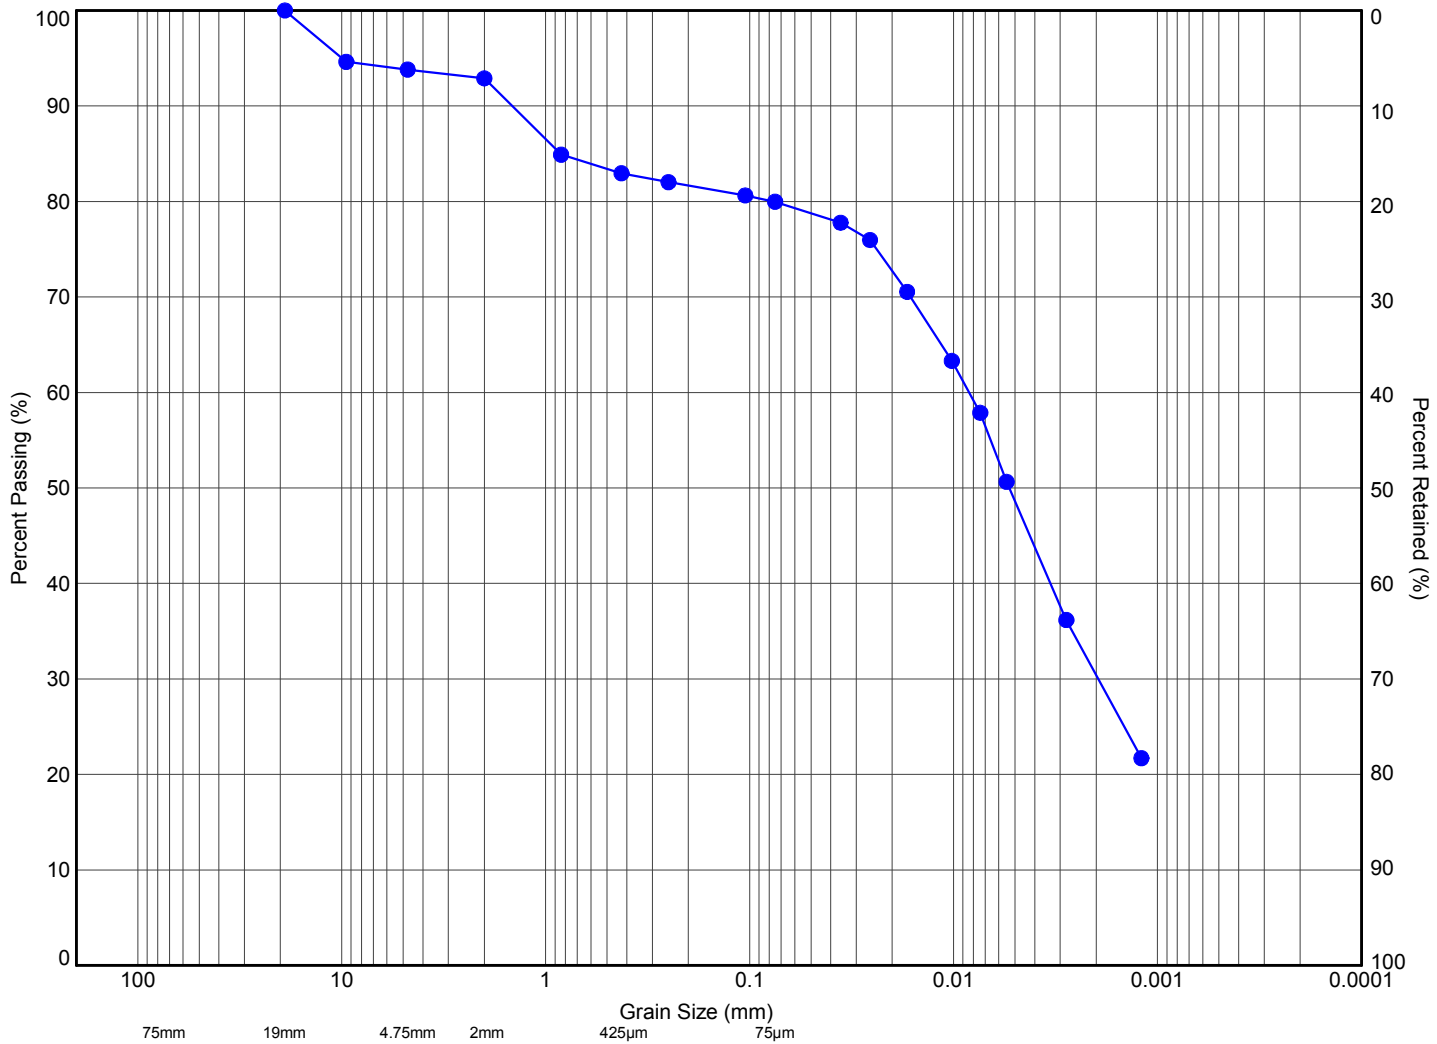
Hole ID	Sample	Depth (m)	Elev. (m)	Gravel (%)	Sand (%)	Silt & Clay (%)	Sample Description
● NB1	SS6	4.0	236.3	6	14	80

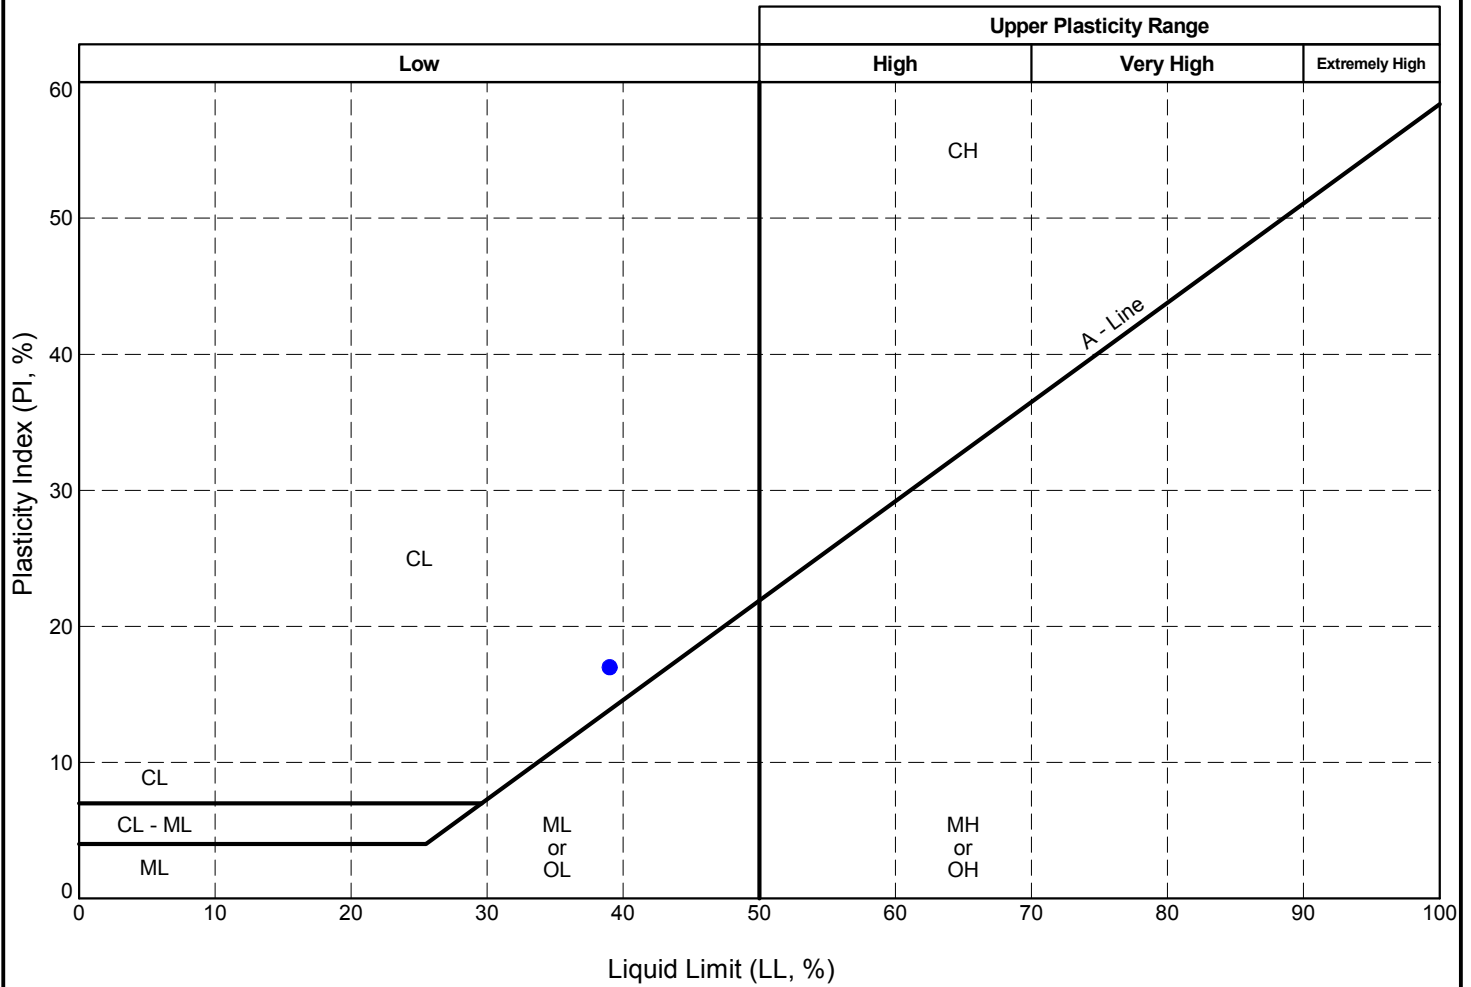
Borehole	Sample	Depth (m)	Elev. (m)	LL (%)	PL (%)	PI (%)	USCS Description
● NB1	SS6	4.0	236.3	39	22	17

Liquid Limit:	39%
Plastic Limit:	22%
Plasticity Index:	17%
Natural Moisture Content:	15%

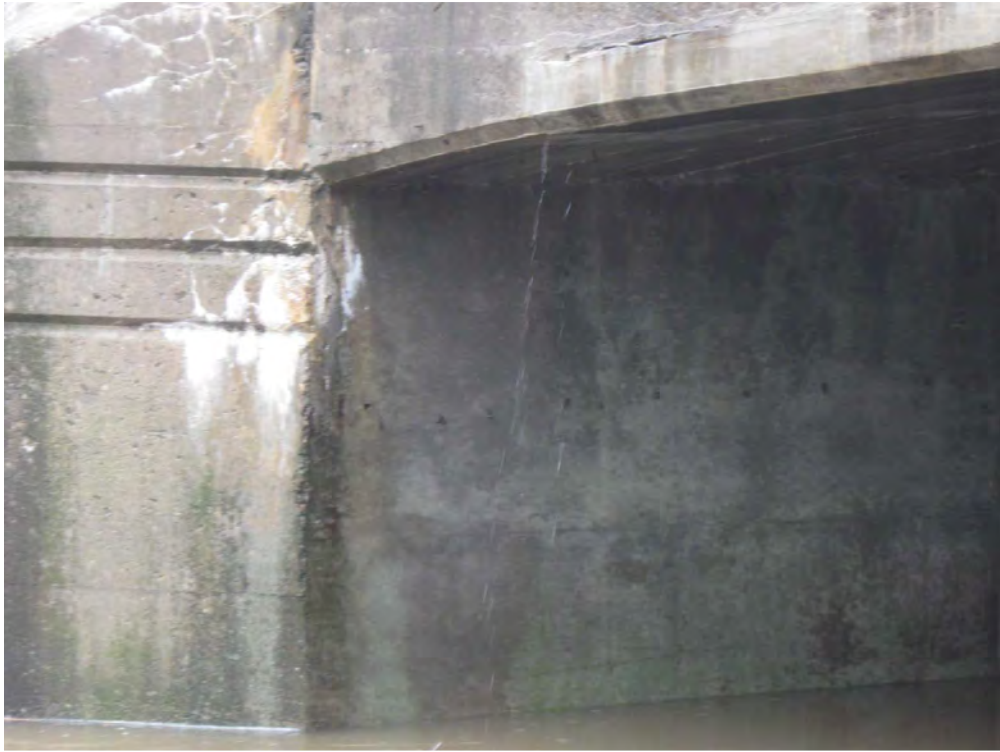
7. Efflorescent and staining on wingwall

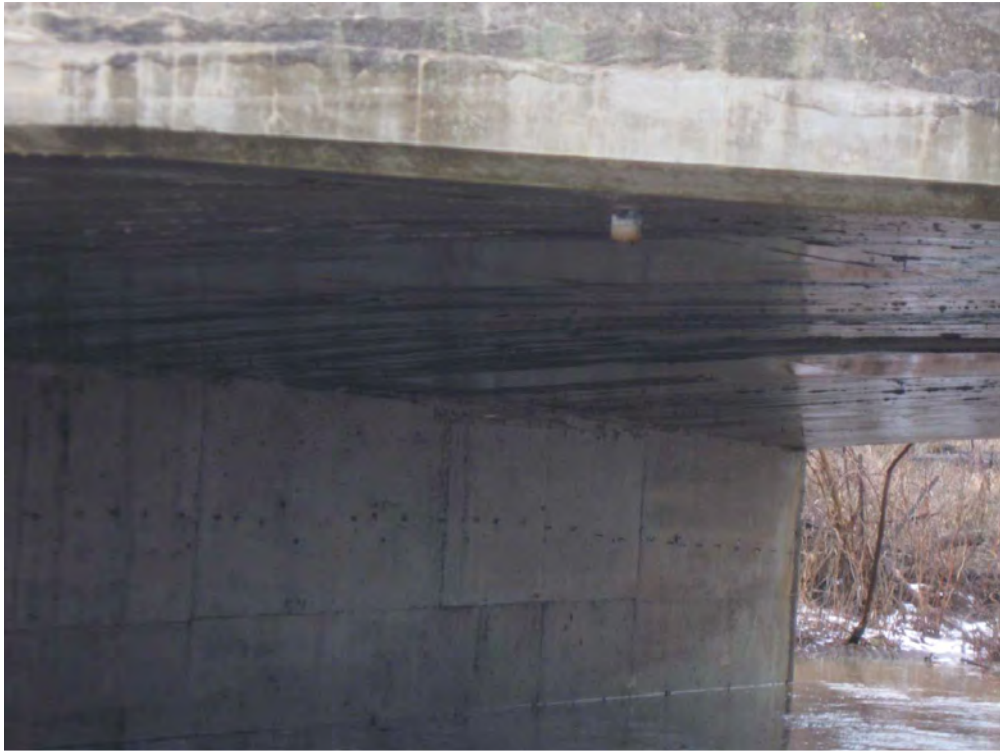
11. Deck Drain in Soffit

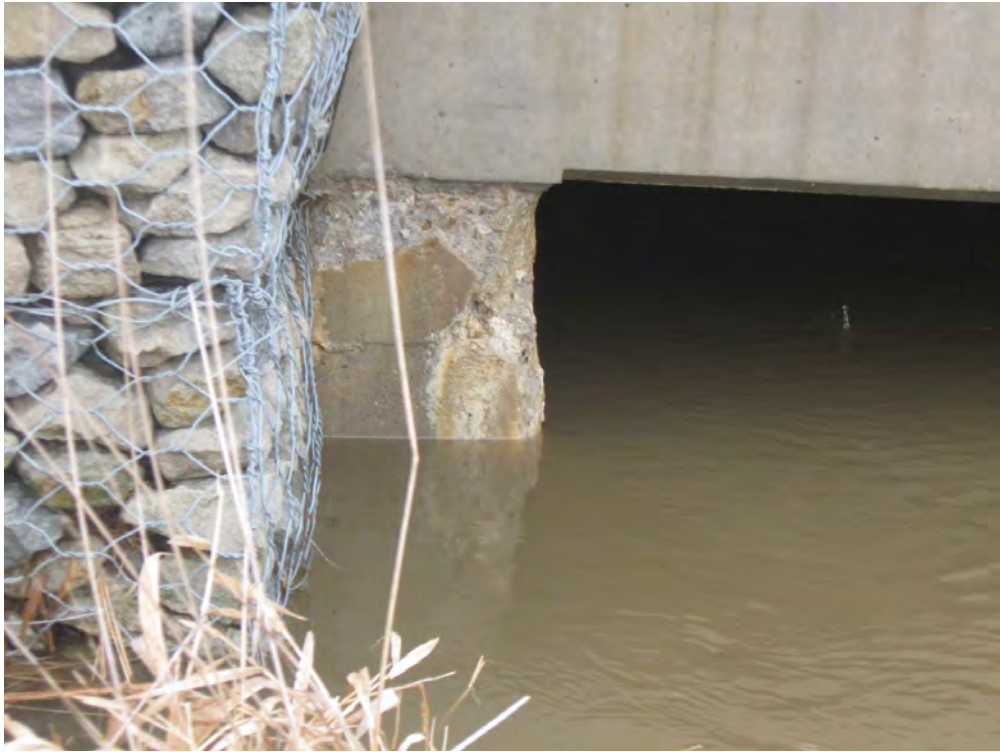
3. Severe scaling on North- West Culvert Wall

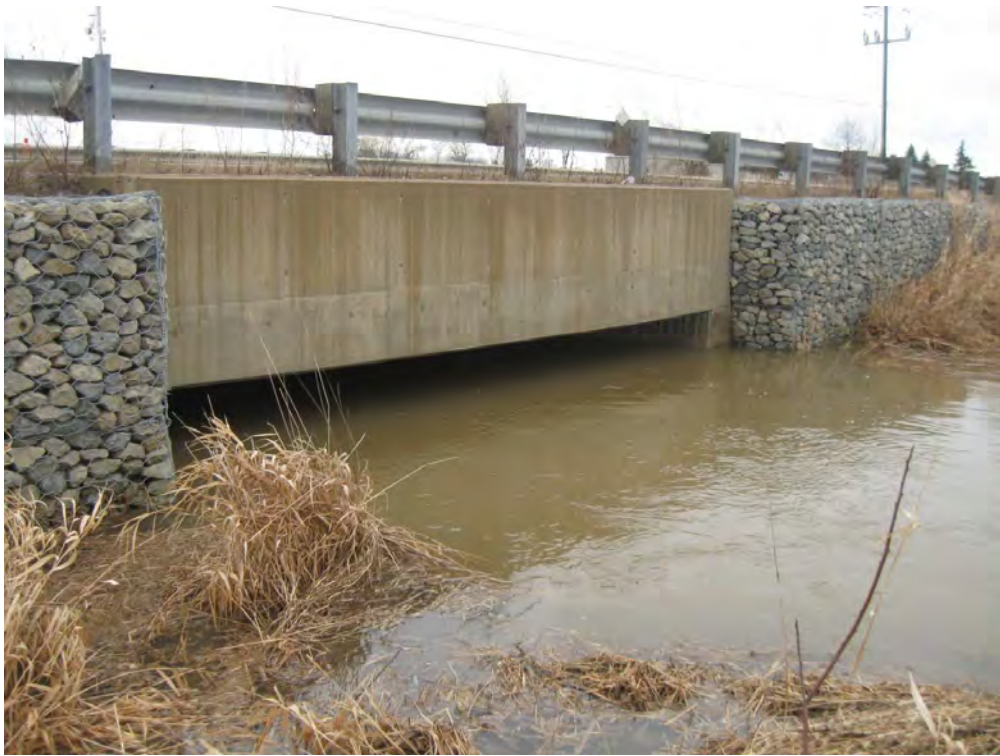
5. Culvert Inlet – East Gabion Retaining Walls

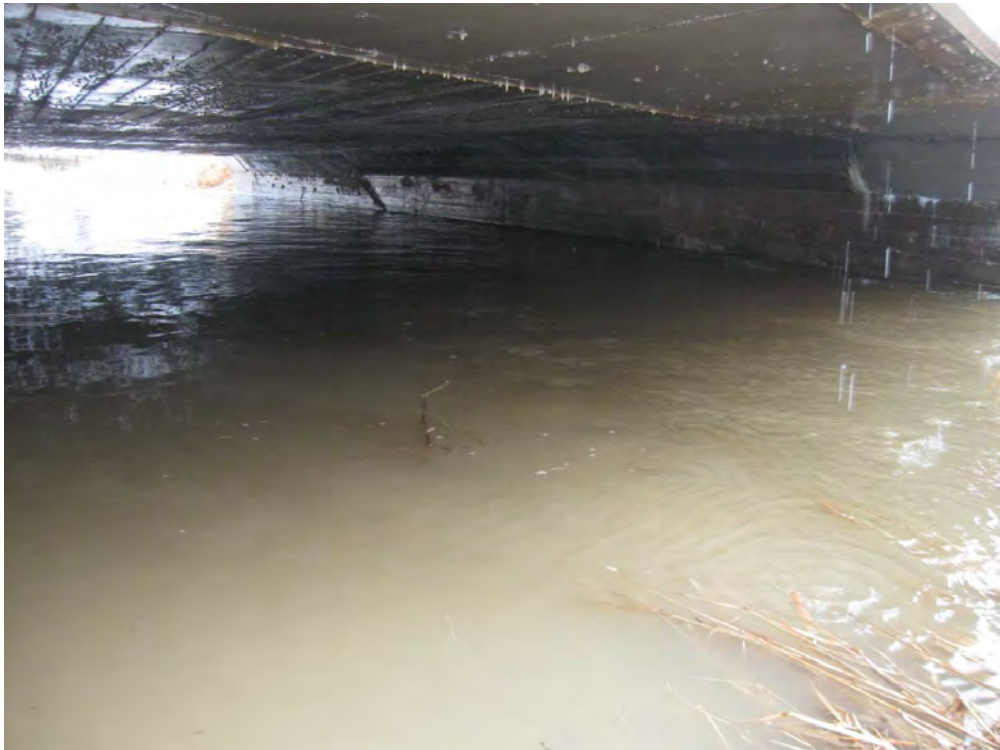
4. Efflorescence and leaking construction joint in soffit

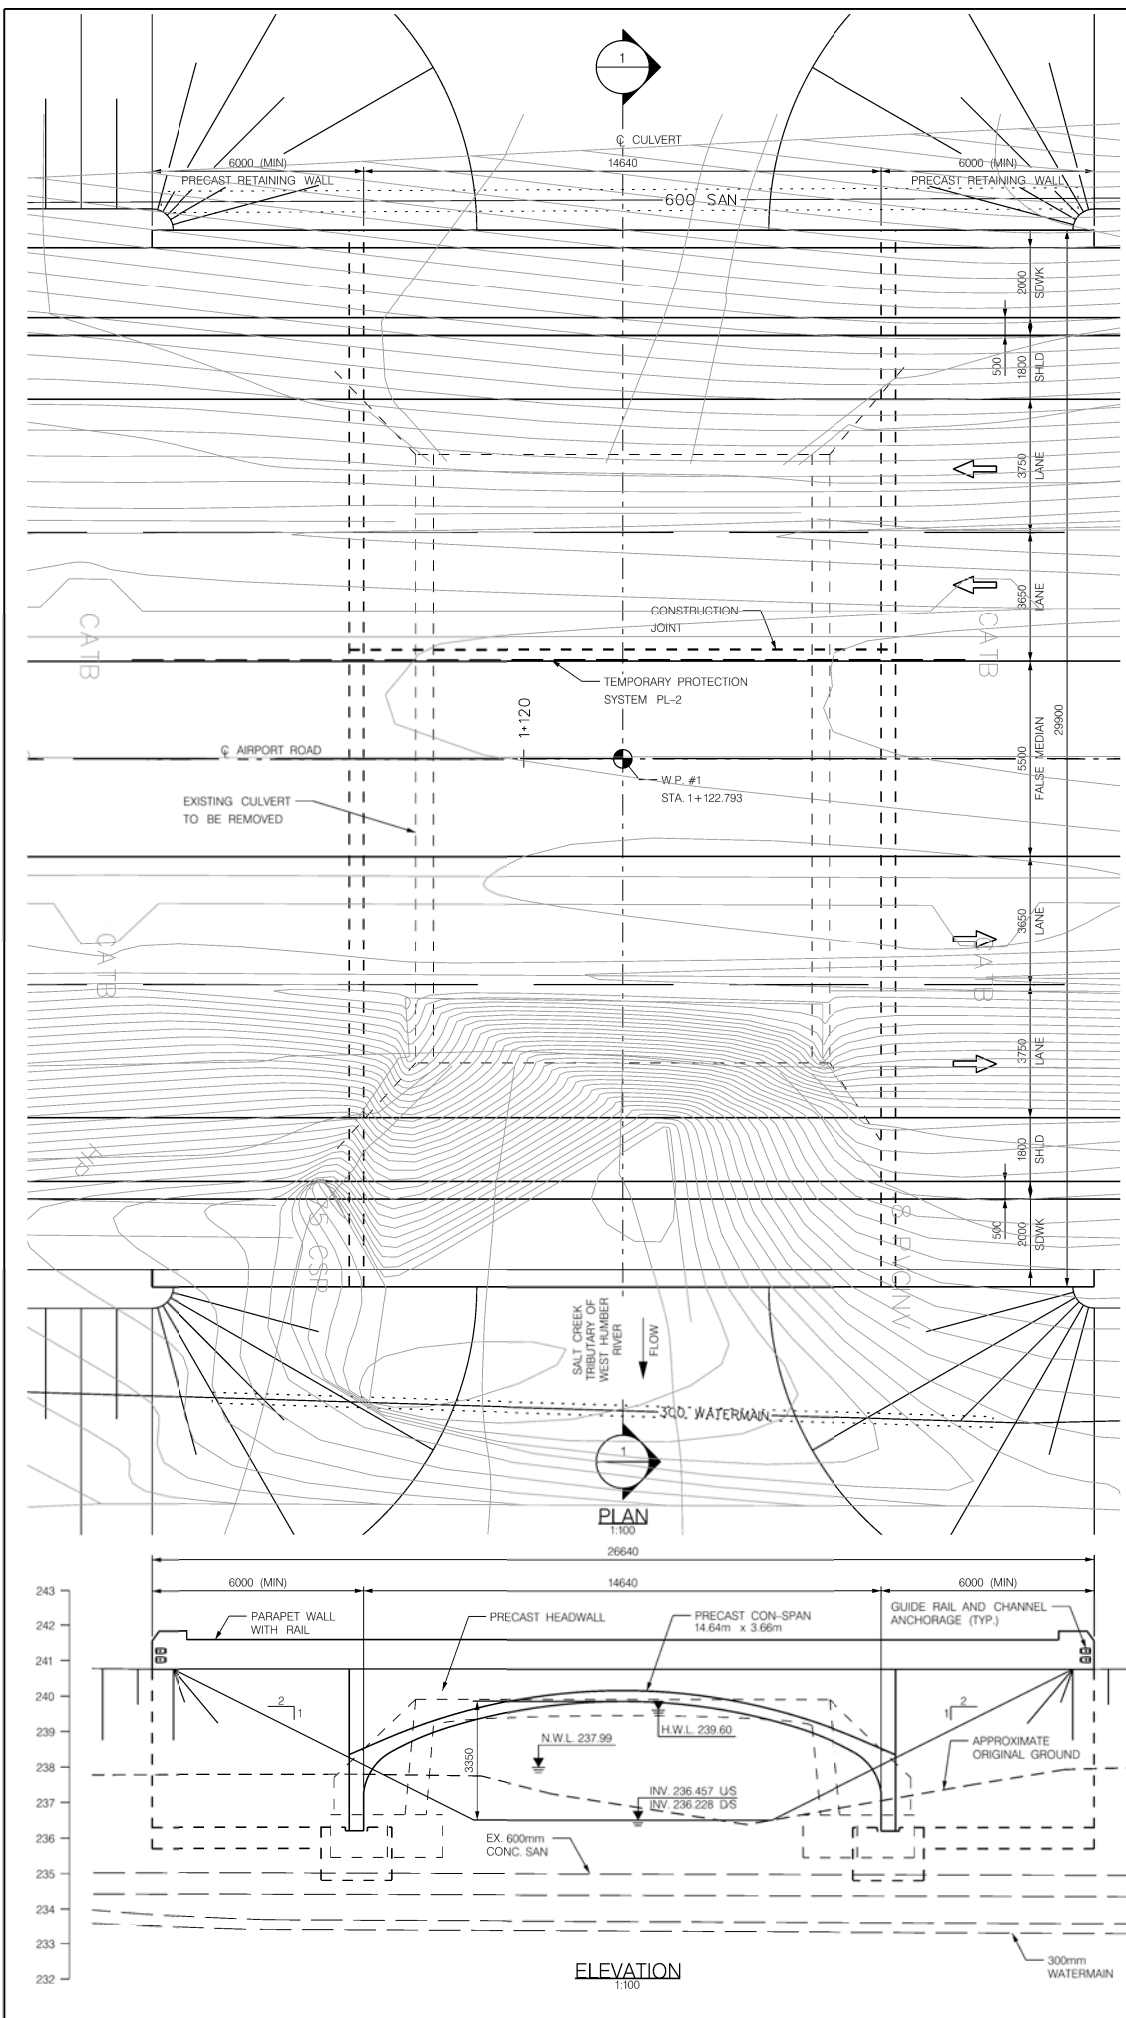
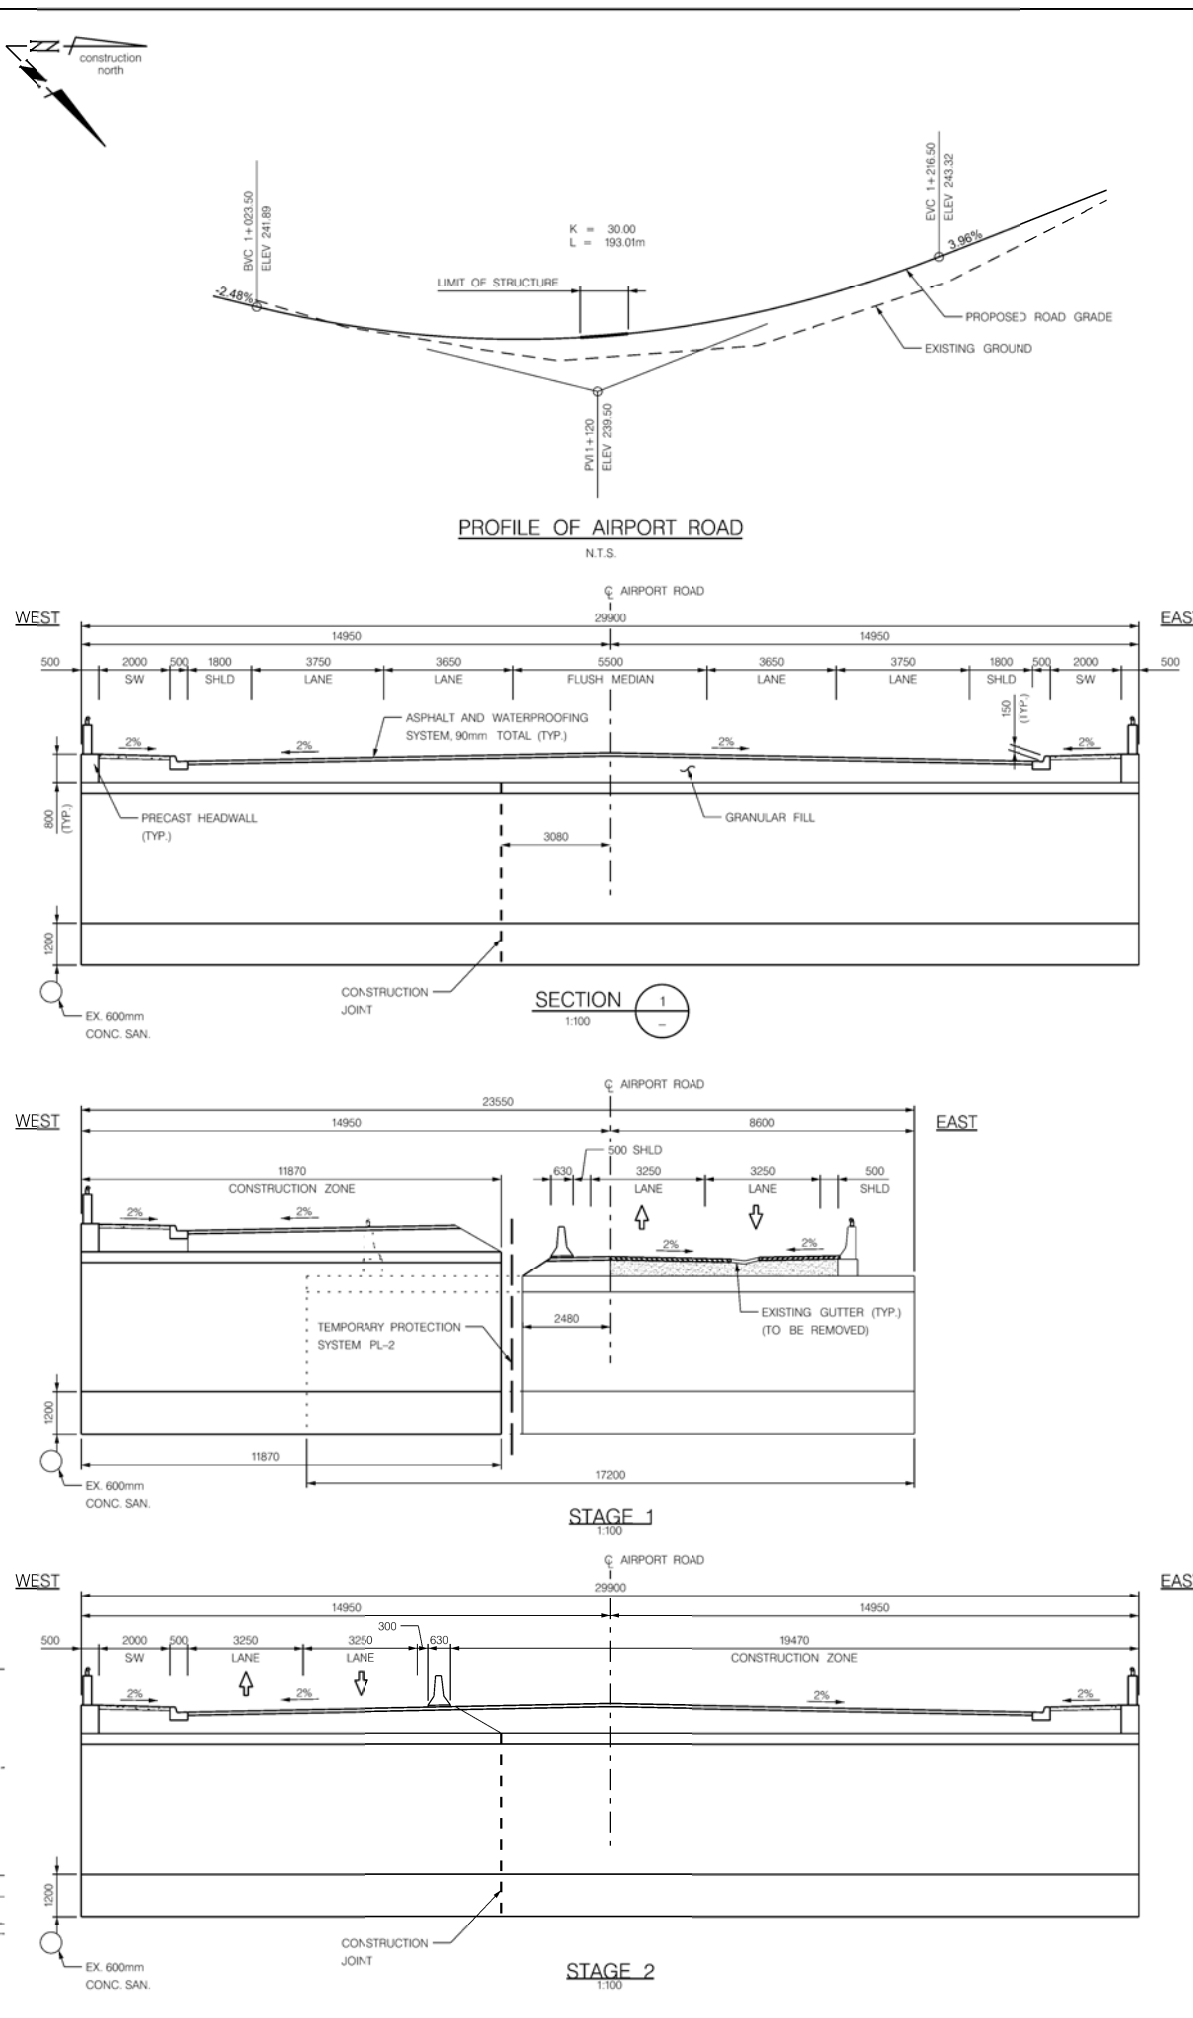
**AIRPORT ROAD**  
 (FROM N. OF WAYFIELD RD. TO N. OF OLD SCHOOL RD.)  
 NORRIS RIGID FRAME BRIDGE  
 PRELIMINARY GENERAL ARRANGEMENT

- Salt Creek Culvert, replace existing structure with a 10.67 m x 2.44 m precast open footing culvert;
- Deans Culvert, replace existing structure with 10.67 m x 2.44 m precast open footing culvert; and
- Norris Bridge, replace existing bridge with a 14.64 m x 3.35 m CON-SPAN structure.

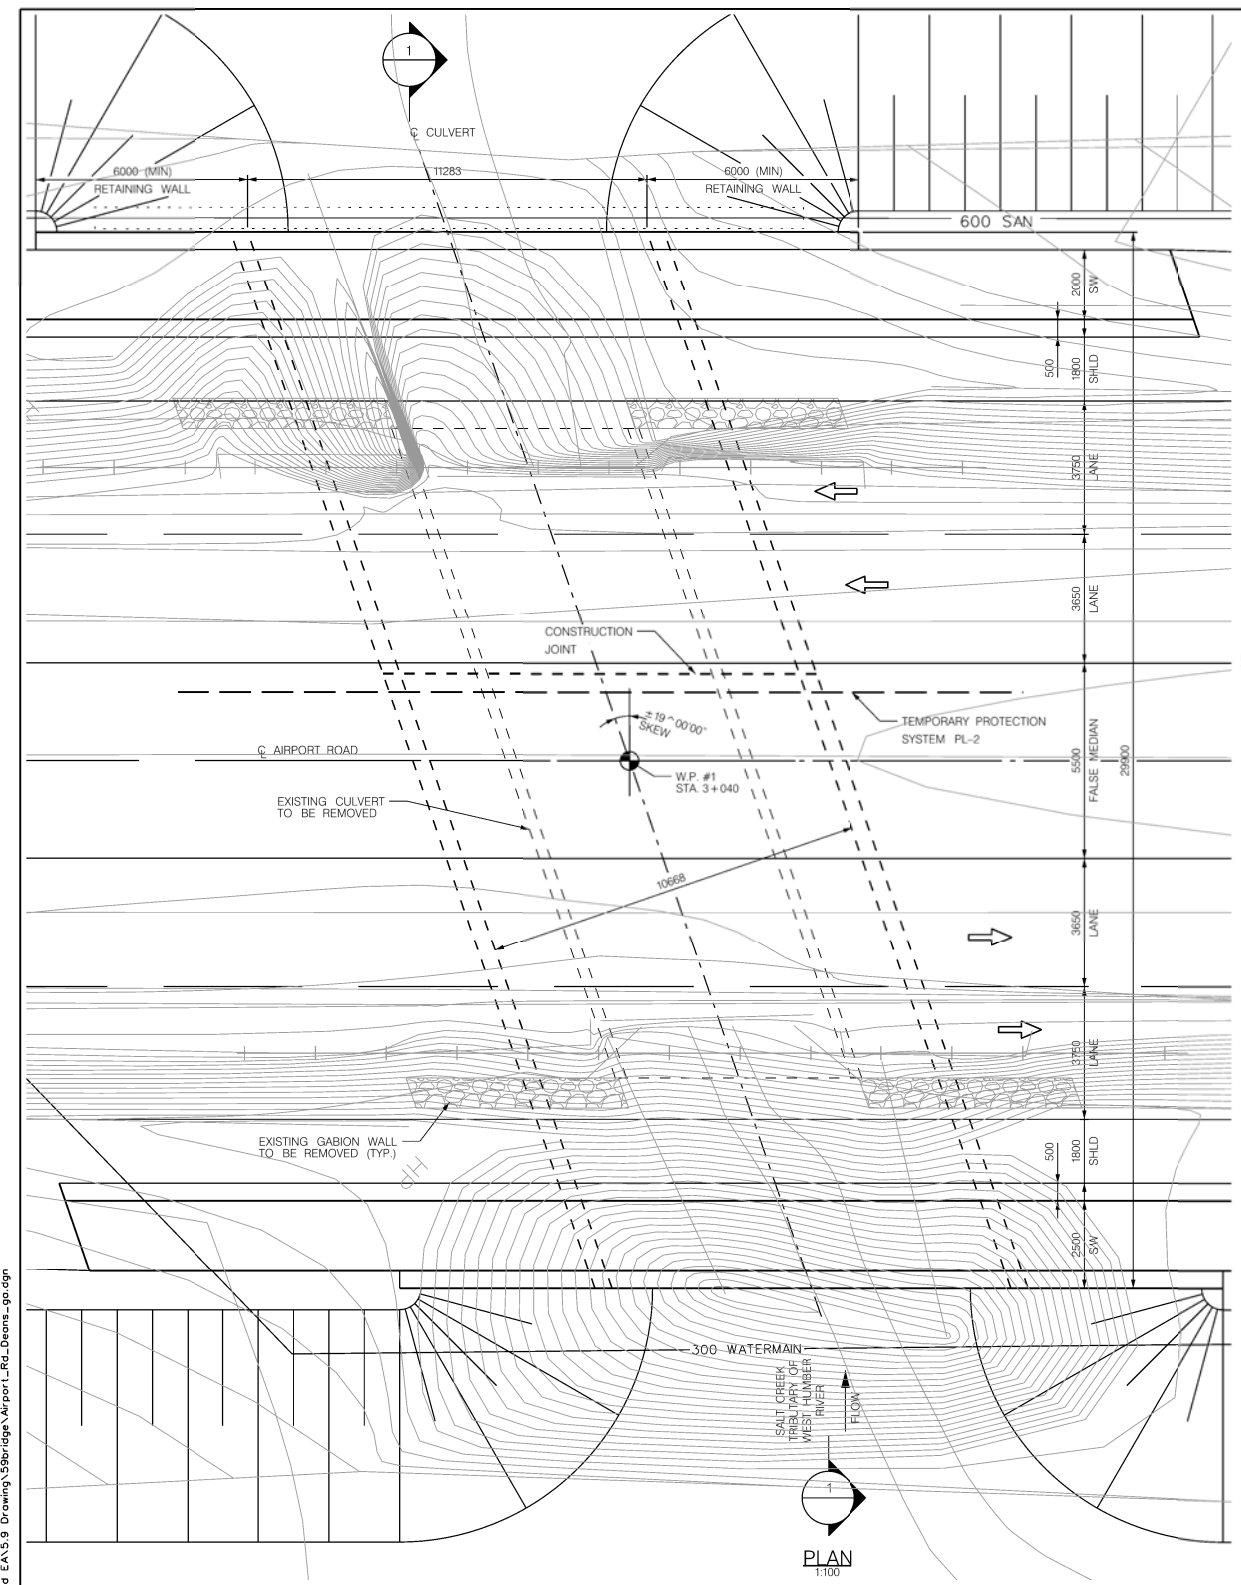
**AIRPORT ROAD**  
 (FROM N. OF WAYFIELD RD. TO N. OF OLD SCHOOL RD.)  
 DEANS CULVERT  
 PRELIMINARY GENERAL ARRANGEMENT

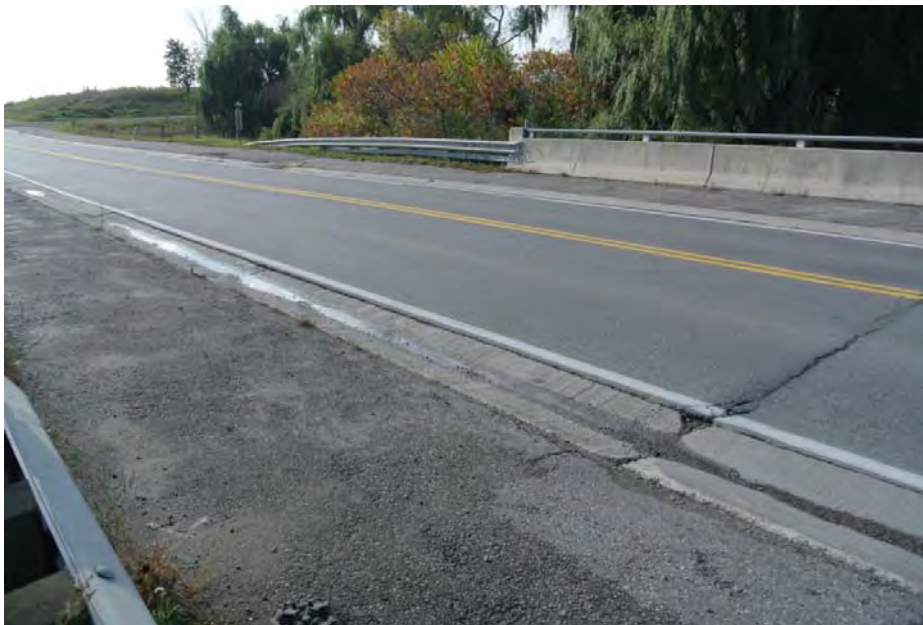
Plate 6: View of the bridge deck, concrete drainage system, asphalt shoulders, and concrete railing system, looking southwest.

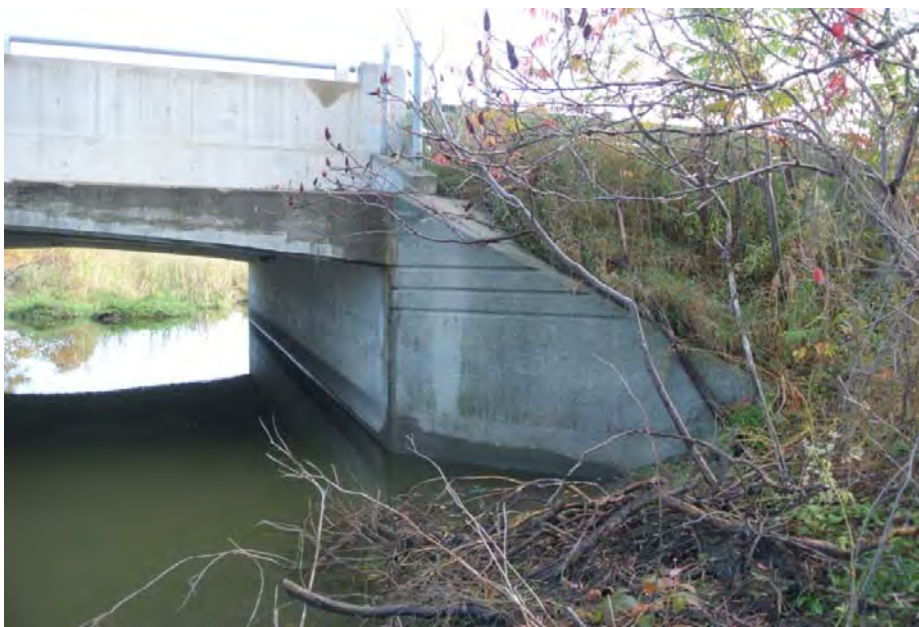
Plate 10: Detail of south abutment, looking east. Note the horizontal fluting on the wingwall.

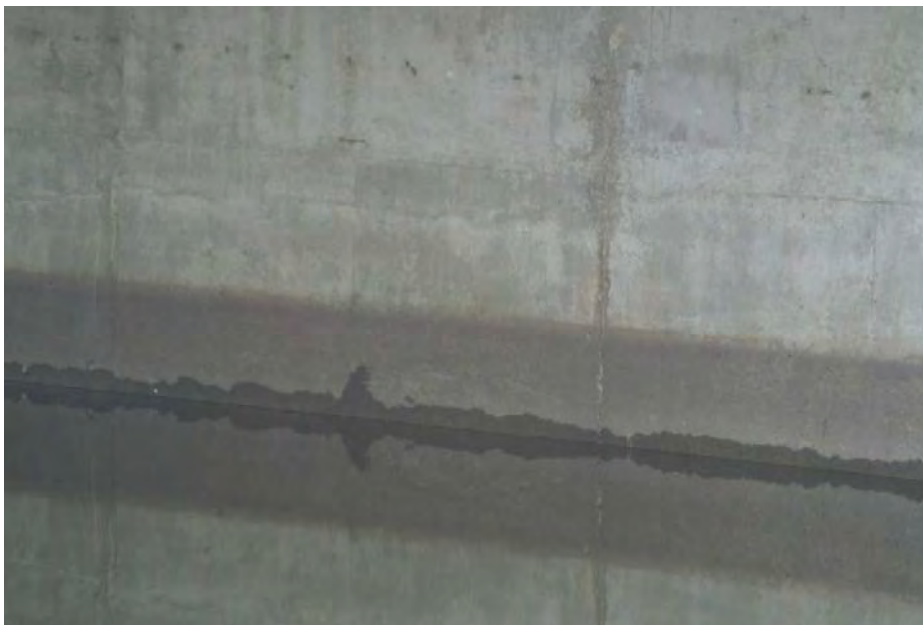
Plate 14: Detail of the north abutment. Note the indication of fluctuating water level.

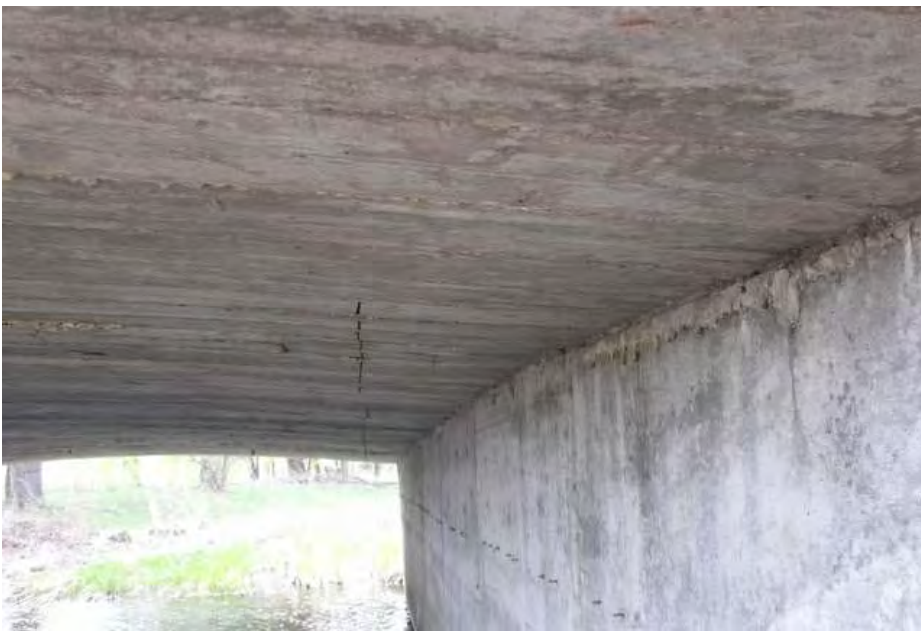
**Plate 16: Detail of the bridge soffit and north abutment, looking west.**

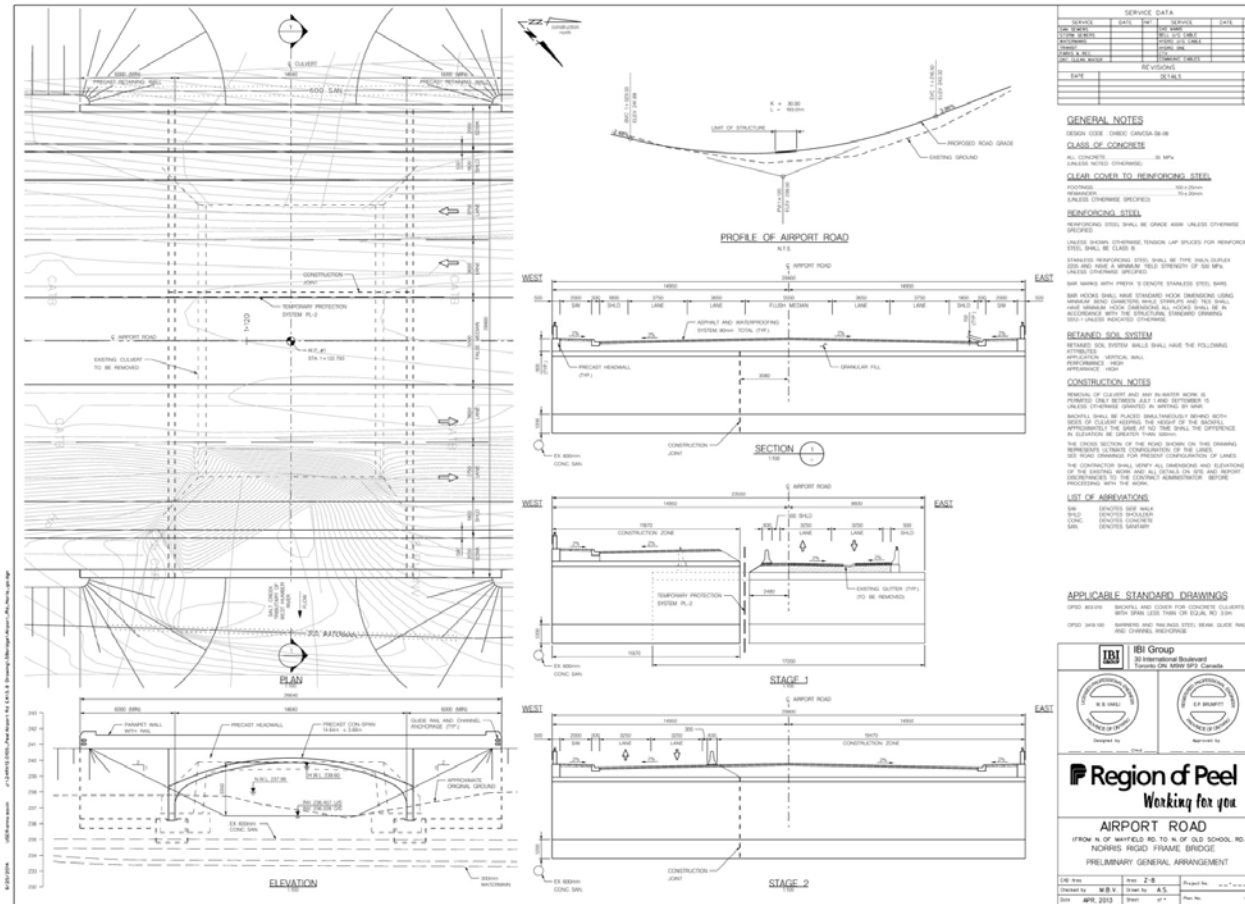
Figure 7: Preliminary General Arrangement of Norris Bridge.
