STORMWATER MANAGEMENT REPORT FOR ENVIRONMENTAL ASSESSMENT (EA) AND PRELIMINARY DESIGN FOR DRAINAGE IMPROVEMENTS OF HIGHWAY 50 FROM MAYFIELD ROAD TO HEALEY ROAD

Draft

November 15, 2021

Region of Peel

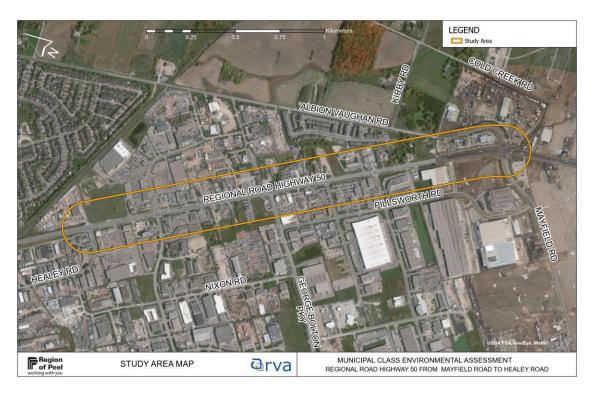
Figure 1.1: Study Area

The existing subcatchments on RR50 were delineated based on the information provided by TRCA, localized survey information, and from previous studies as provided by the Region and the Town of Caledon. Current land uses in the study catchments are primarily industrial paved areas.

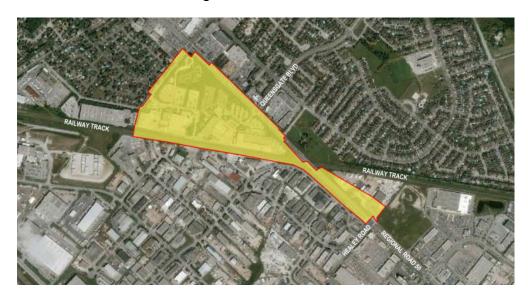
RVA performed an onsite investigation to determine the approximate external drainage areas that drain to these ditches and included them in the InfoWorks model. Since limited information about the outside drainage areas was available, runoff surface area parameters, such as imperviousness and runoff factors, were estimated. Flows from these areas were limited to a maximum runoff value into the west side ditch based on available rail crossing culvert capacity (750 mm diameter culvert, pfc = $1.08 \text{ m}^3/\text{ s}$, restricted 1 - year flows to approximately 500 l / s peak flow). This estimate was made based on the assumption that the rail line should not flood for a 10 - year design storm. Figure 4.1 below shows the extent of the described external drainage area.

Figure 4.1: External Drainage Area That Contributes into Study Area

To the north of Healey Road there is a railway track that crosses RR50. The ditches along the railway track west of RR50 and the external drainage area draining to those ditches, were added to the Region's InfoWorks model since they contribute runoff and flows into the study area. Flows from these additional drainage areas contribute to the west side road ditch and enter the Robinson Creek culvert at George Bolton Parkway.

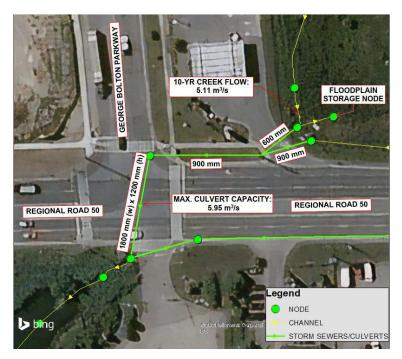
Figure 4.2: Existing Drainage Configuration at George Bolton Parkway
Intersection

A site investigation was also carried out to understand the online pond's drainage condition. The site investigation revealed that the inlet of the wet pond has a significant amount of silt and debris accumulated which causes a tail water condition and permanent submergence within the 1800 mm x 1200 mm rectangular box culvert. The outlet of the pond was also observed to be approximately 0.5 m higher than the inlet of the wet pond which leads to the silt and debris built up and standing water in the culvert.

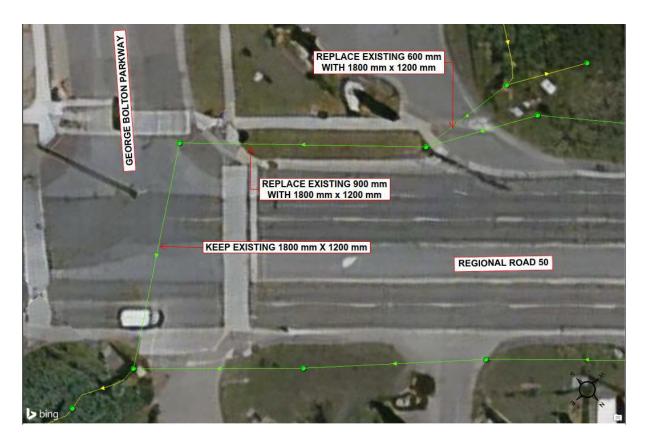
Figure 4.4: Creek Bypass Enhancements at George Bolton and RR50

RVA carried out a site investigation to understand the hydraulic situation and condition of the online pond into which the existing 1800 mm x 1200 mm box culvert outlets. It is proposed to remove the debris and silt built up at the inlet of the online pond. To avoid future built up at the inlet again, it is also proposed to lower the outlet of the online pond by approximately 0.5 m. Figure 4.5 shows the online wet pond and proposed maintenance required to mitigate tailwater condition at the existing 1800 mm x 1200 mm box culvert.

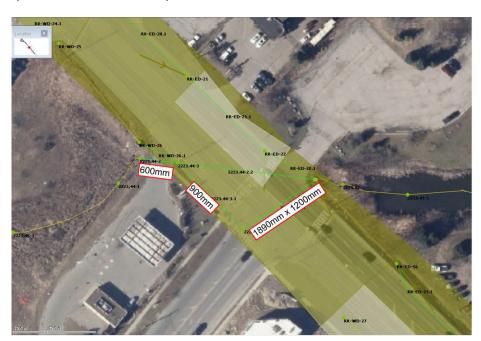
Figure 5.1: George Bolton Parkway and RR50 Intersection Culverts

The results indicate that under a 10 - year storm the culverts under George Bolton Parkway and RR50 flood. The existing culverts on this intersection are 600 mm diameter PVC pipe, which is connected to a 900 mm diameter CSP culvert. The 900 mm diameter pipe connects to an 1800 mm x 1200 mm concrete box culvert that crosses RR50 and outlets into the online pond. Robinson Creek flows through this pipe/culvert arrangement. Based on the created InfoWorks model, for10-year storm and 100-year storm events under existing conditions, there is road ponding of 230 mm and 311 mm respectively predicted for the RR50 and George Bolton Parkway intersection. Figure 5.1 represents the culverts under the George Bolton Parkway and RR50 intersection. Based on TRCA's HEC - RAS model, the 10 - year flow at the intersection is 5.10 m³/s and the InfoWorks model predicts hydraulic restrictions due to the small culverts (600 mm and 900mm) under the intersection.

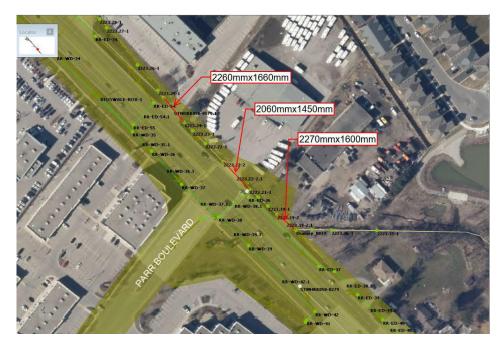
For a section of Robinson Creek that is located upstream of the above described flood complaint property, the following hydraulic capacity restrictions exist. Under a 100 - year storm, there are three culverts that run along RR50 that show hydraulic restrictions to convey the 100 - year storm flows. The three culverts are located near the Parr Boulevard and RR50 intersection and their crossing ID numbers are 2223.22 - 2.1, 2223.25 - 2.1 and 2223.19 - 2.1. These culverts are made of corrugated metal arch culverts with sizes 2060 mm x 1450 mm, 2260 mm x 1660 mm and 2270 mm x 1600 mm. Figure 5.2 highlights the three culverts that show hydraulic restrictions in the existing condition.

Figure 5.2: Culverts on RR50 and Parr Boulevard Showing Hydraulic Restrictions Under 100 - year flows

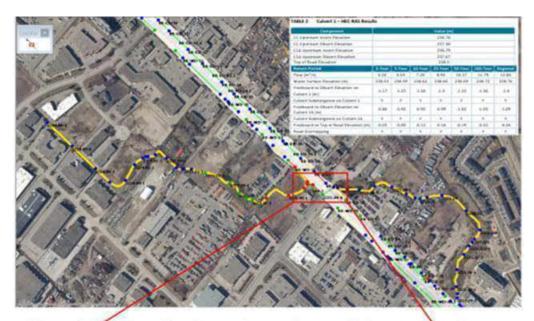
Region
of Peel
working with you
We'd like to arrange for a meeting with the TRCA to discuss HEC-Ras hydraulics and flows in Rainbow Creek. Specifically, why creek flows to the west side of RR50 are so high so that road flooding is predicted from a 2-year storm event onwards (see insert below and Figure 2 writeup attached). Kindly let us know your availability to meet (digitally)... hopefully some time next week. Feel free to include other staff as required.

Figure 2: Rainbow Creek crossing at George Bolton Intersection

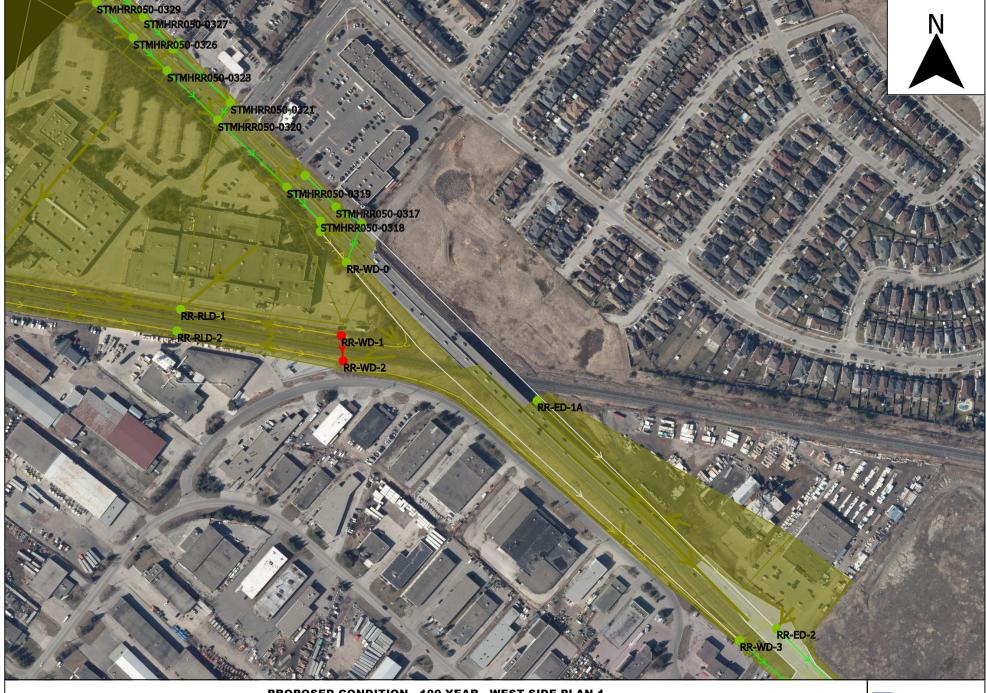
PROPOSED CONDITION - 100-YEAR - WEST SIDE PLAN 1

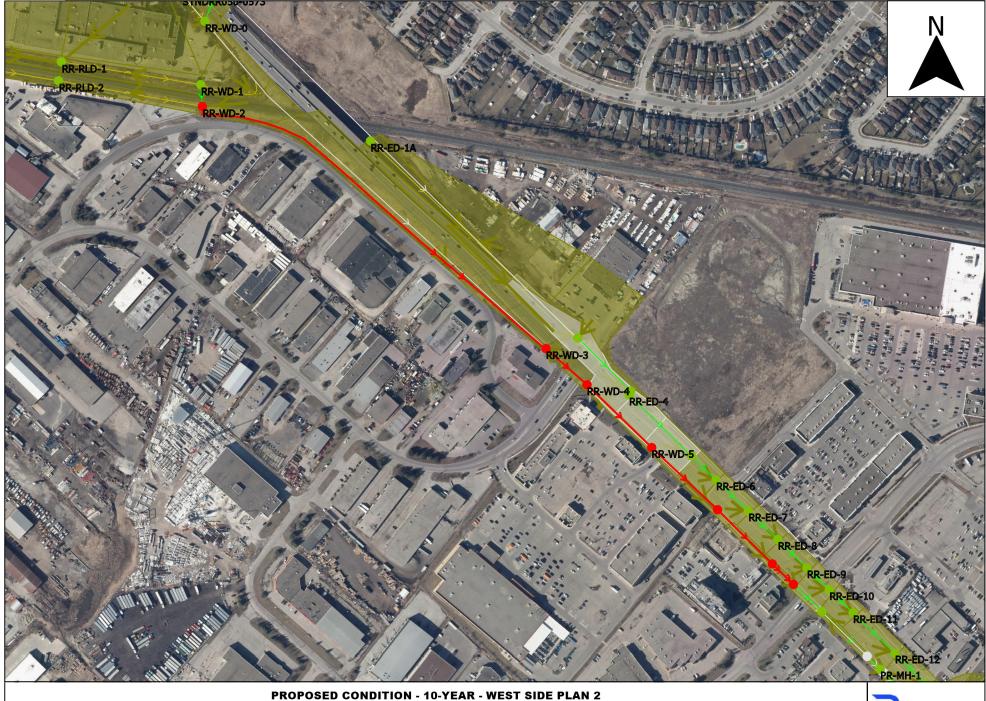
PROPOSED CONDITION - 10-YEAR - WEST SIDE PLAN 2

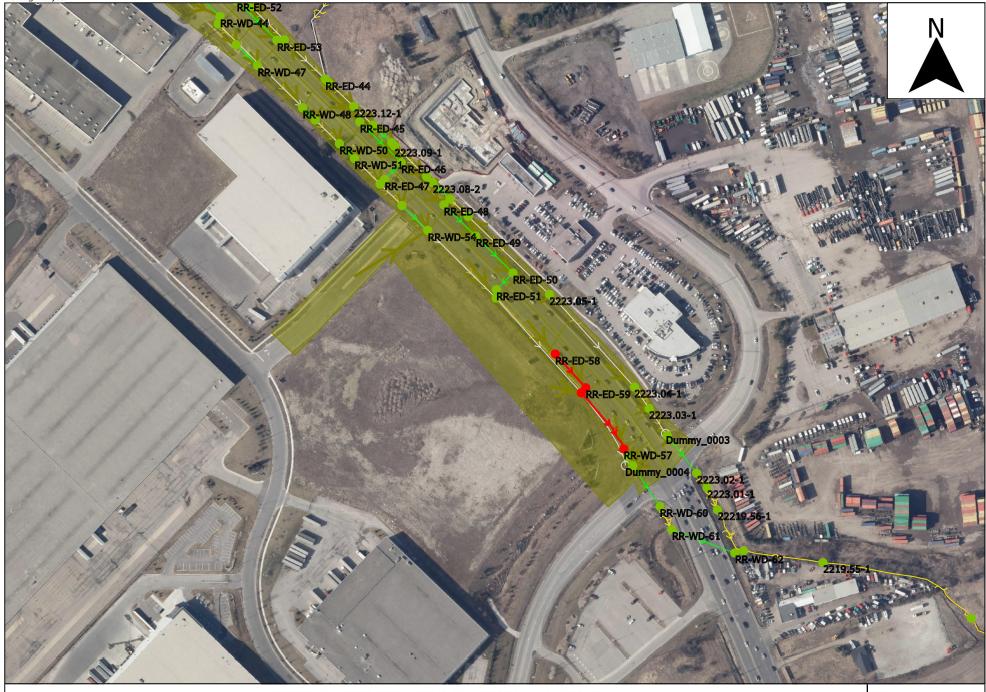
FIGURE NO. 19E

EXISTING CONDITION - 100-YEAR - WEST SIDE PLAN 19

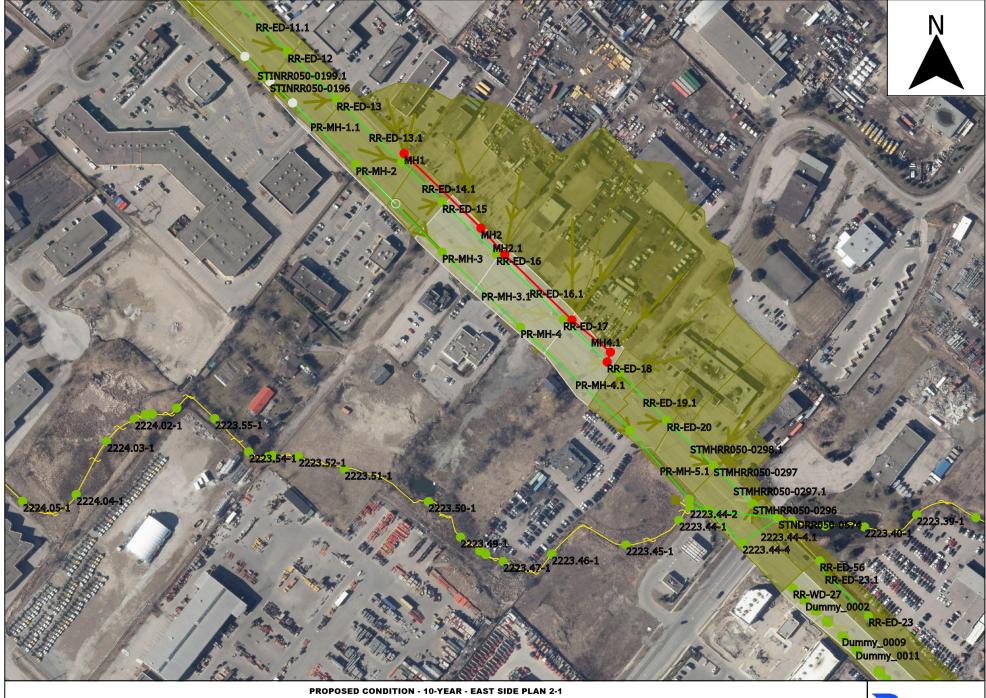
PROPOSED CONDITION - 10-YEAR - EAST SIDE PLAN 2-1 (PROPOSED STORM SEWERS UNDERNEATH THE PROPOSED SIDEWALK)

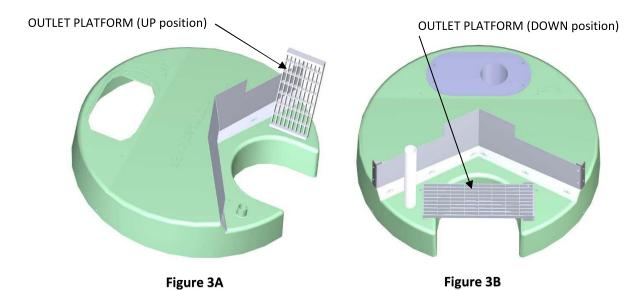
Figure 2

- Insert separates vessel into upper and lower chambers, and provides double-wall containment of hydrocarbons
- Weir creates stormwater ponding and driving head on top side of insert
- **Drop pipe** conveys stormwater and pollutants into the lower chamber
- **Outlet riser** conveys treated stormwater from the lower chamber to the outlet pipe, and provides primary inspection and maintenance access into the lower chamber
- **Outlet riser vane** prevents formation of a vortex in the outlet riser during high flow rate conditions
- Outlet platform (optional) safety platform in the event of manned entry into the unit
- Oil inspection pipe primary access for measuring oil depth

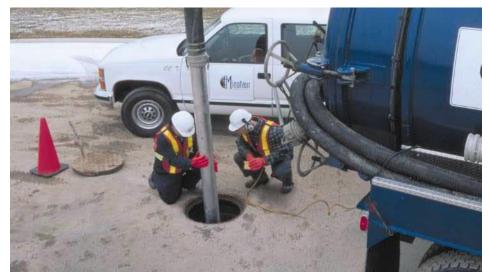
Figure 9

• When maintenance is required, a standard vacuum truck is used to remove the pollutants from the lower chamber of the unit through the **Outlet Riser**.
