Mayfield Road Improvements

Airport Road to Coleraine Drive –
Class Environmental Assessment

ENVIRONMENTAL STUDY REPORT

**Preliminary Geotechnical
Investigation Report**
Mayfield Road
Airport Road to Coleraine Drive,
Brampton and Caledon, Ontario

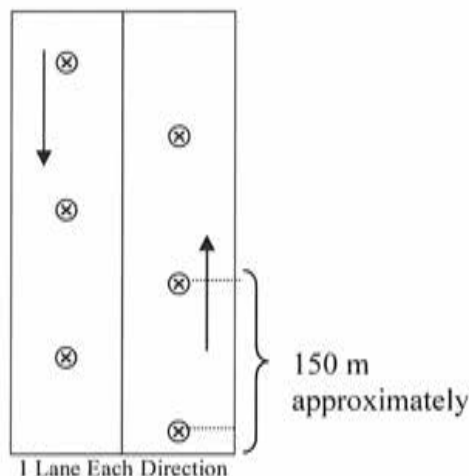
Figure 4.1: FWD Testing Protocol for Flexible Pavements

Falling Weight Deflectometer (FWD) testing was performed using Stantec's LTPP-SHRP calibrated FWD to determine the in-situ structural capacity of the pavement structure (and subgrade soil conditions) located within the project limits. Deflection testing was carried out in accordance with the Falling Weight Deflectometer (FWD) Testing Guidelines by the Ontario Ministry of Transportation (MERO-019). For general project level work, this procedure recommends testing every 50 m to 200 m or a minimum of 15 test points per uniform pavement section.

For this project, testing was completed on Mayfield Road at approximate 150 m intervals in each direction, with the test points being staggered between directions to ensure maximum coverage, as depicted in Figure 4.1. Stations were measured from the intersections at both ends of the project with station zero being the middle of the Mayfield Road and Airport Road intersection and the middle of the Mayfield Road and Coleraine Drive intersection, for the east and westbound lanes respectively.

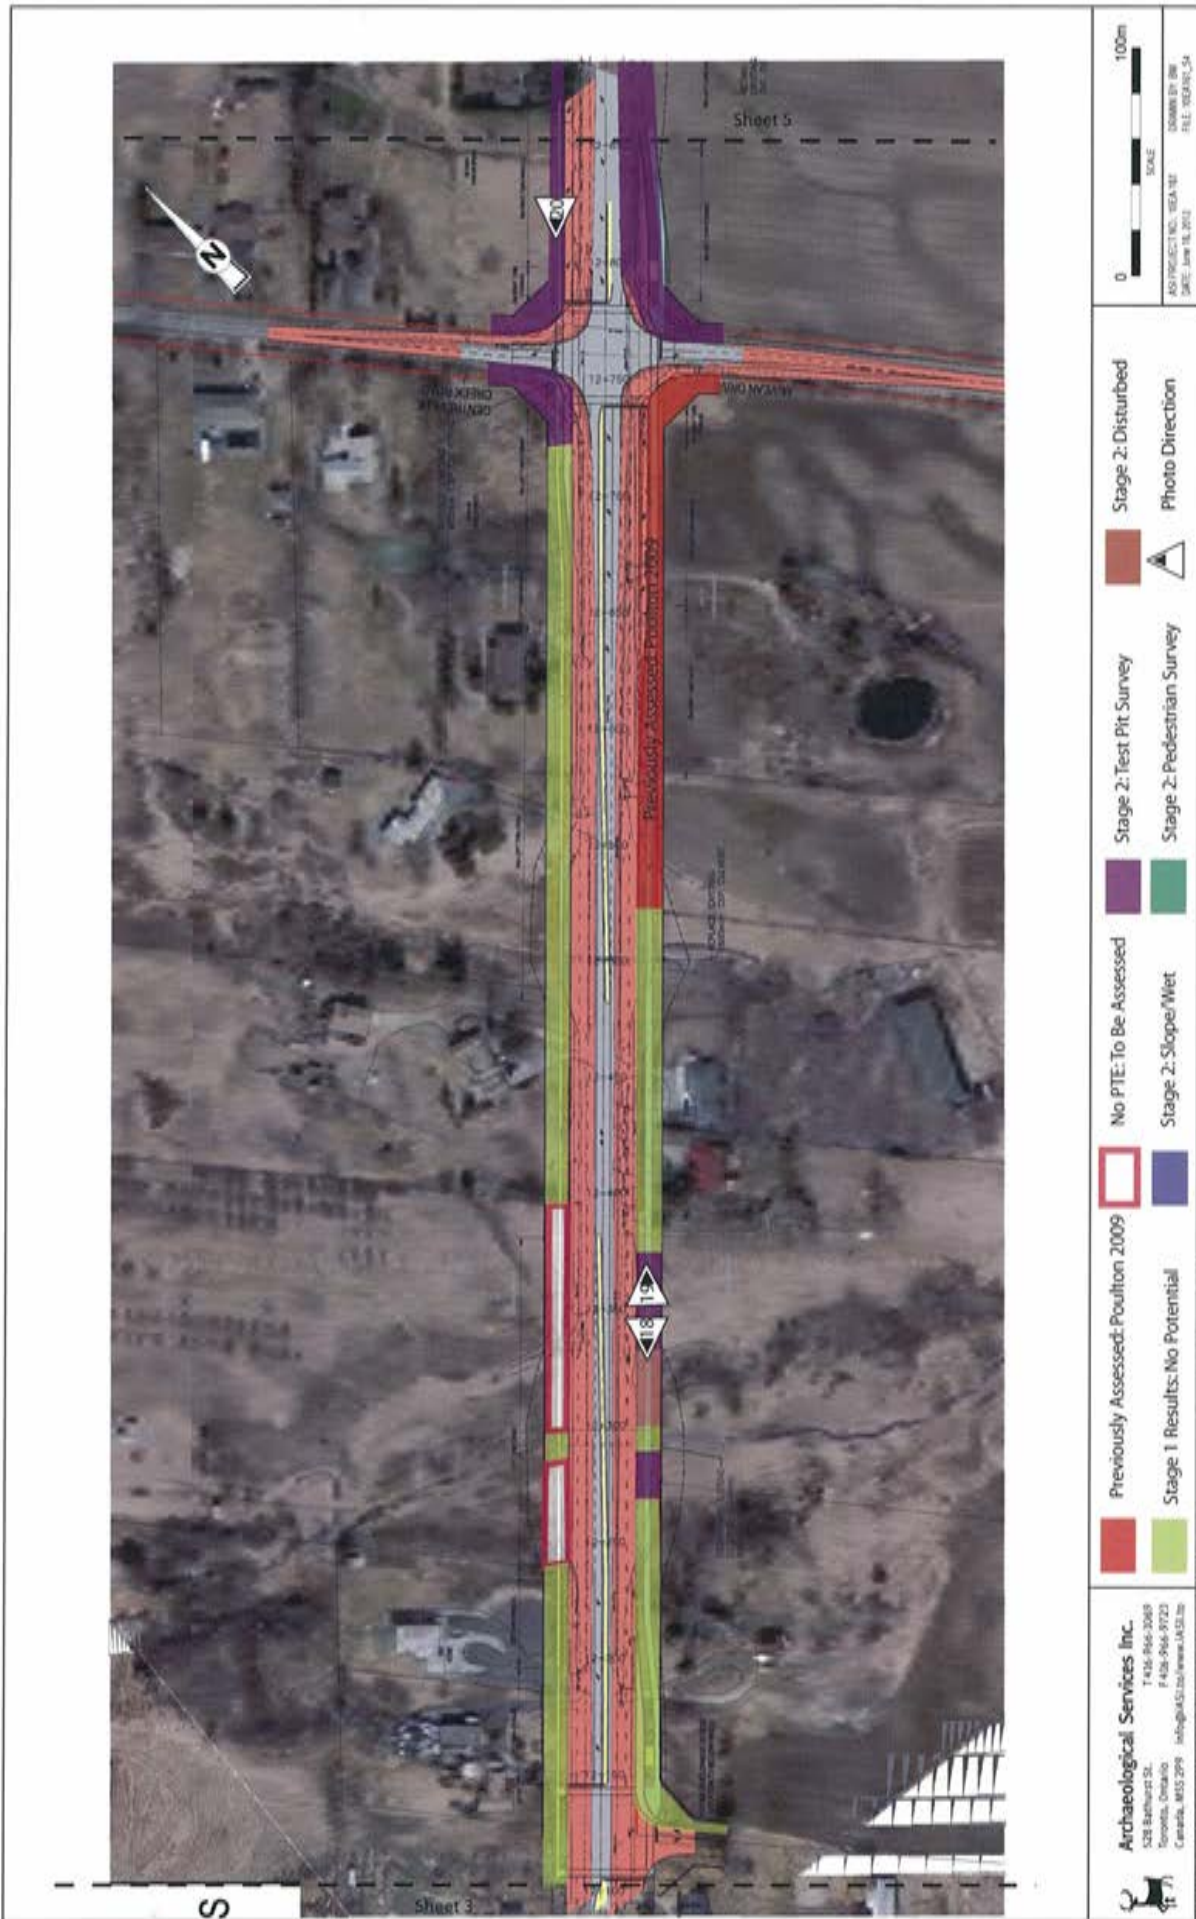
10EA-161: Mayfield Rd - Stage 2 Archaeological Assessment Results (Sheet 4)

Previously Assessed: Poulton 2009
 Stage 1 Results: No Potential
 No PTE: To Be Assessed
 Stage 2: Disturbed
 Stage 2: Test Pit Survey
 Stage 2: Slope/Wet
 Stage 2: Pedestrian Survey
 Photo Direction

Approximately 1.4 ha (28.8%) of the study corridor was subject to test pit survey (Figures 2-10; Plates 2, 3, 4, 6, 10, 12, 13, 14, 15, 16, 19, 20, 22, 23, 26, 27, 28, 30, 31, 34, and 42). Undisturbed test pits varied in depth, typically 25-30 cm, and consisted of medium brown clayey loam topsoil underlain by yellow-brown clayey subsoil (see Plate 17, 45 and 46 for an example of soils). Test pit stratigraphy and soil composition indicated that several of properties had been previously disturbed by residential, utility and infrastructure construction .5 ha; or 10.5% (see Fig 2-10 and Plates 24, 25, 41, and 43).

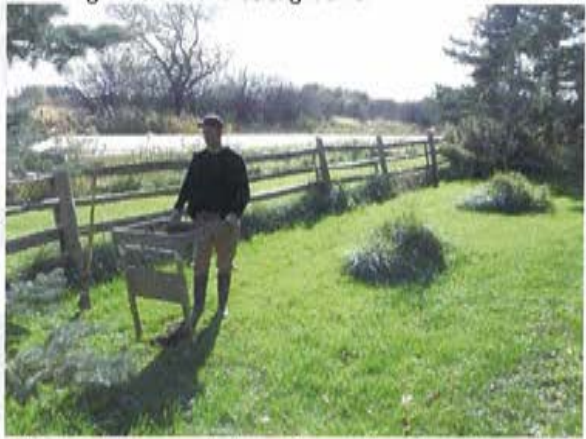
Plate 16: View south from the north side of MR showing test pit survey in progress.

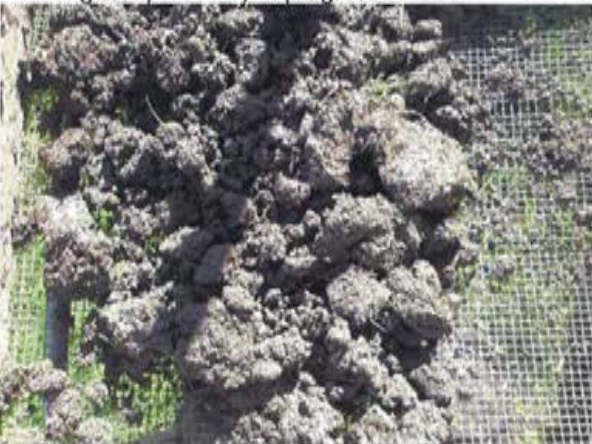
Plate 17: Close up of clayey soil from location seen in Plate 16.

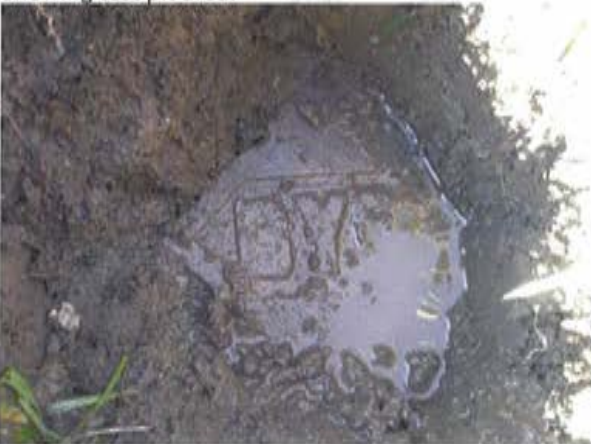
Plate 29: Footstone uncovered during test pit survey on the edge of St. Patrick's Cemetery.

While no artifacts were recovered in this location, the test pit survey along the northern edge of St. Patrick's Cemetery resulted in the discovery of a single buried footstone within cemetery grounds (Figure 7 and Plate 29). This footstone was likely covered with fill during previous construction of the adjacent overpass and may indicate that the cemetery boundaries have been encroached upon over time.

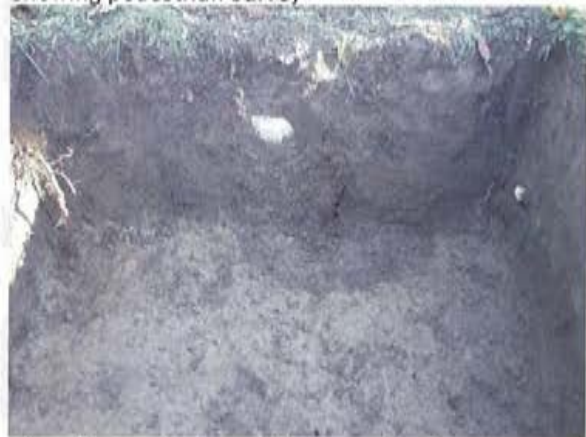
Plate 45: View south of the test unit from site AkGw-454 showing possible feature in the southern part of the unit.

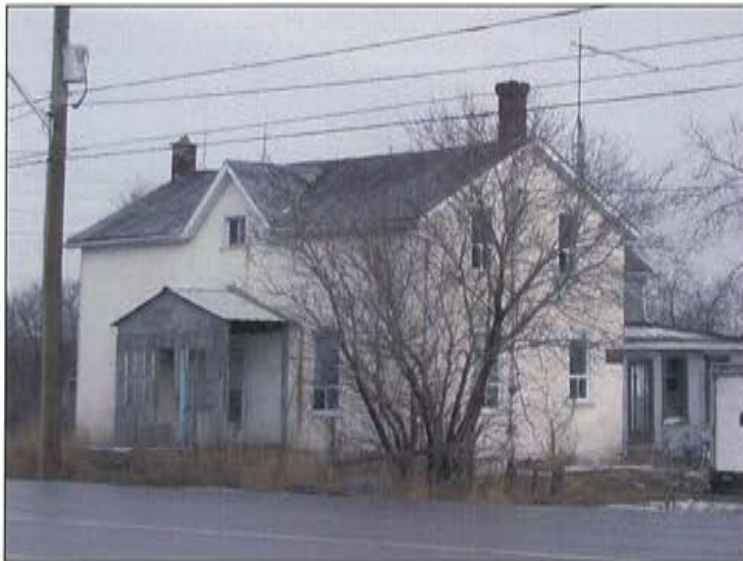
Built Heritage Feature:	BHF 1
Location:	11903 Airport Road
Construction Period:	Pre-1900
Construction Materials:	Frame construction on an unknown foundation
Description:	This one and a half storey Vernacular Farmhouse features a stucco or lathe plaster exterior, a construction material found among other structures located in the vicinity. The residence features a centrally-located gabled dormer, aluminum roof, an older wooden portico adorning the front entrance, and addition on the rear of the building. The two brick chimneys and massing of this structure suggest that it may not have originally been used as a residence. Historical research suggests that this structure may have been one of the two original hotels that were located in the Village of Tullamore in the mid-nineteenth century.
Comments:	Associated with the Village of Tullamore

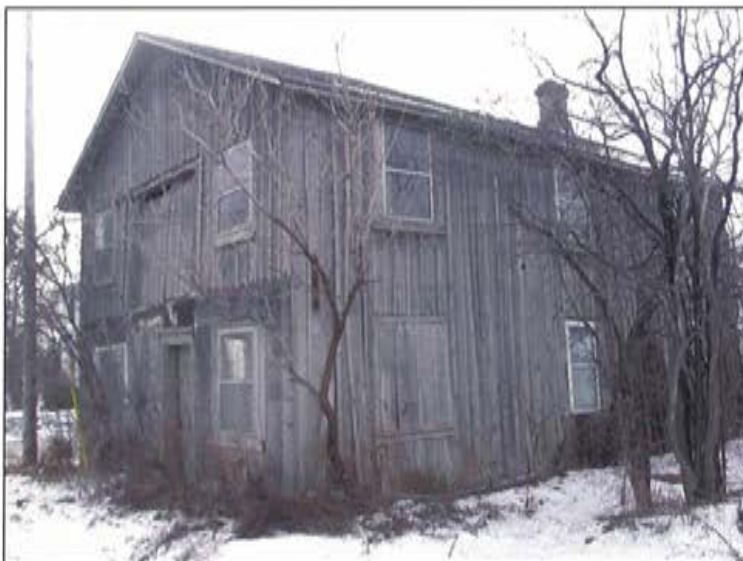
- Built Heritage Feature:** BHF 2
- Location:** 11850 Airport Road
- Construction Period:** Mid-nineteenth century
- Construction Materials:** Vertical plank exterior
- Description:** This two storey structure features a front-facing gabled roof-line. Given the lay-out and location of this structure, it is very likely that this building stands as the original blacksmith's shop that was located in the Village of Tullamore. Wooden window openings, brick chimney, and the double-door located on the second storey are evocative of this structure's original function.
- Comments:** Associated with development in the Village of Tullamore

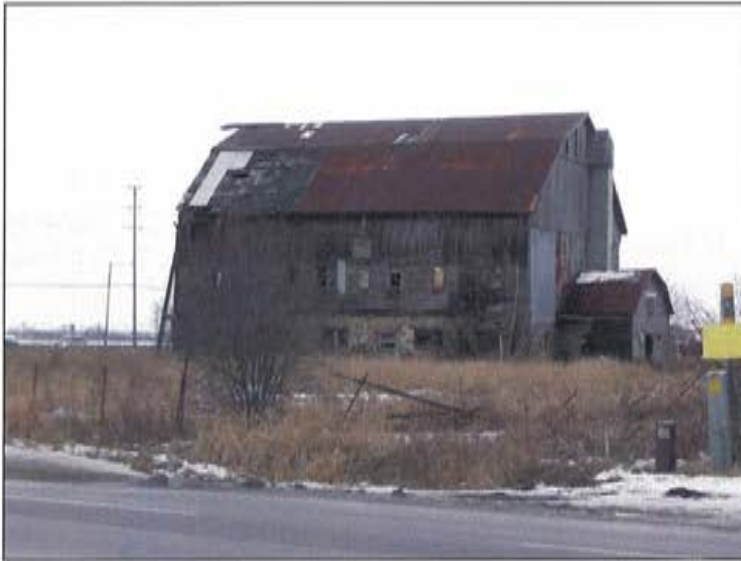
Built Heritage Feature:	BHF 3
Location:	no address; northeast corner of Airport Road and Mayfield Road
Construction Period:	Mid-nineteenth century
Construction Materials:	Vertical plank exterior and aluminium siding on stone foundation
Description:	This barn features an aluminium-clad gambrel roof with a vertical plank exterior on a stone foundation. The location of this structure at the northeast intersection of the Mayfield Road and Airport Road intersection and its scale and massing provides contextual value of the area's productive agricultural past.
Comments:	This structure forms part of the Village of Tullamore cultural landscape.

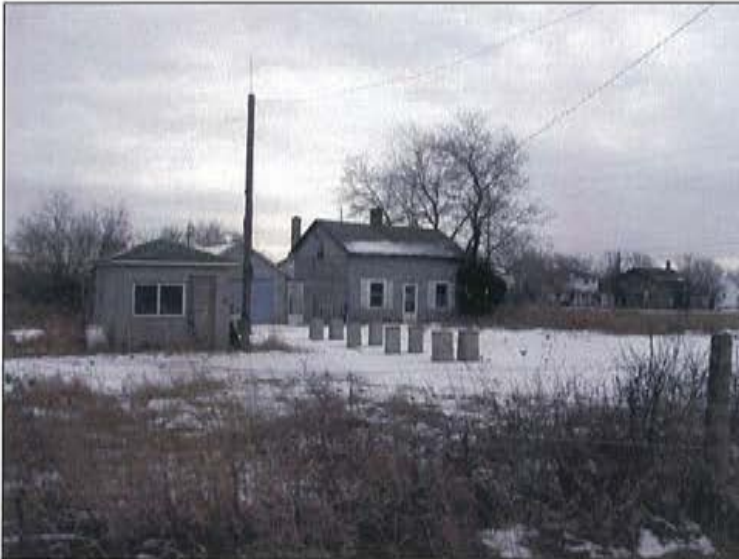
Built Heritage Feature:	BHF 4
Location:	no address; south side of Mayfield Road, east of Airport Road
Construction Period:	Late nineteenth century/early twentieth century
Construction Materials:	Brick exterior on block concrete foundation
Description:	This simple and modest one and a half storey residence features an asphalt gabled roof-line, symmetrical façade, wooden windows opening and a brick chimney.
Comments:	The date of this structure is difficult to ascertain. However, given its simple detailing and centre-hall floor plan it may date back to the early twentieth century.

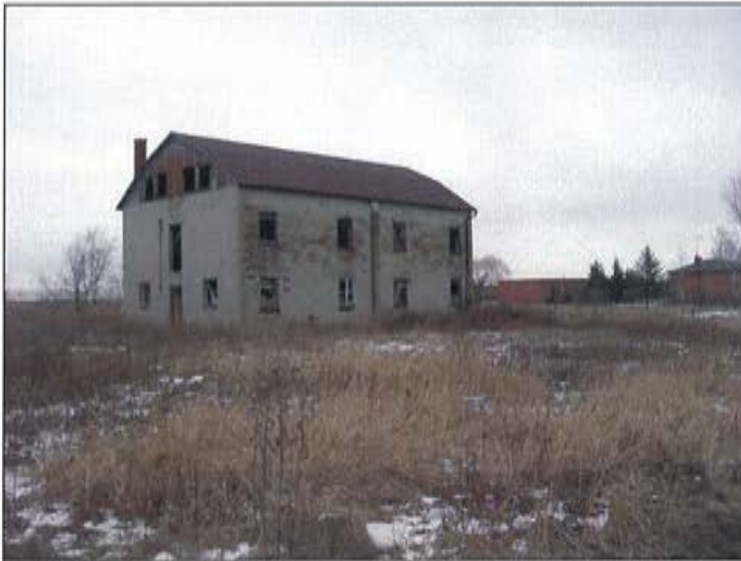
- Built Heritage Feature:** BHF 5
- Location:** no address; north side of Mayfield Road
- Construction Period:** Pre-1900
- Construction Materials:** Block concrete exterior and some aluminium siding
- Description:** This structure features a recently rehabilitated roof that is set into a combination gable-gambrel pitched roof. Brick lug sills sit beneath the window openings and a brick chimney is situated on the northwest elevation.
- Comments:**

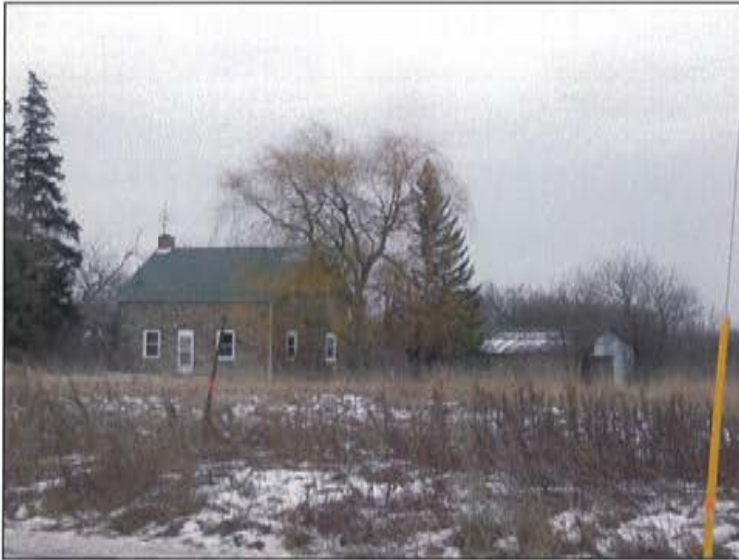
- Built Heritage Feature:** BHF 6
- Location:** 6461 Mayfield Road
- Construction Period:** Mid-nineteenth Century
- Construction Materials:** Fieldstone exterior on stone foundation
- Description:** This one and a half storey residence features an aluminium, gabled roof-line and T-shaped floor plan. The windows on the front façade appear to be newer additions. A long drive leads off of Mayfield Road to this structure.
- Comments:**

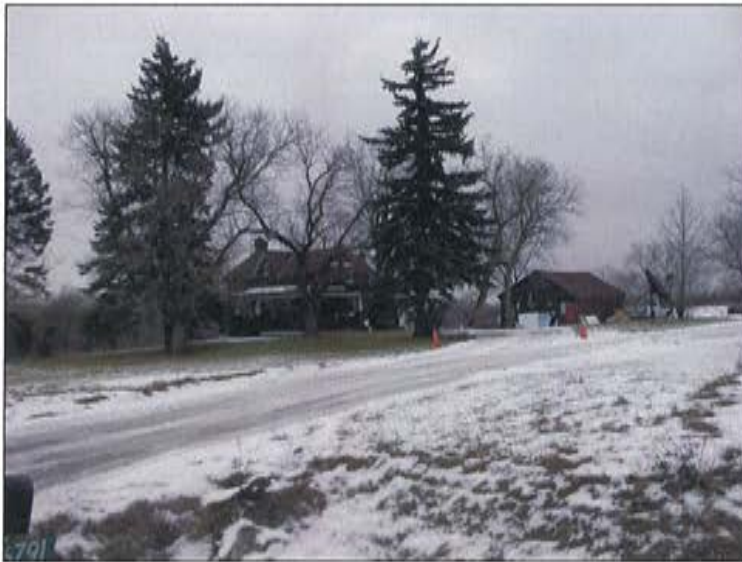
- Built Heritage Feature:** BHF 7
- Location:** 6791 Mayfield Road
- Construction Period:** Nineteenth-century
- Construction Materials:** Brick exterior on an unknown foundation
- Description:** This one and a half storey residence features an asphalt, gabled roof-line and brick exterior. A centrally-placed gabled, dormer with inset window adorns the front façade. The wrap-around veranda appears to be an original feature and is supported by wood posts set into a tapered shape, which sit on brick piers, capped with concrete.
- Comments:**

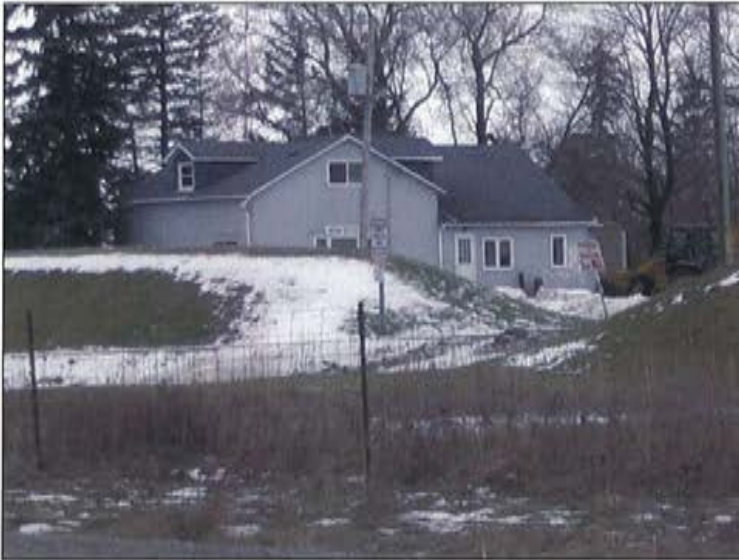
- Built Heritage Feature:** BHF 8
- Location:** No Address; Located on the northwest side of Mayfield Road, northeast of Centreville Creek Road.
- Construction Period:** Pre-1900
- Construction Materials:** Frame construction on an unknown foundation
- Description:** This residence features a medium-pitched, asphalt gabled-roof line and has been relatively altered. The exterior appears to be laid with stucco and newer gabled dormers have been added, along with a sizeable addition on the rear.
- Comments:** Sight lines of this structure were obstructed during the field review. The property appears to be used for commercial purposes currently. No address could be located, however it is likely that this structure corresponds to 7072 Mayfield Road, which has been identified by the Town of Caledon as being of cultural heritage interest.

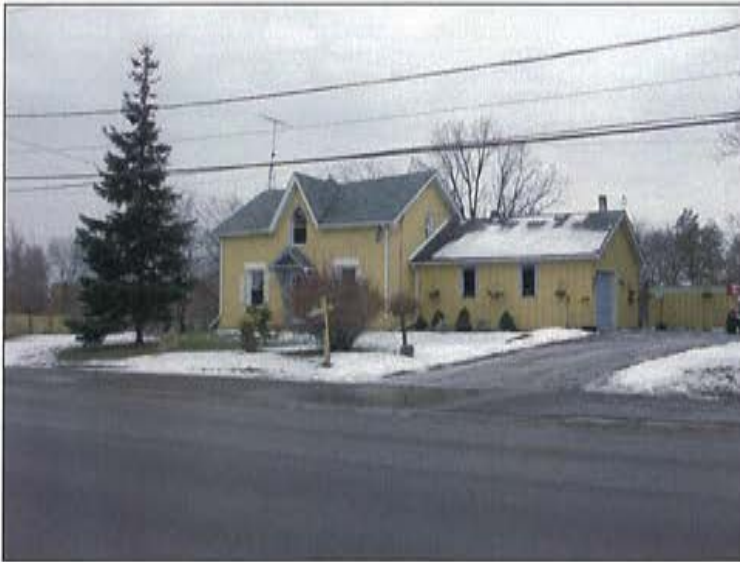
Built Heritage Feature:	BHF 9
Location:	11962 Gore Road
Construction Period:	Mid nineteenth century
Construction Materials:	Brick exterior on an unknown foundation
Description:	This one and a half storey residence features an asphalt, gabled roof-line. The centrally placed dormer, pointed inset window, covered entrance, and wooden door opening contribute to the resource's character.
Comments:	Associated with the Hamlet of Wildfield

7. Cultural heritage resources located at 11962 the Gore Road (BHF 9) are expected to be removed. A separate, resource-specific heritage impact assessment has been prepared to evaluate the heritage significance of this resource and to evaluate impacts of the undertaking and to propose appropriate conservation and/or mitigation measures (See Appendix D). Recommendations contained therein should be considered as part of the finalization of the preferred alternative and to inform the detailed designed phase.

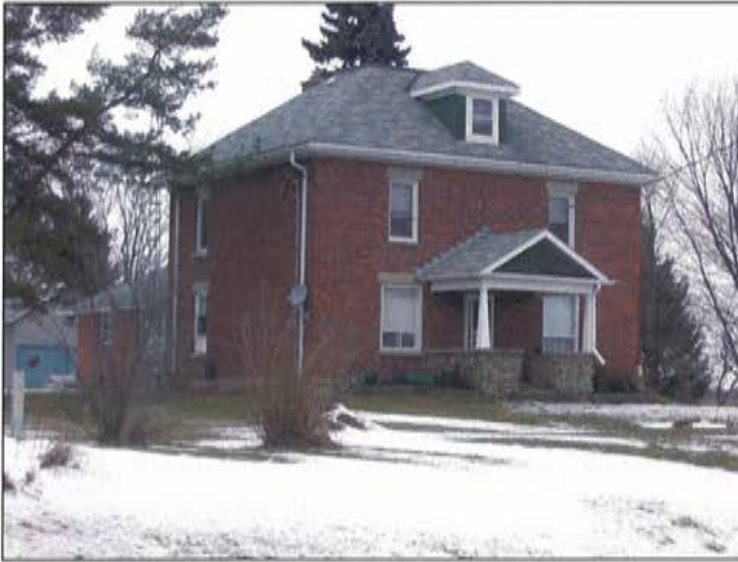
Built Heritage Feature: BHF 10

Construction Materials: Brick exterior on concrete foundations with remnants of a stone foundation visible

Description: This residence is a two and a half storey structure with an asphalt, hipped roof, featuring a hipped roof dormer. The symmetrical façade is adorned with a portico entrance, supported by tapered wood posts on concrete-capped, stone piers. Outbuildings are located southwest of the residence.

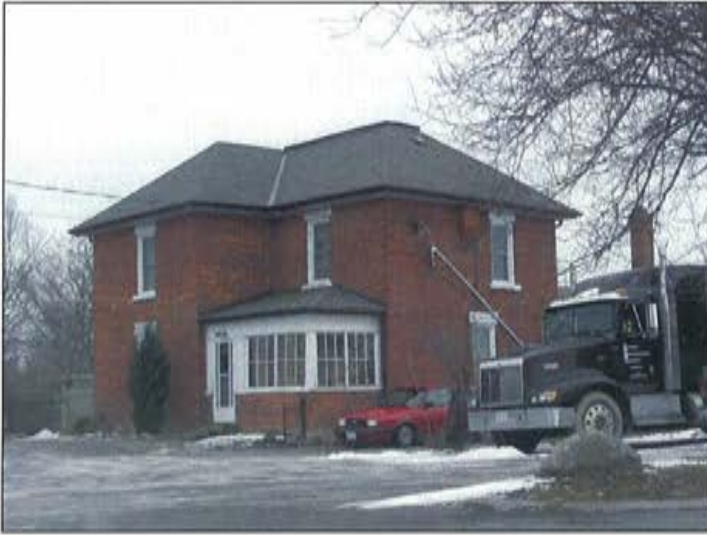
- Built Heritage Feature:** BHF 11
- Location:** 12031 The Gore Road
- Construction Period:** Mid-nineteenth century
- Construction Materials:** Brick exterior on stone foundation
- Description:** This two storey residence features a mildly hipped, asphalt roof with project eaves. Additional design features that contribute to the resource's character include: a square floor plan and enclosed veranda with a mildly shaped bell cast roof.
- Comments:**

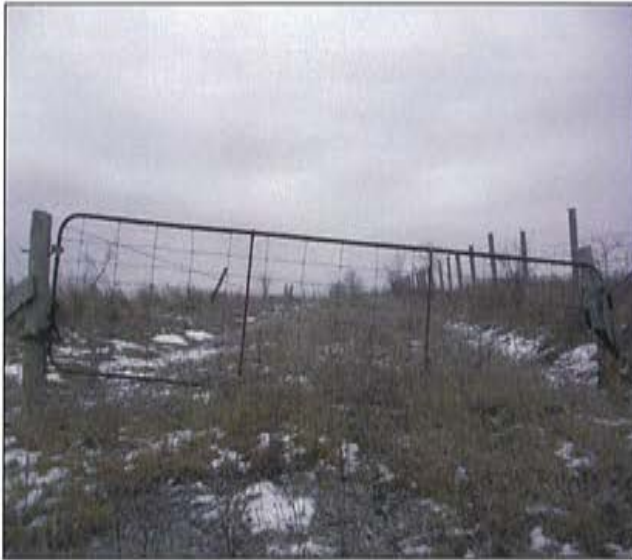
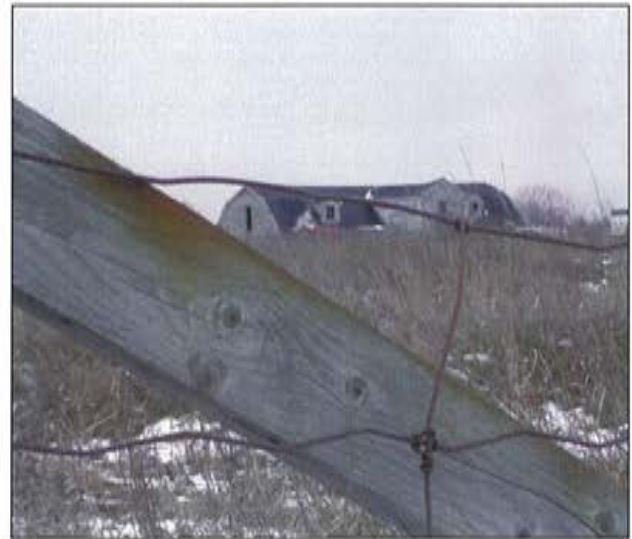
This landscape consists of a residence, barns, outbuildings, and silo. The largest barn is constructed with vertical plank on a stone foundation and features a gabled roof line. A concrete silo is situated to the rear of the barn and outbuildings. The residence features a stucco or lathe plaster exterior on an unknown foundation and an asphalt hipped roof. A post and rail fence line runs along the perimeter of the property, affording Mayfield Road.

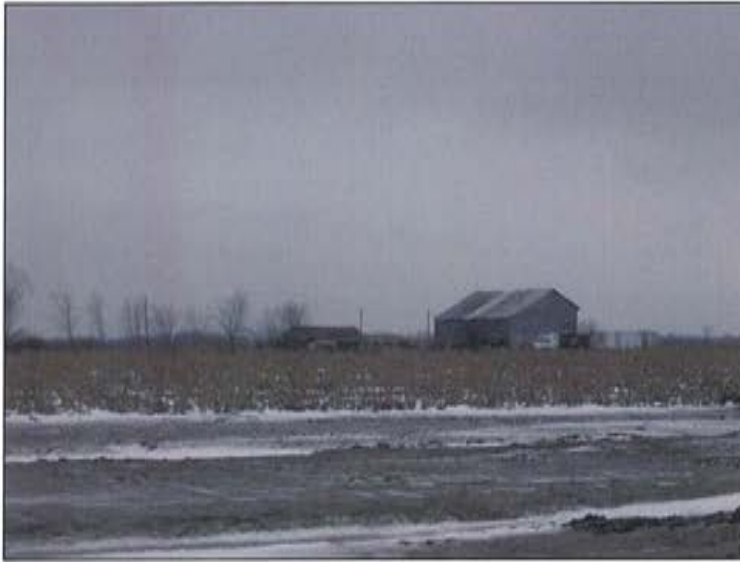
Cultural Landscape Unit: CLU 8

Description: This remnant landscape consists of a gambrel roofed barn, long entrance avenue, and vestiges of post and rail fencing. While gaining a sufficient view of the barn was difficult during the field review, this barn appears to feature a concrete exterior, suggesting a possible rehabilitation effort.

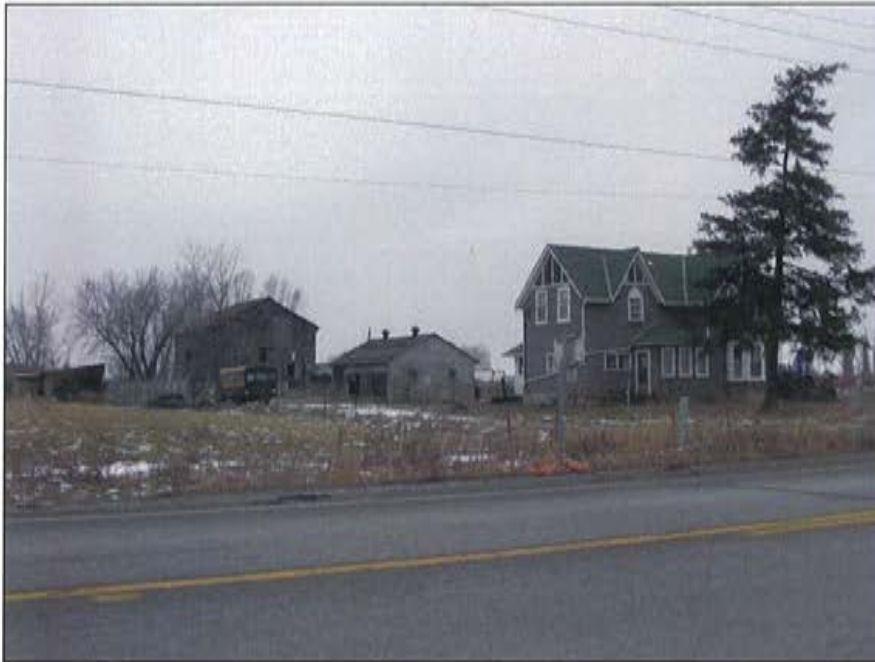
Cultural Landscape Unit: CLU 9

Description: This landscape consists of a barn and outbuildings. This gabled roof barn is possibly constructed with vertical plank or corrugated metal. A smaller barn constructed with vertical plank is located adjacent to the larger barn. A modern residence is located on the southeast elevation of the property.

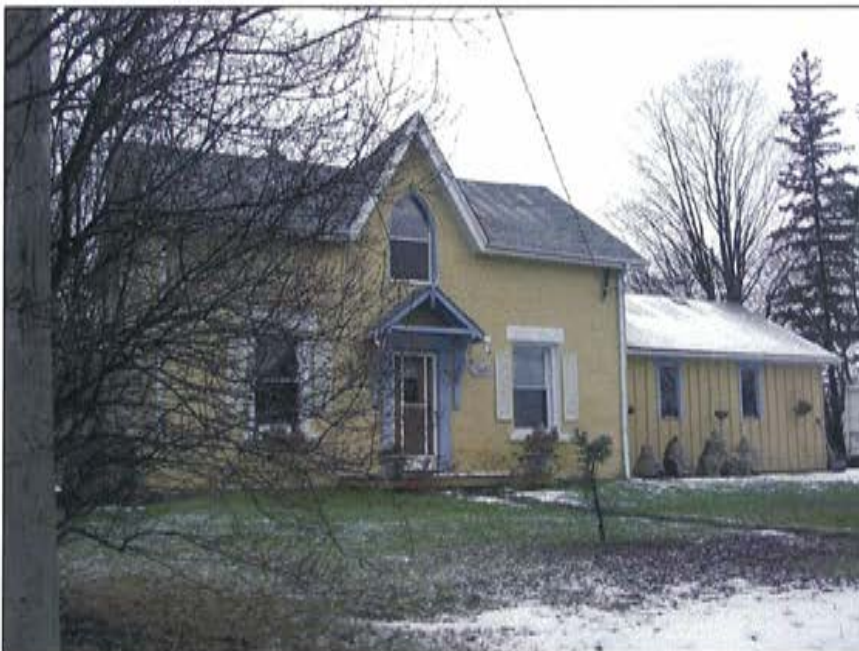
Plate 3: Eastern elevation of residence

The rectangular and pointed arch windows have been updated on the eastern elevation with new materials in a double-hung style. It is highly probable that double-hung windows would have been originally used; however, they would have featured a segmental layout. The pointed arch window has been replaced with a rectangular, modern window. Retention of the original wooden opening and a double-line of voussoirs has helped maintain the original shape of this structural opening (Plate 6). The dressed concrete lug sills and lintels found on the first floor windows also appear to be later additions that were possibly added when the exterior was painted (Plate 7). It is possible that the dressed concrete lintels were installed to replace deteriorating wooden hood mouldings, which could have been an original design feature. The trim that surrounds the front entrance appears to have been altered in two stages. Currently, a moulded wooden lintel is supported by detailed pilasters. The wooden lintel conceals a dressed concrete lintel that is identical to those found above the rectangular windows (Plate 8). Presumably, the concrete lintels were installed above the first floor windows and front entrance to replace deteriorated structural components. The front entrance was further modified by erecting a pediment, at which point the currently extant wooden lintel and pilasters were likely added (Plate 9). The roof appears to have been recently replaced, featuring aluminum projecting eaves and verges. Wooden, decorative verge board possibly once decorated the fascia of the gabled dormer; however, this material is no longer extant.

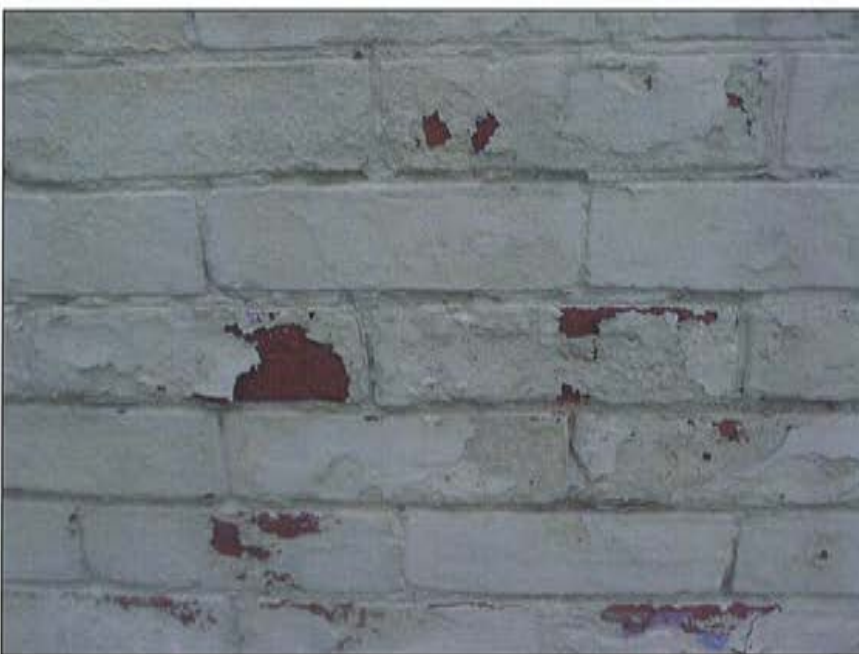
Plate 4: Peeling paint on eastern elevation, exposing original red brickwork

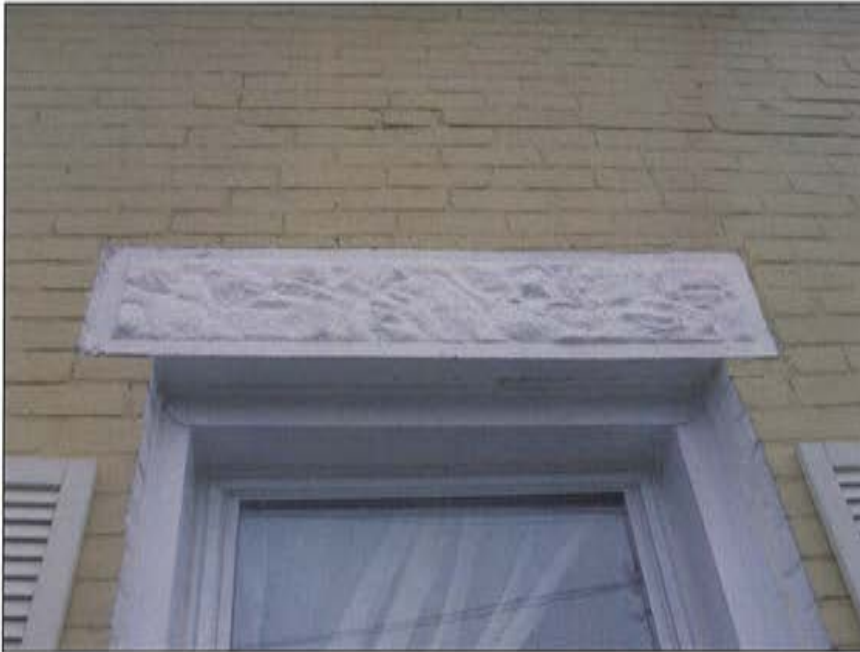
Plate 5: Dressed concrete lintels above windows on eastern elevation

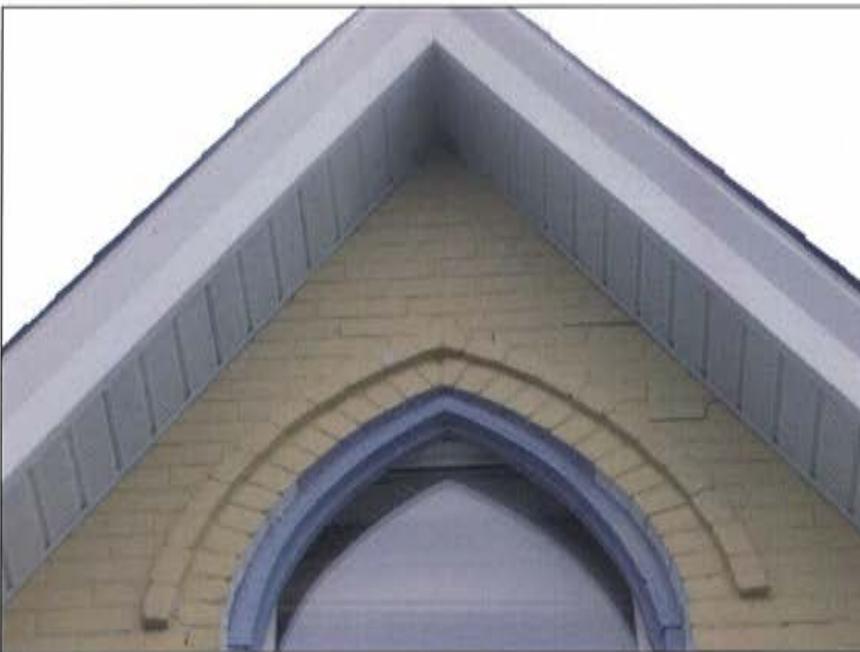
Plate 6: Inset, arched window and brick voussoirs, eastern elevation.

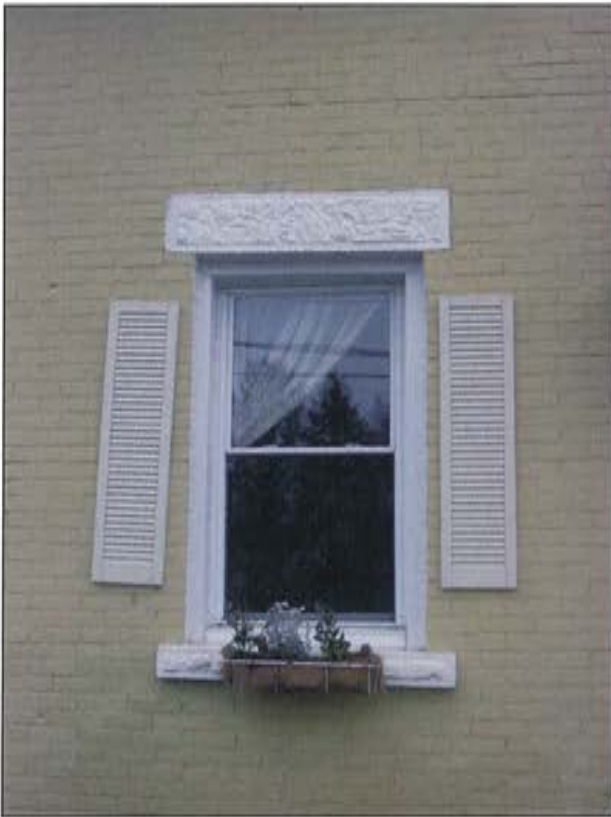
Plate 7: Window detail, eastern elevation

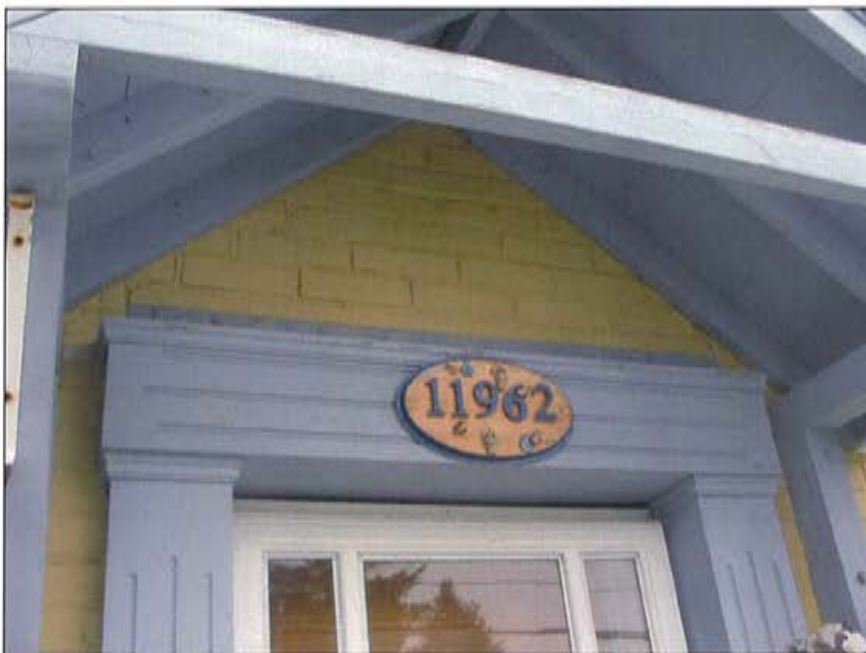
Plate 8: Front entrance, eastern elevation, showing dressed concrete lintel

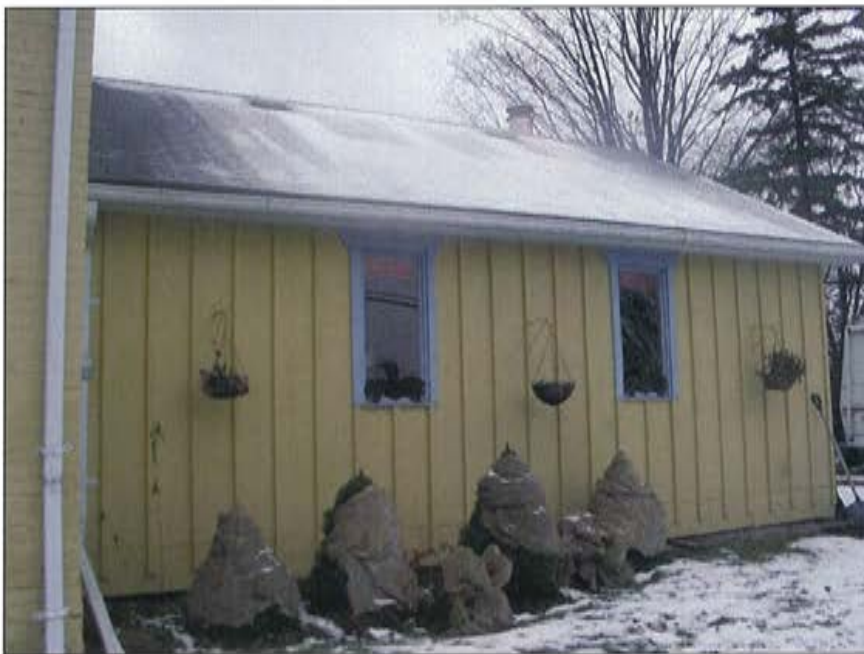
The northern elevation of the dwelling has been extended by adding a 1 storey structure that presumably once functioned as a garage, but is now used as living space (Plate 10). A review of aerial mapping dating to 1994 confirms that this addition was in place at this time. This extension conceals the majority of the original northern façade of the dwelling; however, an original window opening is extant on this façade and is framed by brick voussoirs (Plate 11). The extension was constructed with wooden materials and using a board and batten construction method (Plate 12). Traditional board and batten siding features vertically applied boards, which are covered by a raised strip of wood to conceal joints between wooden boards. This structure also features a series of single-paned windows which are capped by wooden lintels. On the northern elevation of the addition, a garage door is extant, as well as an upper storey opening (Plate 13). Both of these structural openings, combined with the structure's use of board and batten siding, are reminiscent of detailing used on blacksmith shops. The garage door imitates the large horse doors that are typically found at the ground level of nineteenth century blacksmith shops, while the door that is nestled in the gabled end is congruent with structural openings found in the upper storey of blacksmith shops, which provide access to storage spaces. A small horse shoe ornament is installed on the northern elevation of the extension (Plate 14). The chimney of an internal wood burning stove is visible from the western elevation of the extension (Plate 15). This association with architectural detailing found amongst blacksmith shops is interesting given that Michael O'Leary was documented to have been a blacksmith.

Plate 10: Extension on northern elevation

The northern elevation of the dwelling has been extended by adding a 1 storey structure that presumably once functioned as a garage, but is now used as living space (Plate 10). A review of aerial mapping dating to 1994 confirms that this addition was in place at this time. This extension conceals the majority of the original northern façade of the dwelling; however, an original window opening is extant on this façade and is framed by brick voussoirs (Plate 11). The extension was constructed with wooden materials and using a board and batten construction method (Plate 12). Traditional board and batten siding features vertically applied boards, which are covered by a raised strip of wood to conceal joints between wooden boards. This structure also features a series of single-paned windows which are capped by wooden lintels. On the northern elevation of the addition, a garage door is extant, as well as an upper storey opening (Plate 13). Both of these structural openings, combined with the structure's use of board and batten siding, are reminiscent of detailing used on blacksmith shops. The garage door imitates the large horse doors that are typically found at the ground level of nineteenth century blacksmith shops, while the door that is nestled in the gabled end is congruent with structural openings found in the upper storey of blacksmith shops, which provide access to storage spaces. A small horse shoe ornament is installed on the northern elevation of the extension (Plate 14). The chimney of an internal wood burning stove is visible from the western elevation of the extension (Plate 15). This association with architectural detailing found amongst blacksmith shops is interesting given that Michael O'Leary was documented to have been a blacksmith.

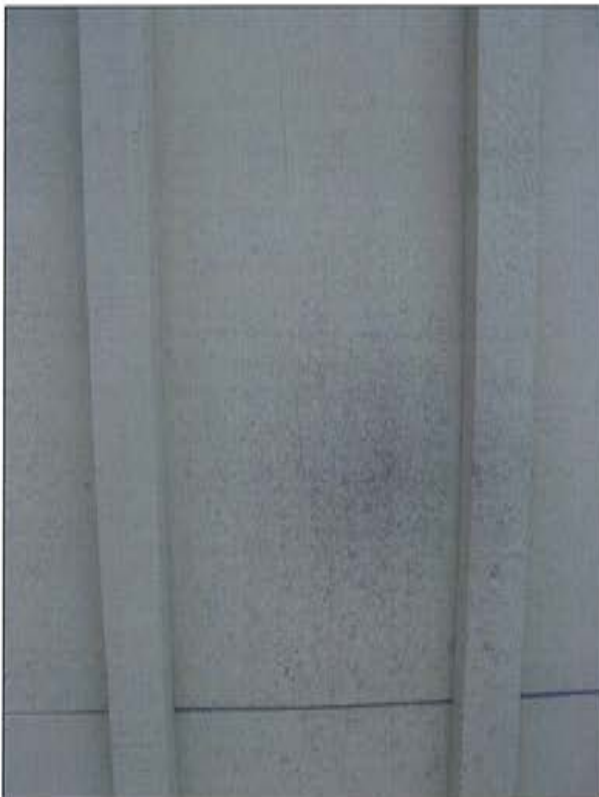
Plate 12: Board and batten detail on extension

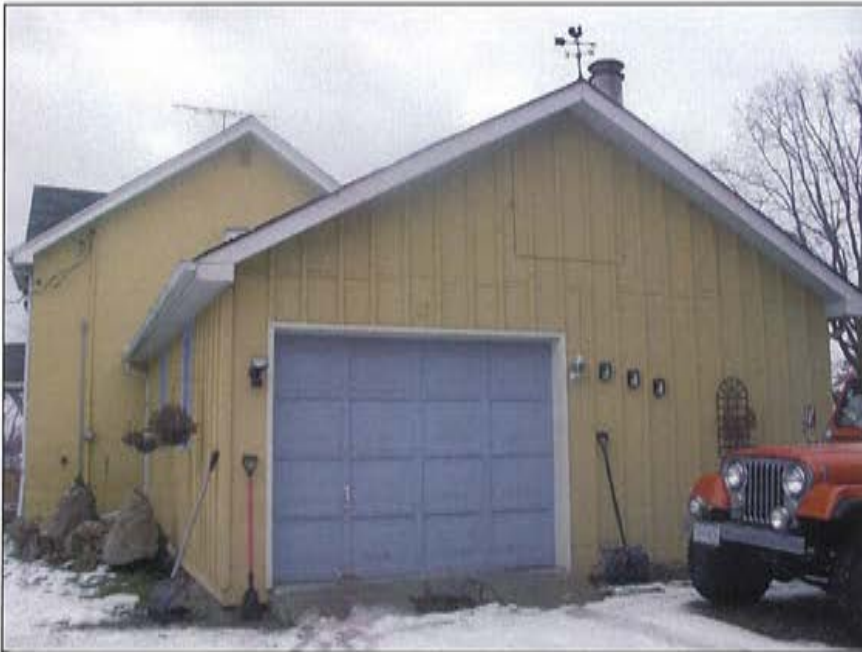
Plate 13: View of extension and upper storey opening

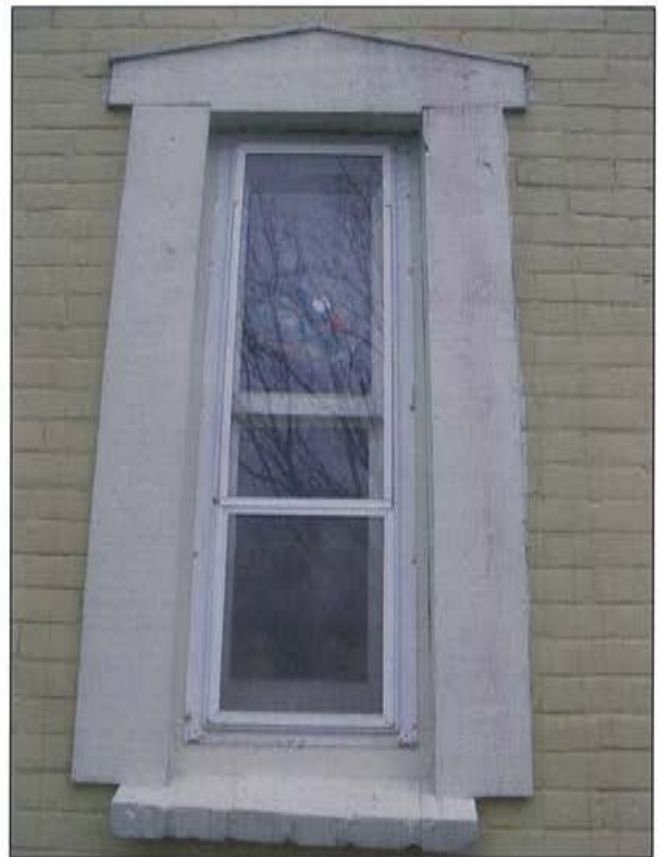
Plate 19: View of structural opening, featuring brick sills.

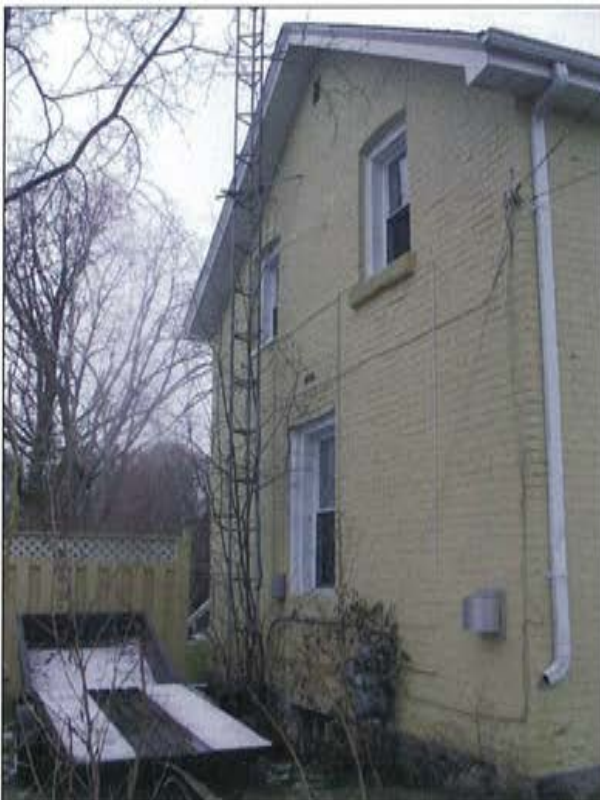
Plate 21: View of unaltered southern elevation.

The southern elevation of the dwelling is relatively unaltered (Plate 21). Three windows are located on this façade and likely mark original structural openings. All three windows have been recently replaced. The two upper storey windows have maintained their structural openings and brick voussoirs (Plate 22). The window on the eastern half of this façade retains a concrete lug sill. The window located on the ground floor lacks original brick voussoirs and lug sill (Plate 23). It appears that brick work located immediately above this window has required rehabilitation (Plate 23).

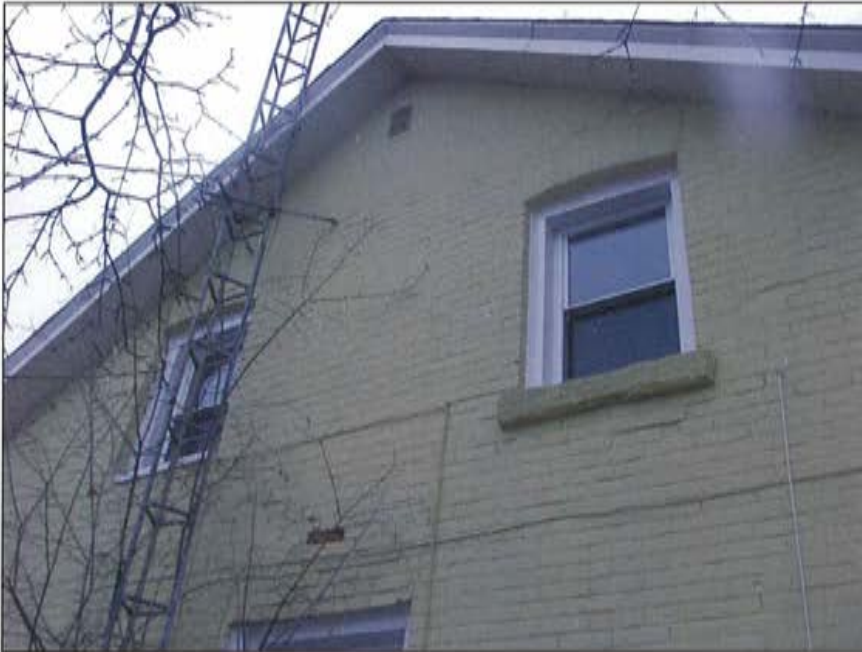
Plate 22: View of upper storey windows on southern elevation, showing new windows and retention of original structural opening and brick voussoirs in the upper storey.

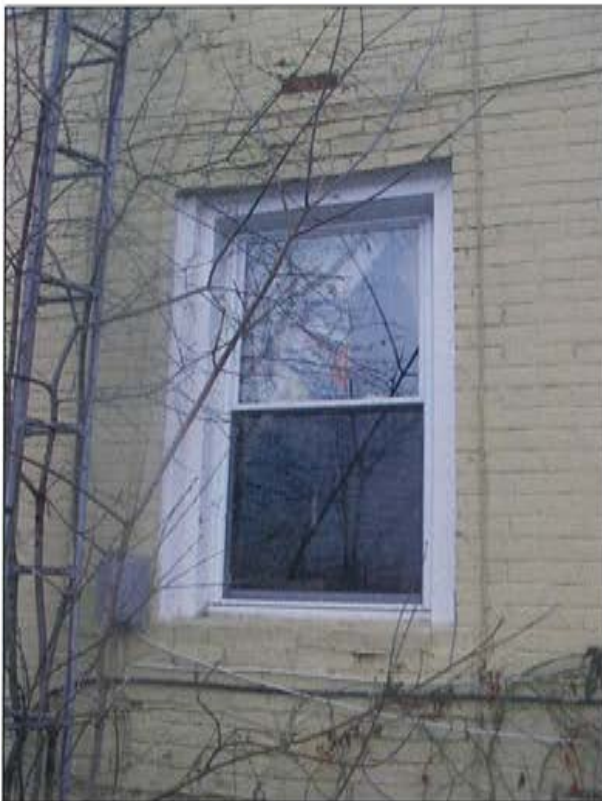
Plate 23: Ground floor window on southern elevation, lacking original voussoirs and sill.

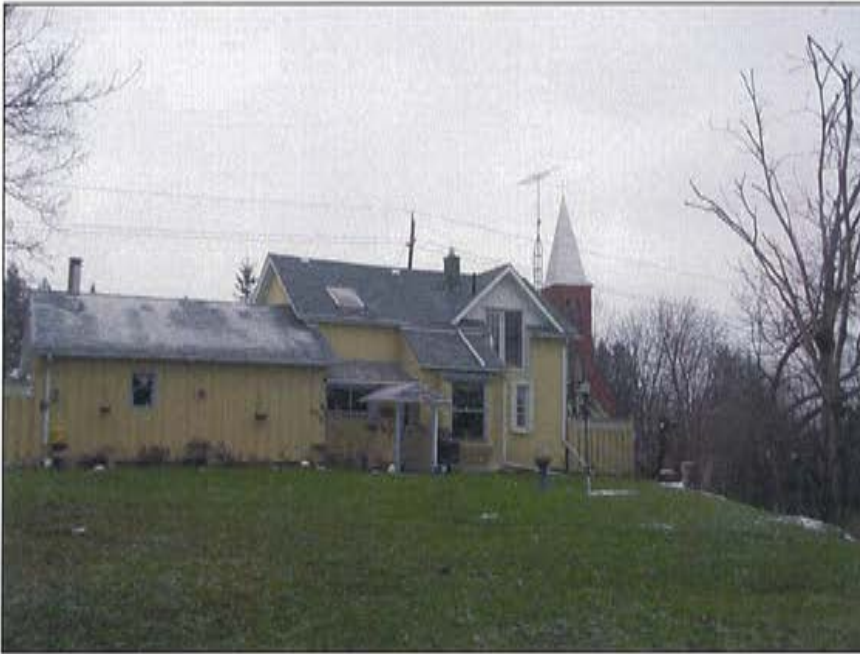
Plate 26: View of steeply sloped terrain on southern and western elevations of property.

The remainder of the lot retains two greenhouse structures and an aluminum shed. These structures are relatively recent additions (Plates 24 - 25). On the south and west sides of the property, the terrain is steeply sloped (Plate 26). Currently, the subject dwelling is situated in close proximity to the current Gore Road right-of-way (Plate 27). An asphalt pedestrian pathway is located between the road bed and the small grassed area situated in front of the dwelling. Relatively young vegetation is located on the eastern elevation of the property.
