Mayfield Road Improvements

Airport Road to Coleraine Drive –
Class Environmental Assessment

ENVIRONMENTAL STUDY REPORT

**Preliminary Geotechnical
Investigation Report**
Mayfield Road
Airport Road to Coleraine Drive,
Brampton and Caledon, Ontario

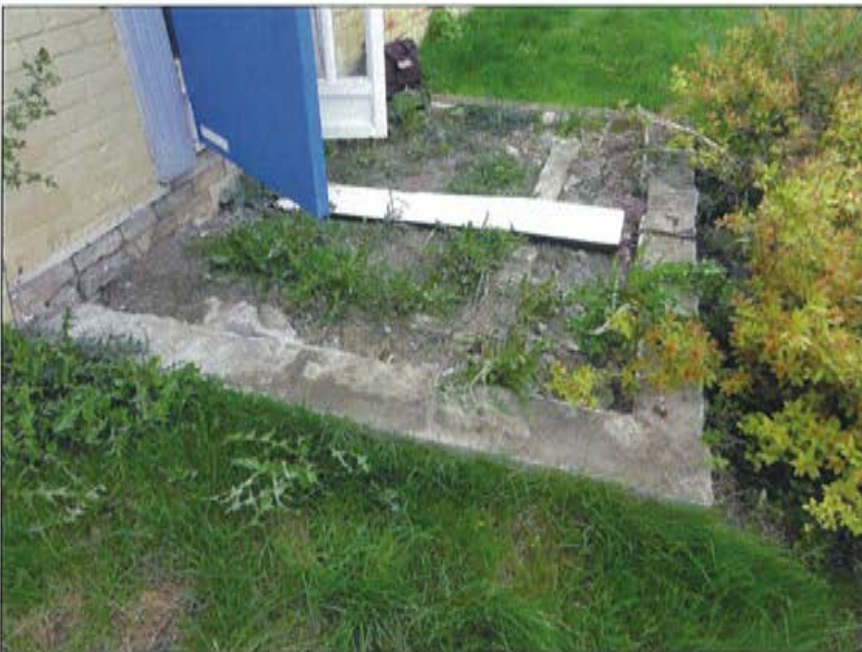
Plate 31: Detail of primary entrance to residence in May 2011 showing location of previous wooden deck and detail of poured concrete base.

The primary point of entry to the interior of the structure is provided on the eastern elevation of the building. As previously mentioned, a veranda originally framed this entrance, of which a structural marking for its roof line is still extant. As of May 2011, a previous wooden deck that had been constructed beneath the front entrance had been removed. The primary entrance consists of a modern storm door and solid wood door (Plates 32 and 33). Both are recent introductions and are of modern fabrication. The wooden door is detailed in a sympathetic manner, consisting of two recessed panels with a single pane of glass located within the upper panel.

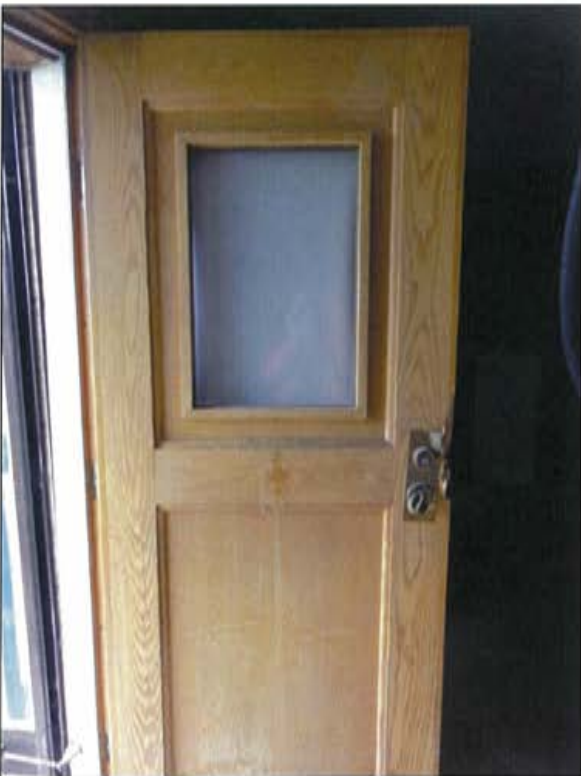
Plate 33: View of modern wood door located on eastern elevation, showing recessing panels and single pane of glass.

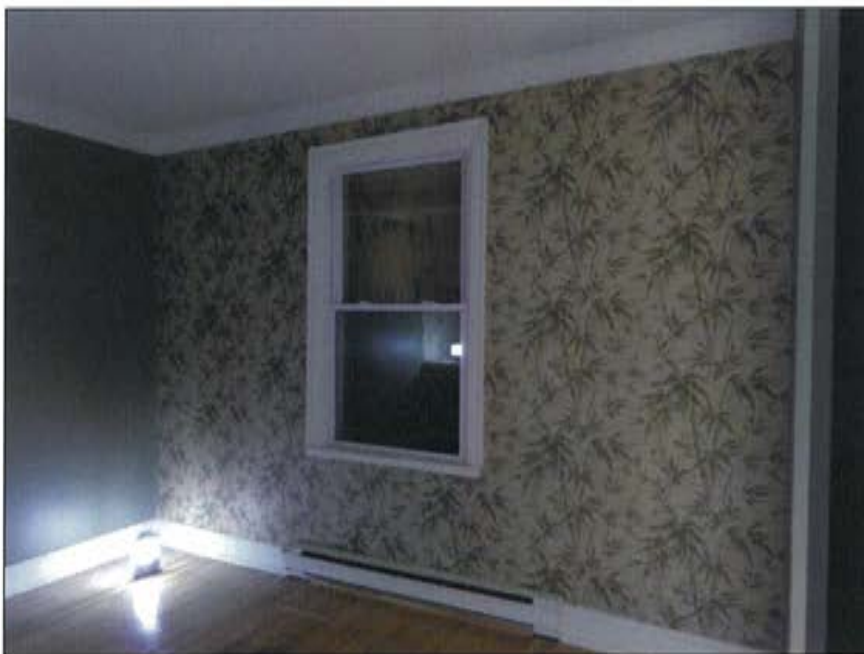
Plate 35: View of original window opening in Living Room on first floor.

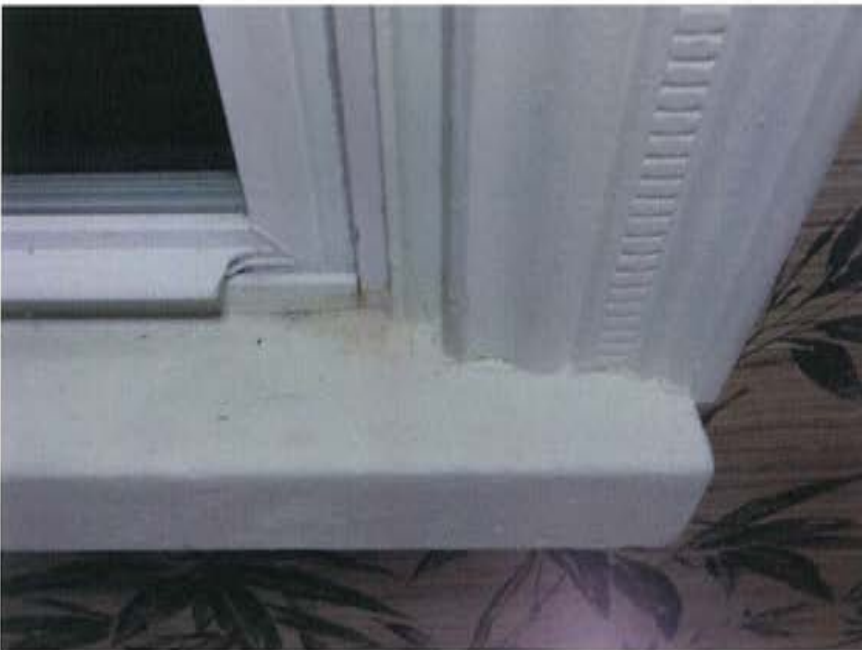
Plate 37: Detail of wooden sill found in the Living Room.

The first floor layout of the residence is typical of mid nineteenth century floor plans with a central staircase flanked by two rooms and with a kitchen located behind the staircase and to the north. A bathroom is located behind the staircase on the south side. These four rooms comprise the original footprint of the residence with overall dimensional measurements of 8.94 m by 6.5 m. Generally, the first floor is characterized by open-concept circulation and illustrates evidence of removal of original partition walls. The living room is located north of the primary entrance and is accessed through an opening measuring approximately 1.2 m (Plate 34). It is highly probable that a standard doorway would have been originally constructed to provide access to a sitting area in this location. The living room features one window which is in its original location, situated approximately 1.6 m north of the primary entrance and equidistant between the northern edge of the primary entrance way and the northern elevation of the residence (Plate 35). This room features modern baseboards and crown moulding, as well as updated window trim and door trim (Plate 36). The window sill is likely original to construction of the house (Plate 37). The flooring in this room consists of narrow hardwood boards (4.5 cm) that appear to date to at

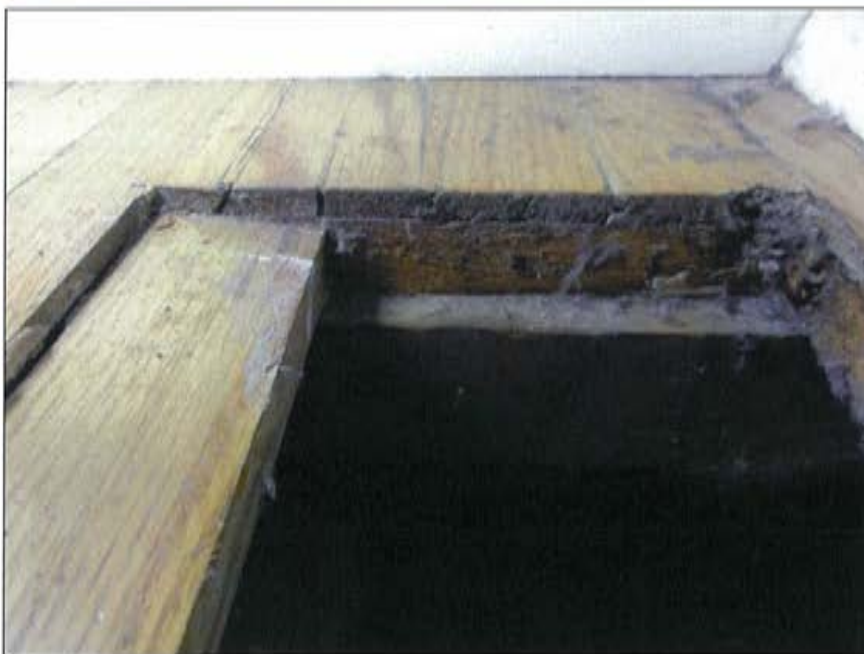
Plate 39: Cross section of flooring in Living Room showing extant narrow floor boards on top of older flooring.

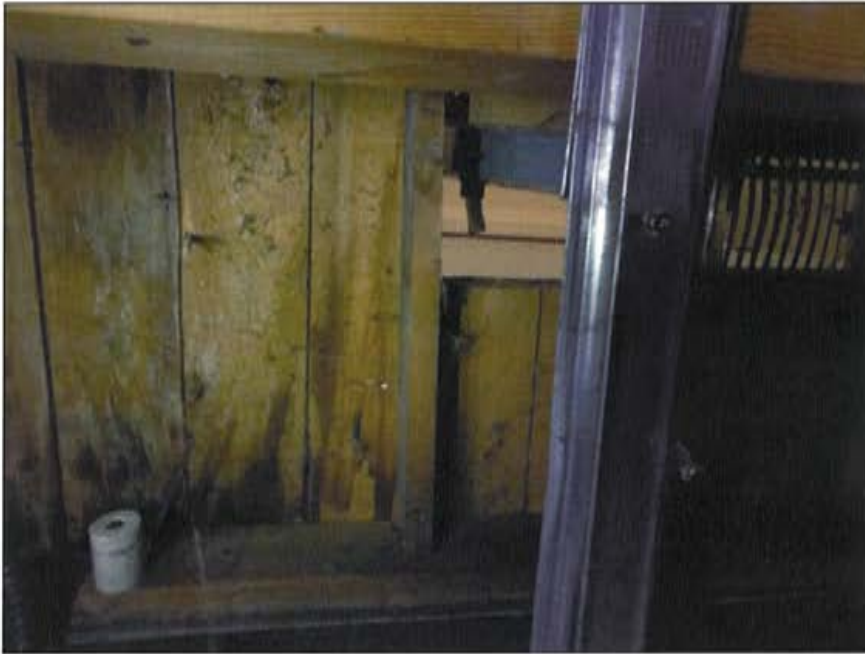
Plate 40: View from basement of location illustrated in Plate 39 showing floor joists, subfloor and hardwood boards on top of the subfloor, running in a direction opposite to the extant narrow hard wood flooring found in the Living Room.

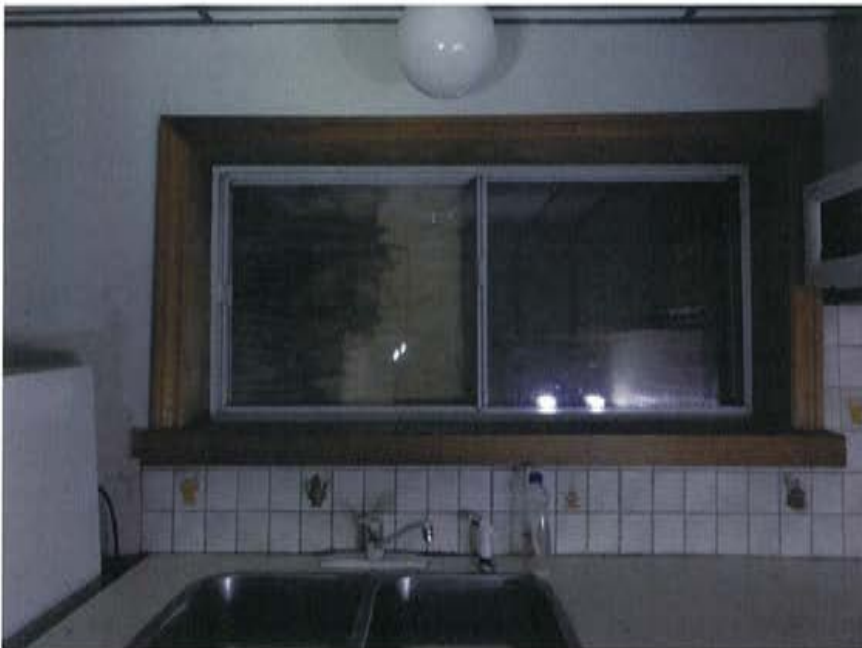
Plate 43: Detail of horizontal window (new structural opening) in the Kitchen.

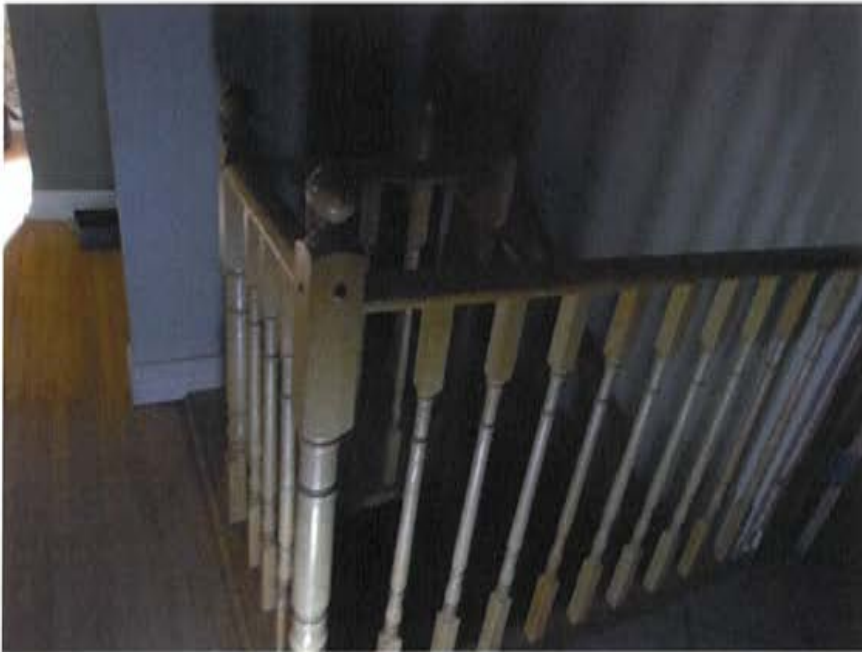
Plate 44: Location context of spiral staircase behind original central staircase, showing railing and balusters. This staircase is a recent addition.

A bathroom and spiral staircase is located directly opposite the kitchen area. The staircase is located directly behind the primary central staircase and based on its materials and design is a relatively recent addition. The staircase is extremely narrow and steep and is constructed of oak materials (Plates 44 and 45). Flooring surrounding the staircase is parquet and not found elsewhere in the house. The bathroom is located west of the staircase. It features modernized, twentieth century building materials and appliances (Plate 46). The window located in this room features frosted glass, older trim, and a wooden sash (Plate 47). Similarly the doorway in this room features older wooden trim. West and north of the bathroom, an eating area is extant. This area has been constructed by making a structural addition to the structure. This area was likely created by enclosing a portion of a veranda located on the building's western elevation and increasing the height of this area. This enclosure/addition features two windows and a rear point of entry to the residence. A simple, modern, double hung window is located on the southern elevation of the addition and features simple wooden trim and sill constructed of knotty pine (Plate 48). The window located on the western elevation of the addition features a pivoted opening mechanism and wooden sashes (Plate 49). The door located on the northern elevation of the addition is constructed of wood and features two vertical panels in the lower section and a single pane of glass in the upper section (Plate 50). This door is framed by trim fabricated of knotty pine. Flooring in the eating area is ceramic tile.

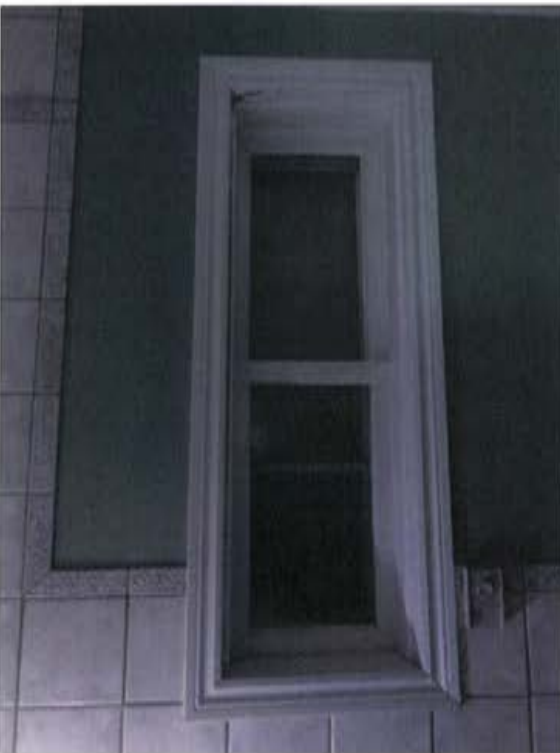
Plate 47: View of window in bathroom showing wooden sashes and older wooden trim.

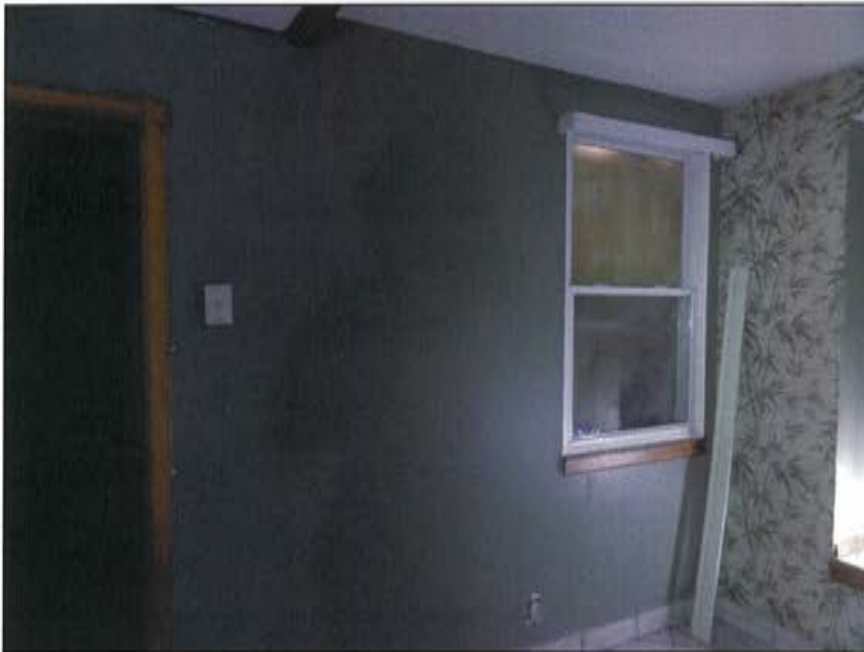
Plate 48: View of new structural opening and window located on the southern elevation of the rear addition..

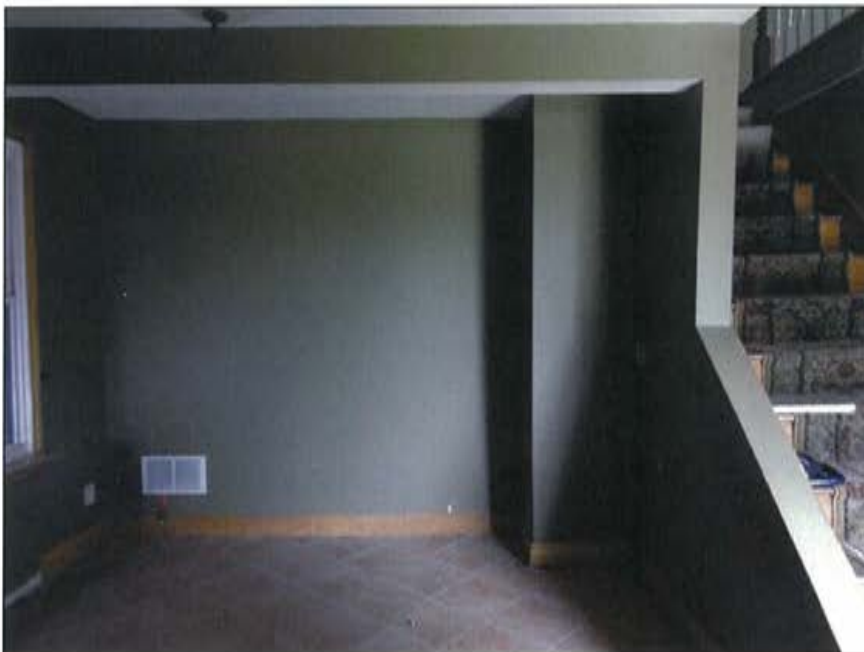
Plate 51: View from south of main entrance looking west showing Family Room and location of previous partition wall adjacent to staircase.

The remainder of the first floor is comprised of the family room, situated south of the central staircase and primary point of entry. Similar to the living room, this area is accessed through an opening measuring approximately 1.7 m (Plate 51). A standard doorway may have been originally located in this area for the purposes of establishing a completely separate room on the south side of the stairs. The family room features two double-hung windows, both of which are of relatively new fabrication. They are both surrounded by identical new wooden trim and sills (Plates 52 and 53). The flooring in this room consists of ceramic tile which may have been laid over older or original floor boards. There is an uneven transition between the ceramic tile located in the family room and the hardwood flooring located in the living room, suggesting that there may be older or original materials extant beneath the ceramic materials. The staircase which provides access to the upper half storey appears to have been partially modified when an interior partition wall between the family room and front foyer was removed (Plate 54). The tread, nosing, and risers are all constructed of solid wood and appear to date to construction of the house (Plate 55). Similarly, the wall string is constructed of identical materials and appears to also serve as an example of original materials. The staircase lacks any railing or balusters on the first floor.

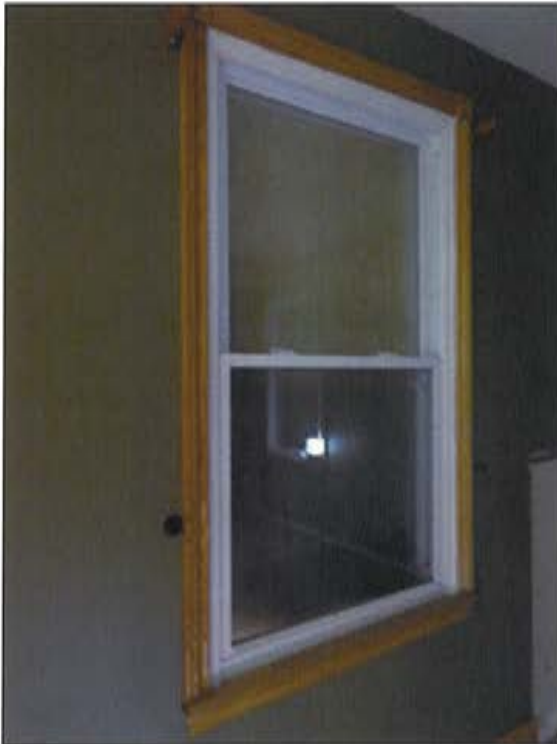
Plate 52: View of original structural opening on east wall of Family Room showing new window, trim and sill.

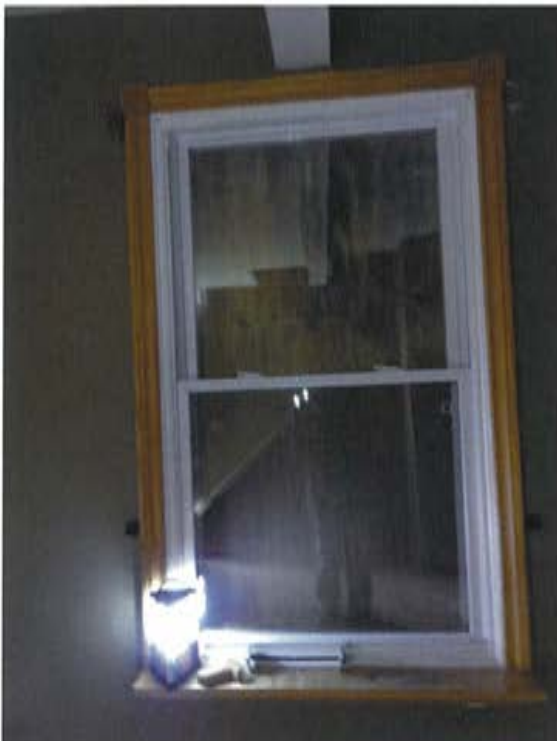
Plate 53: View of original structural opening on south wall of Family Room showing new window, trim and sill.

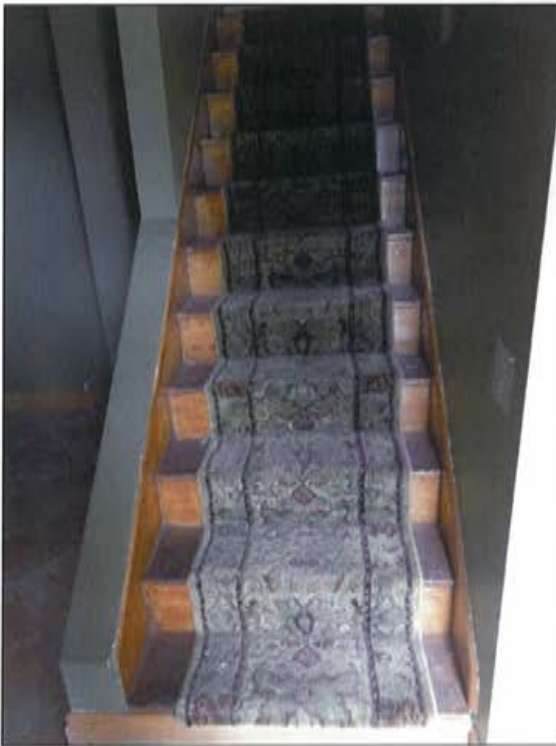
Plate 54: View of central staircase on first floor showing removed partition wall (left) and overall arrangement and materials.

The remainder of the first floor is comprised of the family room, situated south of the central staircase and primary point of entry. Similar to the living room, this area is accessed through an opening measuring approximately 1.7 m (Plate 51). A standard doorway may have been originally located in this area for the purposes of establishing a completely separate room on the south side of the stairs. The family room features two double-hung windows, both of which are of relatively new fabrication. They are both surrounded by identical new wooden trim and sills (Plates 52 and 53). The flooring in this room consists of ceramic tile which may have been laid over older or original floor boards. There is an uneven transition between the ceramic tile located in the family room and the hardwood flooring located in the living room, suggesting that there may be older or original materials extant beneath the ceramic materials. The staircase which provides access to the upper half storey appears to have been partially modified when an interior partition wall between the family room and front foyer was removed (Plate 54). The tread, nosing, and risers are all constructed of solid wood and appear to date to construction of the house (Plate 55). Similarly, the wall string is constructed of identical materials and appears to also serve as an example of original materials. The staircase lacks any railing or balusters on the first floor.

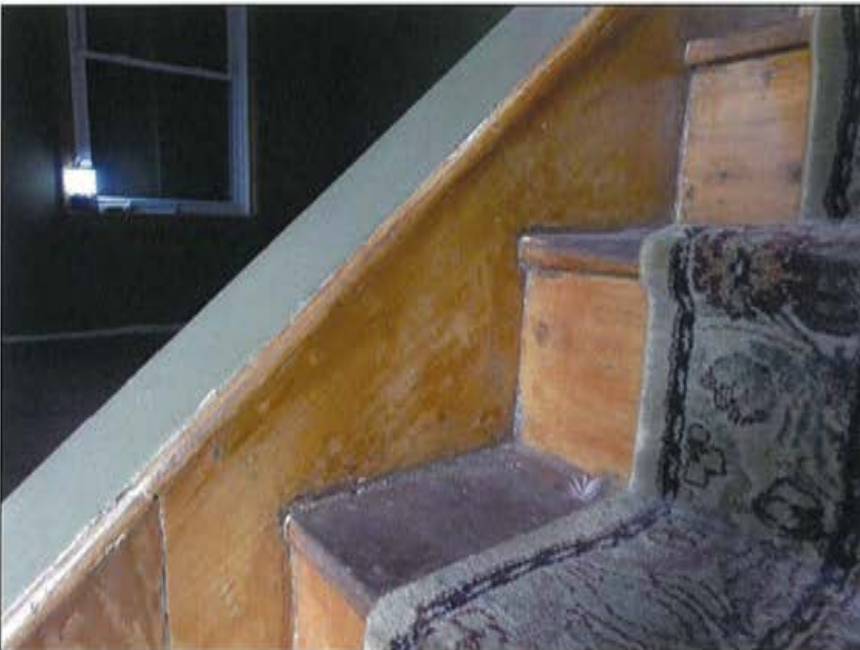
Plate 55: Detail of central staircase showing solid wood wall string, nosing, tread, and risers that appear to date to construction of the house.

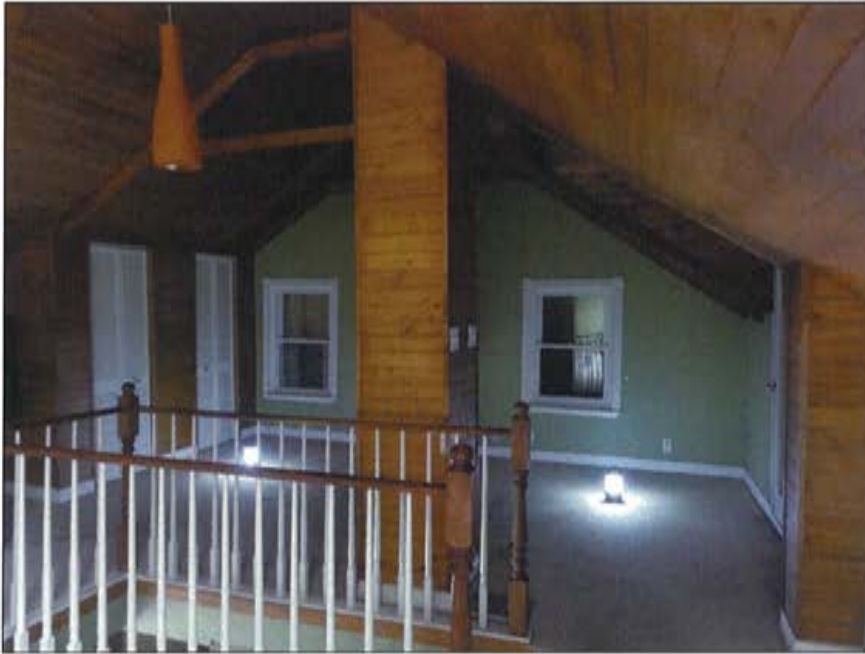
Plate 56: View of upper story that has been converted into a master bedroom looking south.

strip siding that has been applied to the walls and which also matches replaced roof joists (Plate 56). This room features four windows: a pointed arch window opening is located on the east wall and has been updated with a double-hung window, new trim and sills; two double-hung windows are located on the southern wall and both feature new trim but may retain original sills; and one double-hung window is located on the west wall and also features new trim and lacks sills (Plates 57 – 60). ‘His and Hers’ closets are located on the east wall and are accessed by louvered doors. Wall to wall carpeting fully covers the floor, extending into both closets. Inspections revealed that the wall to wall carpeting has been installed directly over subfloor; no original or older floor materials appear to be extant beneath. Other additions include two doors on the south half of the west elevation, one of which is fixed, and a skylight on the north half (Plate 61). This upper half storey would have originally functioned as a space comprised of multiple bedrooms, however, has since been updated to respond to modern living conditions. It is probable that there would have been a wall originally extant immediately south of the staircase, running in an east-west direction, providing space for two bedrooms; each with one window. A hallway would have been present along the north, east, and west sides of the staircase. Two additional rooms would have been located on the north side of the staircase with an interior partition wall likely running east-west roughly at the southern terminus of the closet located on the north half of the east wall. One of these previous rooms would have functioned as a bedroom and it is likely that this would have been situated towards the front of the house and would have contained a window. It is possible that a washroom would have been located behind (west) of this room.

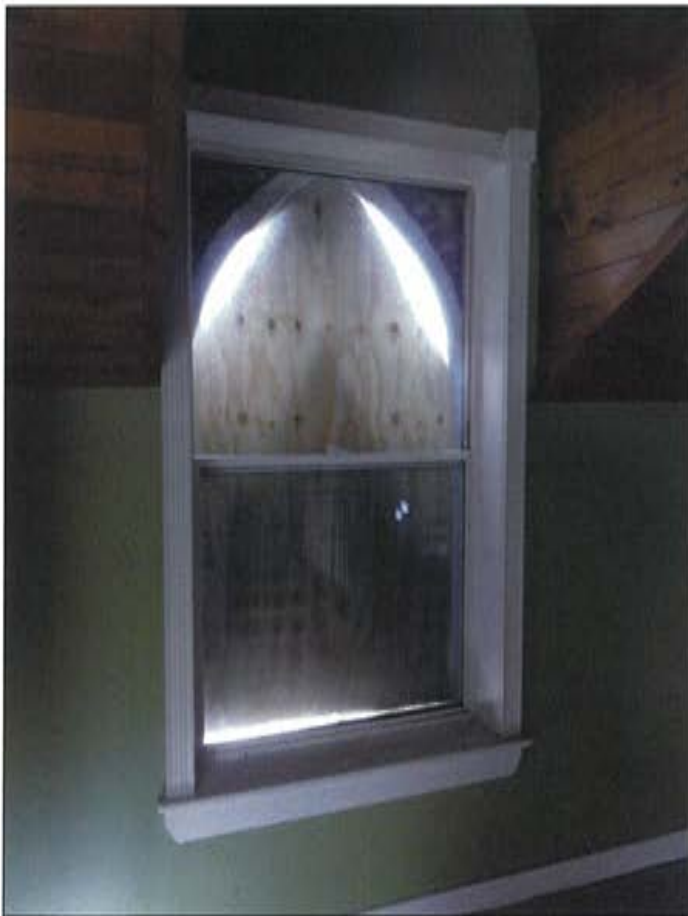
Plate 57: View of pointed window on east wall showing rectangular window and pointed structural opening.

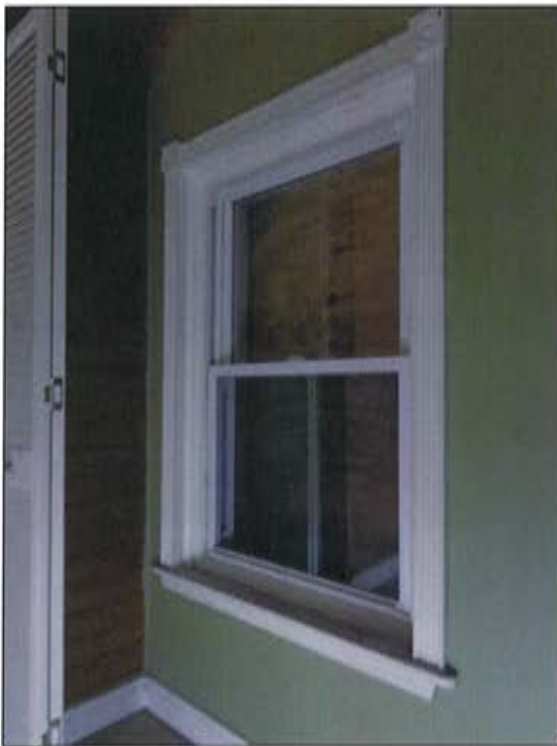
Plate 58: View of original structural opening and new window on south wall (east half).

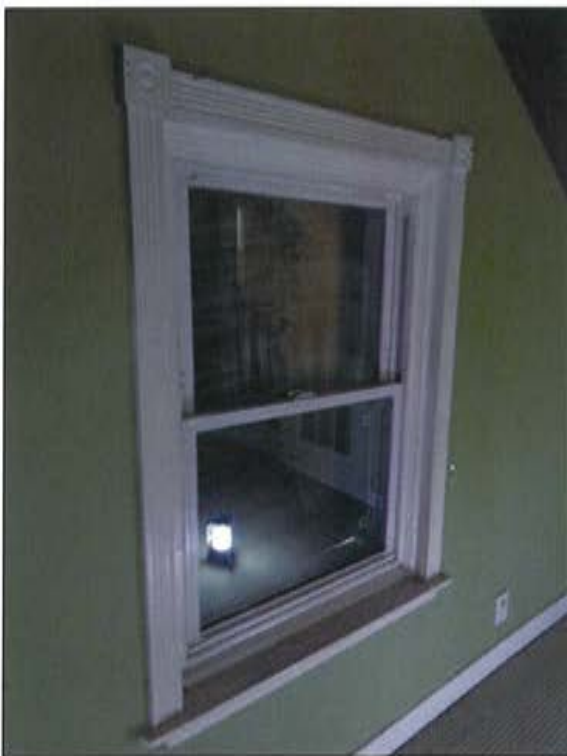
Plate 59: View of original structural opening and new window on south wall (west half).

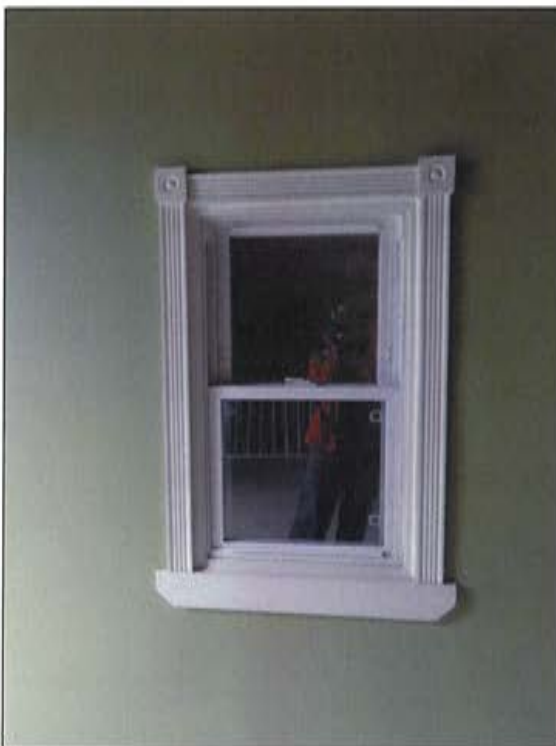
Plate 60: View of double-hung window on north wall of upper floor; the size of this structural opening has been altered through filling in of brick on the east side.

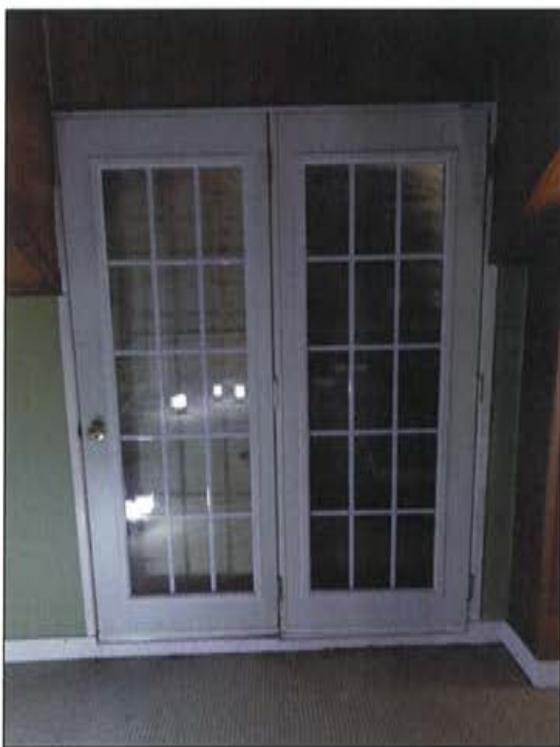
Plate 61: New French doors added on the west wall (south half) in the upper storey.

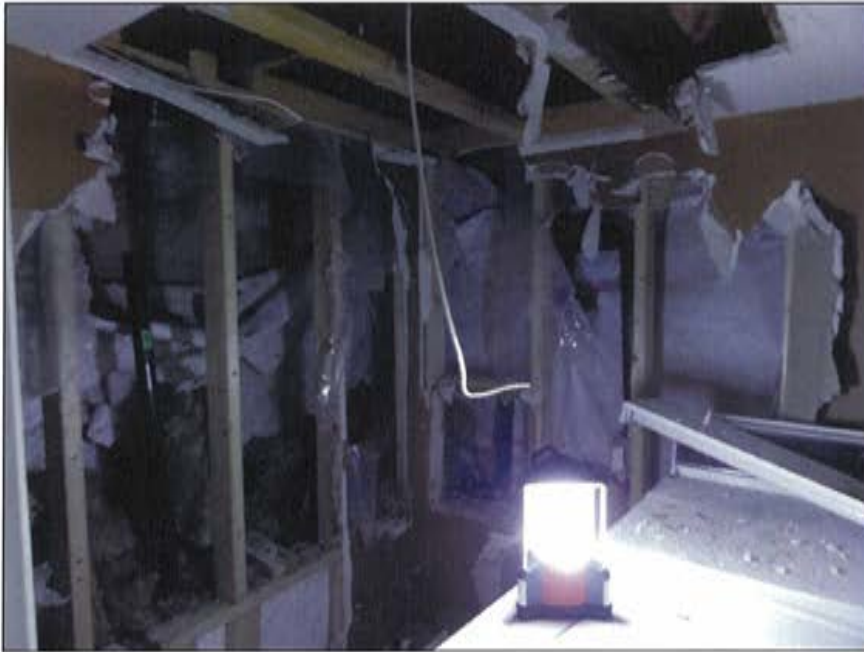
Plate 64: View of Area 3 (laundry room) showing removed drywall, wall studs, and concrete parging in background.

As previously discussed the basement is accessed off of the kitchen area, behind the central staircase, via a newly added spiral staircase. Exterior access to the basement is also provided on the building’s western elevation. The basement is divided into three areas: the largest space measures approximately 5 m by 5m and is located below the living room and kitchen areas (Plate 62). This area has been fully updated and modernized and most likely functioned as a sitting room or den up until recently. Although having suffered some vandalism, this area features wall to wall carpeting, modern cabinetry and shelving and wooden bench seating along the north and east walls. This room has had dry walling erected and likely featured a drop ceiling, prior to acts of vandalism. The bench seating along the north and east walls was probably a functional and aesthetic design scheme chosen to pleasantly conceal concrete shoring that may be extant along these walls. South of this area, a bathroom (Area 2) and laundry room (Area 3) are extant. The bathroom is accessed via a doorway off the main area and features a stand-up shower, sink and vanity (Plate 63). The laundry room is accessed from the bathroom and continues to retain modern appliances (Plate 64). Dry wall has been removed in this area, revealing wall studs and structural foundations. The foundations of the structure appear to have been parged with extensive concrete as part of rehabilitation and stabilization strategies for the original stone foundations. Investigation of this area revealed extant stone foundations and original sill plate (Plate 65).

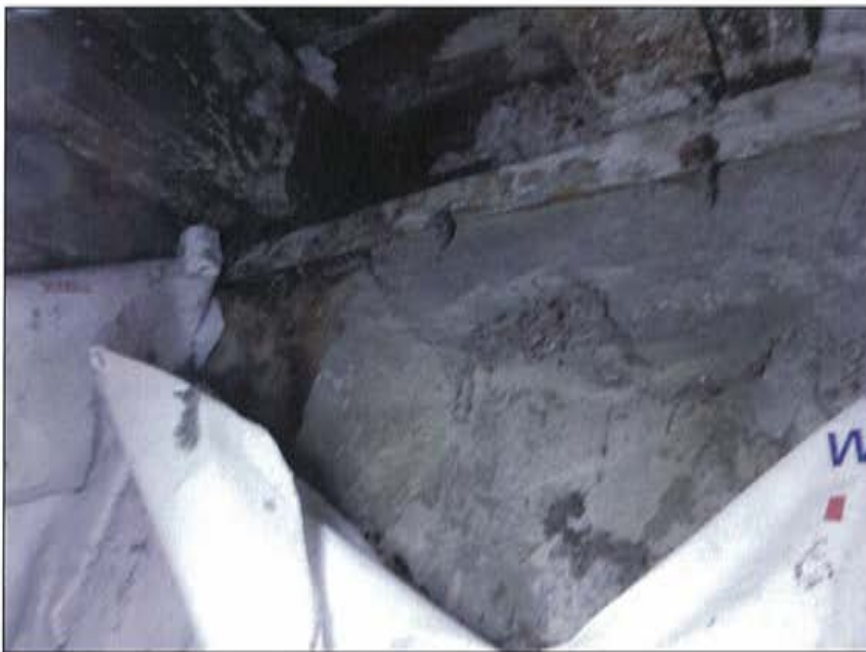
Plate 65: Detail of original sill plate sitting on top of parged concrete which conceals original stone foundations.

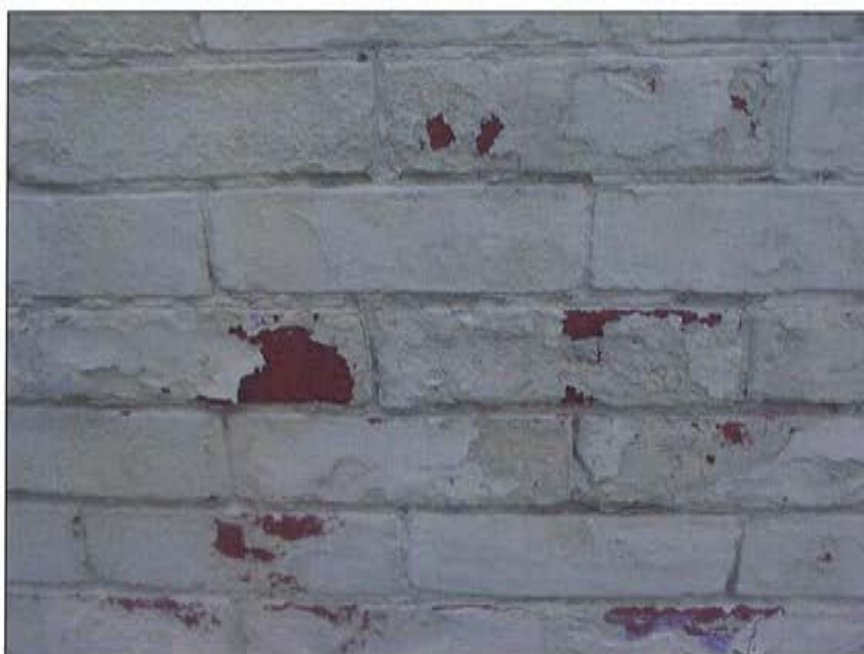
Plate 4: Peeling paint on eastern elevation, exposing original red brickwork

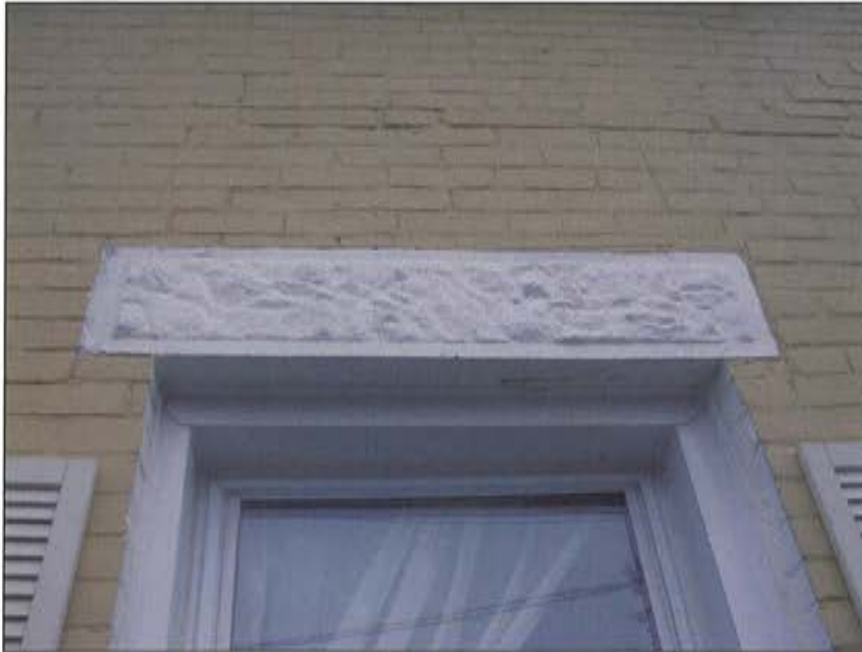
Plate 5: Dressed concrete lintels above windows on eastern elevation

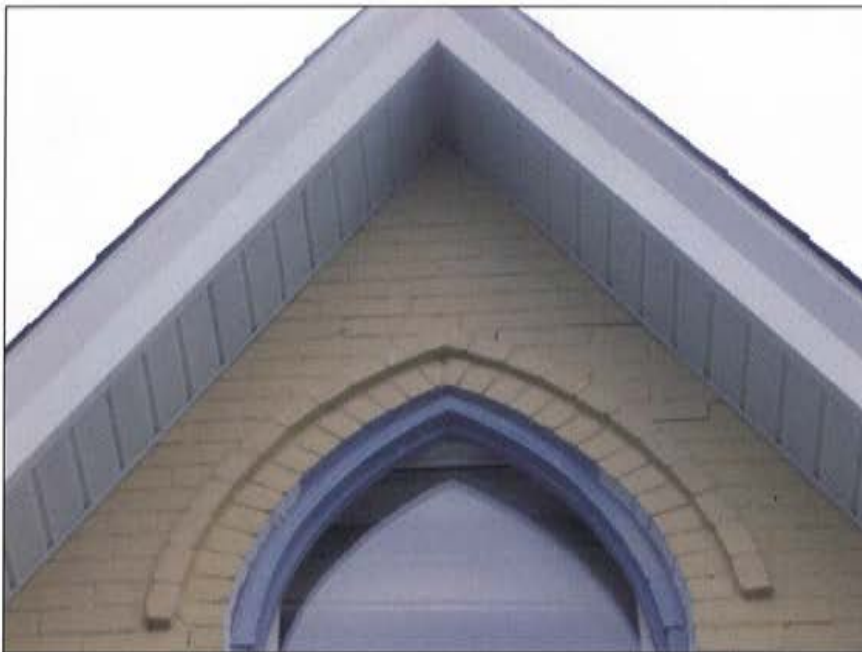
Plate 6: Inset, arched window and brick voussoirs, eastern elevation.

The rectangular and pointed arch windows have been updated on the eastern elevation with new materials in a double-hung style. It is highly probable that double-hung windows would have been originally used; however, they would have featured a segmental layout. The pointed arch window has been replaced with a rectangular, modern window. Retention of the original wooden opening and a double-line of voussoirs has helped maintain the original shape of this structural opening (Plate 6). The dressed concrete lug sills and lintels found on the first floor windows also appear to be later additions that were possibly added when the exterior was painted (Plate 7). It is possible that the dressed concrete lintels were installed to replace deteriorating wooden hood mouldings, which could have been an original design feature. The trim that surrounds the front entrance appears to have been altered in two stages. Currently, a moulded wooden lintel is supported by detailed pilasters. The wooden lintel conceals a dressed concrete lintel that is identical to those found above the rectangular windows (Plate 8). Presumably, the concrete lintels were installed above the first floor windows and front entrance to replace deteriorated structural components. The front entrance was further modified by erecting a pediment, at which point the currently extant wooden lintel and pilasters were likely added (Plate 9). The roof appears to have been recently replaced, featuring aluminum projecting eaves and verges. Wooden, decorative verge board possibly once decorated the fascia of the gabled dormer; however, this material is no longer extant.

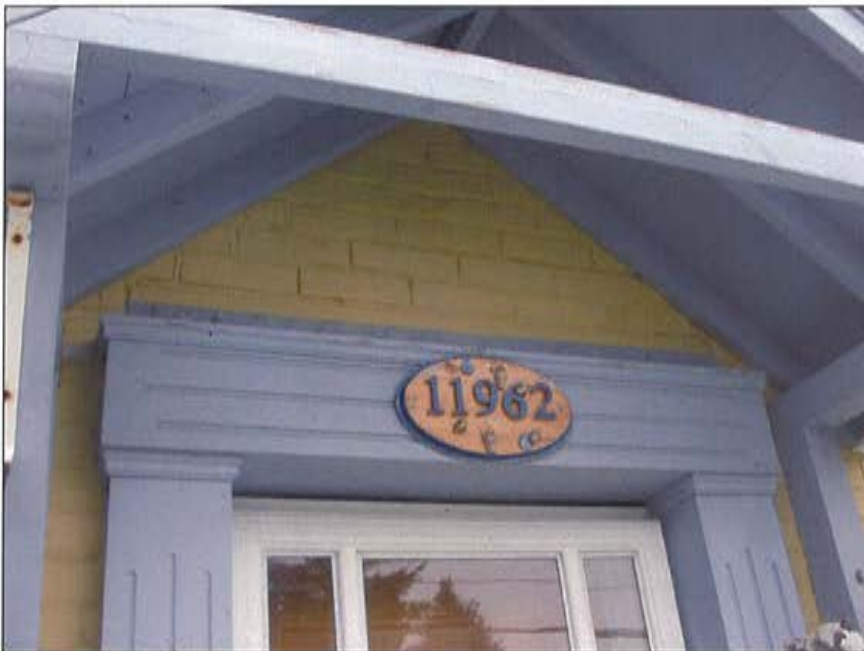
Plate 8: Front entrance, eastern elevation, showing dressed concrete lintel

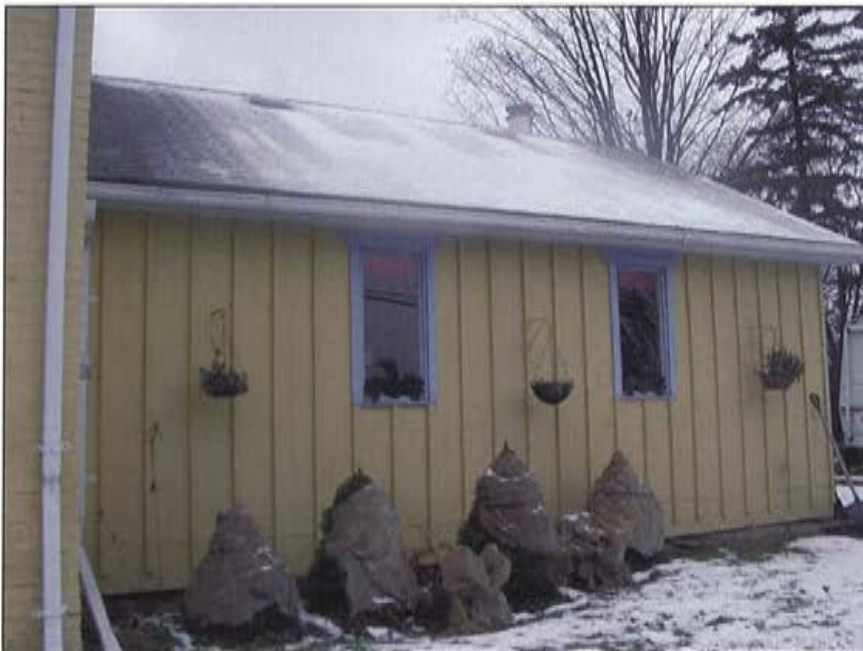
Plate 10: Extension on northern elevation

The northern elevation of the dwelling has been extended by adding a 1 storey structure that presumably once functioned as a garage, but is now used as living space (Plate 10). A review of aerial mapping dating to 1994 confirms that this addition was in place at this time. This extension conceals the majority of the original northern façade of the dwelling; however, an original window opening is extant on this façade and is framed by brick voussoirs (Plate 11). The extension was constructed with wooden materials and using a board and batten construction method (Plate 12). Traditional board and batten siding features vertically applied boards, which are covered by a raised strip of wood to conceal joints between wooden boards. This structure also features a series of single-paned windows which are capped by wooden lintels. On the northern elevation of the addition, a garage door is extant, as well as an upper storey opening (Plate 13). Both of these structural openings, combined with the structure's use of board and batten siding, are reminiscent of detailing used on blacksmith shops. The garage door imitates the large horse doors that are typically found at the ground level of nineteenth century blacksmith shops, while the door that is nestled in the gabled end is congruent with structural openings found in the upper storey of blacksmith shops, which provide access to storage spaces. A small horse shoe ornament is installed on the northern elevation of the extension (Plate 14). The chimney of an internal wood burning stove is visible from the western elevation of the extension (Plate 15). This association with architectural detailing found amongst blacksmith shops is interesting given that Michael O'Leary was documented to have been a blacksmith.

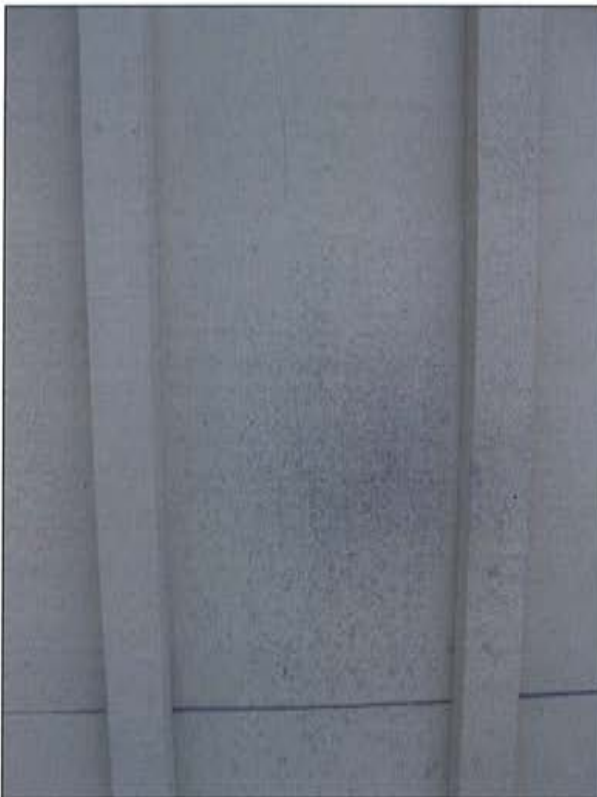
Plate 12: Board and batten detail on extension

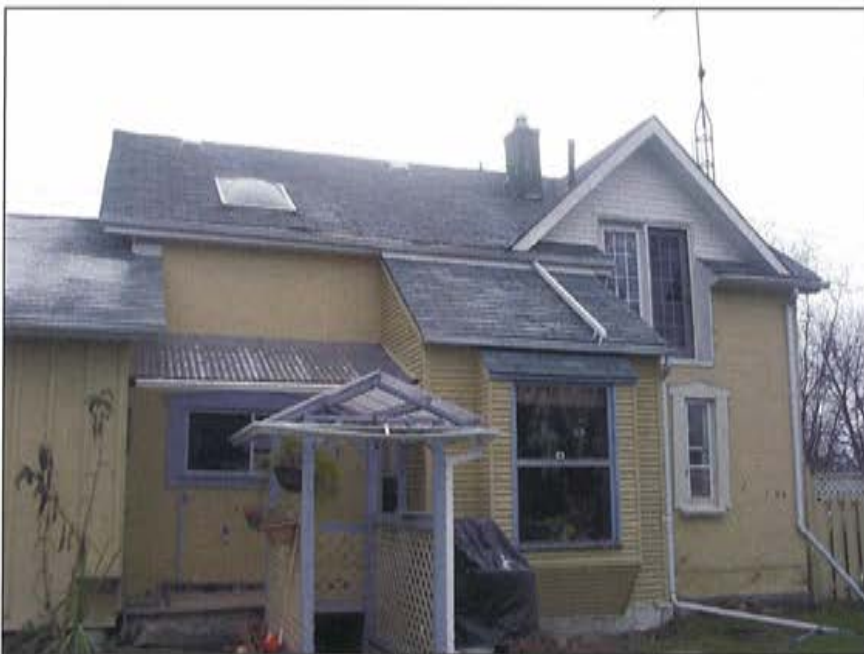
Plate 16: Western elevation of original portion of residence, showing remnant veranda

The western elevation of the original dwelling reveals layers of structural adaptations. On the northern half of the western elevation, remnants of an original side veranda appear to be extant, topped with a corrugated metal roof and supported by a wooden pillar (Plate 16). A small extension is located adjacent to the remnant veranda (Plate 17). This extension appears to have resulted by enclosing a portion of the former veranda and increasing its original height. On the southern half of the western elevation, a gabled dormer has been added. This dormer features two doors (Plate 18). Curiously, there do not appear to be

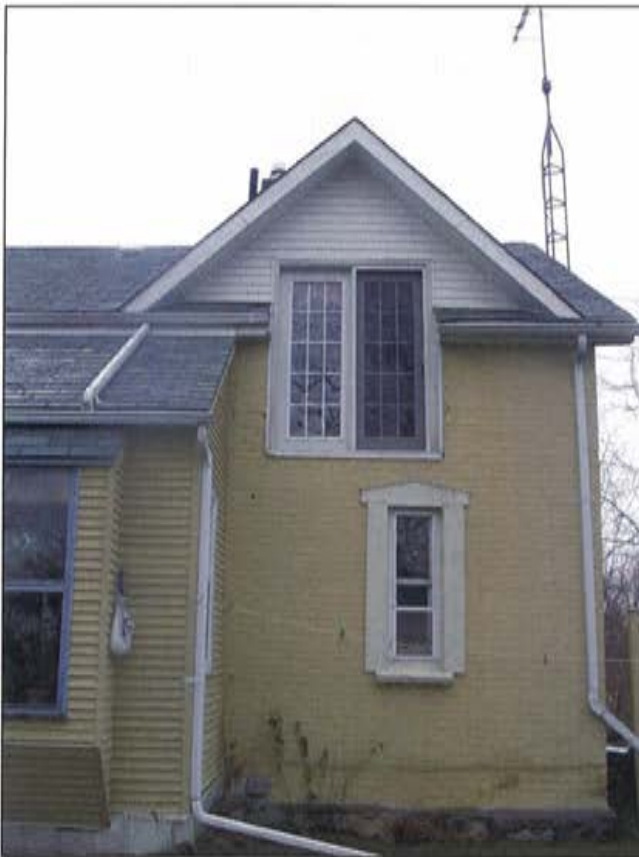
Plate 18: View of addition and alteration, showing gabled dormer and sliding, glass door.

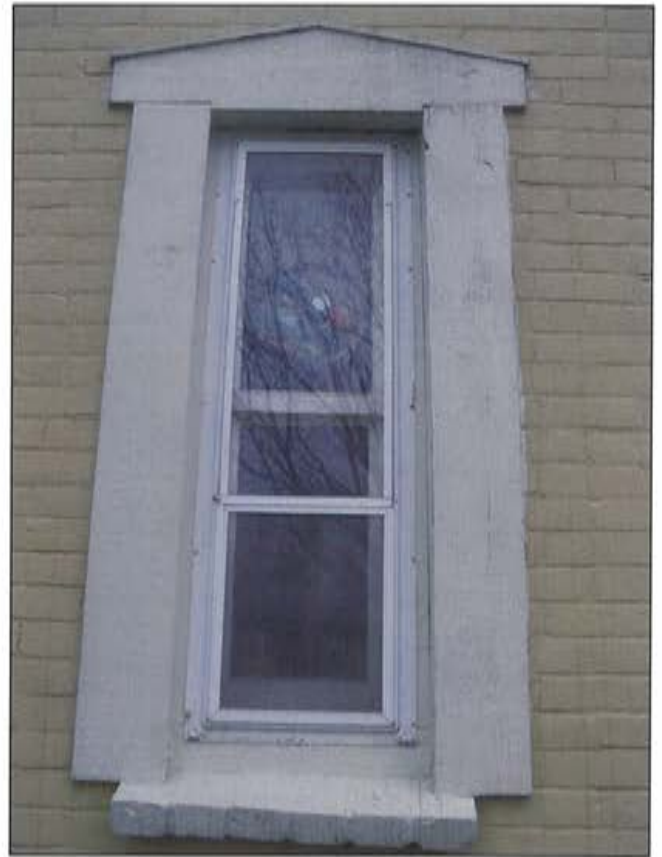
Plate 19: View of structural opening, featuring brick sills.

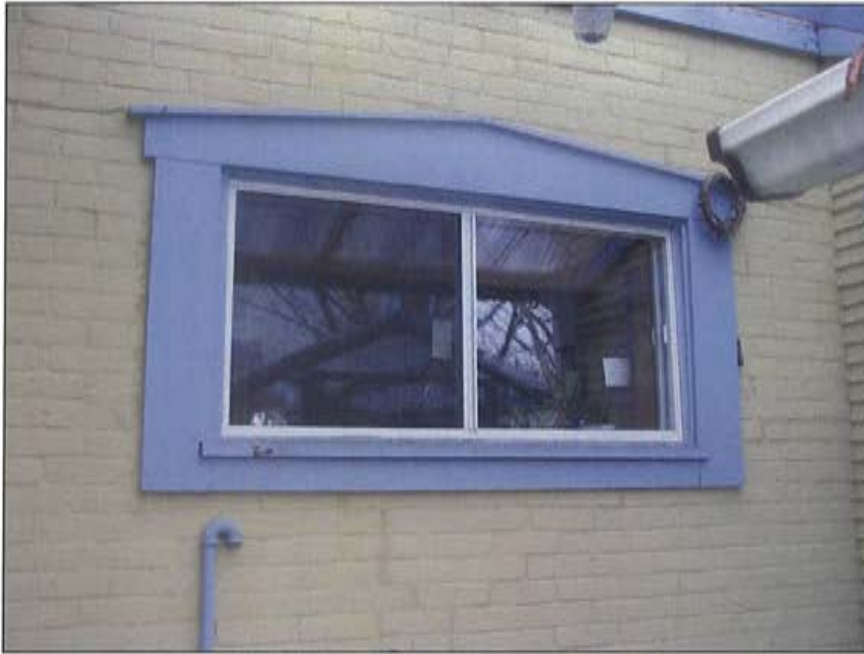
Plate 20: Rectangular window located on northern half of western elevation

any traces of a former walk-out associated with this entrance. It is possible that the sliding door addition and accompanying alterations were never completed. A review of aerial mapping confirms that the dormer was not present in 1994 but had been added by 2001. The window that is located on the ground floor on the southern half of the western elevation is likely a new structural opening that was incorporated following internal renovations (Plate 19). The narrow rectangular window likely serves as a bathroom window, which would have been a later addition. This window is double hung and features a wooden sash; the storm window is constructed of fiberglass materials. Wide wooden trim adorns the sides of this window, while a shaped wooden lintel surrounds the top. Painted bricks serve as the lug sill. A wide rectangular window is located on the northern half of this elevation and features identical wood trim and a shaped lintel (Plate 20).
