Mayfield Road Improvements

Airport Road to Coleraine Drive –
Class Environmental Assessment

ENVIRONMENTAL STUDY REPORT

**Preliminary Geotechnical
Investigation Report**
Mayfield Road
Airport Road to Coleraine Drive,
Brampton and Caledon, Ontario

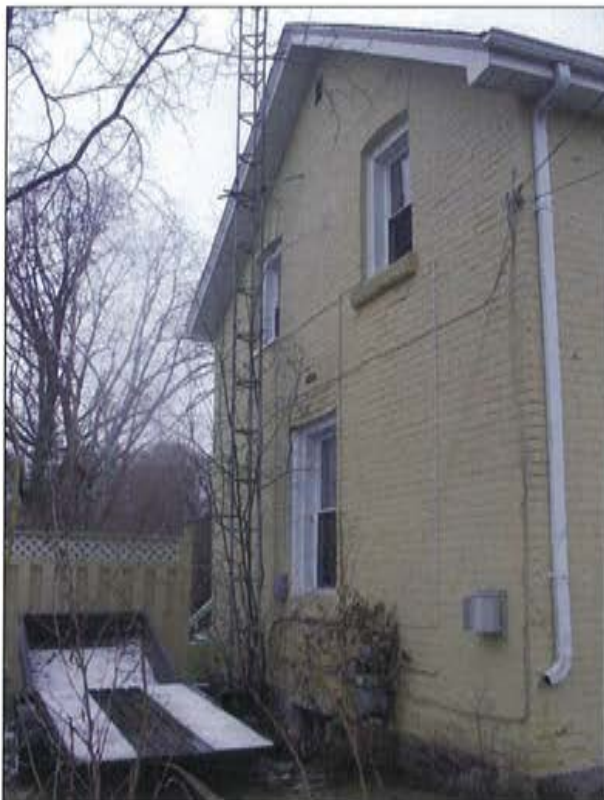
Plate 21: View of unaltered southern elevation.

The southern elevation of the dwelling is relatively unaltered (Plate 21). Three windows are located on this façade and likely mark original structural openings. All three windows have been recently replaced. The two upper storey windows have maintained their structural openings and brick voussoirs (Plate 22). The window on the eastern half of this façade retains a concrete lug sill. The window located on the ground floor lacks original brick voussoirs and lug sill (Plate 23). It appears that brick work located immediately above this window has required rehabilitation (Plate 23).

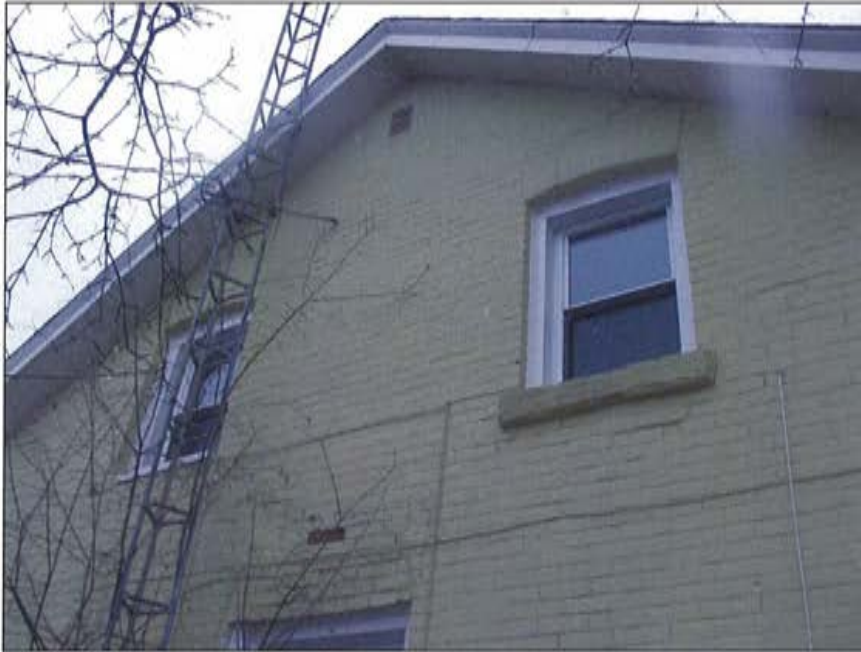
Plate 22: View of upper storey windows on southern elevation, showing new windows and retention of original structural opening and brick voussoirs in the upper storey.

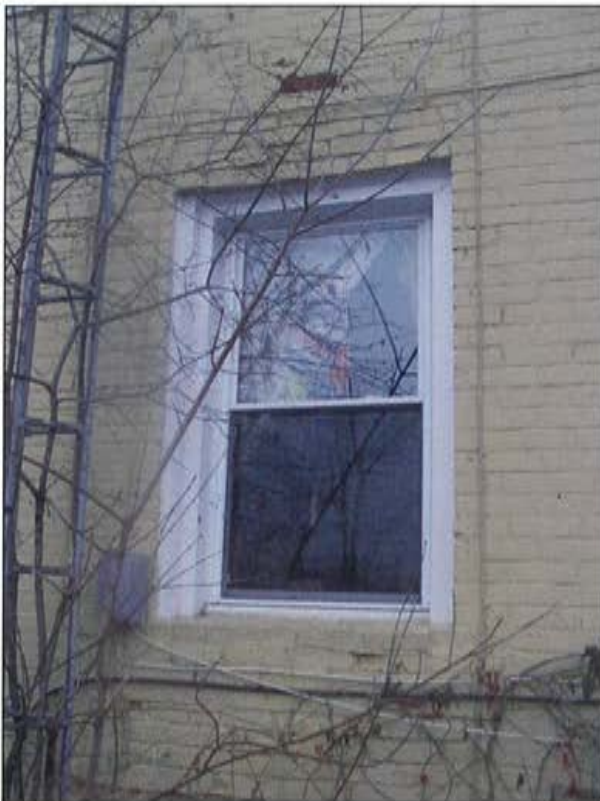
Plate 23: Ground floor window on southern elevation, lacking original voussoirs and sill.

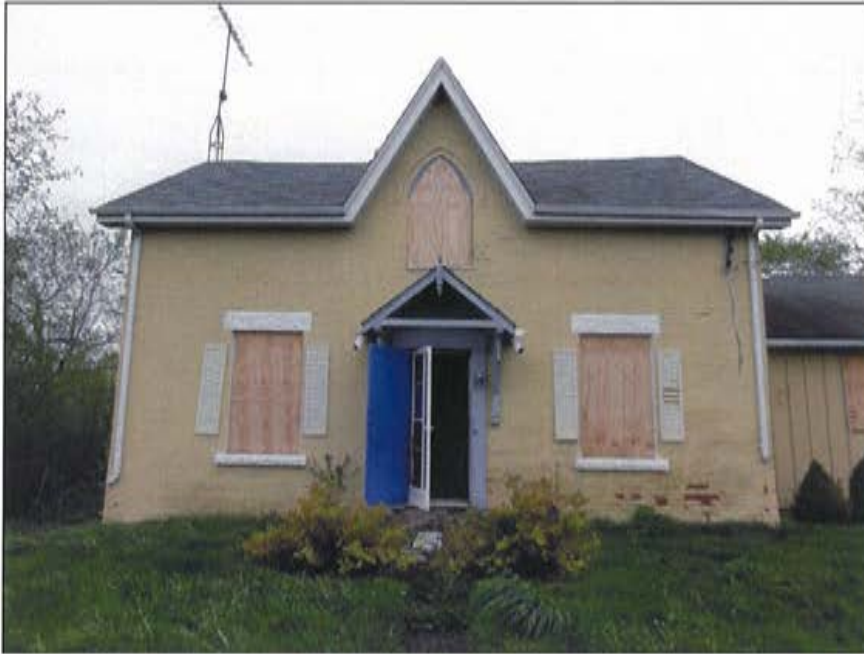
Plate 30: View of eastern elevation of residence in May 2011.

The height of the front doorway, situated one to two feet above ground, further confirms that a front porch was an original design feature, which would have been in keeping with the Gothic-Revival architectural style. In January 2009, the primary point of entry to the residence was accessed via an axial pathway leading from The Gore Road, which terminated at a new wooden deck providing access to the front door. As of May 2011, the wooden deck had been removed and its poured concrete base exposed (Plates 30 and 31). In May 2011 all structural openings had been secured with plywood.

The primary point of entry to the interior of the structure is provided on the eastern elevation of the building. As previously mentioned, a veranda originally framed this entrance, of which a structural marking for its roof line is still extant. As of May 2011, a previous wooden deck that had been constructed beneath the front entrance had been removed. The primary entrance consists of a modern storm door and solid wood door (Plates 32 and 33). Both are recent introductions and are of modern fabrication. The wooden door is detailed in a sympathetic manner, consisting of two recessed panels with a single pane of glass located within the upper panel.

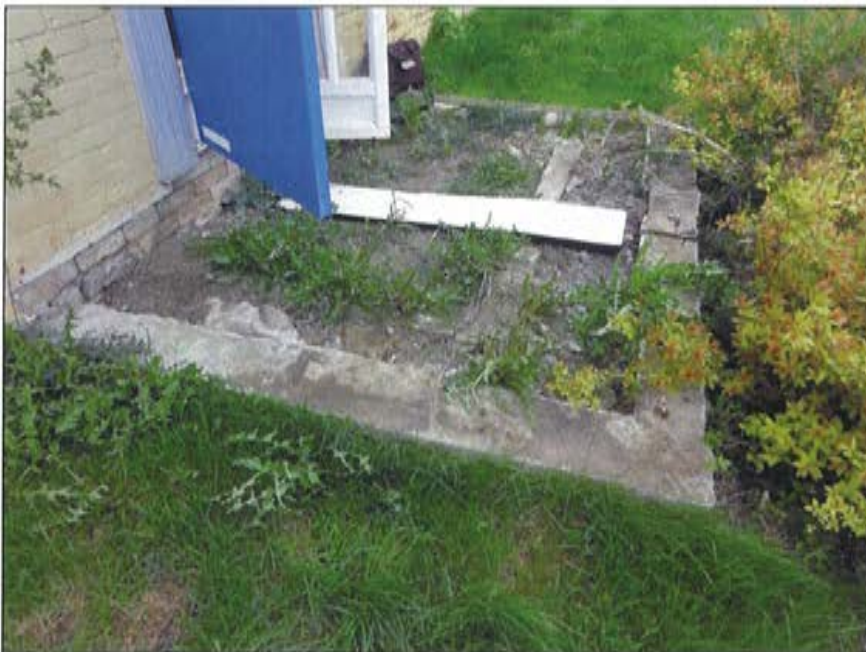
Plate 31: Detail of primary entrance to residence in May 2011 showing location of previous wooden deck and detail of poured concrete base.

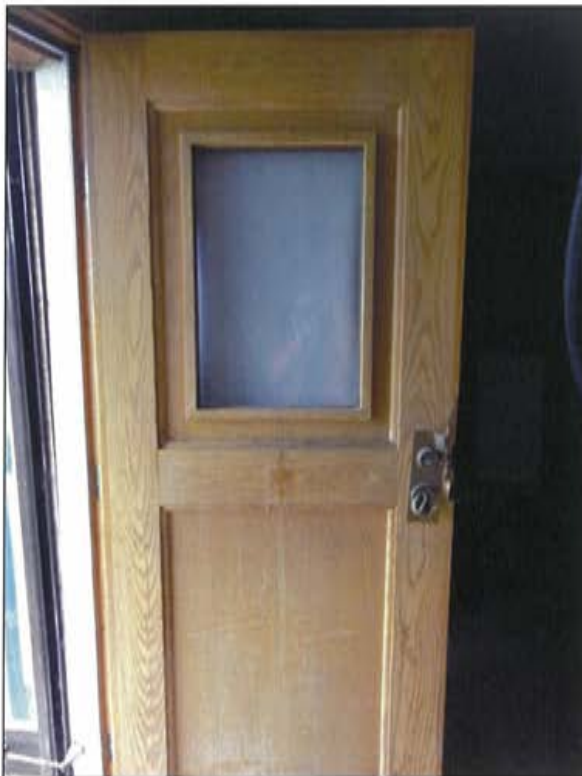
Plate 33: View of modern wood door located on eastern elevation, showing recessing panels and single pane of glass.

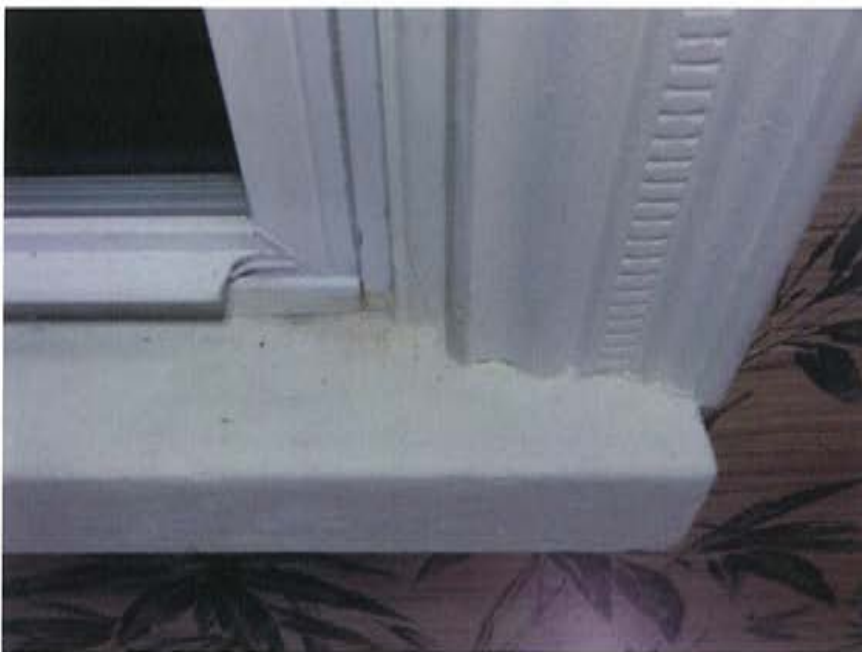
Plate 37: Detail of wooden sill found in the Living Room.

The first floor layout of the residence is typical of mid nineteenth century floor plans with a central staircase flanked by two rooms and with a kitchen located behind the staircase and to the north. A bathroom is located behind the staircase on the south side. These four rooms comprise the original footprint of the residence with overall dimensional measurements of 8.94 m by 6.5 m. Generally, the first floor is characterized by open-concept circulation and illustrates evidence of removal of original partition walls. The living room is located north of the primary entrance and is accessed through an opening measuring approximately 1.2 m (Plate 34). It is highly probable that a standard doorway would have been originally constructed to provide access to a sitting area in this location. The living room features one window which is in its original location, situated approximately 1.6 m north of the primary entrance and equidistant between the northern edge of the primary entrance way and the northern elevation of the residence (Plate 35). This room features modern baseboards and crown moulding, as well as updated window trim and door trim (Plate 36). The window sill is likely original to construction of the house (Plate 37). The flooring in this room consists of narrow hardwood boards (4.5 cm) that appear to date to at

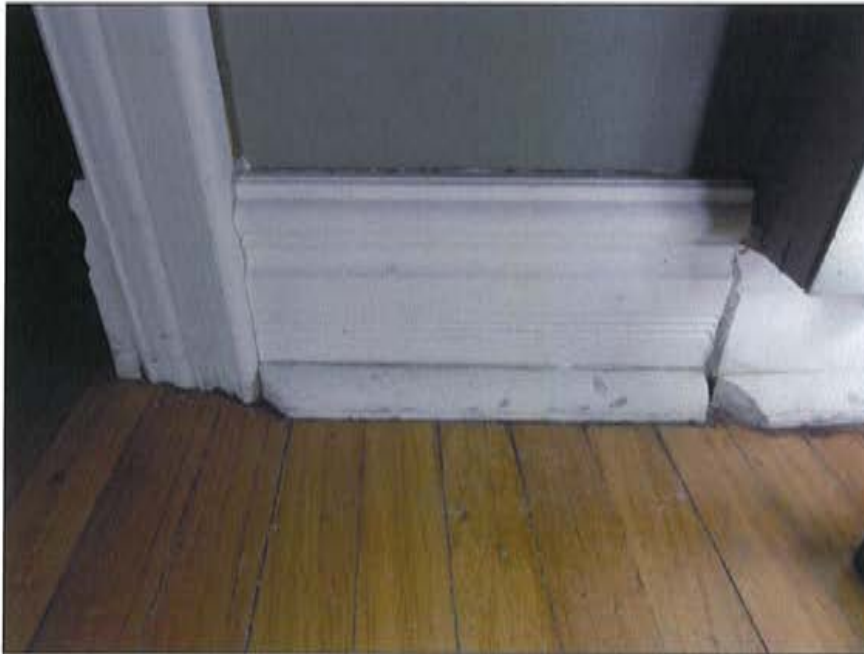
Plate 38: Detail of narrow hardwood flooring found in the living room.

least the mid twentieth century, if not earlier (Plate 38). In this room examination of an area in the floor that previously had an air circulation vent revealed that there is potential for original floor boards to survive beneath the narrow floor boards that are extant (Plates 39 and 40). Electric baseboard heaters and existing baseboards, including quarter round, is secured on top of extant floor boards. A kitchen is located to the rear of the living room (Plate 41). The kitchen is accessed through an open doorway from the living room and appears to have been remodelled in the mid twentieth century. The primary kitchen area is located on the northern side of the rear portion of the house while a staircase to the basement and a bathroom are located on the southern side. Cabinetry in the kitchen appears to date to the mid twentieth century as well and features solid wood doors that are recessed (Plate 42). Modern appliances are extant. A window is located on the western side of the kitchen area and on the original exterior wall. This window has a horizontal sliding opening mechanism and features modern wooden trim. The sill on this window features a notable depth of 25 cm which illustrates the width of the exterior walls of this structure (Plate 43). Flooring in the primary area of the kitchen consists of narrow floor boards, similar to those located in the living room. Floor boards in the kitchen measure approximately 4 cm.

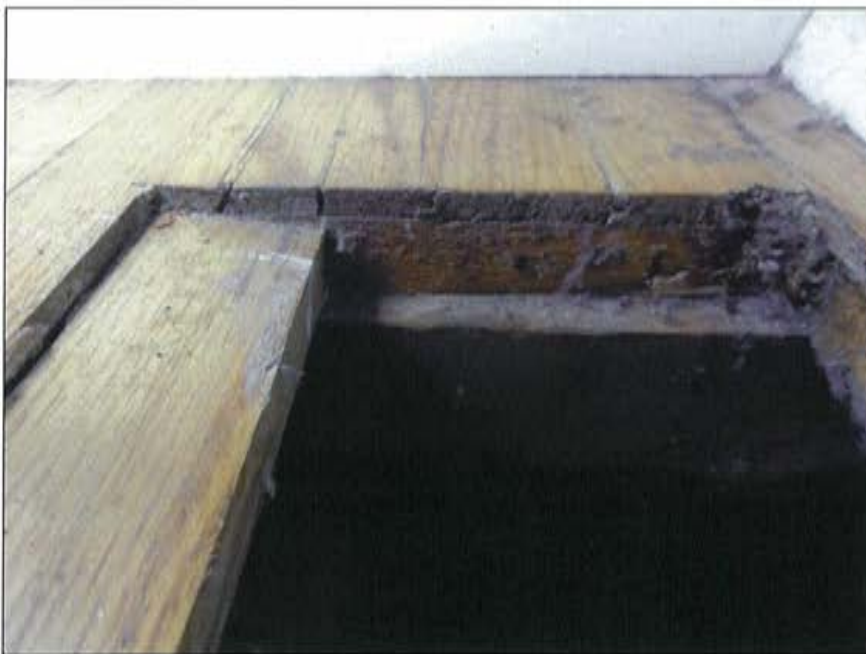
Plate 39: Cross section of flooring in Living Room showing extant narrow floor boards on top of older flooring.

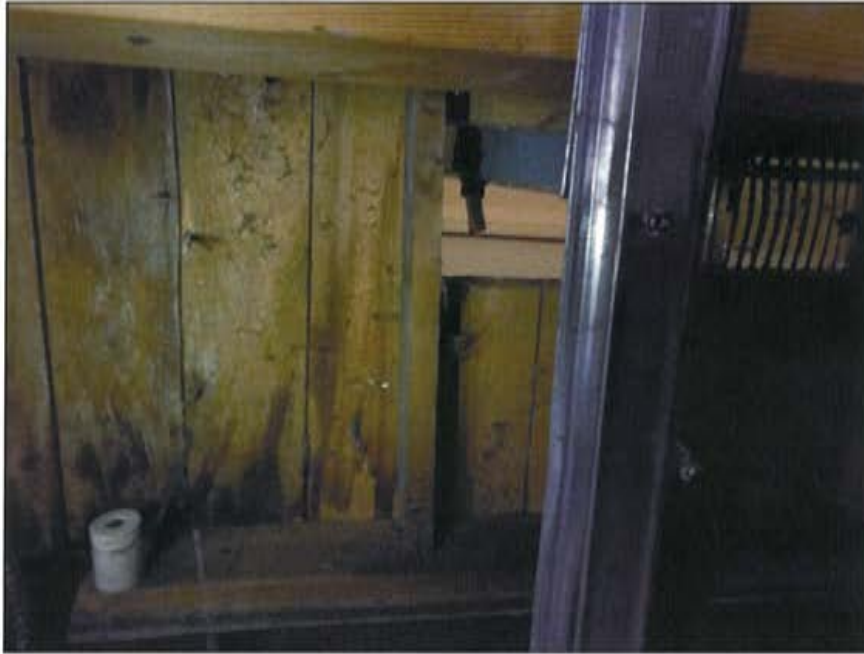
Plate 40: View from basement of location illustrated in Plate 39 showing floor joists, subfloor and hardwood boards on top of the subfloor, running in a direction opposite to the extant narrow hard wood flooring found in the Living Room.

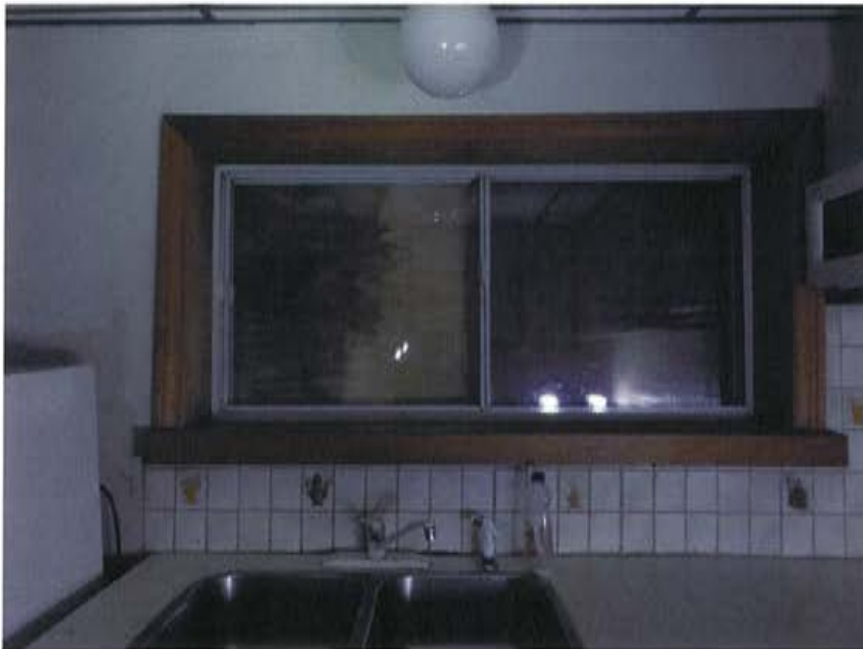
Plate 43: Detail of horizontal window (new structural opening) in the Kitchen.

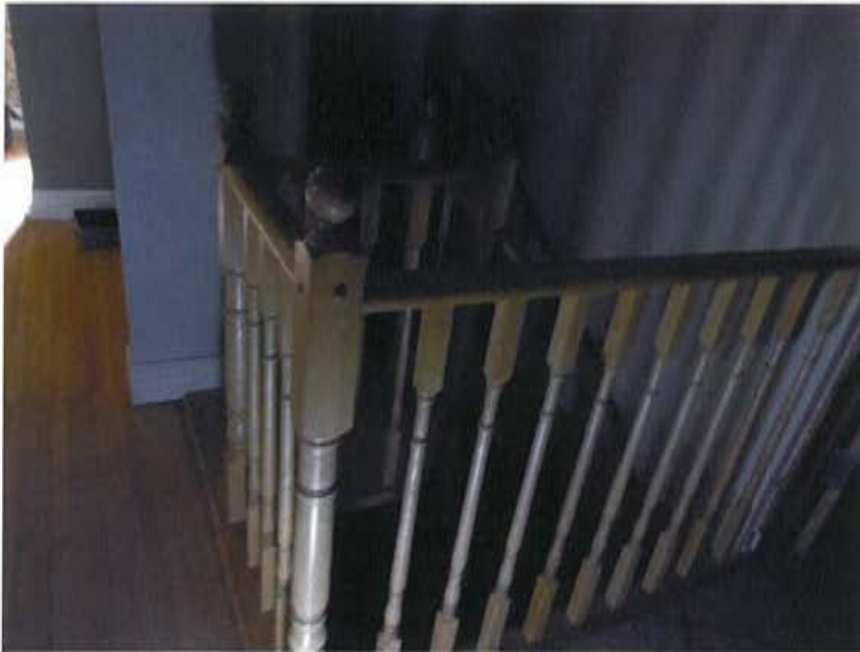
Plate 44: Location context of spiral staircase behind original central staircase, showing railing and balusters. This staircase is a recent addition.

A bathroom and spiral staircase is located directly opposite the kitchen area. The staircase is located directly behind the primary central staircase and based on its materials and design is a relatively recent addition. The staircase is extremely narrow and steep and is constructed of oak materials (Plates 44 and 45). Flooring surrounding the staircase is parquet and not found elsewhere in the house. The bathroom is located west of the staircase. It features modernized, twentieth century building materials and appliances (Plate 46). The window located in this room features frosted glass, older trim, and a wooden sash (Plate 47). Similarly the doorway in this room features older wooden trim. West and north of the bathroom, an eating area is extant. This area has been constructed by making a structural addition to the structure. This area was likely created by enclosing a portion of a veranda located on the building's western elevation and increasing the height of this area. This enclosure/addition features two windows and a rear point of entry to the residence. A simple, modern, double hung window is located on the southern elevation of the addition and features simple wooden trim and sill constructed of knotty pine (Plate 48). The window located on the western elevation of the addition features a pivoted opening mechanism and wooden sashes (Plate 49). The door located on the northern elevation of the addition is constructed of wood and features two vertical panels in the lower section and a single pane of glass in the upper section (Plate 50). This door is framed by trim fabricated of knotty pine. Flooring in the eating area is ceramic tile.

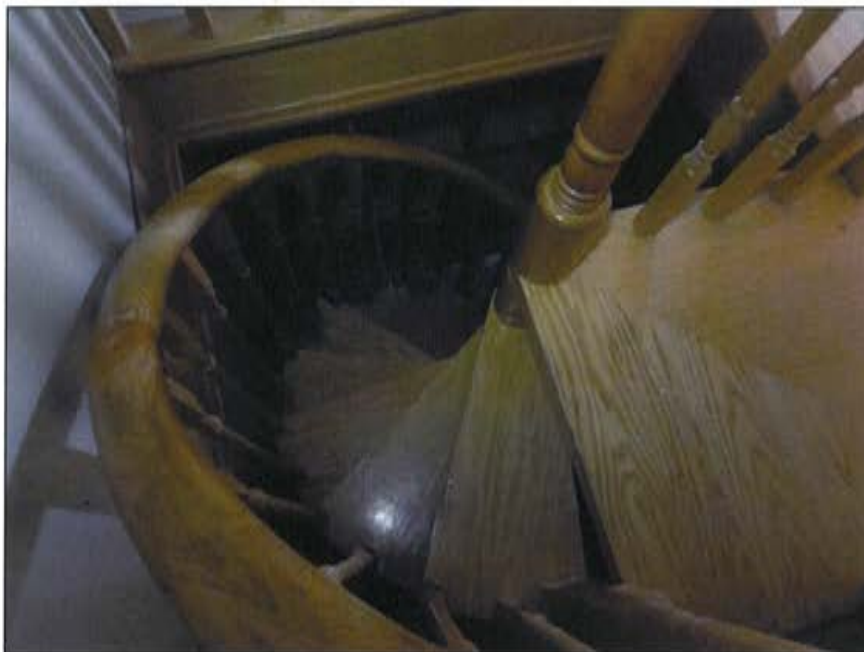
Plate 45: Detail of spiral staircase.

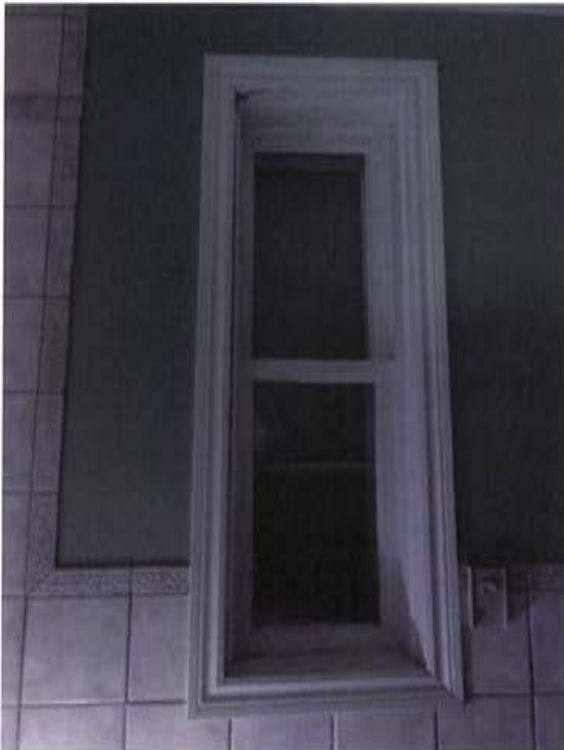
Plate 47: View of window in bathroom showing wooden sashes and older wooden trim.

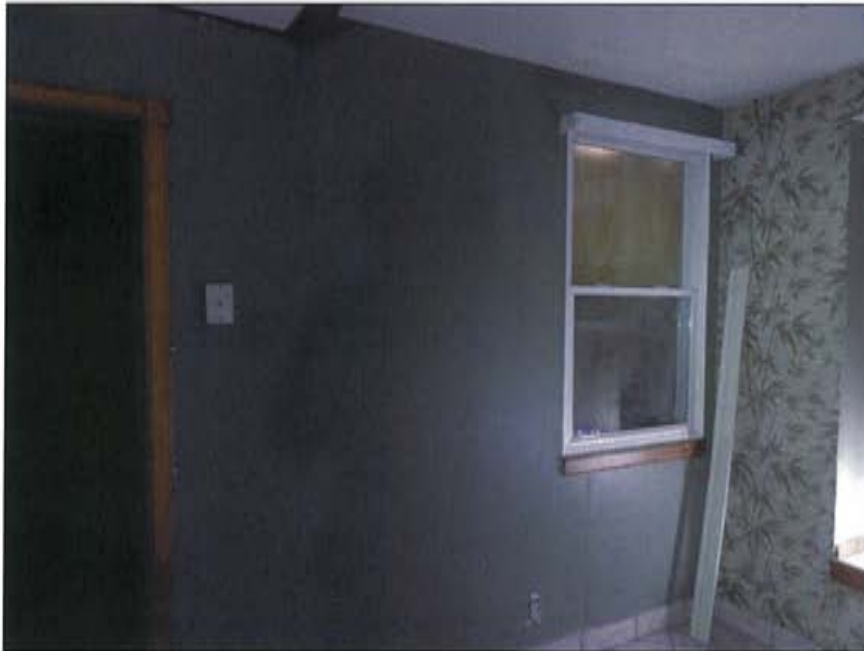
Plate 48: View of new structural opening and window located on the southern elevation of the rear addition..

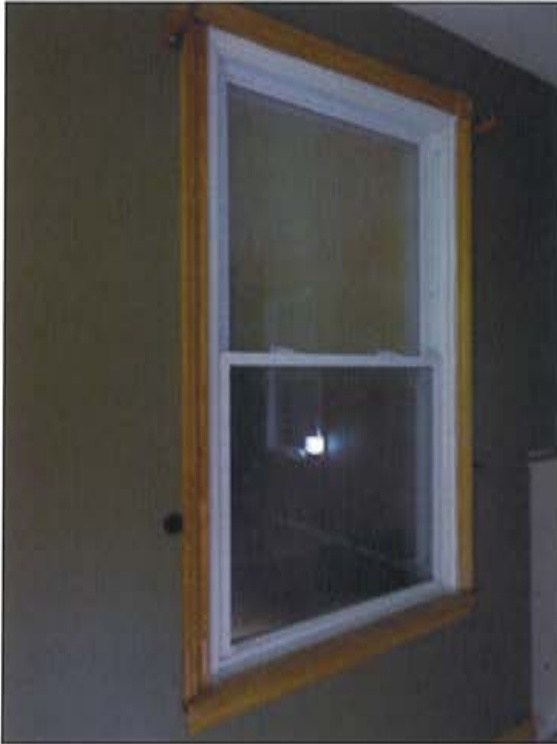
Plate 52: View of original structural opening on east wall of Family Room showing new window, trim and sill.

strip siding that has been applied to the walls and which also matches replaced roof joists (Plate 56). This room features four windows: a pointed arch window opening is located on the east wall and has been updated with a double-hung window, new trim and sills; two double-hung windows are located on the southern wall and both feature new trim but may retain original sills; and one double-hung window is located on the west wall and also features new trim and lacks sills (Plates 57 – 60). ‘His and Hers’ closets are located on the east wall and are accessed by louvered doors. Wall to wall carpeting fully covers the floor, extending into both closets. Inspections revealed that the wall to wall carpeting has been installed directly over subfloor; no original or older floor materials appear to be extant beneath. Other additions include two doors on the south half of the west elevation, one of which is fixed, and a skylight on the north half (Plate 61). This upper half storey would have originally functioned as a space comprised of multiple bedrooms, however, has since been updated to respond to modern living conditions. It is probable that there would have been a wall originally extant immediately south of the staircase, running in an east-west direction, providing space for two bedrooms; each with one window. A hallway would have been present along the north, east, and west sides of the staircase. Two additional rooms would have been located on the north side of the staircase with an interior partition wall likely running east-west roughly at the southern terminus of the closet located on the north half of the east wall. One of these previous rooms would have functioned as a bedroom and it is likely that this would have been situated towards the front of the house and would have contained a window. It is possible that a washroom would have been located behind (west) of this room.

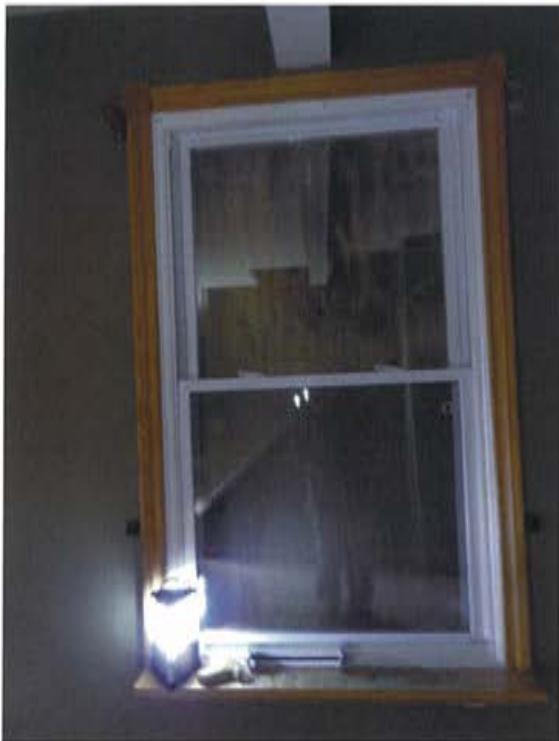
Plate 53: View of original structural opening on south wall of Family Room showing new window, trim and sill.

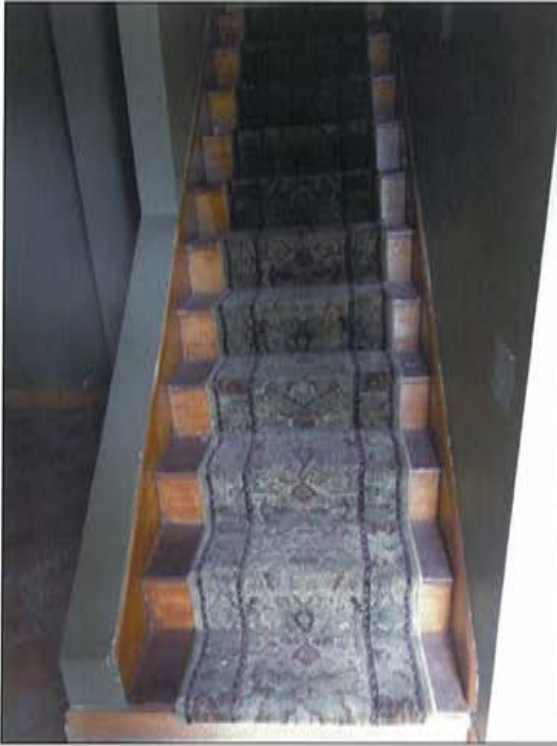
Plate 54: View of central staircase on first floor showing removed partition wall (left) and overall arrangement and materials.

The remainder of the first floor is comprised of the family room, situated south of the central staircase and primary point of entry. Similar to the living room, this area is accessed through an opening measuring approximately 1.7 m (Plate 51). A standard doorway may have been originally located in this area for the purposes of establishing a completely separate room on the south side of the stairs. The family room features two double-hung windows, both of which are of relatively new fabrication. They are both surrounded by identical new wooden trim and sills (Plates 52 and 53). The flooring in this room consists of ceramic tile which may have been laid over older or original floor boards. There is an uneven transition between the ceramic tile located in the family room and the hardwood flooring located in the living room, suggesting that there may be older or original materials extant beneath the ceramic materials. The staircase which provides access to the upper half storey appears to have been partially modified when an interior partition wall between the family room and front foyer was removed (Plate 54). The tread, nosing, and risers are all constructed of solid wood and appear to date to construction of the house (Plate 55). Similarly, the wall string is constructed of identical materials and appears to also serve as an example of original materials. The staircase lacks any railing or balusters on the first floor.

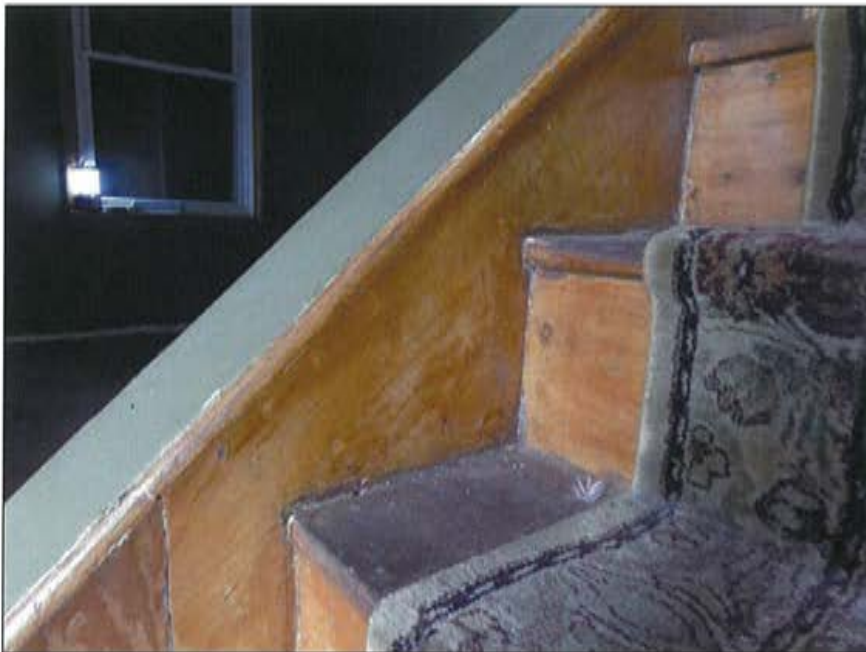
Plate 55: Detail of central staircase showing solid wood wall string, nosing, tread, and risers that appear to date to construction of the house.

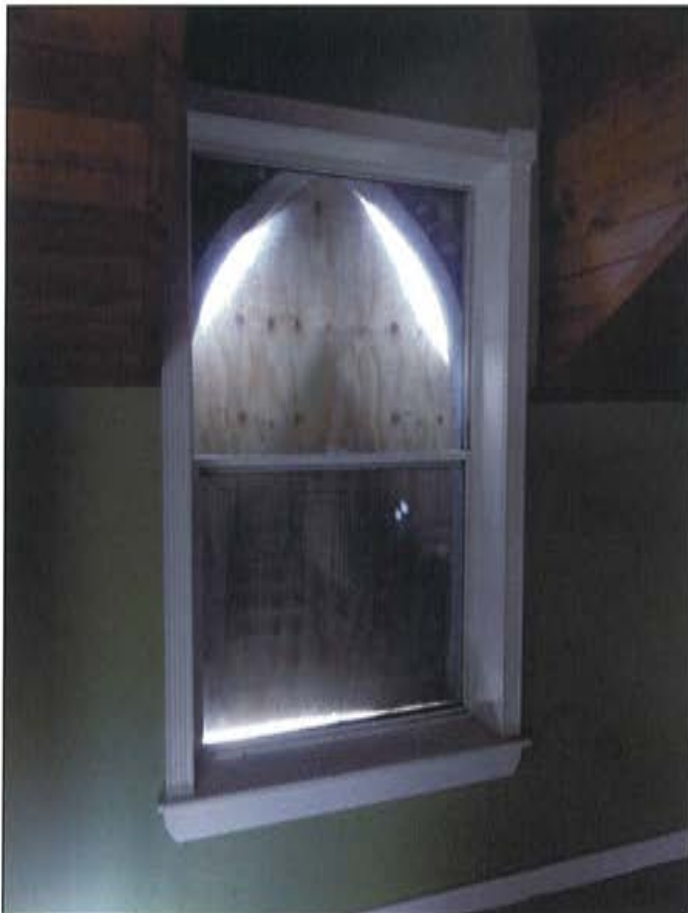
Plate 57: View of pointed window on east wall showing rectangular window and pointed structural opening.

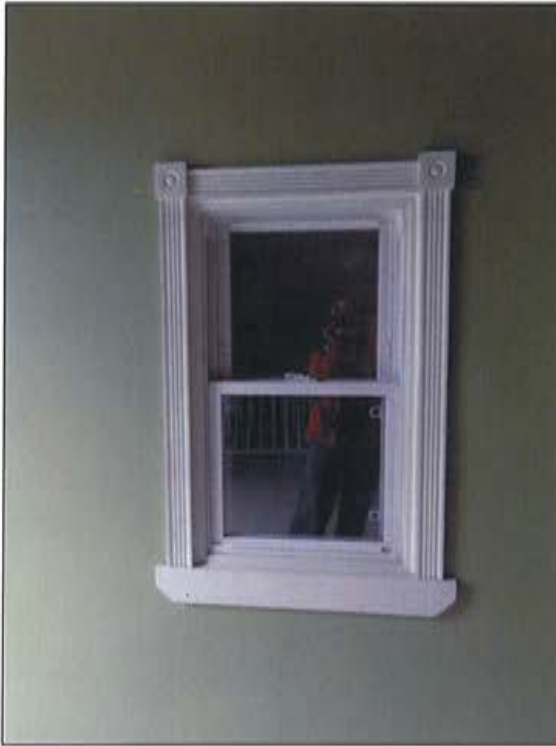
Plate 60: View of double-hung window on north wall of upper floor; the size of this structural opening has been altered through filling in of brick on the east side.

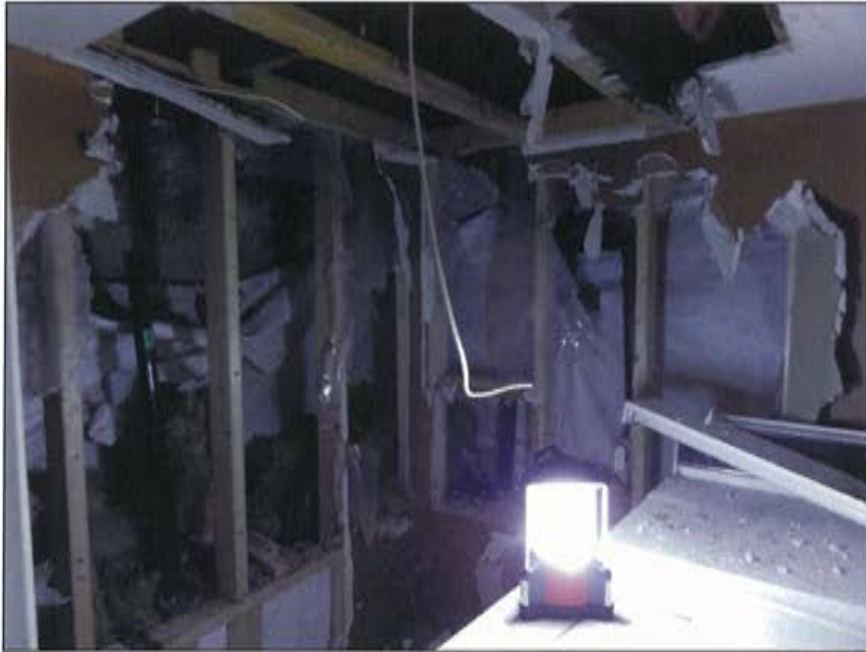
Plate 64: View of Area 3 (laundry room) showing removed drywall, wall studs, and concrete parging in background.

As previously discussed the basement is accessed off of the kitchen area, behind the central staircase, via a newly added spiral staircase. Exterior access to the basement is also provided on the building’s western elevation. The basement is divided into three areas: the largest space measures approximately 5 m by 5m and is located below the living room and kitchen areas (Plate 62). This area has been fully updated and modernized and most likely functioned as a sitting room or den up until recently. Although having suffered some vandalism, this area features wall to wall carpeting, modern cabinetry and shelving and wooden bench seating along the north and east walls. This room has had dry walling erected and likely featured a drop ceiling, prior to acts of vandalism. The bench seating along the north and east walls was probably a functional and aesthetic design scheme chosen to pleasantly conceal concrete shoring that may be extant along these walls. South of this area, a bathroom (Area 2) and laundry room (Area 3) are extant. The bathroom is accessed via a doorway off the main area and features a stand-up shower, sink and vanity (Plate 63). The laundry room is accessed from the bathroom and continues to retain modern appliances (Plate 64). Dry wall has been removed in this area, revealing wall studs and structural foundations. The foundations of the structure appear to have been parged with extensive concrete as part of rehabilitation and stabilization strategies for the original stone foundations. Investigation of this area revealed extant stone foundations and original sill plate (Plate 65).

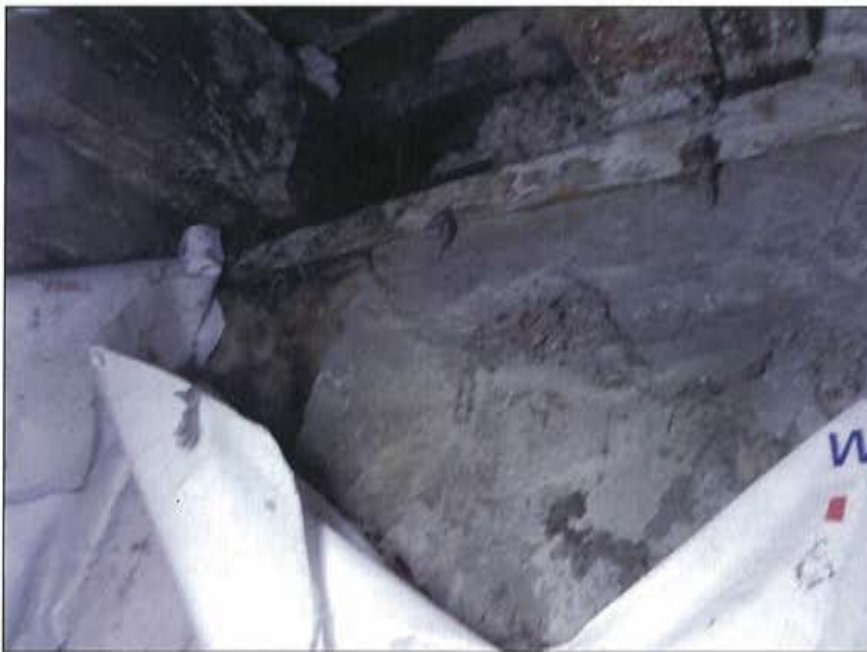
Plate 65: Detail of original sill plate sitting on top of parged concrete which conceals original stone foundations.

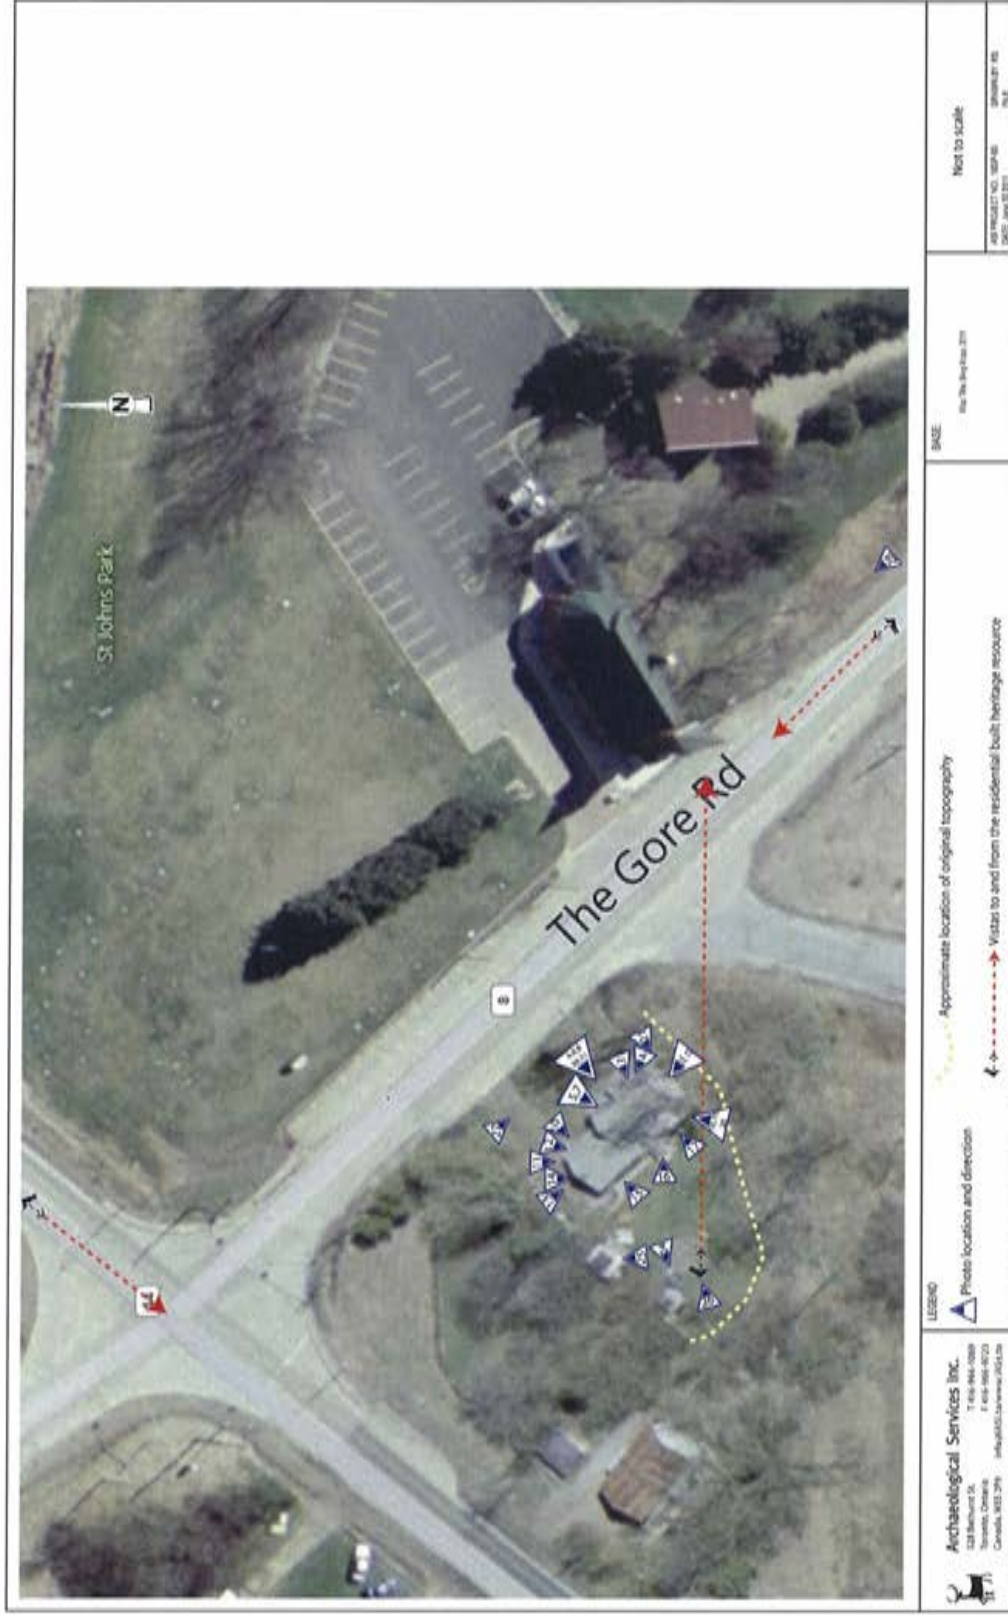
Figure 4: Photographic key plan showing exterior photo locations, cultural heritage landscape features, and site context.

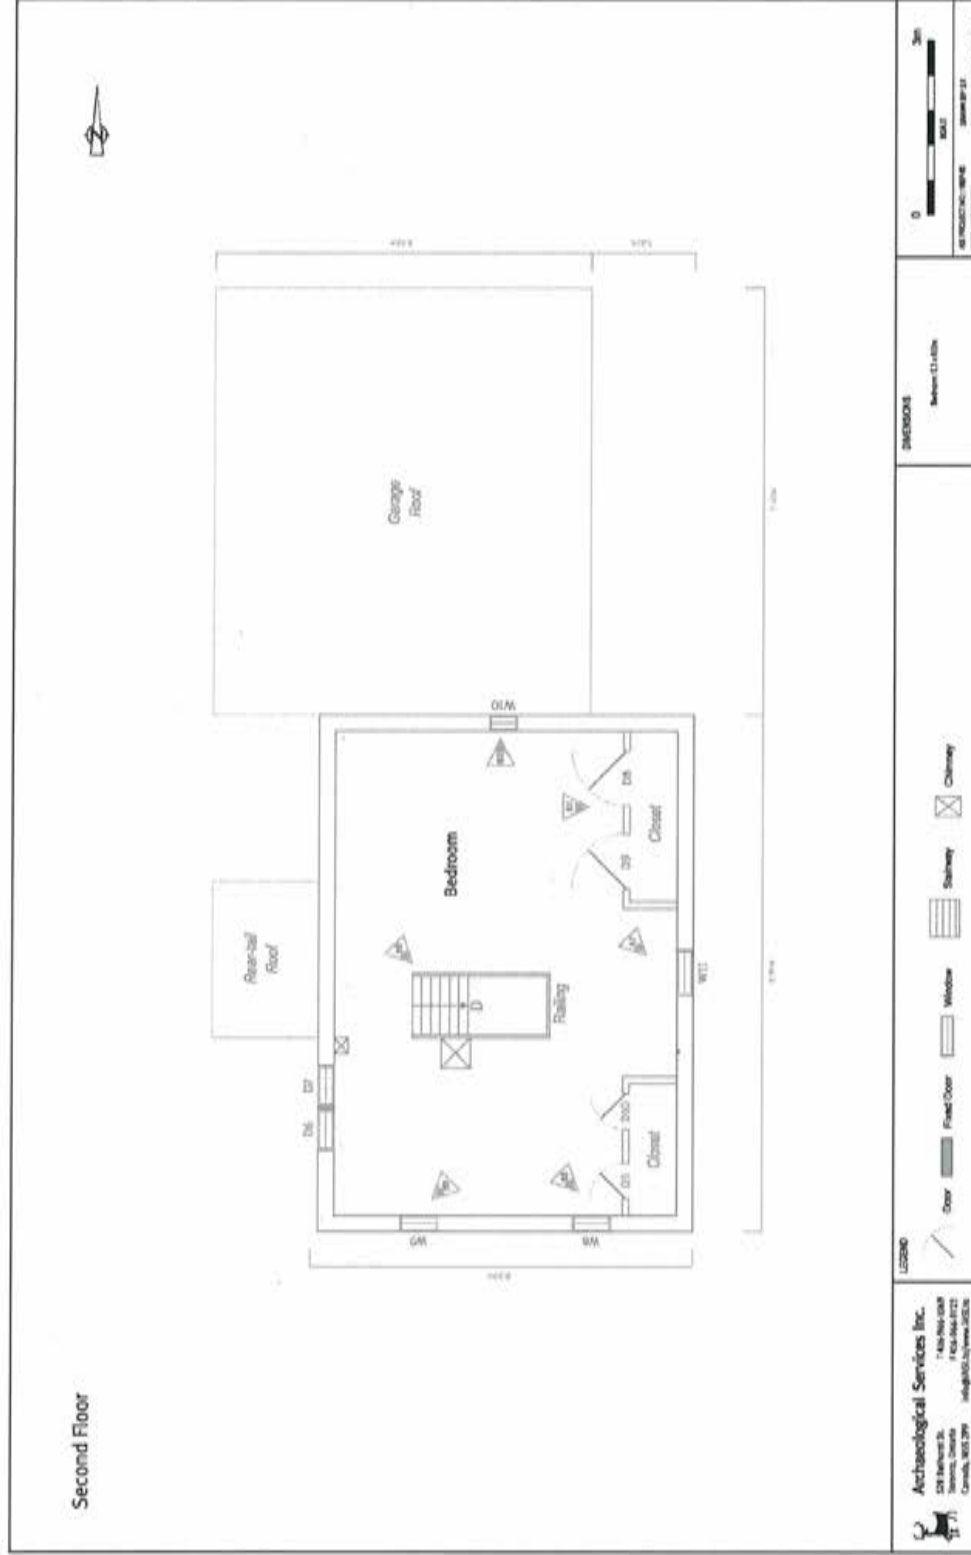
Figure 6: Interior floor plan of upper storey showing overall dimensional measurements of residential exterior and internal rooms.

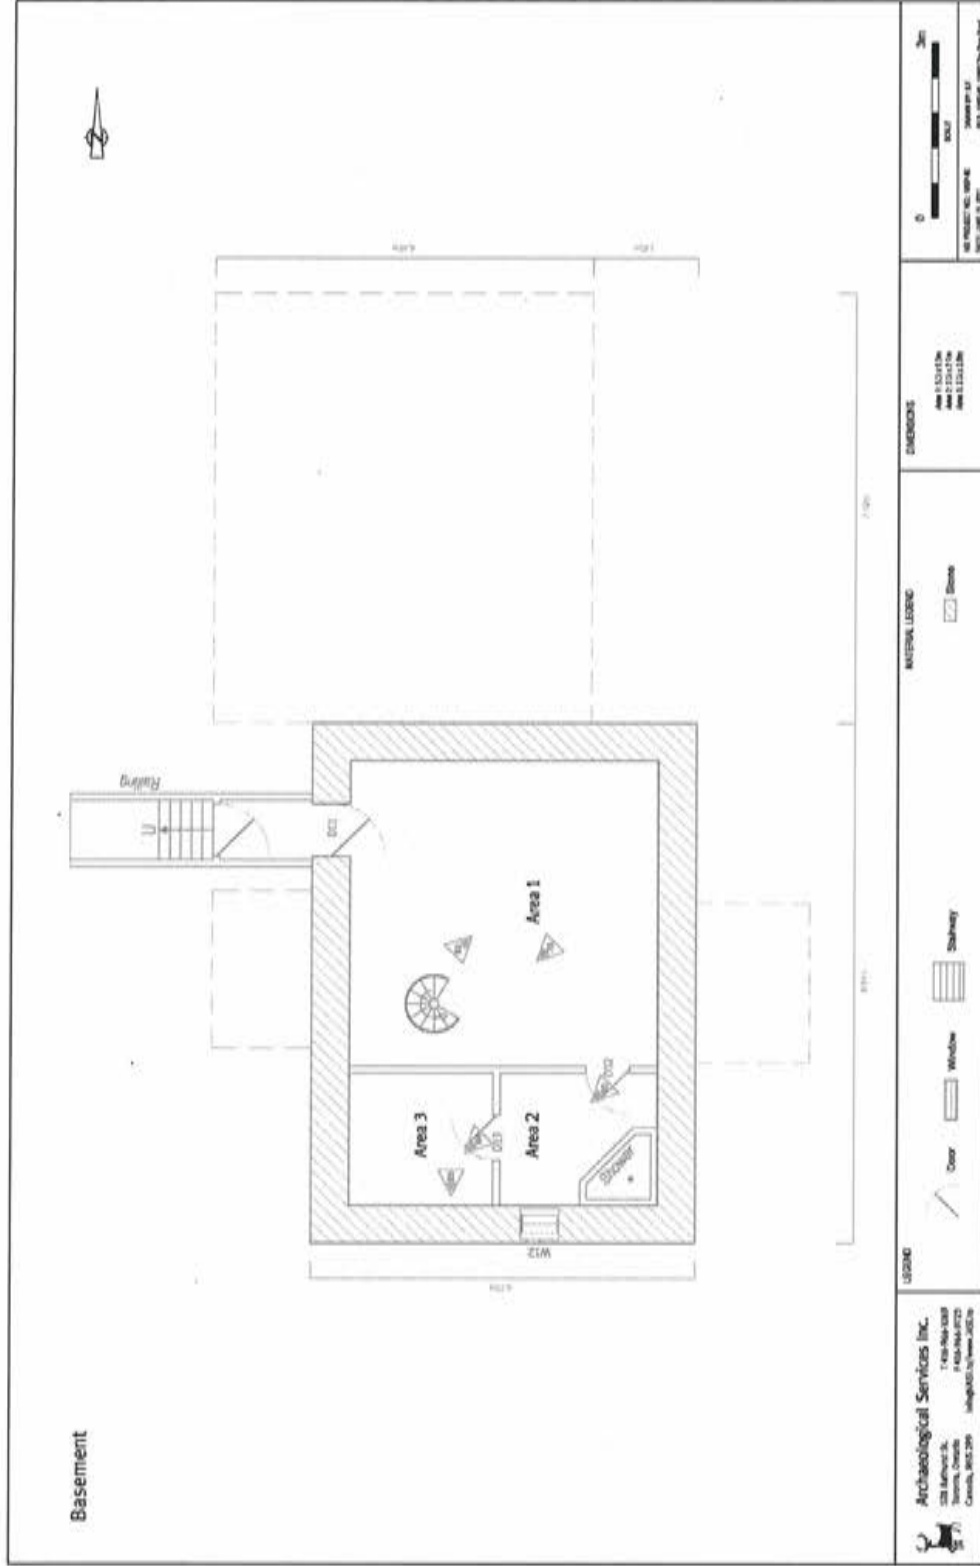
Figure 7: Interior floor plan of basement showing overall dimensional measurements of residential exterior and internal rooms.

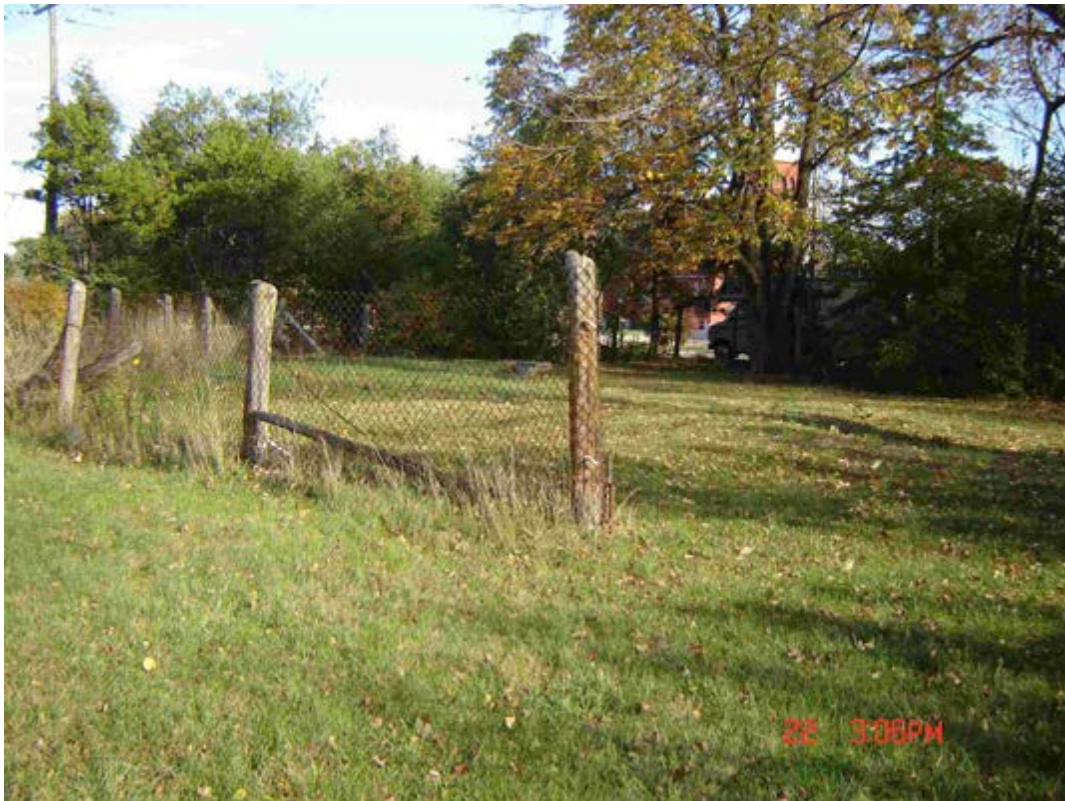
Photograph 2 – Possible Septic System at 7481 Mayfield Road

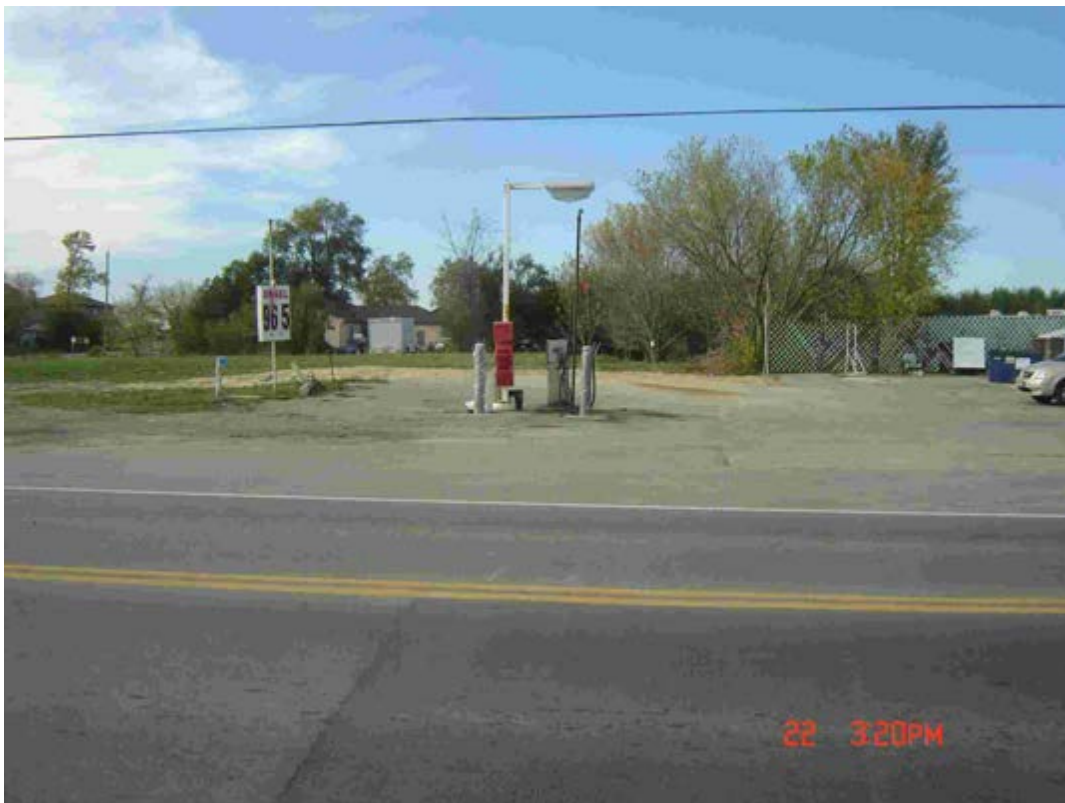
Photograph 4 – Northern View of Diesel Pump Island at 7536 Mayfield Road
