Mayfield Road Improvements

Airport Road to Coleraine Drive –
Class Environmental Assessment

ENVIRONMENTAL STUDY REPORT

**Preliminary Geotechnical
Investigation Report**
Mayfield Road
Airport Road to Coleraine Drive,
Brampton and Caledon, Ontario

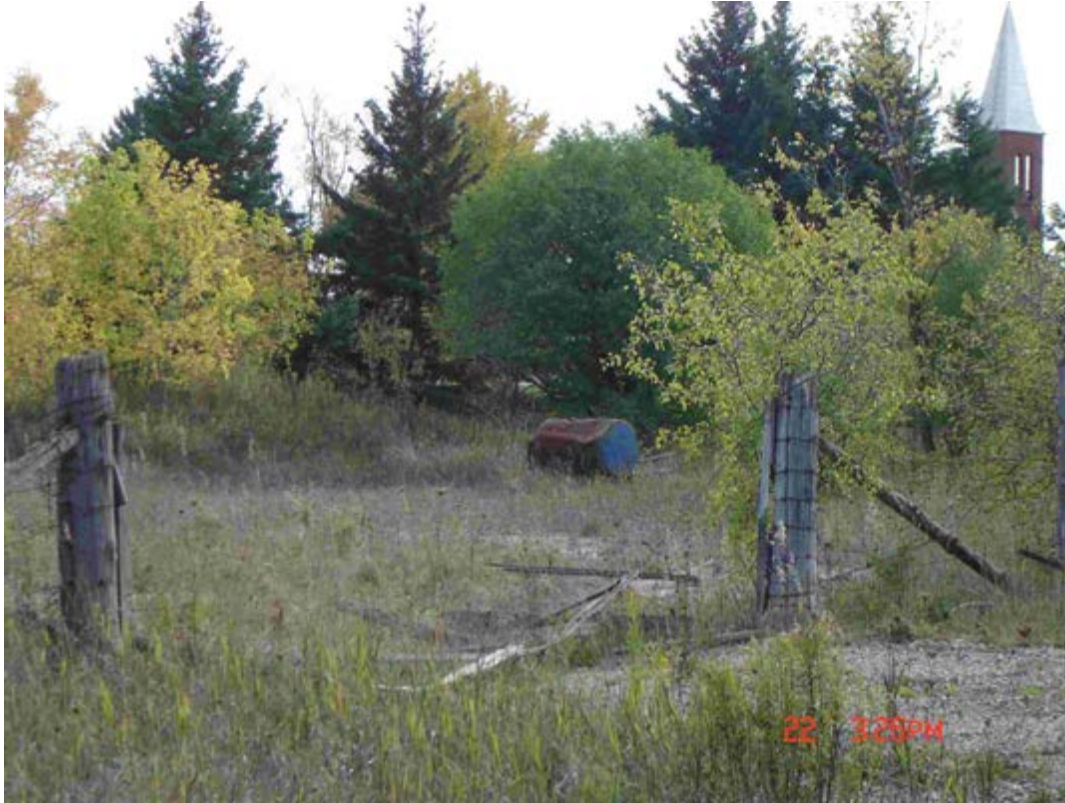
Photograph 5 – Southern View of AST in Vacant Field (Northeast of The Gore Road)
