Arborist Report

KIRWIN AVENUE AND LITTLE JOHN LANE SANITARY SEWER REPLACEMENT MUNICIPAL CLASS ENVIRONMENTAL ASSESSMENT

LGL Limited
environmental research associates

January 2024

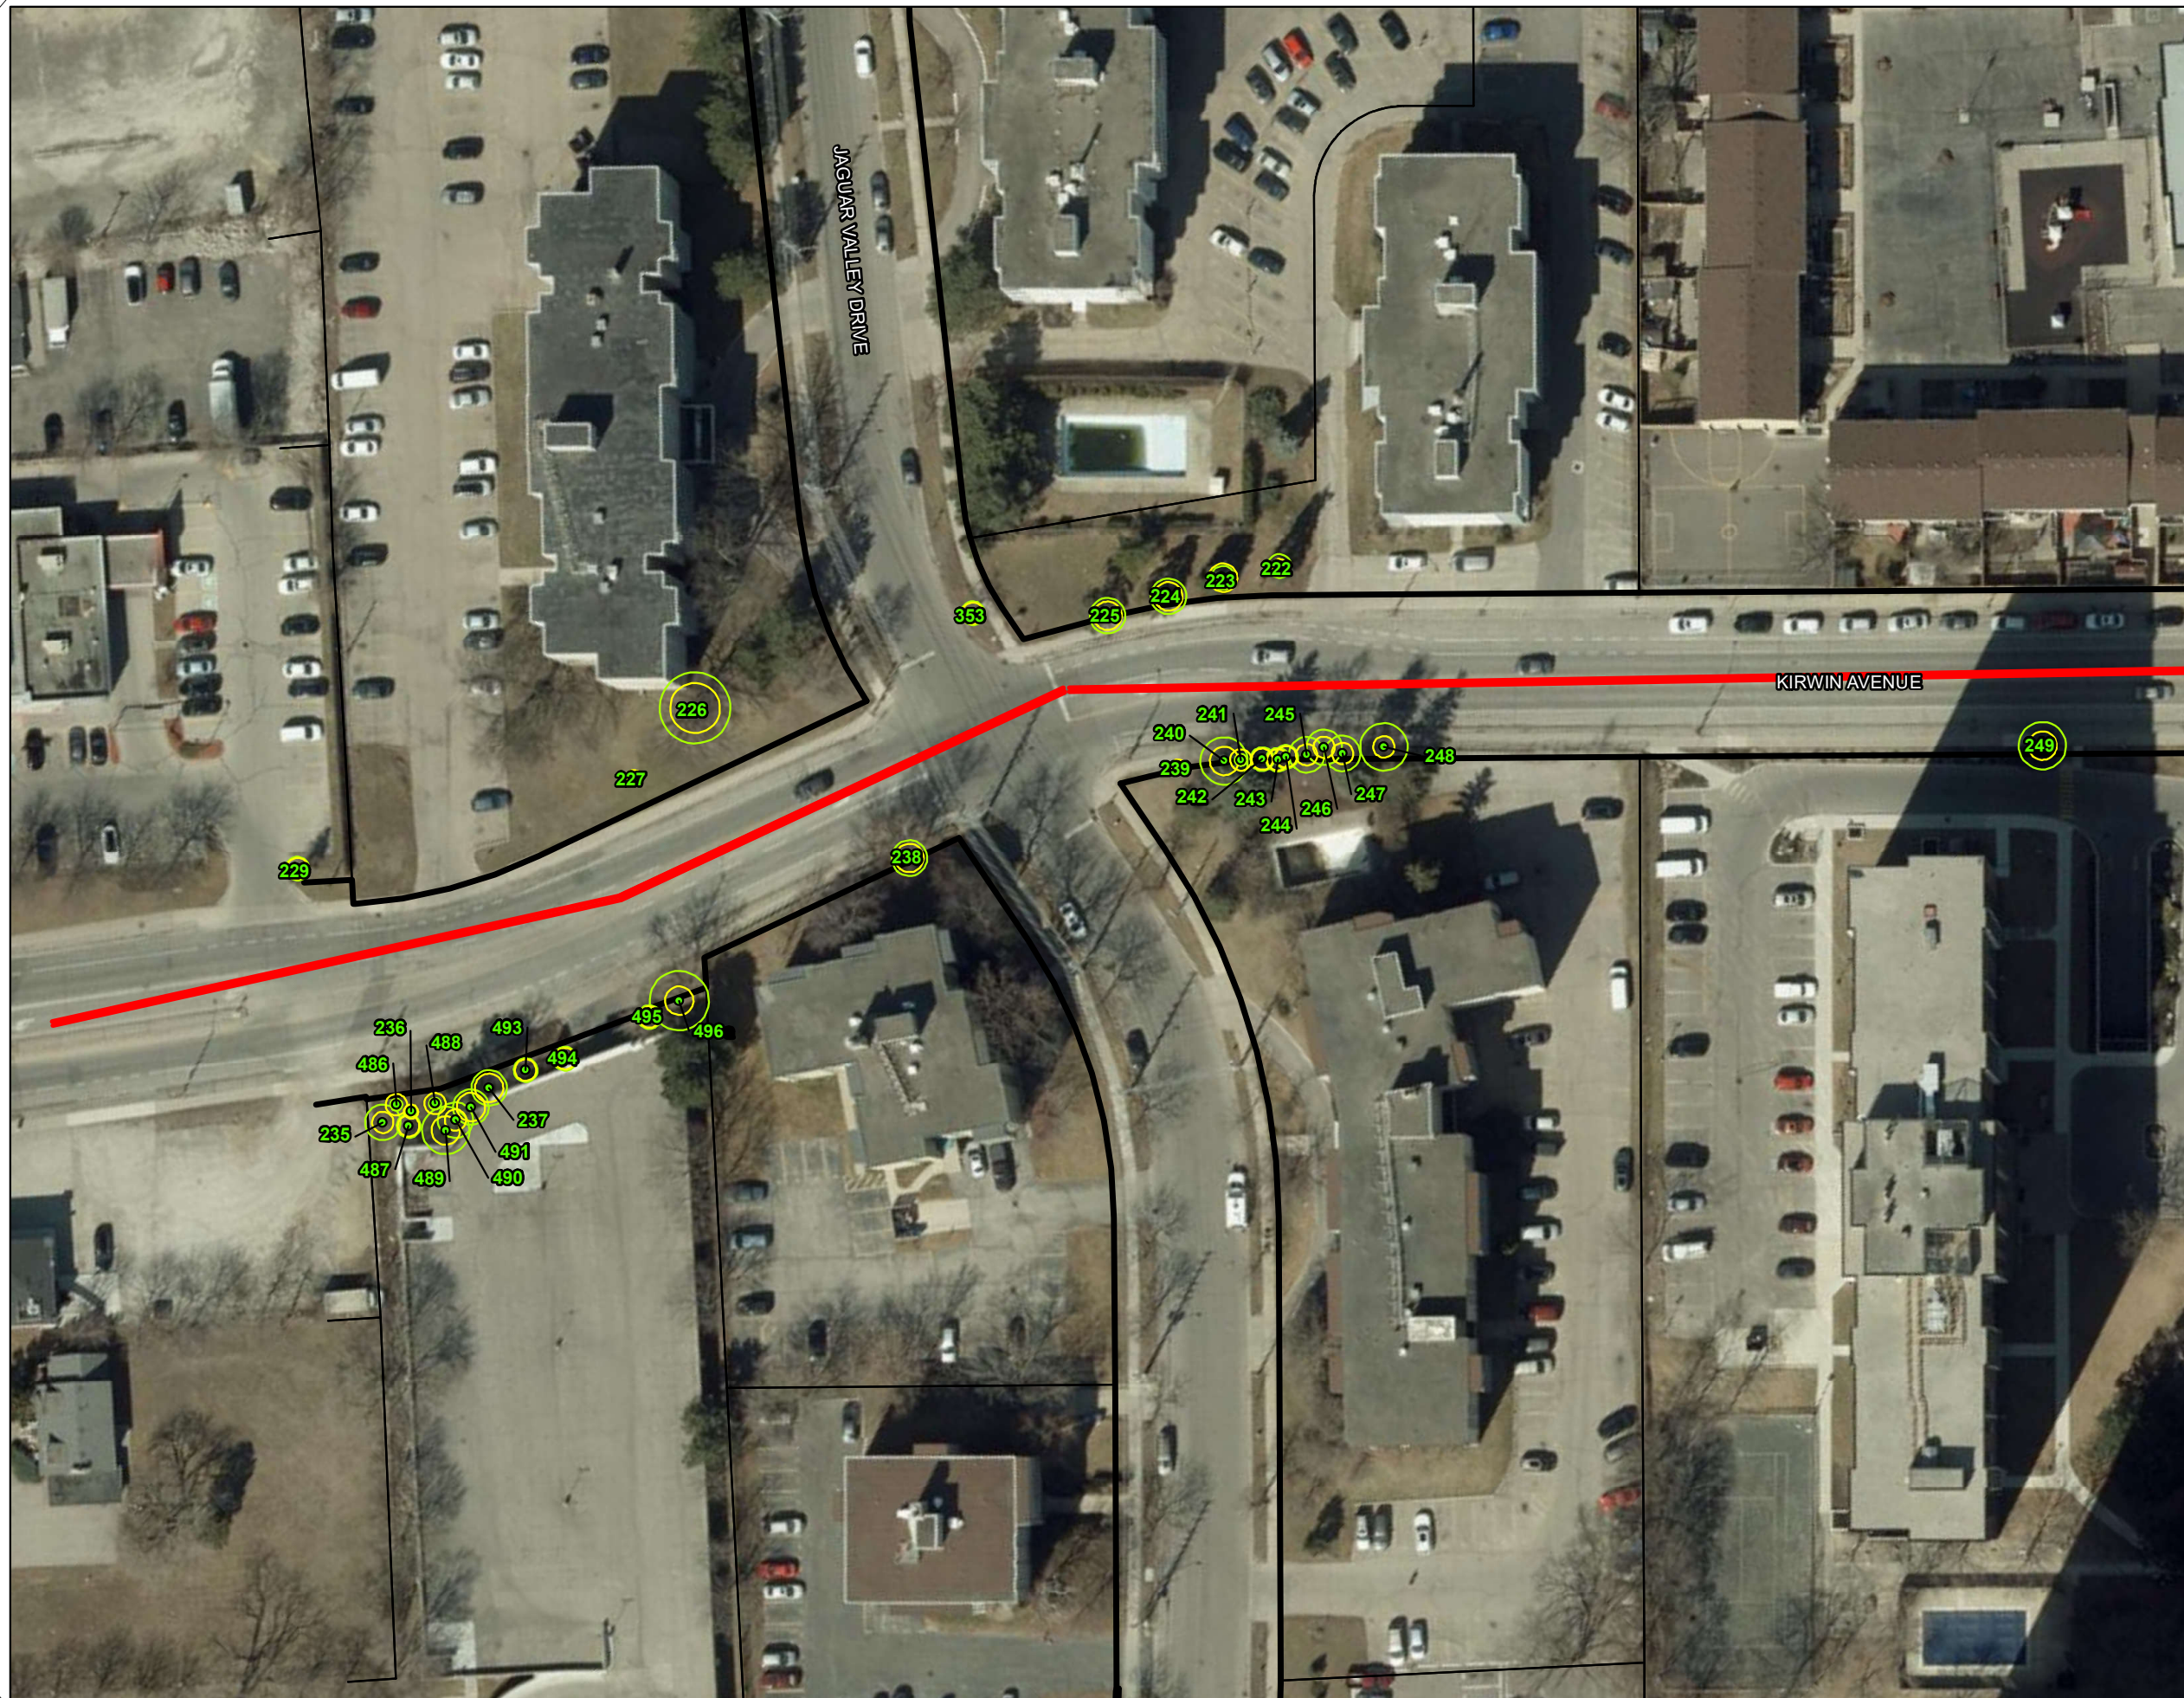
Project: TA9334	Figure: 2-A
Date: January, 2024	Prepared By: VLG
Scale: 1:800	Checked By: JPB

**KIRWIN AVENUE SEWER
TREE RESOURCES**

A total of 131 trees were identified and assessed during the tree inventory. Trees within the Study Area range in size from 3 to 65 cm DBH and are generally in good to fair condition. Out of the 131 surveyed trees, 110 trees are regulated under the Mississauga Preservation By-laws. A detailed summary of all trees surveyed is presented in **Appendix A - Tree Inventory** and the locations of each tree (by identifier number) are presented in **Figure 2**.

A tree impact assessment was completed to determine impacts to tree resources as a result of the proposed works. The impact assessment was completed by comparing the extent of tree dripline and tree protection zones with the proposed disturbance limits provided in the design drawings. Trees recommended for removal include trees within or outside the disturbance limits that would not be able to withstand construction related impacts. Trees identified as injured may require root and/or canopy pruning where encroachment occurs, however, impacts will be minor and the trees are considered retainable. In addition, trees identified as retained are considered to be not affected and will be protected through mitigation measures. Note that this impact assessment is an estimate based on the information available at the time of report preparation and some assumptions have been made since the exact machine type and dimension, limits of disturbance, and roots zones are not identified at this time. A summary of the results of the impact assessment is provided below. Additionally, the results of the impact assessment are summarized in the **Appendix A - Tree Inventory** and illustrated in **Figure 2**.

One hundred-fourteen (114) trees are recommended for retention with no injury and hoarding specifications are included in **Appendix A - Tree Inventory** and illustrated in **Figure 2**.

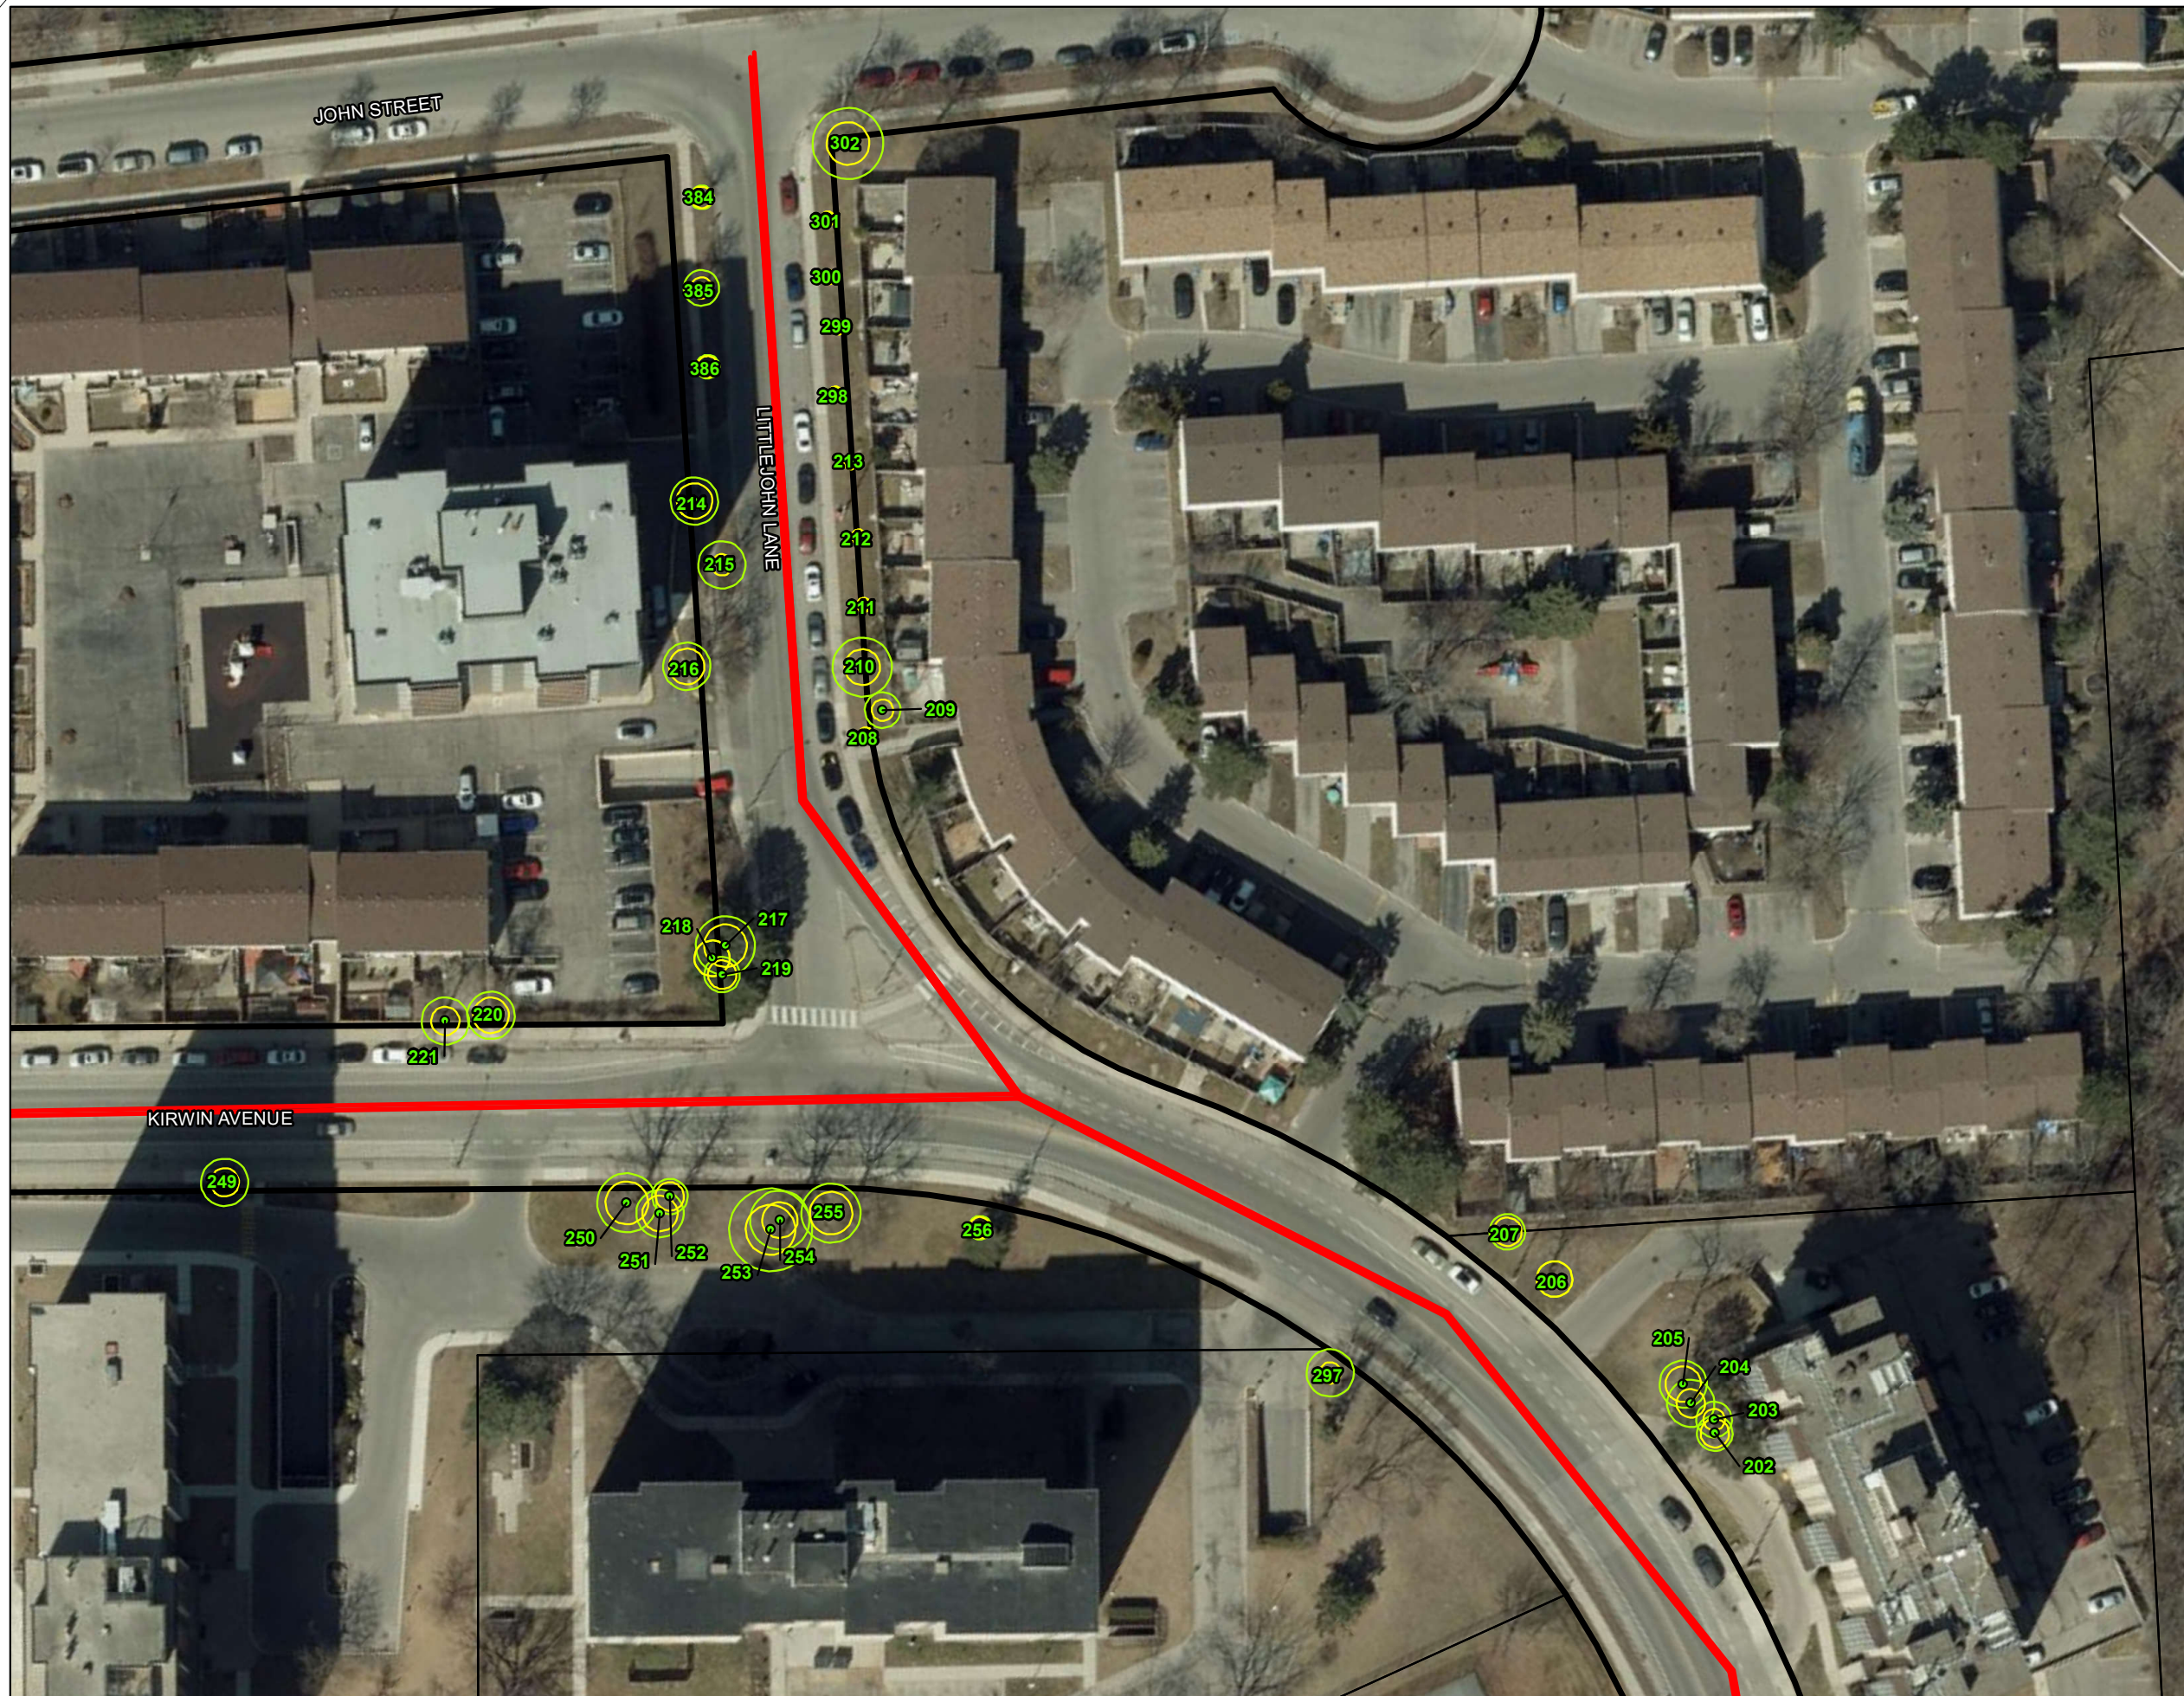
Project: TA9334	Figure: 2-B
Date: January, 2024	Prepared By: VLG
Scale: 1:800	Checked By: JPB

**KIRWIN AVENUE SEWER
TREE RESOURCES**

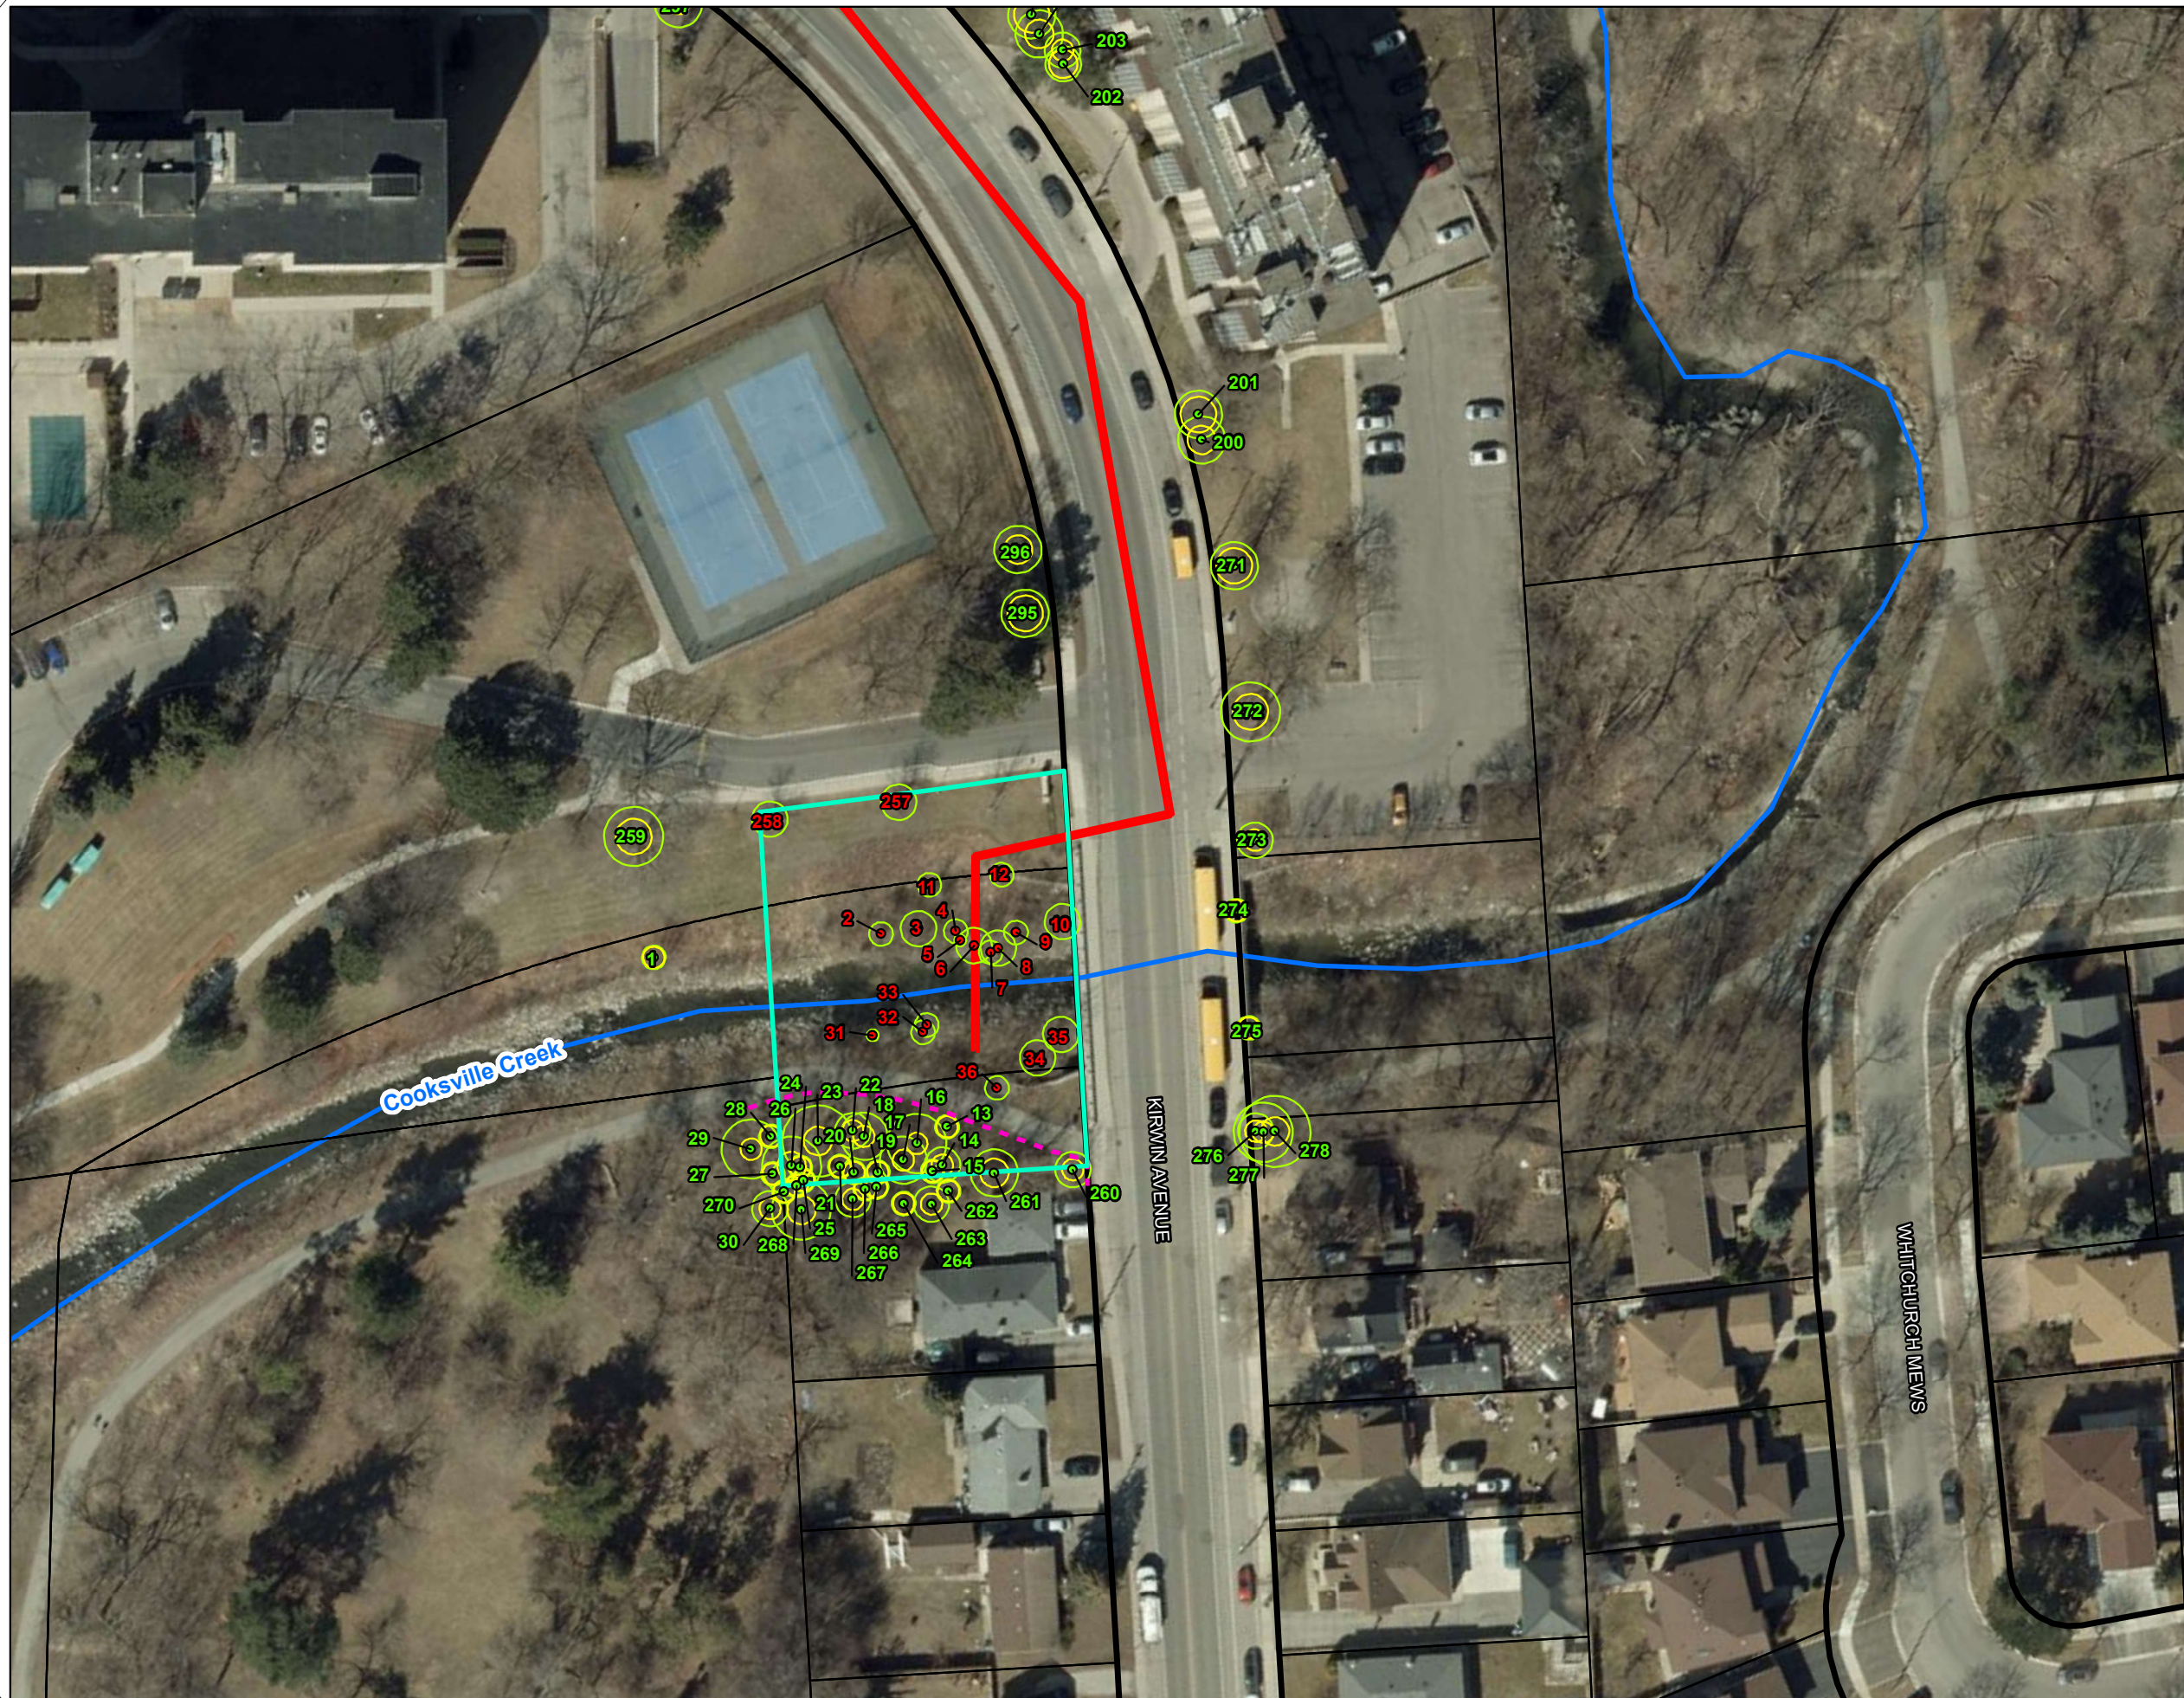
Project: TA9334	Figure: 2-C
Date: January, 2024	Prepared By: VLG
Scale: 1:800	Checked By: JPB

**KIRWIN AVENUE SEWER
TREE RESOURCES**

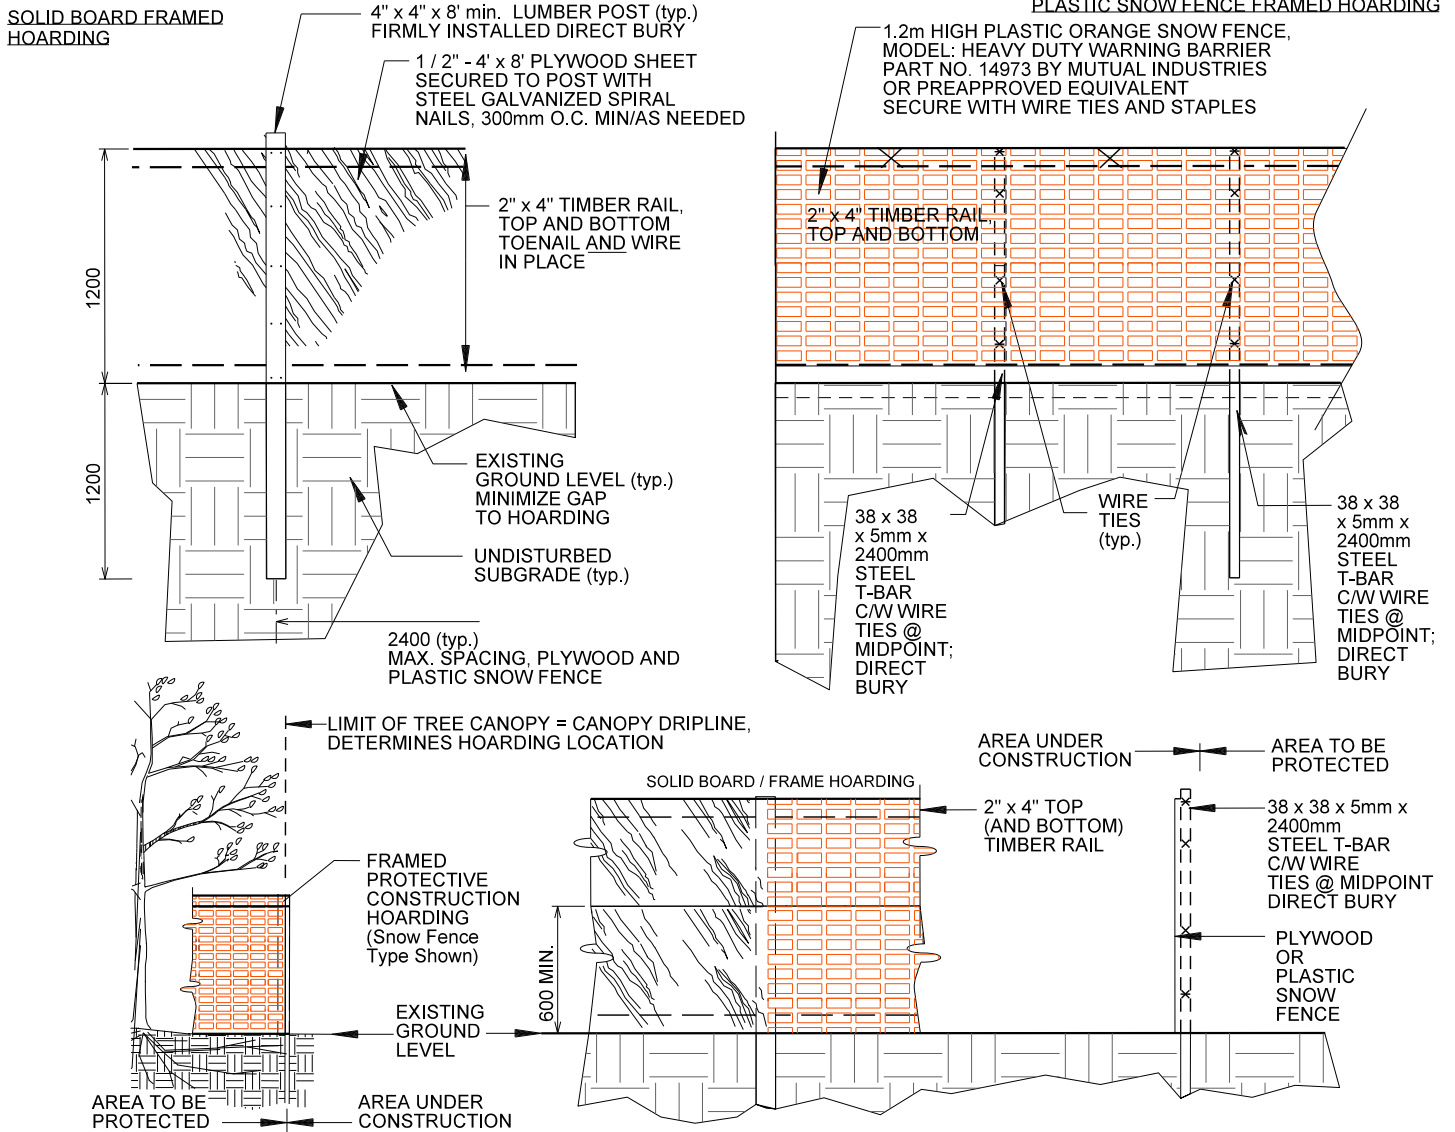
02830-6

Hoarding Framed Protective Construction Hoarding Solid Board- Plastic Snow Fence

1. HOARDING LOCATION AS PER DRAWINGS. HOARDING INSTALLATIONS ARE TO INCLUDE WOVEN GEOTEXTILE FABRIC FOR SEDIMENT CONTROL.
2. NO MOBILIZATION OR CONSTRUCTION WORK TO OCCUR UNTIL HOARDING HAS BEEN INSPECTED AND APPROVED BY COMMUNITY SERVICES PROJECT MANAGER (CSPM). CONTRACTOR TO ARRANGE FOR A HOARDING INSPECTION WITH (CSPM), 48 HOUR NOTICE REQUIRED.

3. HOARDING TO BE SUPPLIED, INSTALLED AND MAINTAINED BY THE CONTRACTOR THROUGH ALL PHASES OF WORK ON SITE.
4. THE CONTRACTOR IS TO REMOVE AND DISPOSE THE HOARDING OFF SITE WHEN DIRECTED BY THE (CSPM).

5. ALL WOOD PRODUCTS TO BE NEW AND LUMBER KILN DRIED SPF.
6. ALL FASTENERS TO BE NEW GALVANIZED STEEL AND SECURELY INSTALLED. WIRE TIES MIN 3.5mm DIA. GALVANIZED STEEL.

7. DO NOT ALLOW WATER TO COLLECT AND/OR POND ON EITHER SIDE OF THE HOARDING.
8. WHEN INSTALLING DIRECT BURY TIMBER POSTS AND T-BARS, TAKE CARE TO AVOID VISIBLE AND ASCERTAINABLE TREE ROOTS.

9. PLACE HOARDING AT LIMIT OF TREE CANOPY DRIP LINE OR BEYOND (E.G. FURTHER AWAY FROM TRUNK) OF TREE.
10. HOARDED OFF AREA TO REMAIN UNDISTURBED. NO STOCKPILING, STAGING OR MOVEMENT OF VEHICLES TO OCCUR WITHIN PROTECTED AREA.

11. FOR PROTECTION OF TREE'S AND ROOT SYSTEM, CONTRACTOR MAY BE REQUIRED TO PROVIDE WATERING, MULCHING, FERTILIZING, PRUNING OR OTHER ACTIVITIES TO ENSURE THE HEALTH OF THE TREE(S).

Designation of a tree protection zone (TPZ) is imperative for the protection of trees (roots, trunks, branches) adjacent to construction works. The TPZ will restrict construction related machinery and activities from damaging trees identified for retention. Physical protection (plywood hoarding, Fast Fence, or other as approved by the City) shall be considered for all trees in proximity to construction. Protection distances are listed in **Appendix A - Tree Inventory**. Note that site specific deviations from the City's standards may be required, particularly to alleviate conflicts with pedestrian and vehicle traffic and private Study Area.

- Prior to the start of any site work, the Contractor shall supply and install tree protection barriers around each tree designated for protection;
- The protective barrier is to comply with City specifications for tree protection;
