Peel Walking Audit

Dixie Road Walking Audit
Results and Recommendation Report
Healthy Peel by Design
May 3, 2024

Peel Public Health conducted a Walking Audit as part of the Peel Region Dixie Road Complete Corridor Study and Preliminary Design. The project limit runs along Dixie Road from Rometown Drive to Lakeshore Road East in the City of Mississauga, Ontario. The Region of Peel is leading the project and Arcadis Professional Services (Canada) Inc., has been retained as the project consultant for the Study. The objective of the project is to transform the Dixie Road Corridor into a “complete street” that supports all modes of transportation.

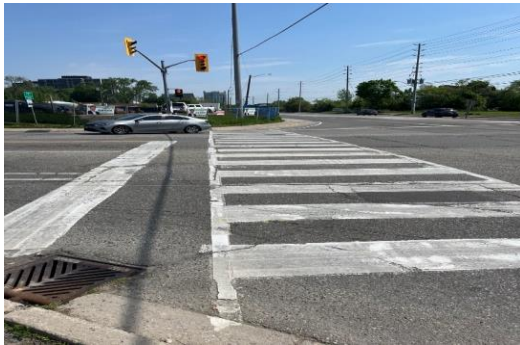
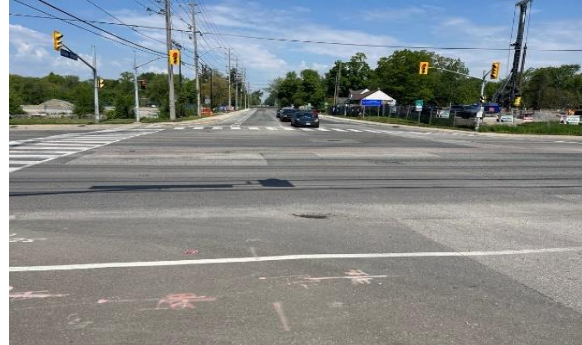
Dixie Road and Lakeshore Road Intersection

Three crosswalk legs at a four-way intersection. No crosswalk on the east side of the intersection. Also, no crosswalk indicator button from the north to the west side.

7. **Crosswalk Deficiencies:** The Dixie Road and Lakeshore Road intersection is missing a crosswalk leg and crossing button on the northeast side. Additionally, there are only three locations to cross Dixie Road east-west along the study corridor – Rometown Drive, at the mall entrance (just south of Rometown Drive), and Lakeshore Road – with over 1 km between Lakeshore Road and the mall entrance crossings. Additional crossing opportunities should be considered between these locations to improve connectivity between the east and west sides of Dixie Road for vulnerable road users.

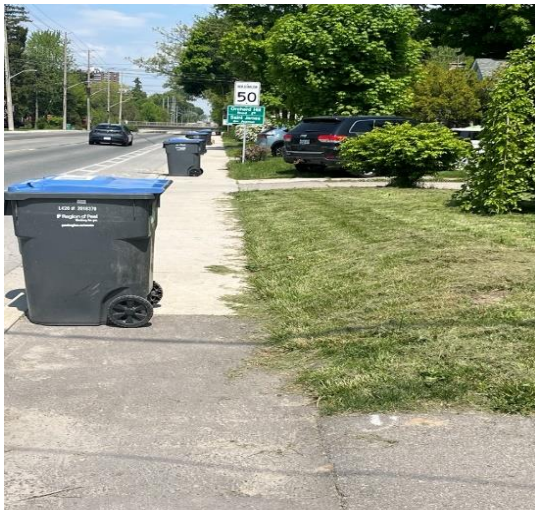
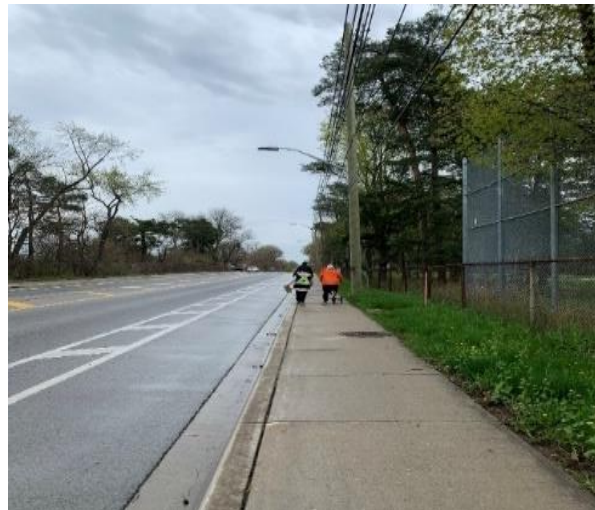
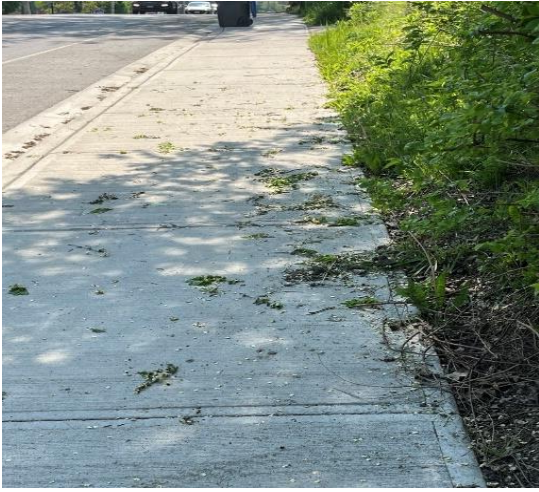
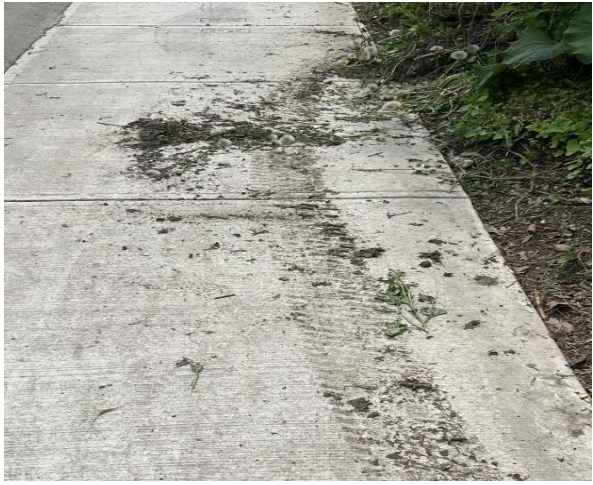
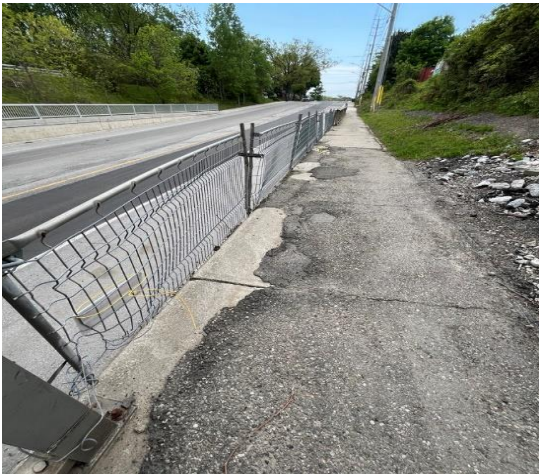
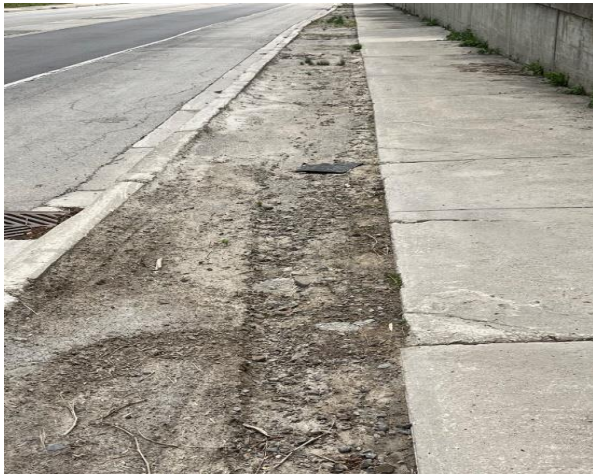
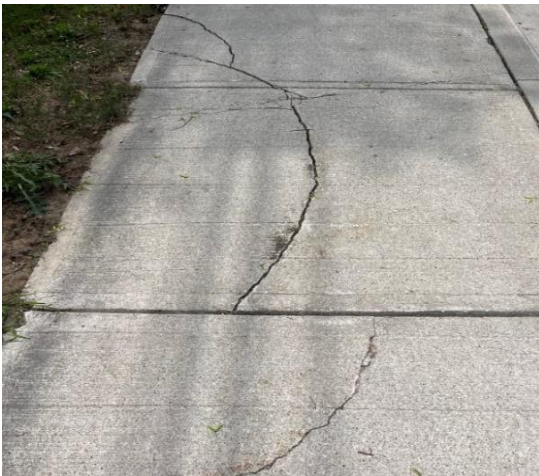
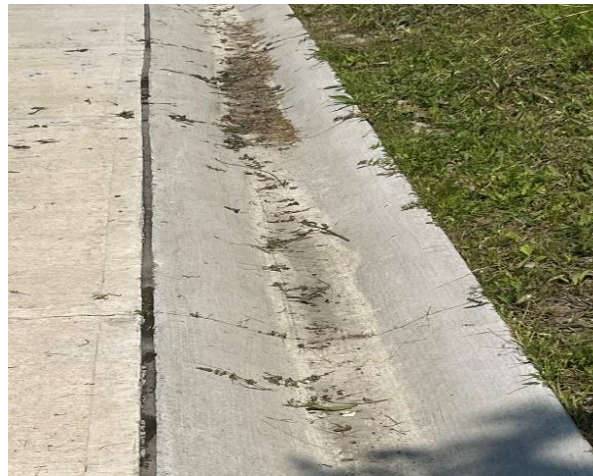
Sidewalks

As pedestrians head north on Dixie Road toward the golf courses, they encounter narrow sidewalks that force them to walk single file. Low-hanging street signs add to the challenge. On the west side of Dixie Road, two walkers and a non-electric scooter user share the space, with the pedestrian very close to the bike lane.

6. **Pedestrian Challenges:** Narrow sidewalks force single-file walking by Dixie Road and Lakeshore Road especially on garbage days. Low-hanging street signs also impact the pedestrian environment.

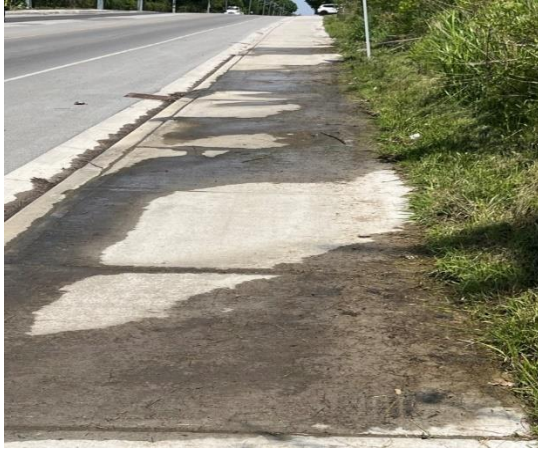
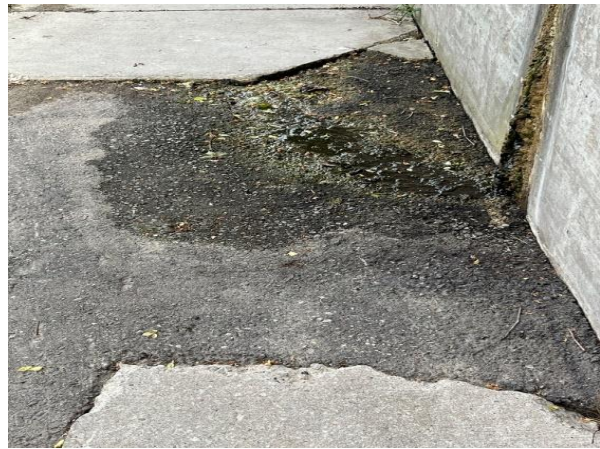
Drainage Concerns

Poor drainage causing sidewalks to be wet, covered in leaves, and moss making it slippery. In addition, cracks, and uneven sidewalks were noted by the participants, a deterrent for residents to walk, cycle or scooter. Addressing these concerns would improve accessibility and safety.

5. **Poor Sidewalk Conditions:** Wet, moss-covered, and uneven sidewalks deter residents from walking, cycling, or scootering. Opportunities to improve sidewalk conditions should be explored.

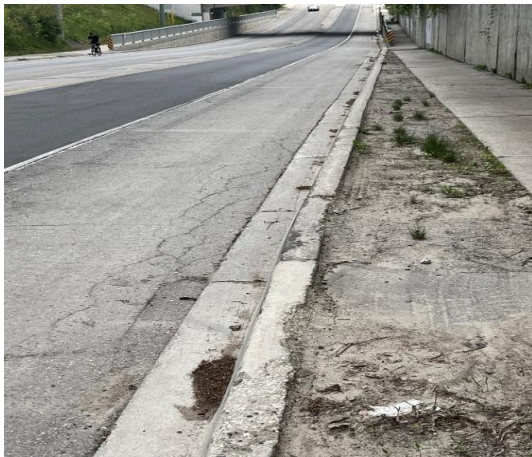
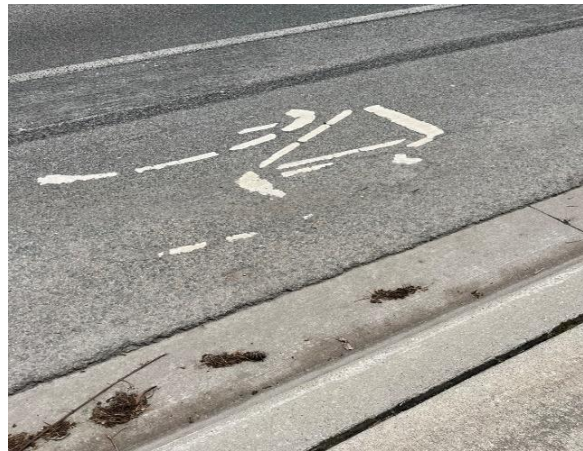
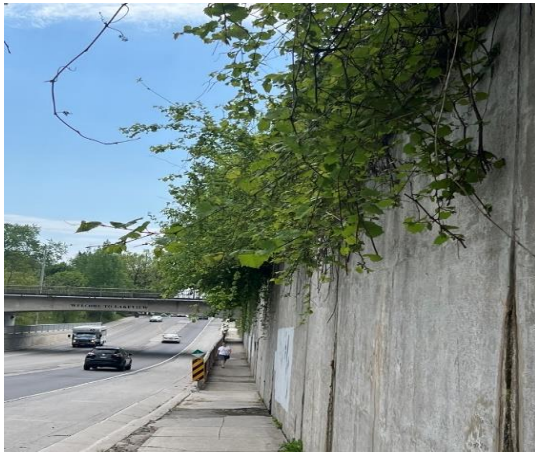
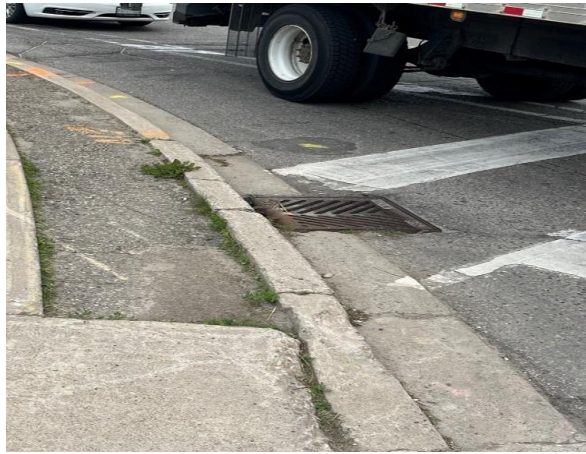
Bike Lanes

It was identified that the current bike lane pavement markings are fading and cracking in areas, requiring repainting and repairs. Barriers were also suggested between the cars, cyclists, and scooters as an enhanced safety measure.

4. **Bike Lane Maintenance and Barriers:** Fading bike lanes require repainting. Installing barriers between cars, cyclists, and scooters can enhance safety.

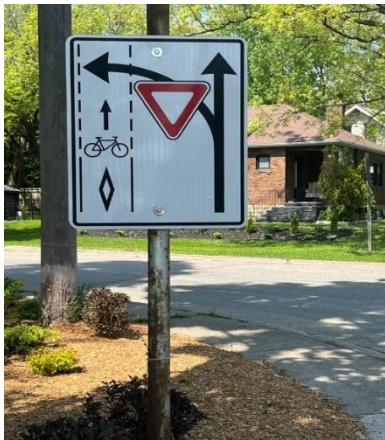
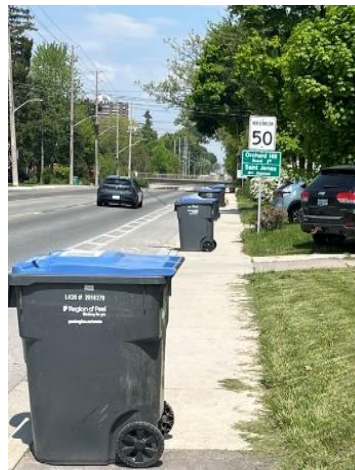
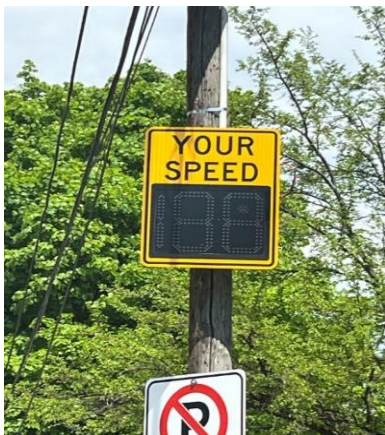
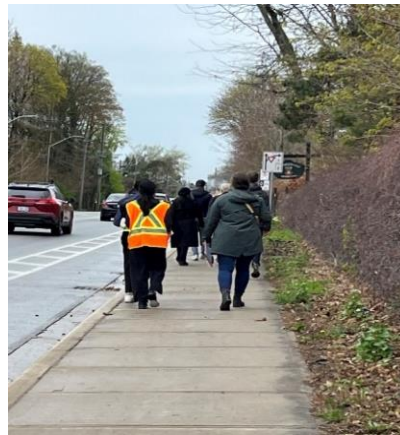
Signage

There are several low hanging signs along the corridor and close to the sidewalks, making this a hazard for those using the sidewalks. It was identified to have more speed signs along the corridor and monitor area for speed and increased traffic.

1. **Low-Hanging Signs and Hazards:** Low-hanging signs near sidewalks pose risks to pedestrians. Sign placement should be adjusted where possible to improve safety.

2. **Speed Signs and Traffic Monitoring:** The corridor lacks sufficient posted speed signs. Increasing their presence and monitoring traffic can enhance safety.

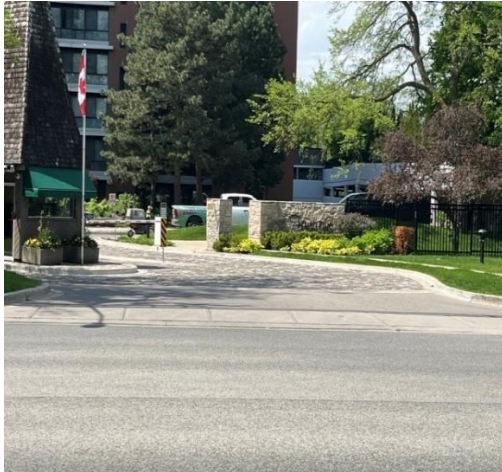
Fairways Condominium (mostly seniors) and Golf Courses

At the condominium, there are no crosswalks, stop signs, or traffic lights, making it difficult to turn out of the condominium or safely cross the street. The heavy, fast-moving traffic from the QEW and Lakeshore Road exacerbates the situation. Similarly, those exiting both golf courses on Dixie Road face the same issue due to the lack of existing crosswalks or traffic lights.

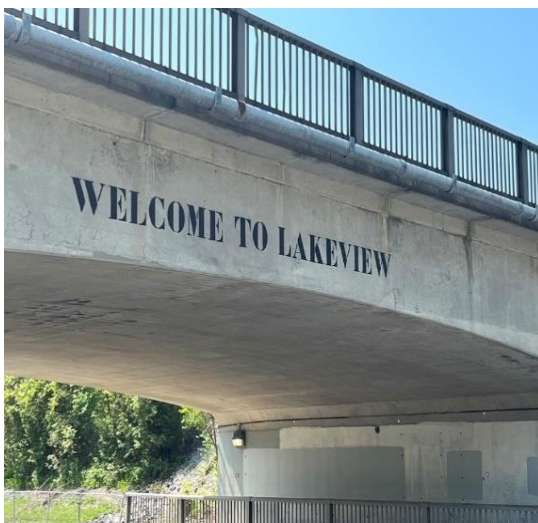
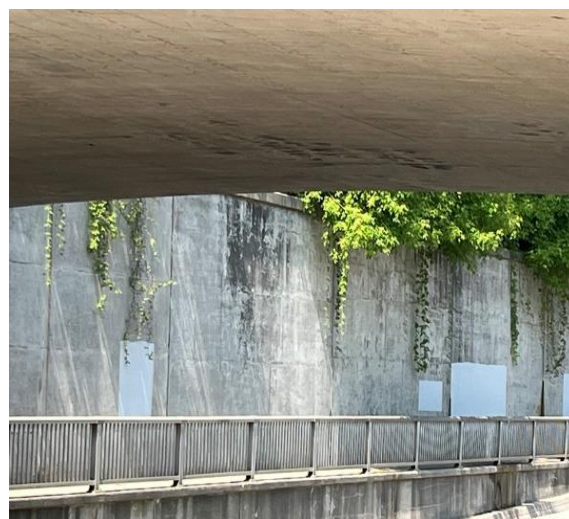
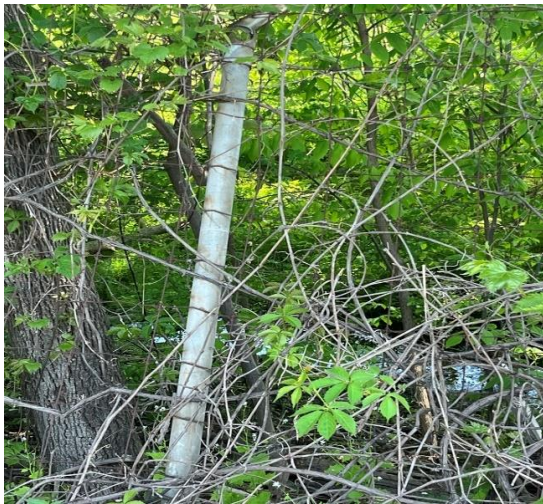
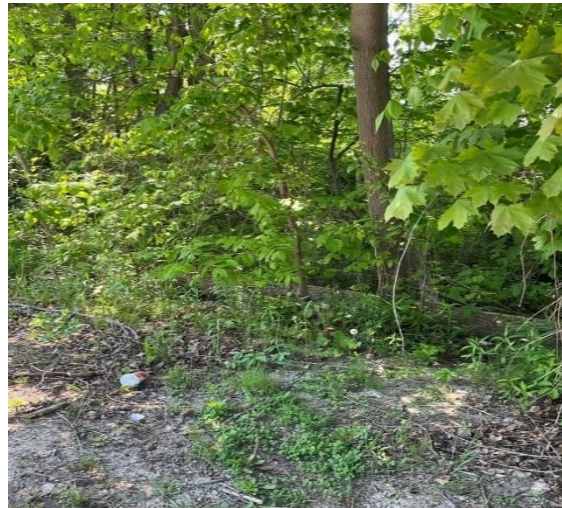
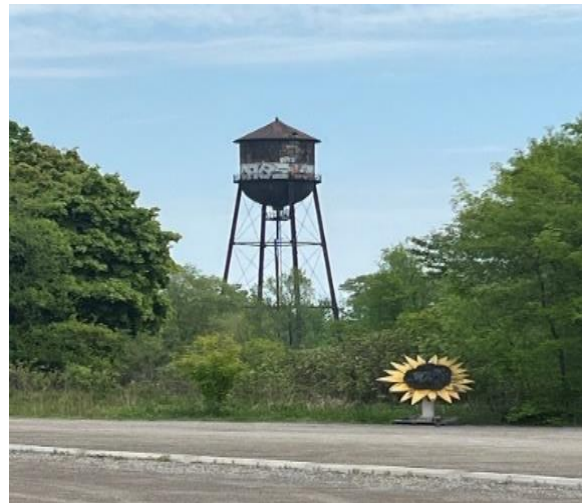
Aesthetics

While the existing walking infrastructure is in place, there are specific areas that require enhancements to ensure residents can fully enjoy safe walking, cycling, and scooter use. Addressing issues such as garbage and broken fences, adding more flowers, plants, benches, and garbage cans, installing lighting on the east side, and considering artwork or a welcoming sign on the water tower would contribute to a more pleasant and inviting environment.

1. **Infrastructure Enhancements:**
 - Repair broken fences, cracks, and uneven sidewalks, improve drainage system and the maintenance of over growing trees and cleaning of sidewalks.
 - Consider the implementation of multi-use pathways and/or enhanced cycling infrastructure along the corridor.
 - Provide garbage containers along the corridor for pedestrians and dog walkers to reduce garbage and waste.
 - Install benches for resting along the corridor.

2. **Beautification Efforts:**
 - Add flowers and plants to create an inviting environment.
 - Consider artwork on and under bridge and a welcoming sign on the water tower.
3. **Lighting Installation:**
 - Install lighting on the east side for safety and visibility.
4. **Crosswalks and Traffic Control**
 - Consider additional crosswalks and or traffic lights along Dixie Road within the study area, for example by the golf courses and Fairway condominiums.

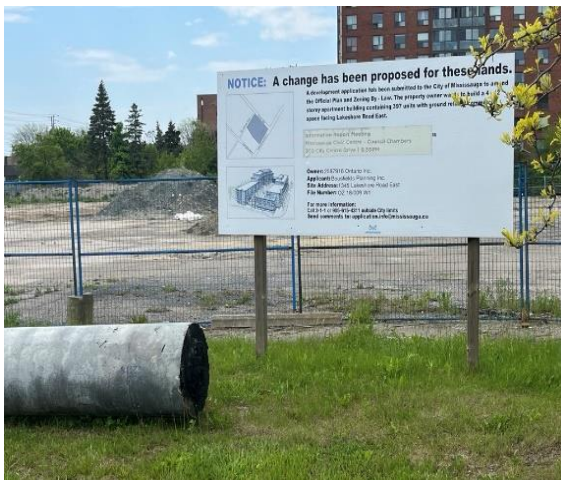
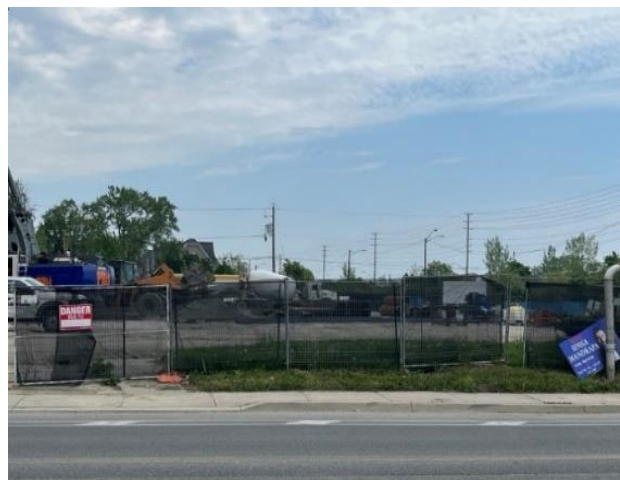
Future Development – Dixie Road and Lakeshore Road

The already busy area has the potential to experience an increase in traffic due to population growth and development on both sides of the corridor.

3. **Population Growth and Increased Traffic:** The current development on both sides of Dixie Road have the potential to increase traffic. Opportunities to address and mitigate traffic impacts should be considered.
