REPORT

**HYDRAULIC AND FLUVIAL GEOMORPHIC HAZARD
ASSESSMENT TO INFORM MITIGATION
REQUIREMENTS FOR REGION OF PEEL
STORMWATER SERVICING MASTER PLAN AT
MULTIPLE SITES**

Region of Peel, Ontario

November 2022

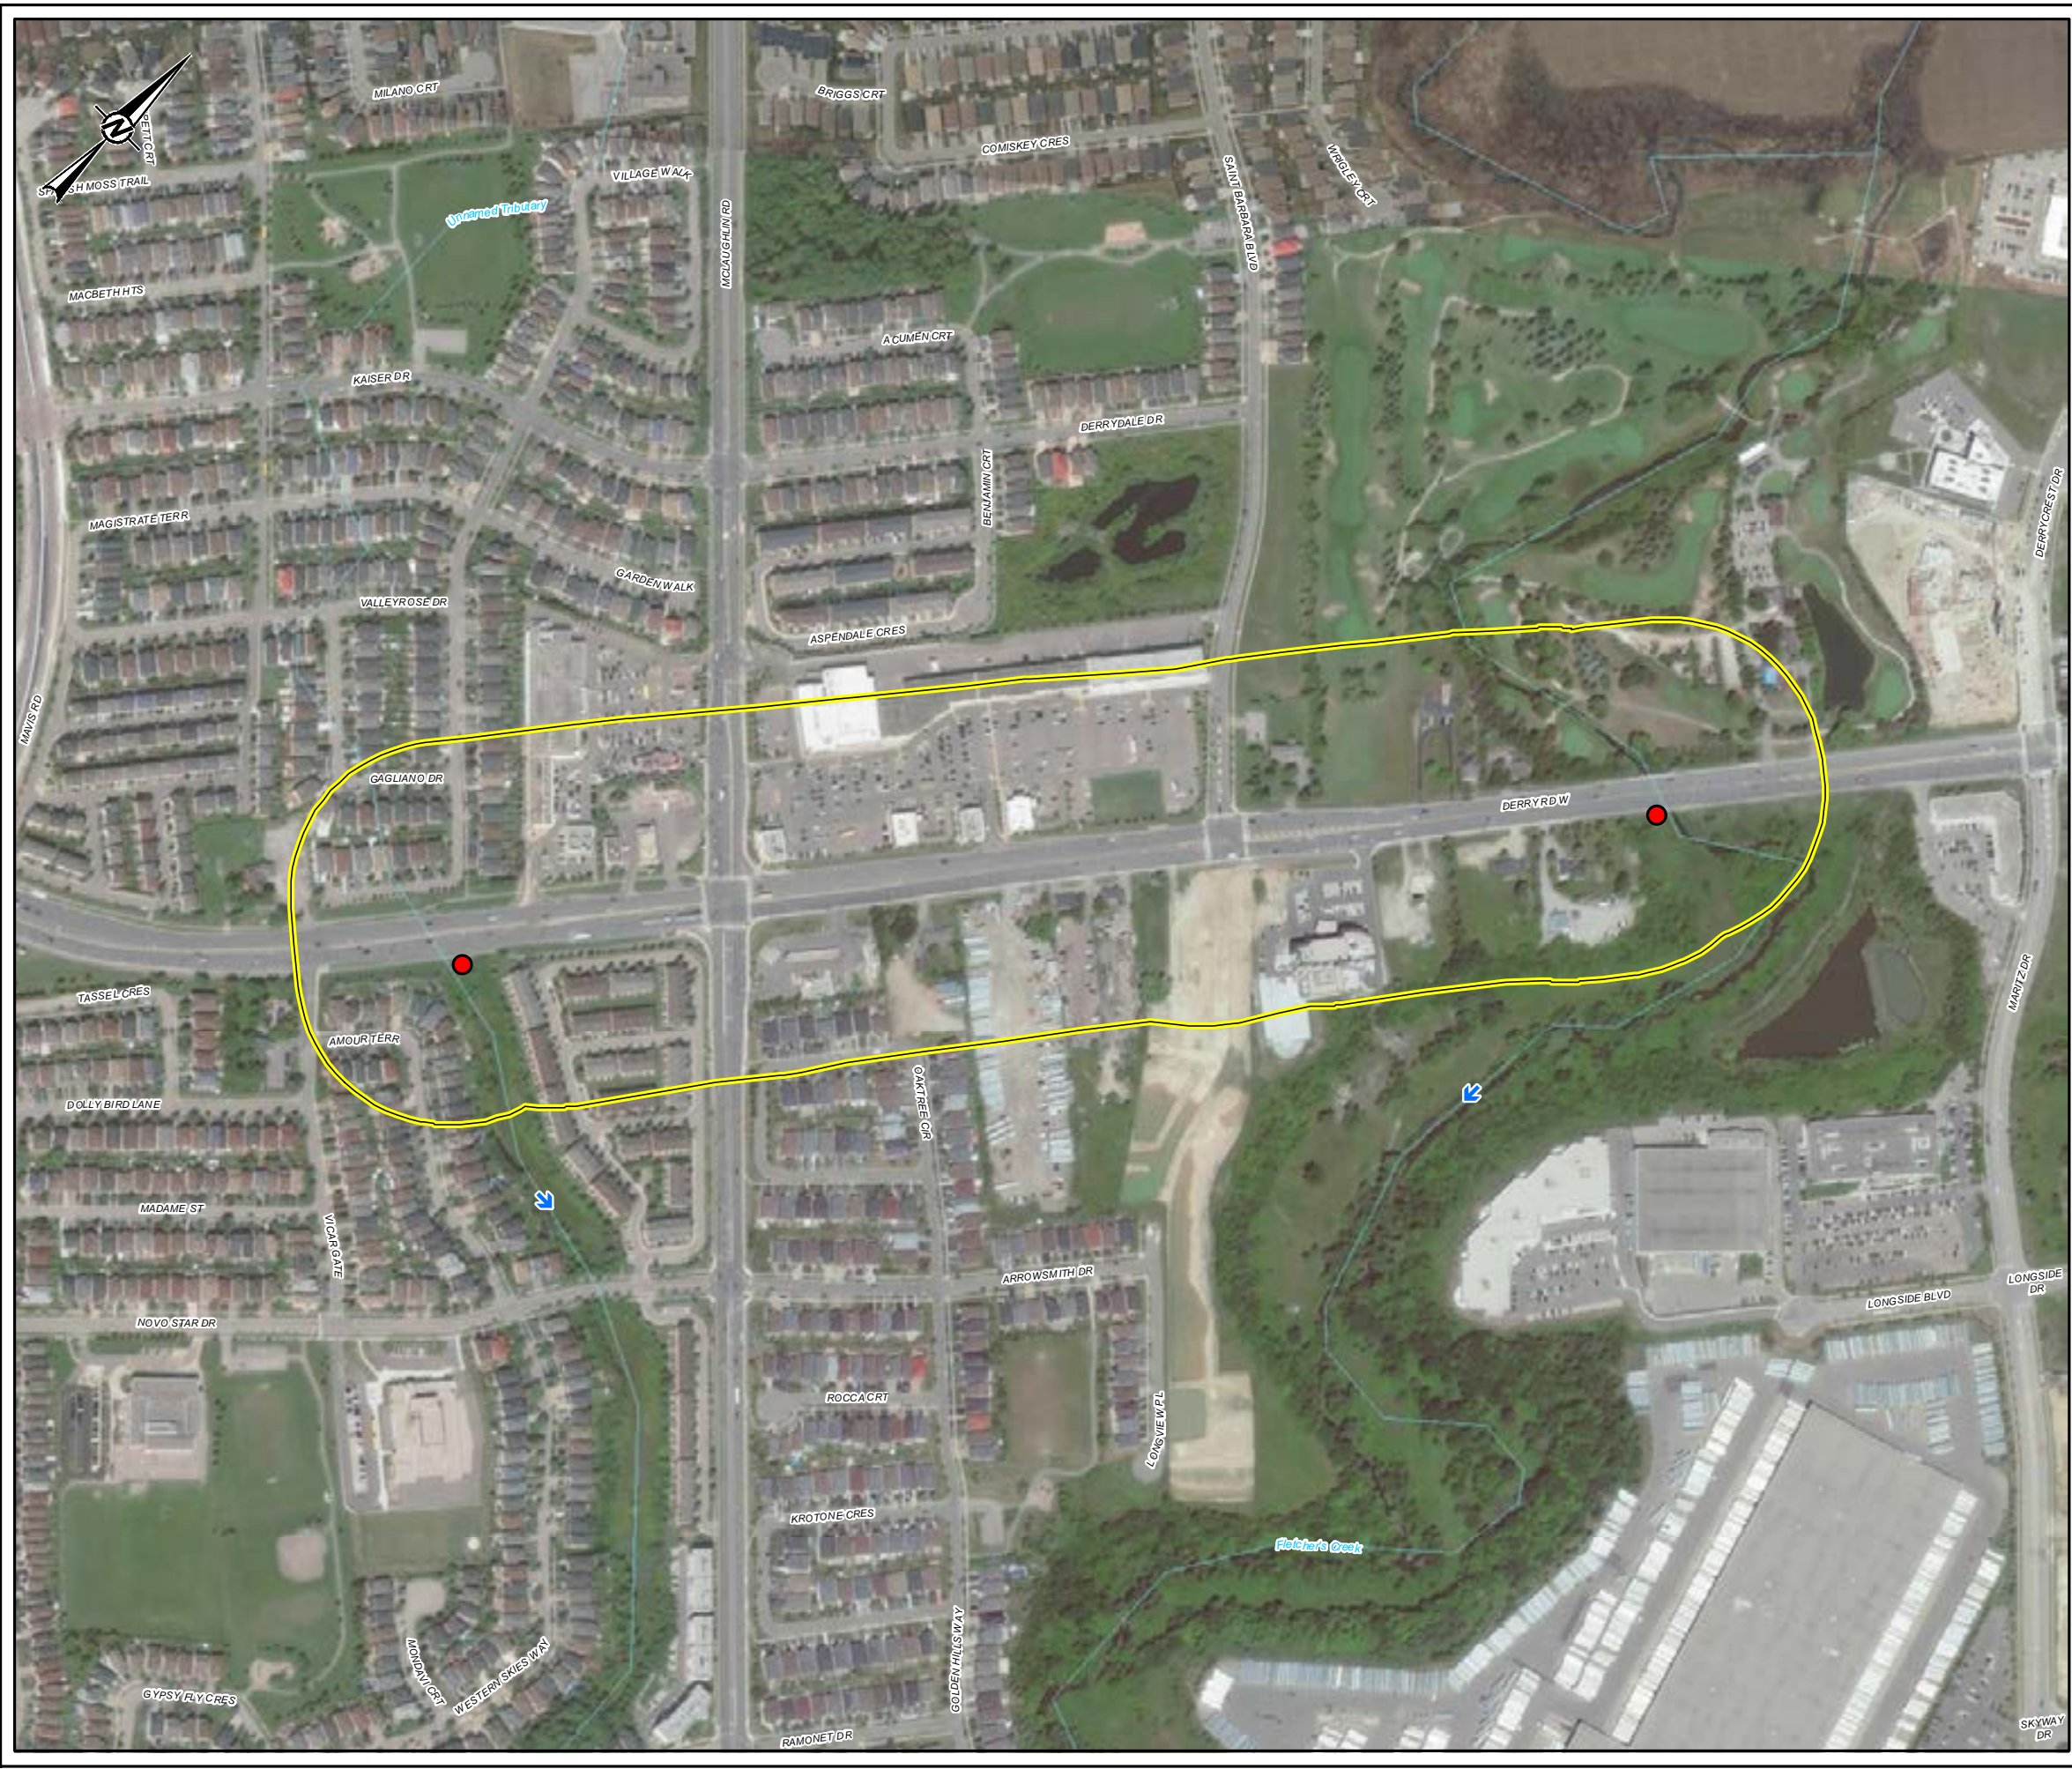
TITLE
HYDRAULIC AND FLUVIAL GEOMORPHIC - DERRY ROAD WEST AND MCLAUGHLIN ROAD (MISSISSAUGA)

Fletcher's Creek – Located approx. 740 m east of McLaughlin Road	A review of available historical air photographs/imagery between 1966 and 2021 demonstrated the following: <ul style="list-style-type: none"> Land Use – Dominated by agricultural activities or recreational facilities (golf course) prior to 2002 followed by prominent urbanization since that time. Channel Change – Moderate evidence of natural channel change prior to 1975 followed by channel alterations between 1975 and 1989 (i.e., straightening to support crossing structure installations) and then fairly stable channel conditions in the more recent period of record. 	Estimated to be 31 m based on: <ul style="list-style-type: none"> Meander amplitude with multiplier = 17 m x 1.5 = 25.5 m Channel width = 5.5 m 	<ul style="list-style-type: none"> Moderate likelihood: Location of proposed outlets of LID features expected to be within the hazard limit, but channel appears to support relatively stable conditions. 	<ul style="list-style-type: none"> Implementation of erosion protection (i.e., armour stone and targeted plantings) along the conveyance path between the outlet of the proposed discharge pipe and the receiving channel, as well as at the bank of the channel itself. Installation of headwall at proposed outlet to reduce the risk of undercutting in the event of channel encroachment/migration.

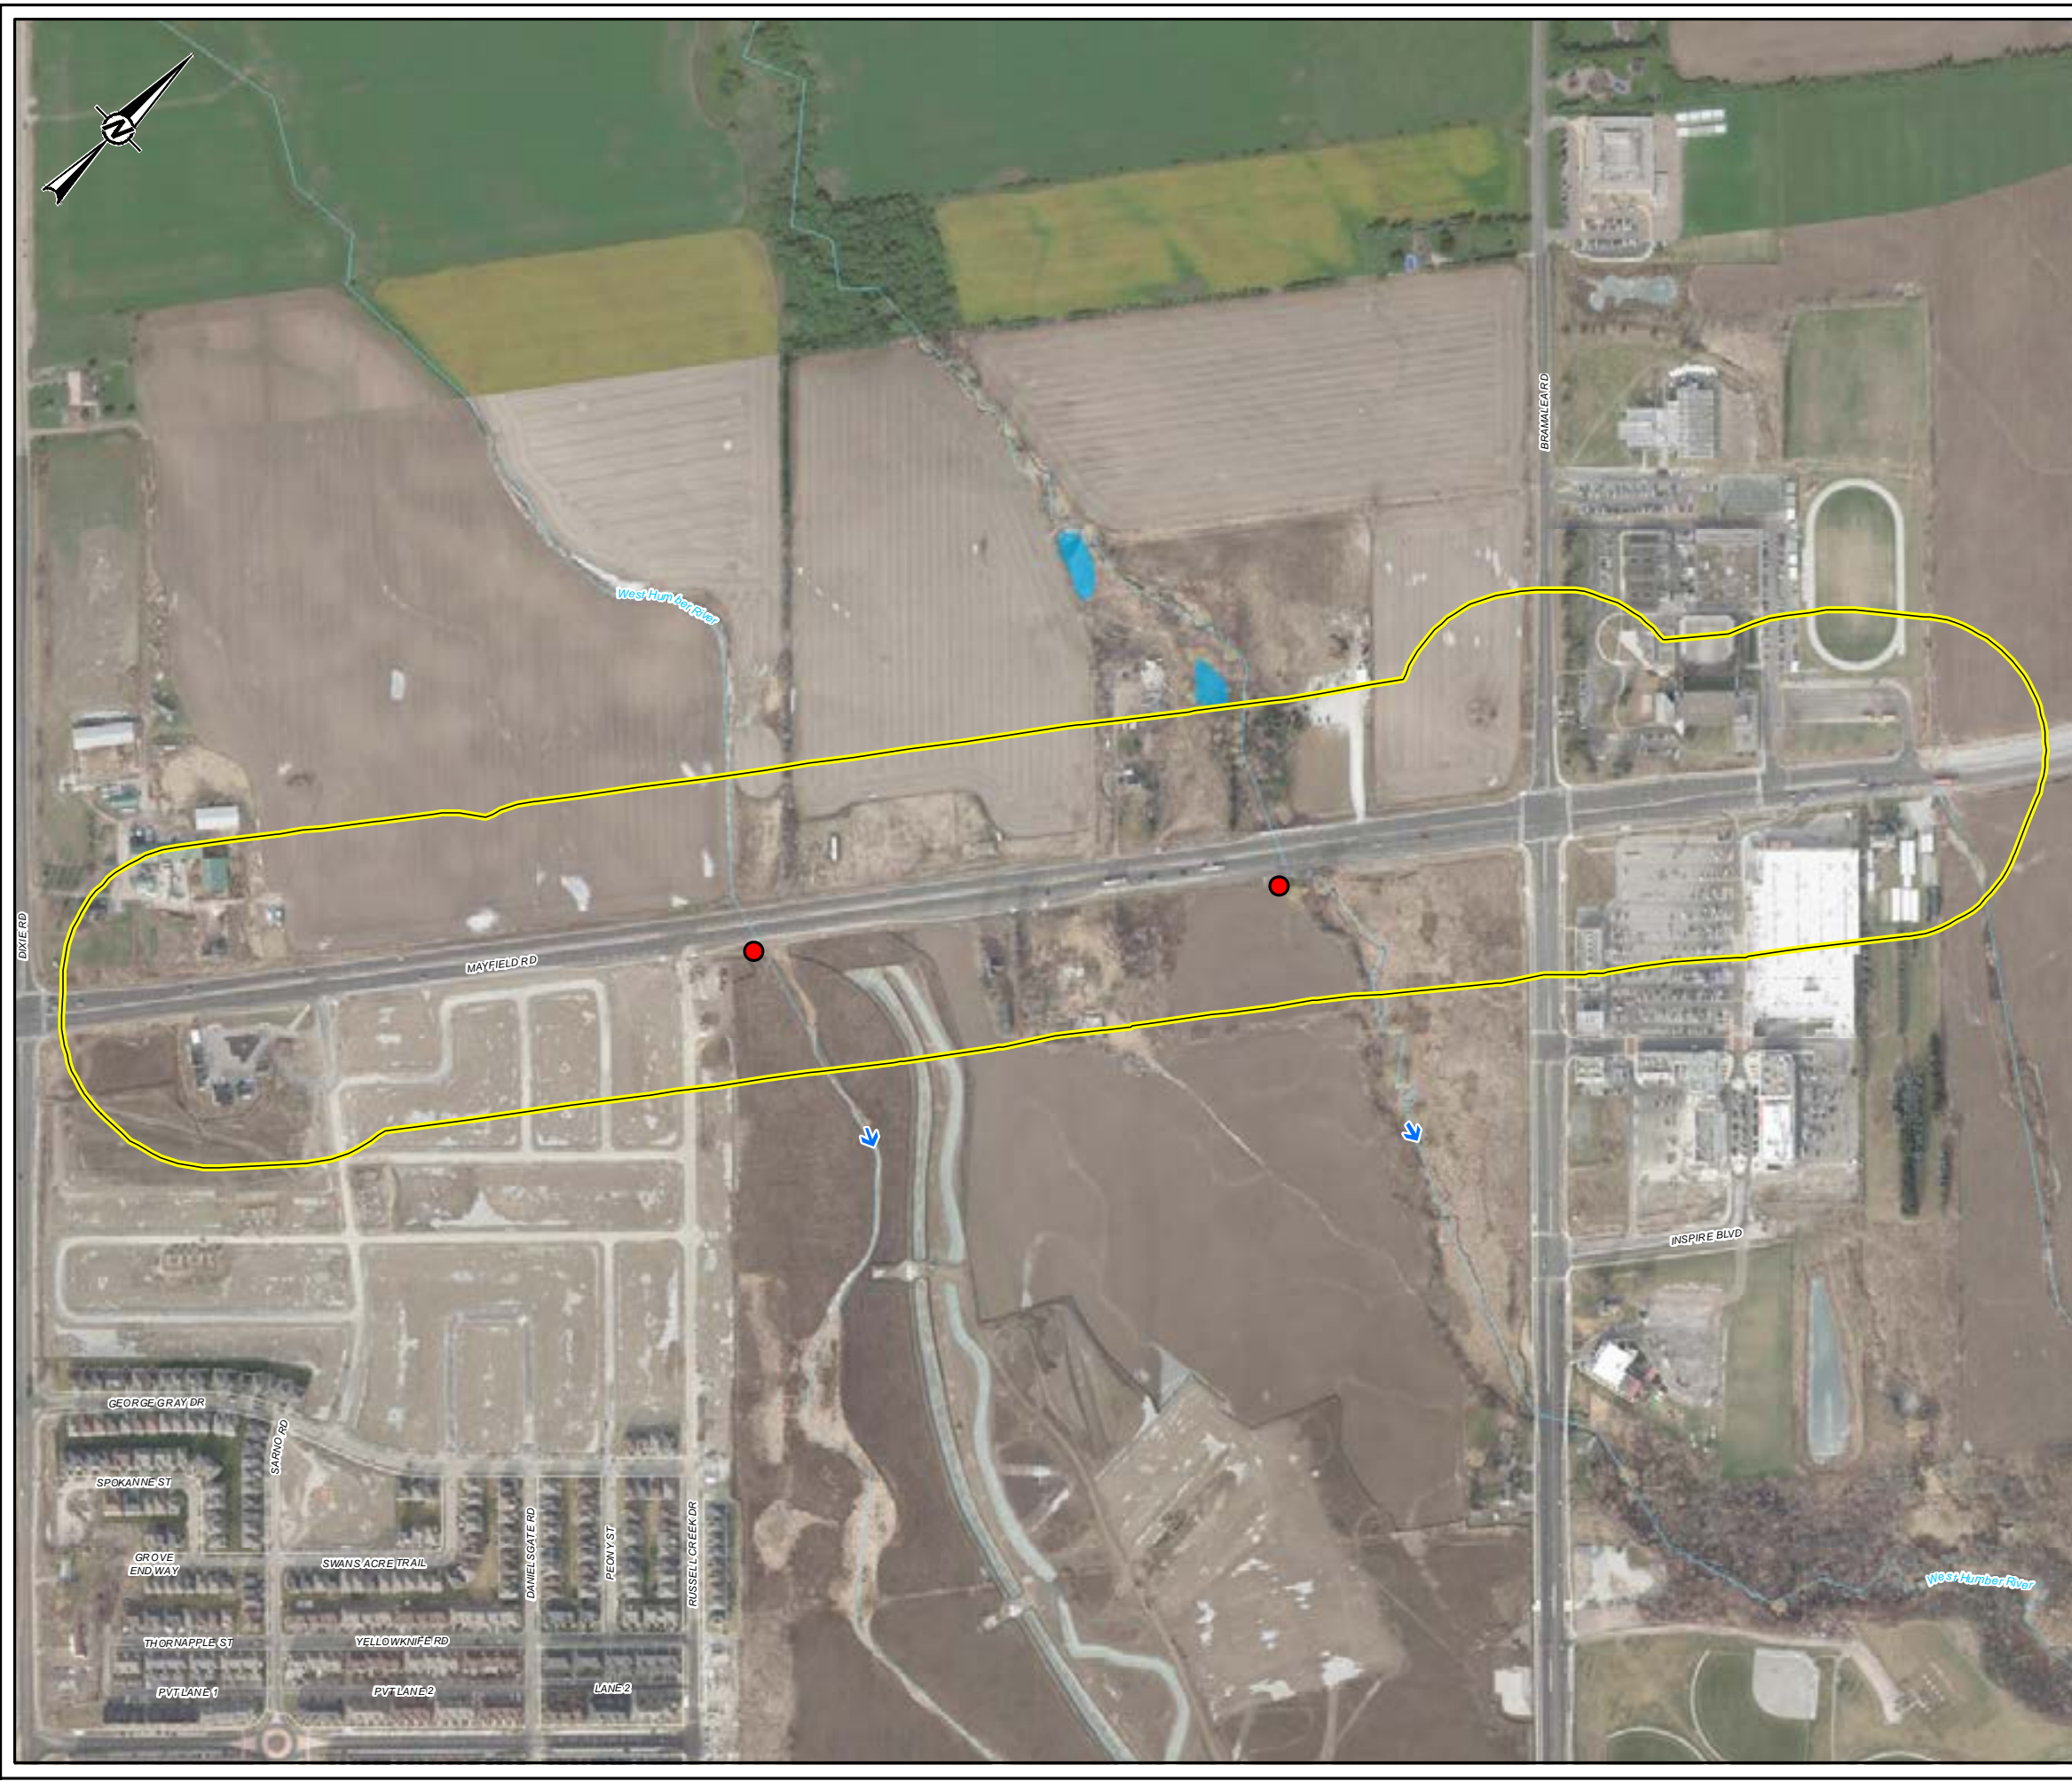
TITLE
HYDRAULIC AND FLUVIAL GEOMORPHIC - MAYFIELD ROAD
EAST OF DIXIE ROAD (MISSISSAUGA)

Mayfield Road east of Dixie Road (Figure 2; Site 5)	West Humber River – Located approx. 660 m east of Dixie Road	A review of available historical air photographs/imagery between 2000 and 2021 demonstrated the following: <ul style="list-style-type: none"> Land Use – Dominated by agricultural activities with some urban development over the most recent period of record. Channel Change – Moderate evidence of natural channel change prior to 2020 followed by channel alterations in the most recent period of record (i.e., straightening to support new crossing structure installations) and fairly stable channel conditions. 	Estimated to be 46.5 m based on: <ul style="list-style-type: none"> Meander amplitude with multiplier = 31 m x 1.5 = 45.5 m Channel width = 1 m 	<ul style="list-style-type: none"> Low likelihood: Location of proposed outlets of LID features expected to be outside of the hazard limit. 	<ul style="list-style-type: none"> Implementation of erosion protection (i.e., armour stone and targeted plantings) along the conveyance path between the outlet of the proposed discharge pipe and the receiving channel.

West Humber River – Located approx. 1220 m east of Dixie Road	A review of available historical air photographs/imagery between 2000 and 2021 demonstrated the following: <ul style="list-style-type: none"> Land Use – Dominated by agricultural activities with some light industry development over the most recent period of record. Channel Change – Moderate evidence of natural channel change prior to 2020 followed by channel alterations in the most recent period of record (i.e., straightening to support new crossing structure installations) and fairly stable channel conditions. 	Estimated to be 12.5 m based on: <ul style="list-style-type: none"> Meander amplitude with multiplier = 7 m x 1.5 = 10.5 m Channel width = 2 m 	<ul style="list-style-type: none"> Low likelihood: Location of proposed outlets of LID features expected to be outside of the hazard limit, noting that channels appears to support stable conditions and risk of encroachment/migration likely further constrained by the lateral confinement of the channel on the right bank side by the existing subdivision developments (i.e., hard controls likely in place), as well as the presence of culvert crossing at Mayfield Road. 	<ul style="list-style-type: none"> Implementation of erosion protection (i.e., armour stone and targeted plantings) along the conveyance path between the outlet of the proposed discharge pipe and the receiving channel.

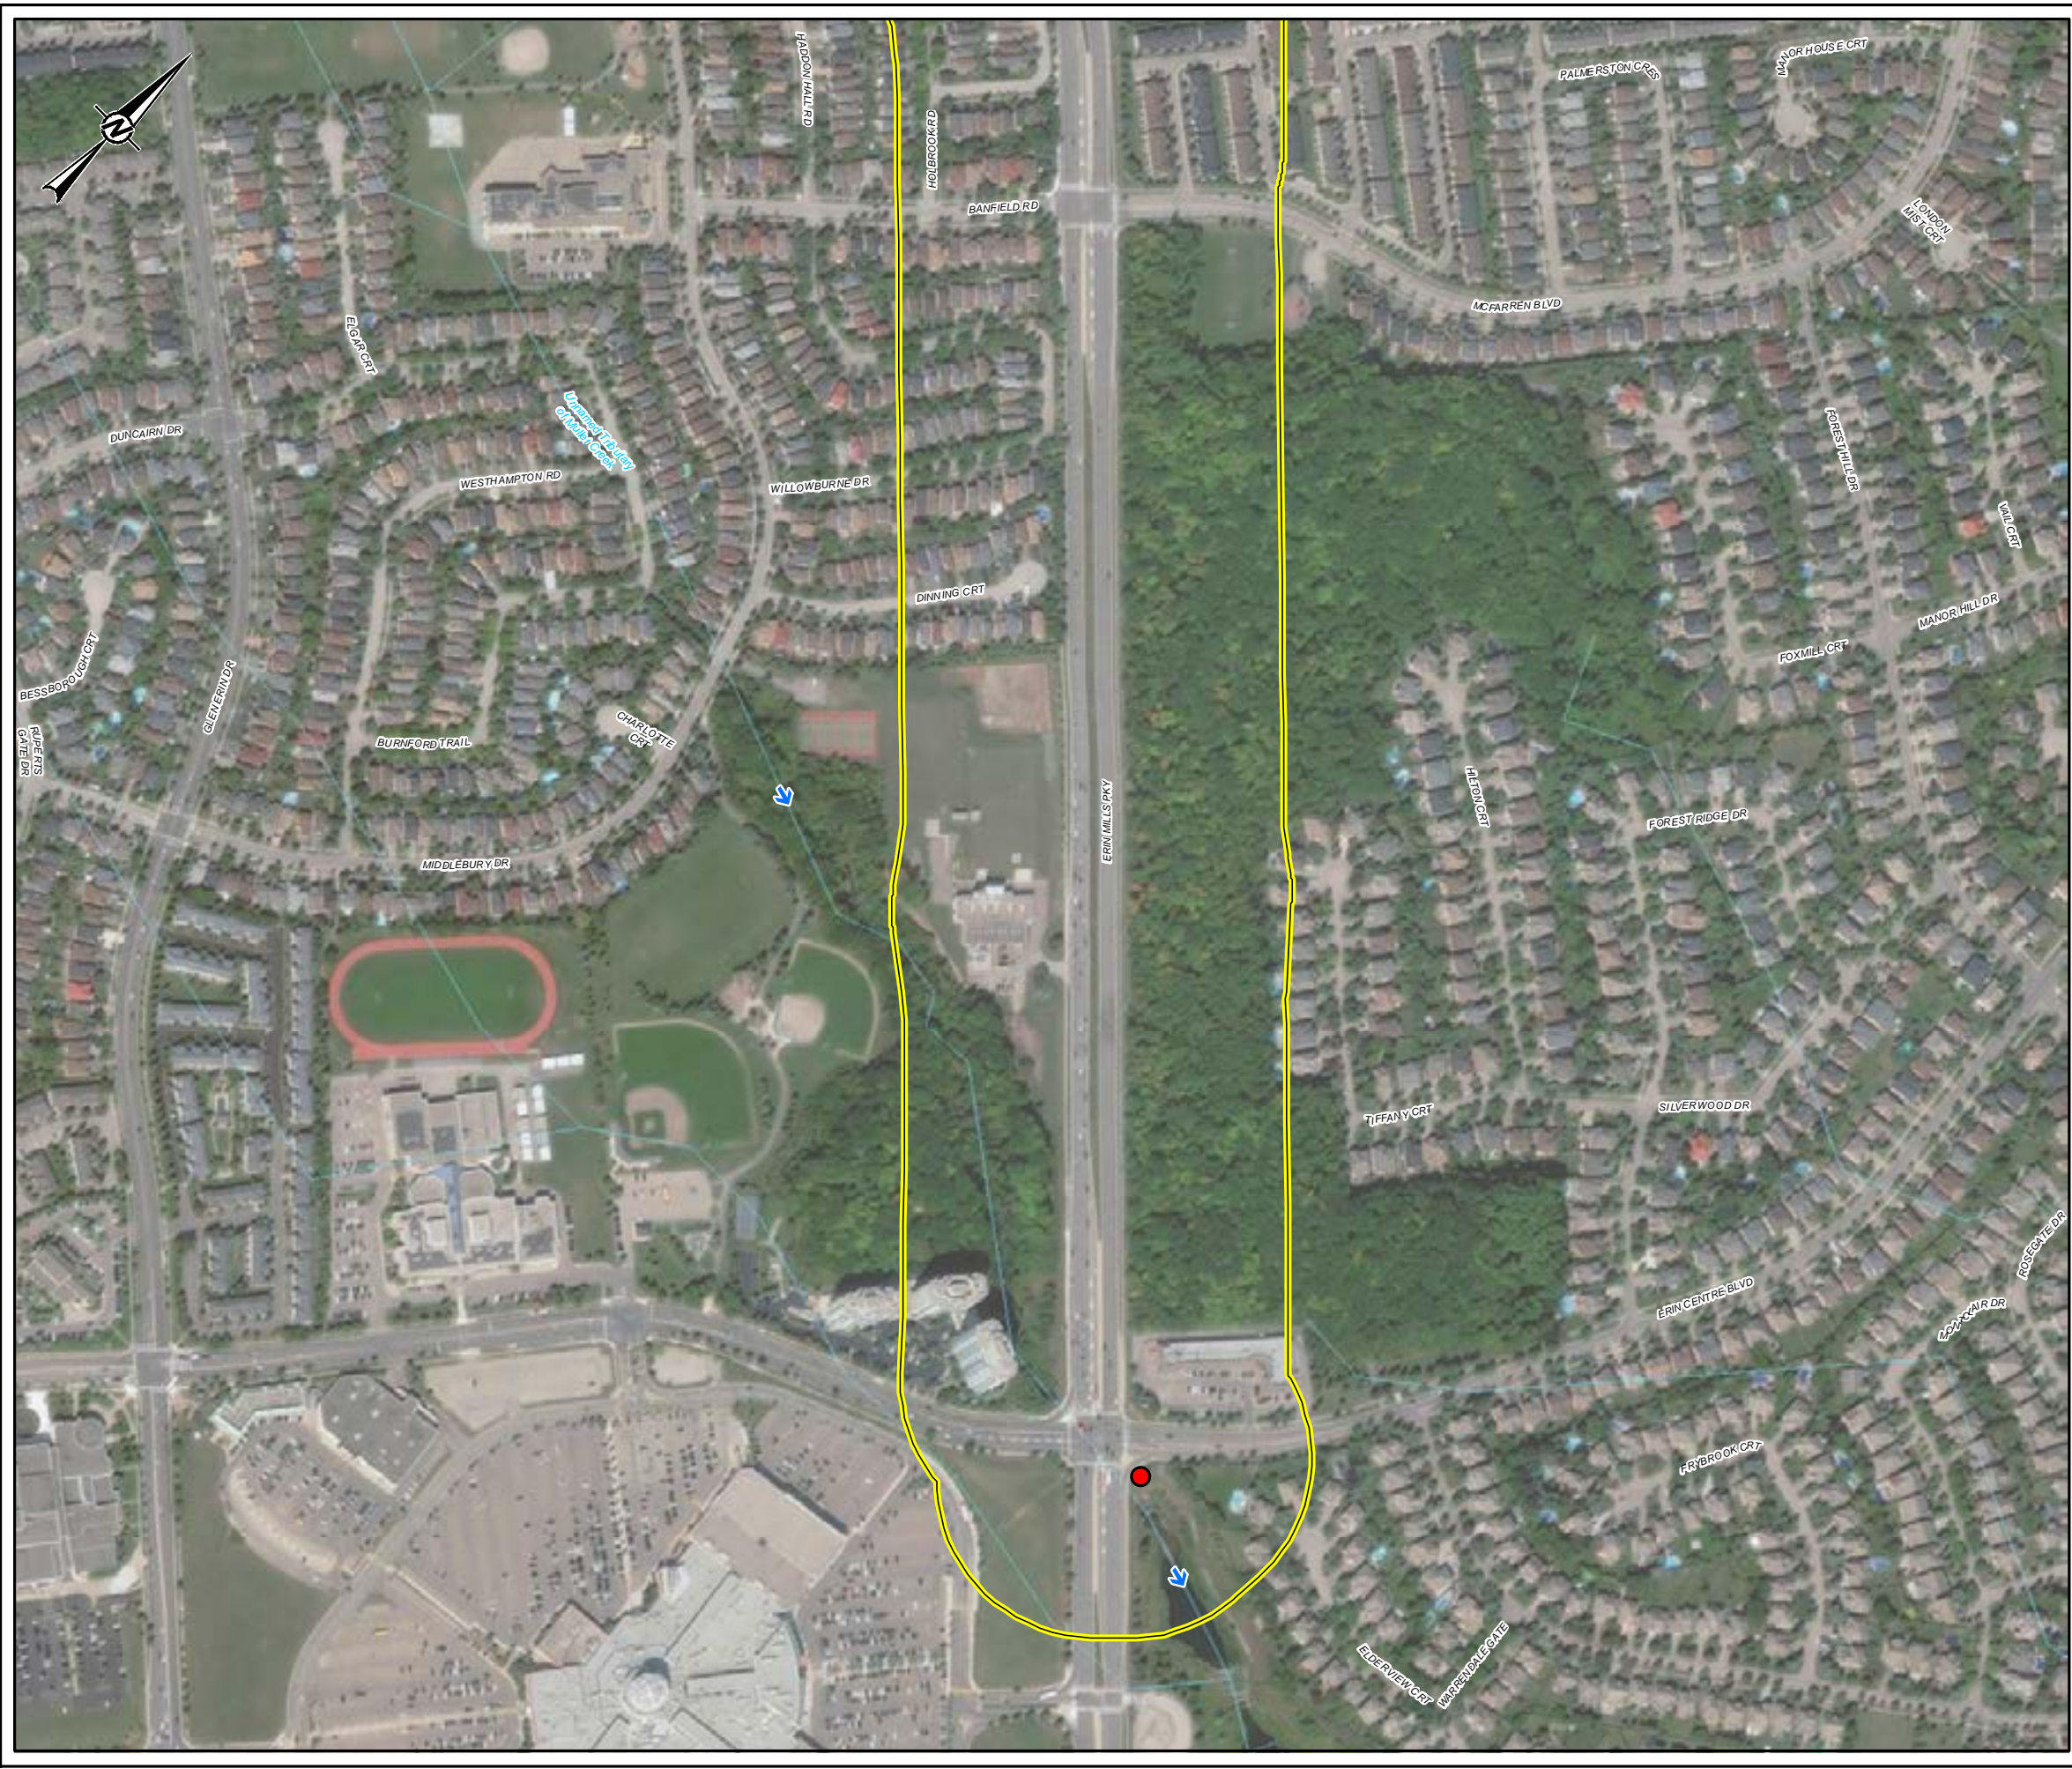
TITLE
HYDRAULIC AND FLUVIAL GEOMORPHIC - ERIN MILLS SOUTH OF MISSISSAUGA ROAD (MISSISSAUGA)

Crossing Location	Watercourse	Observed Evidence of Channel Migration, Active Erosion-Sedimentation, etc.	Preliminary Estimate of Hazard Limit (Centered Over Mid-Point of Channel)	Likelihood that Works will Require Installation within Hazard Limit and Associated Risk of Channel Encroachment/Migration on Works	Suggested Mitigation Measures
Erin Mills south of Mississauga Road (Figure 3; ; Site 6)	Unnamed Tributary of Mullet Creek – <i>Located at intersection of Erin Mills Parkway and Erin Centre Boulevard</i>	<p>A review of available historical air photographs/imagery between 1966 and 2021 demonstrated the following:</p> <ul style="list-style-type: none"> Land Use – Dominated by mostly urban development Channel Change – Minor evidence of natural channel change prior to 1985 (noting the maintenance of a strong meander pattern) followed by channel alterations between 1985 and 1989 (i.e., straightening to support new crossing structure installations) and again between 2007 and 2008 (i.e., development of an online settling basin downstream of the crossing), with fairly stable channel conditions over the past 30 years of record. 	<p>Estimated to be 25.5 m based on:</p> <ul style="list-style-type: none"> Meander amplitude with multiplier = $15 \text{ m} \times 1.5 = 22.5 \text{ m}$ Channel width = 3 m 	<ul style="list-style-type: none"> Low likelihood: Location of proposed outlets of LID features expected to be outside of the hazard limit, noting that culvert crossing at Erin Mills Parkway likely serves as an added constraint on channel encroachment/migration. 	<ul style="list-style-type: none"> Implementation of erosion protection (i.e., armour stone and targeted plantings) along the conveyance path between the outlet of the proposed discharge pipe and the receiving channel.

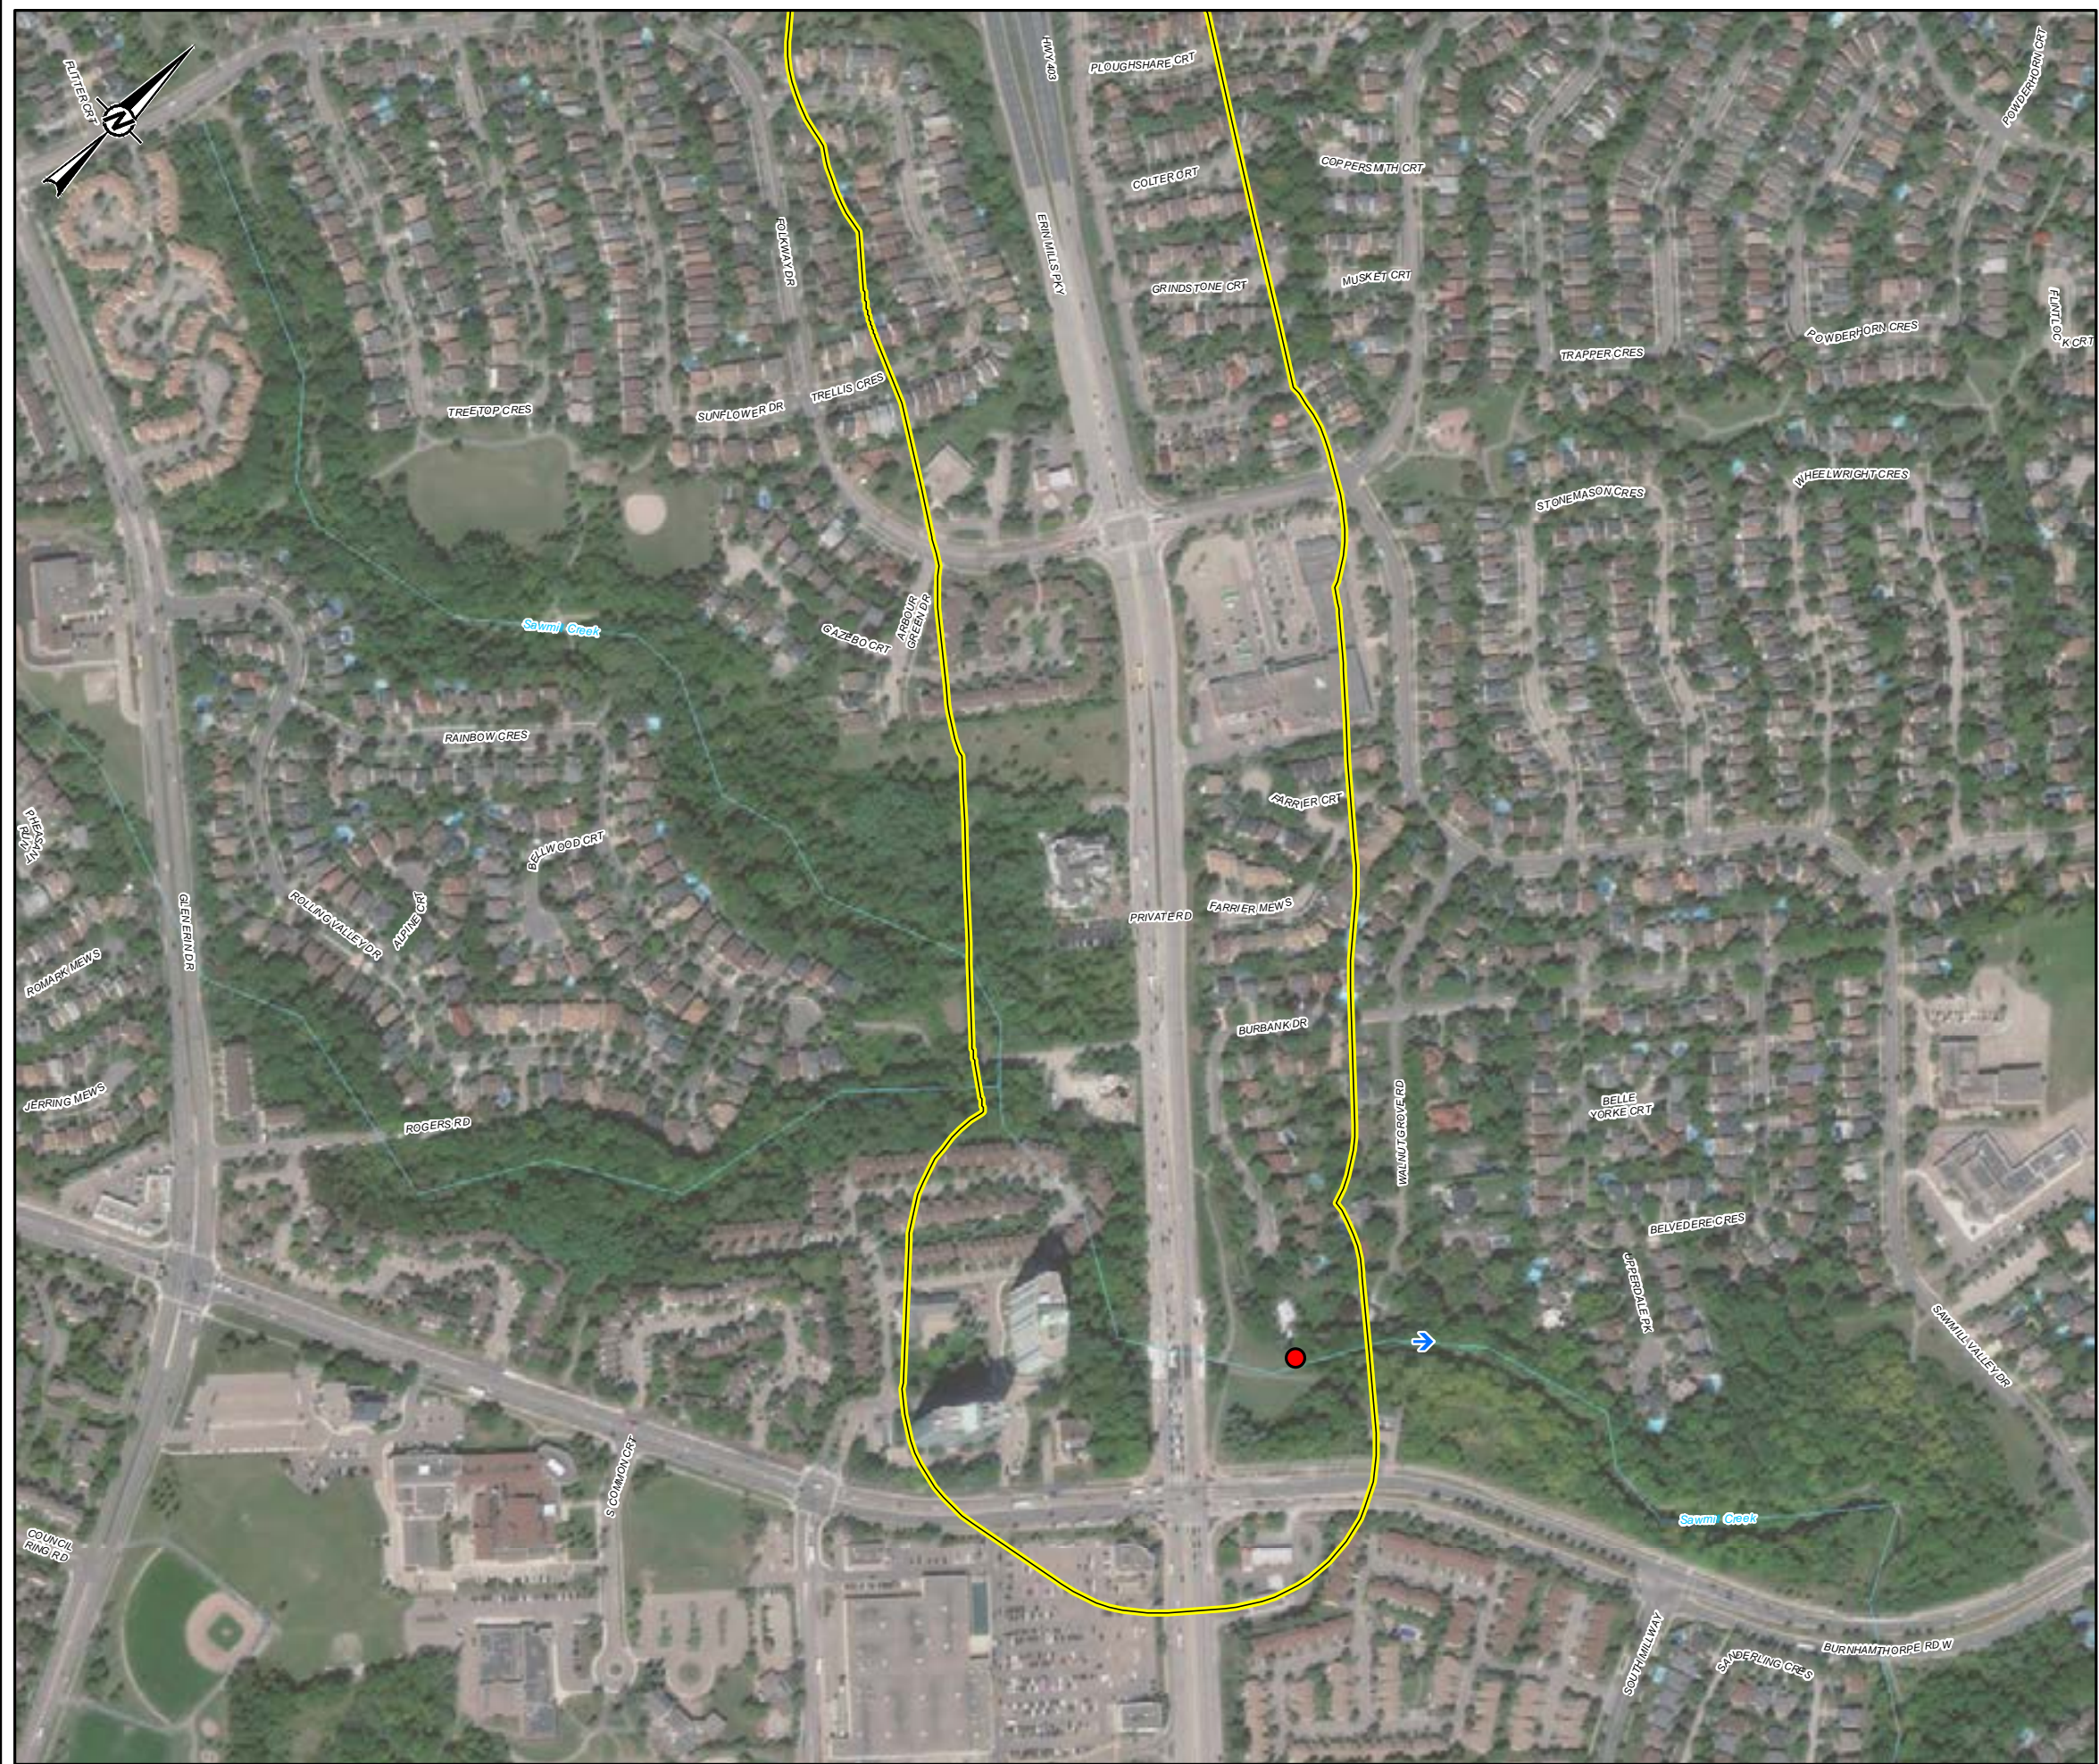
TITLE
HYDRAULIC AND FLUVIAL GEOMORPHIC - ERIN MILLS SOUTH OF HIGHWAY 403 (MISSISSAUGA)

Erin Mills south of Highway 403 (Figure 4; ; Site 8)	Sawmill Creek – <i>Located approx. 80 m east of Burnhamthorpe Road West</i>	<p>A review of available historical air photographs/imagery between 1966 and 2021 demonstrated the following:</p> <ul style="list-style-type: none"> Dominated by agricultural activities prior to 1977 followed by incremental stages of urbanization since that time. Channel Change – Minor evidence of natural channel change prior to 1989 followed by fairly stable channel conditions since that time. 	<p>Estimated to be 14.5 m based on:</p> <ul style="list-style-type: none"> Meander amplitude with multiplier = $7 \text{ m} \times 1.5 = 10.5 \text{ m}$ Channel width = 4 m 	<ul style="list-style-type: none"> Low likelihood: Location of proposed outlets of LID features expected to be outside of the hazard limit, noting that culvert crossing at Erin Mills Parkway likely serves as an added constraint on channel encroachment/migration. 	<ul style="list-style-type: none"> Implementation of erosion protection (i.e., armour stone and targeted plantings) along the conveyance path between the outlet of the proposed discharge pipe and the receiving channel.
