## TECHNICAL MEMORANDUM

**DATE** September 10, 2019

**Project No.** 1665649

### **FLUVIAL GEOMORPHIC ASSESSMENT IN SUPPORT OF THE SCHEDULE C MUNICIPAL CLASS ENVIRONMENTAL ASSESSMENT, COLERAINE DRIVE, TOWN OF CALEDON, ONTARIO**

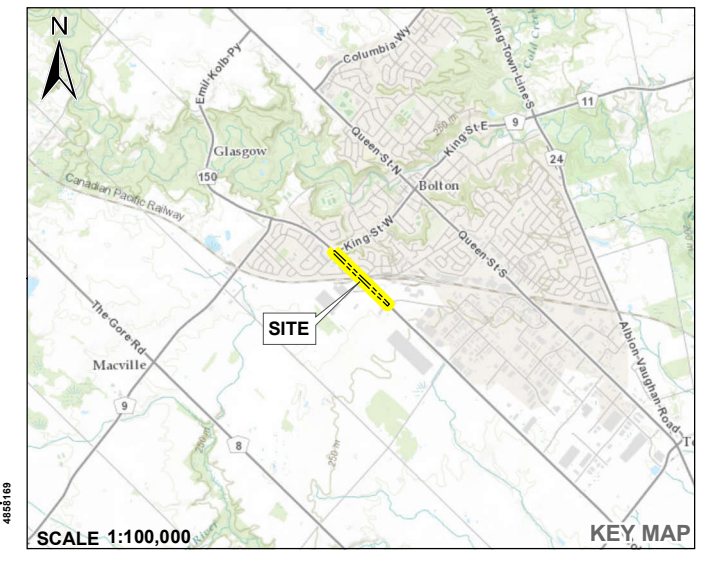
TITLE  
**SITE OVERVIEW AND FIELD OBSERVED WATERCOURSE CROSSING AT COLERAINE DRIVE FOR UT-01**

Figure 1: Site Overview and Field Observed Watercourse Crossing at Coleraine Drive for UT-01

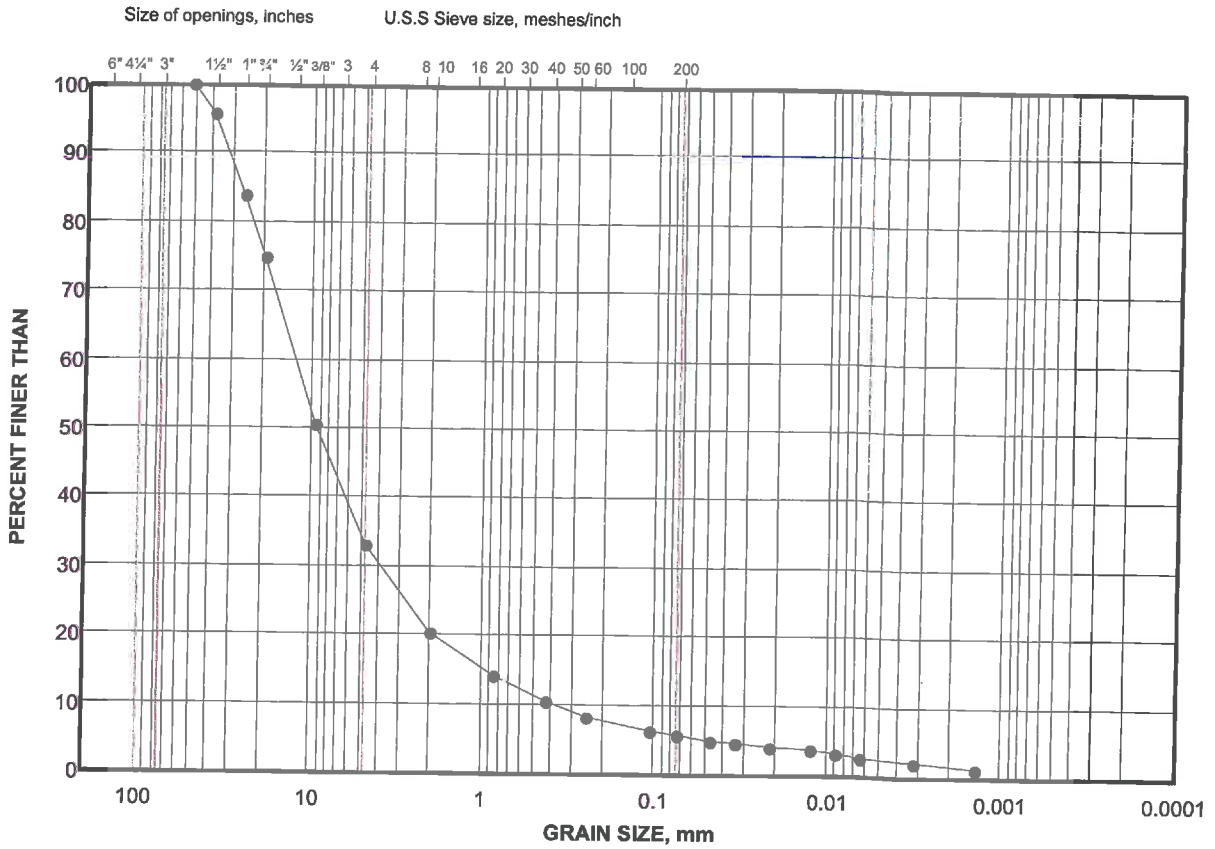
# GRAIN SIZE DISTRIBUTION

The completed RGA form for UT-01 is presented in Attachment B. The results of the RGA suggest that the evaluated reach length at the unnamed tributary is in a transitional state with evidence of aggradation, degradation and widening. Grain size results for UT-01 are presented in Attachment C.
