D-3 SAFETY REVIEW OF EXISTING CONDITIONS

**Environmental
Assessment Study of
Arterial Roads Within
Highway 427 Industrial
Secondary Plan Area
(Area 47)
Safety Review of Existing
Conditions**

March 2016

CIMA
Partners in excellence

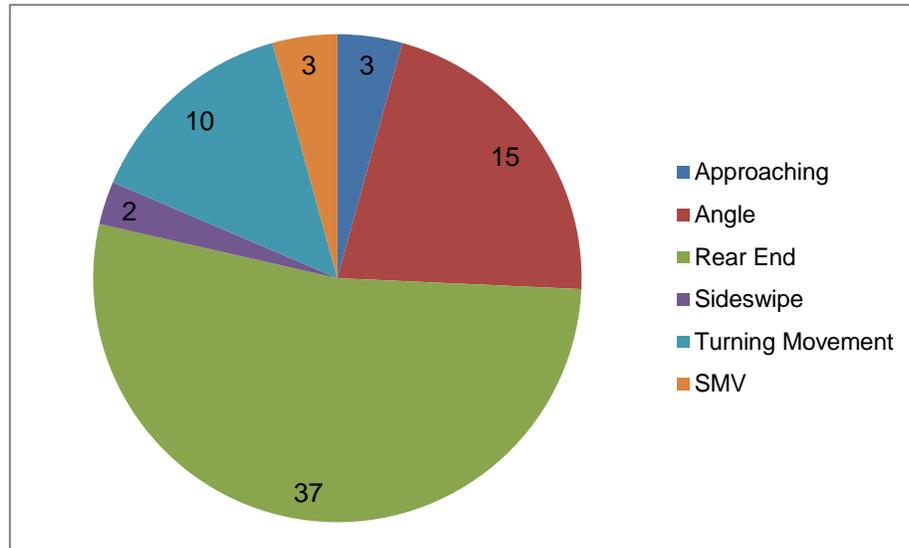
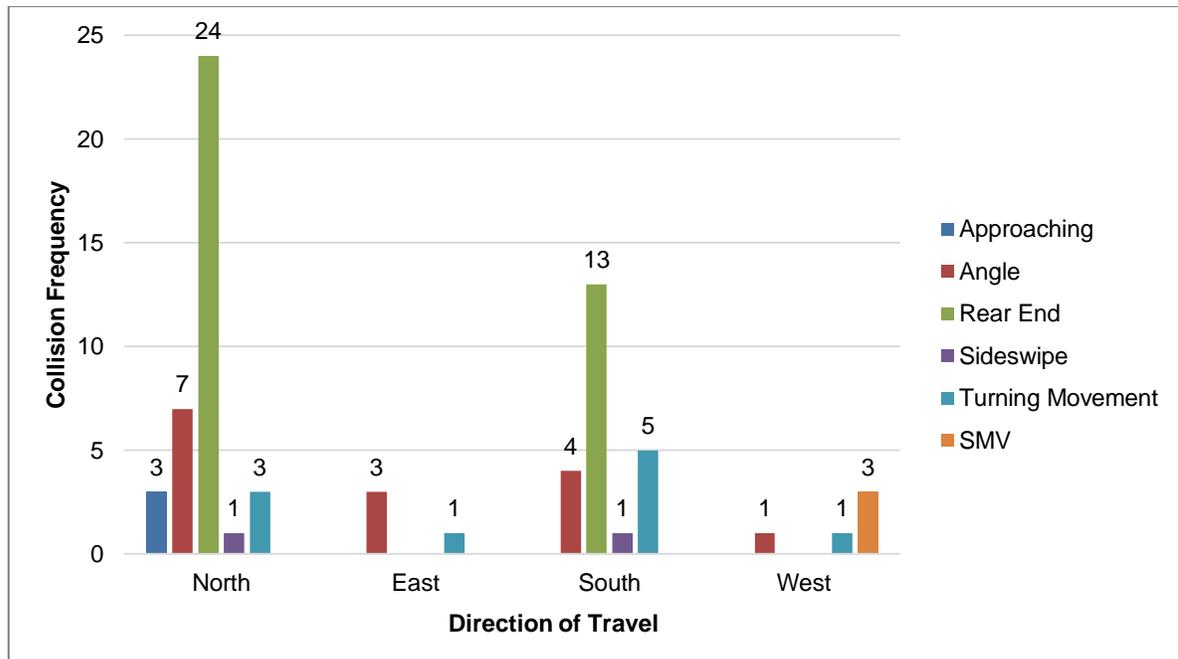
Figure 3: Collision Impact Type (Coleraine Drive and Regional Road 50)

The total number of collisions by impact type is illustrated in Figure 3 while Figure 4 presents the collisions impact type by direction of travel.

Based on the results on the historical collisions at the intersection of Coleraine Drive and Regional Road 50, the following observations and inferences can be made:

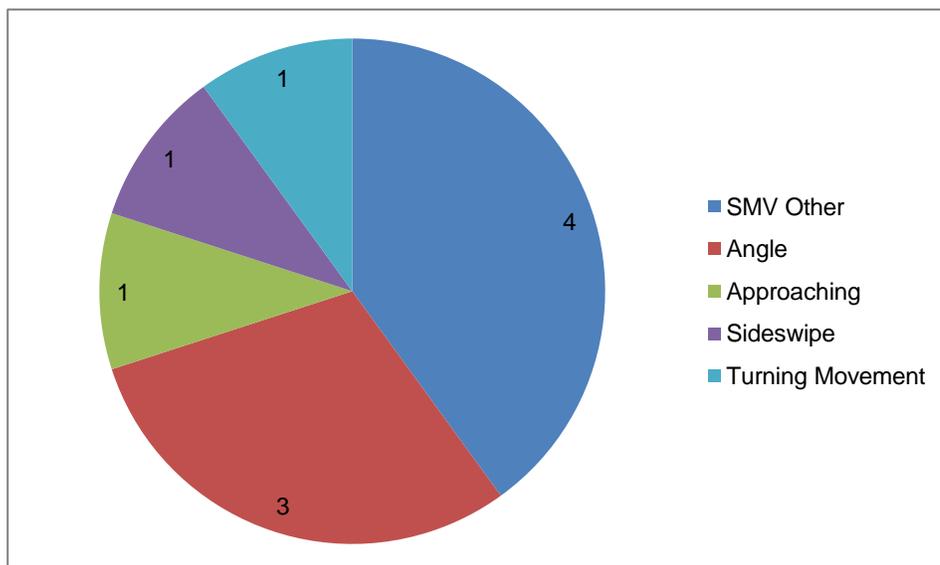
Figure 5: Collision Impact Type (Coleraine Drive and Countryside Drive)

SMV collisions were the predominant collision type, with 4 out of 10 collisions, followed by 3 angle collisions as illustrated in Figure 5. The majority of collisions (8) occurred during dark condition. It should be noted that 3 out of 4 SMV collisions occurred on wet surface condition.

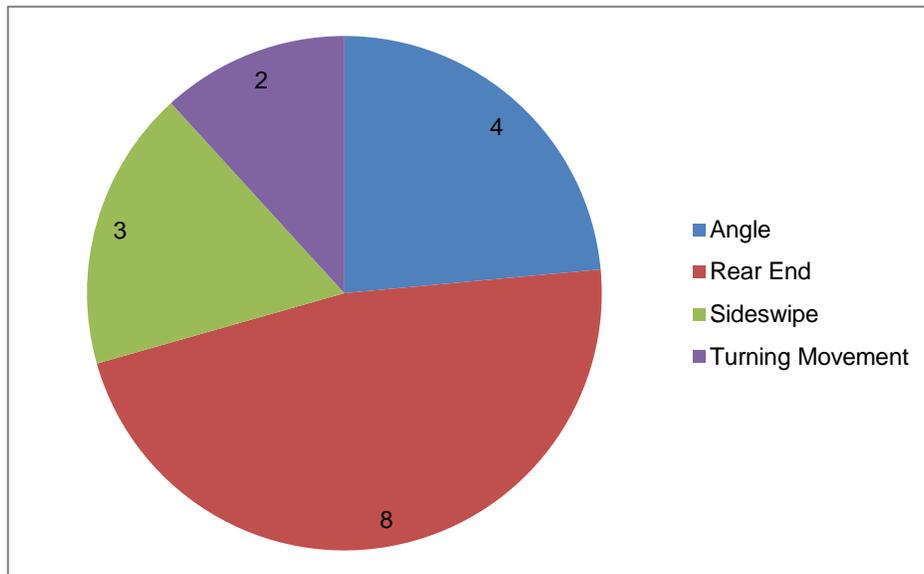
Figure 6: Collision Impact Type (Coleraine Drive and Mayfield Road)

Based on the results on the historical collisions at the intersection of Coleraine Drive and Mayfield Road, the following observations and inferences can be made:

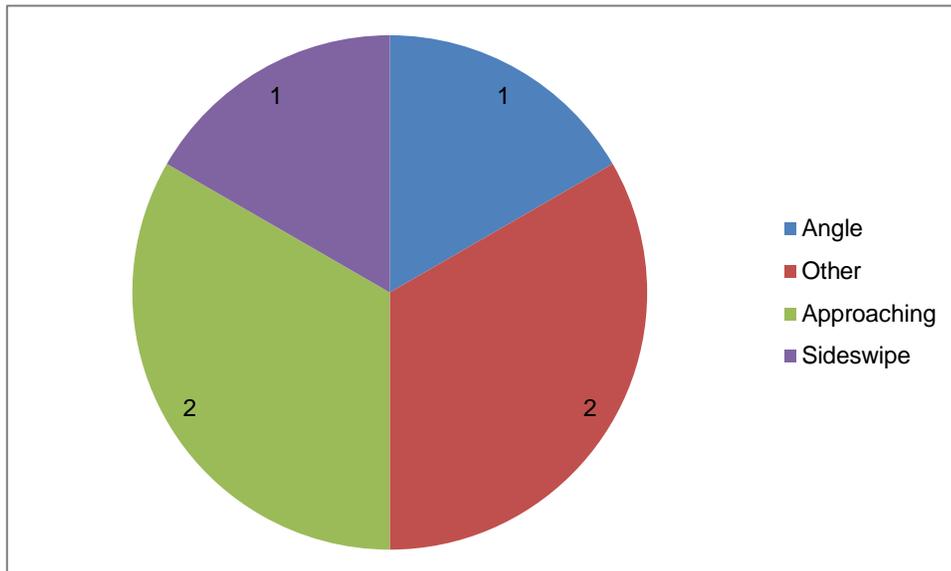
Figure 8: Collision Impact Type (Coleraine Drive and Countryside Drive)

- + *Clarkway Drive between Castlemore Road and Countryside Drive:* this section experienced 2 collisions within the study period. The collision data did not reveal any collision patterns;
- + *Clarkway Drive between Countryside Drive and Mayfield Road:* There were no reported collisions during the study period for this section of the roadway;
- + *Clarkway Drive and Mayfield Road Intersection:* This intersection experienced 2 collisions within the study period. The collision data did not reveal any collision patterns; and
- + *Intersection of Clarkway Drive and Countryside Drive:* Approaching and sideswipe collisions presented the highest collision frequency, with 2 out of 6 collisions, followed by the other collision impact types of collisions as illustrated in Figure 8. The collision data did not reveal any collision patterns.

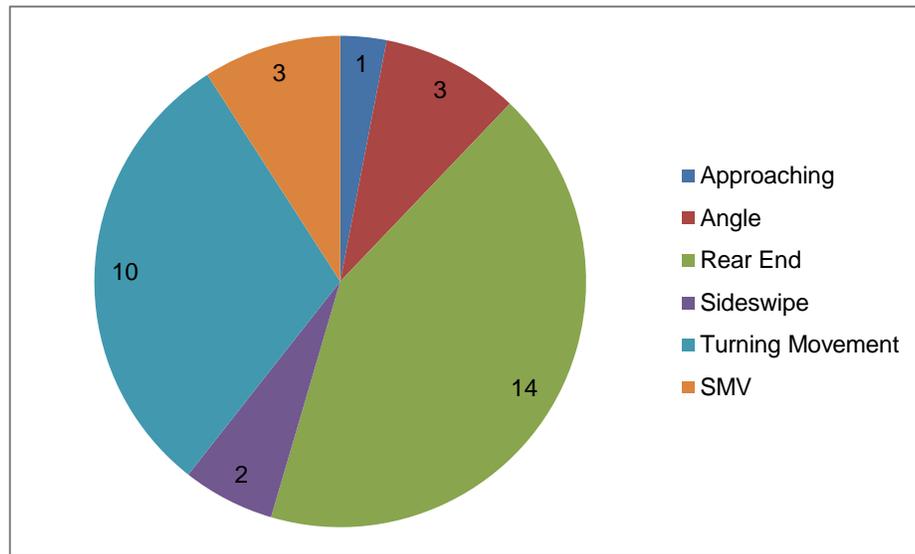
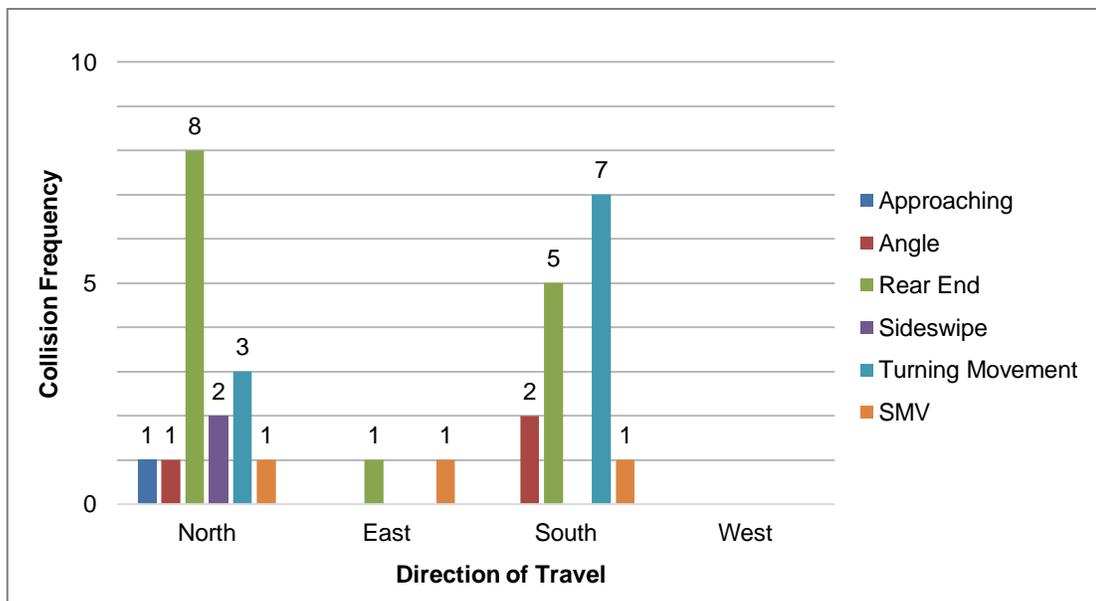
Figure 10: Collision Impact Type (Countryside Drive and Regional Road 50)

The following observations can be made from the above figures and the detailed analysis of collisions:
