# Appendix K:

# Municipal Class Environmental Assessment Airport Road Between King Street and Huntsmill Drive, Town of Caledon

## Fluvial Geomorphological Assessment Centreville Creek and East Credit River Tributary

August 20, 2020  
Project No. 17101

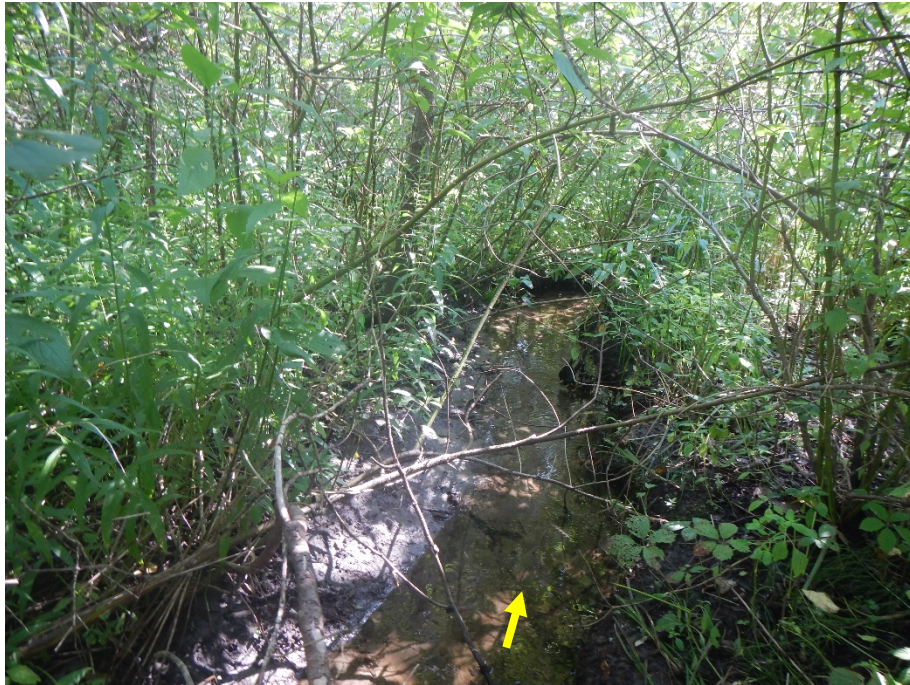
Photo 7  
Centreville Creek Tributary - Reach CCT-1

Approximately 250 m upstream of Crossing 2, the Centreville Creek tributary meanders through an immature deciduous forest.

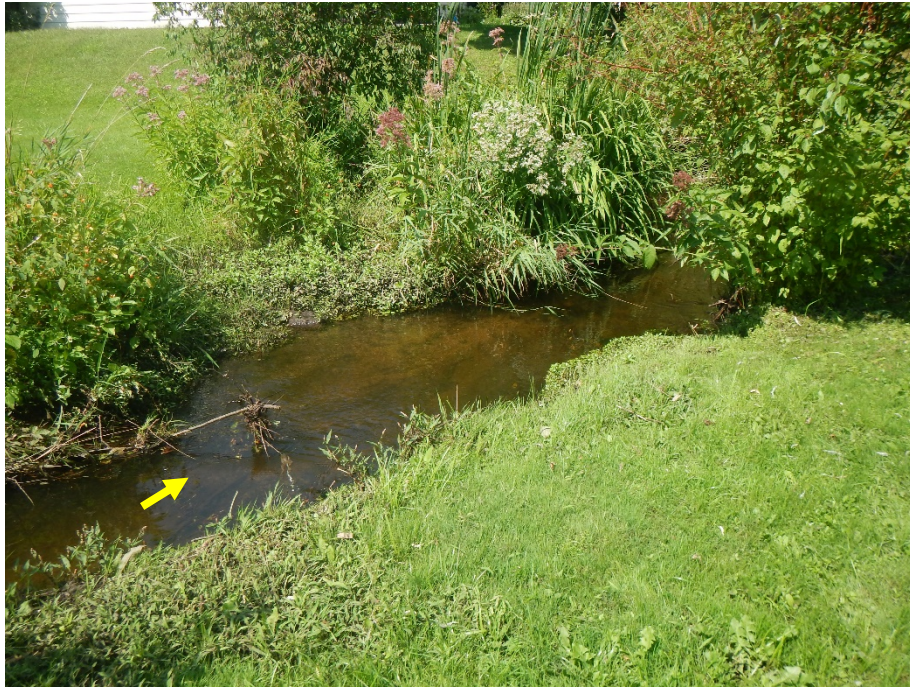
Photo 18  
Centreville Creek - Reach CC-1

Near the Caledon Trailway bridge spanning Centreville Creek, a meander bend passes through a residential property where manicured grass and herbaceous plants flanked the channel.

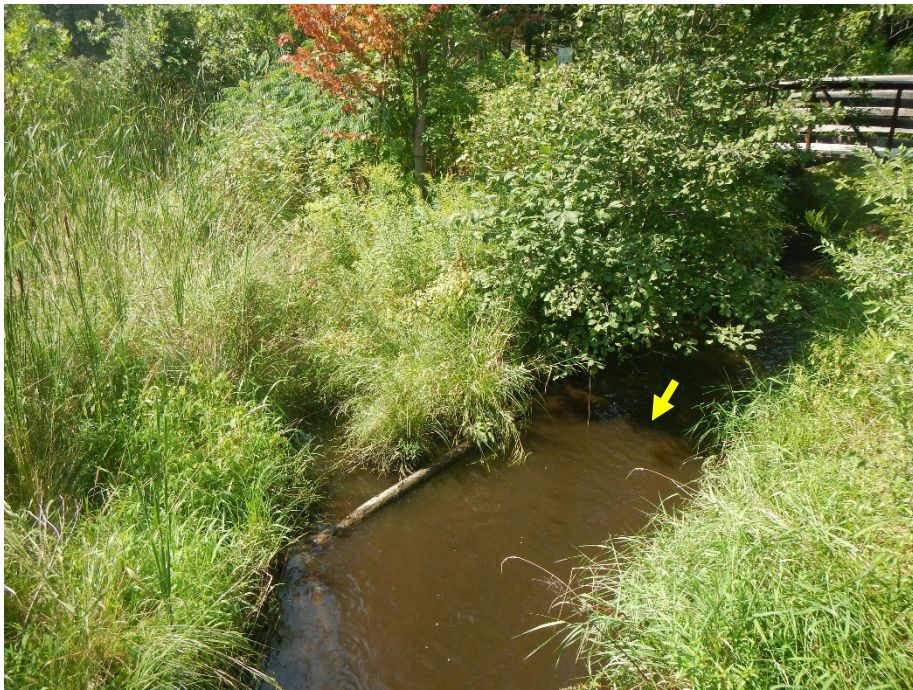
Photo 21  
Centreville Creek - Reach CC-1

Reach CC-1 formed a confluence with a small channel draining a violin shaped pond located south of the Caledon railway path, immediately upstream of Crossing 3.

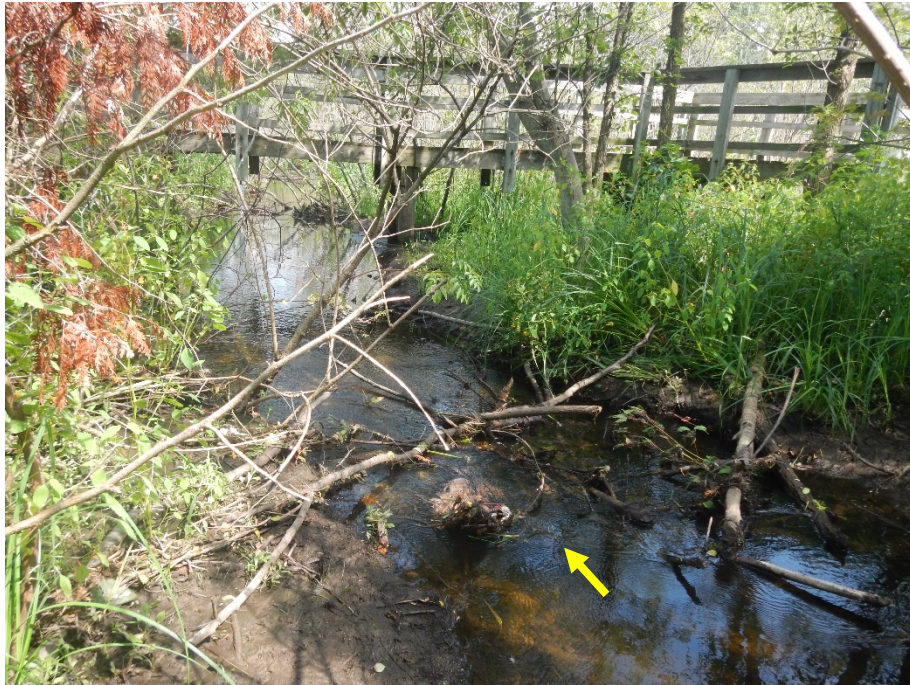
Photo 27  
East Credit River Tributary - Reach ECRT-1

The downstream extent of the observed section of Centreville Creek was at the elevated boardwalk approximately 170 m downstream from Crossing 3.
