Structural Memo

OSIM Inspection Forms

For the Bridge on Winston Churchill Blvd
Located 2.70 km North of Steeles Avenue
Structure No. 19-1196390 BR01

Hatch Mott MacDonald
2800 Speakman Drive
Mississauga, ON, Canada L5K 2R7
T: 905 403 4455 F: 905 855 2607
Project Number: 336921

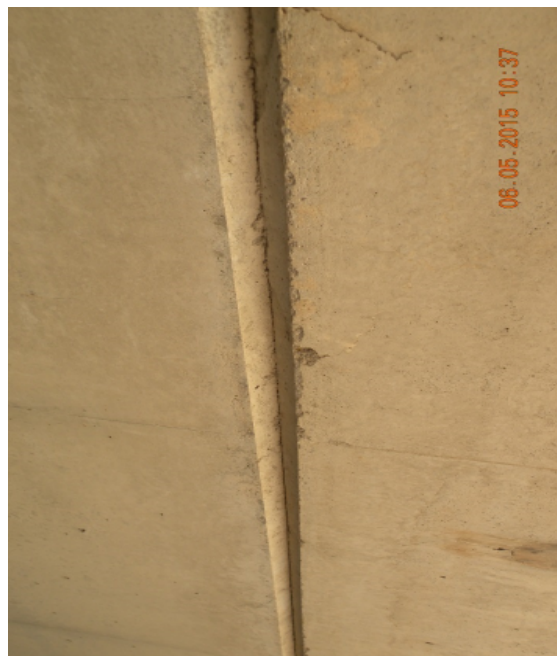
- 3rd box from West End, 2.5 m from South Abutment Wall: 300mmx500mm delaminated piece of concrete
 - Some joints have light spalling and light scaling
 - foam has been forced out from between some joints (East Side)

Typical Joint

Rehab/Rehabilitation Recommendations	Priority	Cost	Comments
Minor Rehabilitation	1-5 yrs	\$3,500	Removal and patch repair concrete
