Culvert Assessment

Minor Culvert Condition Survey along Bush Street, Mississauga Road,
Old Base Line Road and Winston Churchill Boulevard, Belfountain, ON
GEOTETOB21649AA

02 April 2014

**RE: SUMMARY OF FINDINGS (final)
Minor Culvert Condition Survey along Bush Street, Mississauga Road, Olde Baseline Road
and Winston Churchill Boulevard, Belfountain, ON**

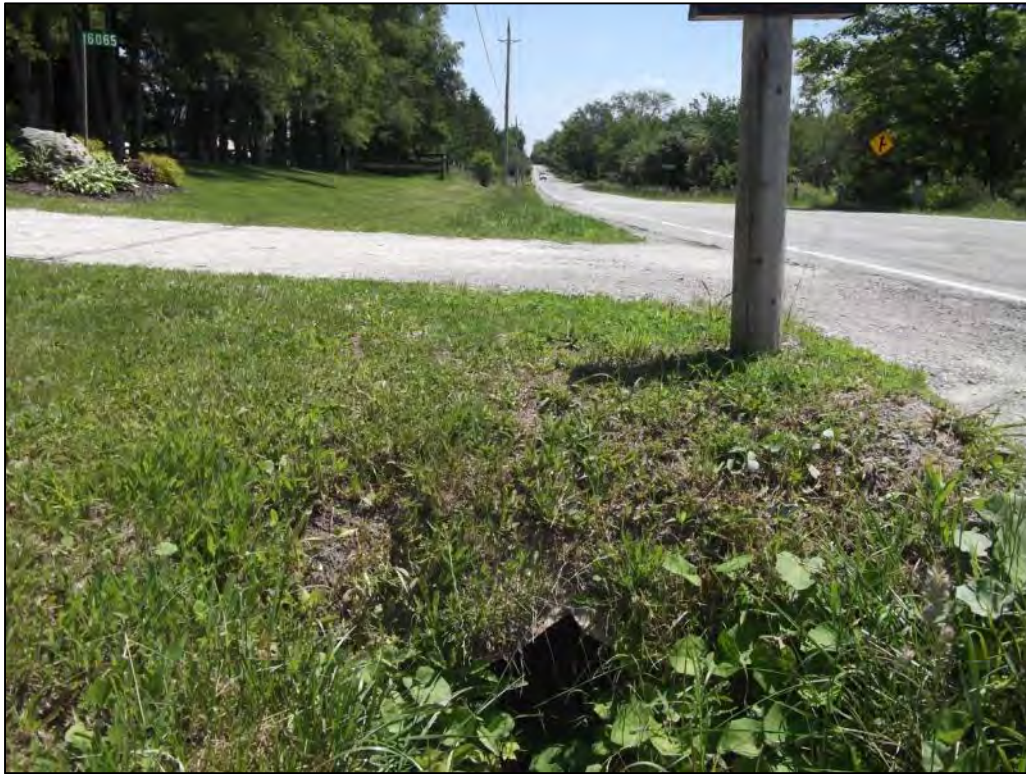
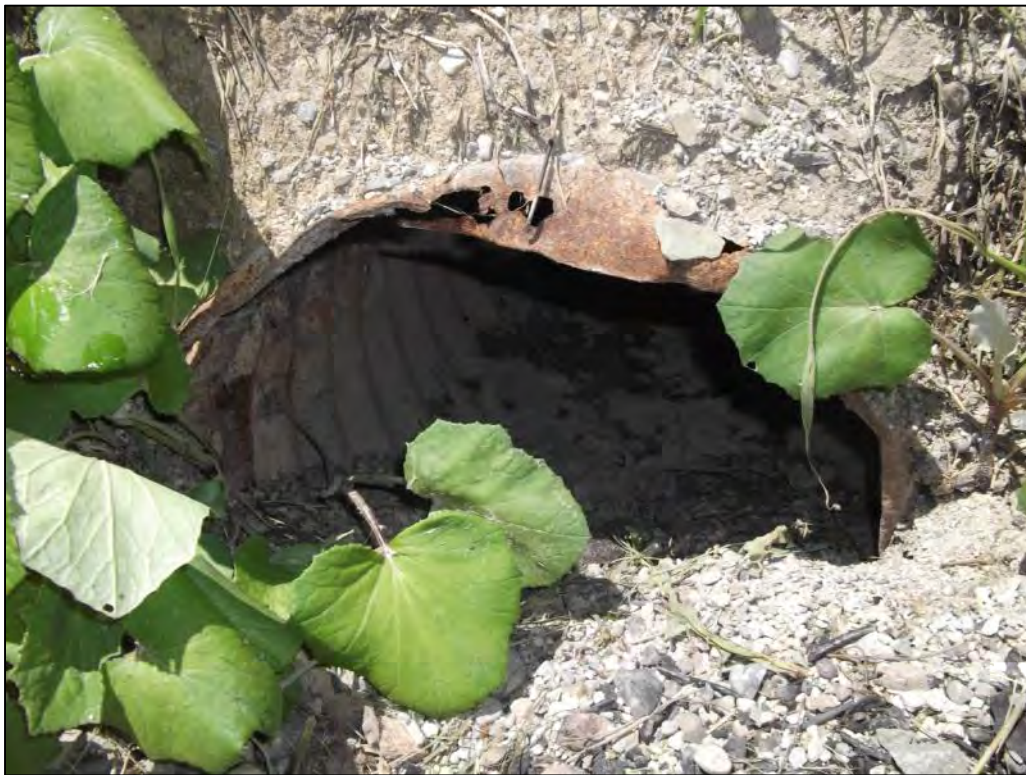
Photo P1 – CUL-019-336

Culvert ID*	Type	Stationing ¹	Picture No.s	Street Name	Location Reference	Intersection Reference	Loc_Traffic	Dia. (mm)	Material	Shap	Barrier	Length (m)	X_co-ord.*	Y-Co-ord.*	Insp_Date	Overall Condition	Remarks	Recommendations
CUL-019-336	CUL-EC	P1-P2		WINSTON CHURCHILL BLVD	16065	5TH SRD -- THE GRANGE SRD	NORTH BOUND	460	CS	R	N	8.90	580712.44	4845232.61	23-Sep-2011	F	Rusted and damaged	Needs to be repaired
CUL-019-338	CUL-EC	P3-P4		WINSTON CHURCHILL BLVD	5032	OLDE BASELINE RD -- 5TH SRD	SOUTH BOUND	350	CS	R	N	9.40	581595.60	4844322.33	23-Sep-2011	F	50% Blocked at south end, needs flushing	Needs flushing
CUL-019-339	CUL-EC	P5-P6		WINSTON CHURCHILL BLVD	5024	OLDE BASELINE RD -- 5TH SRD	SOUTH BOUND	400	CS	R	N	8.00	581692.51	4844223.26	23-Sep-2011	F	30% filled with accumulated debris	Needs flushing
CUL-019-340-1	CUL-FE	P7-P8		WINSTON CHURCHILL BLVD	OPPOSITE ENTRAQNC # 15547	OLDE BASELINE RD -- 5TH SRD	SOUTH BOUND	400	CS	R	N	9.40	581838.00	4844076.17	20-Sep-2011	F	20% filled with accumulated debris	May needs flushing

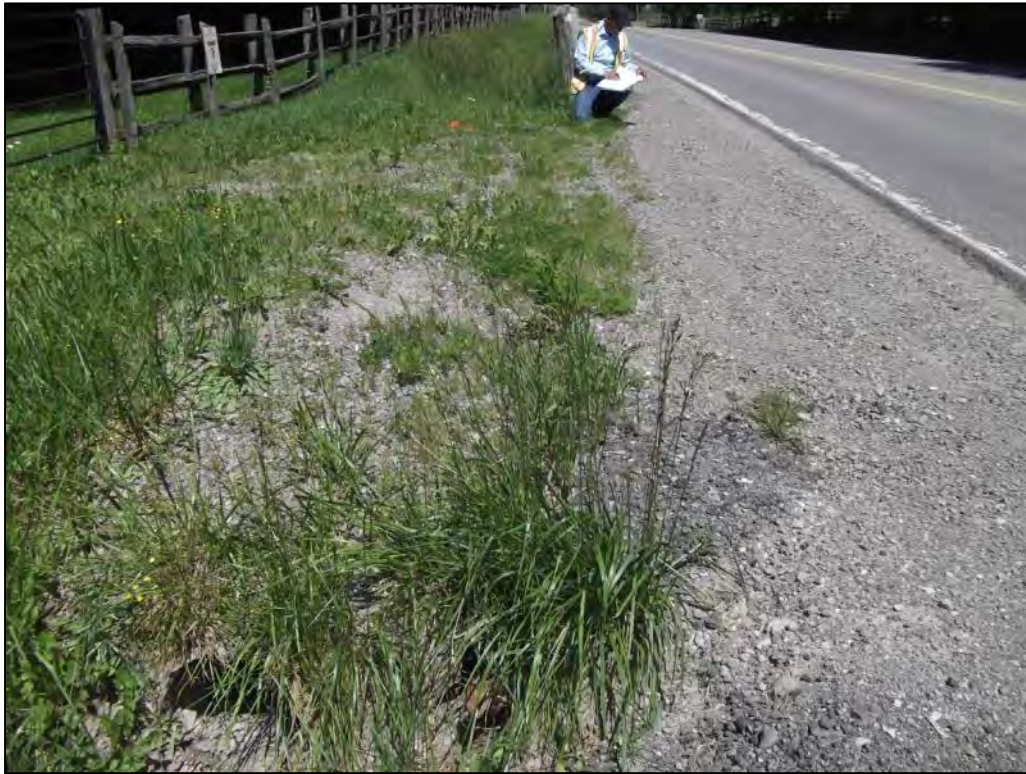
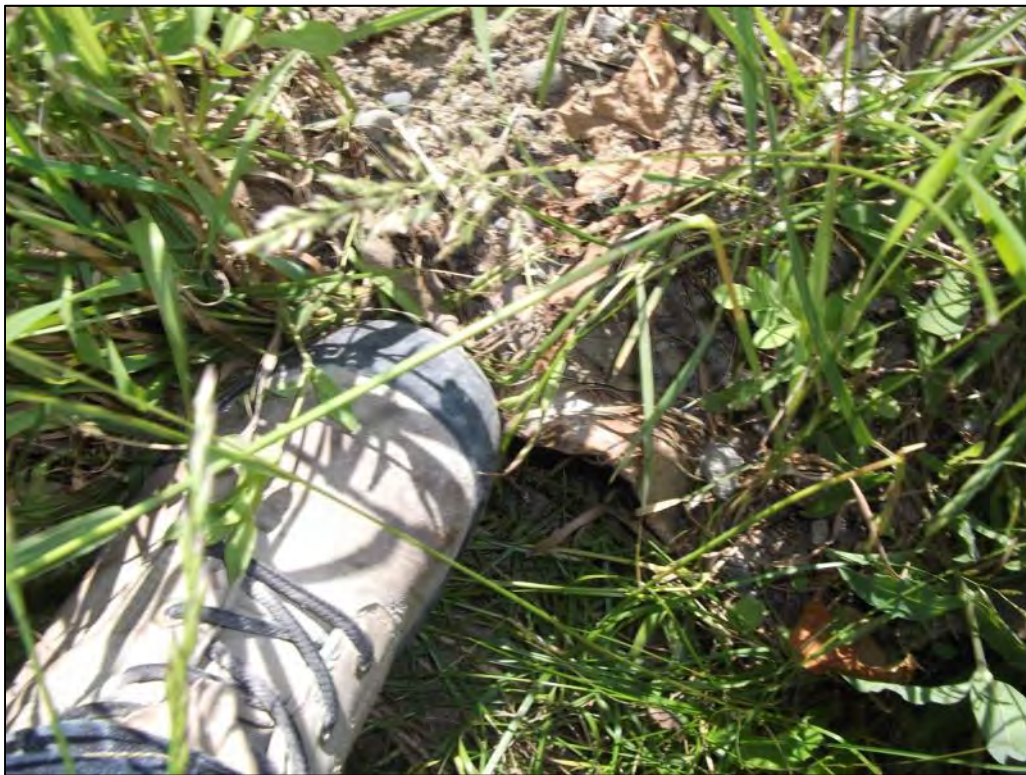
Photo P7 – CUL-019-340-2

CUL-019-340-2	CUL-FE	P7-P8		WINSTON CHURCHILL BLVD	OPPOSITE ENTRAQNC # 15547	OLDE BASELINE RD -- 5TH SRD	SOUTH BOUND	Can't Measur	CS	R	N	9.40	581838.00	4844076.17	23-Sep-2011	P	Almost blocked/burried and damaged	To be replaced
CUL-019-341	CUL-EC	P9-P10		WINSTON CHURCHILL BLVD	HOUSE #5006	OLDE BASELINE RD -- 5TH SRD	SOUTH BOUND	460	CS	R	N	9.40	581893.19	4844016.45	20-Sep-2011	F-G	A bit rusted inside and damaged at south end	To be repaired
CUL-019-342	CUL-EC	P11-P12		WINSTON CHURCHILL BLVD	HOUSE #4996	OLDE BASELINE RD -- 5TH SRD	SOUTH BOUND	460	CS	R	N	9.30	581976.59	4843934.90	20-Sep-2011	F	Rusted, damaged at north end and 10-20% filled with accumulated debris	Repair, flushing
CUL-019-343	CUL-CC	P13-P14		WINSTON CHURCHILL BLVD	95 M NORTH OF 16245	5TH SRD -- THE GRANGE SRD	CENTRE	400	CS	R	N	12.70	580242.86	4845699.96	23-Sep-2011	F	Rusted, damaged at east end, 20% filled with accumulated debris at west end	Repair, flushing

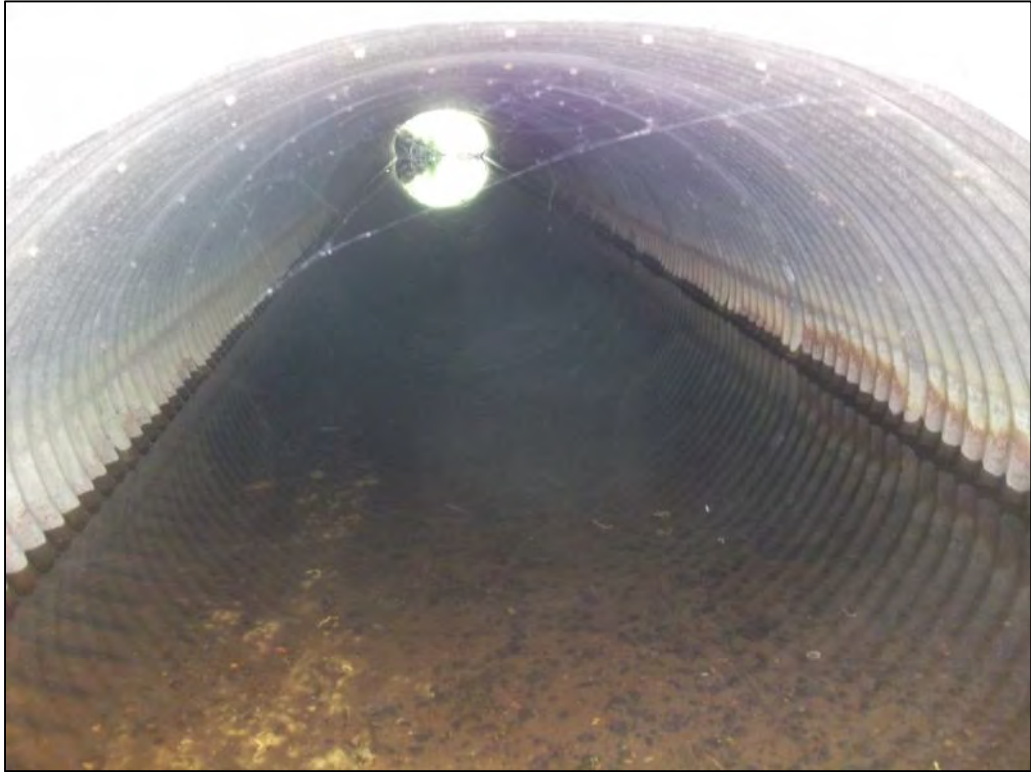
Photo P15 – CUL-019-344

CUL-019-344	CUL-CC	P15-P16		WINSTON CHURCHILL BLVD	118 M NORTH OF 16065 TO THE WEST SIDE OF OUTLAND END	5TH SRD -- THE GRANGE SRD	CENTRE	Looks 1000	CS	O	N	15.30	580631.74	4845305.19	23-Sep-2011	F	20% filled with accumulated debris	May needs flushing
CUL-019-345	CUL-CC	P17-P18		WINSTON CHURCHILL BLVD	J/O 5TH SRD	5TH SRD -- THE GRANGE SRD	CENTRE	600	P	R	N	13.60	580841.19	4845092.50	23-Sep-2011	G		Do nothing
CUL-019-346	CUL-CC	P19-P20		WINSTON CHURCHILL BLVD	286 M NORTH OF 5072	OLDE BASELINE RD -- 5TH SRD	CENTRE	400	CS	R	N	12.35	580974.61	4844956.58	23-Sep-2011	P	60% Blocked, rusted and damaged. Needs flushing	Repair, flushing
CUL-019-347	CUL-CC	P21-P22		WINSTON CHURCHILL BLVD	AT SOUTH ENTRAQNC OF 5072	OLDE BASELINE RD -- 5TH SRD	CENTRE	660	CS	R	N	11.00	581181.47	4844747.54	23-Sep-2011	F	30 - 40% filled with accumulated debris	Needs flushing
CUL-019-348	CUL-CC	P23-P24		WINSTON CHURCHILL BLVD	50 M NORTH OF 15739	OLDE BASELINE RD -- 5TH SRD	CENTRE	400	CS	R	N	12.80	581389.23	4844538.44	23-Sep-2011	F	Rusted , damaged at west end	West end needs to be repaired

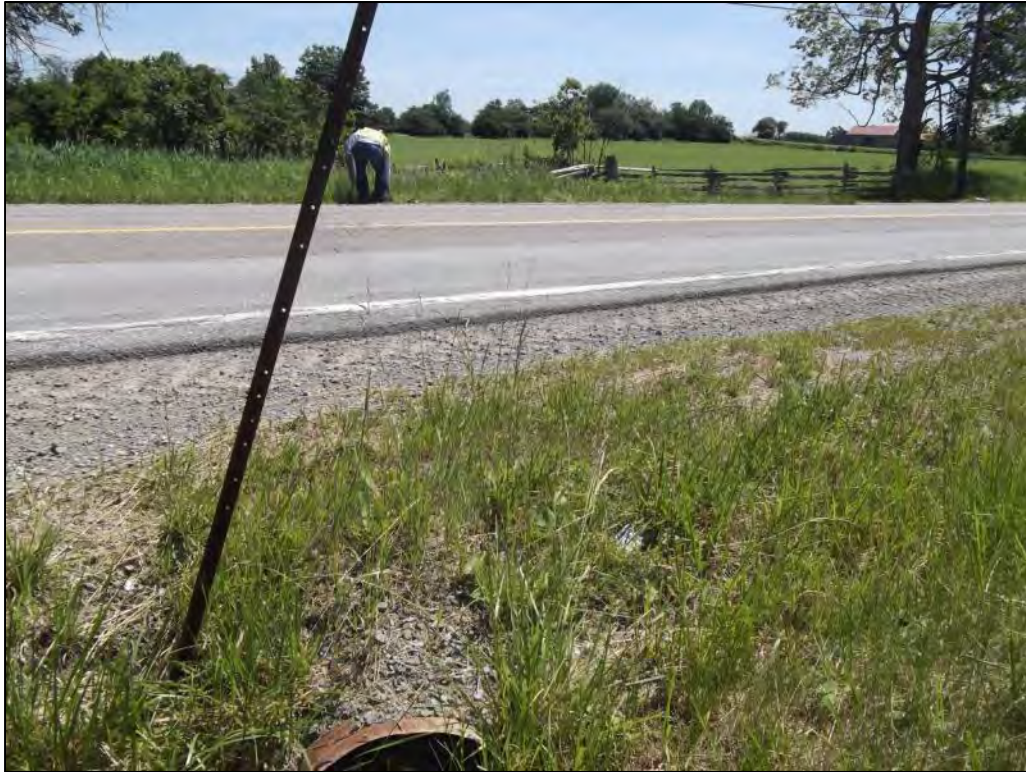
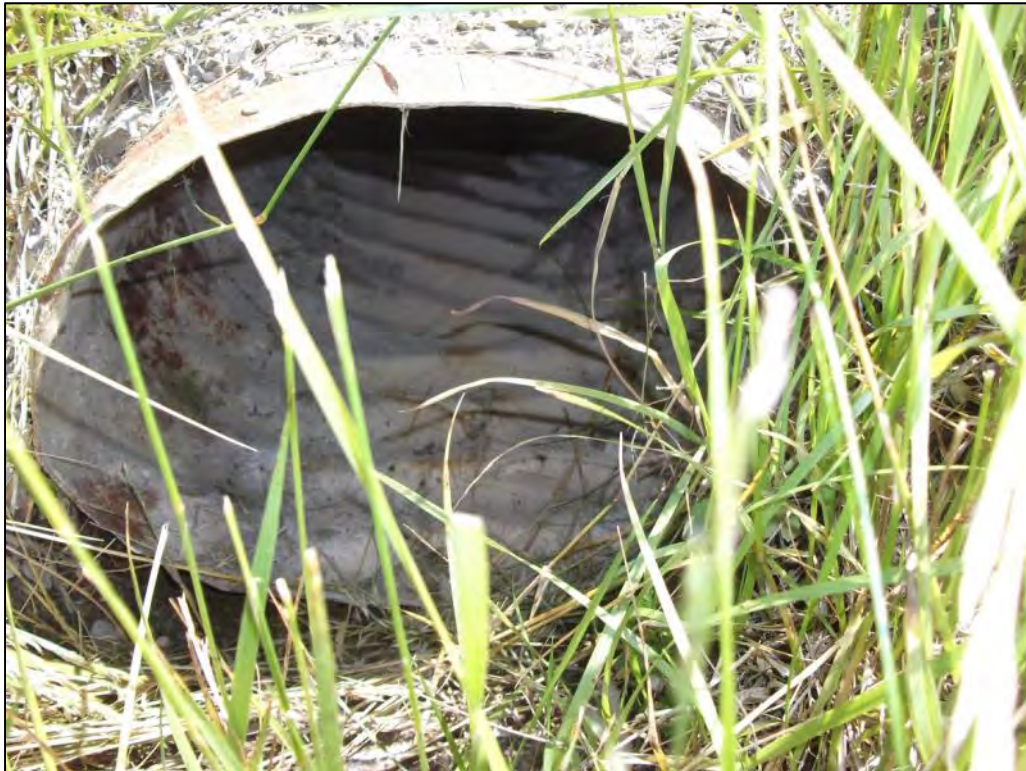
Photo P25 – CUL-019-349

CUL-019-349	CUL-CC	P25-P26		WINSTON CHURCHILL BLVD	125 M NORTH OF 15669	OLDE BASELINE RD -- 5TH SRD	CENTRE	350	CS	R	N	13.75	581557.04	4844371.75	23-Sep-2011	F-G	Rusted at west end, slight cracks found on asphalt wearing surface right above the culvert	West end needs to be repaired
CUL-019-350	CUL-CC	P27-P28		WINSTON CHURCHILL BLVD	7 M SOUTH OF 5024	OLDE BASELINE RD -- 5TH SRD	CENTRE	400	CS	R	N	12.10	581709.28	4844220.50	23-Sep-2011	P	50% filled with accumulated debris, damaged at east end	To be replaced
CUL-019-351	CUL-CC	P29-P30		WINSTON CHURCHILL BLVD	INLET ON EAST SIDE 8 M N OF 15547	OLDE BASELINE RD -- 5TH SRD	CENTRE	400	CS	R	N	12.20	581834.25	4844094.13	23-Sep-2011	F-P	50% filled with accumulated debris, west end is damaged and rusted	Repair, flushing
CUL-019-356	CUL-EC	P31-P32		WINSTON CHURCHILL BLVD	15819	OLDE BASELINE RD -- 5TH SRD	NORTH BOUND	400	CS	R	N	8.80	581252.94	4844685.68	23-Sep-2011	F	Rusted at both ends	Repair, Grading

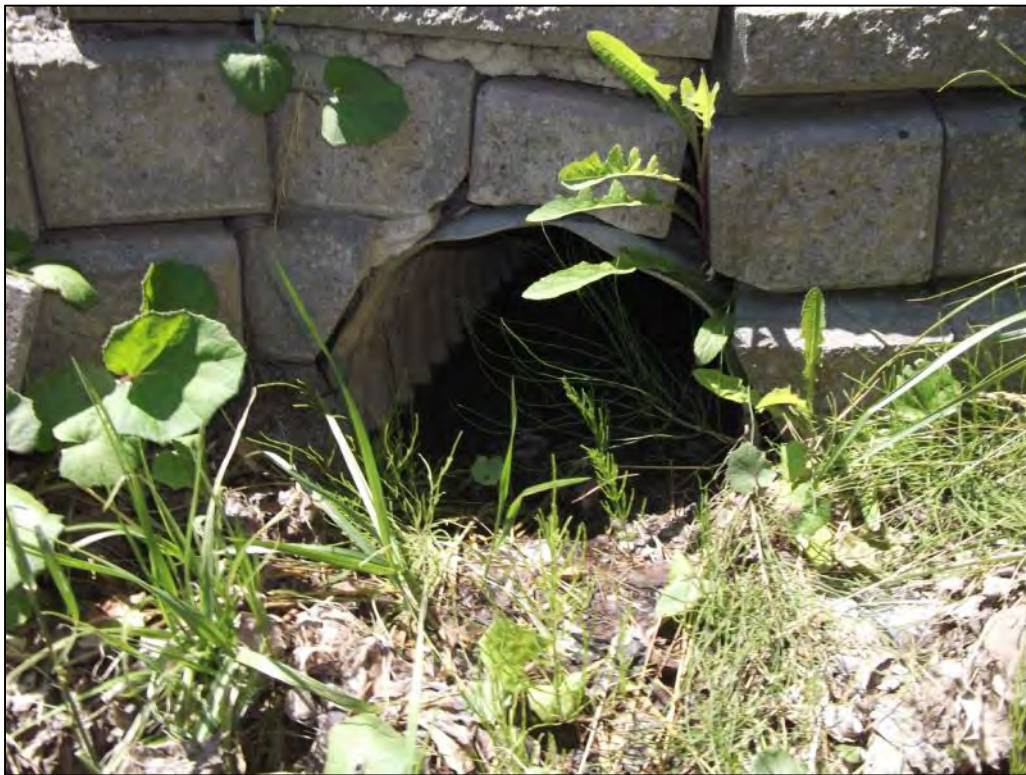
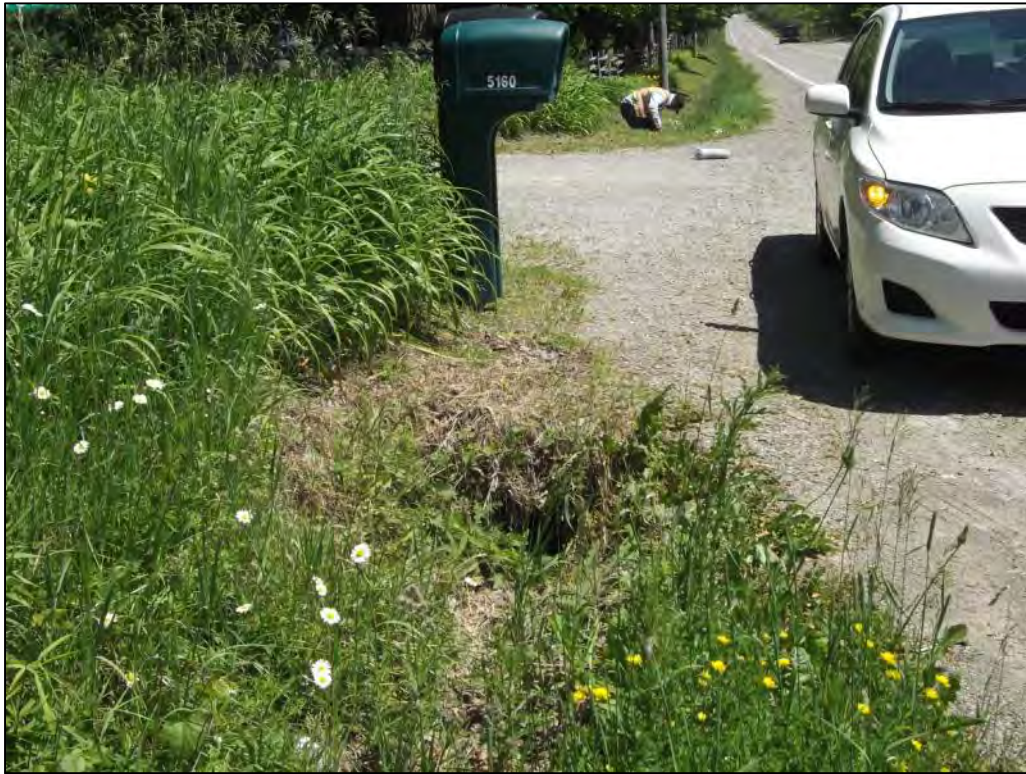
Photo P33 – CUL-019-357

CUL-019-357	CUL-EC	P33-P34		WINSTON CHURCHILL BLVD	16199	5TH SRD -- THE GRANGE SRD	NORTH BOUND	400	CS	R	N	8.90	580397.00	4845552.00	23-Sep-2011	F-G	30% filled with accumulated debris at south end	May needs flushing
CUL-019-358	CUL-EC	P35-P36		WINSTON CHURCHILL BLVD	16245	5TH SRD -- THE GRANGE SRD	NORTH BOUND	400	CS	R	N	15.20	580311.41	4845639.60	23-Sep-2011	F-G	A bit damaged at north end	North end needs to be fixed
CUL-019-359	CUL-EC	P37-P38		WINSTON CHURCHILL BLVD	16225	5TH SRD -- THE GRANGE SRD	NORTH BOUND	450	CS	R	N	12.30	580188.55	4845770.48	23-Sep-2011	G		Do nothing
CUL-019-361	CUL-EC	P39-P40		WINSTON CHURCHILL BLVD	57 M NORHT OF SIDE ROAD 5	5TH SRD -- THE GRANGE SRD	SOUTH BOUND	900	CS	R	N	10.00	580664.72	4845260.29	23-Sep-2011	F-G	Bottom is rusted	Repair
CUL-019-362	CUL-EC	P41-P42		WINSTON CHURCHILL BLVD	THE NORTH DRIVEWAY OF HOUSE #4986	OLDE BASELINE RD -- 5TH SRD	SOUTH BOUND	400	CS	R	N	6.40	582051.77	4843860.64	20-Sep-2011	P	75% Blocked/burried at north end. This culvert is side by side with 363	To be removed as the adjacent culvert is functioning well

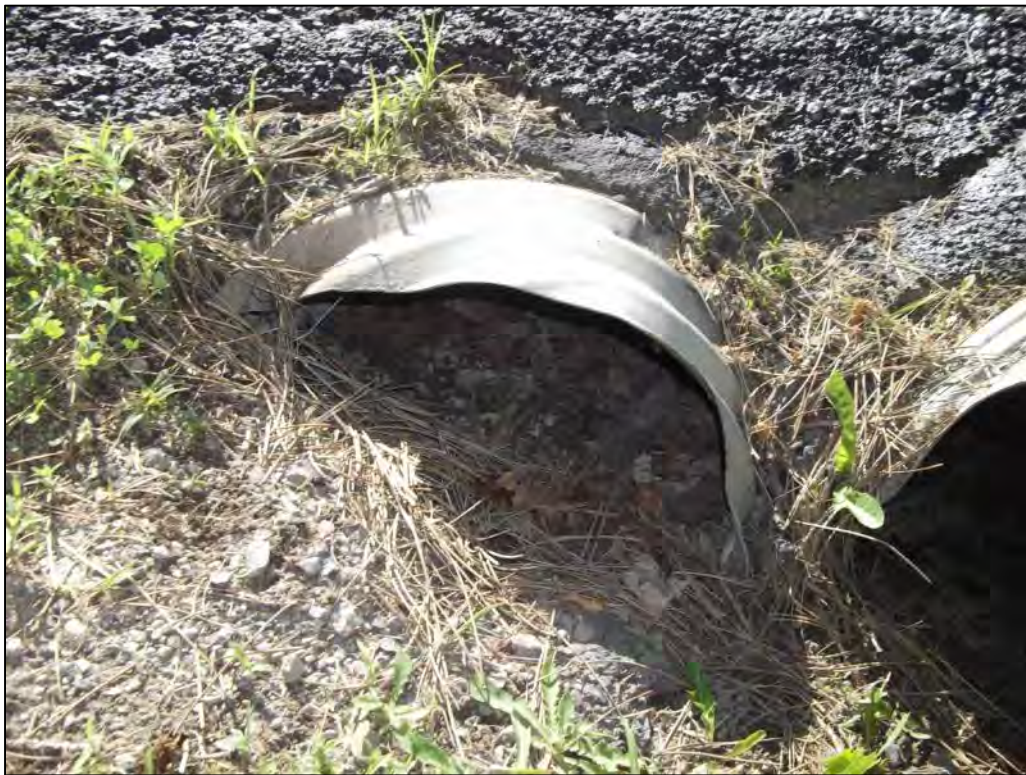
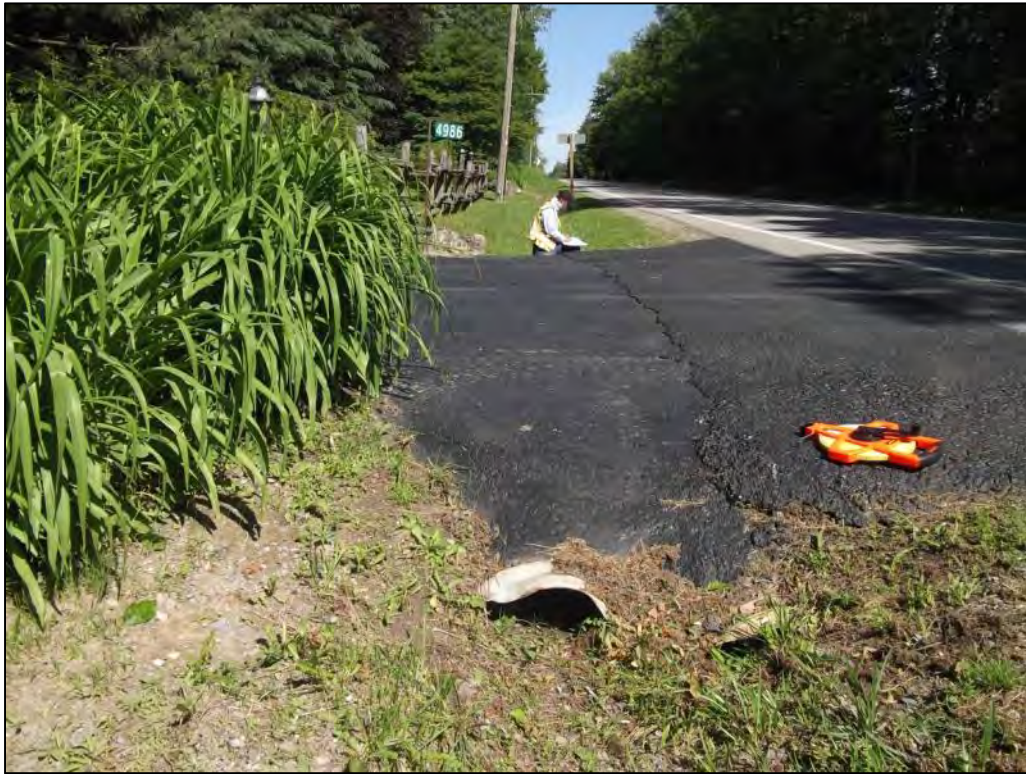
Photo P45 – CUL-019-364

CUL-019-363	CUL-EC	P43-P44		WINSTON CHURCHILL BLVD	NORTH DRIVEWAY OF HOUSE #4986	OLDE BASELINE RD -- 5TH SRD	SOUTH BOUND	460	CS	R	N	6.40	582051.77	4843860.64	20-Sep-2011	G	25% filled with accumulated debris	Needs Flushing
CUL-019-364	CUL-EC	P45-P46		WINSTON CHURCHILL BLVD	SOUTH DRIVEWAY OF HOUSE #4986	OLDE BASELINE RD -- 5TH SRD	SOUTH BOUND	460	CS	R	N	9.20	582079.39	4843832.52	20-Sep-2011	P	Rusted and almost burried at south end. North end is 50% blocked by accumulated debris. This culvert is bv side with 365	To be removed as the adjacent culvert is functioning well
CUL-019-365	CUL-EC	P47-P48		WINSTON CHURCHILL BLVD	SOUTH DRIVEWAY OF HOUSE #4986	OLDE BASELINE RD -- 5TH SRD	SOUTH BOUND	460	CS	R	N	9.10	582079.39	4843832.52	20-Sep-2011	F	50% filled with accumulated debris at south end, needs flushing	Needs flushing
CUL-019-366	CUL-EC	P49-P50		WINSTON CHURCHILL BLVD	HOUSE #4982	OLDE BASELINE RD -- 5TH SRD	SOUTH BOUND	460	CS	R	N	8.60	582108.43	4843804.84	20-Sep-2011	F	South end is damaged, needs repair	South end to be repaired

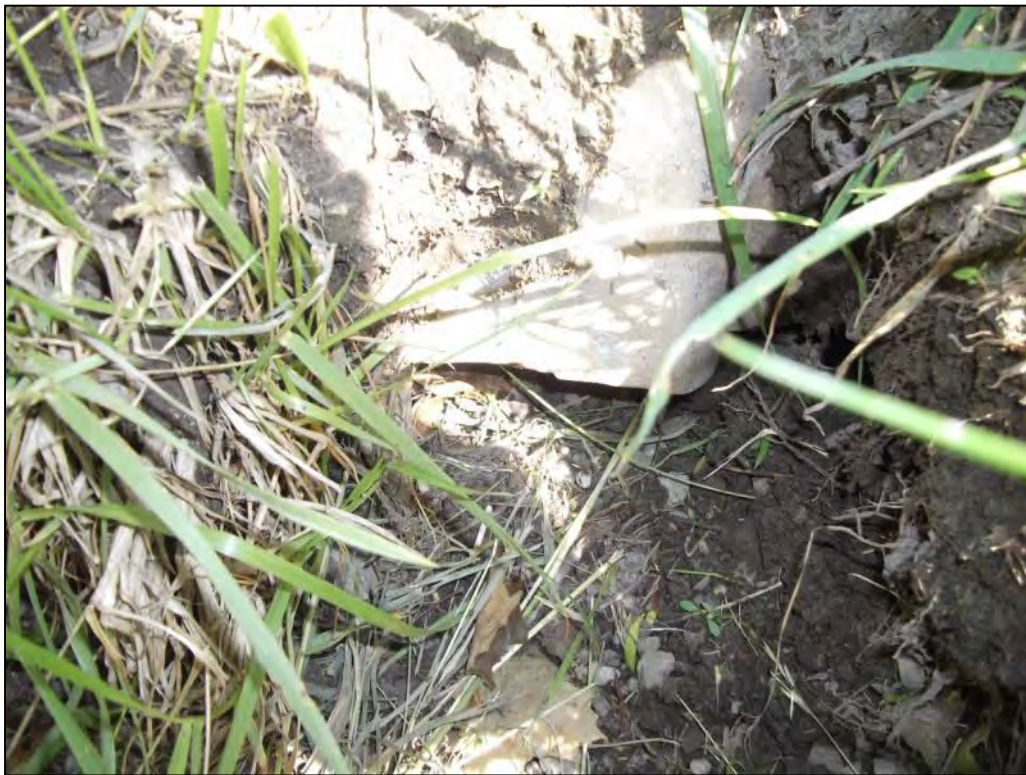
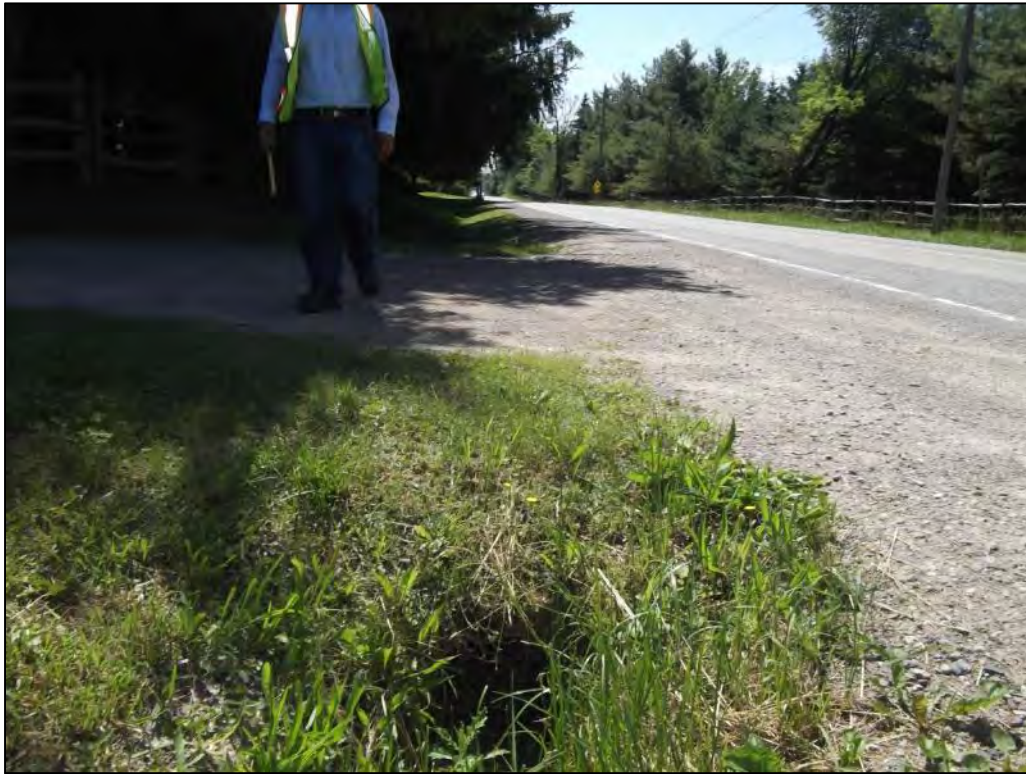
Photo P51 – CUL-019-367

CUL-019-367	CUL-EC	P51-P52		WINSTON CHURCHILL BLVD	HOUSE #4982	OLDE BASELINE RD -- 5TH SRD	SOUTH BOUND	Can't Measur	CS	R	N	8.65	582108.43	4843804.84	20-Sep-2011	P	Completely burried at both ends, needs replacement	To be replaced
CUL-019-376	CUL-EC	P53-P54		WINSTON CHURCHILL BLVD	15565	OLDE BASELINE RD -- 5TH SRD	NORTH BOUND	400	CS	R	N	9.30	581801.92	4844135.09	23-Sep-2011	F	25% filled with accumulated debris and a bit rusted and damaged at south end	Repair, flushing

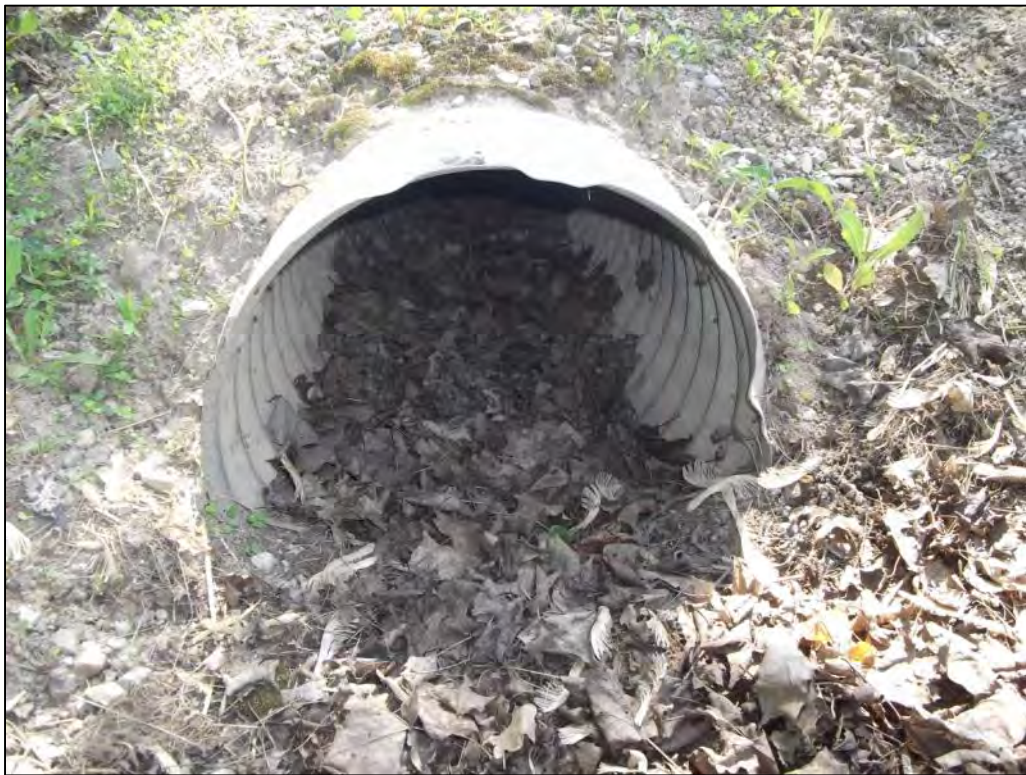
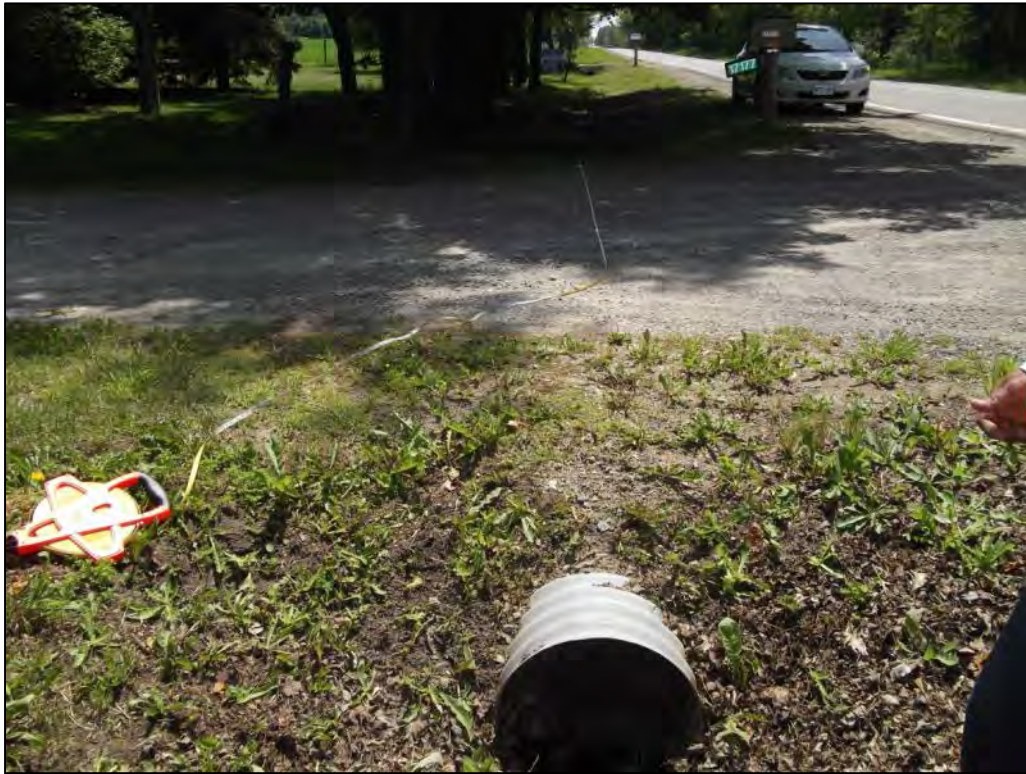
Photo P61 – CUL-019-381

CUL-019-381	CUL-EC	P61-P62		WINSTON CHURCHILL BLVD	17159	10TH SRD -- BUSH ST	NORTH BOUND	460	CS	R	N	9.30	578340.29	4847634.54	23-Sep-2011	F-G	25% filled with accumulated debris and a bit rusted at south end	May needs flushing
CUL-019-382	CUL-EC	P63-P64		WINSTON CHURCHILL BLVD	17177	10TH SRD -- BUSH ST	NORTH BOUND	460	CS	R	N	9.20	578302.00	4847671.57	23-Sep-2011	G		Do nothing
CUL-019-383	CUL-EC	P65-P66		WINSTON CHURCHILL BLVD	17197	10TH SRD -- BUSH ST	NORTH BOUND	460	CS	R	N	9.40	578257.67	4847716.62	23-Sep-2011	G		Do nothing
CUL-019-384	CUL-FE	P67-P68		WINSTON CHURCHILL BLVD	13M NORTH OF 17197	10TH SRD -- BUSH ST	NORTH BOUND	460	CS	R	N	6.50	578244.00	4847732.00	23-Sep-2011	G		Do nothing
CUL-019-385	CUL-EC	P69-P70		WINSTON CHURCHILL BLVD	5364	10TH SRD -- BUSH ST	SOUTH BOUND	Can't Measur	CS	R	N	12.60	577963.33	4848019.76	23-Sep-2011	P	80% Blocked/burried, damaged at north end	Repair, flushing
CUL-019-386	CUL-EC	P71-P72		WINSTON CHURCHILL BLVD	5348	10TH SRD -- BUSH ST	SOUTH BOUND	900	CS	R	N	9.60	578088.53	4847862.48	23-Sep-2011	F	50% filled with accumulated debris at north end, need some flushing	Needs flushing

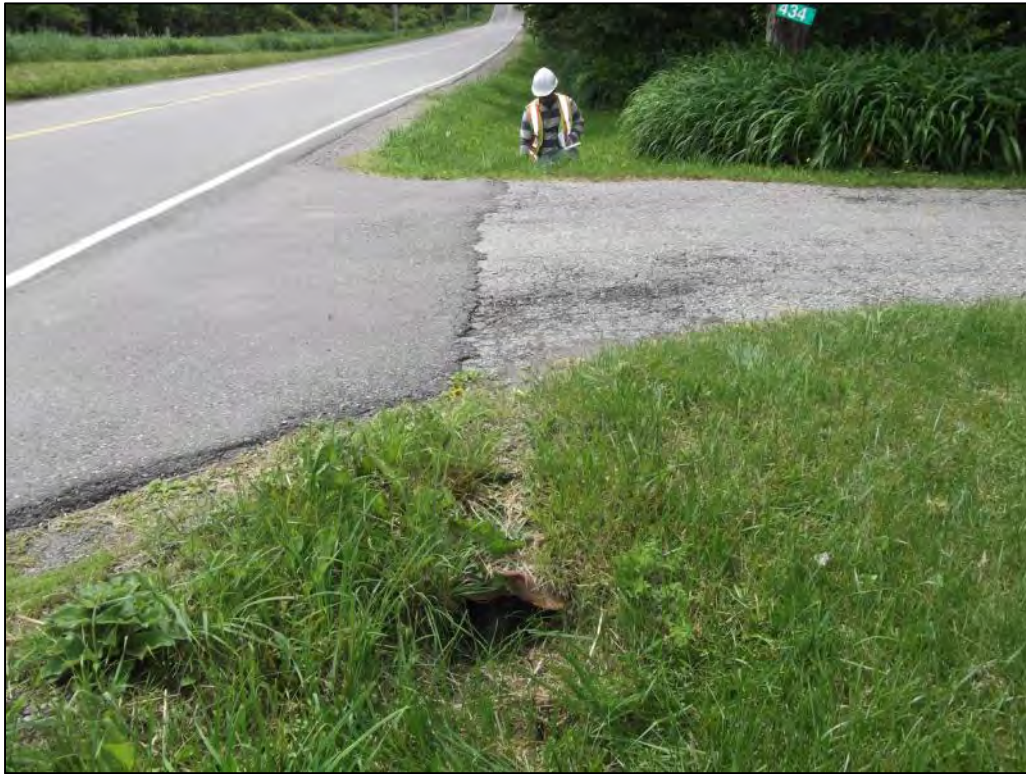
Photo P19 – CUL-012-149

CUL-012-149	CUL-EC	P19-P20	OLDE BASE LINE RD	434	SHAWS CREEK RD -- WINSTON CHURCHILL BLVD	WEST BOUND	350	CS	R	N	6.20	582820.11	4844625.64	13-Jun-2013	P	Rusted, damaged and almost burried at west end	To be replaced
CUL-012-150	CUL-CC	P21-P22	OLDE BASE LINE RD	Just east of 338-340	SHAWS CREEK RD -- WINSTON CHURCHILL BLVD	CENTRE	3300*1200	PRCONC	B	N	23.10	582727.37	4844496.67	13-Jun-2013	G		Do nothing
CUL-012-151	CUL-EC	P23-P24	OLDE BASE LINE RD	338-340	SHAWS CREEK RD -- WINSTON CHURCHILL BLVD	WEST BOUND	400	CS	R	N	9.50	582716.52	4844492.36	13-Jun-2013	P-F	Rusted, damaged, 40% filled with accumulated debris, needs some grading and flushing	Needs to be repaired, flushing and grading
CUL-012-152	CUL-CC	P25-P26	OLDE BASE LINE RD	JUST WEST OF SHAWS CREEK INTERSECTION	SHAWS CREEK RD -- WINSTON CHURCHILL BLVD	CENTRE	450	CS	R		12.50	582943.50	4844773.29	13-Jun-2013	F	20% filled with accumulated debris on both ends, Rusted and damaged on south end	South end needs repair, flushing and grading

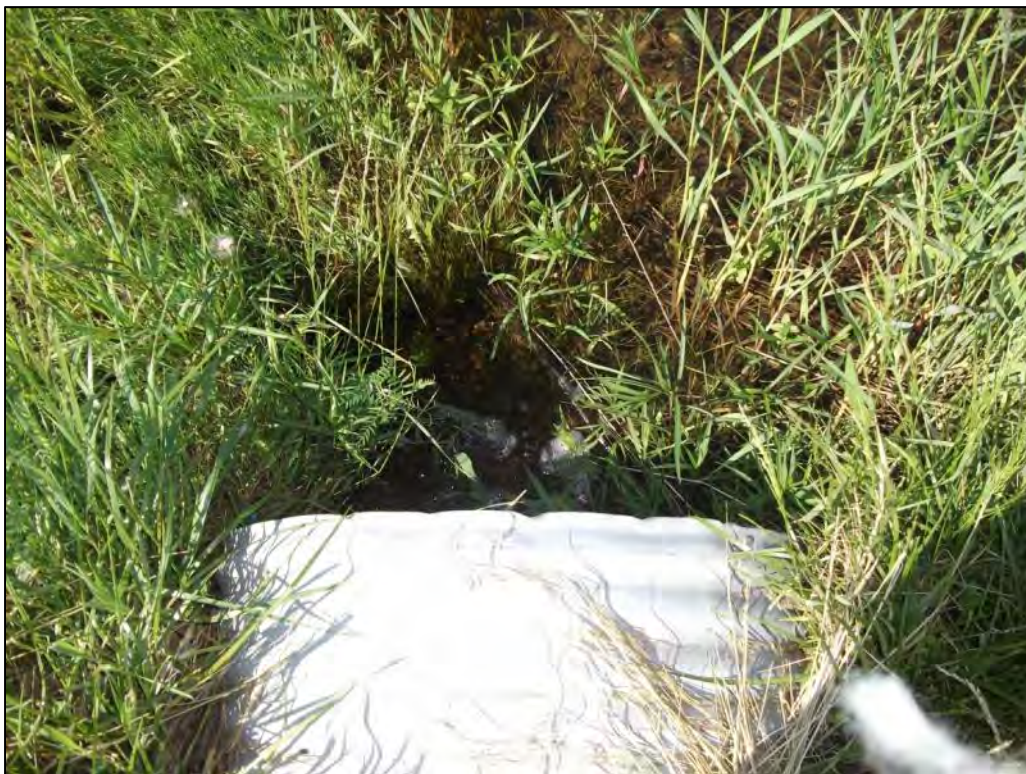
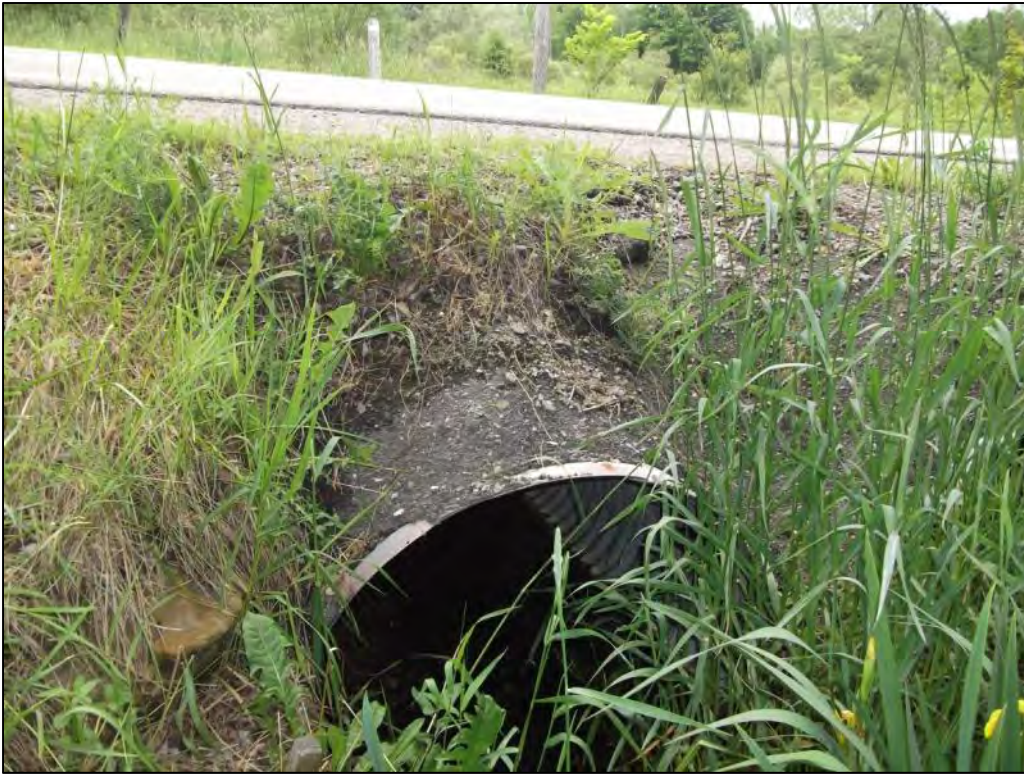
Photo P9 – CUL-001-283

CUL-001-283	CUL-CC		P9-P10	MISSISSAUGA RD	17 METERS NORTH OF HOUSE #16065	OLD BASE LINE RD(REG. RD. # 12) -- THE GRANGE SRD	CENTRE	800	CS	R	N	12.40	582407.11	4847280.07	14-Jun-2013	G	Pressed on West end (Oval Shape)	West end needs to be repaired
CUL-001-284	CUL-CC		P11-P12	MISSISSAUGA RD	99 METERS NORTH OF HOUSE #16014	OLD BASE LINE RD(REG. RD. # 12) -- THE GRANGE SRD	CENTRE	1000	CS	R	N	13.50	582460.67	4847226.83	14-Jun-2013	F-G	30% filled with accumulated debris, Damaged on West end	Flushing
CUL-001-285	CUL-CC		P13-P14	MISSISSAUGA RD	100 METERS NORTH OF HOUSE #16014	OLD BASE LINE RD(REG. RD. # 12) -- THE GRANGE SRD	CENTRE	1000	CS	R	N	13.50	582457.02	4847230.42	14-Jun-2013	G	20% filled with accumulated debris	May need some flushing
CUL-001-286	CUL-CC		P15-P16	MISSISSAUGA RD	67 METERS NORTH OF HOUSE #15915	OLD BASE LINE RD(REG. RD. # 12) -- THE GRANGE SRD	CENTRE	400	CS	R	N	12.50	582724.42	4846962.38	14-Jun-2013	P	Damaged and Rusted on both ends	Needs to be replaced and regraded.

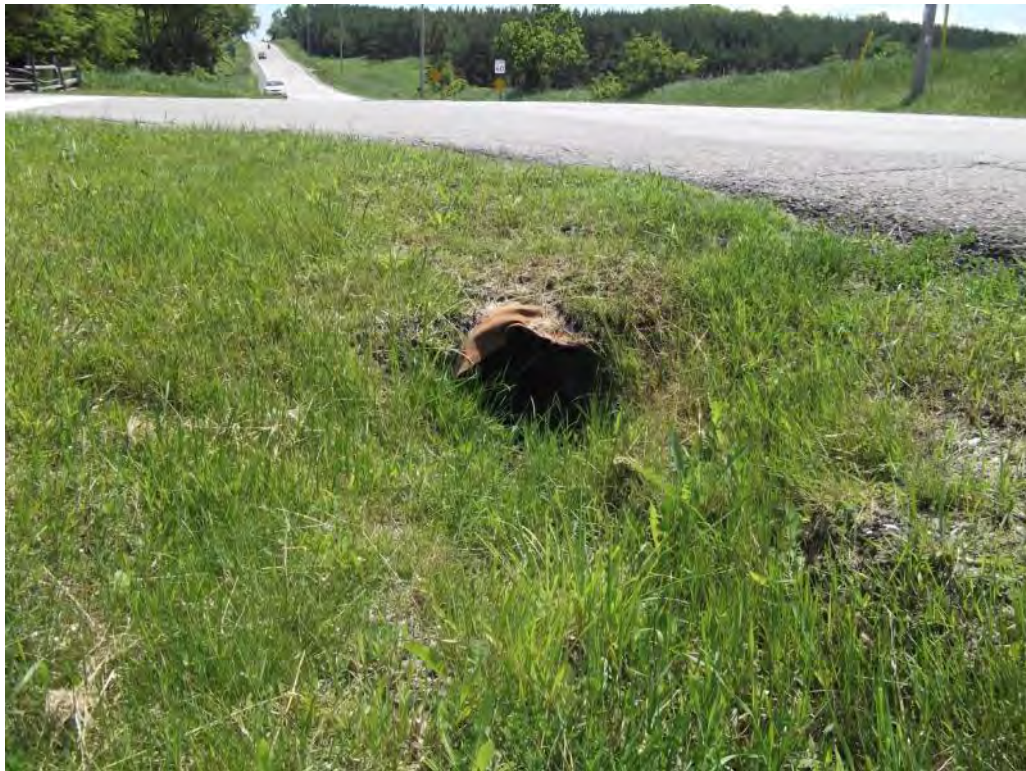
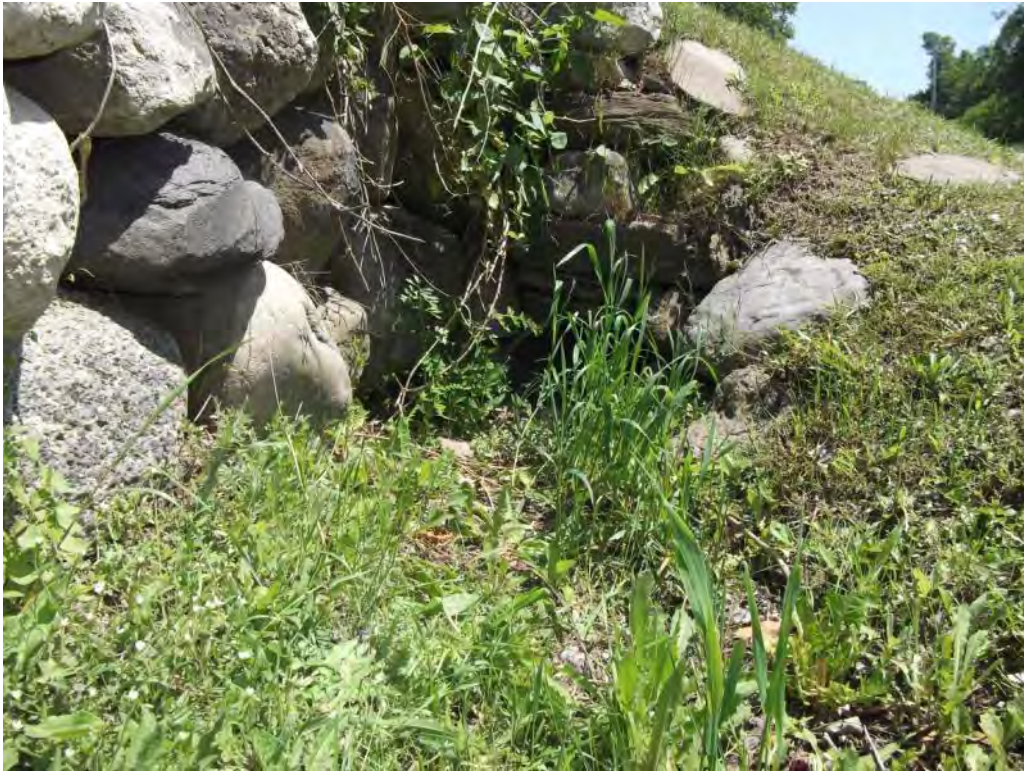
Photo P27 – Additional Culvert#3

Additional Culvert#3		4+700	P27-P28	MISSISSAUGA RD	J/O Woodland Courte & Mississauga Rd.	THE GRANGE SRD & BUSH STREET	NORTH BOUND	400	CS	R	N	20.90			14-Jun-2013	F-P	Damaged and rusted	Needs to be repaired
Additional Culvert#4		4+900	P29-P30	MISSISSAUGA RD	HOUSE # 17025	THE GRANGE SRD & BUSH STREET	NORTH BOUND	400	CS	R	N	15.70			14-Jun-2013	G		Do Nothing
Additional Culvert#5		4+855	P31-P32	MISSISSAUGA RD	50m South of HOUSE # 17025	THE GRANGE SRD & BUSH STREET	NORTH BOUND	400	CS	R	N	6.20			14-Jun-2013	F-P	Damaged at ends	Needs to be repaired, flushing and grading
Additional Culvert#6		2+755	P33-P34	MISSISSAUGA RD	HOUSE # 16311	OLD BASE LINE RD(REG. RD. # 12) -- THE GRANGE SRD	NORTH BOUND	460/550	CS/P	R	N	19.25			14-Jun-2013	G	CS at north end, Plastic at south end with different diameter	Do Nothing
Additional Culvert#7		3+025	P35-P36	MISSISSAUGA RD	J/O Mississauga Rd. & The Grange SRD	JUNCTION OF MISSISSAUGA RD. &THE GRANGE SRD	NORTH BOUND	400	CS	R	N	20.20			14-Jun-2013	P	Damaged and rusted	Needs flushing and grading

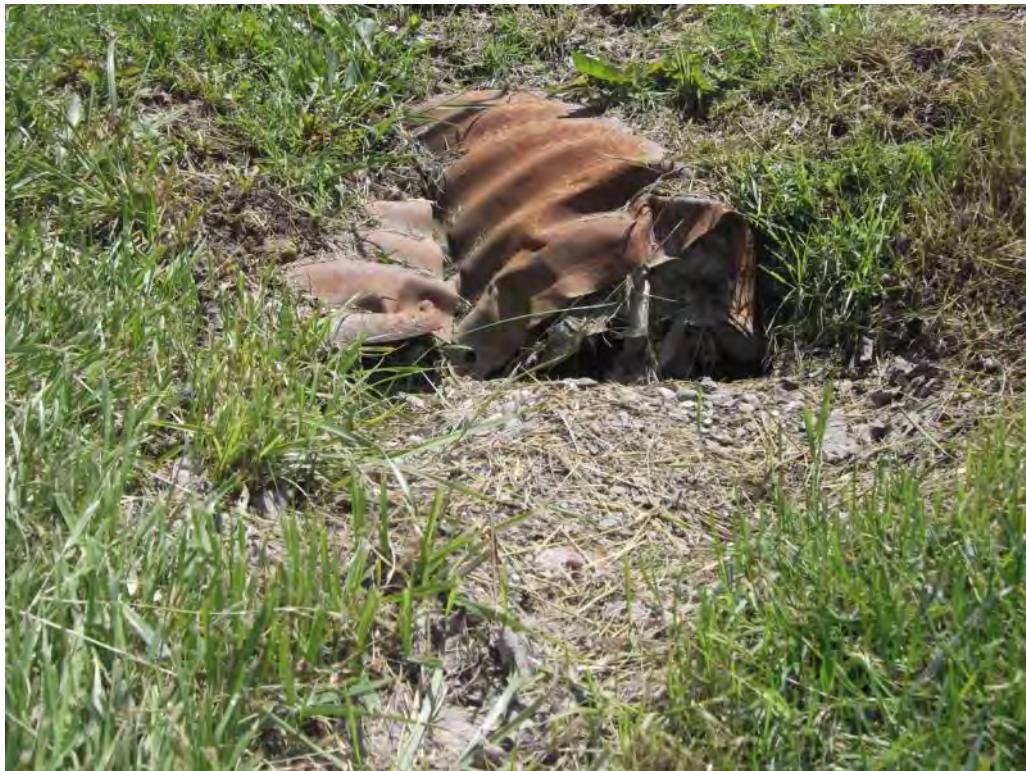
Photo P47 – Additional Culvert#13

Additional Culvert#13		4+065	P47-P48	MISSISSAUGA RD	HOUSE # 16735	THE GRANGE SRD & BUSH STREET	NORTH BOUND	400	CS	R	N	7.60			14-Jun-2013	V.P	Badly damaged and rusted	Needs to be replaced
Additional Culvert#14		0+165	P49-P50	MISSISSAUGA RD	HOUSE # 15457	OLD BASE LINE RD(REG. RD. # 12) -- THE GRANGE SRD	NORTHBOUND	400	CS	R	N	12.80			14-Jun-2013	F	South end completely blocked/burried, can't be seen	Needs flushing and grading
Additional Culvert#15		0+475	P51-P52	MISSISSAUGA RD	Just west of HOUSE # 15601	OLD BASE LINE RD(REG. RD. # 12) -- THE GRANGE SRD	SOUTH BOUND	CANT MEASURE	CS	R	N	9.50			14-Jun-2013	P	Almost burried/blocked, south end can't be seen	Needs flushing and grading
Additional Culvert#16		0+713	P53-P54	MISSISSAUGA RD	50m north of HOUSE # 15663	OLD BASE LINE RD(REG. RD. # 12) -- THE GRANGE SRD	CENTRE	400	CS	R	N	11.40			14-Jun-2013	P	50% filled with accumulated debris, rusted and damaged	Needs to be repaired, flushing and grading

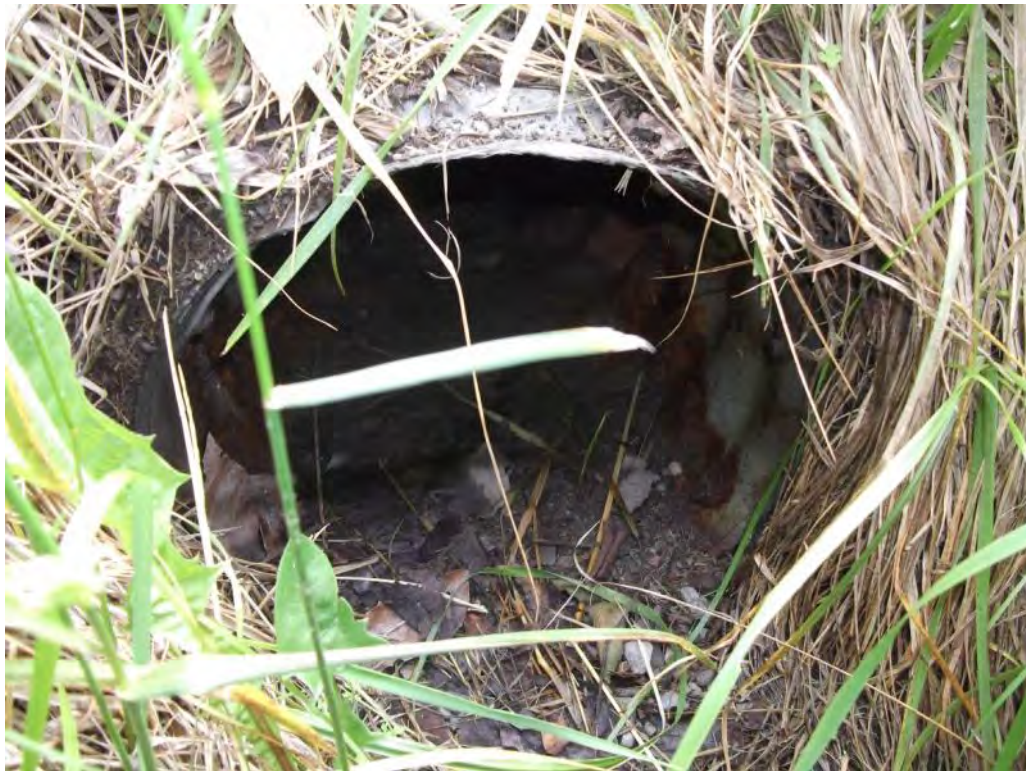
Photo P55 – Additional Culvert#17

Additional Culvert#17		0+818	P55-P56	MISSISSAUGA RD	150m north of HOUSE # 15663	OLD BASE LINE RD(REG. RD. # 12) -- THE GRANGE SRD	CENTRE	300	CS	R	N	11.80			14-Jun-2013	F-G	20% filled with accumulated debris	Might needs some flushing
Additional Culvert#18		1+025	P57-P58	MISSISSAUGA RD	HOUSE # 15775	OLD BASE LINE RD(REG. RD. # 12) -- THE GRANGE SRD	NORTHBOUND	300	CS	R	N	7.40			14-Jun-2013	F	Rusted, Damaged on South end,	Needs to be repaired
Additional Culvert#19		1+025	P59-P60	MISSISSAUGA RD	HOUSE # 15774	OLD BASE LINE RD(REG. RD. # 12) -- THE GRANGE SRD	SOUTH BOUND	400	CS	R	N	6.20			14-Jun-2013	F-G	Damaged on north end, Pressed with Oval shape	Needs to be repaired
Additional Culvert#20		1+050	P61-P62	MISSISSAUGA RD	South Driveway of HOUSE # 15790	OLD BASE LINE RD(REG. RD. # 12) -- THE GRANGE SRD	SOUTH BOUND	400	CS	R	N	5.80			14-Jun-2013	F	40% filled with accumulated debris,Damaged on north end	Flushing, North end needs to be repaired

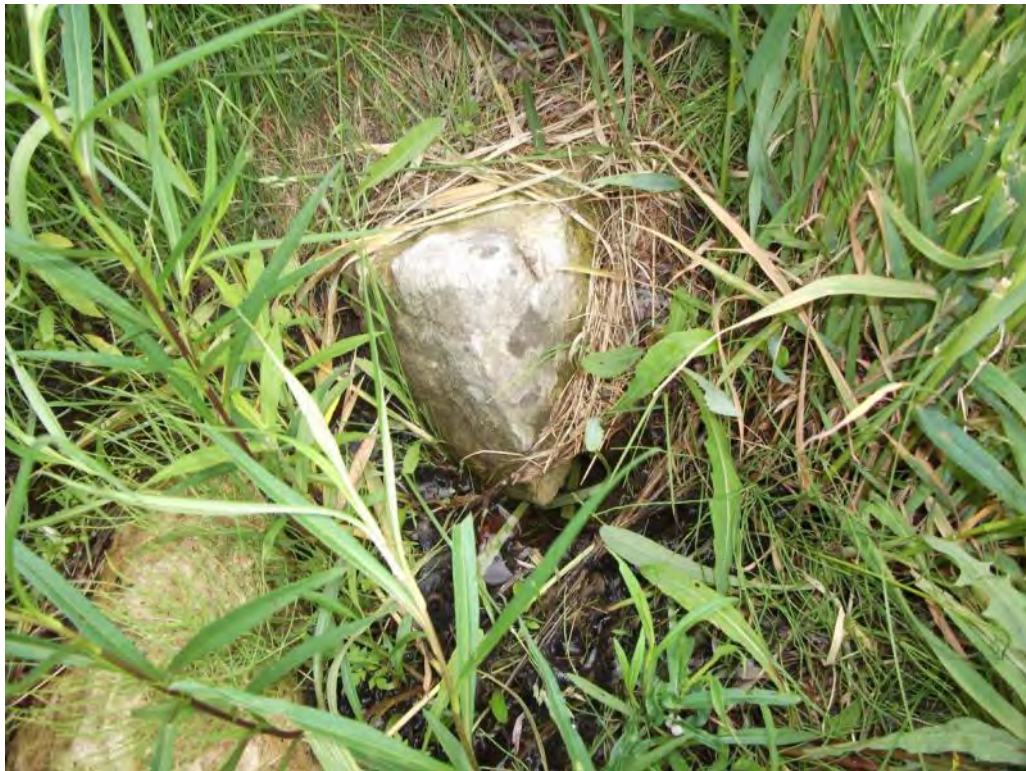
Photo P63 – Additional Culvert#21

Additional Culvert#21		1+075	P63-P64	MISSISSAUGA RD	North Driveway of HOUSE # 15790	OLD BASE LINE RD(REG. RD. # 12) -- THE GRANGE SRD	SOUTH BOUND	300	CS	R	N	6.20			14-Jun-2013	P	Damaged, completely burried on South end	Needs to be replaced
Additional Culvert#22		1+100	P65-P66	MISSISSAUGA RD	HOUSE # 15797 & 15801	OLD BASE LINE RD(REG. RD. # 12) -- THE GRANGE SRD	NORTHBOUND	400	CS	R	N	18.50			14-Jun-2013	F	Rusted, Damaged on both end	Needs to be repaired
Additional Culvert#23		5+635	P67-P68	MISSISSAUGA RD	60M SOUTH OF HOUSE # 17153	THE GRANGE SRD & BUSH STREET	CENTRE	400	CS	R	N	19.20			14-Jun-2013	F-G	50% filled with accumulated debris on east end	Needs flushing
Additional Culvert#24		5+635	P69-P70	MISSISSAUGA RD	60M SOUTH OF HOUSE # 17153	THE GRANGE SRD & BUSH STREET	SOUTH BOUND	300	CS	R	N	8.00			14-Jun-2013	F	South end looks fair, north end is burried	Needs repair on north end
Additional Culvert#25		6+100	P71-P72	MISSISSAUGA RD	HOUSE # 17266	THE GRANGE SRD & BUSH STREET	SOUTH BOUND	375	P	R	N	6.20			14-Jun-2013	G		Do Nothing
