Culvert Assessment

Minor Culvert Condition Survey along Bush Street, Mississauga Road,
Old Base Line Road and Winston Churchill Boulevard, Belfountain, ON
GEOTETOB21649AA

02 April 2014

**RE: SUMMARY OF FINDINGS (final)
Minor Culvert Condition Survey along Bush Street, Mississauga Road, Olde Baseline Road
and Winston Churchill Boulevard, Belfountain, ON**

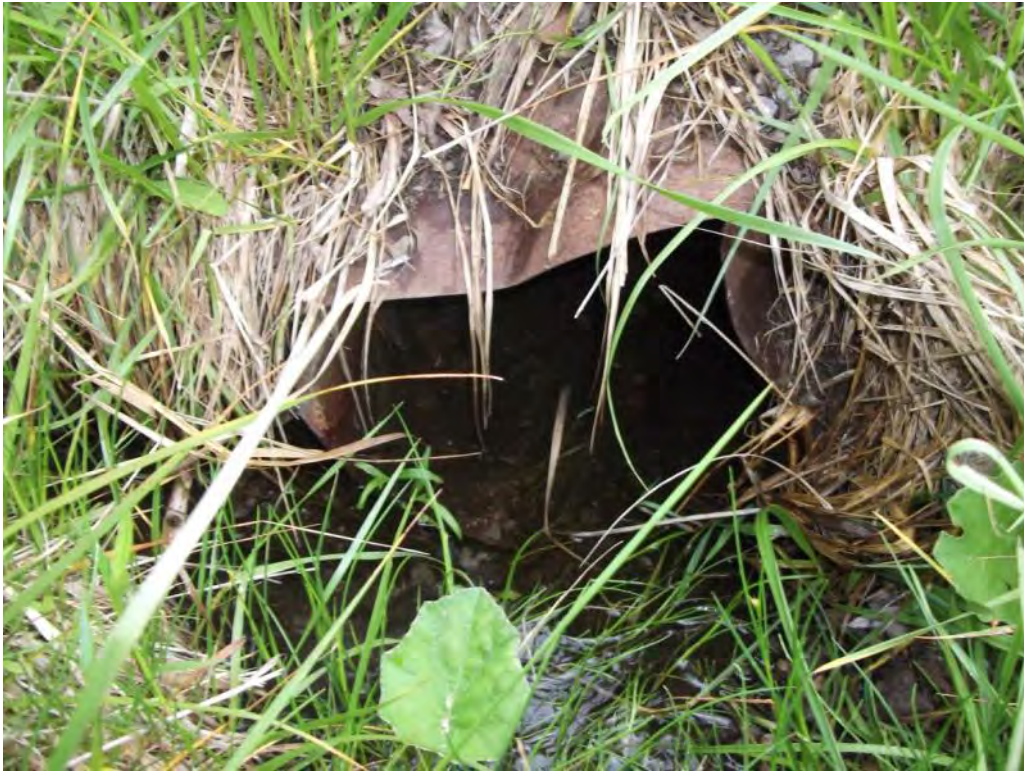
Photo P64 – Additional Culvert#21

Additional Culvert#21		1+075	P63-P64	MISSISSAUGA RD	North Driveway of HOUSE # 15790	OLD BASE LINE RD(REG. RD. # 12) -- THE GRANGE SRD	SOUTH BOUND	300	CS	R	N	6.20			14-Jun-2013	P	Damaged, completely burried on South end	Needs to be replaced
Additional Culvert#22		1+100	P65-P66	MISSISSAUGA RD	HOUSE # 15797 & 15801	OLD BASE LINE RD(REG. RD. # 12) -- THE GRANGE SRD	NORTHBOUND	400	CS	R	N	18.50			14-Jun-2013	F	Rusted, Damaged on both end	Needs to be repaired
Additional Culvert#23		5+635	P67-P68	MISSISSAUGA RD	60M SOUTH OF HOUSE # 17153	THE GRANGE SRD & BUSH STREET	CENTRE	400	CS	R	N	19.20			14-Jun-2013	F-G	50% filled with accumulated debris on east end	Needs flushing
Additional Culvert#24		5+635	P69-P70	MISSISSAUGA RD	60M SOUTH OF HOUSE # 17153	THE GRANGE SRD & BUSH STREET	SOUTH BOUND	300	CS	R	N	8.00			14-Jun-2013	F	South end looks fair, north end is burried	Needs repair on north end
Additional Culvert#25		6+100	P71-P72	MISSISSAUGA RD	HOUSE # 17266	THE GRANGE SRD & BUSH STREET	SOUTH BOUND	375	P	R	N	6.20			14-Jun-2013	G		Do Nothing

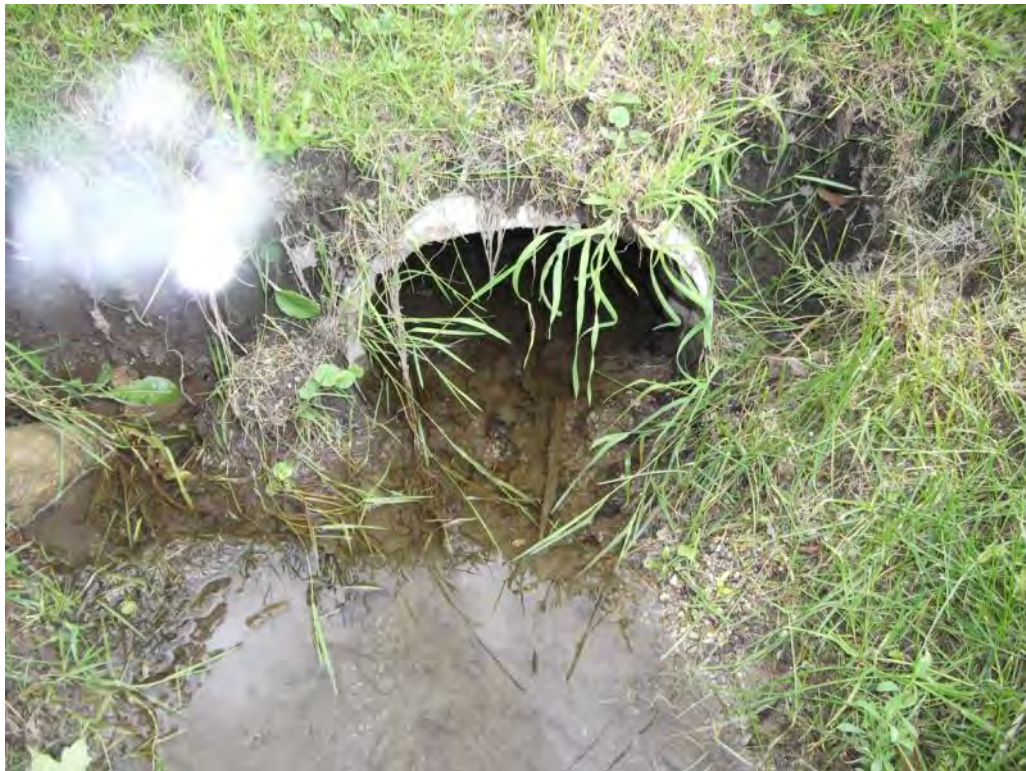
Photo P73 – Additional Culvert#26

Additional Culvert#26		6+070	P73-P74	MISSISSAUGA RD	OPPOSITE HOUSE # 17257	THE GRANGE SRD & BUSH STREET	SOUTH BOUND	400	CS	R	N	9.60			14-Jun-2013	G	20% filled with accumulated debris on south end	Might needs some flushing
Additional Culvert#27		6+060	P75-P76	MISSISSAUGA RD	JUST SOUTH OF HOUSE # 17257	THE GRANGE SRD & BUSH STREET	CENTRE	600	CS	R	N	18.00			14-Jun-2013	F-G	Rusted, Damaged on east end	East end needs to be repaired

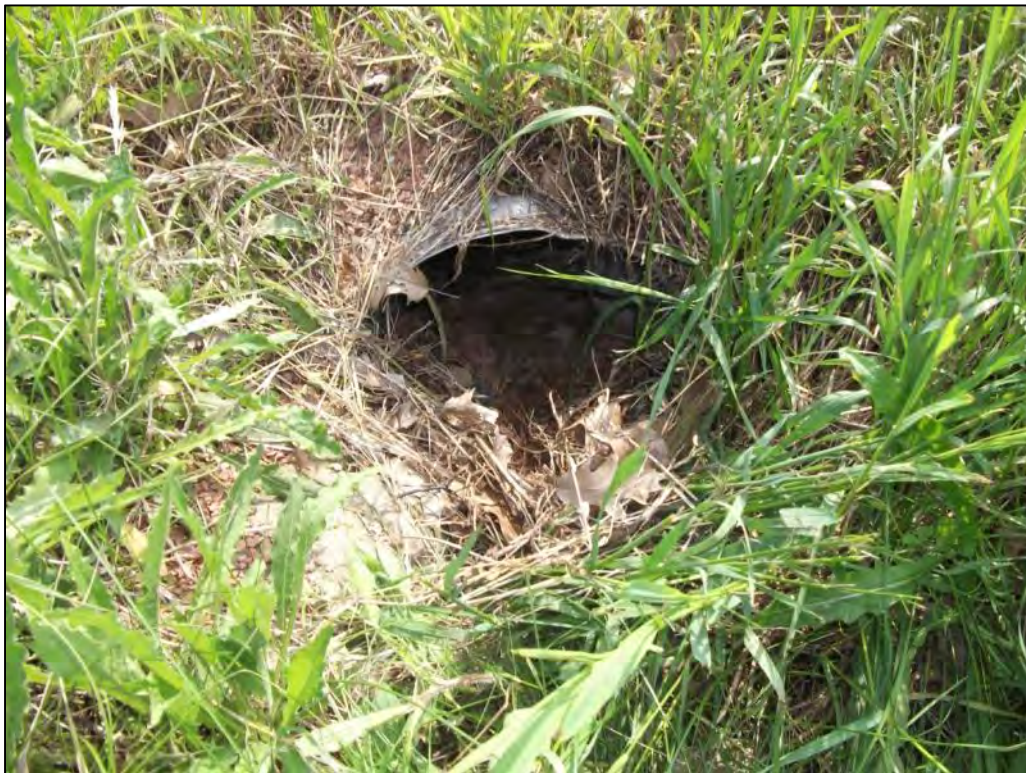
Photo P5 – CUL-011-059

<u>Culvert ID*</u>	<u>Type</u>	<u>Stationing¹</u>	<u>Picture No.</u>	<u>Street Name</u>	<u>Location Reference</u>	<u>Intersection Reference</u>	<u>Loc_Traffic</u>	<u>Dia. (mm)</u>	<u>Material</u>	<u>Shap</u>	<u>Barrier</u>	<u>Length (m)</u>	<u>X_co-ord.*</u>	<u>Y-Co-ord.*</u>	<u>Insp_Date</u>	<u>Overall Condition</u>	<u>Remarks</u>	<u>Recommendations</u>
CUL-011-057	CUL-EC		P1-P2	BUSH ST	523	OLD MAIN ST -- SHAWCREEK RD	EAST BOUND	400	CS	R	N	9.30	578877.21	4848964.10	12-Jun-2013	F - G	Damaged and 50% filled with accumulated debris at East end	Needs Flushing
CUL-011-058	CUL-EC		P3-P4	BUSH ST	593	OLD MAIN ST -- SHAWCREEK RD	EAST BOUND	400	CS	R	N	9.50	578964.63	4849068.21	12-Jun-2013	P	Damaged and 25% filled with accumulated debris, West end completely blocked/burried	To be replaced
CUL-011-059	CUL-EC		P5-P6	BUSH ST	595	OLD MAIN ST -- SHAWCREEK RD	EAST BOUND	400	CS	R	N	9.30	578975.04	4849079.90	12-Jun-2013	G	10% filled with accumulated debris	Do nothing

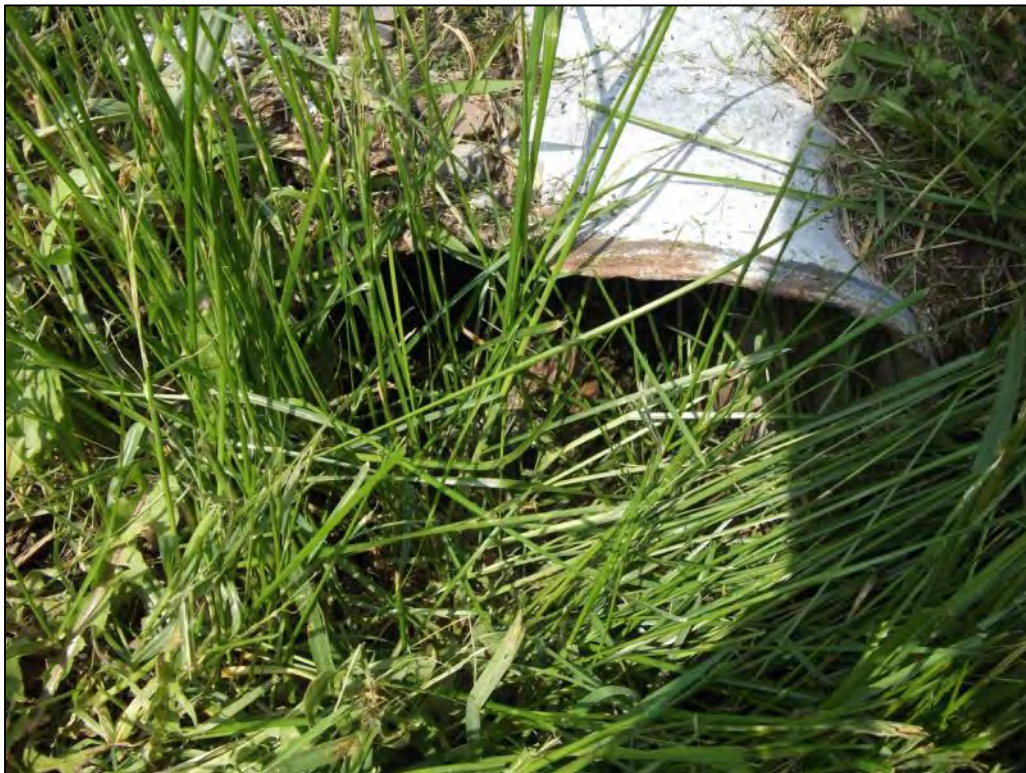
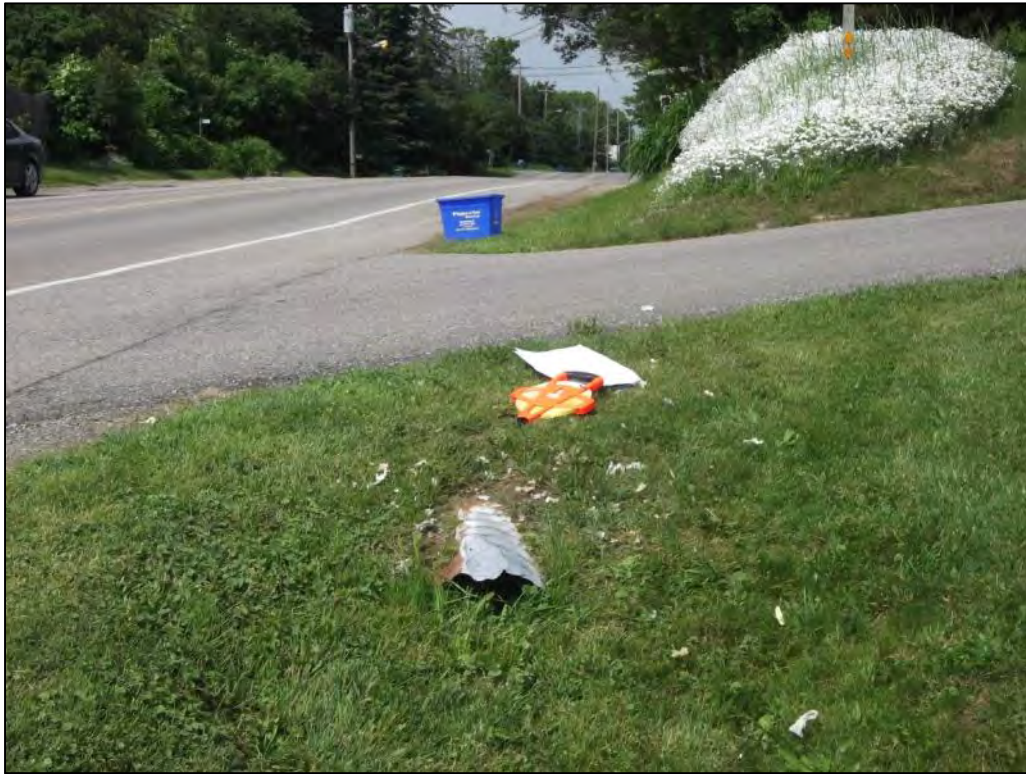
Photo P7 – CUL-011-060

CUL-011-060	CUL-EC		P7-P8	BUSH ST	597	OLD MAIN ST -- SHAWCREEK RD	EAST BOUND	400	CS	R	N	9.35	578998.81	4849109.33	12-Jun-2013	F	15% filled with accumulated debris, damaged at West end	West end to be repaired
CUL-011-061	CUL-EC		P9-P10	BUSH ST	599	OLD MAIN ST -- SHAWCREEK RD	EAST BOUND	400	CS	R	N	7.70	579010.55	4849127.06	12-Jun-2013	P	Damaged and rusted, 25% filled with accumulated debris	To be replaced
Additional Culvert #1		0+000	P11-P12		735	OLD MAIN ST -- SHAWCREEK RD	EAST BOUND	400	P	R	N	27.1			12-Jun-2013	F-G	20% filled with accumulated debris	needs some grading and flushing
Additional Culvert#2		0+110	P13		715	OLD MAIN ST -- SHAWCREEK RD	Centre	500	P	R	N	14			12-Jun-2013	F	North end is inaccessible	Do nothing
CUL-011-064	CUL-PR		P14-P15	BUSH ST	Large Bell boxes just west of Shaw's Creek Rd.	SHAWCREEK RD -- WINSTON CHURCHILL BLVD	WEST BOUND	460	CS	R	N	9.30	578762.00	4848842.00	12-Jun-2013	G	10% filled with accumulated debris.	Do nothing

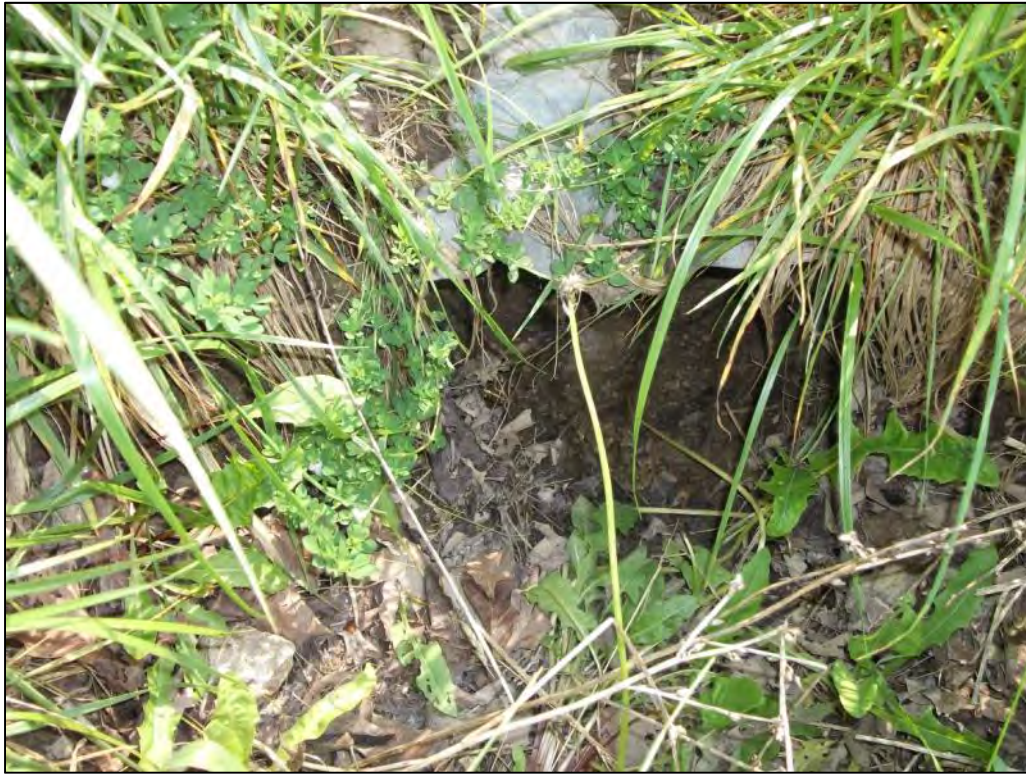
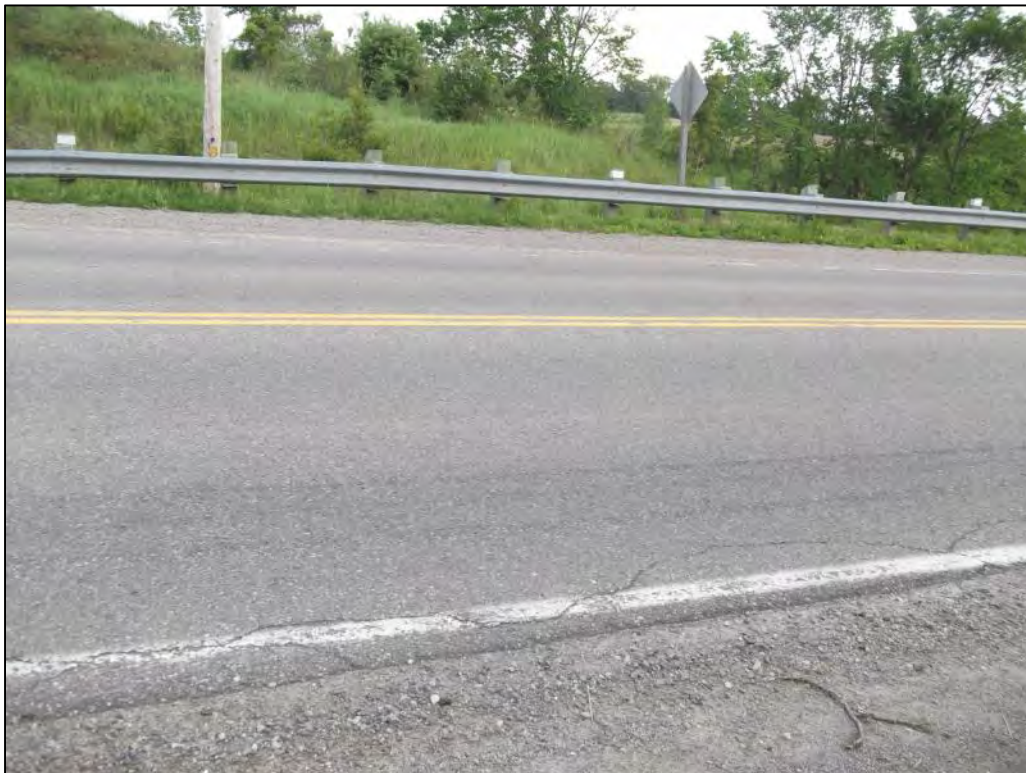
Photo P16 – CUL-011-065

CUL-011-065	CUL-FE		P16-P17	BUSH ST		SHAWCREEK RD -- WINSTON CHURCHILL BLVD	EAST BOUND	400	CS	R	N	6.20	578574.54	4848574.85	12-Jun-2013	F - P	25% filled with accumulated debris, damaged and rusted on West end	Needs to be repaired, flushing
CUL-011-066	CUL-CC		P18-P19	BUSH ST	JUST WEST OF 462 BUSH ST.	SHAWCREEK RD -- WINSTON CHURCHILL BLVD	CENTRE	900	CS	R	Y	30.20	578702.76	4848743.88	12-Jun-2013	G	25% filled with accumulated debris, North end of culvert is inaccessible so length is unconfirmed	Needs Flushing
CUL-011-067	CUL-IS		P20-P21	BUSH ST	SHAW CREEK RD	AT J/O SHAWCREEK RD	EAST BOUND	400	CS	R	N	14.70	578824.25	4848900.84	12-Jun-2013	F	25% filled with accumulated debris at West end	Needs some grading and flushing
												Total Length (m):-		106.80
