**FLUVIAL GEOMORPHOLOGY AND HYDRAULIC ASSESSMENTS
ENVIRONMENTAL ASSESSMENT (EA) AND PRELIMINARY DESIGN
FOR DRAINAGE IMPROVEMENTS OF HIGHWAY 50 FROM
MAYFIELD ROAD TO HEALEY ROAD
REGION OF PEEL, CALEDON, ONTARIO**

Prepared for:
R.V. ANDERSON ASSOCIATES LIMITED

Prepared by:
MATRIX SOLUTIONS INC.

Version 1.1
November 2021
Mississauga, Ontario

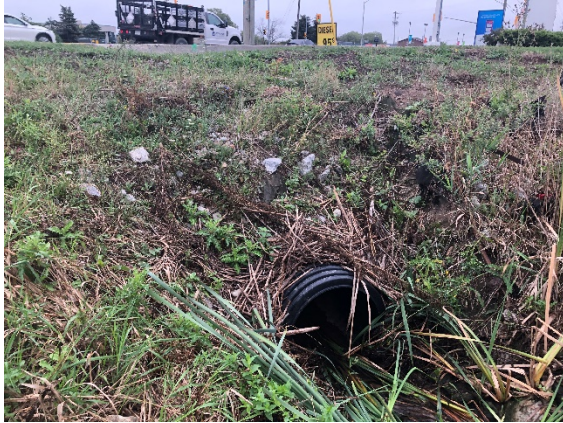
FIGURE 1 Culvert 1 Upstream End

The upstream end is comprised of two protruding culvert barrels: one oriented westerly to convey approaching watercourse flows (Culvert 1) and one oriented northerly to convey approaching roadside ditch flows (Culvert 1A). Culvert 1 is a 600 mm diameter high-density polyethylene (HDPE) pipe with vegetated embankments and no formalized end treatment (Figure 1). Culvert 1A is a 900 mm diameter corrugated steel pipe (CSP) with riprap stone embankments and no formalized end treatment (Figure 2).

It is recommended, at minimum, the upstream end be further understood by the EA team, as it pertains to ramifications of the assessed alternatives for improvement.

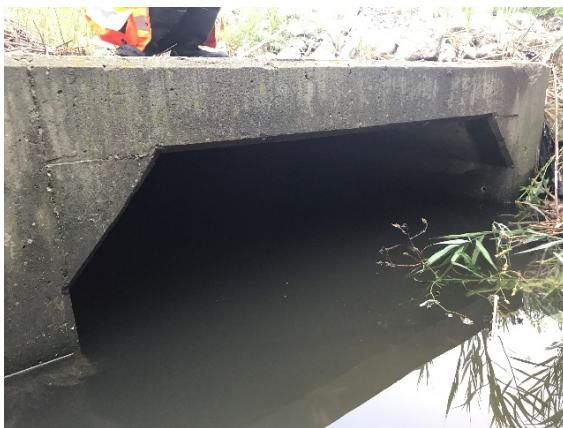
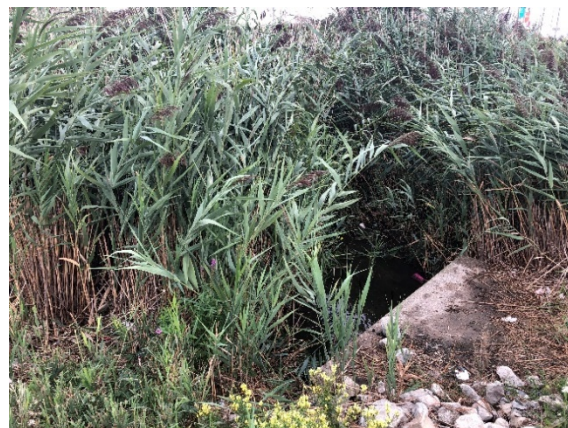
The downstream end is a single span cast in place concrete box culvert. The culvert was significantly backwatered and silted-in at the time of the site visit, but it is presumed to be an open bottom structure with span of 1.88 m and rise of 1.05 m (Figures 3 and 4).

FIGURE 3 Culvert 1 Downstream End

FIGURE 4 Culvert 1 Downstream End

Downstream of RR50, the culvert end was extensively backwatered due to dense instream vegetation (phragmites) and siltation downstream, impeding flow. Backwatering has resulted in local widening of the channel at the culvert, with minor bank erosion noted. Channel banks are poorly defined, making it difficult to accurately determine bankfull dimensions. Locally, at the culvert end the channel, width is larger than the width of the culvert measuring 3.6 m in width with a maximum depth of 1 m. The channel is depositional in nature due to the abundance of instream vegetation and substrate dominantly consists of clay and silt. The watercourse subsequently discharges immediately into a heavily vegetated online pond downstream.

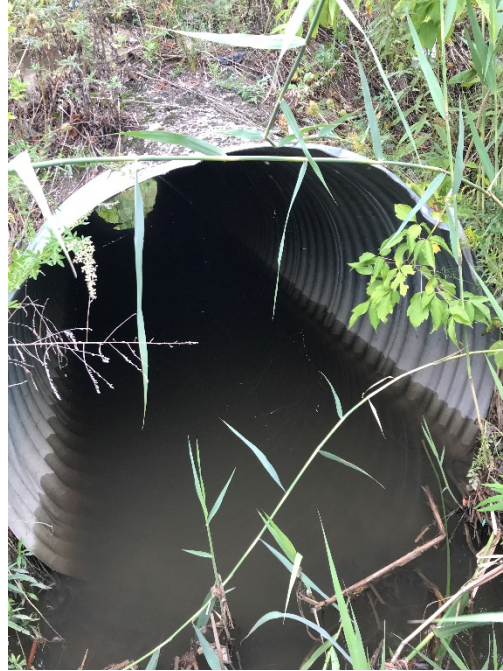
FIGURE 6 Culvert 2 Downstream End

The upstream end is comprised of a protruding culvert barrel; oriented northerly to convey approaching watercourse flows with vegetated embankments and concrete block end walls. The upstream end is partially obstructed by debris (both natural and “urban” debris), slumping slopes, and overhanging vegetation (Figure 5). The downstream end is comprised of a protruding culvert barrel with vegetated embankments and no formalized end treatments (Figure 6).

Notably, this structure was not appraised as part of the Region of Peel condition assessments provided to Matrix, likely because of its location being situated on private property.

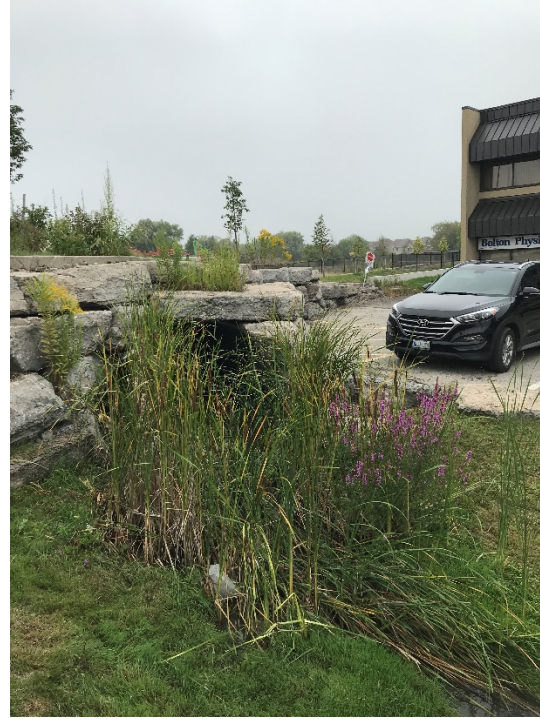
FIGURE 8 Culvert 3 Downstream End

The upstream end is comprised of an open culvert span, oriented northerly to convey approaching watercourse flows with armourstone wingwalls/headwall (Figure 7). The downstream end is comprised of an open culvert span with armourstone wingwalls/headwall (Figure 8).

Notably, this structure was appraised as “Fair Condition” by the structure condition assessments completed by Region of Peel. The corresponding Region of Peel structure ID is: “FROM - RR050-0215 TO - RR050-0216.”

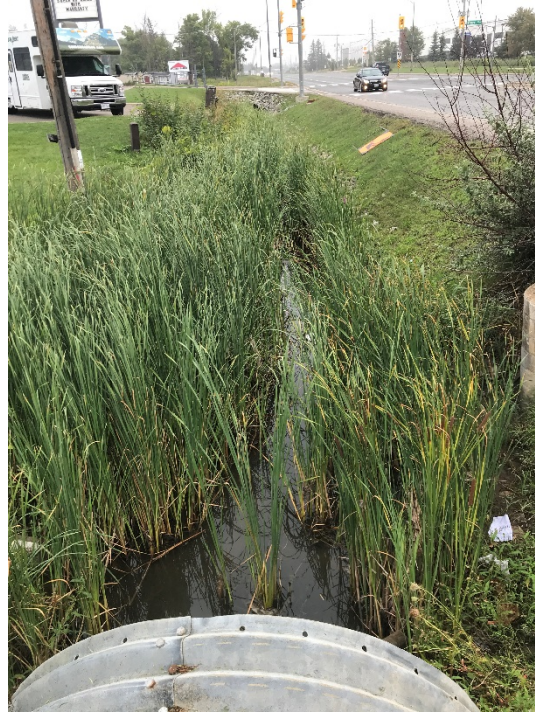
The upstream end is comprised of a protruding culvert barrel, oriented northerly to convey approaching watercourse flows with riprap stone/manicured grass embankments and no formalized end treatment (Figure 9). The downstream end is comprised of a protruding culvert barrel with manicured grass embankments and no formalized end treatment (Figure 10).

Notably, this structure was appraised as “Fair Condition” by the structure condition assessments completed by Region of Peel. The corresponding Region of Peel structure ID is: “FROM - RR050-0213 TO - RR050-0214.”

FIGURE 10 Culvert 4 Looking Downstream

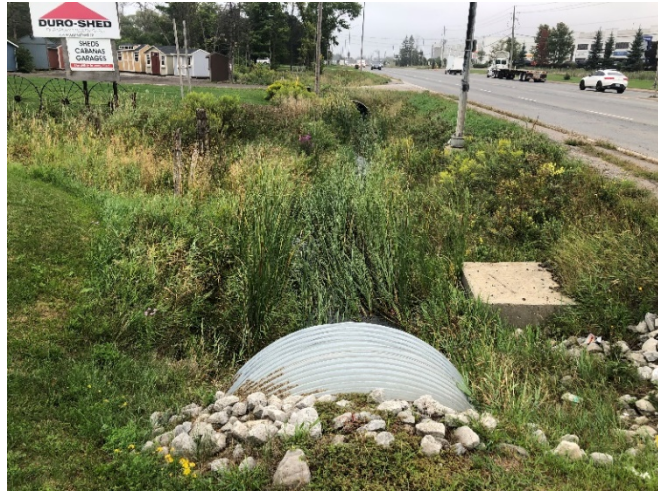
Notably, this structure was appraised as “Fair Condition” by the structure condition assessments completed by Region of Peel. The corresponding Region of Peel structure ID is: “FROM - RR050-0211 TO - RR050-0212.”

FIGURE 12 Culvert 5 Looking Downstream

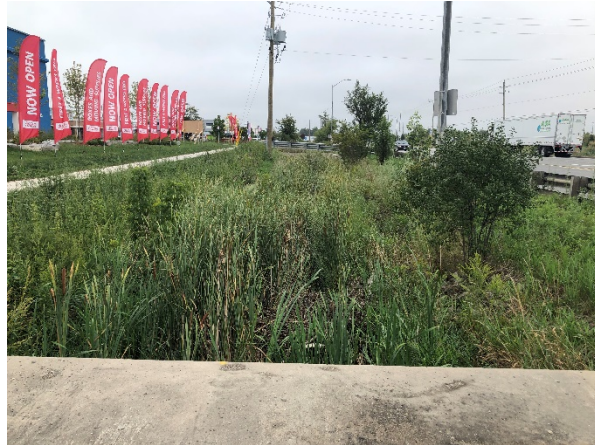
The upstream end is comprised of an open culvert span; oriented northerly to convey approaching watercourse flows with vegetated embankments and no formalized end treatment (Figure 14). The downstream end is comprised of an open culvert span with vegetated embankments and no formalized end treatment (Figure 15).

Notably, this structure was appraised as “Very Good Condition” by the structure condition assessments completed by Region of Peel. The corresponding Region of Peel structure ID is: “501227.”

FIGURE 15 Culvert 7 Looking Downstream

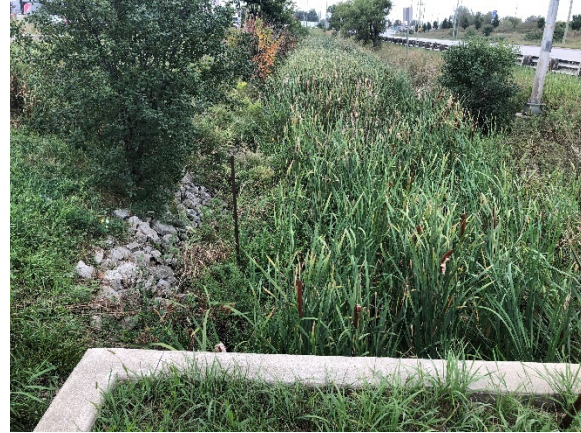
The upstream end is comprised of an open culvert span; oriented northerly to convey approaching watercourse flows with riprap/vegetated embankments, a concrete headwall and armour stone wingwall along the roadside embankment (Figure 16). The downstream end is comprised of an open culvert span with riprap/vegetated embankments and a concrete headwall and armour stone wingwall along the roadside embankment (Figure 17).

Notably, this structure was appraised as “Very Good Condition” by the structure condition assessments completed by Region of Peel. The corresponding Region of Peel structure ID is: “501220.”

FIGURE 17 Culvert 8 Looking Downstream

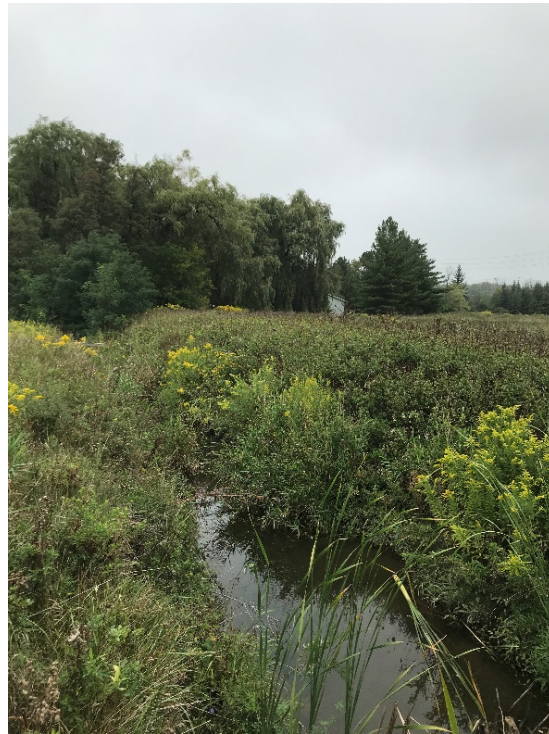
In consultation with the project team, it has been identified that an approximate 80 m length of the watercourse upstream of Culvert 7 has been historically realigned by a private landowner (Figure 20), for which TRCA is currently involved and pursuing restitution.

FIGURE 20 Previous Channel Realignment Looking Upstream

It is recommended that the status of this realignment be further understood by the EA team, as it pertains to ramifications of the assessed alternatives for improvement.

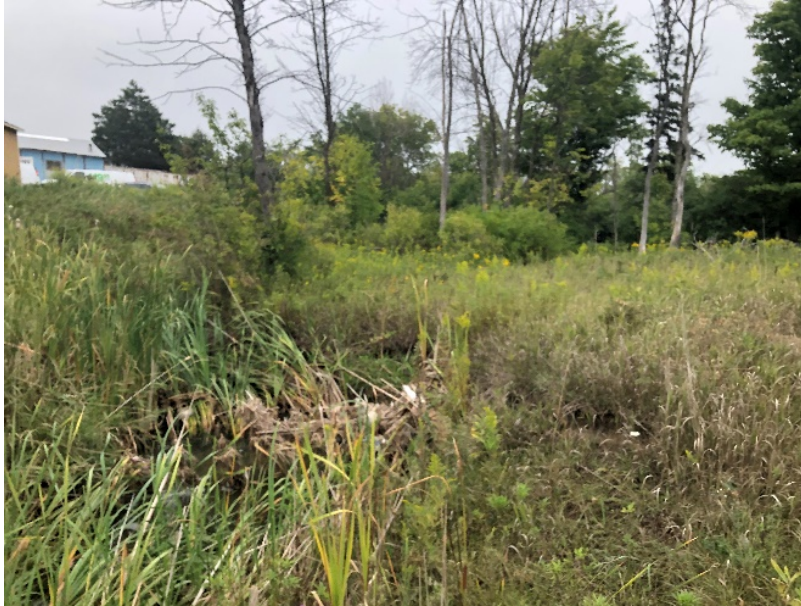
In consultation with the project team, a private landowner located immediately downstream of Culvert 6 has raised concerns associated with recent stormwater/ditching revisions along the RR50 frontage of the subject property exacerbating/resulting in increased watercourse flows at the rear of the subject property (Figure 21). Furthering landowner concern in this regard is the new establishment of a stormwater management pond on the opposing side of the watercourse, particularly during periods of pond maintenance.

FIGURE 21 Looking Downstream from Culvert 6 (Subject Property on Right)

The nature of these issues is deemed beyond the scope of the current study by Matrix and the EA project team. However, if jurisdictions having authority (i.e., Region of Peel/Town of Caledon/TRCA) opt to further investigate the issues cited by the landowner, a series of recommended initial steps include the following:

- meeting with landowner onsite to understand issues
- reviewing historic changes along RR50 frontage, watercourse reach, subject property, stormwater management pond, and adjacent properties

- conducting desktop and detailed field investigation, topo survey, etc. of subject property and adjacent properties
- conducting site-specific hydraulic analysis to review flood extents and frequency

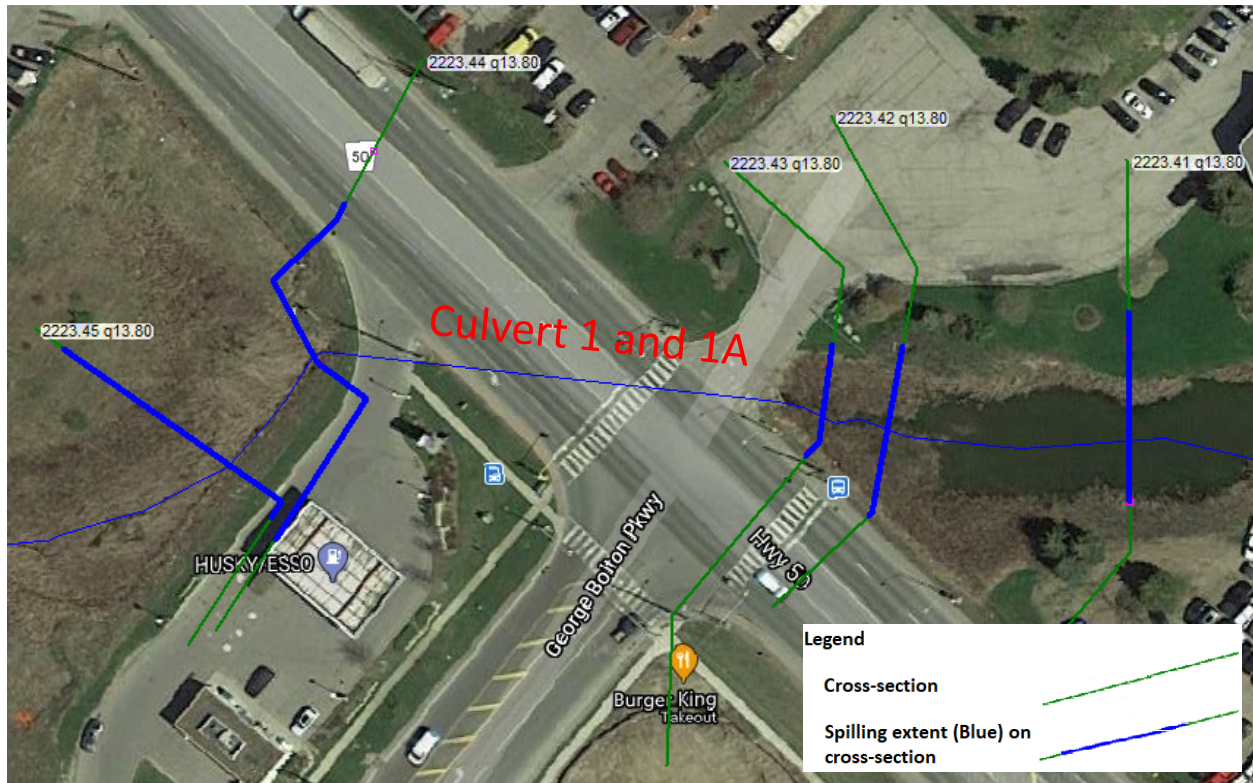
Table 3 presents the hydraulic results of Culverts 1 and 1A. The results indicate that both Culverts 1 and 1A experience full submergence during the 2-year event and greater. The driveway over Culvert 1, which serves as the northern entrance to the gas station, has a ground elevation of 238.5 m according to the RVA topographic survey data. The water level results from the model indicate that this driveway over Culvert 1 experiences overtopping during the 2-year event and greater. Figure 22 shows the water extent on cross-sections adjacent to Culvert 1 for the Regional event. It is shown that water overtopping the adjacent gas station driveway will spill eastly toward RR50 and spill southerly through the gas station.

FIGURE 22 Culvert 1 Water Extents on Cross-sections During the Regional Event

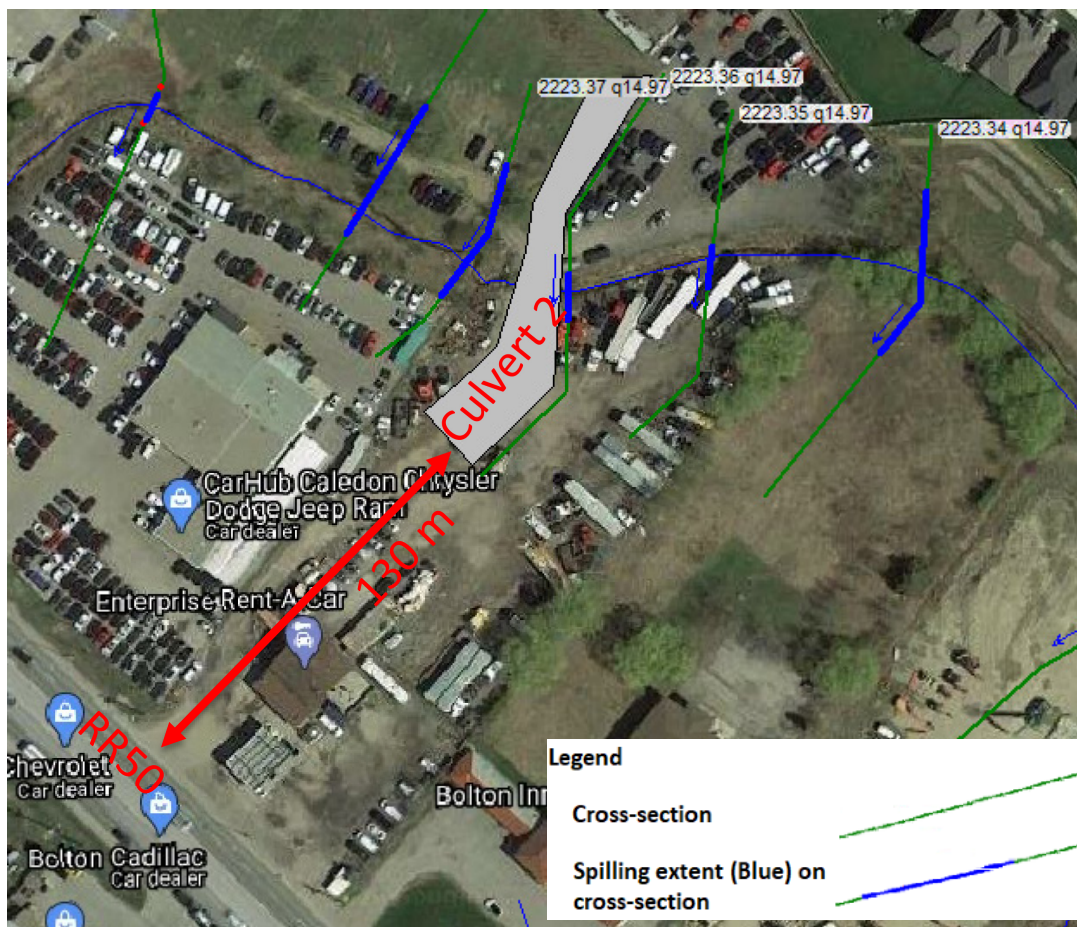
Table 4 presents the hydraulic results of Culvert 2. The results indicate that Culvert 2 experiences full submergence during the 2-year event and greater. The driveway over Culvert 2 experiences overtopping during the 5-year event and greater. Figure 23 plots water extents on cross-sections adjacent to Culvert 2

FIGURE 23 Culvert 2 Water Extents on Cross-sections during the Regional Event

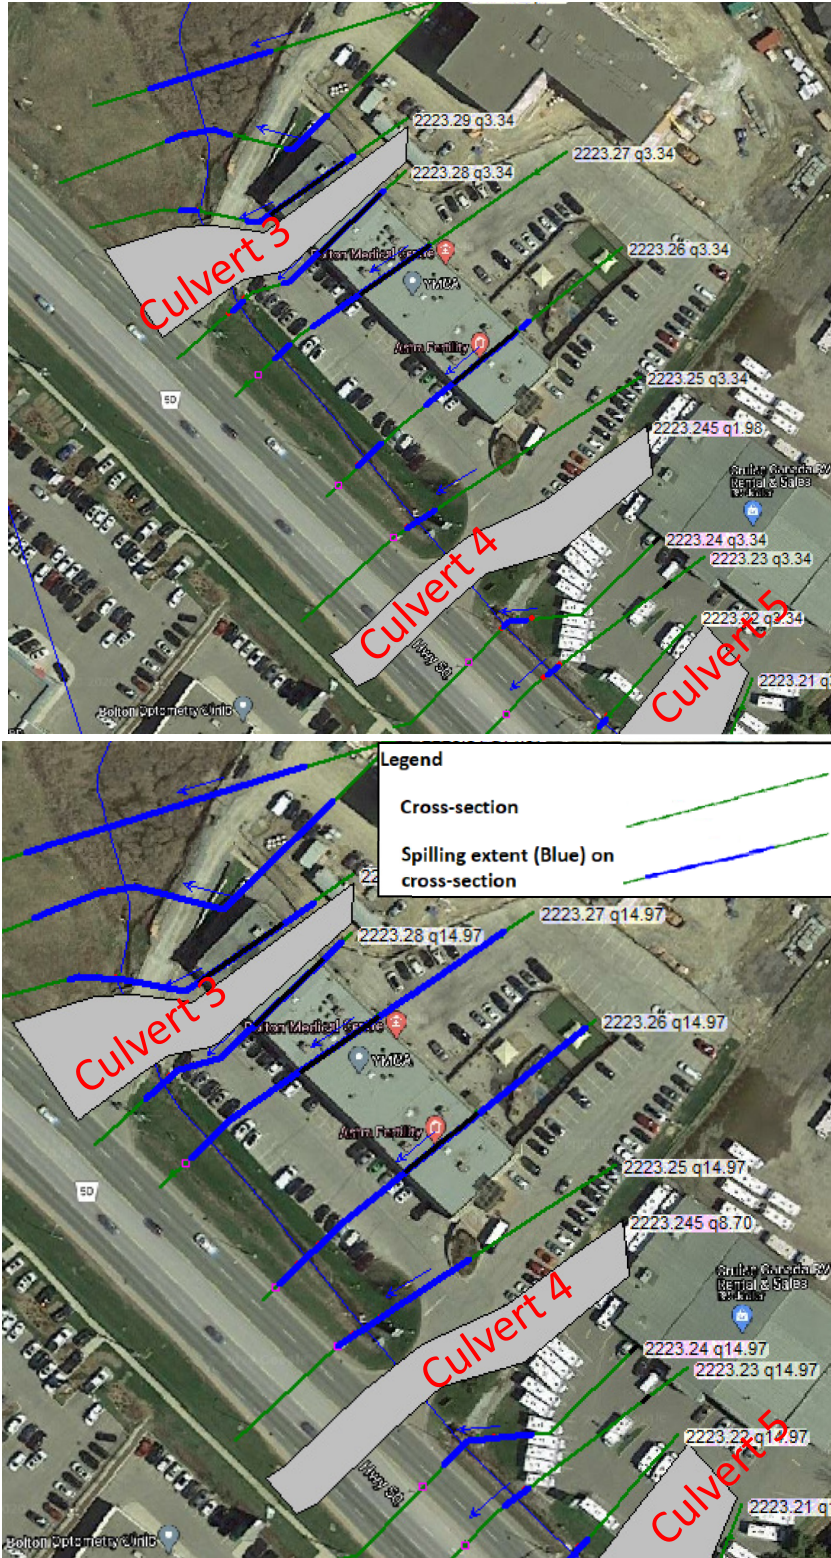
Figure 24 plots water extents on cross-sections adjacent to Culvert 3 and 4 for the 2-year and Regional events. The watercourse in this area experiences high water level during the 2-year through the Regional event. The multi-unit commercial property and its parking lot, which is on the east bank of the watercourse, experience flooding during the 2-year event and greater. RR50, which is on the west bank of the watercourse, does not experience flow on the road during the 2-year through 100-year events. During the Regional event, water at the downstream channel of Culvert 4 encroaches on RR50 but does not overtop the road crown or spill to other side of RR50.

FIGURE 24 Culverts 3 and 4 Water Extents on Cross-sections During the 2-year (Top) and Regional Event (Bottom)

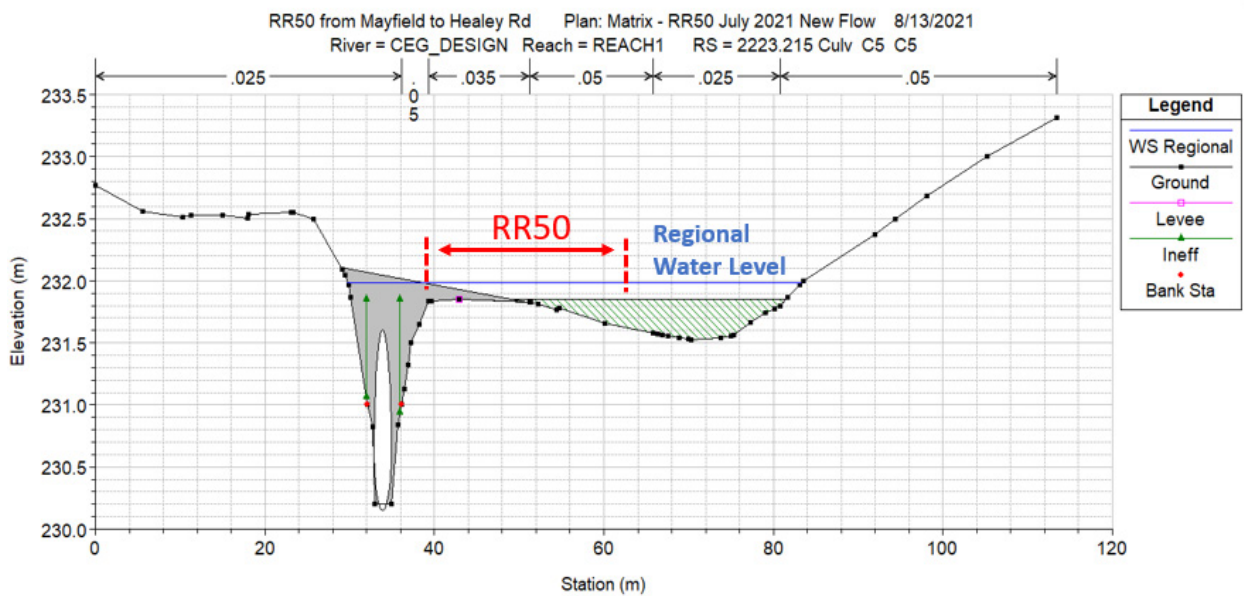
Table 7 presents the hydraulic results of Culvert 5. The results indicate that Culvert 5 experiences full submergence during the Regional event. Also, during the Regional event, water encroaches on RR50 and the water level is high enough to overtop to the west side of RR50, as shown in Figure 25. The driveway over Culvert 5 does not experience overtopping during any modelled events.

FIGURE 25 Water Levels Overtopping to the West Side of RR50 During the Regional Event at Upstream Face of Culvert 5 (Left to Right Looking Downstream).

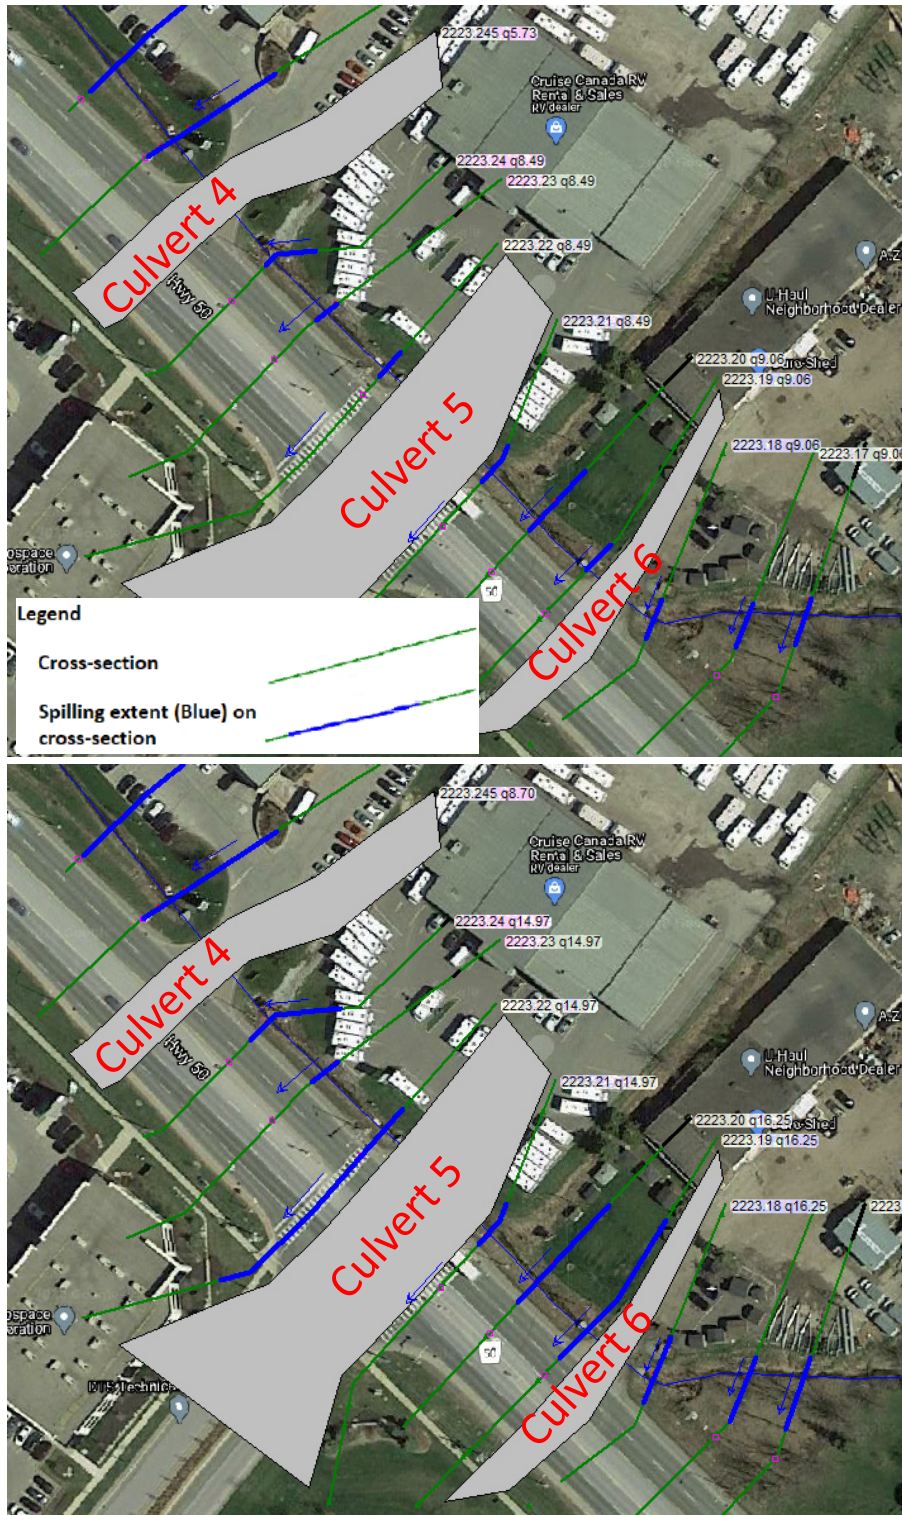
Figure 26 plots water extents on cross-sections adjacent to Culverts 4, 5, and 6 for the 100-year and Regional events. During 2-year through 100-year events, water is contained in the channel and does not encroach on RR50. During the Regional event, the watercourse experiences high water levels from backwater upstream of Culvert 5. In this case, water encroaches RR50 and spills across to the west side of the road. Water is contained in the channel sections between Culvert 5 and 6 during 2-year through 100-year events. During the Regional event in this reach, water encroaches on RR50 but does not overtop the road crown.

FIGURE 26 Culverts 5 and 6 Water Extents on Cross-sections during the 100-year (Top) and Regional Events (Bottom)

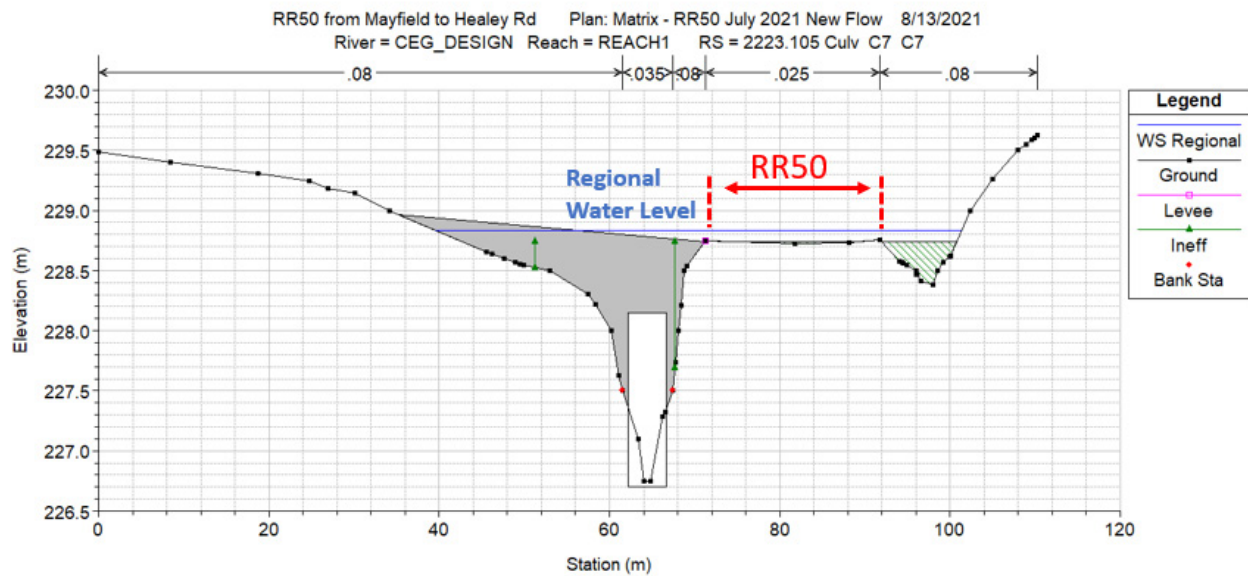
Tables 9 presents the hydraulic results of Culverts 7. The results indicate that Culvert 7 experiences full submergence during the 25-year event and greater. The driveway over Culvert 7 experiences overtopping during the Regional event. RR50 Adjacent to Culvert 7 has the same roadway elevation with driveway elevation. During the Regional event, water encroaches on RR50 and the water level is high enough to overtop to the west side of RR50, as shown in Figure 27.

FIGURE 27 Water Levels Overtopping to the West Side of RR50 During the Regional Event at Upstream Face of Culvert 7 (Left to Right Looking Downstream).

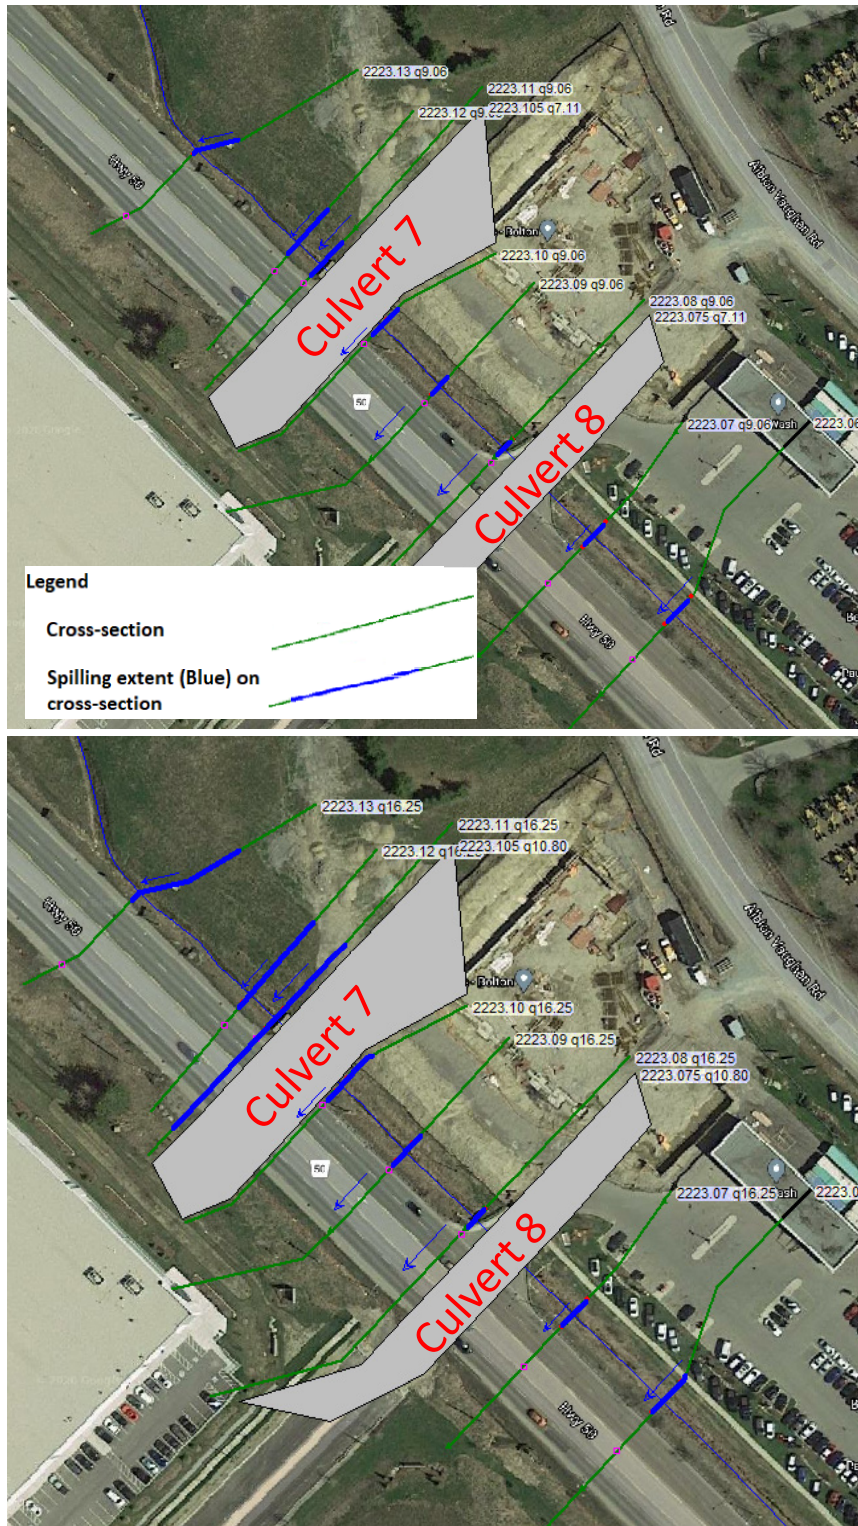
Figure 28 plots water extents on cross-sections adjacent to Culverts 7 and 8 for the Regional event. During the 2-year through 100-year events, water does not encroach RR50 at any adjacent. During the Regional event, the watercourse experiences high water levels from backwater upstream of Culvert 7. In this case, water encroaches RR50 and spills across to the west side of the road. For reaches downstream of Culvert 7 and adjacent to Culvert 8, water is contained in the channel and does not encroach RR50.

FIGURE 28 Culverts 7 and 8 Water Extents on Cross-sections During the 100-year (Top) and Regional Event (Bottom)

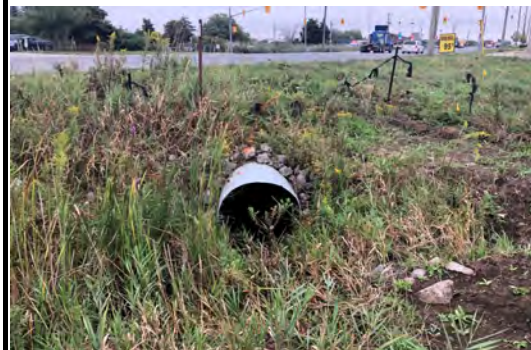
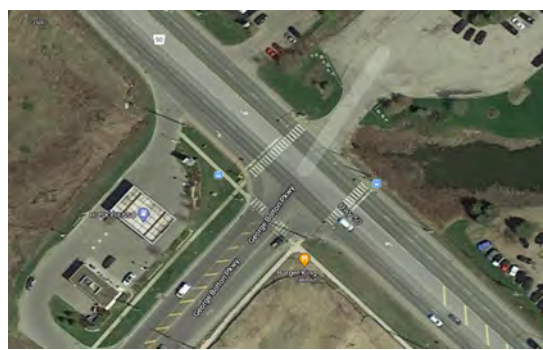
Channel Disturbance Hardened with riprap around culvert at road

Embankment Erosion Protection
Rip Rap Vegetation Armour Stone
Slope Paving Retaining Wall Other riprap old and failing

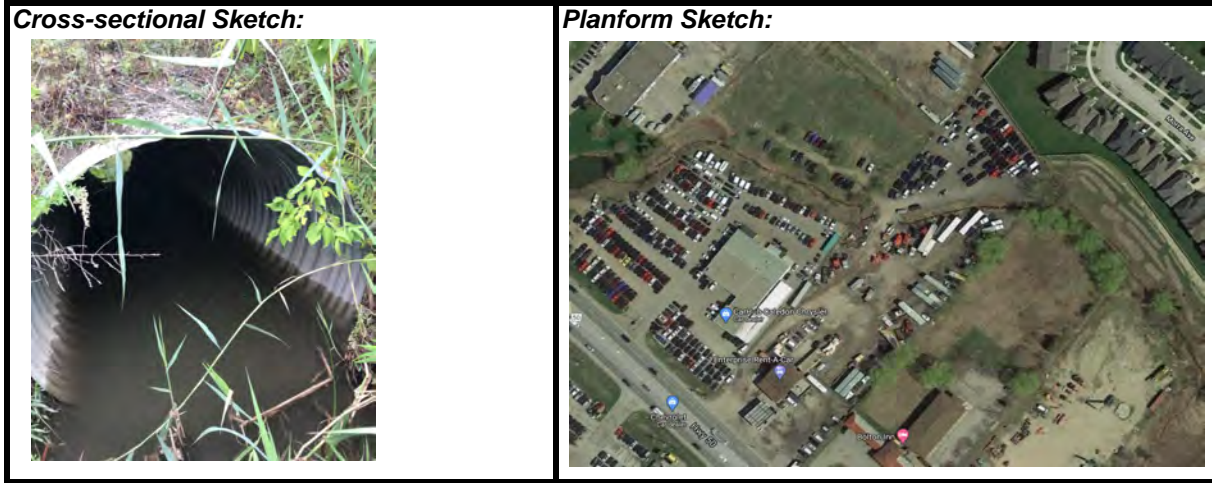
Channel Disturbance Old concrete blocks around culvert sides (failing)

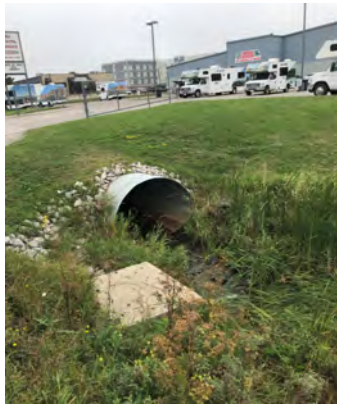
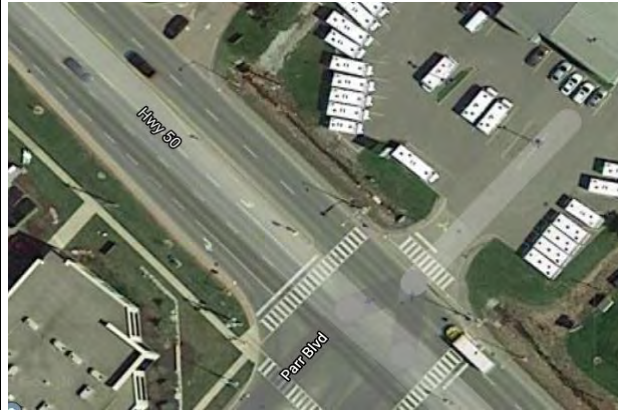
Channel Disturbance riprap at crossing on banks and road embankment

Good Collapsed Mechanical Damage Rust X Other rusting through bottom

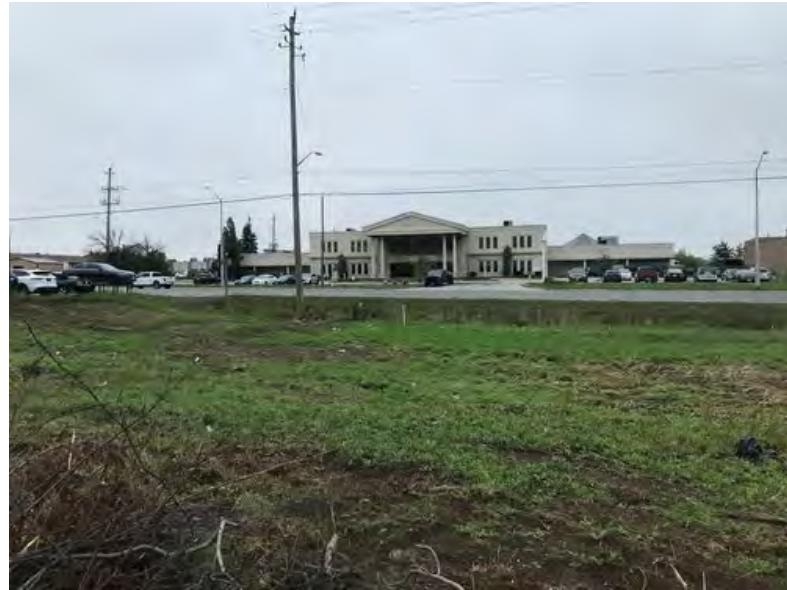
1. Upstream of Culvert 1

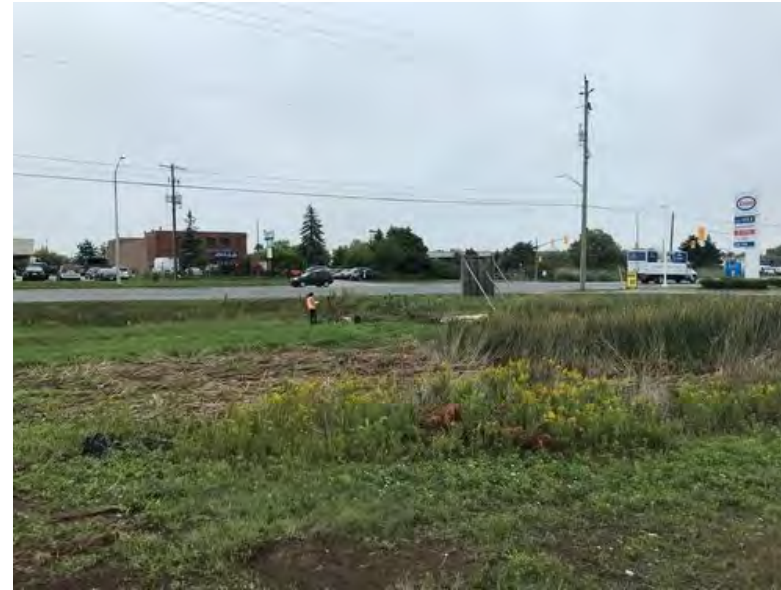
2. Upstream of Culvert 1

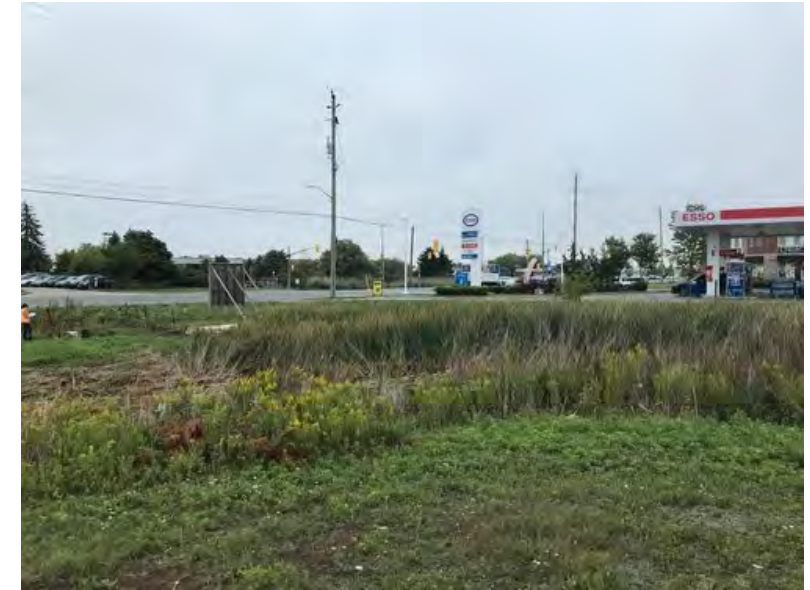
3. Upstream of Culvert 1

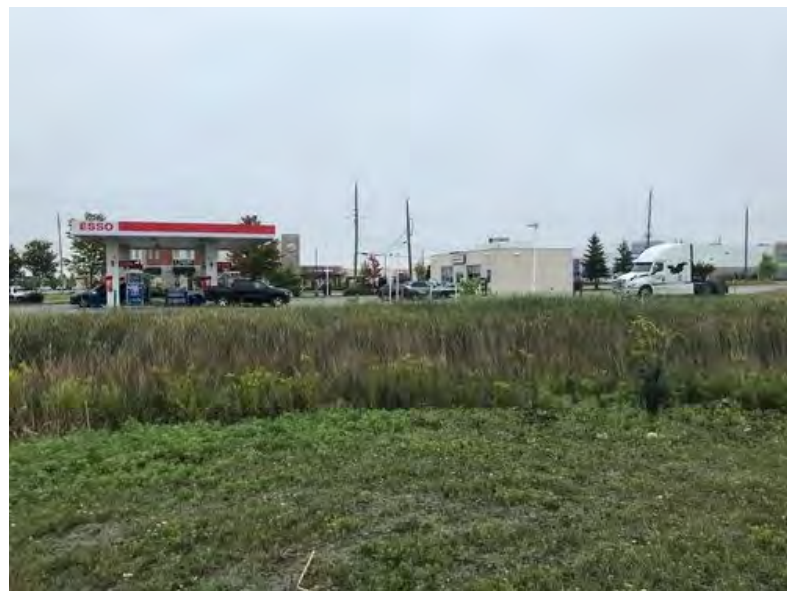
4. Upstream of Culvert 1

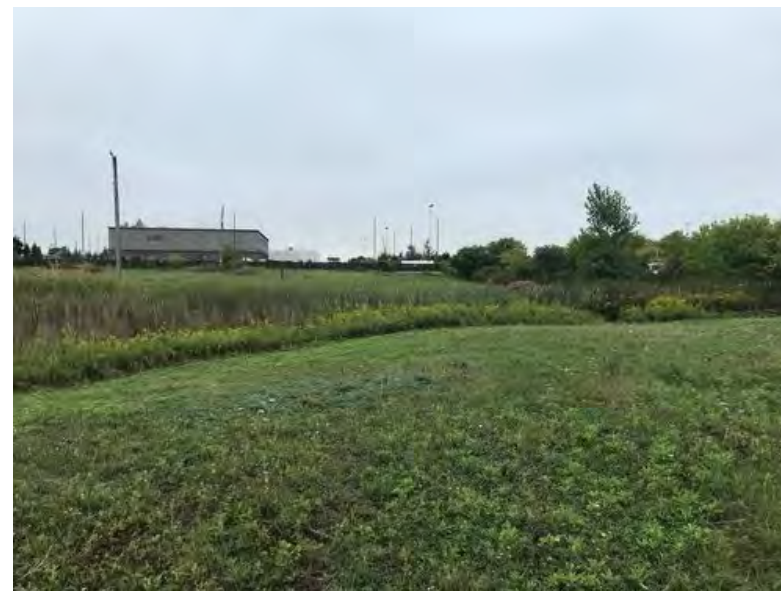
5. Upstream of Culvert 1

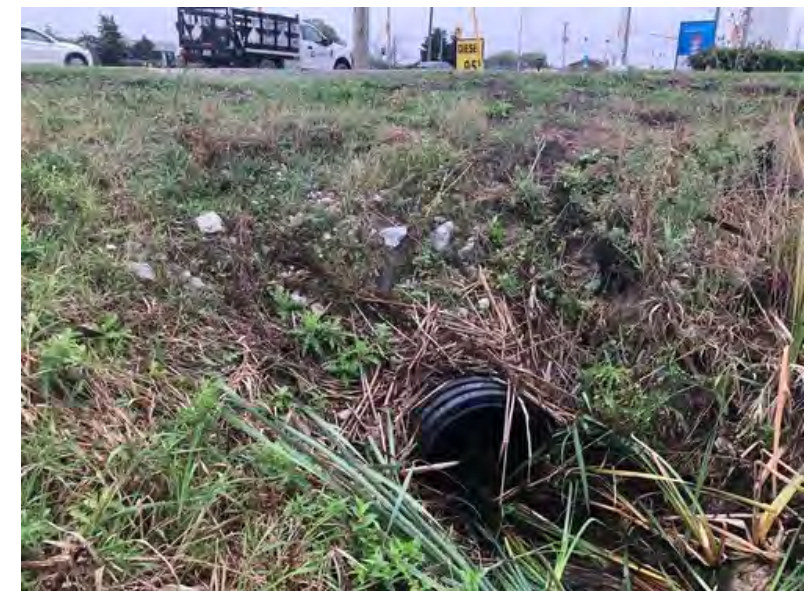
6. Culvert C1 (Inlet)

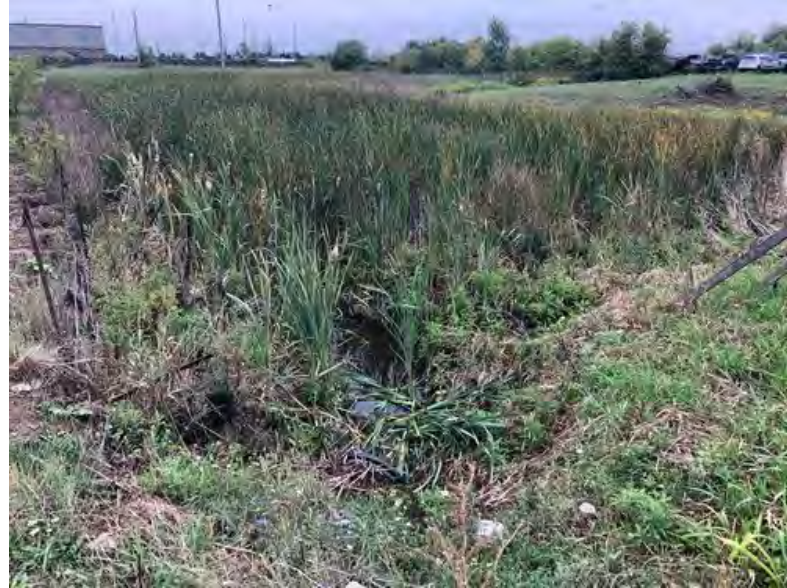
7. Culvert C1 (Inlet)

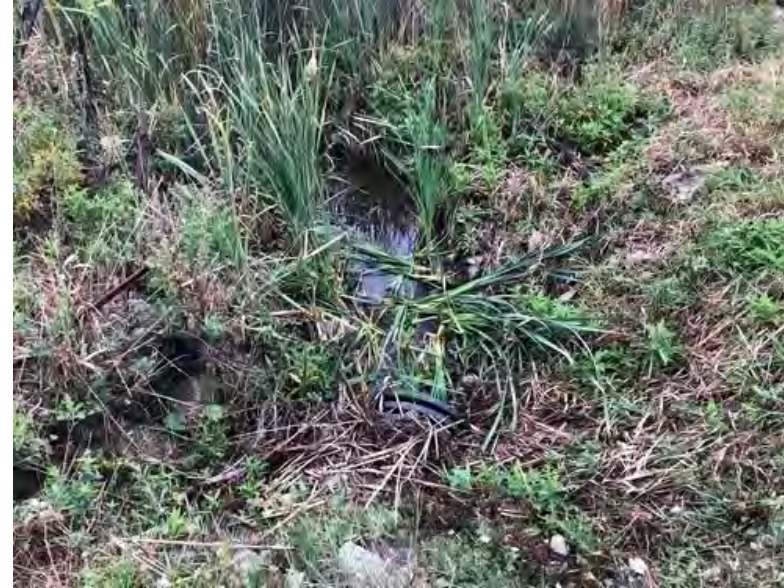
8. Culvert C1 (Inlet)

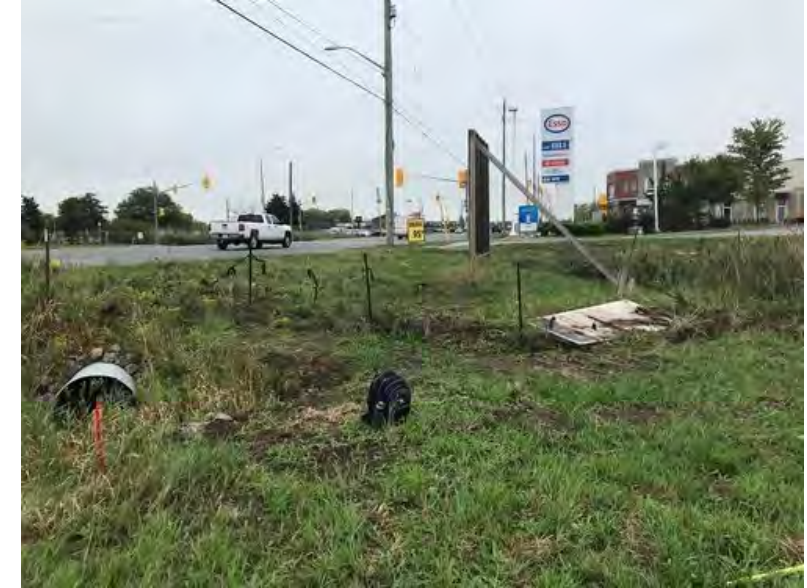
9. Culvert C1a (Inlet)

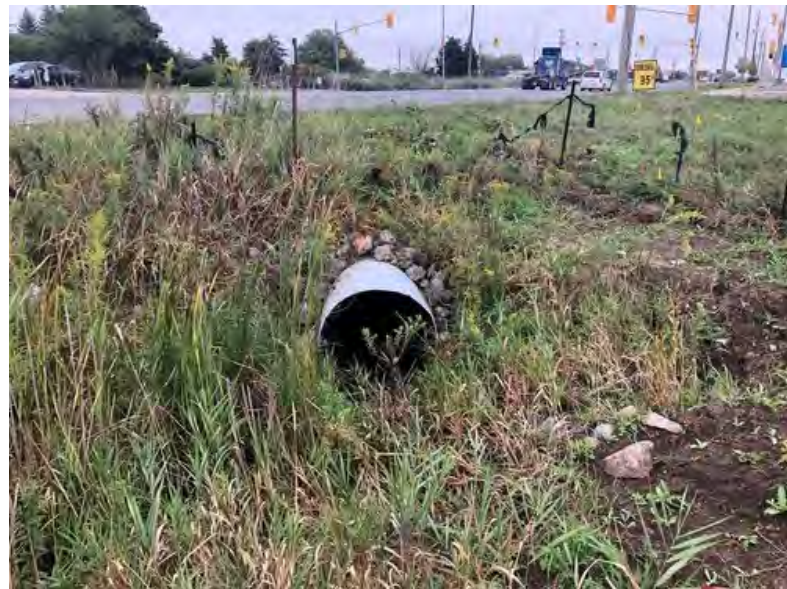
10. Culvert C1a (Inlet)

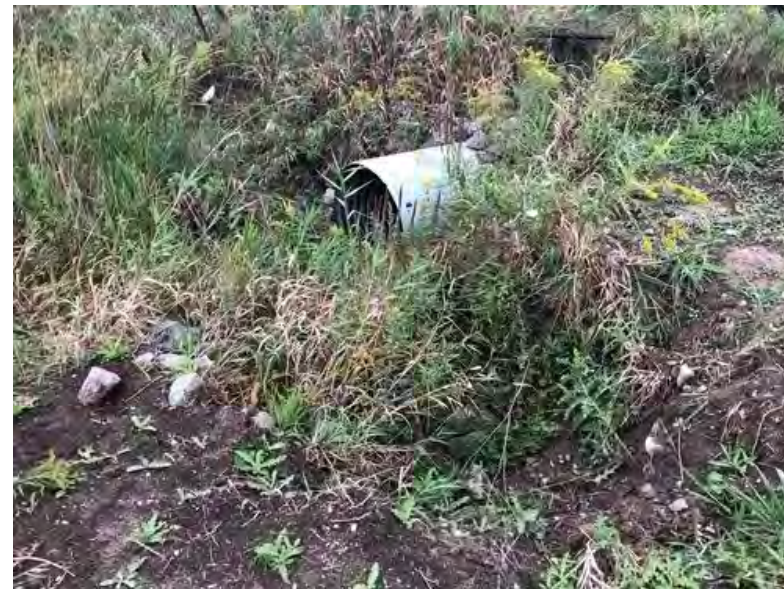
11. Culvert C1a (Inlet)

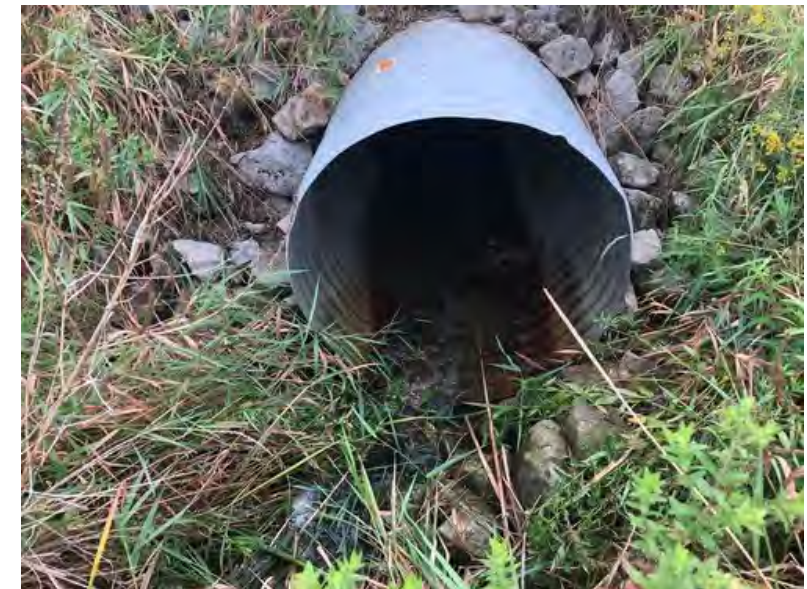
12. Culvert C1a (Inlet)
