Appendix O

Structural Memo

Region of Halton

For the Bridge on Winston Churchill Blvd
 Located 2.70 km North of Steeles Avenue
 Structure No. 19-1196390 BR01

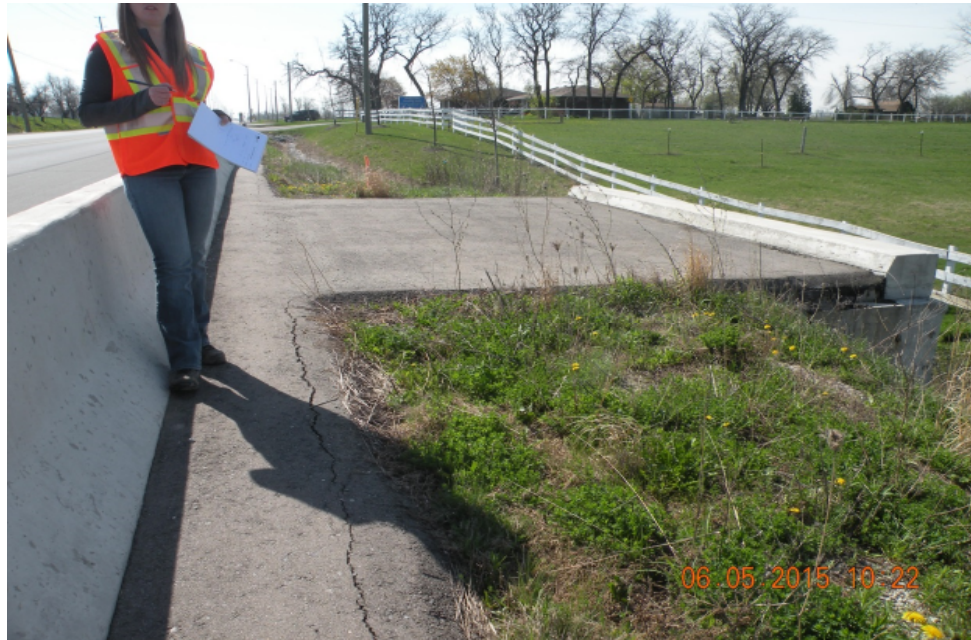
Extension on West Side
